Metallurgical Analysis of Rim Cracking in an LP Steam Turbine Disc

NP-1532
Research Project 1398-1

Final Report, September 1980
Work Completed, February 1980

SOUTHWEST RESEARCH INSTITUTE
P.O. Drawer 28510
6220 Culebra Road
San Antonio, Texas 78284

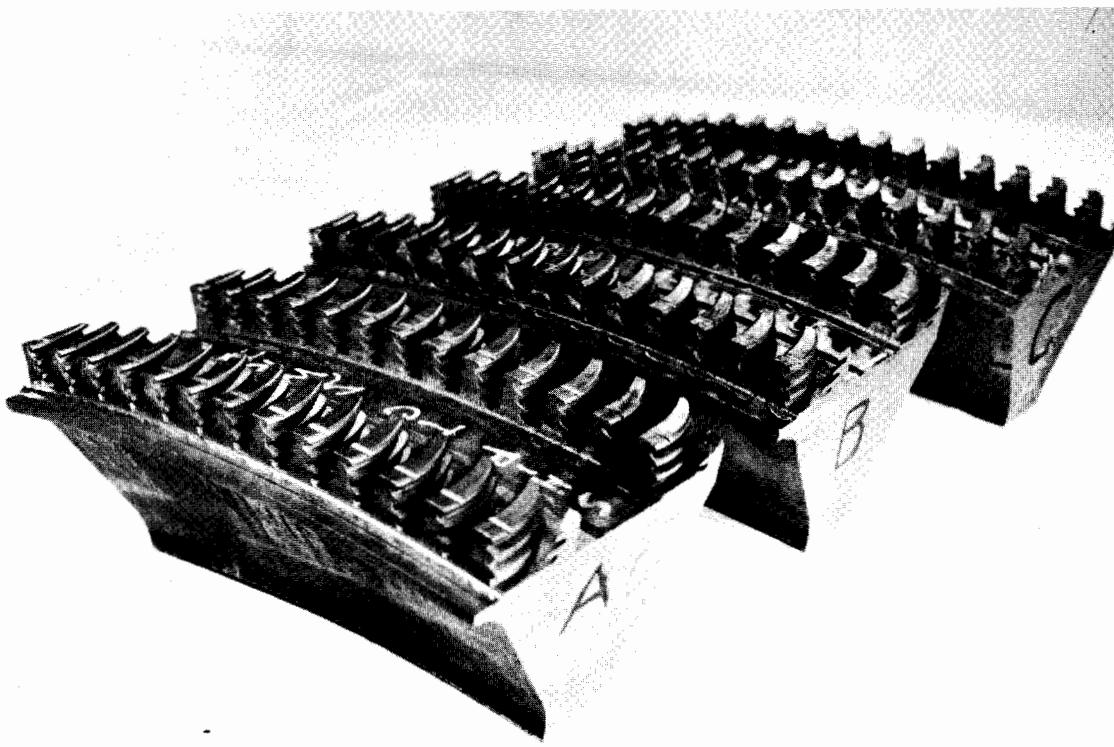
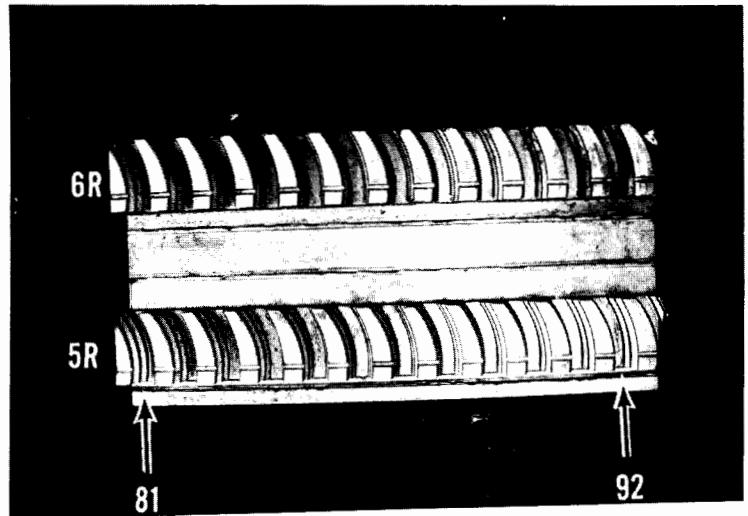
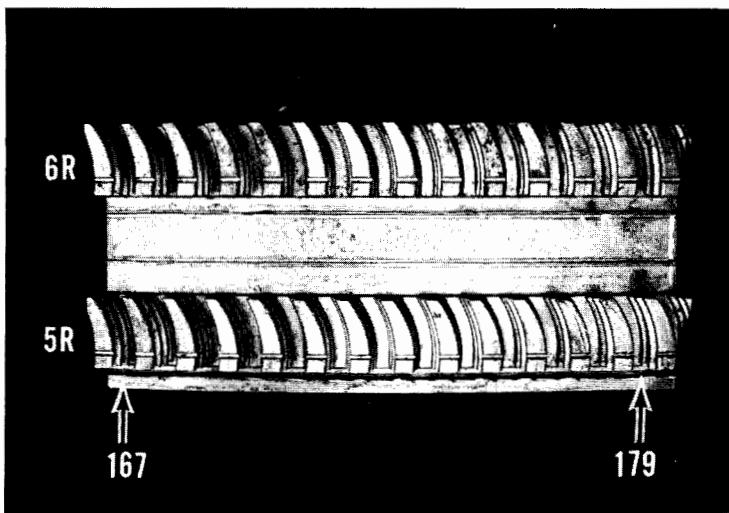
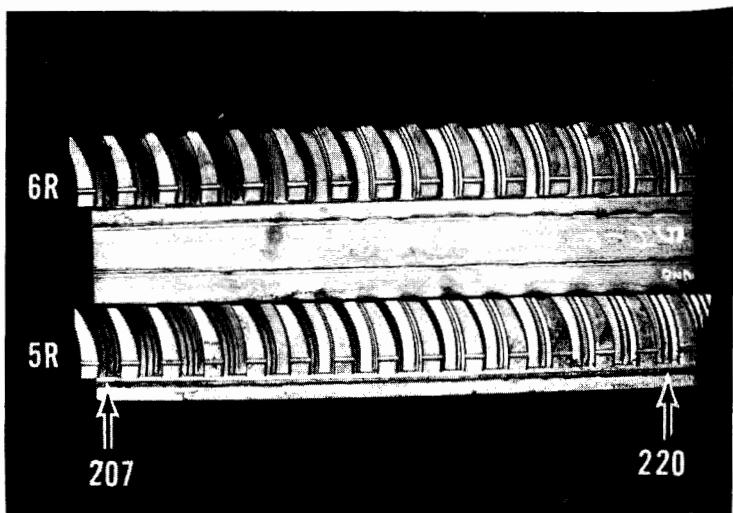
The three specimens furnished for the Task I investigation are shown in Figure 1-2. These rim segments, arbitrarily designated as A, B and C, were cut from the third disc of the generator end of the LP-2 rotor. Each sample contained 12-14 blade grooves from the 5R and 6R rows.

FIGURE 1-2. DISC RIM SAMPLES. Rows 5R and 6R, Disc No. 3,
Generator end. See Appx. A for sample locations.

FIGURE 1-2 (Cont.). DISC RIM SAMPLES. Rows 5R and 6R, Disc No. 3, Generator end. Inlet face is at bottom. Arrows indicate numbered blade positions. See Appx. A for sample locations.

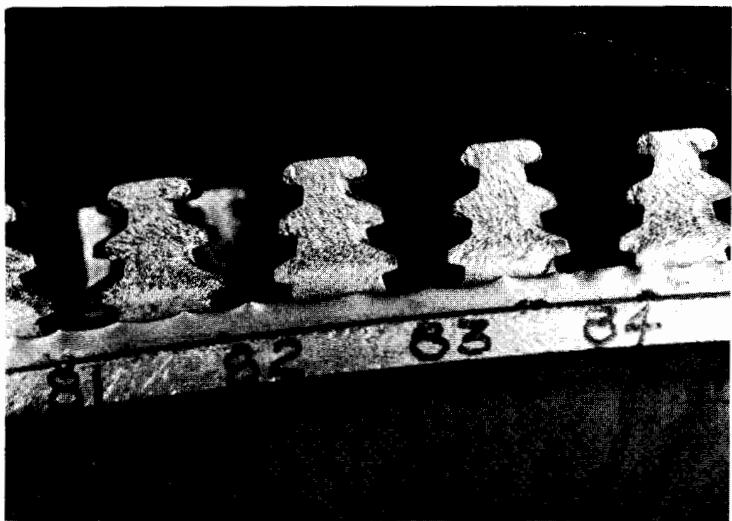
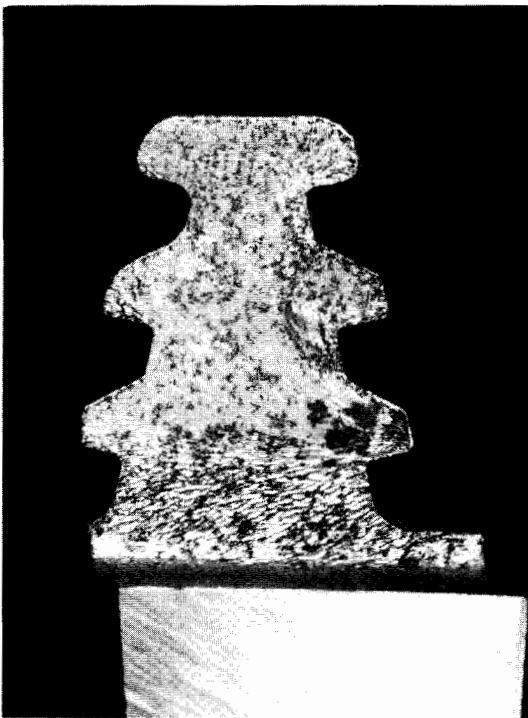
The disc rim samples had been abrasive blast cleaned prior to shipment to SwRI. Upon receipt, all three of the samples presented a clean metallic appearance all over and there was no evidence of any significant rusting or other damage which might have occurred after the abrasive blast cleaning. On the initial visual inspection of the disc rim samples, significant erosion damage was noted on the inlet face of all steeples in both the 5R and 6R rows. Examples of this in-service damage are shown in Figure 2-1.

(a) Row 5R, at Blades No. 81 through No. 85.

2X
(b) Steeple 210/211, Row 6R.

FIGURE 2-1. EROSION DAMAGE ON INLET FACE OF STEEPLES.

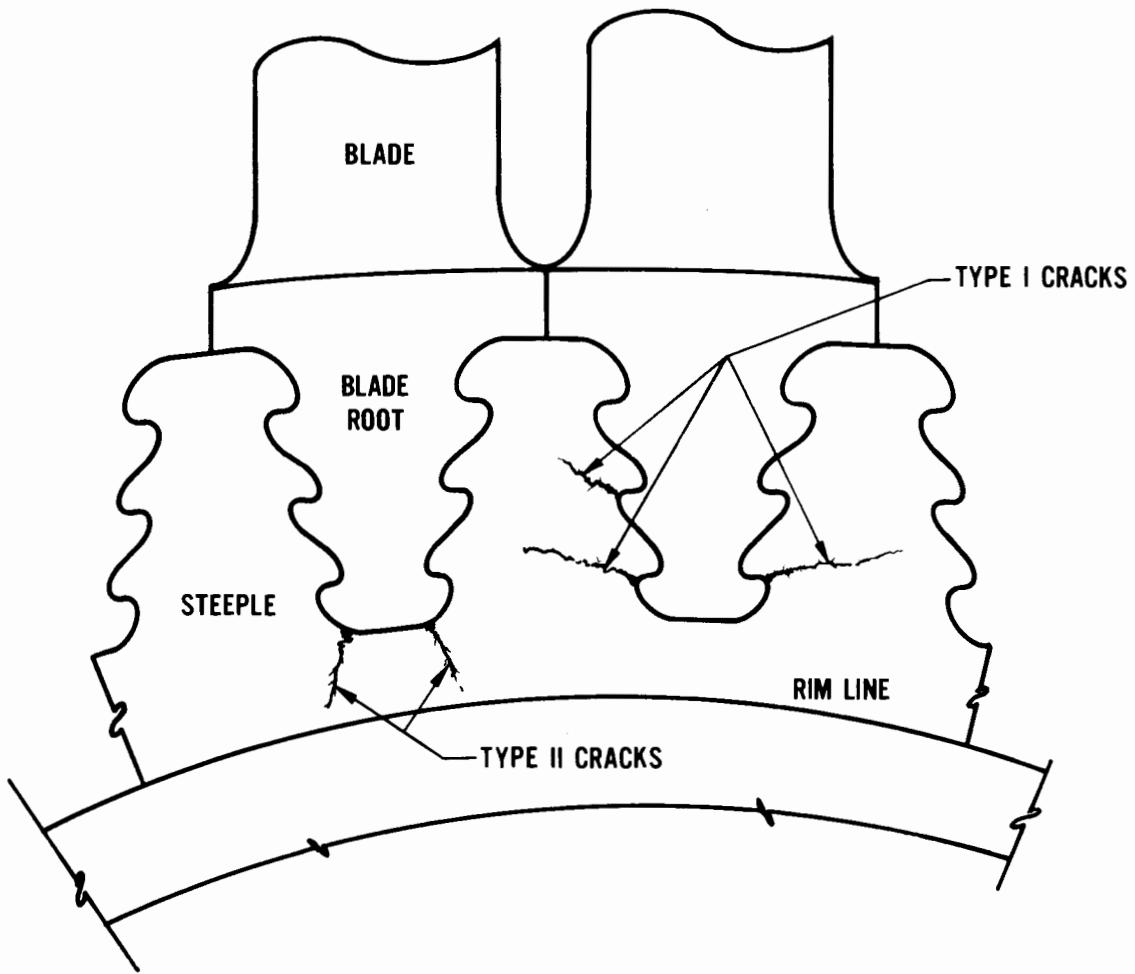
FIGURE 2-3. SCHEMATIC DIAGRAM OF RIM CRACKING.

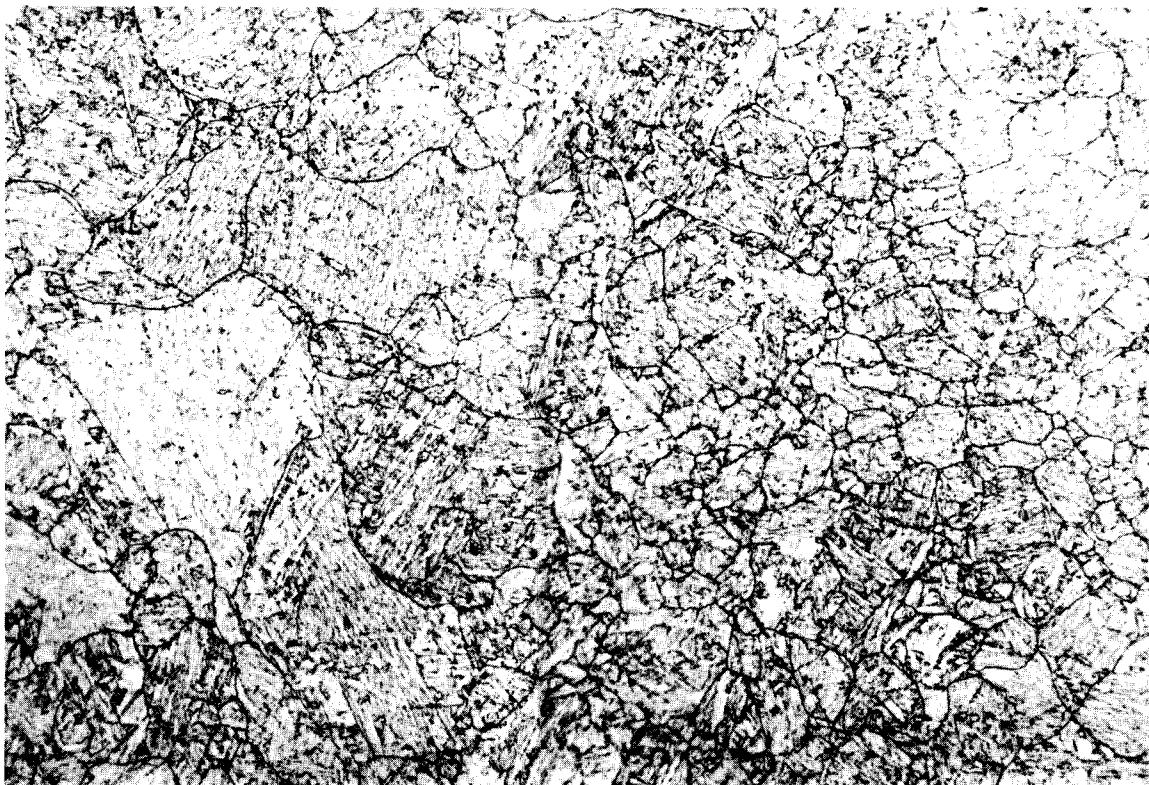
Selected specimens were also examined after etching with a grain boundary etching reagent*. In each case, the grain boundaries were clearly delineated as shown in Figure 4-1(c). A distinct variation in grain size was noted among the various specimens. In each case, zones of a relatively large grain size were noted at random locations throughout a matrix of generally smaller grains. Grain size measurements were made at representative locations in each specimen in accordance with ASTM E 112 (intercept procedure). These measurements established that the duplex microstructure of the disc material is characterized by grain sizes in two categories: ASTM 6-7 and ASTM 4-5.

FIGURE 4-1. TYPICAL MICROSTRUCTURE OF DISC MATERIAL.

(c) Etchant: Picric acid & wetting agent.
Note duplex structure. Grain size
ASTM 6-7 and ASTM 4-5. 300X

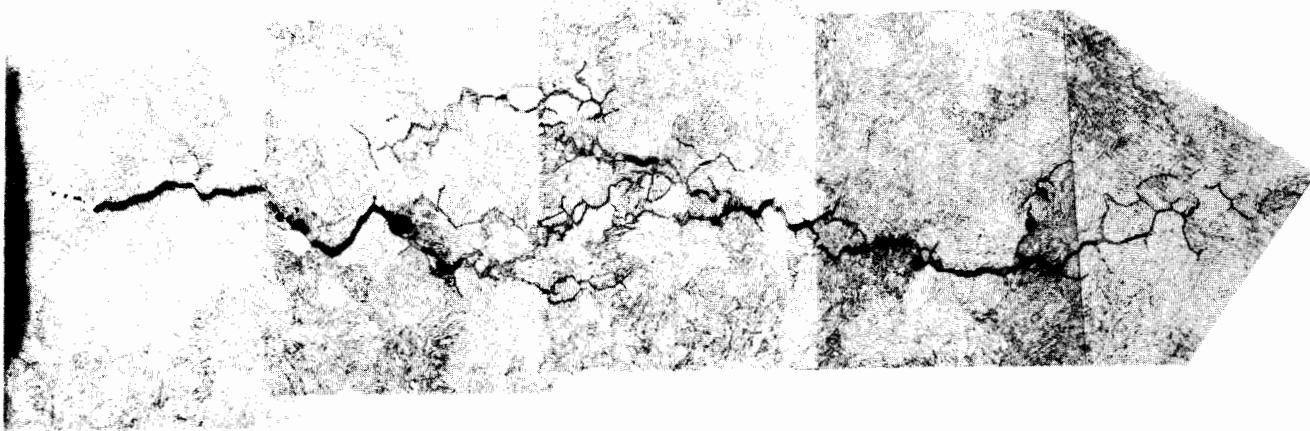
FIGURE 4-6. MICROSTRUCTURE AT CRACK 176-I-2b, ROW 5R.
Section at inlet face. Etchant: Nital.
150X

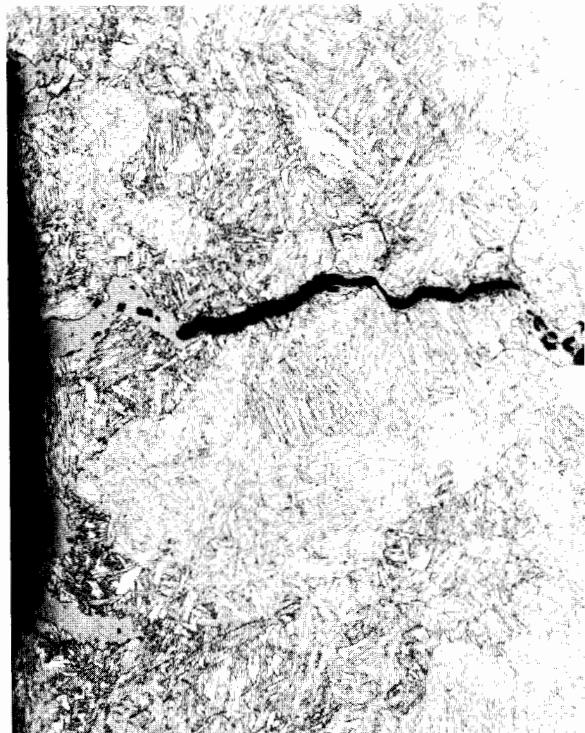
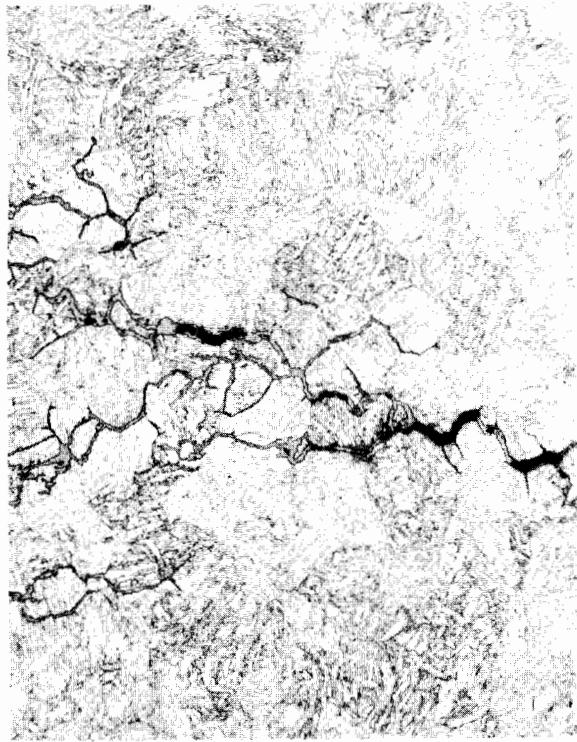
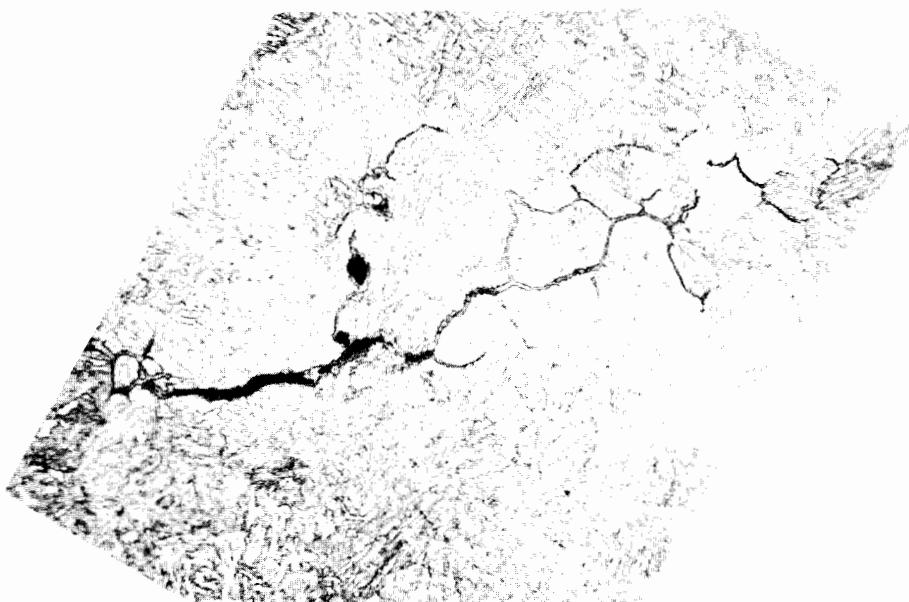
The general configuration of the Type I cracks is illustrated in Figures 4-4 and 4-5. In each case, the cracks are located within the radius on the load bearing side of the serrations and exhibit an irregular path with substantial branching. The microstructural features of each of the Type I cracks examined were similar. The cracks were completely intergranular and exhibited regions with extensive branching or network cracking. The typical microstructural features of the Type I cracks are illustrated by the micrographs of crack 176-I-2b shown in Figures 4-6 and 4-7. In each of the metallographic sections examined the cracks contained a deposit material, particularly within the narrow tight portions near the ends of the cracks. Also, all cracks were nearly filled with this deposit material at the point of intersection with the surface. Other examples of Type I cracks from both the inlet and outlet faces of the 5R and 6R rows are shown in Appendix D, Figures D-1 through D-3.

FIGURE 4-7. SEGMENTS OF CRACK 176-I-2b. See Figures 4-4(b) and 4-6.
Etchant: Nital. 300X

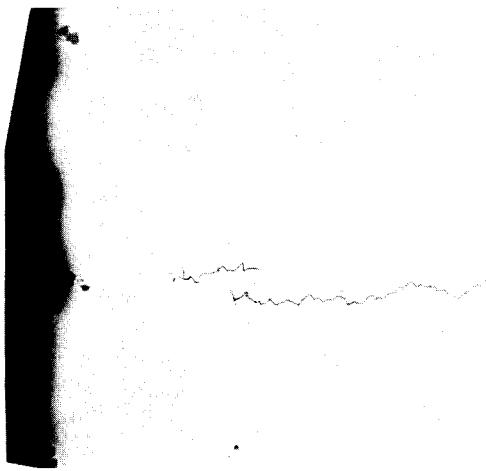
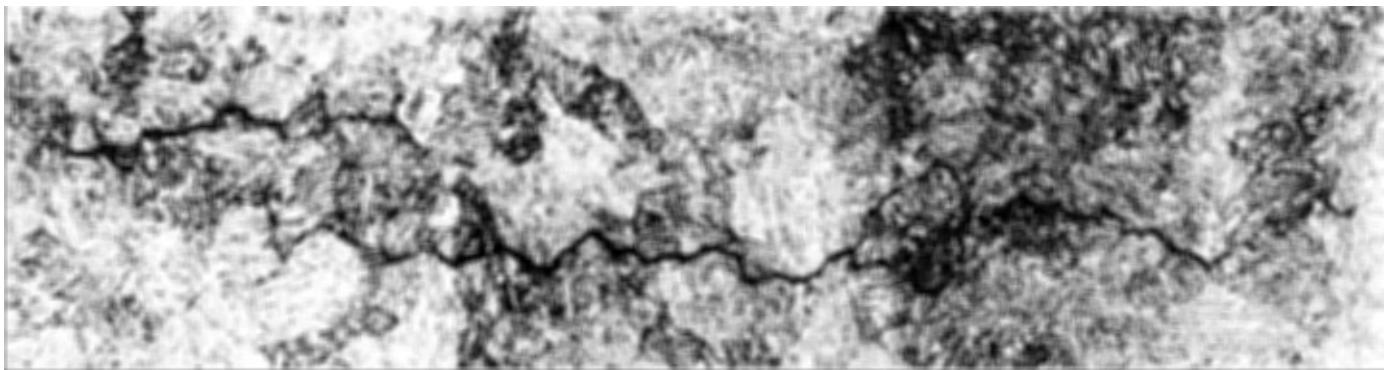
The Type I crack at the outermost serration in steeple 210/211 (Crack 211-I-3c) was isolated from the groove surfaces at the outlet face as shown in Figure 4-8. This defect consisted of a very tight, completely intergranular crack at the outlet face and was completely filled with oxide. In subsequent, sequential metallographic sections the crack decreased in size and was finally completely ground away without exhibiting any connection to the groove surface. These observations indicate that this particular crack initiated on the outlet face of the steeple independent of the blade groove surface.

FIGURE 4-8. CRACK 211-I-3c, ROW 6R. Section at outlet face.
See Figure 4-3. Etchant: Nital.

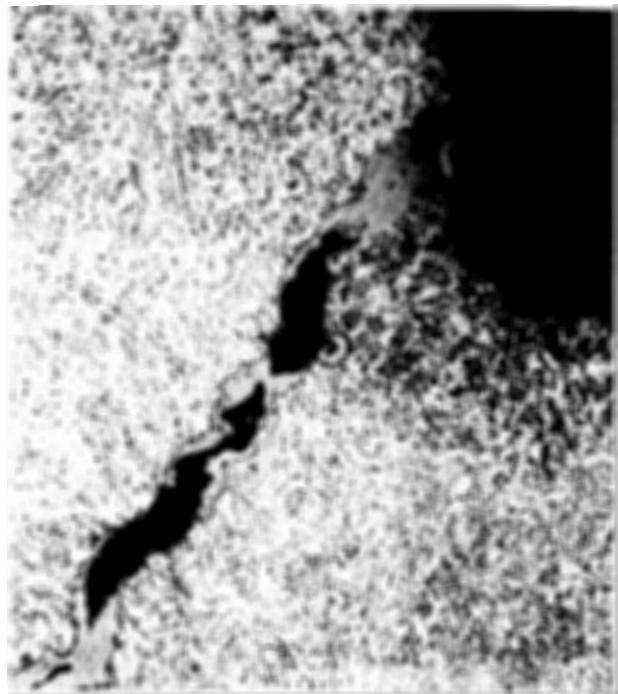
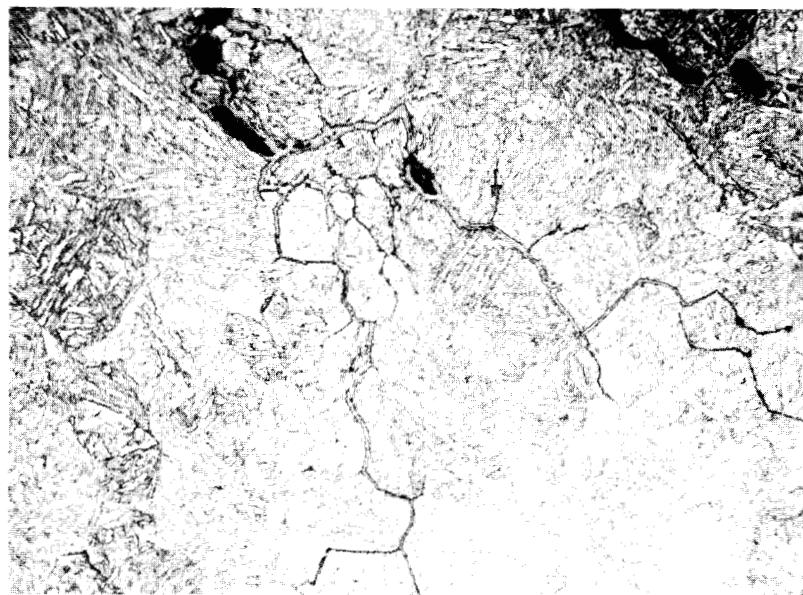
The overall configuration of the Type II crack in steeple 210/211, [crack 210-II(d)], is shown in Figure 4-9. At the outlet face, this particular crack is comprised of several disconnected segments. The microstructural features at this crack location are shown in Figure 4-10. The initial segment, originating from the groove surface, is relatively straight with some branching evident at the very end of the segment. The material in the immediate vicinity of this straight segment of the crack exhibits an ill-defined, atypical microstructure, see Figure 4-10(a). The nature of the microstructure at this particular location precludes classification of this portion of the cracking as either transgranular or intergranular. The other crack

FIGURE 4-10. SEGMENTS OF CRACK 210-II(d).
Etchant: Nital. 300X

segments observed at the outlet face each exhibit irregular crack paths with significant branching and are clearly intergranular, see Figure 4-10(b). Examination of sequential metallographic sections through crack 210-II(d) established that the separate segments observed at the outlet face were actually connected to the groove surface a short distance beyond the outlet face. At a short distance from the outlet face two overlapping cracks existed in the groove. In each of the sequential sections, all segments of the crack were observed to be completely intergranular including that portion in the immediate vicinity of the groove surface. It was also noted that, at positions beyond the outlet face, the microstructure is comparable to the typical microstructure of the disc material indicating that the zone of atypical microstructure observed at the outlet face represents a highly localized condition. Photomicrographs from the sequential sections are shown in Appendix D, Figure D-4.

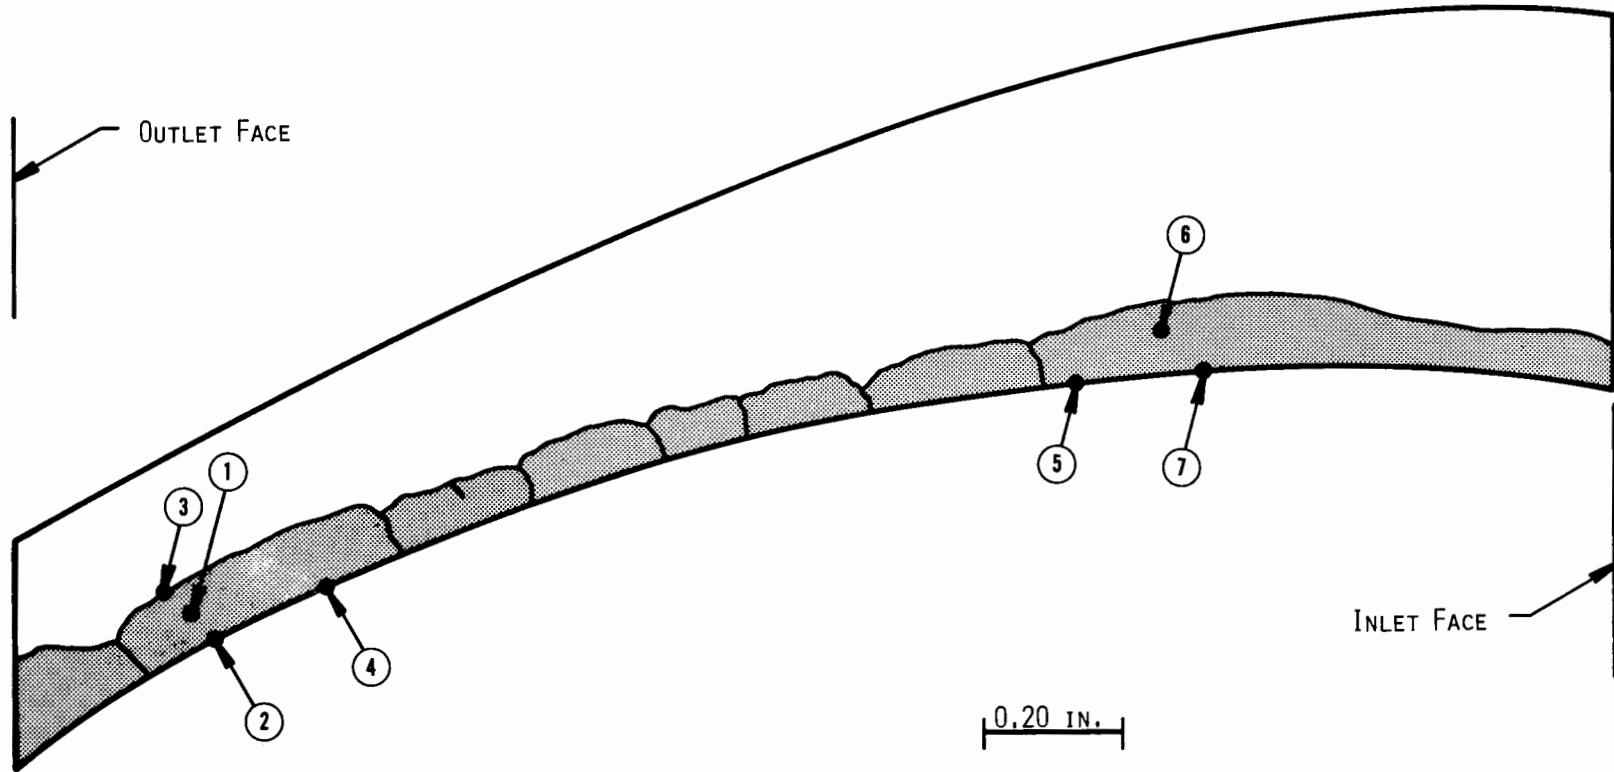
FIGURE 5-3. DIAGRAM OF SURFACE OF CRACK 213-I-2bd, ROW 6R.
Outline represents full cross section of steeple
at crack location. See Figure 5-2. 4X

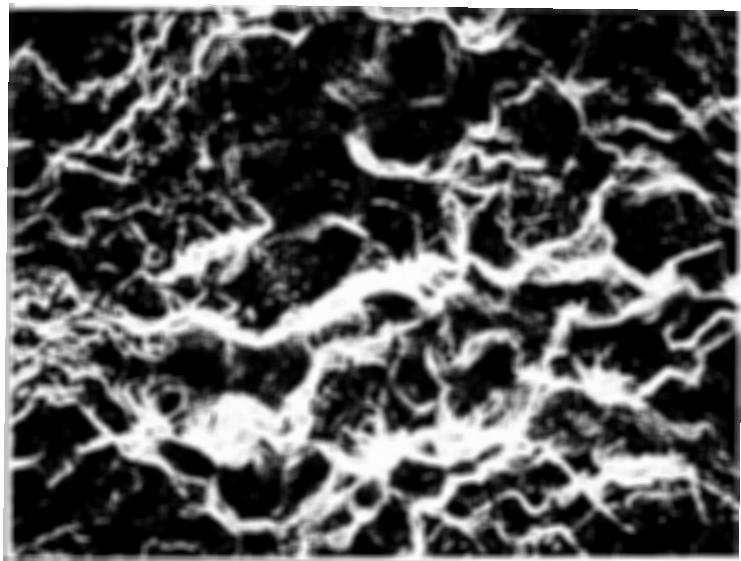
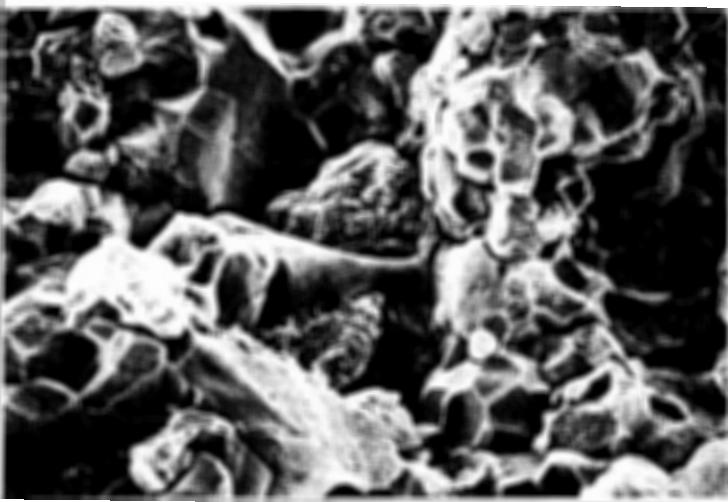
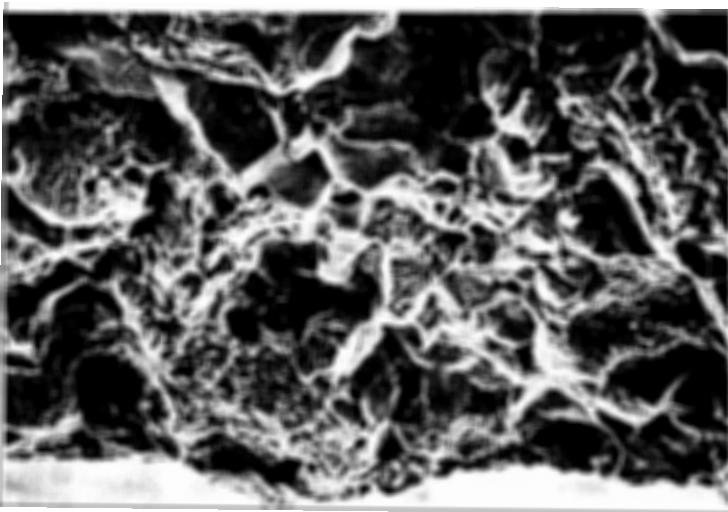
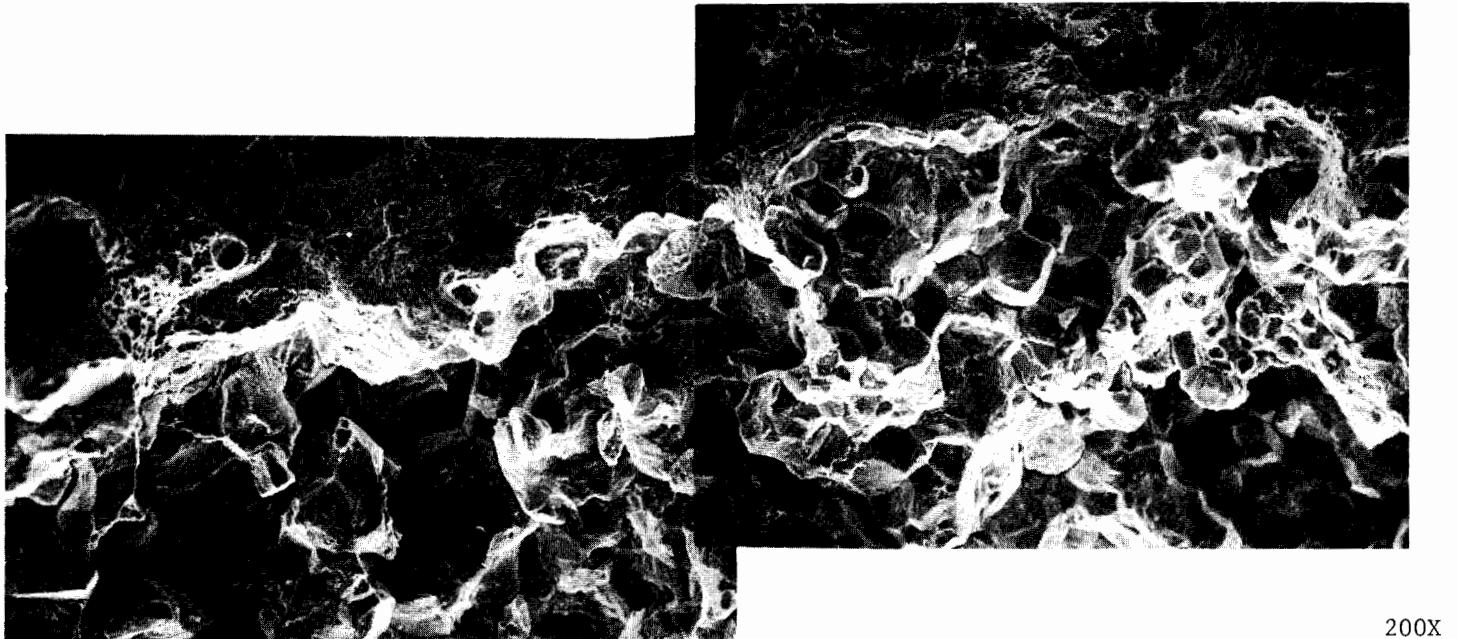
FIGURE 5-4. SEM FRACTOGRAPHS FROM CRACK 213-I-2bd,
ROW 6R. See Figure 5-3 for locations.
Cathodically cleaned unless otherwise
noted.

(d) Location 3. At transition to laboratory fracture. No cleaning.

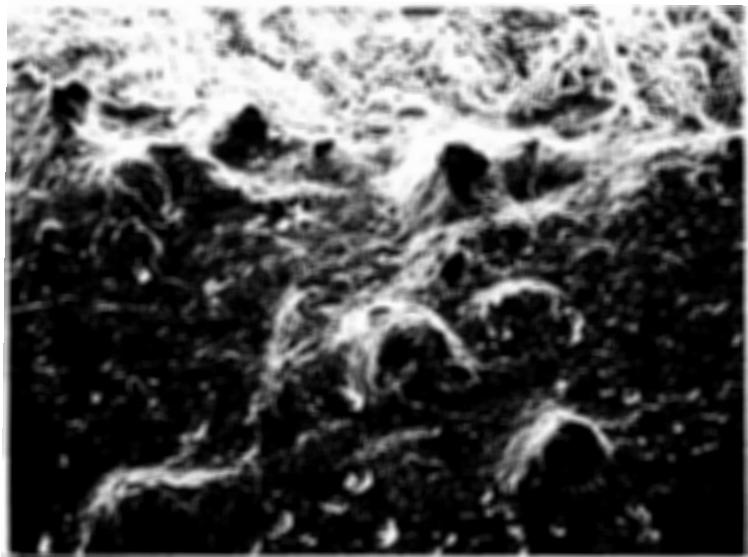
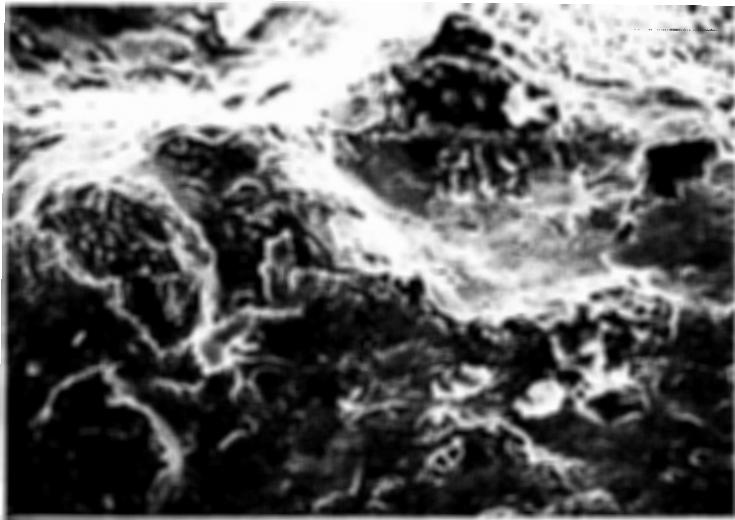
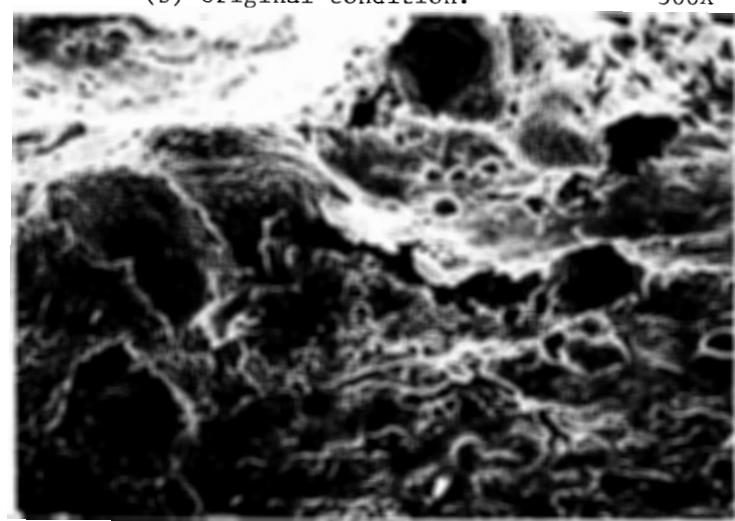
Significant pitting of the steeple surface was also observed at locations adjacent to the crack. Examples of this corrosive attack are shown in Figure 5-5.

FIGURE 5-5 GROOVE SURFACE ADJACENT TO CRACK
213-I-2bd.

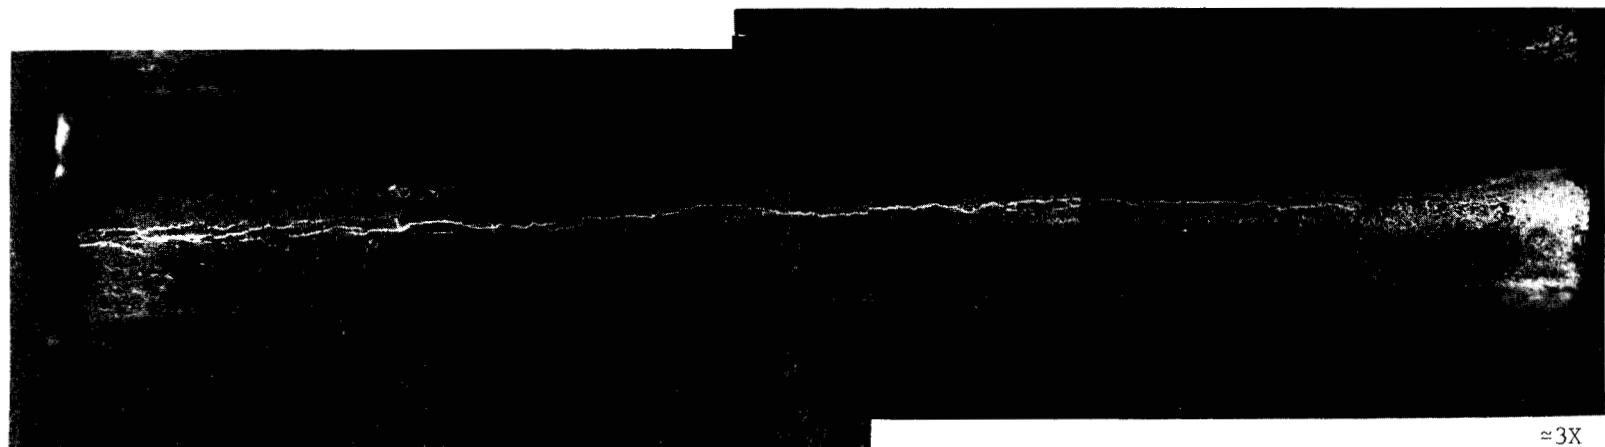
A second Type I crack of extended length, crack 208-I-2bd, Row 6R, is shown in Figures 5-6 and 5-7. This crack is generally similar to 213-I-2bd, but is not as extensive. As may be noted in Figure 5-7, the total crack surface is comprised of at least sixteen separate segments indicating initiation of at least sixteen independent cracks, each of which grew fairly uniformly to the point of joining to form a single crack front. Typical crack depth over the length of crack 208-I-2d was measured as 0.04 to 0.06 inch (1.0-1.5 mm). The crack surface comprises approximately 15% of the total cross sectional area of the steeple at the second serration. The crack is predominantly intergranular but a significant degree of transgranular fracture was noted in areas representing the later stages of crack propagation. Isolated transgranular facets within an otherwise intergranular zone were also noted. The zone at the edge of the crack surface, representing cracking initiation and early stages of propagation, is completely intergranular. Evidence of post-cracking corrosive attack of the crack surfaces is also apparent. A diagram of crack 208-I-2bd and SEM fractographs illustrating these features are shown in Appendix E, Figures E-3, E-4 and E-5.

FIGURE 5-6. MAGNETIC PARTICLE CRACK INDICATIONS, STEEPLE 208/209, ROW 6R.

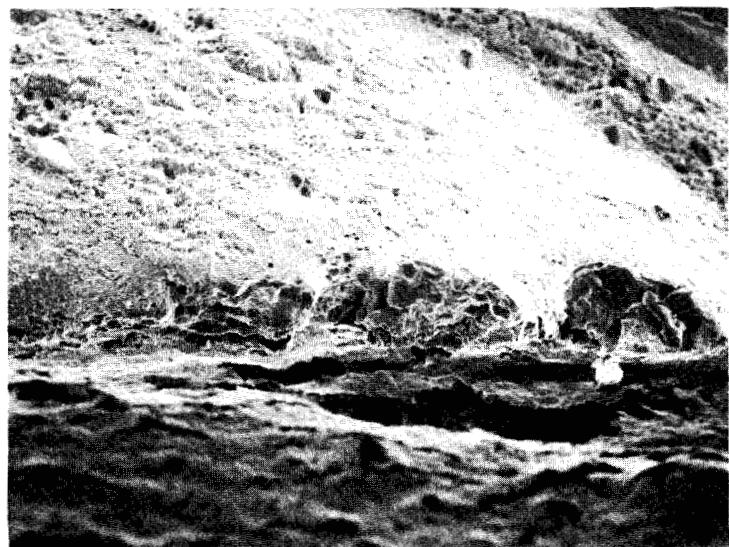
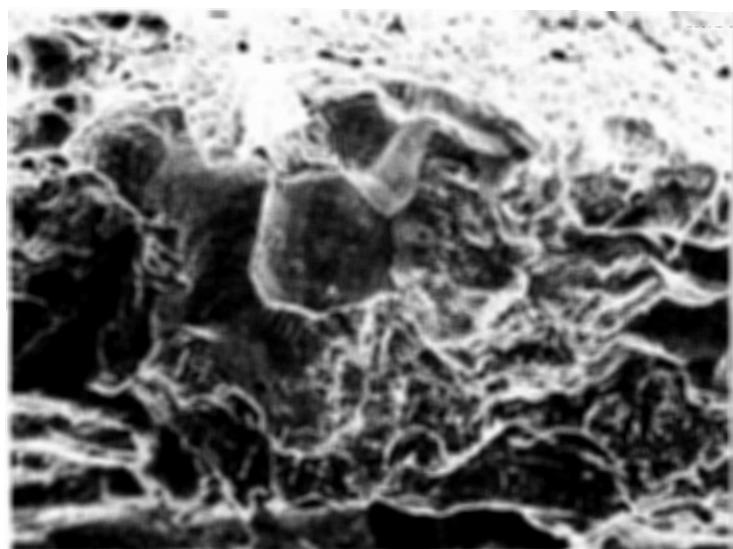
FIGURE 5-8. SEM FRACTOGRAPHS FROM CRACK 208-I-2bd.
Location near inlet face. Note separate
thumbnail segments in surface and
additional partially opened cracks.

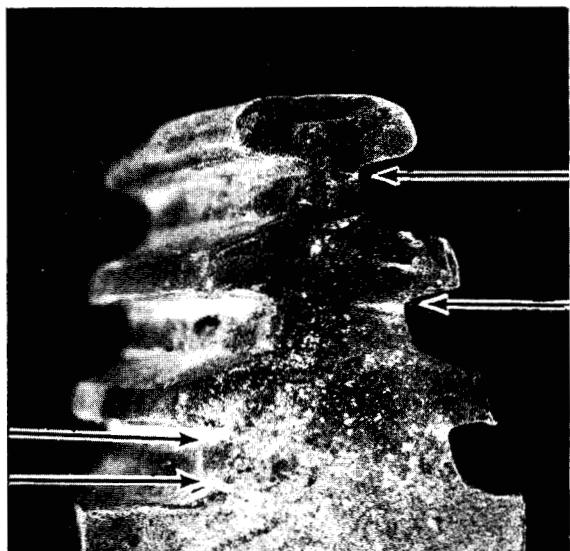
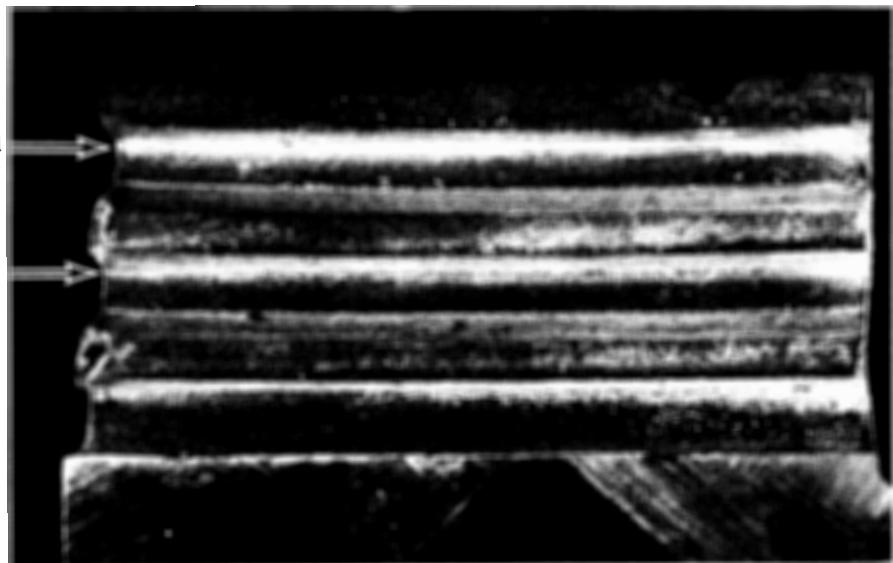
FIGURE 5-9. MAGNETIC PARTICLE INDICATIONS, STEEPLE 207/208, ROW 6R. $\approx 2X$

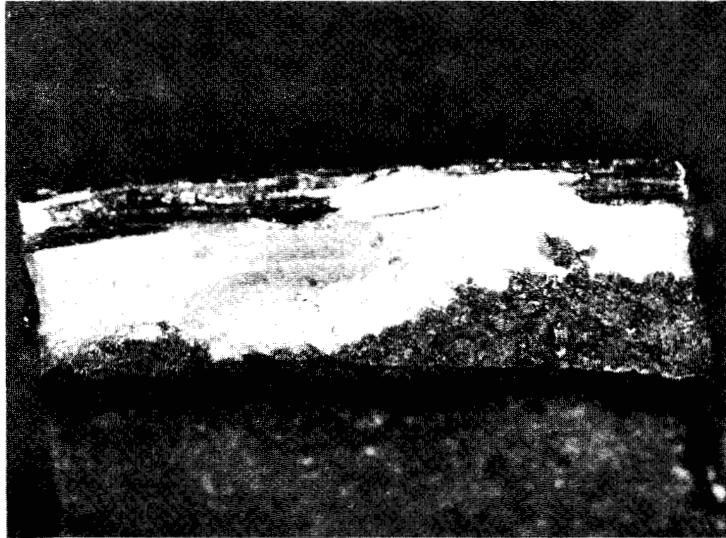
The magnetic particle crack indication and the exposed surfaces of crack 177-I-2b are shown in Figure 5-12. This particular crack was located at the inlet face of Steeple 176/177 in Row 5R. The crack was observed to be comprised of two distinct major segments. The principal segment of the crack (located at the inlet face) measures approximately 0.28 inch (7.1 mm) along the groove surface and approximately 0.08 inch (2.0 mm) on the inlet face. This segment is bounded by curved

(a) Magnetic particle indications. Concave side of steeple 176/177. Inlet side is at right.

(b) Exposed crack surface. View inward. Inlet side is at right.

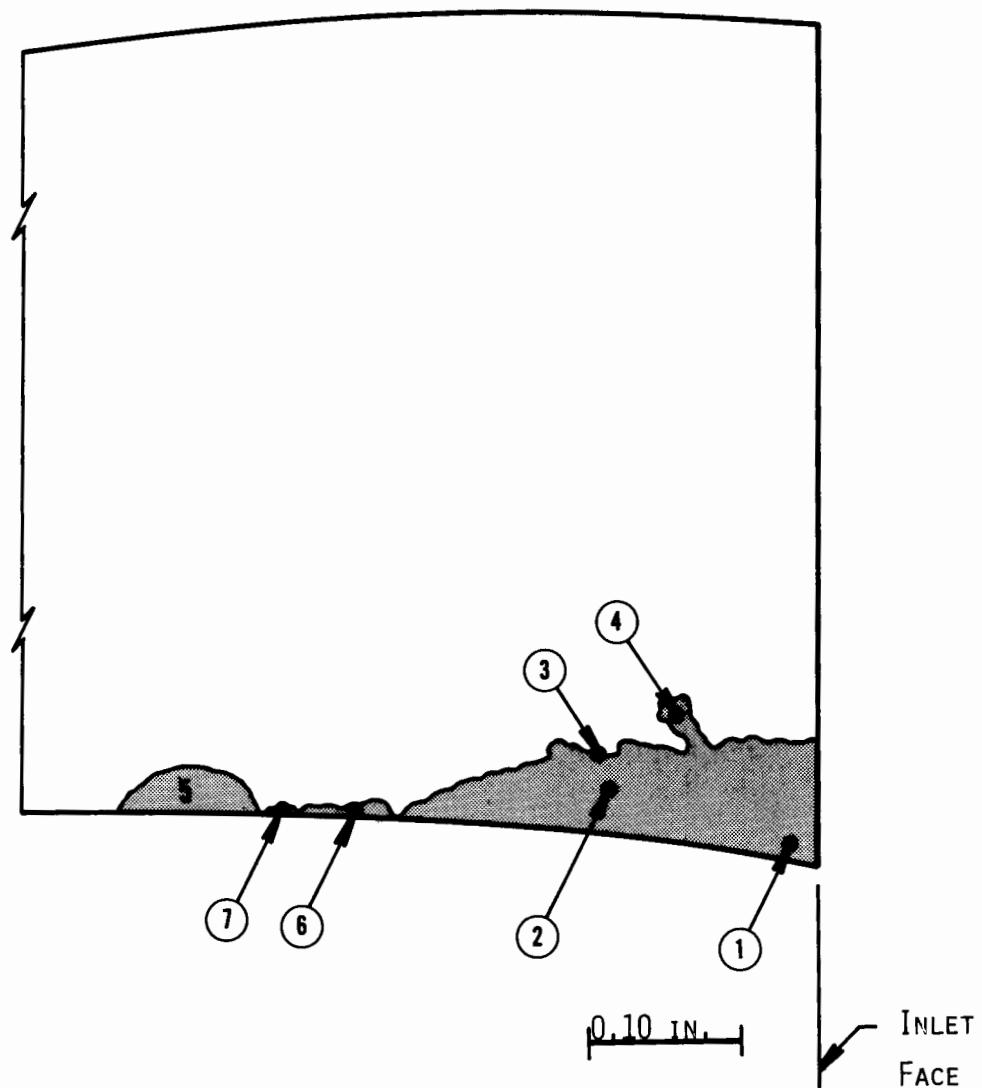
A diagram of crack 177-I-2b illustrating the size of the crack relative to the cross-section of the steeple is shown in Figure 5-13 and the typical fine-scale topographic features of this crack are shown in Figure 5-14. As may be noted, this particular crack was relatively limited in extent and confined to an area near the inlet face of the steeple. The larger segment measures 0.28 inch (7.1 mm) along the groove with a maximum depth of 0.08 inch (2.0 mm). The crack surface represents only approximately 1% of the cross-sectional area. All areas of the two major segments of the crack surface were characterized by a predominance of distinct intergranular facets as illustrated in Figure 5-14. In particular, it should be noted that distinct intergranular facets were evident at the extremities of crack propagation, see Figure 5-14(c). A few isolated transgranular facets were noted at random locations, Figure 5-14(a). Locations within the two principal segments of this crack exhibited evidence of significant corrosive attack of the crack surface. This attack is particularly evident at locations near the groove surfaces representing the earlier stages of crack propagation, see Figures 5-14(d) and 5-14(f). Significant pitting attack of the blade groove surface was also evident in the general vicinity of crack 177-I-2b. Locations between the two major segments of this particular crack exhibit significant corrosive attack at the groove surface and a very limited degree of intergranular cracking. Additional examples of the fine-scale topographic features of crack 177-I-2b are shown in Figure E-8.

FIGURE 5-13. DIAGRAM OF SURFACE OF CRACK 177-I-2b, ROW 5R.
Outline represents cross section of steeple
at crack location. 8X

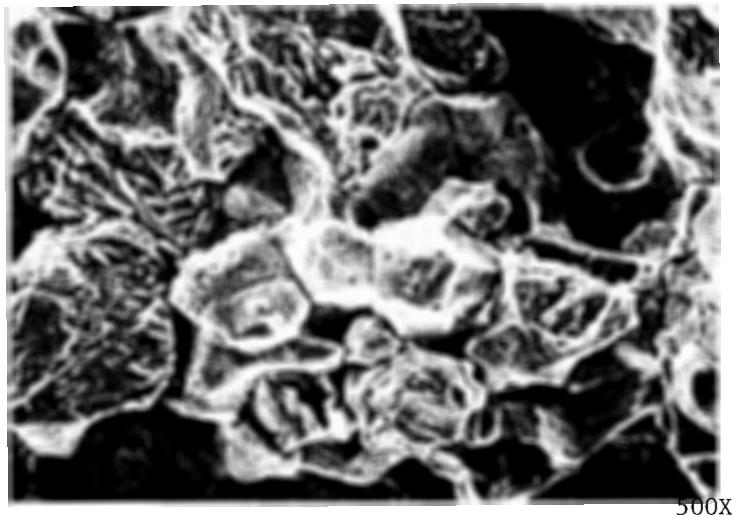
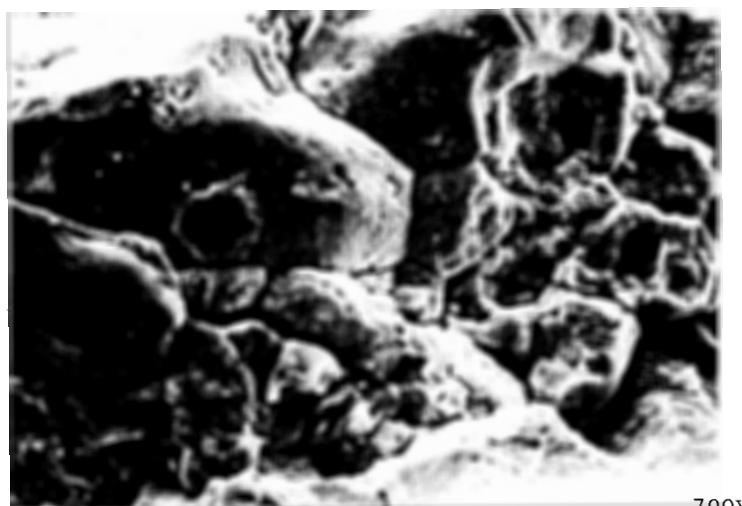
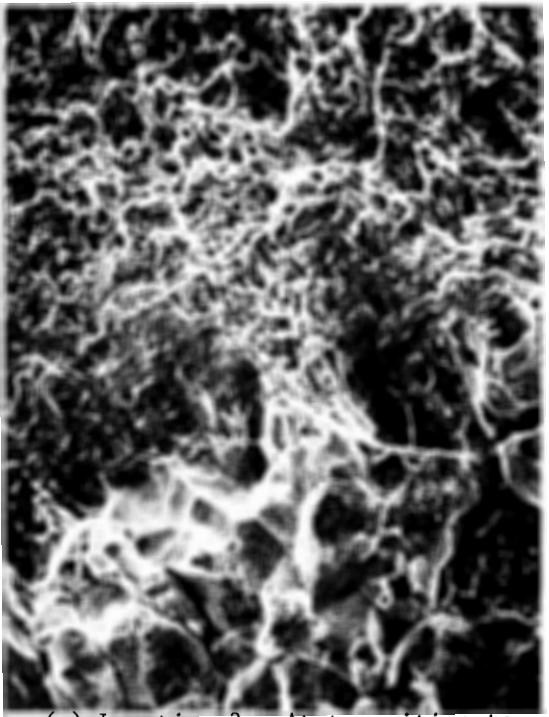
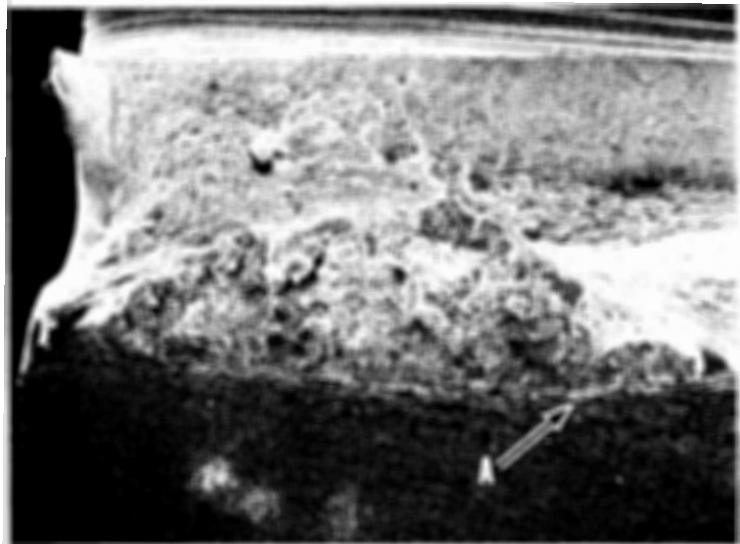
(c) Location 3. At transition to laboratory fracture.

FIGURE 5-14. SEM FRACTOGRAPHS FROM CRACK 177-I-2b.
See Figure 5-13 for locations.

(d) Area 5. Note smaller thumbnail segment at lower right.

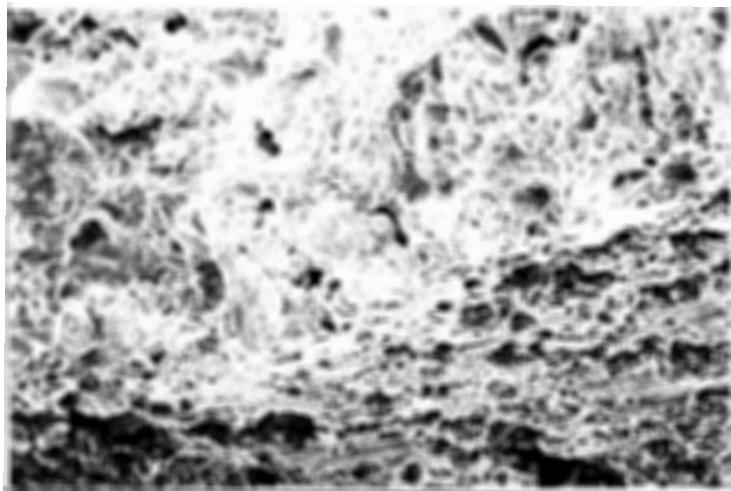
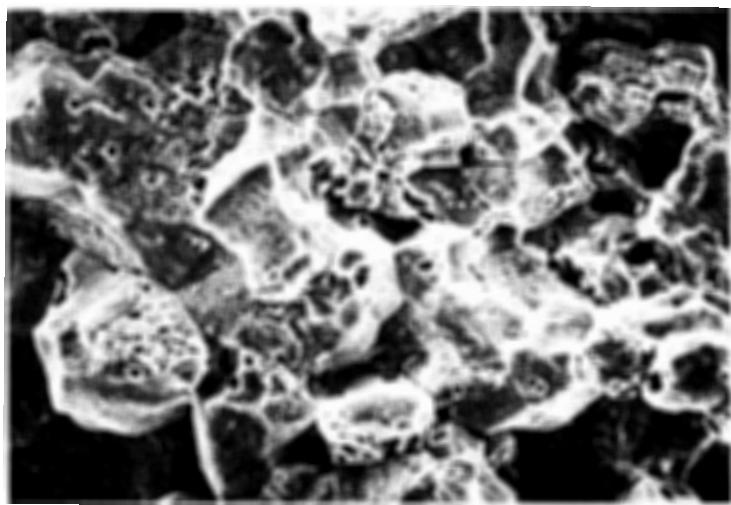
(e) Location 5-A in (d).

(f) Typical topography in Area 5.

FIGURE 5-14 (Continued). SEM FRACTOGRAPHS FROM CRACK 177-I-2b. See Figure 5-13 for locations.

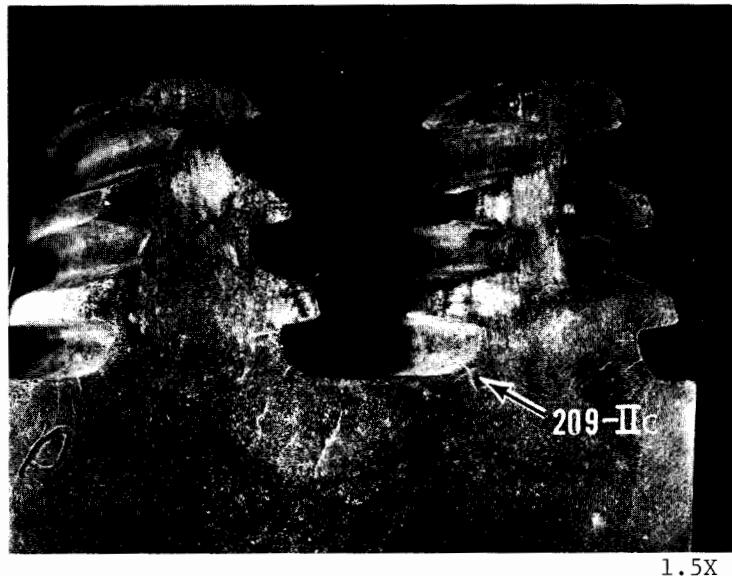
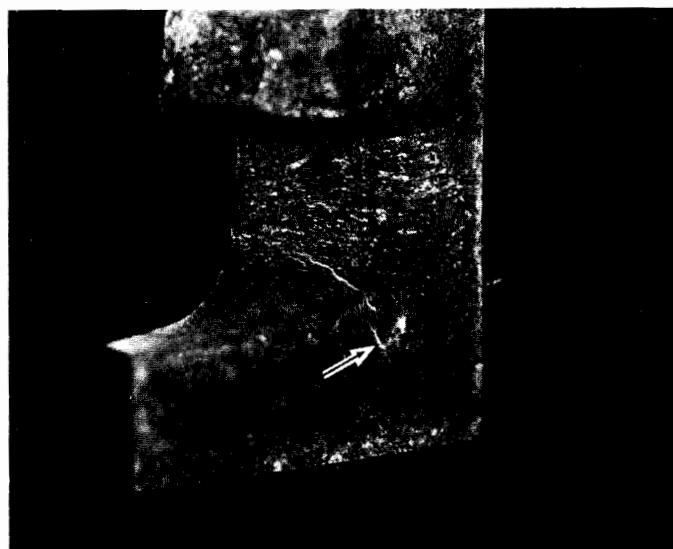
The characteristics of two typical Type II cracks are described in Figures 5-15 through 5-19. The magnetic particle indication of one such crack, 209-II(c) is shown in Figure 5-15. In this case, a distinct Type II crack indication was observed at the radius of the bottom of Steeple 208/209 at the outlet face. In the MP examination a separate independent crack segment, disconnected from the Type II crack indication, was observed on the outlet face. When this particular specimen was broken open, crack 209-II(c) was revealed to consist of a single crack

(a) Outlet face. Arrow indicates crack 209-II(c).

(b) Crack 209-II(c). Note separate crack indication on outlet face (small arrow).

FIGURE 5-15. MAGNETIC PARTICLE CRACK INDICATIONS IN STEEPLE 208/209, ROW 6R.
