Metallurgical Analysis of Rim Cracking in an LP Steam Turbine Disc

NP-1532
Research Project 1398-1

Final Report, September 1980
Work Completed, February 1980

SOUTHWEST RESEARCH INSTITUTE
P.O. Drawer 28510
6220 Culebra Road
San Antonio, Texas 78284

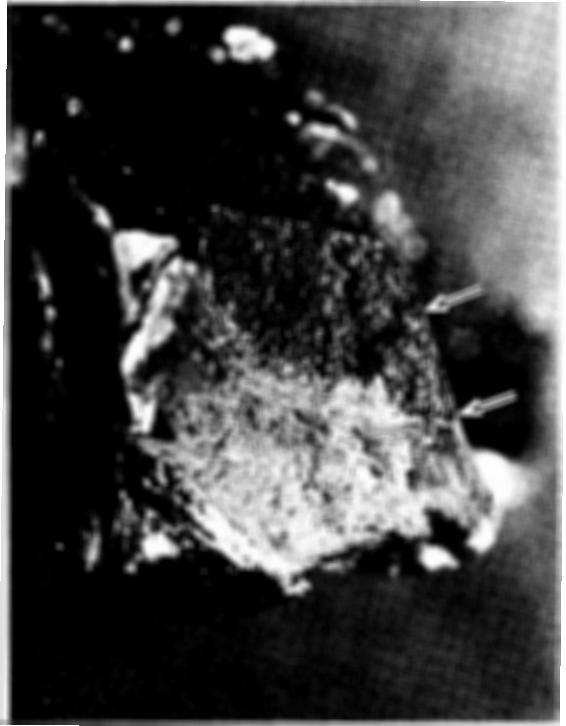
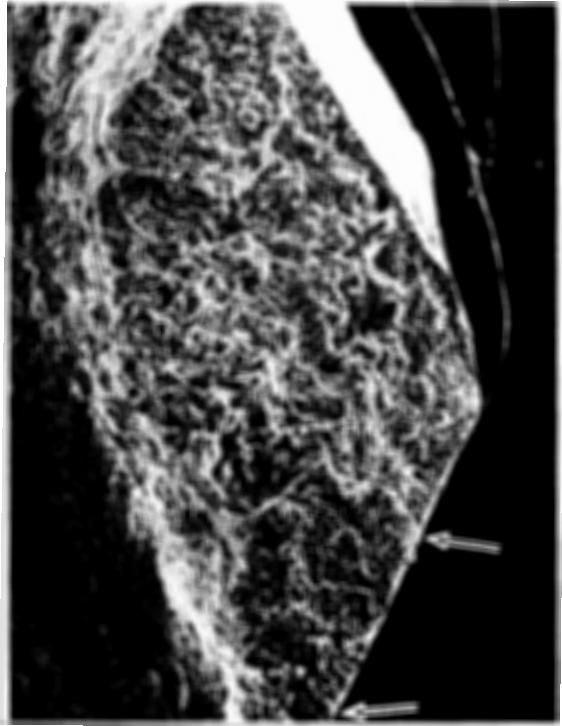
(a) Optical macrograph.
No cleaning.

(b) SEM macrograph.
Cathodically cleaned.

FIGURE 5-16. SURFACE OF CRACK 209-II(c), ROW 6R. Note separate, Type III
crack designated by arrows [209-III(c)].

segment measuring approximately 0.1 inch (2.5 mm) along the groove surface and approximately 0.06 inch (1.5 mm) deep, see Figure 5-16. A second, independent crack segment, separated from 209-II(c) by distinct step, was also evident as shown in Figure 5-16(b). The shape and location of this second segment indicate that this crack corresponds to the separate MP indication noted on the outlet face of the steeple and that it represents a face-initiated crack independent from 209-II(c). The presence of such a face-initiated crack correlates with observations in the metallographic examinations (see Figure D-6).

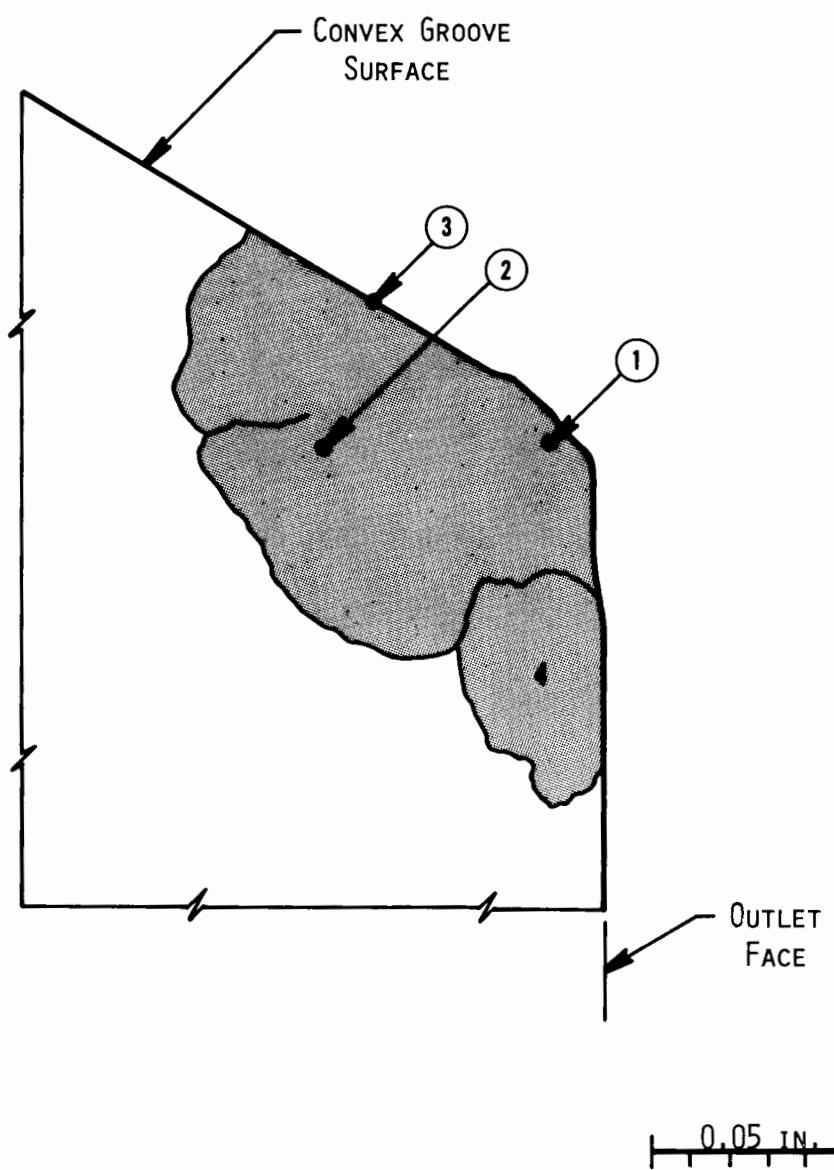
FIGURE 5-17. DIAGRAM OF SURFACE OF CRACK 209-II(c) ROW 6R. 20X

The diagram of the surface of crack 209-II(c) and representative SEM fractographs from that crack are shown in Figures 5-17, 5-18 and 5-19. Crack 209-II(c) is completely intergranular (Figure 5-18), but no features were observed to indicate a specific initiation site. Based on the shape and dimensions of the crack, it appears that this Type II crack initiated within the blade groove a short distance from the outlet face.

Examination of the topography of this exposed crack surface clearly establishes that the area designated as "4" in Figure 5-17 constitutes a separate independent crack. This type of face-initiated crack is designated as Type III to distinguish it from the more common Type I and Type II cracks which are associated with the blade grooves. This particular Type III crack [209-III(c)], is completely intergranular with some evidence of corrosive attack at the outer edge (Figure 5-19).

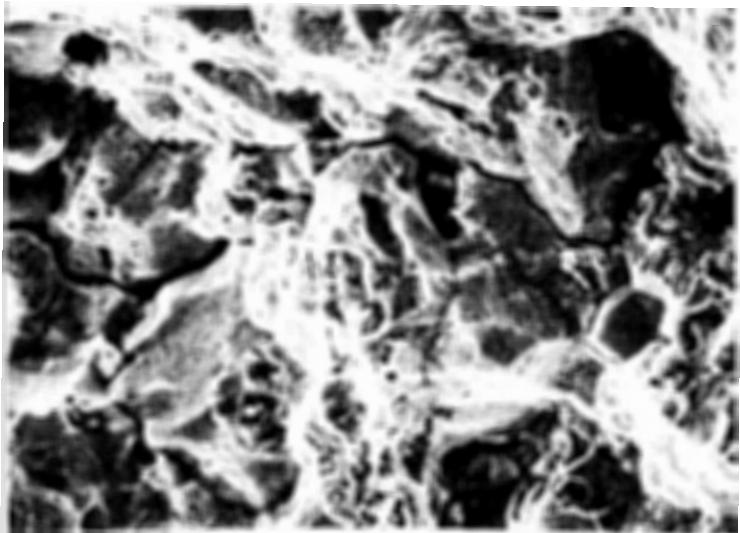
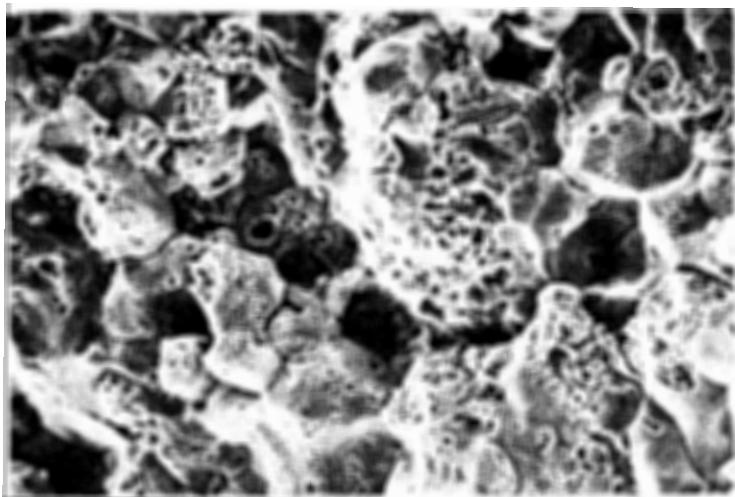
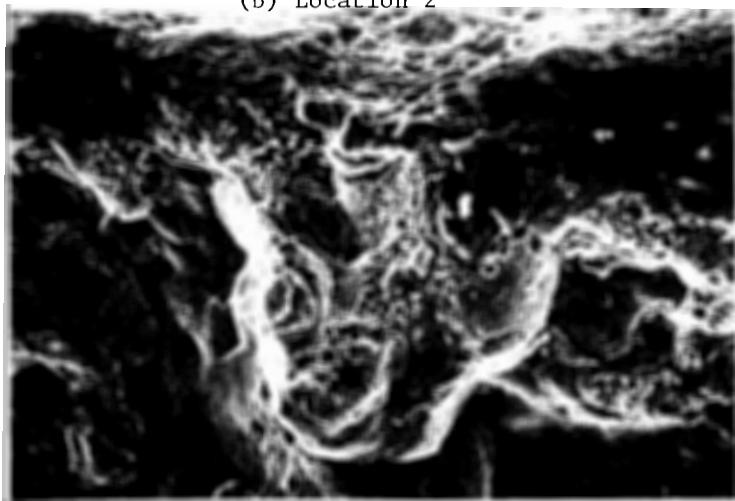
FIGURE 5-18. SEM FRACTOGRAPHS FROM CRACK 209-II(c),
ROW 6R. See Figure 5-17 for locations.

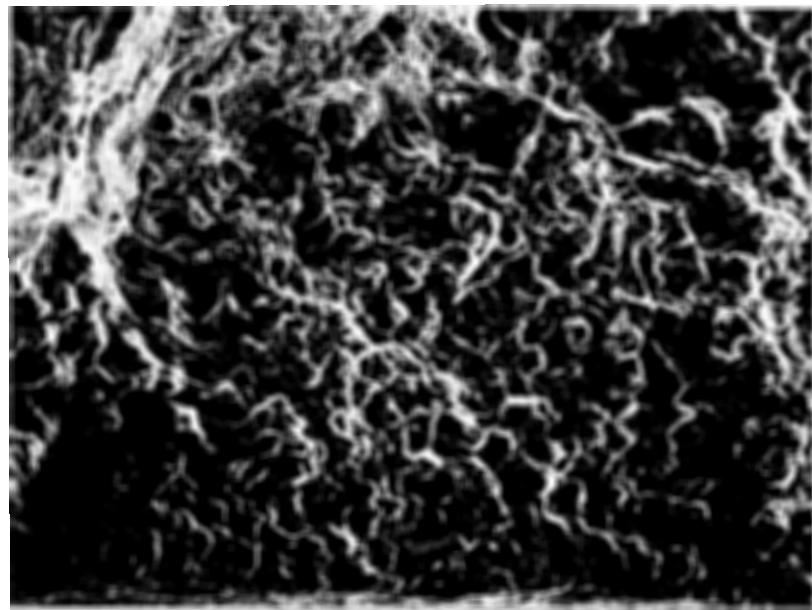
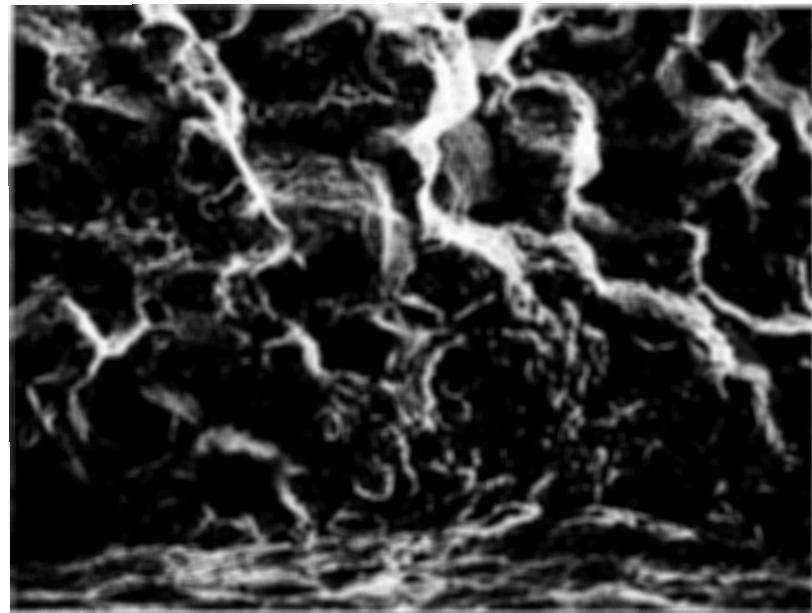
70X
(a) Area 4, Figure 5-17.

300X
(b) Location at outlet face.
Area 4.

FIGURE 5-19. SEM FRACTOGRAPHS FROM CRACK 209-III(c), ROW 6R.

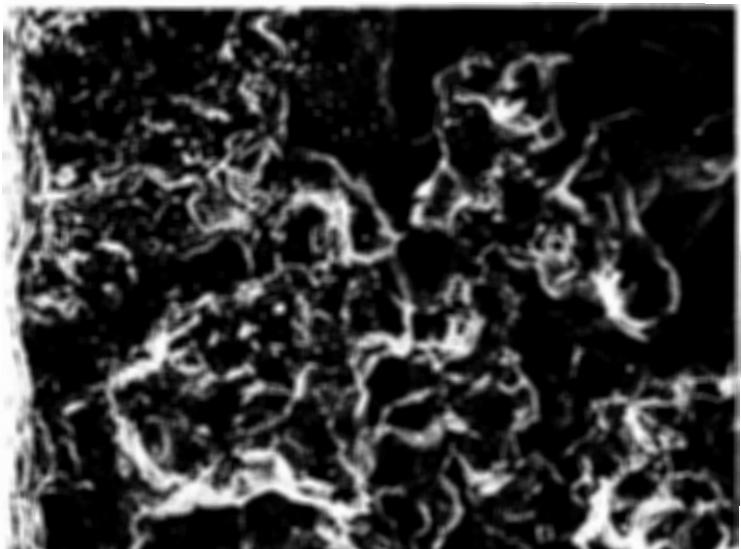
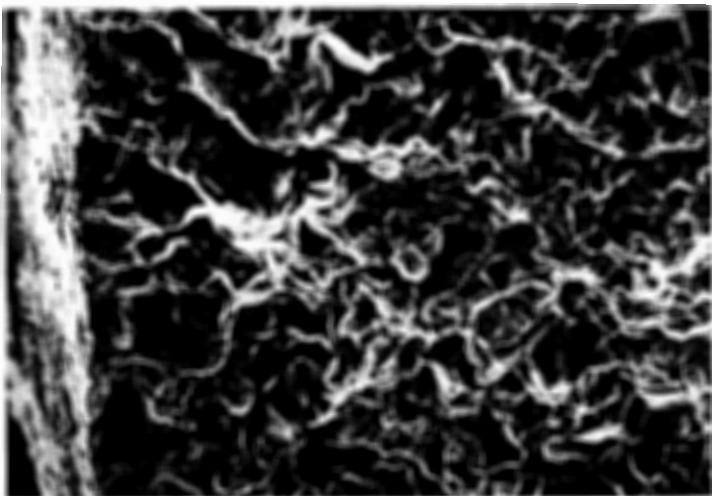
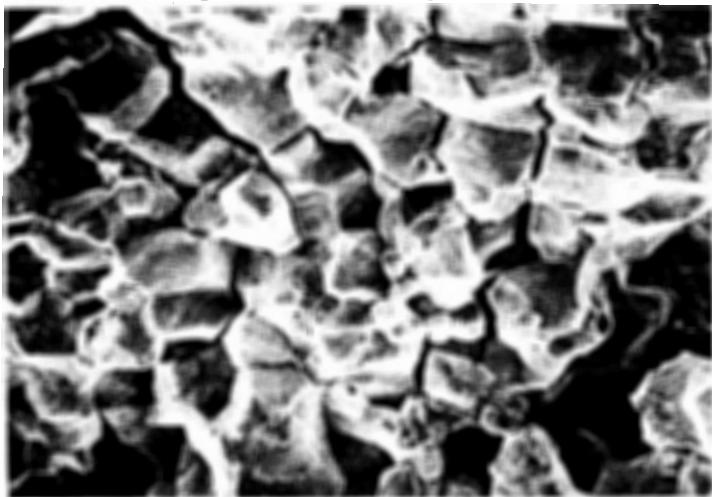
One specimen was cut to contain a Type III MP crack indication isolated from any other cracks. The characteristics of this particular crack, [211-III(d)], are illustrated in Figures 5-20 and 5-21. This crack measured approximately 0.20 inch long x 0.07 inch deep (5.1 mm x 1.8 mm) and is completely intergranular. It is clearly independent of the blade groove and any other cracking. Observations made in the examination of cracks 209-III(c), 212-III(d) and 211-III(d), together with the metallographic observations and overall MP inspection results definitely establish that the numerous small face-initiated cracks developed in these rim segment samples.

(a) At outlet face edge, no cleaning.
Note surface deposit at edge.

100X
(b) At edge. Cathodically cleaned.

300X
(c) Typical topography. Cathodically cleaned.

FIGURE 5-21. SEM FRACTOGRAPHS FROM CRACK 211-III(d).

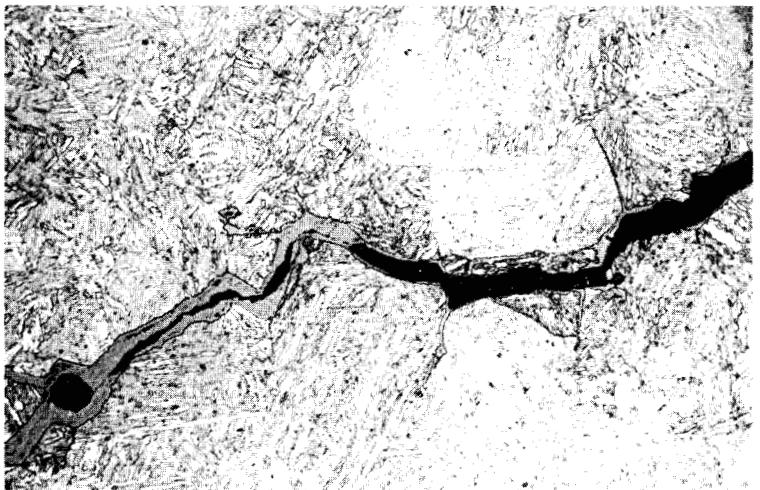
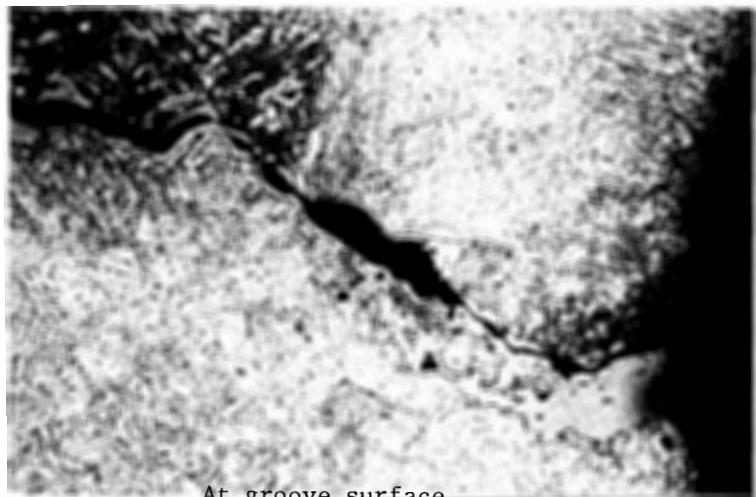
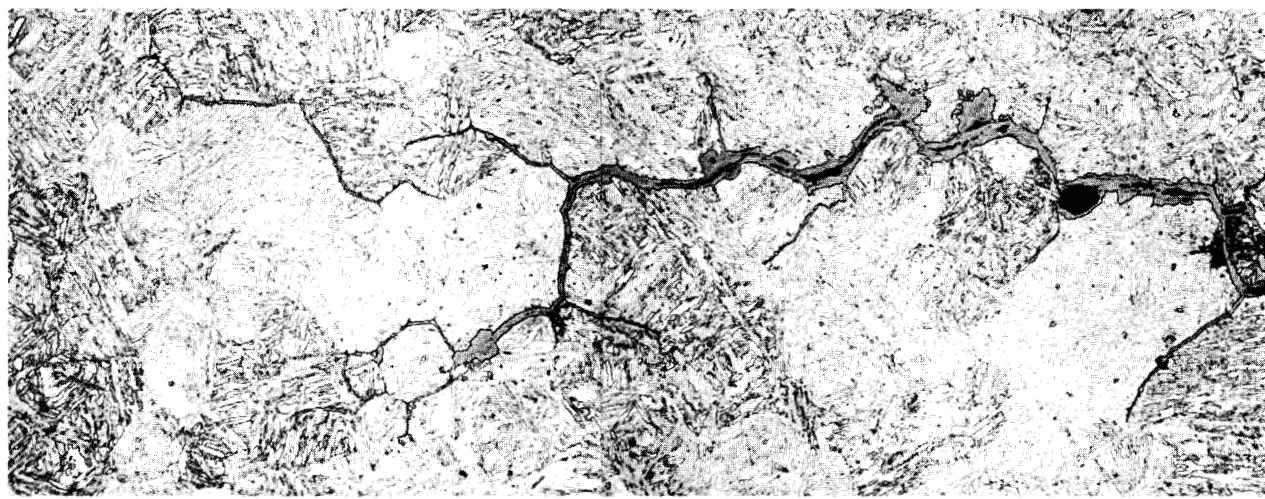
Central portion

At groove surface

Crack tip

FIGURE D-2. SEGMENTS OF CRACK 210-I-2d, ROW 6R. Section at outlet face.
See Figures 4-3 and 4-5. Etchant: Nital. 300X

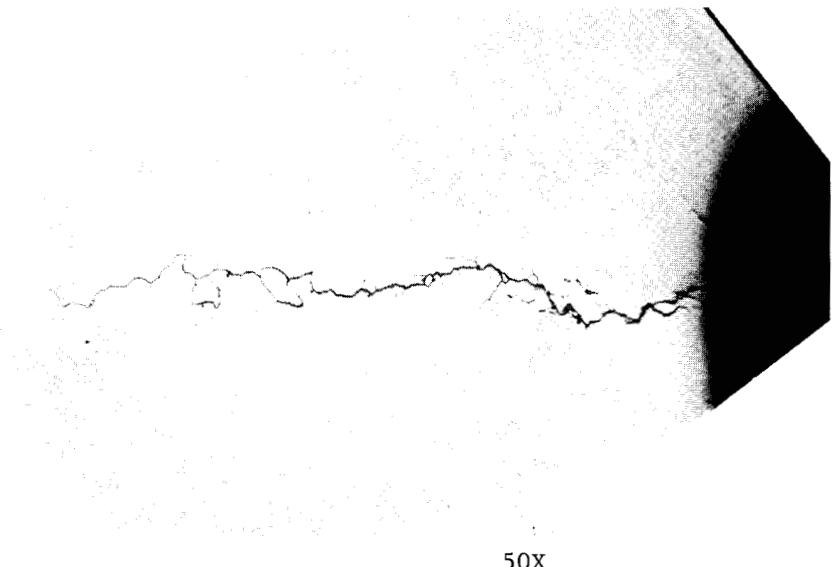
FIGURE D-3. CRACK 210-I-3d, ROW 6R. Section at outlet face. See Figure 4-3. Etchant: Nital.

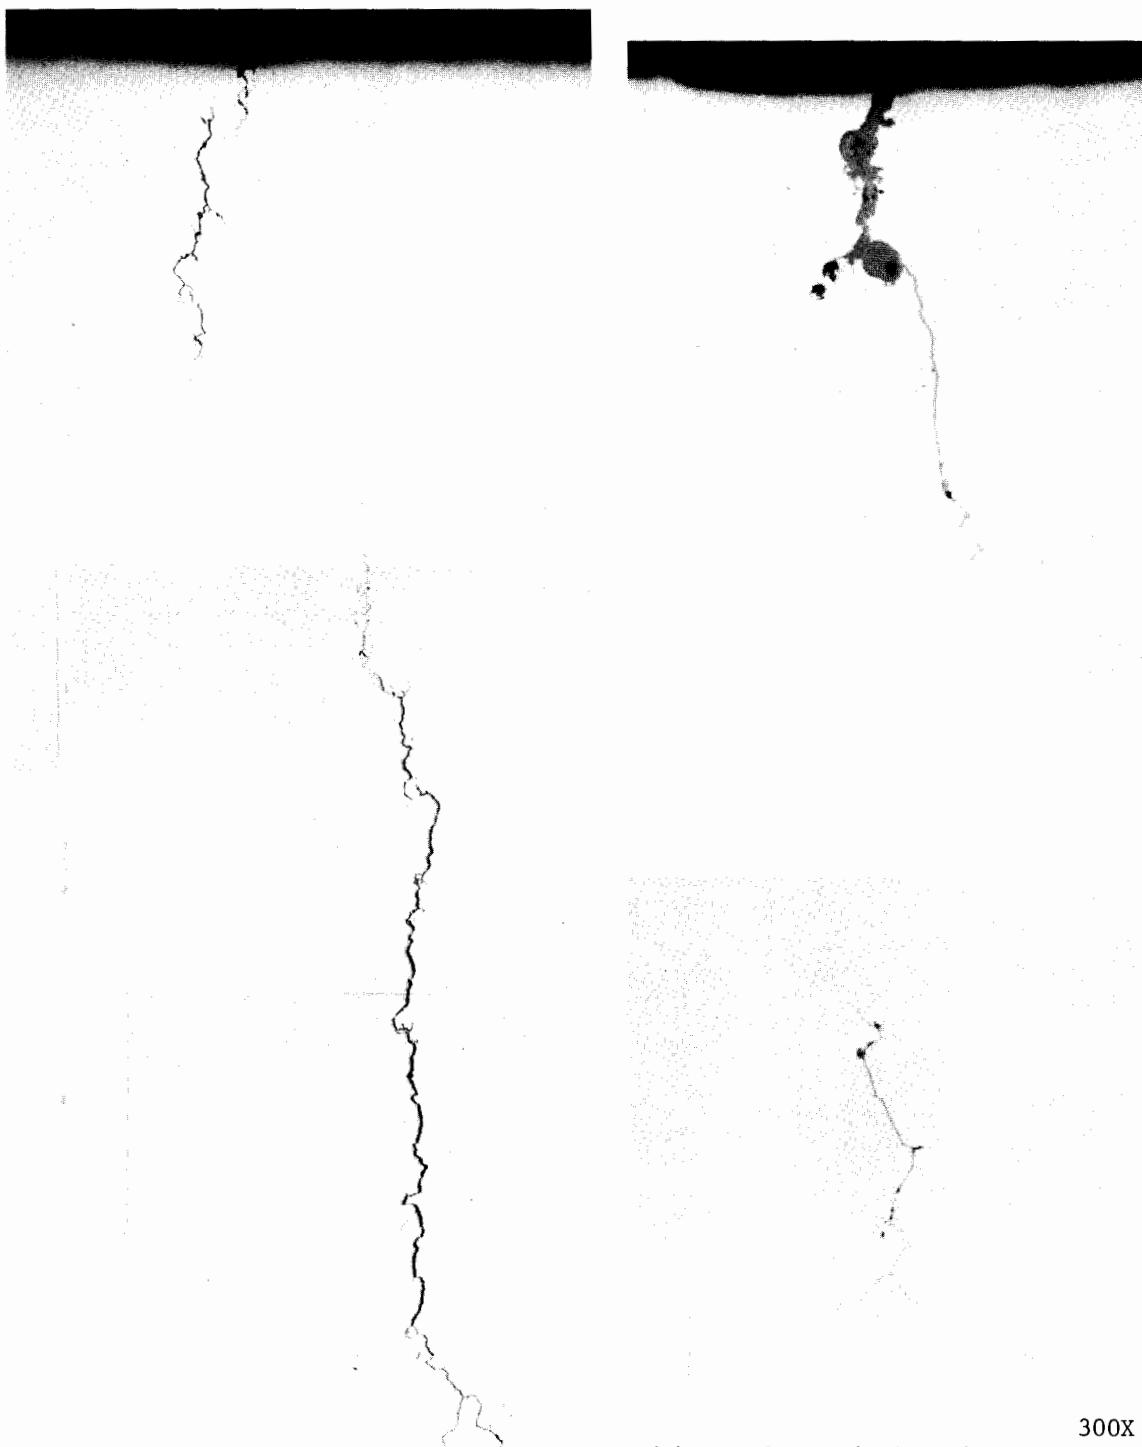
50X
(a) 0.016 in. (0.41 mm) from outlet face.

300X
(b) 0.058 in. (1.47 mm) from outlet face.

FIGURE D-6. SEQUENTIAL SECTIONS THROUGH CRACK 211-II(r), ROW 6R. See Figure 4-11.
(These photographs reduced to 90% of their original size)

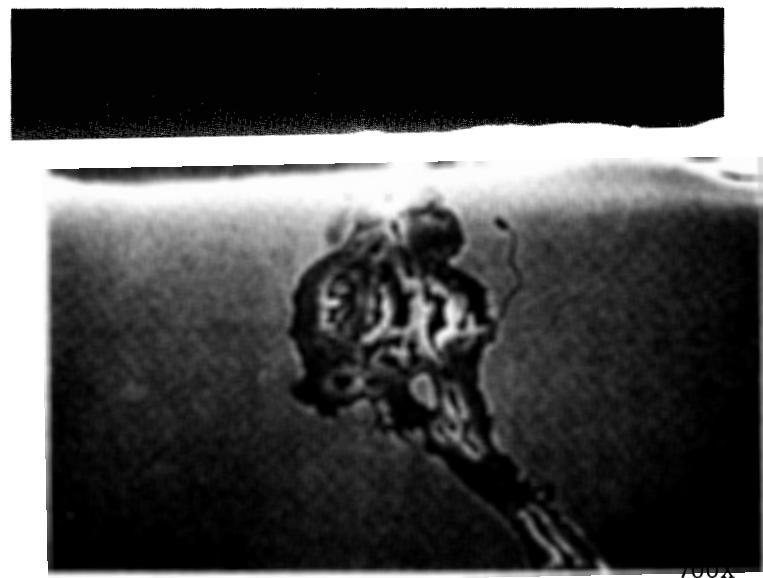
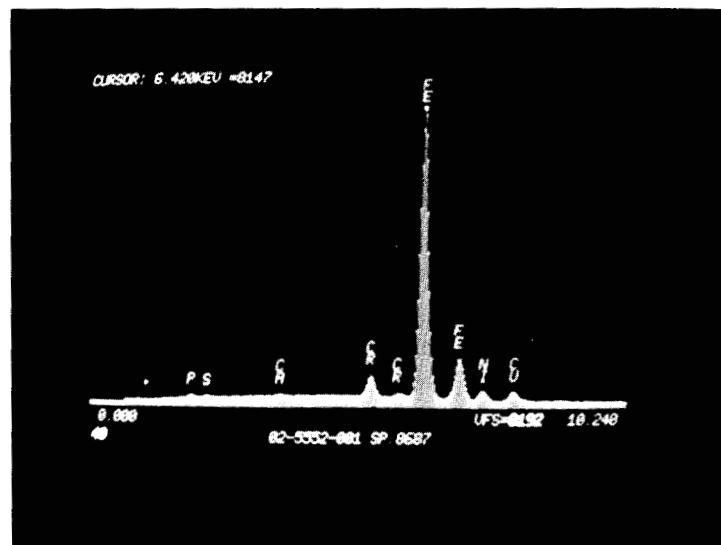
(a) SEM micrograph of deposit in crack at groove surface. Crack 176-I-3b, see Figure D-1.

(b) X-ray energy spectra from deposit in (a).

FIGURE D-8. EDS ANALYSIS OF DEPOSIT WITHIN CRACK.

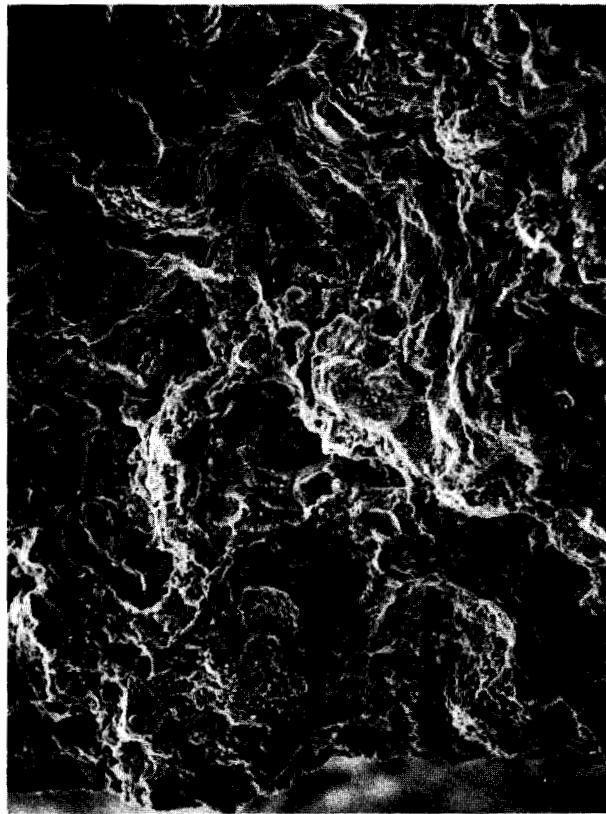
(a) Location 5

(b) Location 2

FIGURE E-1. SEM FRACTOGRAPHS AT EDGE OF CRACK 213-I-2bd, ROW 6R.
Surface as exposed, no cleaning. See Figure 5-3 for
locations. 200X

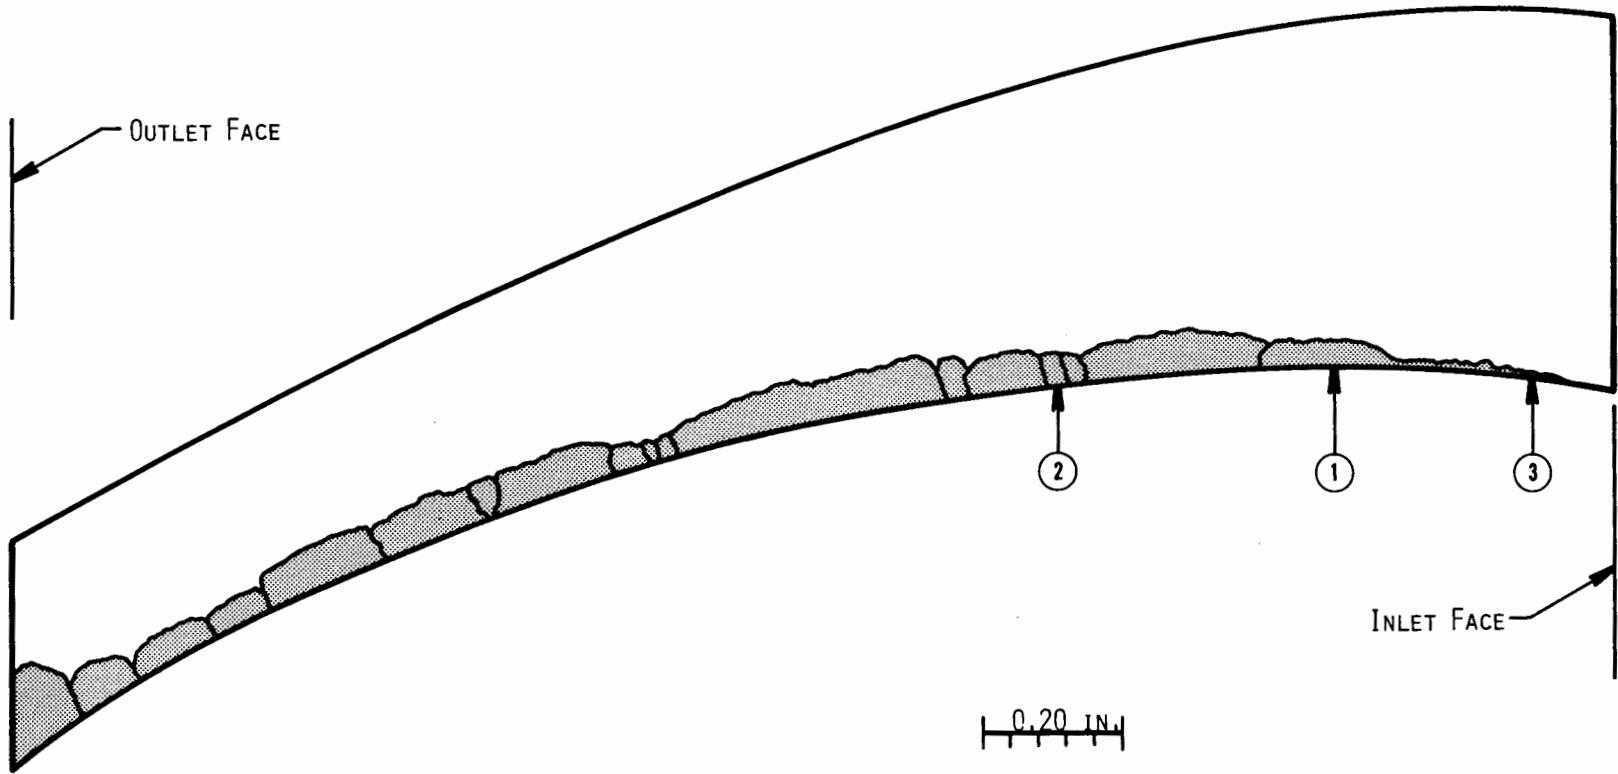
FIGURE E-3. DIAGRAM OF SURFACE OF CRACK 208-I-2b. See Figure 5-7.
Outline represents full cross section of steeple at
crack location. 4X

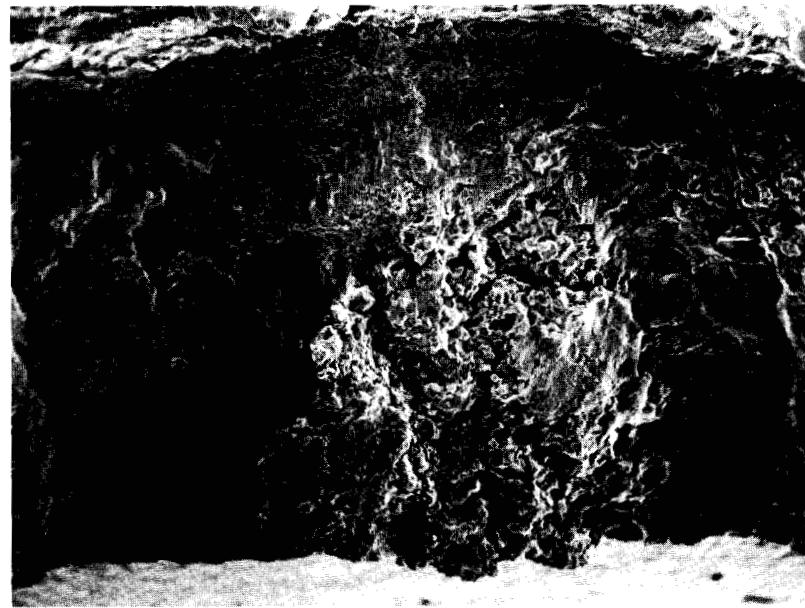
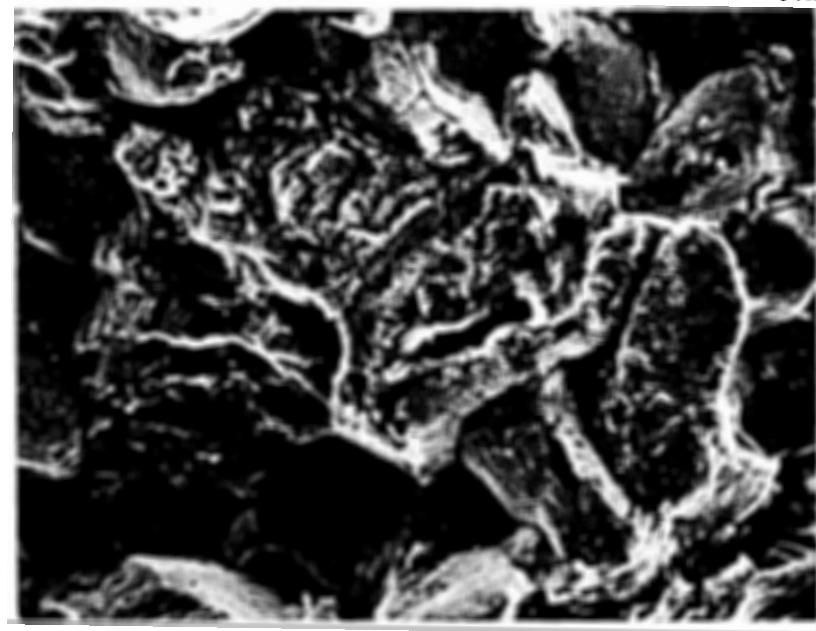
FIGURE E-5. SEM FRACTOGRAPHS FROM CRACK 208-I-2bd.
Location 2, Figure E-3. Surface
cathodically cleaned.

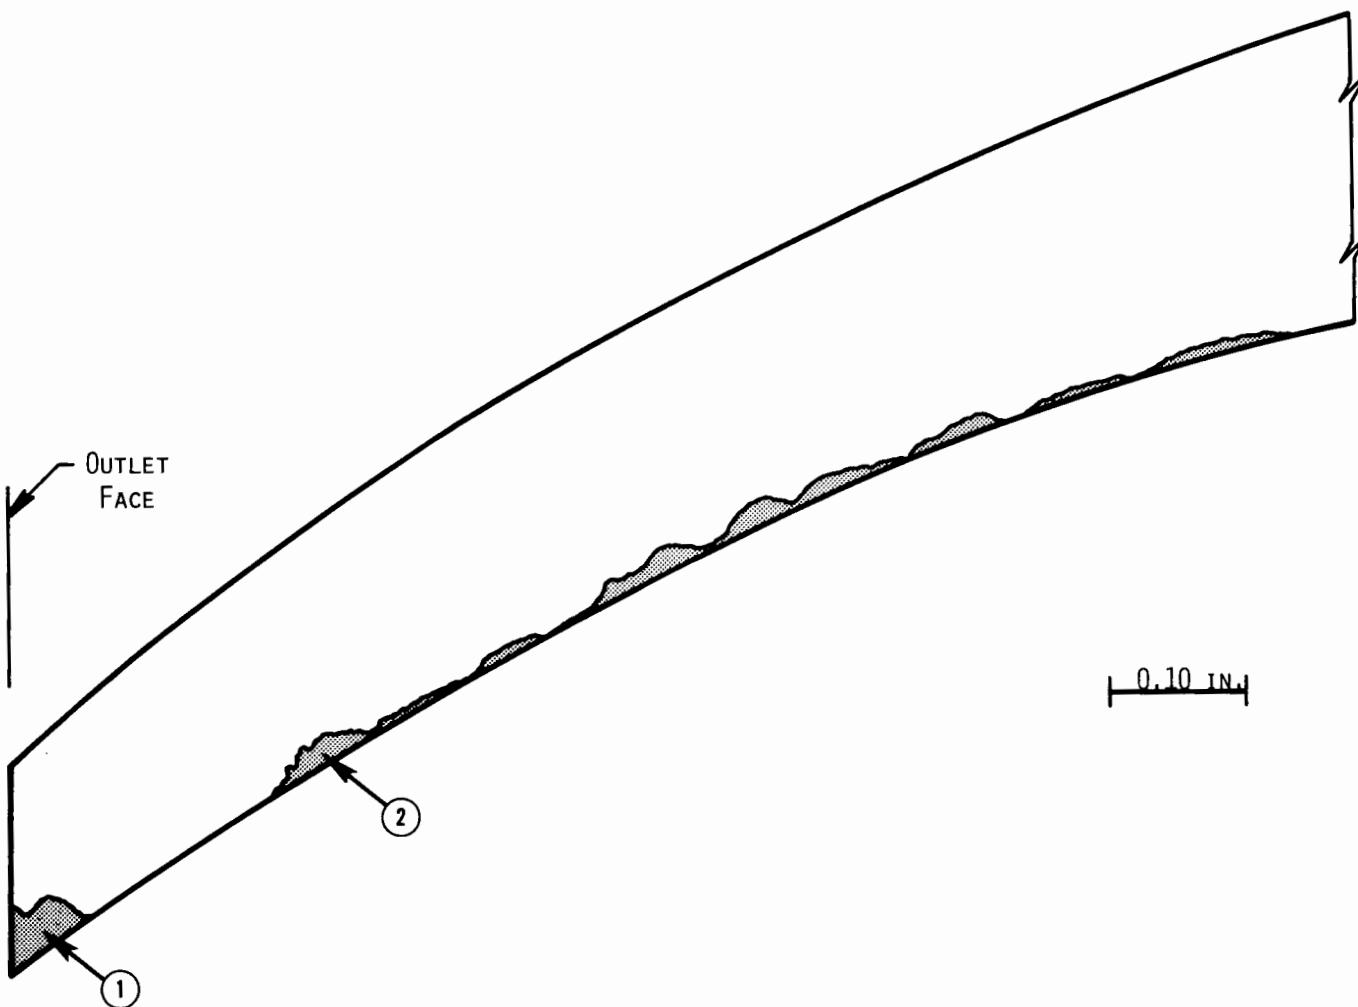
The exposed surface of 207-I-3bd is shown in Figure 5-11. The crack surface at this location is made up of several disconnected segments and the extent of crack propagation is very limited. The maximum crack depth at any point along the groove surface is approximately 0.02 inch (0.51 mm) and the crack surface comprises less than 5% of the cross-sectional area. The separate crack segment located at the outlet face is somewhat larger than any other portion of the crack, and it is this segment that contributed to the MP indication on the outlet face. It should be noted, however, that in the absence of this one larger segment, the remainder of the cracking would probably not be detected by conventional MP inspection. Mixed mode cracking, similar to that of crack 208-I-2d, was also evident in this case. The crack is predominantly intergranular, particularly at the outer edge, but significant proportions of transgranular fracture were noted in the later stages of propagation. A diagram of this crack surface and SEM fractographs from the crack are shown in Appendix E, Figures E-6 and E-7.

FIGURE E-6. DIAGRAM OF SURFACE OF CRACK 207-I-3d, ROW 6R.
Outline represents cross section of steeple at
crack location. See Figure 5-11. 8X
(This diagram reduced 90% of its original size)

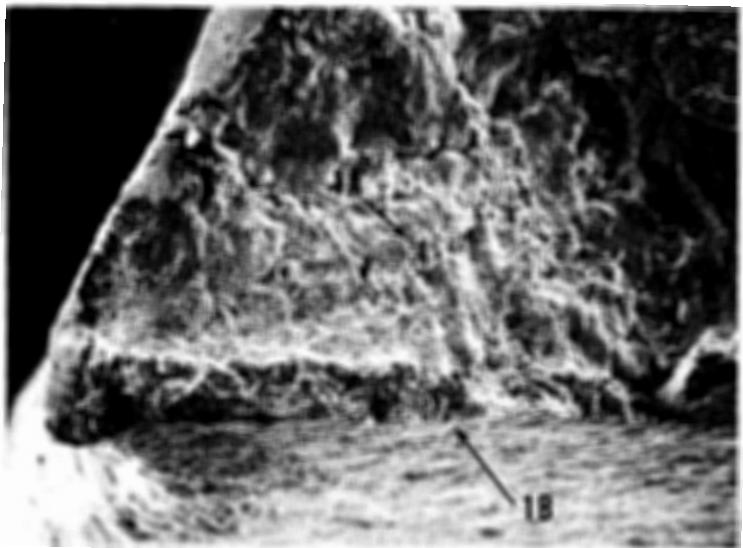
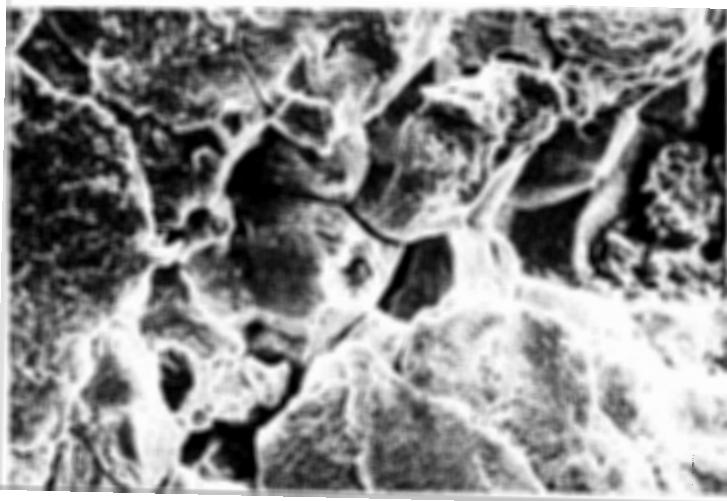
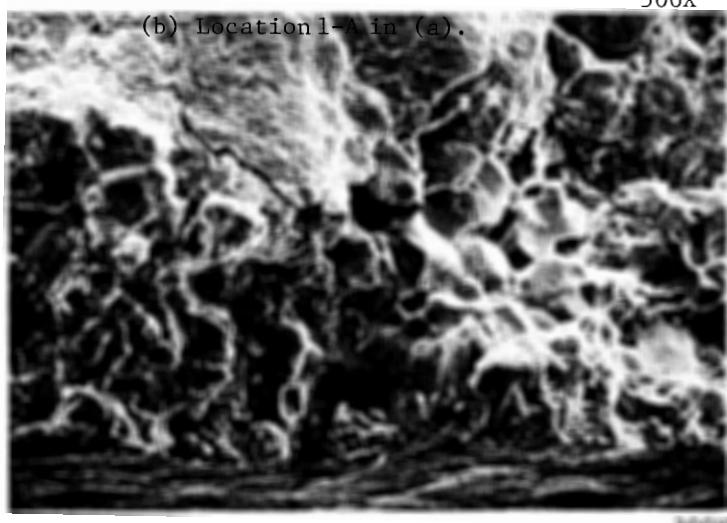
(a) Outlet side corner, Area 1, Figure E-6.

(b) Location 1-A in (a).

(c) Location 1-B in (a).

FIGURE E-7. SEM FRACTOGRAPHS FROM CRACK 207-I-3(d).

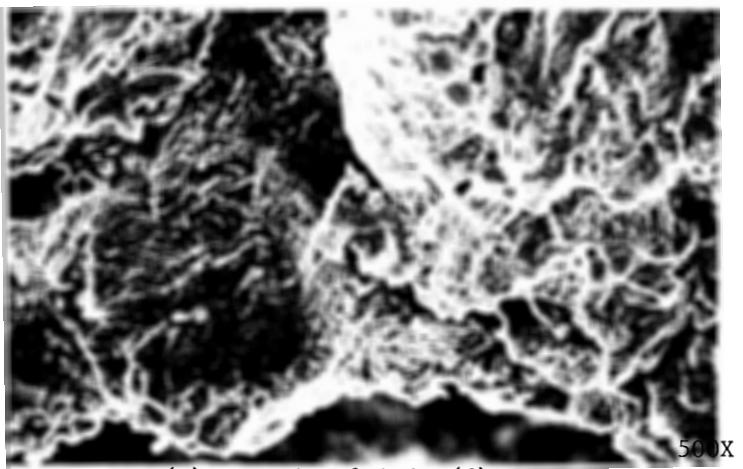
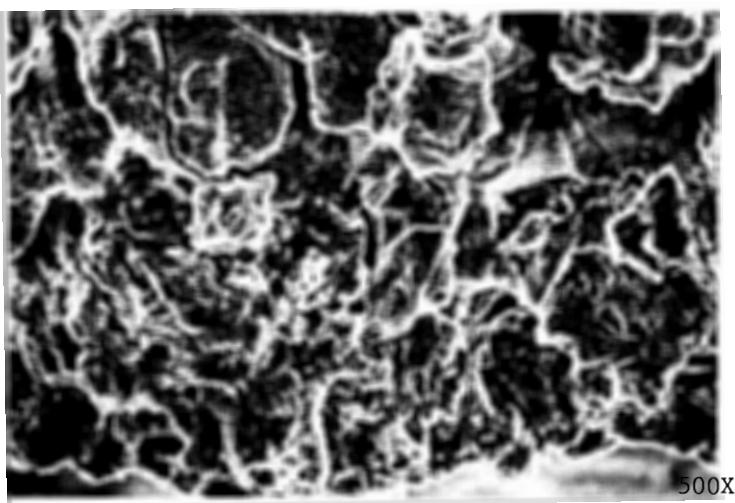
(d) Area 2, Figure E-6.

(e) Location 2-A in (d).

(f) Location 2-B in (d).

FIGURE E-7 (Continued). SEM FRACTOGRAPHS FROM CRACK 207-I-3(d).

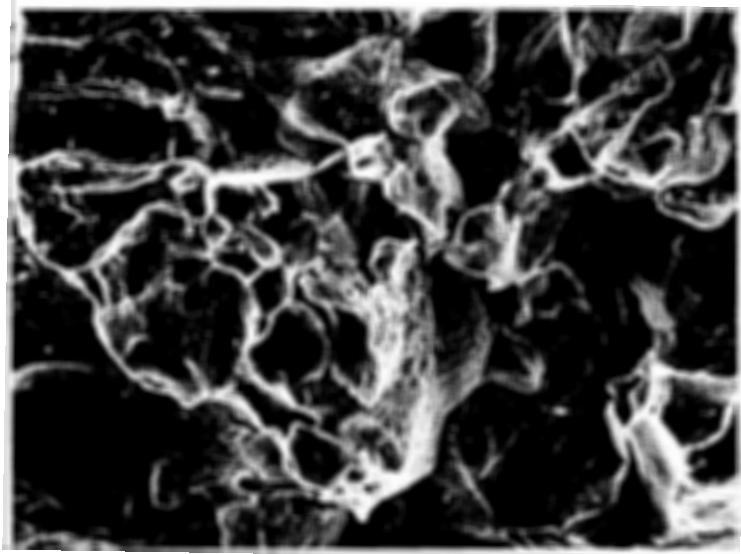
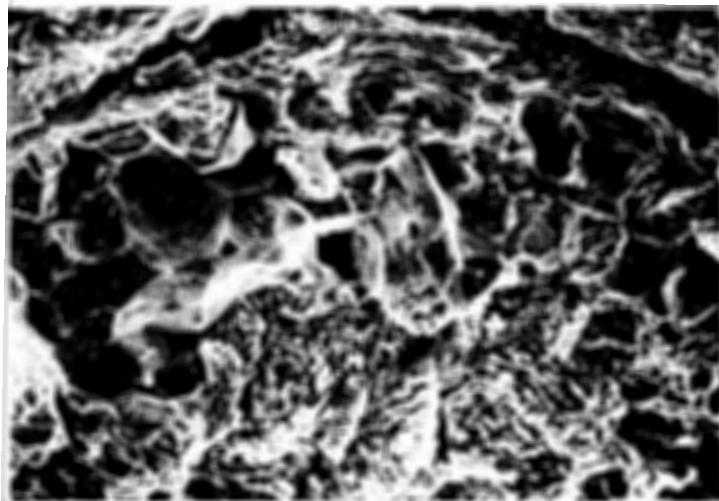
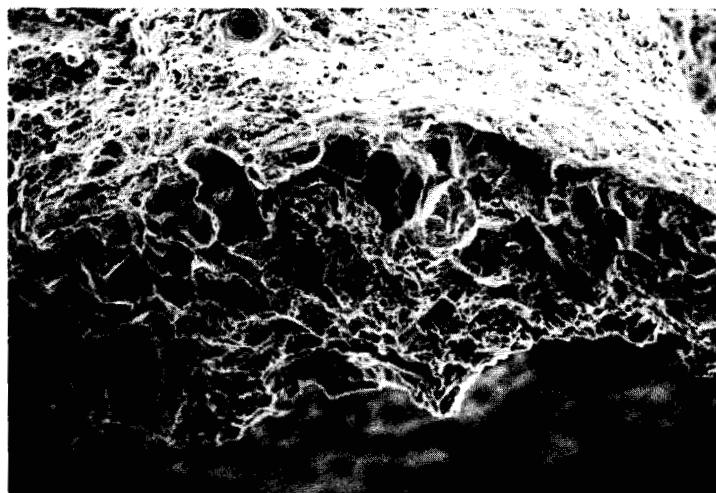
(a) Location 4. At extreme point of crack propagation.

(b) Location 6.

(c) Location 7.

FIGURE E-8. SEM FRACTOGRAPHS FROM CRACK 177-I-2b.
See Figure 5-13 for locations.

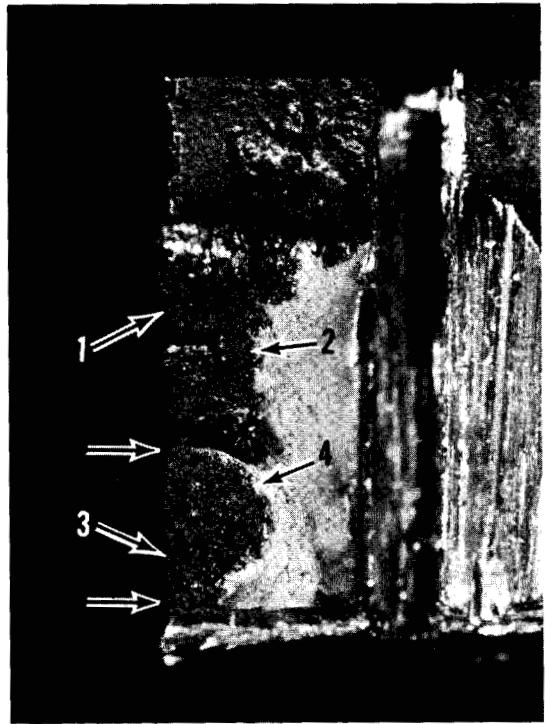
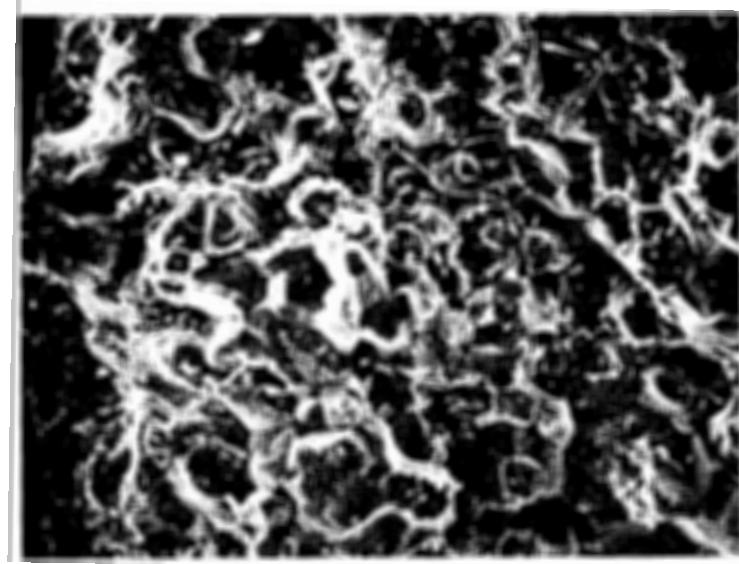
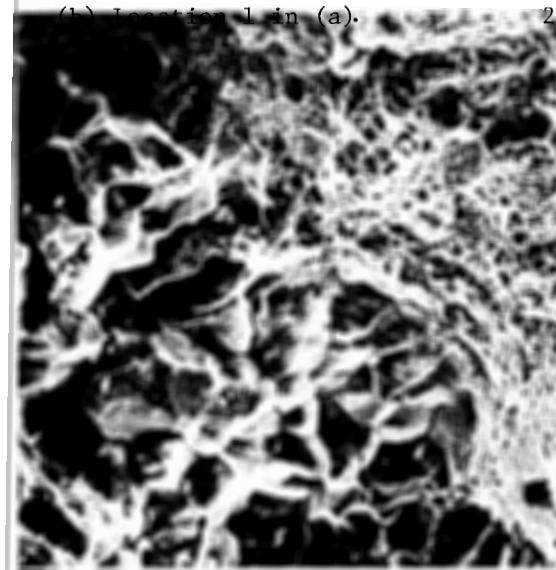
(a) Complete crack surface. Note thumbnail shaped, face initiated crack below 212-II(d) marked by arrows [212-III(d)].

(b) Location 1 in (a).

(c) Location 2
in (a).

FIGURE E-10. SURFACE OF CRACK 212-II(d).

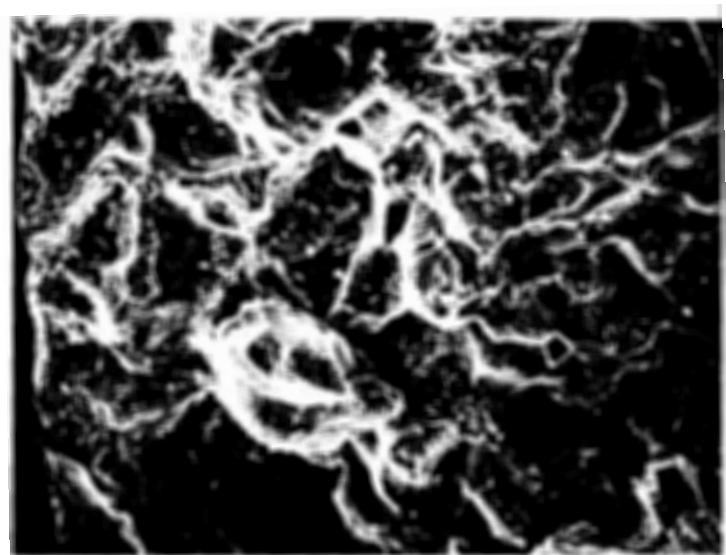
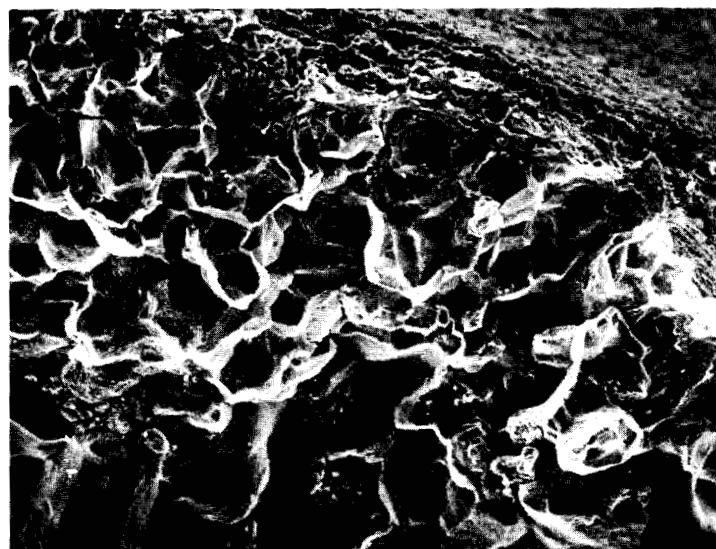
(a) Location 3, Figure E-10(a)

(b) Location 4, Figure E-10(a)

FIGURE E-11. SEM FRACTOGRAPHS FROM FACE INITIATED CRACK AT STEEPLE 212/213. Crack 212-III(d). 200X

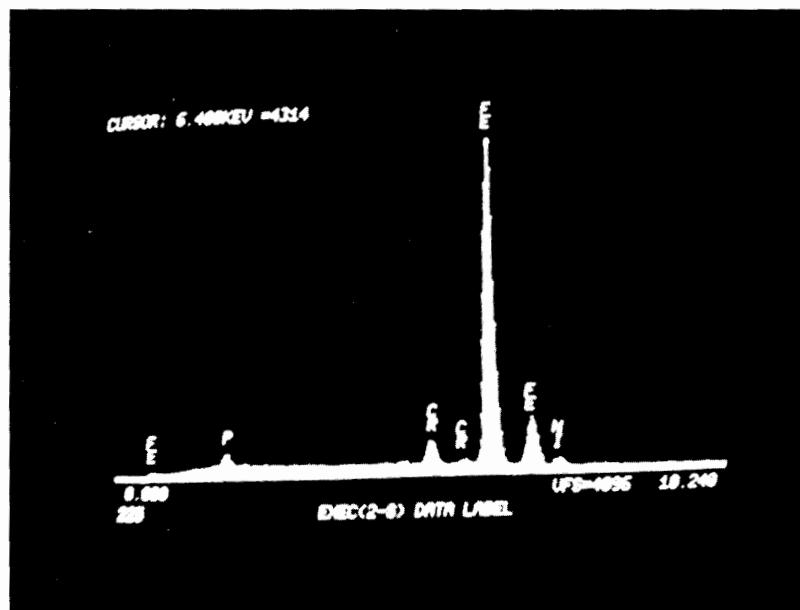
FIGURE E-12. TYPICAL X-RAY ENERGY SPECTRUM FROM CRACK SURFACE.

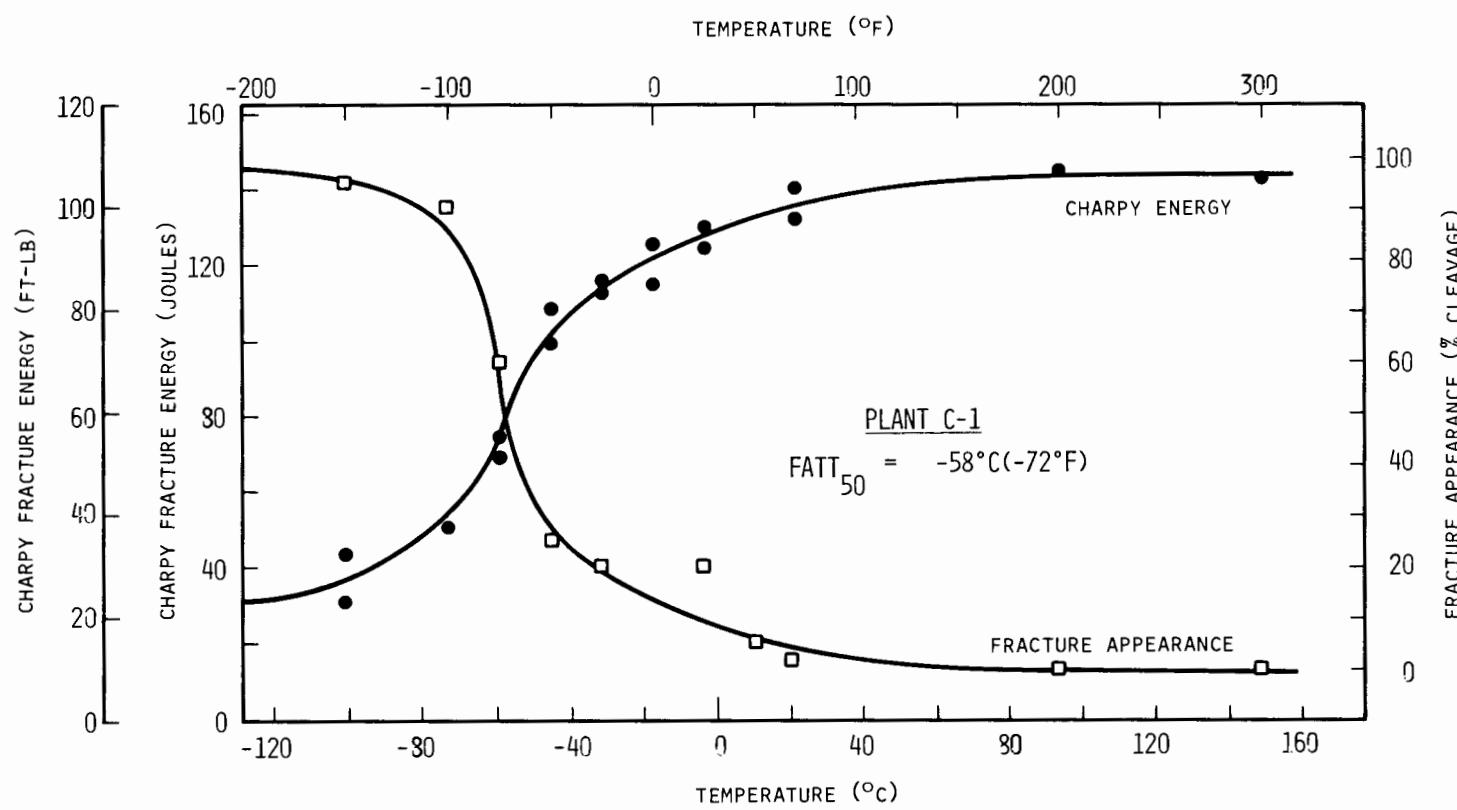
FIGURE 2-1. CHARPY-V IMPACT PROPERTIES. Disc No. 3, Gen. End, LP-2, Plant C-1.

The data for the two discs are generally similar. Both materials exhibit a relatively high upper shelf energy and a clearly defined ductile-brittle transition with decreasing temperature is evident. The upper shelf energies were determined to be 145 J (107 ft-lbs) for the C-1 material and 130 J (90 ft-lbs) for the D-1 material. The absorbed energy values at the lowest test temperature were in the range of 31-44 J (23-33 ft-lbs) for both materials. Extrapolation of the data to lower temperatures indicates a lower shelf energy of approximately 30 J (22 ft-lbs).
