Metallurgical Analysis of Rim Cracking in an LP Steam Turbine Disc

NP-1532
Research Project 1398-1

Final Report, September 1980
Work Completed, February 1980

SOUTHWEST RESEARCH INSTITUTE
P.O. Drawer 28510
6220 Culebra Road
San Antonio, Texas 78284

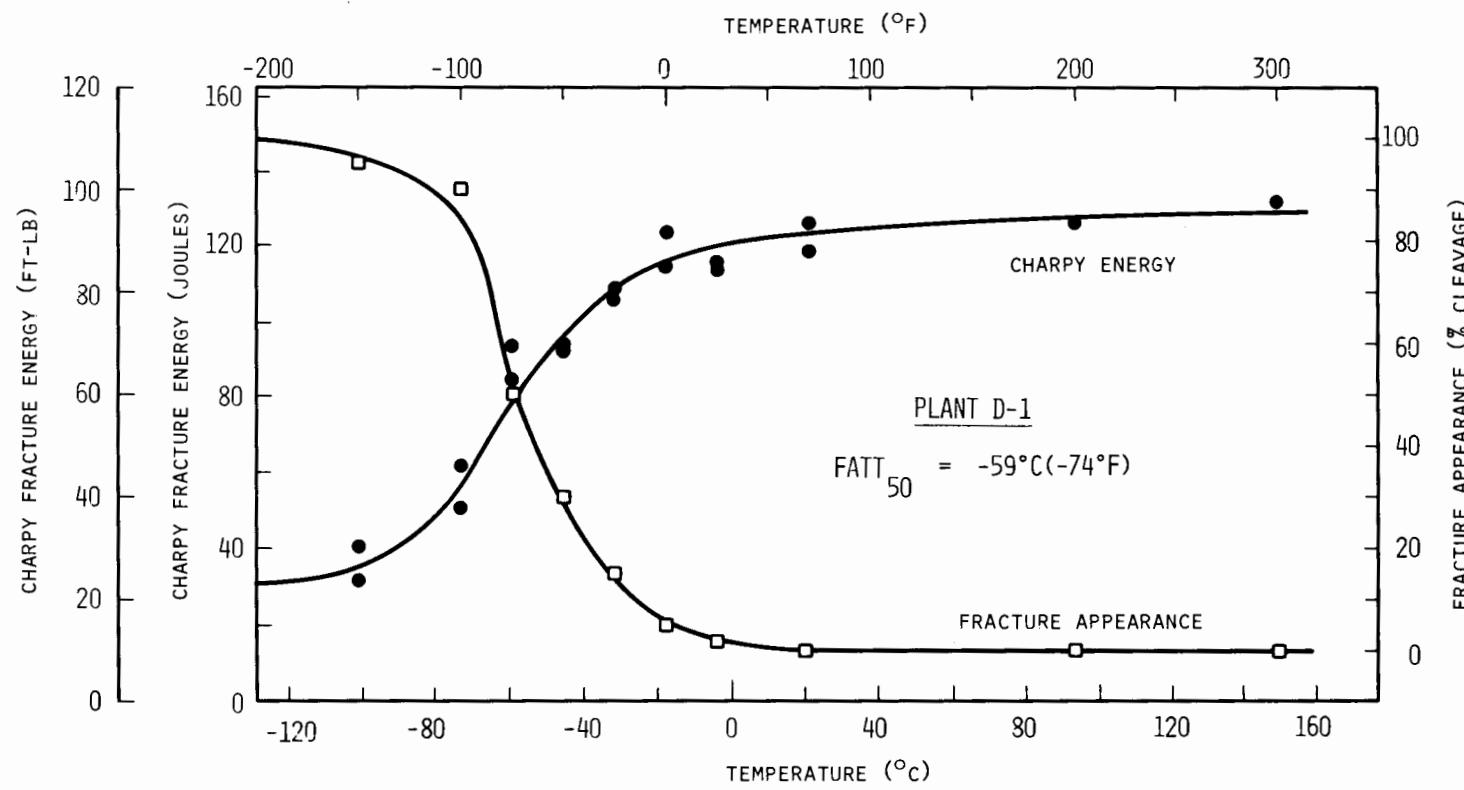
FIGURE 2-2. CHARPY-V IMPACT PROPERTIES. Disc No. 1, Gov. End, LP-1, Plant D-1.

The data for the two discs are generally similar. Both materials exhibit a relatively high upper shelf energy and a clearly defined ductile-brittle transition with decreasing temperature is evident. The upper shelf energies were determined to be 145 J (107 ft-lbs) for the C-1 material and 130 J (90 ft-lbs) for the D-1 material. The absorbed energy values at the lowest test temperature were in the range of 31-44 J (23-33 ft-lbs) for both materials. Extrapolation of the data to lower temperatures indicates a lower shelf energy of approximately 30 J (22 ft-lbs).

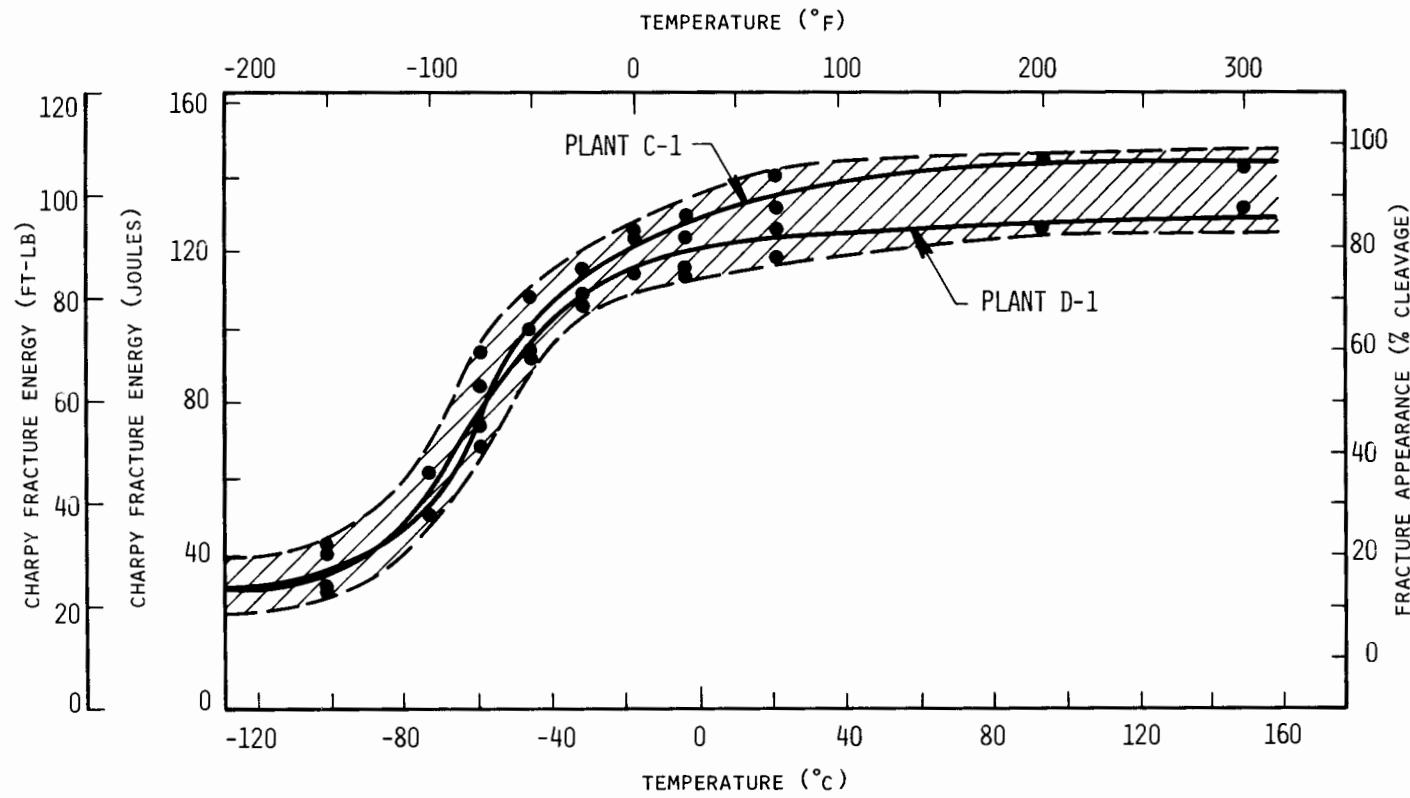
The combined absorbed energy data from all tests on both materials are presented in Figure 2-3. Considering all data as a group, the spread in absorbed energy values at the low temperature end of the curve is 13 J (10 ft-lbs). A maximum spread of 22 J (16 ft-lbs) was noted at 21°C (70°F). The spread in absorbed energy values for the entire group of tests is comparable to the normal scatter for Charpy-V impact tests. The test results indicate that there is no significant difference in the impact behavior of the two materials.

FIGURE 2-3. COMBINED CHARPY-V IMPACT DATA FOR DISCS FROM TWO PLANTS.

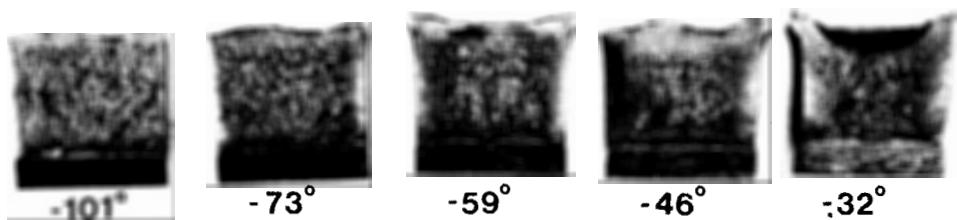
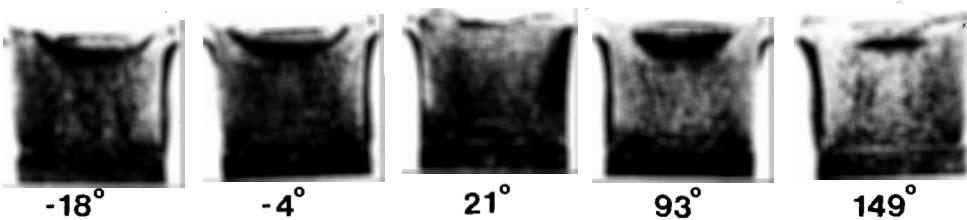
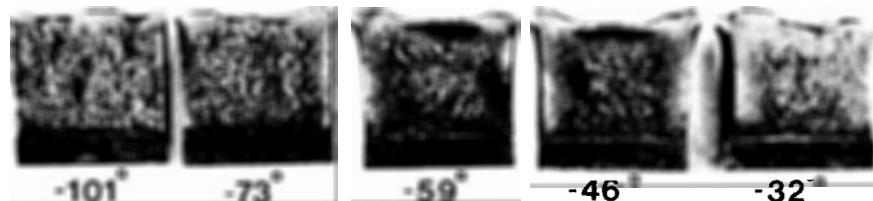
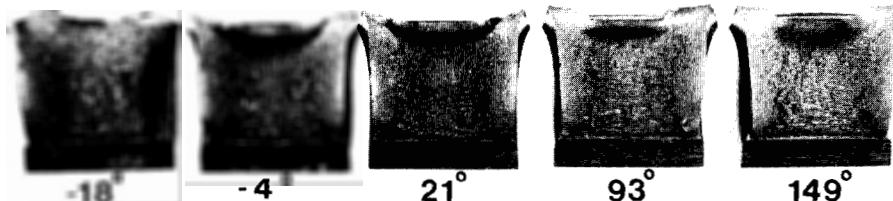
The fracture surfaces of specimens representing all test temperatures are shown in Figure 2-4. Some degree of ductility is apparent at the lowest temperature as evidenced by a relatively rough surface and small but well developed shear lips. The progressive increase in ductility with increasing temperature is clearly evident. Those specimens tested at room temperature and above exhibit a fully ductile appearance. The 50% fracture appearance transition temperatures were established as

FIGURE 2-4. CHARPY V-NOTCH IMPACT SPECIMENS. Temperatures shown in °C. $\approx 2X$
(These photographs reduced to 90% of their original size)

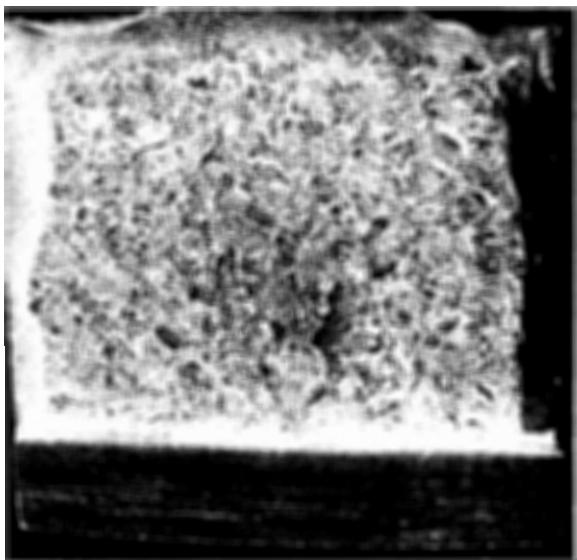
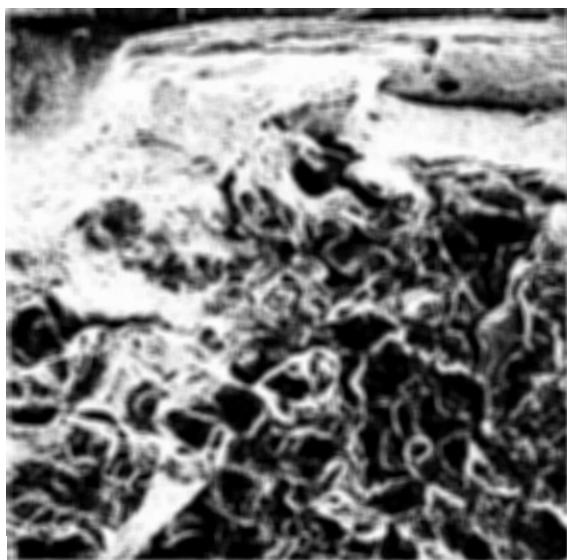
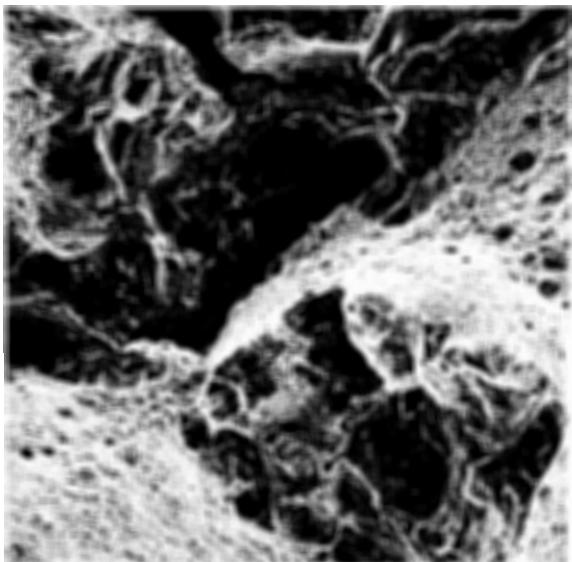
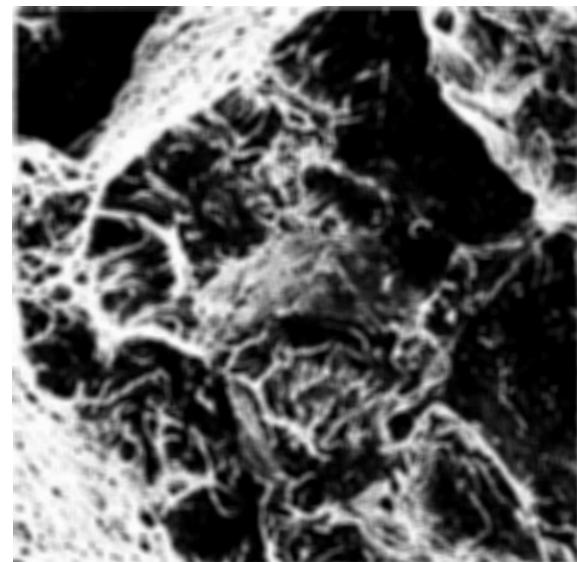
The fractographic features of specimens tested at -101°C (-150°F) are illustrated in Figures 2-5 and 2-6. These specimens were characterized by flat fracture with a relatively rough texture over 95% of the cross-sectional area and small but well developed shear lips, see Figure 2-5(a). A zone of dimpled rupture is apparent at the bottom of the notch, see Figure 2-5(b). This feature is typical of all specimens tested at temperatures within the transition zone.

FIGURE 2-5. CHARPY IMPACT SPECIMEN TESTED AT -101°C (-150°F).
Specimen RO-41, Plant C-1.

A number of isolated zones with smooth features were noted, see Figures 2-5(a), (b) and (c). Some of these smooth features are probably isolated large dimples [Figure 2-5(a)] while others are isolated intergranular facets. The only intergranular fracture observed was confined to 2-3 adjacent grains at widely dispersed locations.

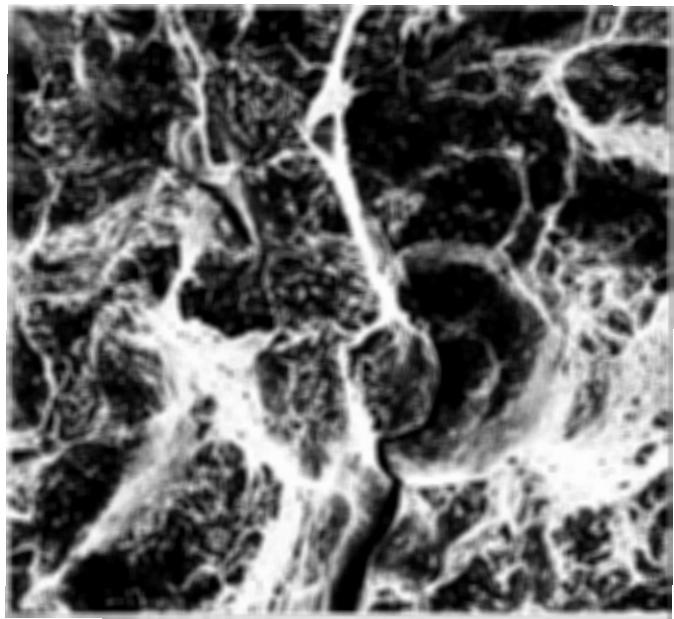
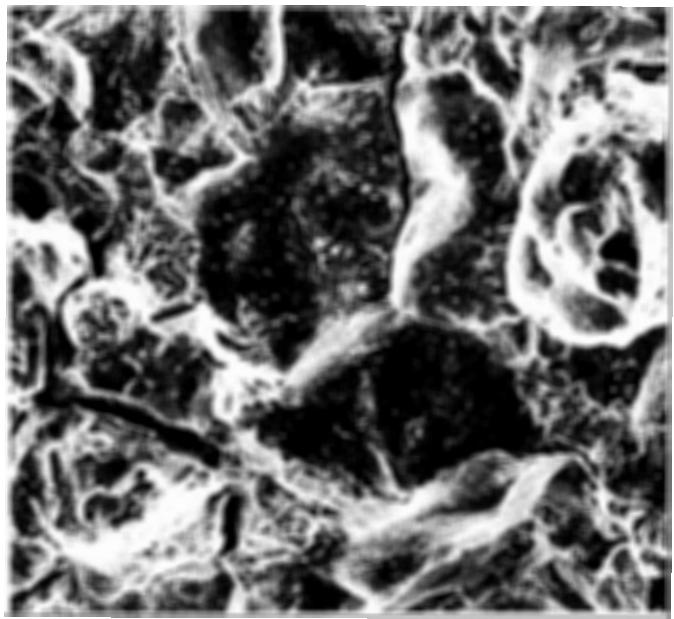
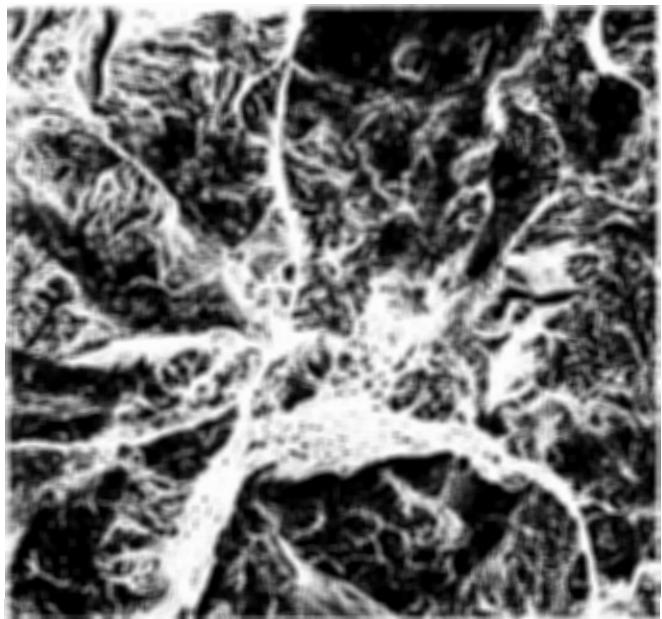
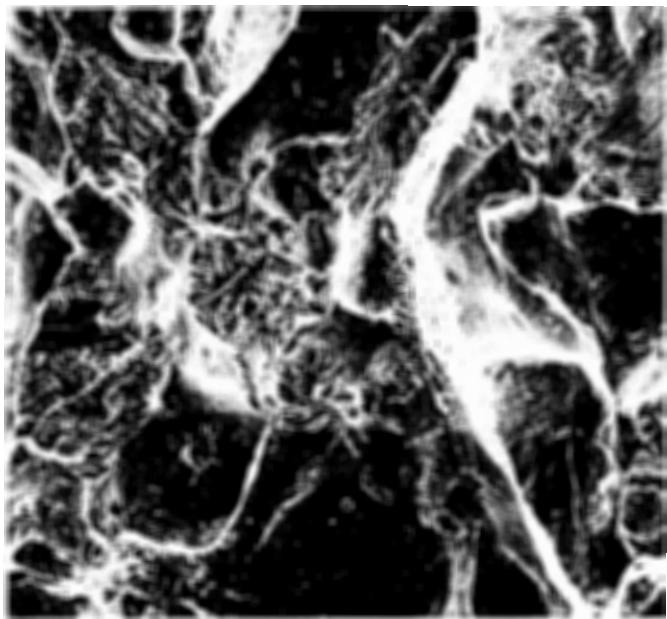
The typical fine-scale features of the flat fracture zones are shown in Figures 2-5(c) and 2-6(c) and (d). The fracture surface is characterized by a

FIGURE 2-6. CHARPY IMPACT SPECIMEN TESTED AT -101°C (-150°F).
(a) and (b) Plant C-1; (c) and (d) Plant D-1.

predominance of cleavage with zones of small dimples at steps connecting cleavage zones. It should be noted that the features are different from those of classic, deformation free cleavage, indicating that some degree of plastic deformation was involved in the formation of the cleavage facets. Short, disconnected secondary cracks were also evident, especially at locations near the notch, see Figures 2-6(a) and (b). The shape of some of the secondary cracks suggest that they may be intergranular, but there was no evidence of linking up of any such cracks so that they do not represent a significant portion of the total fracture surface.

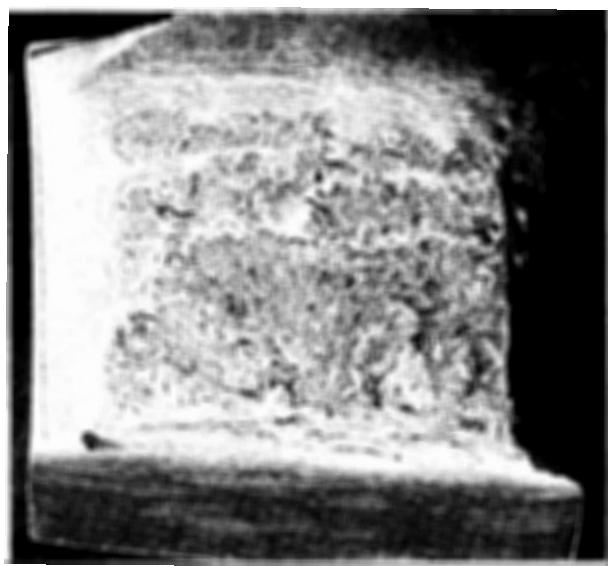
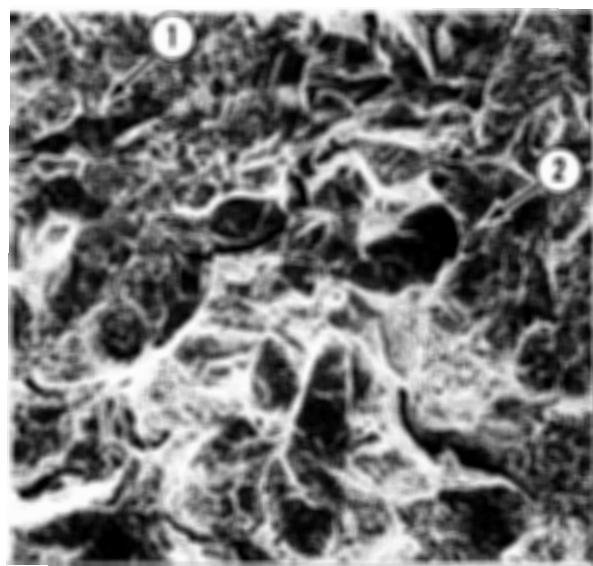
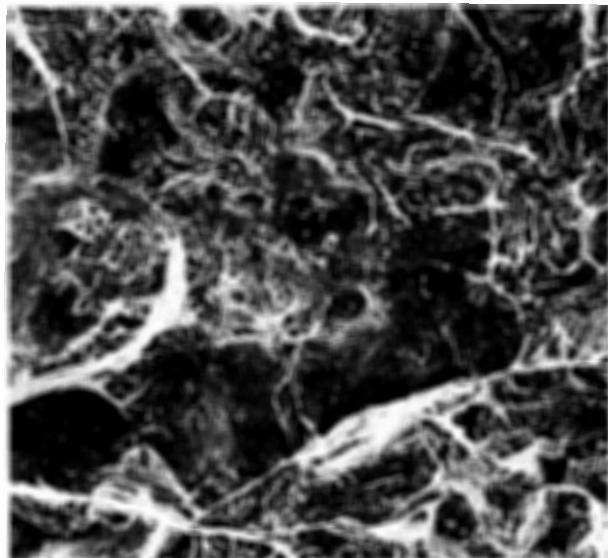
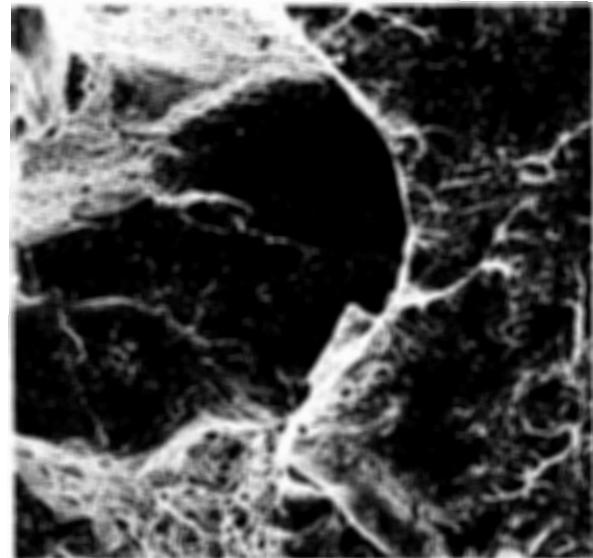
SEM fractographs from specimens corresponding to the 50% fracture appearance transition temperature are shown in Figures 2-7 and 2-8. All areas within the flat fracture zones exhibited a mixture of cleavage and microvoid coalescence. The increased ductility, as compared to the -101°C specimens, is evidenced by more extensive patches of small dimples [Figures 2-7(a) and 2-8(b) and (c)] and more numerous large dimples [Figures 2-7(b) and (d)]. No significant degree of intergranular fracture was observed.

FIGURE 2-7. CHARPY IMPACT SPECIMEN TESTED AT -59°C (-75°F).
Specimen RO-34, Plant C-1.

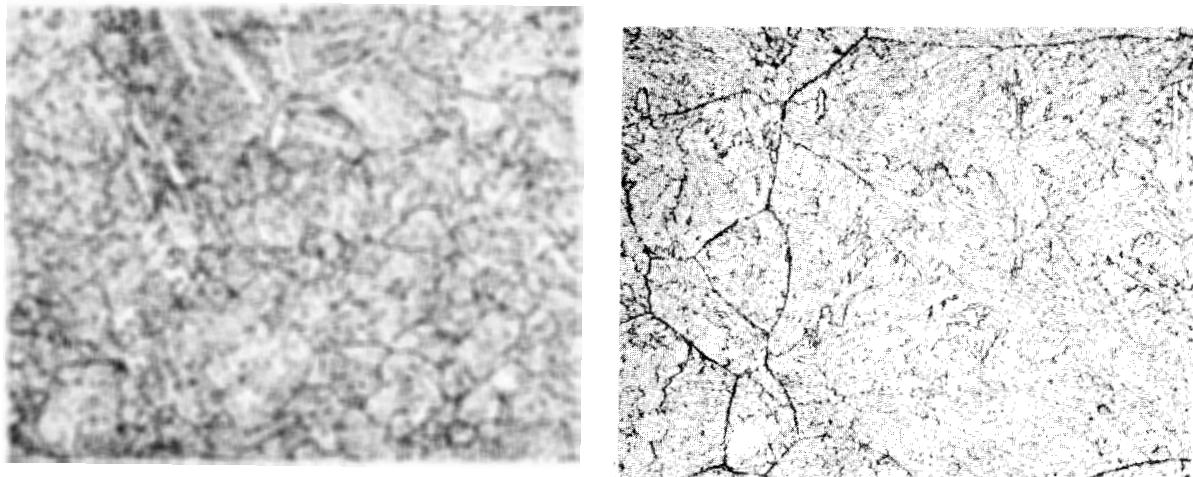
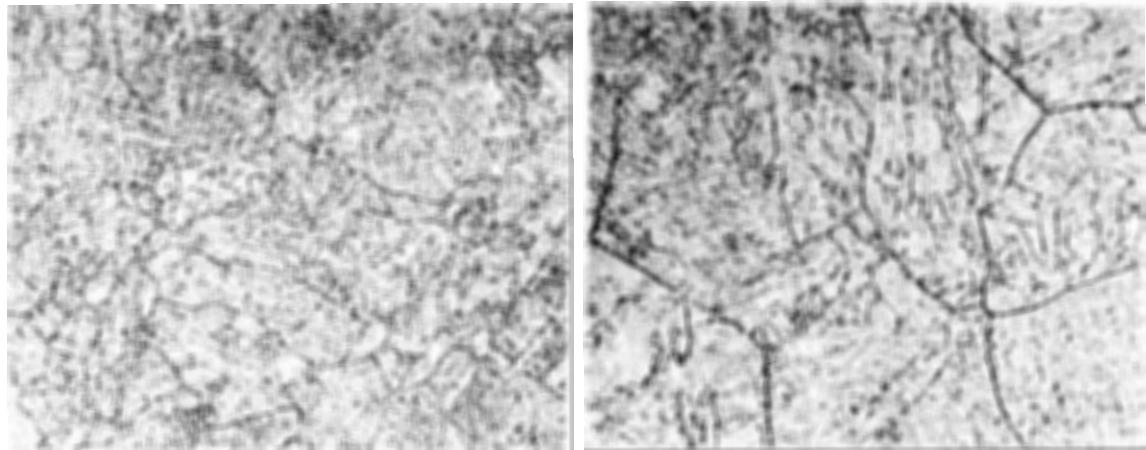
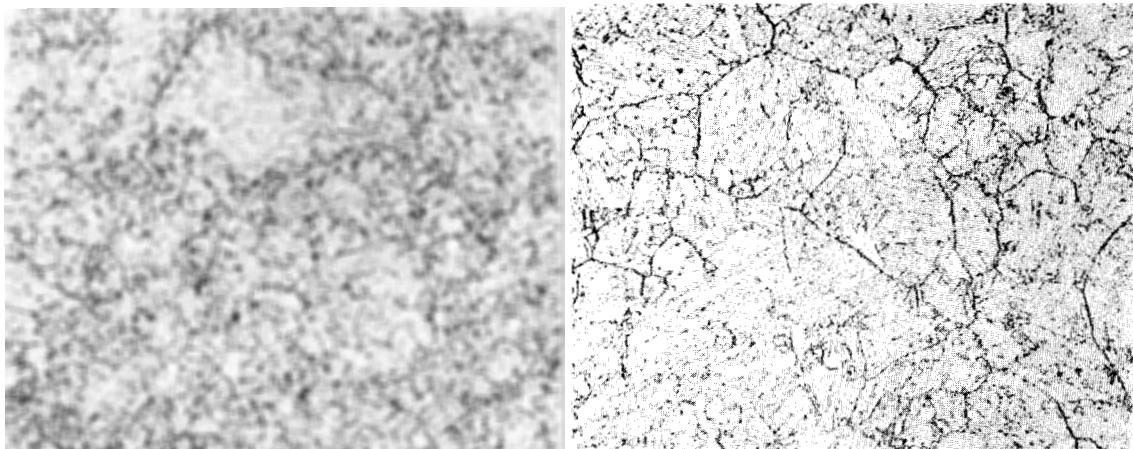
FIGURE 3-1. MICROSTRUCTURE OF DISC MATERIAL.

Metallographic specimens of each of the three disc materials were examined to determine the relative grain boundary etching sensitivity. The specimens were prepared in a single mount and immersion etched for 90 minutes in a saturated aqueous solution of picric acid plus 1% sodium tridecylbenzene sulfonate. The microstructural features developed by this etching procedure are shown in Figure 3-1. In each case, the grain boundaries are clearly delineated but the boundaries are only lightly etched. No differences in grain boundary structure or grain boundary etching response was noted among the three specimens.

The etching sensitivity of a material to this particular reagent is a function of grain boundary phosphorus content(1). In general, the degree of etching of the boundaries increases with increasing phosphorus content. The observed etching response provides evidence of phosphorus segregation at grain boundaries in all three samples. However, this etching effect is not necessarily indicative of abnormally high phosphorus content or of an abnormal degree of grain boundary segregation.

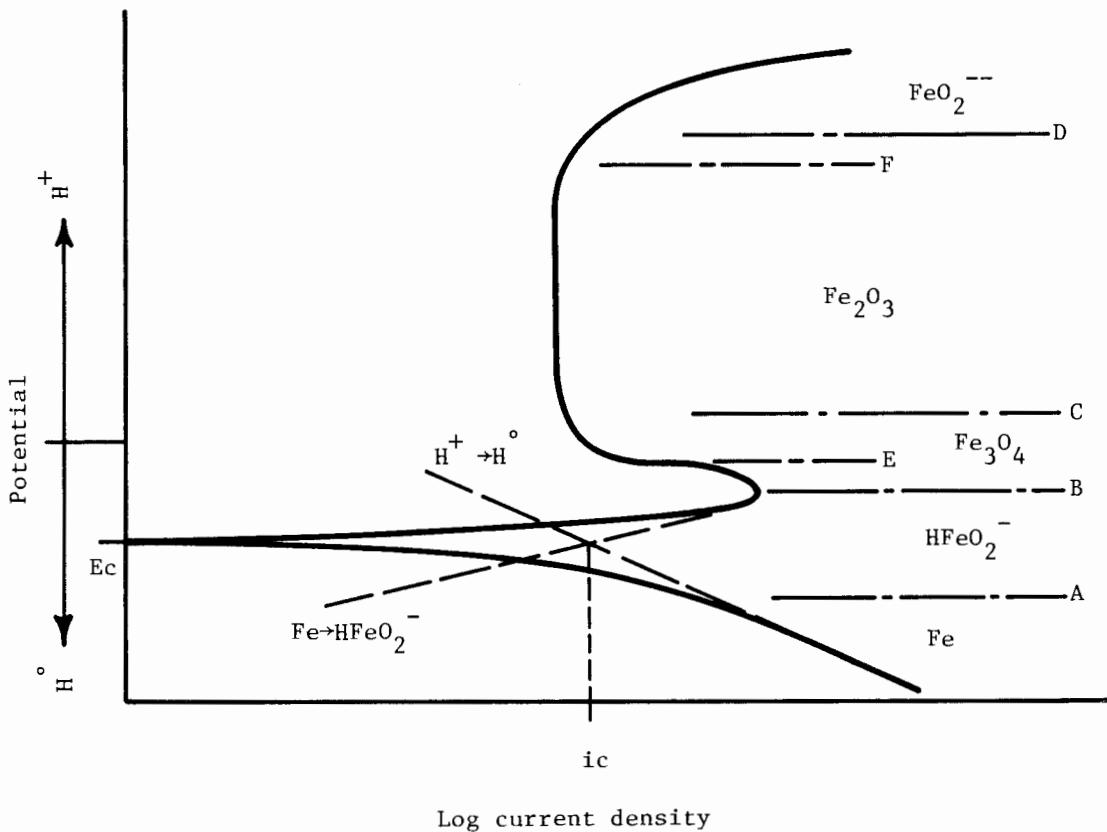
FIGURE 4-1. SCHEMATIC POLARIZATION CURVE.

A schematic diagram of a polarization curve for an iron-base alloy exposed in a strongly alkaline solution is shown in Figure 4-1. The solid curve is the typical potential vs log current density trace recorded from a polarization test. This curve is the sum of the anodic current (dissolution of iron, e.g., $\text{Fe} \rightarrow \text{HFeO}_2^-$) and the cathodic current (reduction of hydrogen, $\text{H}^+ \rightarrow \text{H}$). The free corrosion potential lies at the value at which the anodic and cathodic currents are equal. Since the recorded current density is the sum of these two currents, the point at which current density decreases to zero corresponds to the free corrosion potential (point E_c in Figure 4-1). The value of current i_c , corresponding to the intersection of the anodic and cathodic reaction curves, is the free corrosion current and is a measure of the corrosion rate of the specimen material under freely corroding conditions where iron is oxidized to soluble HFeO_2^- . As the corrosion potential is increased above E_c values are reached where Fe_3O_4 and Fe_2O_3 can be formed (regions B-C and C-D in Figure 4-1). These oxides form partially and fully protective layers, respectively, and reduce the corrosion rate. The region in which the protective Fe_2O_3 layer is formed is termed the passive region (region C-D in Figure 4-1). At potentials above D the stable films begin to dissolve and soluble species, e.g. FeO_2^{--} , form with a corresponding increase in corrosion rate.

borderline between the formation of a stable protective film and active dissolution of the base metal. In terms of the polarization curve there are two such critical potential regions in which caustic SCC is likely to occur. These are designated as regions E-C (lower cracking region) and F-D (upper cracking region) in Figure 4-1. Under some conditions, the lower cracking range may extend below the anodic peak, i.e., into the active corrosion region, A-B.

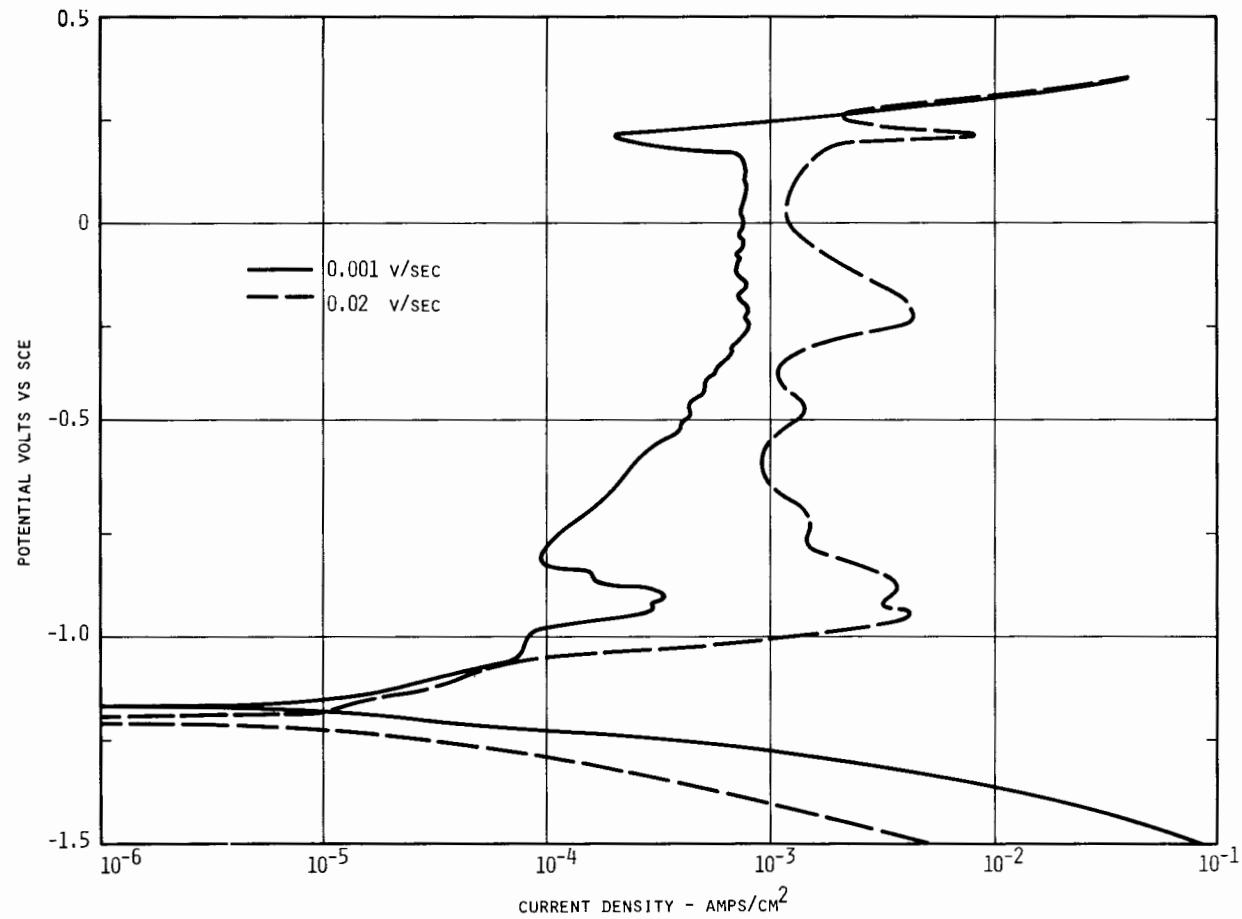
FIGURE 4-2. POLARIZATION CURVE. C-1 Disc material.
28% NaOH, 93.3°C (200°F).

The potentiodynamic polarization curves obtained for the three disc materials in the caustic solution were generally similar and exhibited features characteristic of an iron-base alloy in a high-pH solution. The curves obtained at 93.3°C (200°F) are shown in Figures 4-2, 4-3 and 4-4. The indicated corrosion potentials at 93.3°C (200°F) were in the range of -1.10 to -1.22 volts. Regions of anodic activity were observed for both the fast scan and slow scan at potentials in the range of -0.9 to -1.0 volts. Definite passive zones,

At potentials near the lower anodic peak (-0.8 to -1.1 volts) the current densities for the slow and fast scans differ by an order of magnitude or more in all three cases. By Parkins' criterion, this factor is an indication of susceptibility to SCC and together with the distinct lower anodic peak identifies a lower cracking region. In the case of the C-1 disc material the indicated lower cracking region occurs in the potential range of -0.82 to -0.98 volts. In this region the maximum value of the ratio of current densities (fast-scan/slow-scan is 22, see Figure 4-2. In the corresponding regions of the polarization curves for the D-1 and E-1 materials, the current density ratios were 50 and 77 respectively, see Figures 4-3 and 4-4. These results suggest a lower degree of susceptibility for the C-1 material. For the fast potential scans the D-1 material exhibited the highest value of maximum current density (8×10^{-3} vs 2.8×10^{-3} and 4.1×10^{-3} amps/cm²) indicating a higher corrosion rate for bare metal.

- 1.) C-1 disc material; lowest value of maximum current density ratio.
- 2) E-1 disc material; higher value of maximum current density ratio.
- 3) D-1 disc material; higher value of maximum current density ratio and highest absolute value of current density (i.e., highest bare-metal corrosion rate).

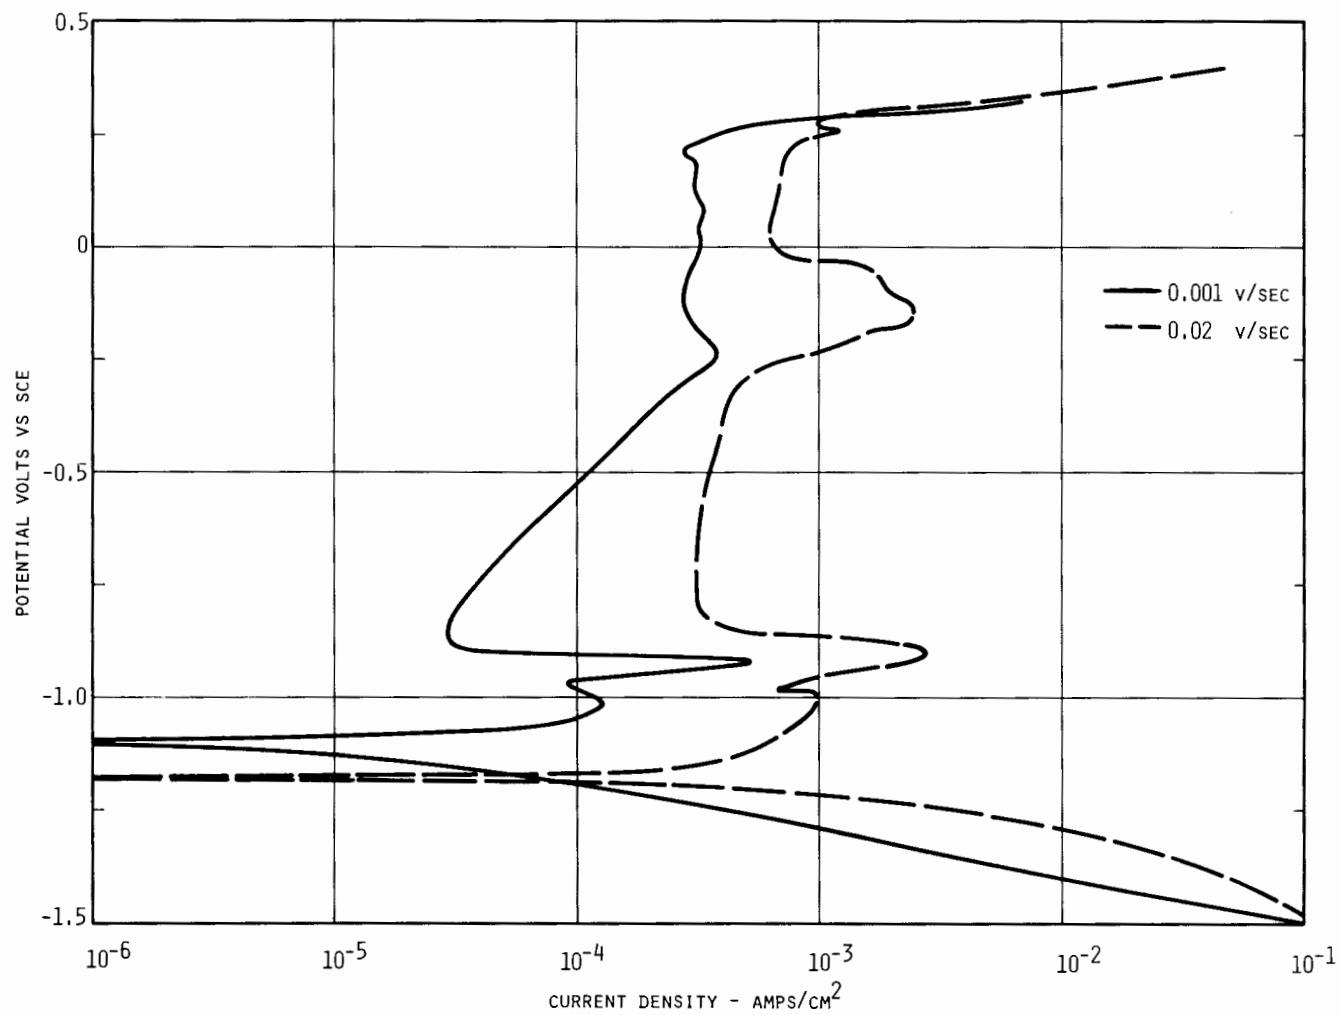
FIGURE 4-4. POLARIZATION CURVE. E-1 Disc material.
28% NaOH, 93.3°C (200°F).

The upper portions of the three polarization curves are similar in that a sharp increase in current density occurs at potentials above 0.2 volts for the slow scan curve in all cases. This increase in current density corresponds to the point of dissolution of the protective films, point D in Figure 4-1. In general, the region immediately below this change in current is a zone of possible SCC susceptibility. In the case of the C-1 and D-1 materials, a marked increase in current for the fast scan and a marked decrease in current for the slow scan occurred at a potential of approximately 0.2 volts, see Figures 4-2 and 4-3. This factor results in a significant difference between the fast scan and slow scan currents (current density ratio of 40) and suggests that these materials may be particularly susceptible to the SCC in the upper cracking region. The E-1 disc material did not exhibit a large anodic peak at the high potential end of the polarization curve, see Figure 4-4.

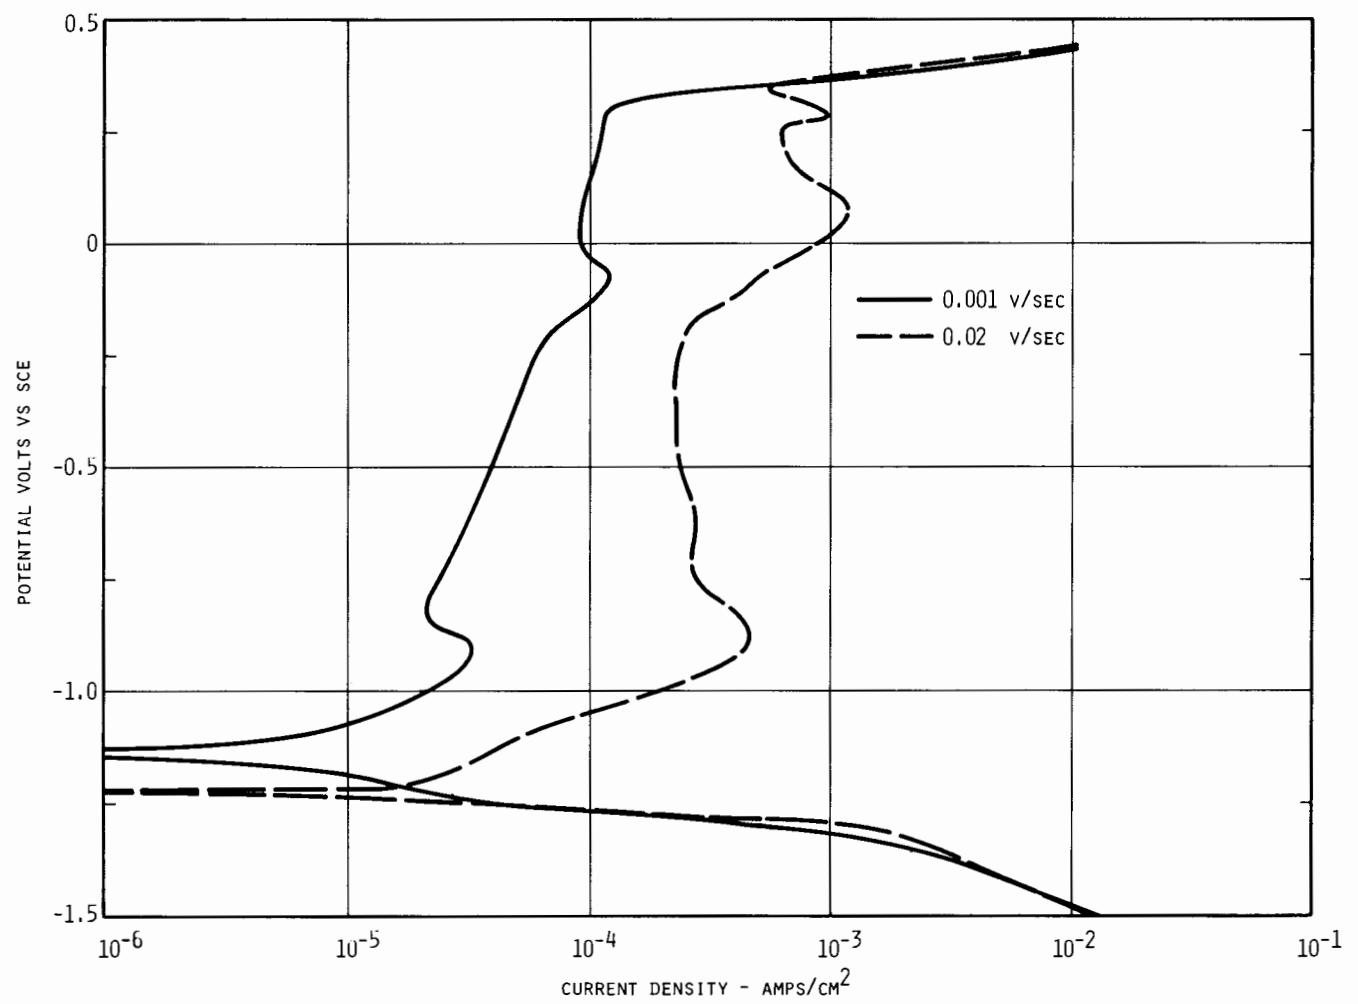
FIGURE 4-5. POLARIZATION CURVE. C-1 Disc material.
28% NaOH, 37.8°C (100°F).

The results of the 37.8°C (100°F) test on the C-1 material in the caustic solution are presented in Figure 4-5. The indicated free corrosion potential is -1.13 volts and the shape of the polarization curve is generally similar to that of the 93.3°C test. Within the passive zone the absolute current values were reduced by an order of magnitude from those measured at the higher temperature. The difference in the current between the slow and fast scans were comparable to or less than those of the 93.3°C test over the entire potential range. These factors are indicative of a lower degree of SCC susceptibility at the lower temperature. In view of these results, no further tests were conducted at 37.8°C.

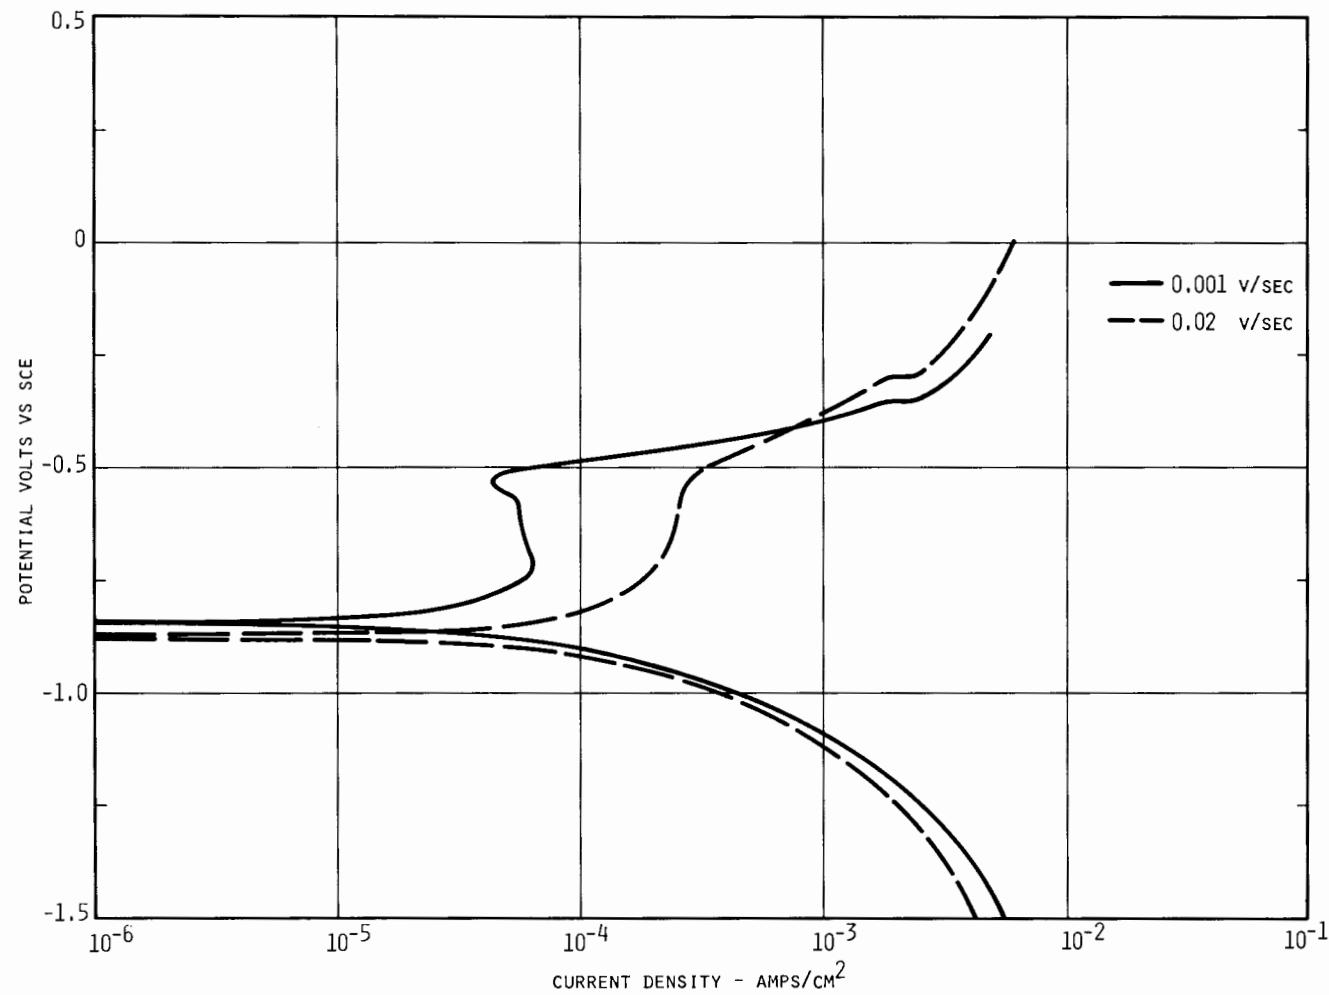
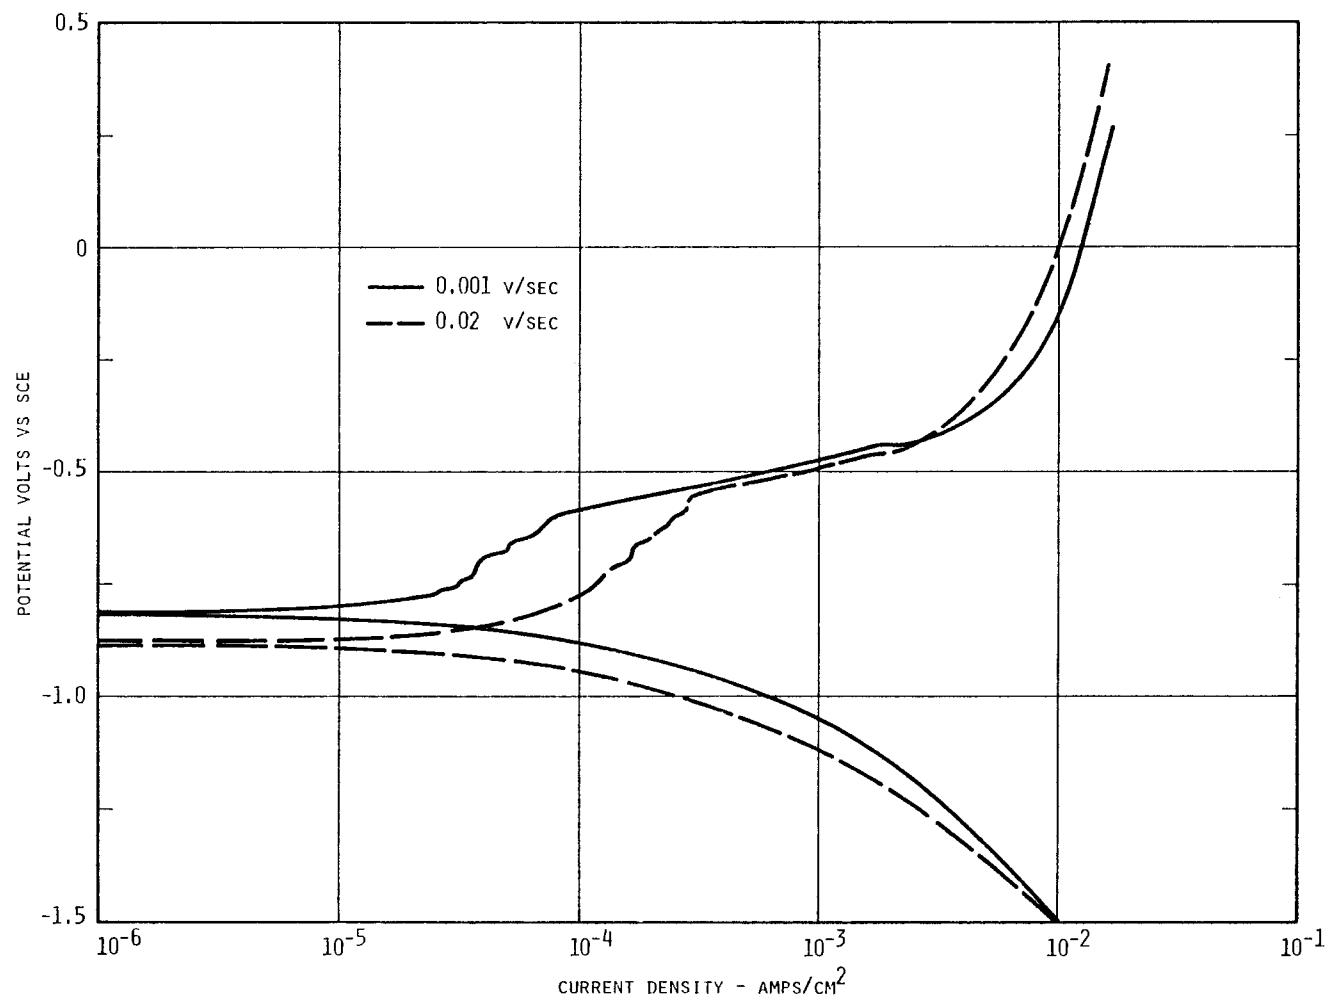
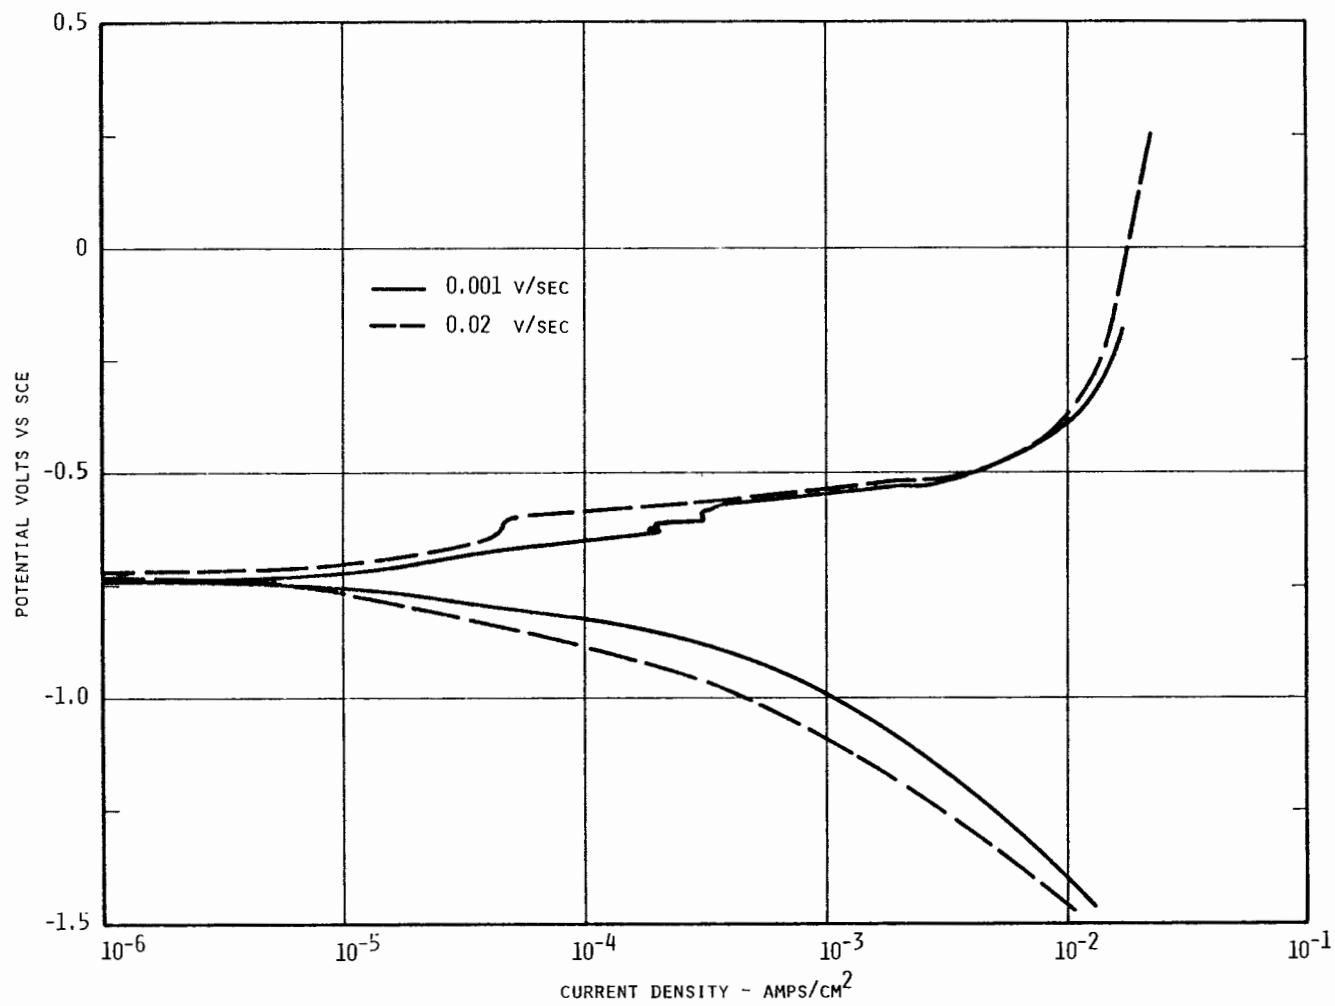
The polarization curves obtained for the three disc samples in deoxygenated water are shown in Figures 4-6, 4-7 and 4-8. The free corrosion potentials indicated in these tests were in the range of -0.75 to -0.85 volts. No anodic peak was observed for any of the materials and the current differences between the fast scan and slow scan curves were relatively small. No distinct passive zone was evident in any case. The C-1 material exhibited a zone of restricted

dissolution over a potential range of -0.75 to -0.5 volts but active corrosion (at a very low corrosion rate) was indicated at all potentials above the free corrosion potential for the D-1 and E-1 materials. The results of the polarization tests in deionized water did not provide any evidence of SCC susceptibility for any of the three disc materials.
