Metallurgical Analysis of Rim Cracking in an LP Steam Turbine Disc

NP-1532
Research Project 1398-1

Final Report, September 1980
Work Completed, February 1980

SOUTHWEST RESEARCH INSTITUTE
P.O. Drawer 28510
6220 Culebra Road
San Antonio, Texas 78284

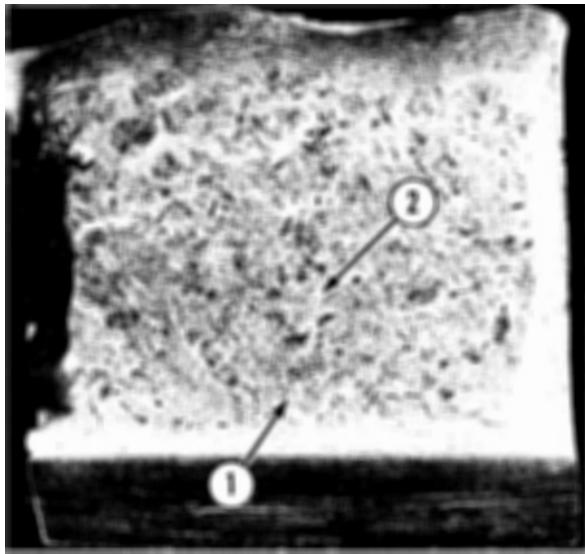
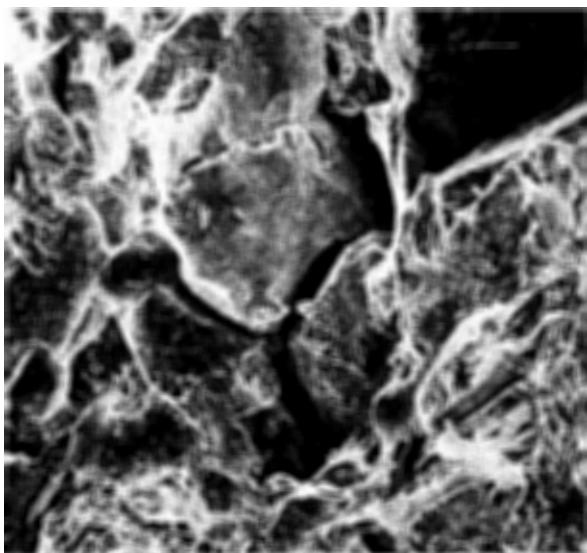
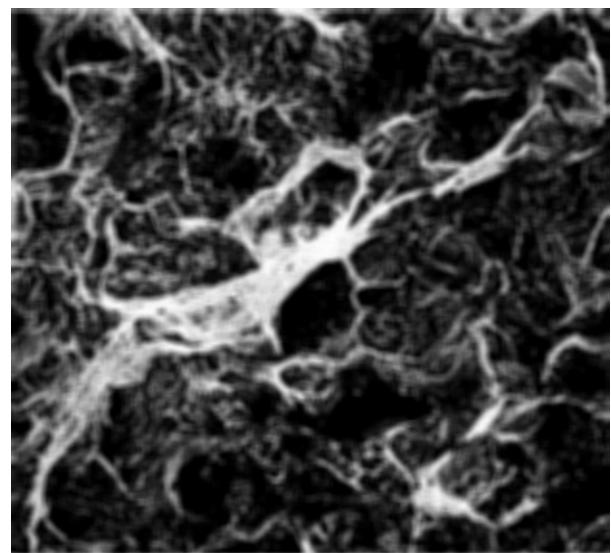
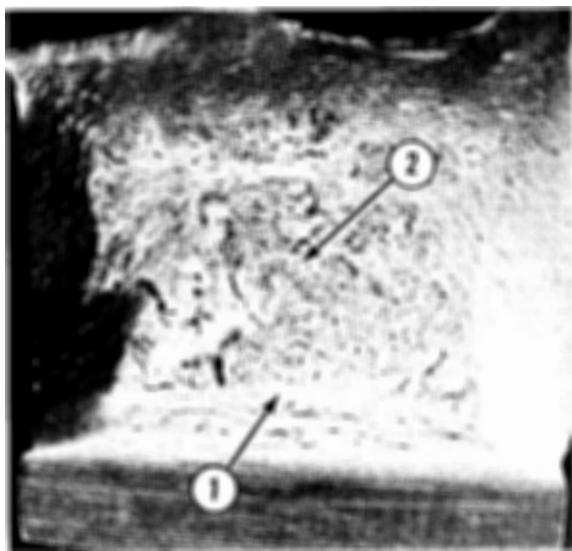
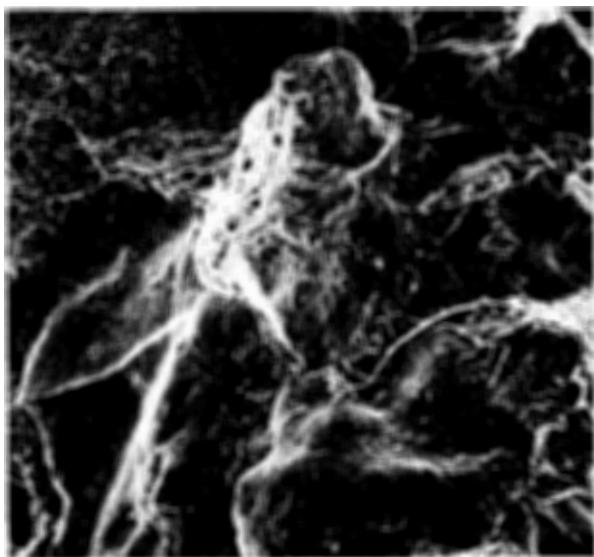
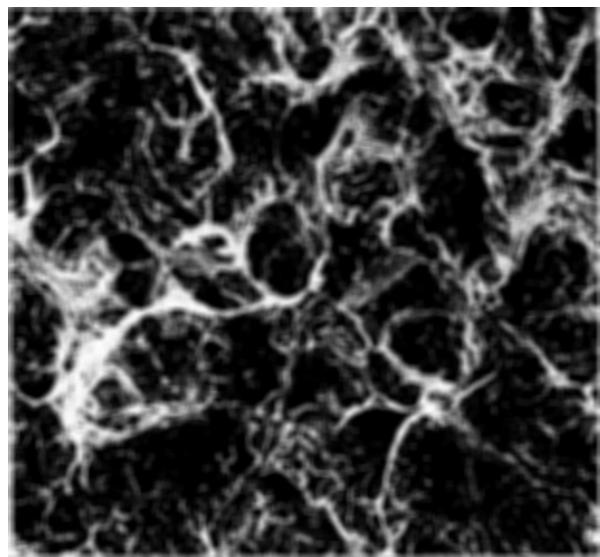
SEM fractographs from other specimens from the ductile-brittle transition zone, demonstrating the increasing degree of microvoid coalescence with increasing test temperature and certain details of the fracture surfaces, are presented in Appendix B, Figures B-1 through B-4.
