Failure-Cause Analysis— Feedwater Heaters

EPRI CS-1776
Project 1265-7
Final Report
April 1981

Prepared by
International Energy Associates Limited
Washington, D.C.

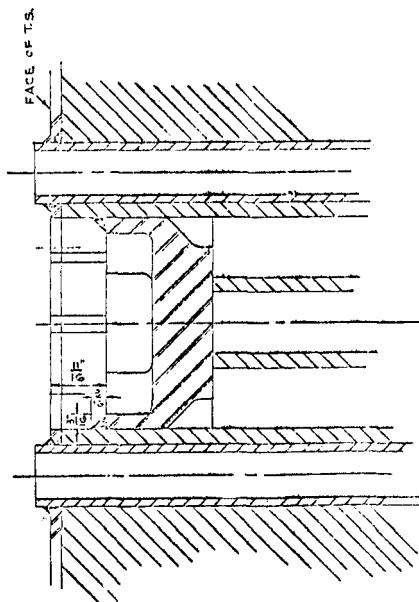
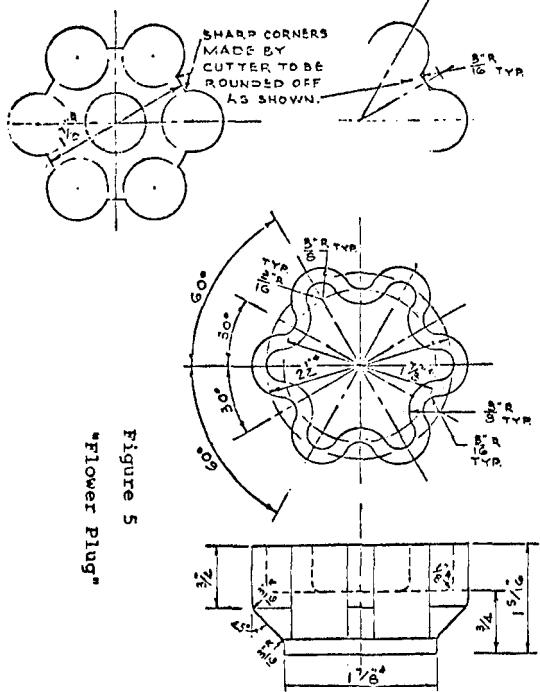
Figure 5
"Flower Plug"

Plugs of various geometries, depending upon preference, experience and hole(s) repair configuration, have been used for years. Recently, as the failure mechanism at the welded plug area has been better understood and its impact upon subsequent failure modes fully realized, a more sophisticated type of plug such as shown in Figure No. 5, Appendix "B" have been used at Public Service Electric and Gas Company, New Jersey.

Bergen Generating Station heater No. 17 again developed leaks and it was found that some of the Explosion weld plugged tubes in the ridges were leaking. The cracked ligaments were machined out and special flower plugs welded to seal 72 holes in one ridge and 31 in the other. Photograph No. 7, Appendix "B" show the locations of flower plugs.

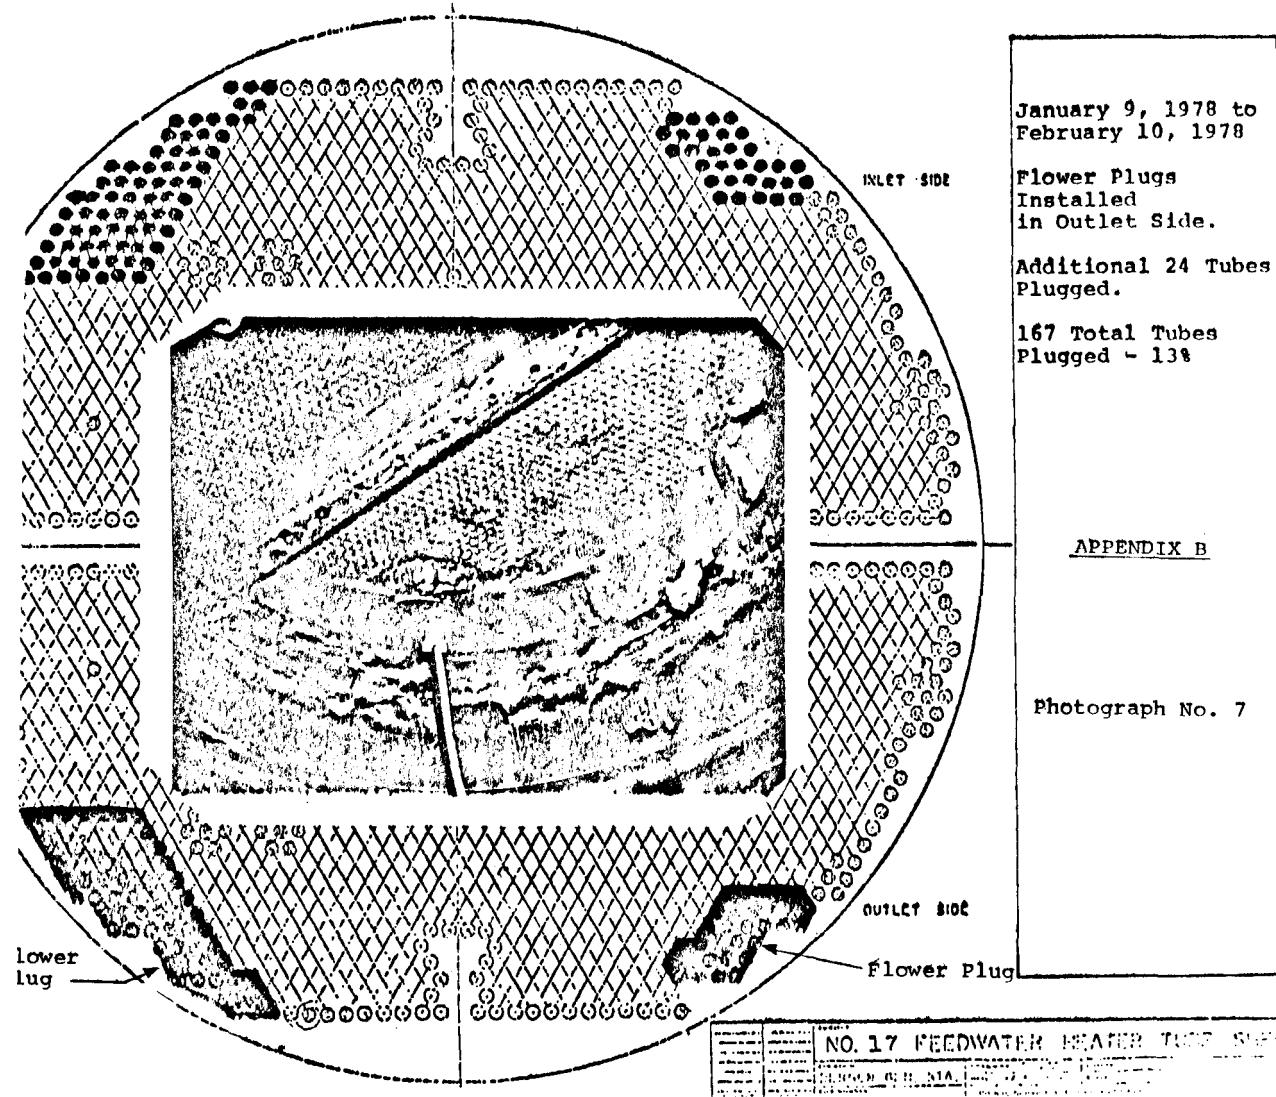
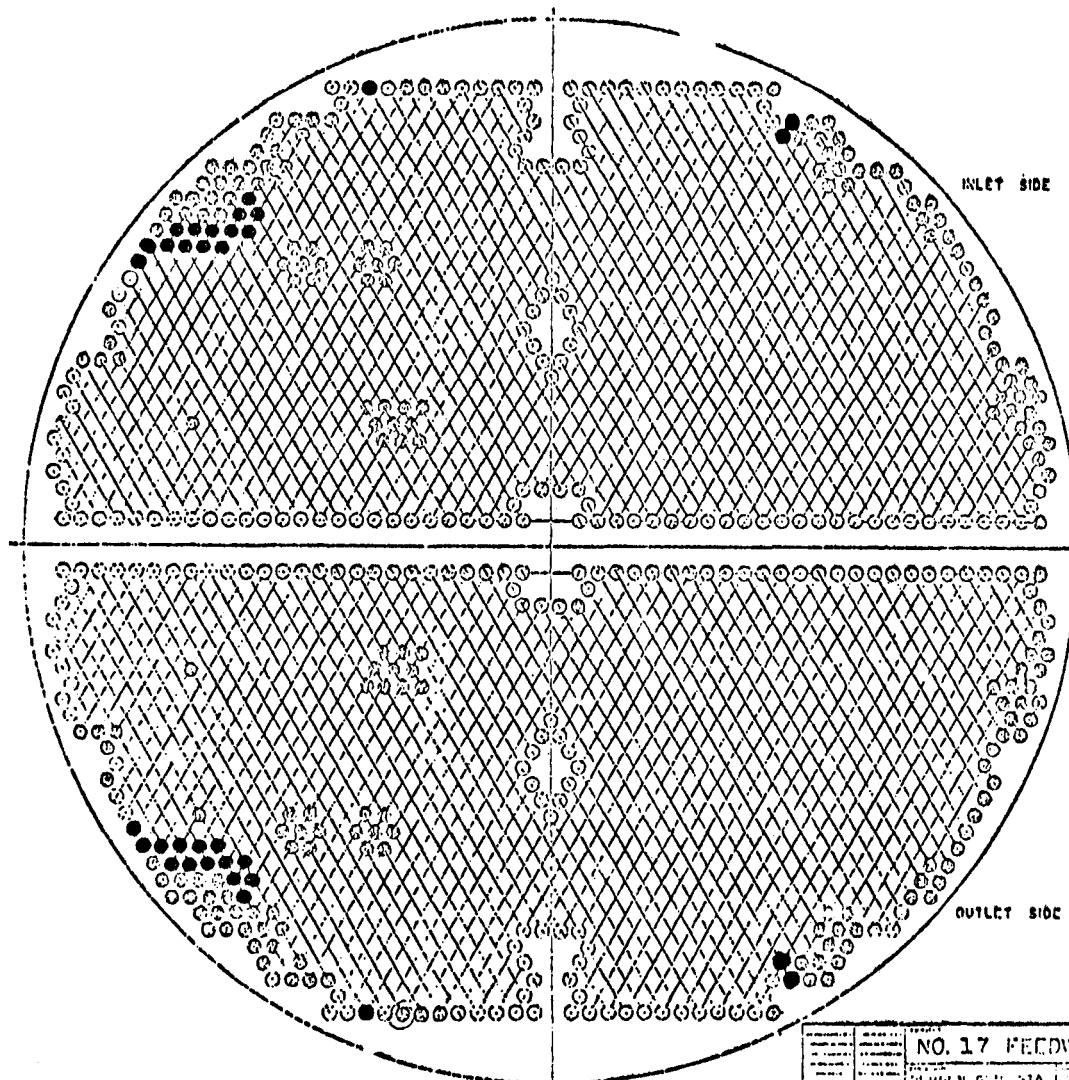
APPENDIX B
FIGURE NO. 8

They have mostly been used for low and moderate pressure exchangers. PSE&G has used them in high pressure feedwater heaters inside the tube-sheet in addition to the welded plugs at the face of the tube-sheet when cracked and/or worm-holed ligaments existed. (Figure No. 8, Appendix "B").

17 Additional Tubes
Plugged - 9.7%

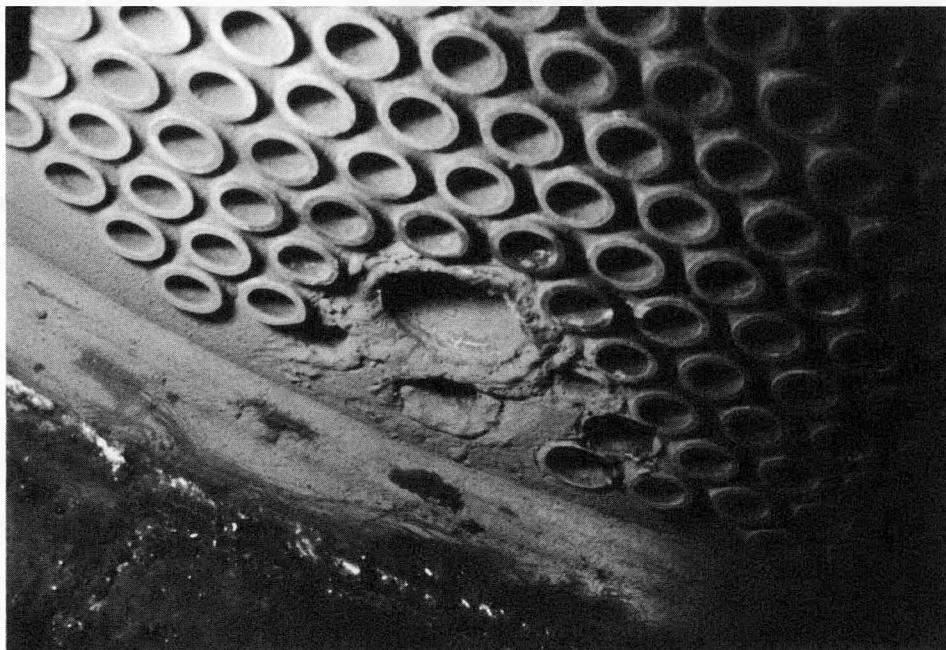
PHOTOGRAPH NO. 7
NO. 16 FEEDWATER HEATER, HUDSON GENERATING STATION
A FLOWER PLUG IN PLACE

Hudson Generating Station feedwater heater No. 16 (a vertical head down, high pressure) had a leaking cluster of tubes previously repaired by welding. These tubes were drilled out and holes inspected. Three ligaments were badly damaged and the explosion weld plugging was doubtful and, therefore, rejected. It was considered advisable to use flower plug for the 7-tube cluster having damaged ligaments and the explosion plugs for 2 adjoining failed tubes and the other end of all the failed tubes. All tubes to be plugged were drilled out 6 to 7 inches from the face of the tube-sheet and the tube-sheet hole reamed and cleaned. The tubes were then rolled with mechanical rollers at the back of the tube-sheet and explosion weld plugged near the back of the tubesheet. A total of 11 explosion welded plugs were used and all of them are holding since July 1977. Figure No. 3, Appendix 'C' shows the location of leaking cluster and Photograph No. 7, Appendix 'E' shows the flower plug repair.

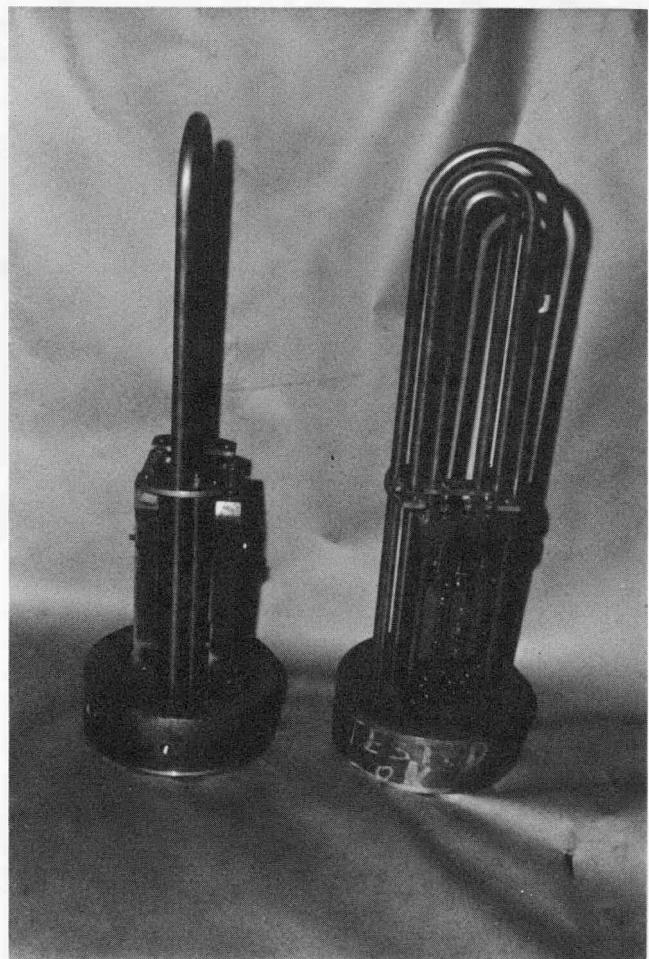
PHOTOGRAPH NO. 9
TX-312 TEST HEAT EXCHANGER TUBE-BUNDLE
AND COUPON CASSETTES

PSE&G has also agreed to allow Foster Wheeler to test their explosion expanded plugs in the test heat exchanger TX-312 Photograph No. 9, Appendix "E" in order to evaluate the plug under actual working conditions.
