## **Effects of Alternate Fuels Refractory Test Facility (RTF) Test 1**

### **Analysis of Selected Aluminosilicate Refractory Bricks, Mortars, and Fibrous Insulations Degraded by Domestic Residual Oil Combustion Products**

A. E. Pasto  
V. J. Tennery

Date Published: June 1978

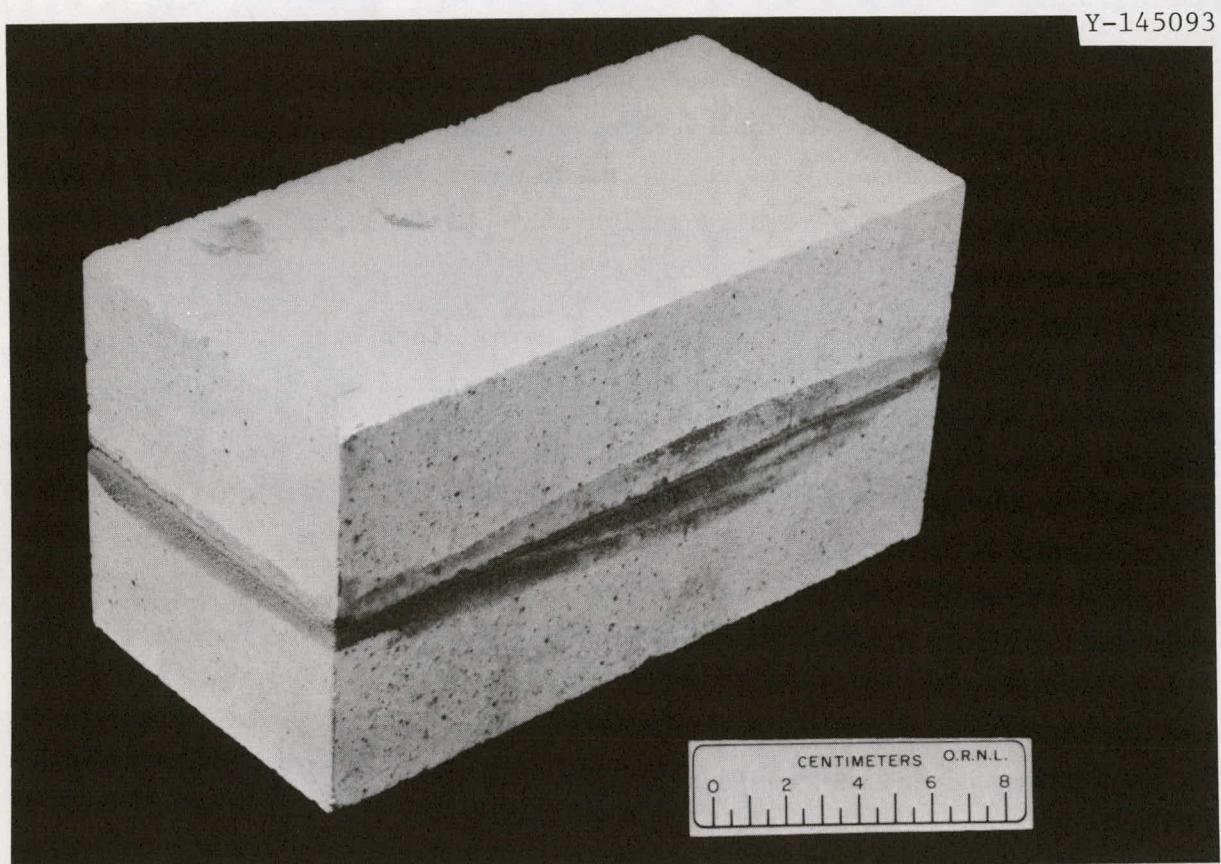
Fig. 3. High Alumina Brick Specimens, Pretest.

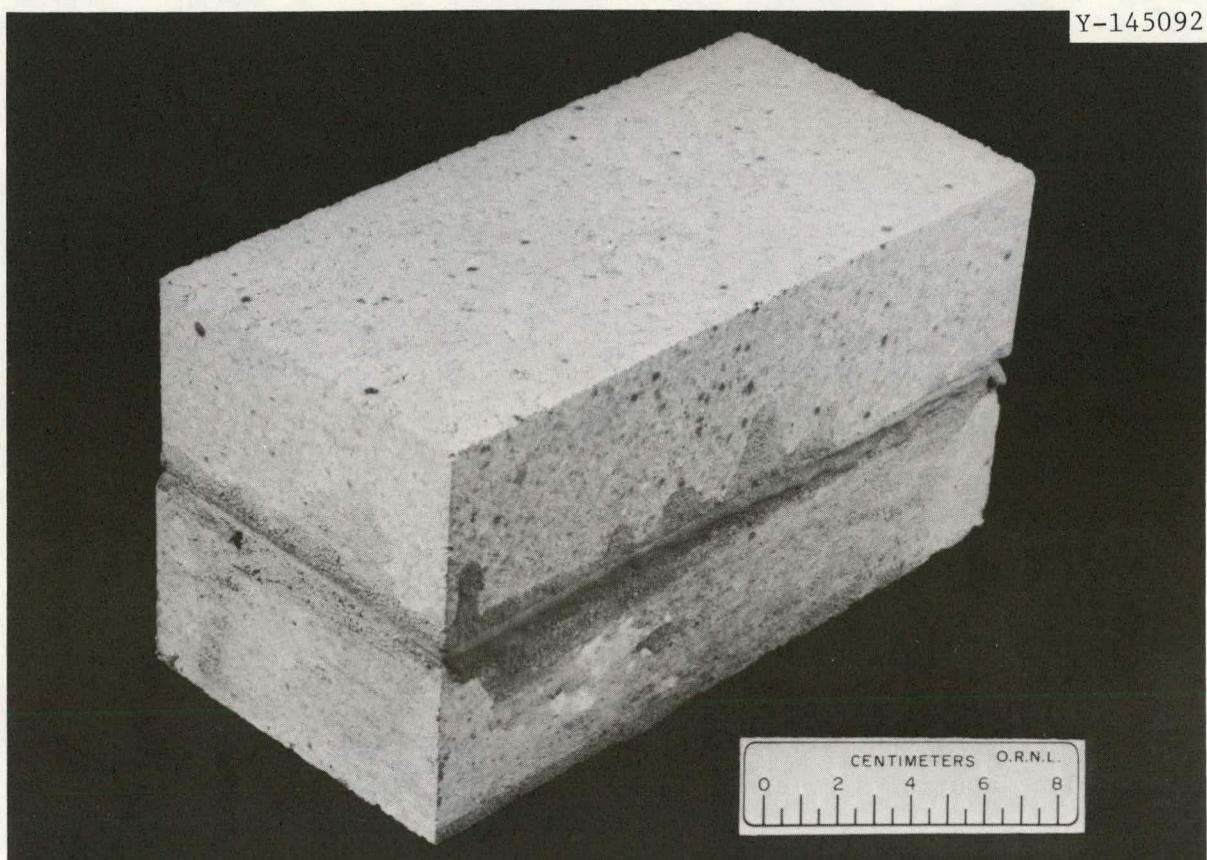
Fig. 4. Mullite-Based Brick Specimens, Pretest.

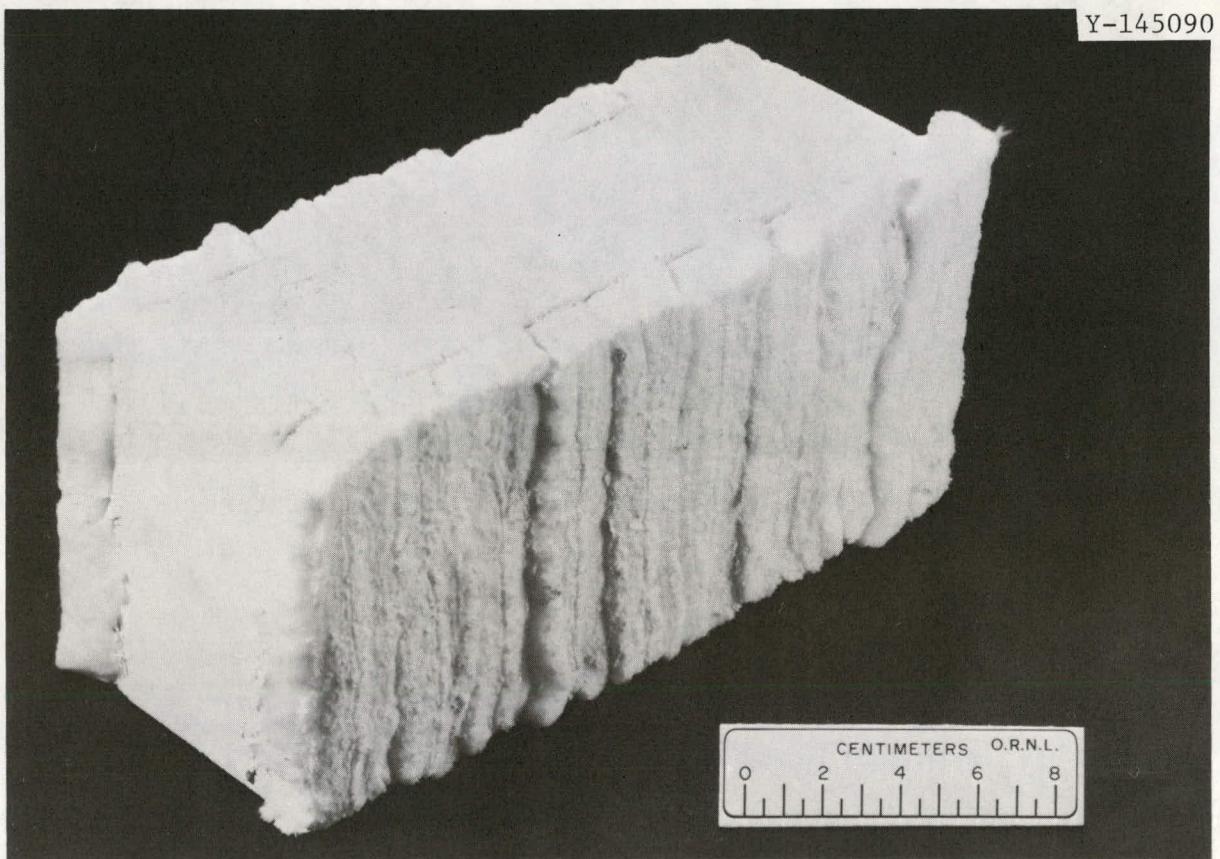
Fig. 5. High Alumina Fiber Specimens, Pretest.

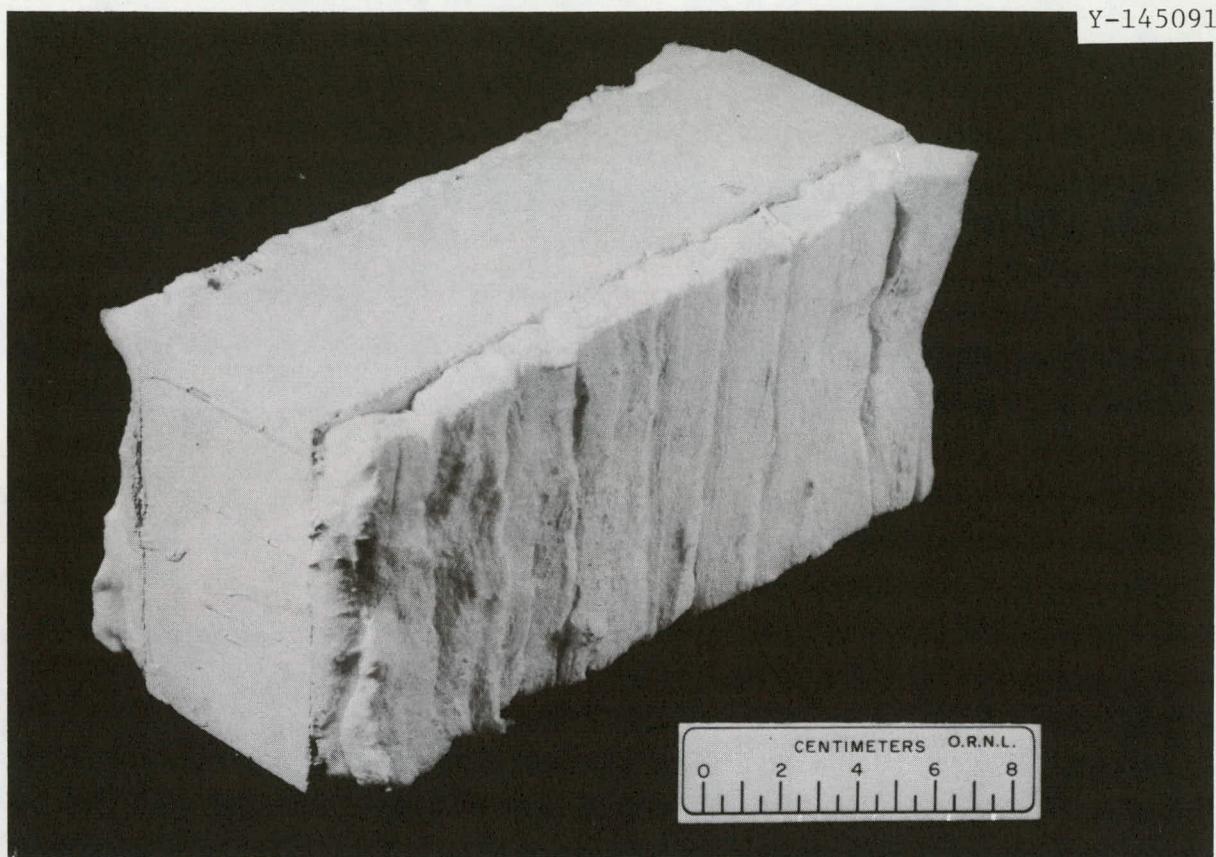
Fig. 6. Medium Alumina Fiber Specimens, Pretest.

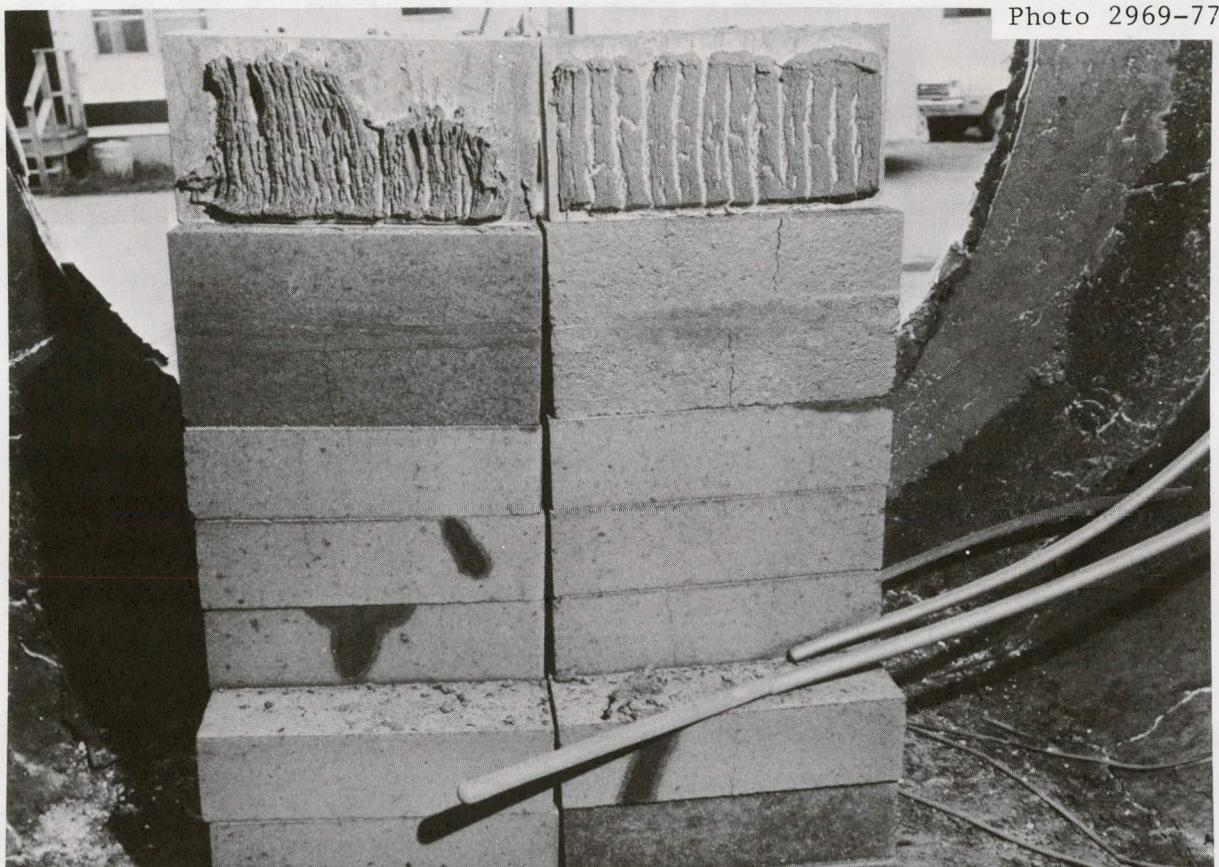
The experiment was terminated 16 June 1977. The panel at this time is shown in Fig. 8 (flame-side) and Fig. 9 (back-side).

Fig. 8. Test Panel at Conclusion of 500+ Hour Exposure, Flame-Side.

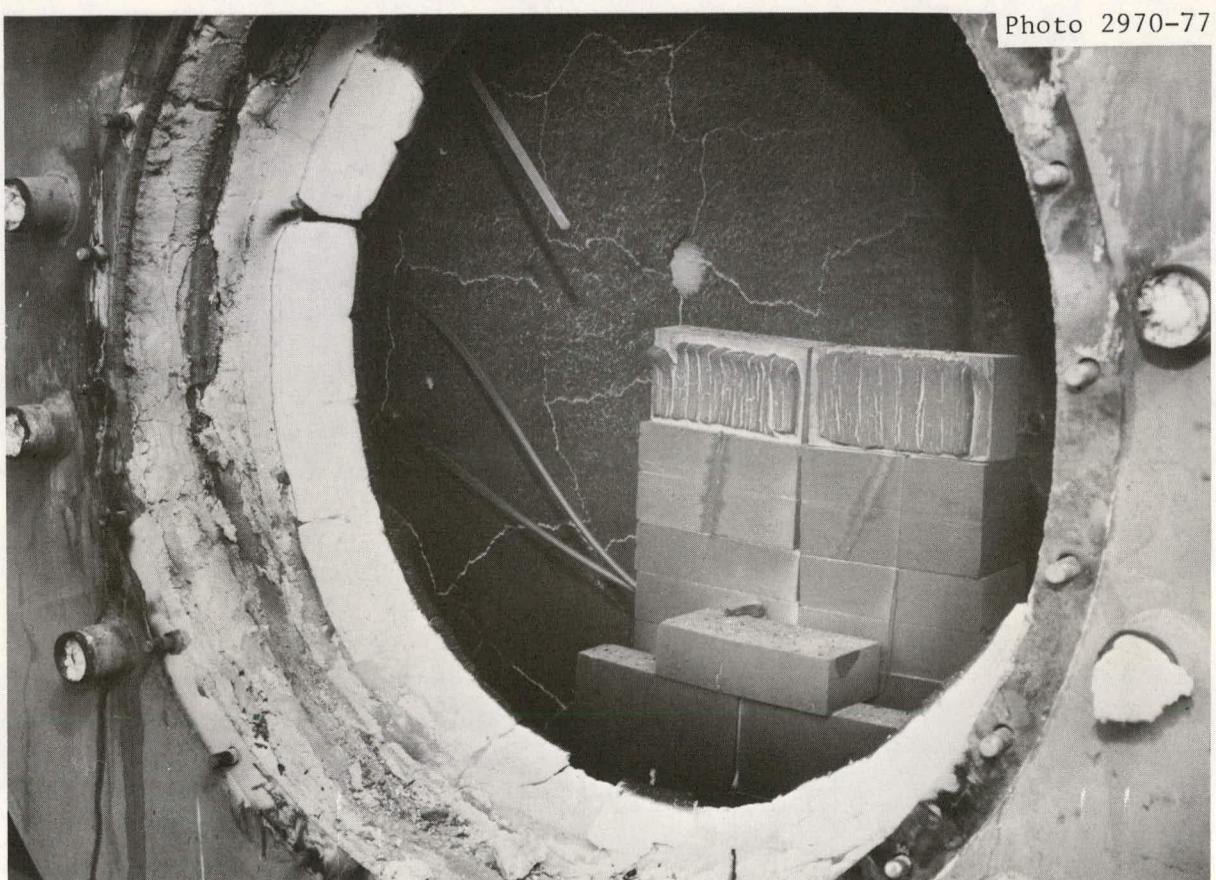
Fig. 9. Test Panel at Conclusion of 500+ Hour Exposure. Back-side.

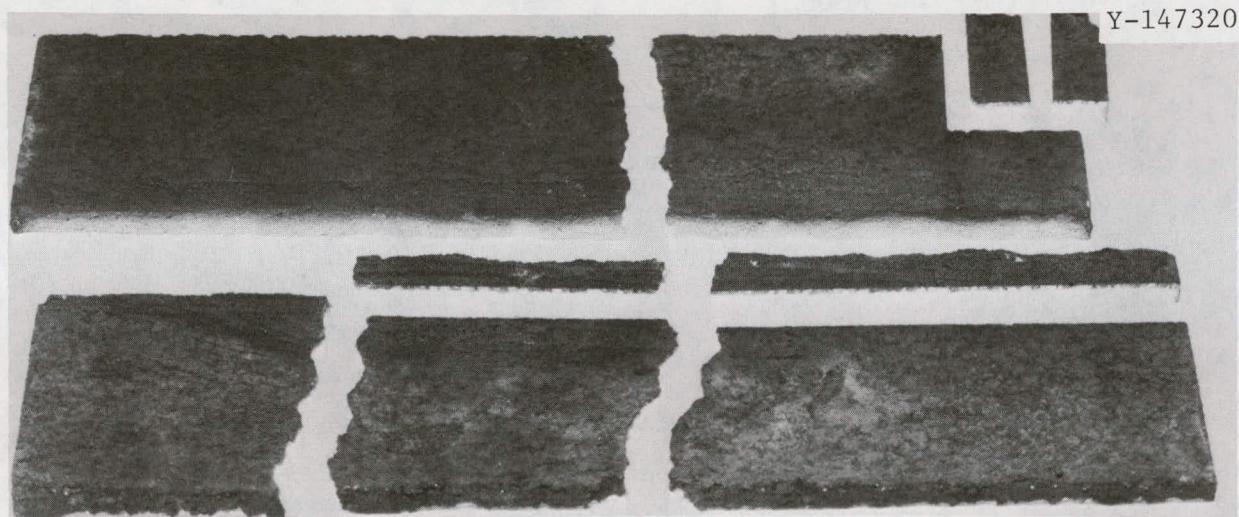
The major faces of the specimens were sectioned with a diamond saw, yielding a plate roughly 6 mm thick (0.25 in.). This was further cut into pieces for analysis as illustrated in Fig. 12. Selected portions of reacted brick and mortar were crushed for chemical and x-ray diffraction analysis. Other specimen pieces were analyzed by SEM, ceramography, and electron microprobe analysis.

Fig. 12. Flame-Side Face of HAB and PBM Specimens as Removed from Brick and Sectioned for Analysis.

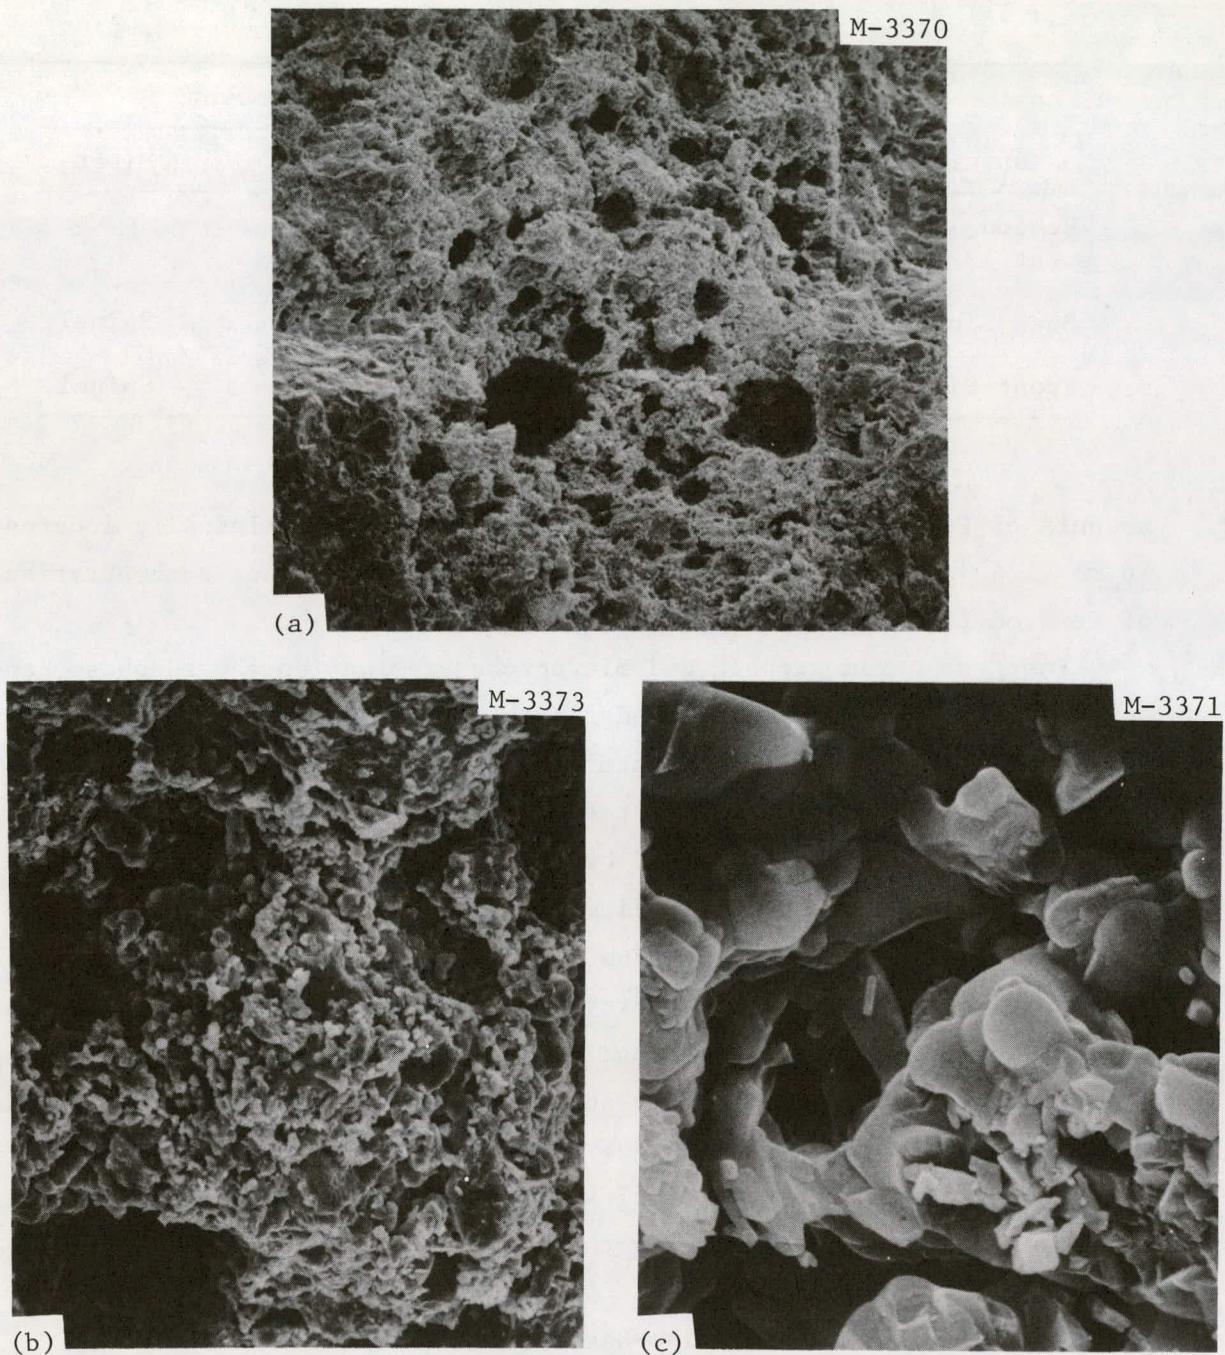
Fig. 18. Pretest Scanning Electron Micrographs of PBM Mortar-Brick Joint. (a) High porosity shown at 55 $\times$ . (b) and (c) Same area at 300 and 3000 $\times$  show heterogeneous crystalline nature of mortar.

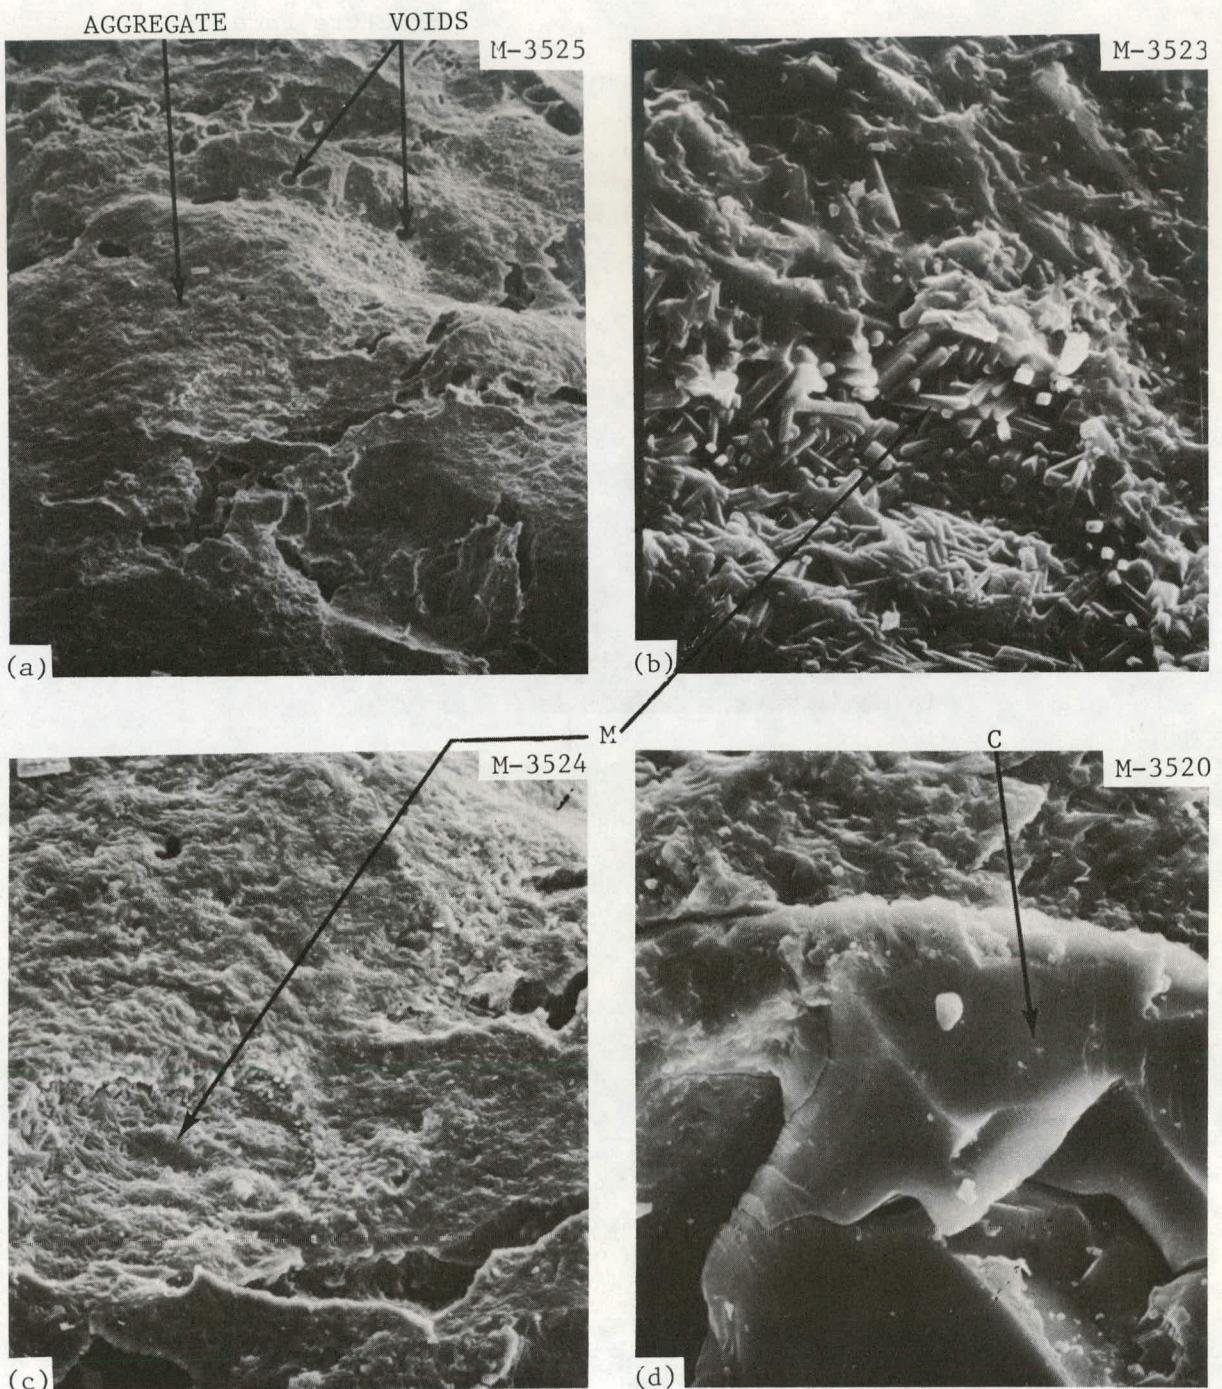
The microstructure of the as-received brick consists of large aggregates of mullite crystals bonded by silicate glass. At low magnification, these appear in large blocks surrounded by an essentially continuous void [Fig. 22(a)]. At higher magnification needles of mullite are observed [Figs. 22(b), (c)] as expected. Also visible are conchoidal fractures in the cristobalite [Fig. 22(d)]. EDX analysis of the smooth region in the field of Fig. 22(d) indicated only Si as expected for the case of the cristobalite polymorph of  $SiO_2$ . The needle-shaped crystals such as those shown in Fig. 22(b) contain detectable Al and Si with minor Ti and Fe. Adjacent to these crystals, the glassy or amorphous area between these crystals contained Al and Si as major detectable elements plus K, Ti, and Fe.

Fig. 22. Scanning Electron Micrographs of PreTest MBB Specimens, M: Mullite; C: Cristobalite. (a) Fracture surface showing mullite aggregates, voids. 300 $\times$ . (b), (c) Same area at 1000 and 3000 $\times$  showing mullite needles, glass matrix. (d) Different area of same specimen, showing cristobalite grain. 1000 $\times$ .

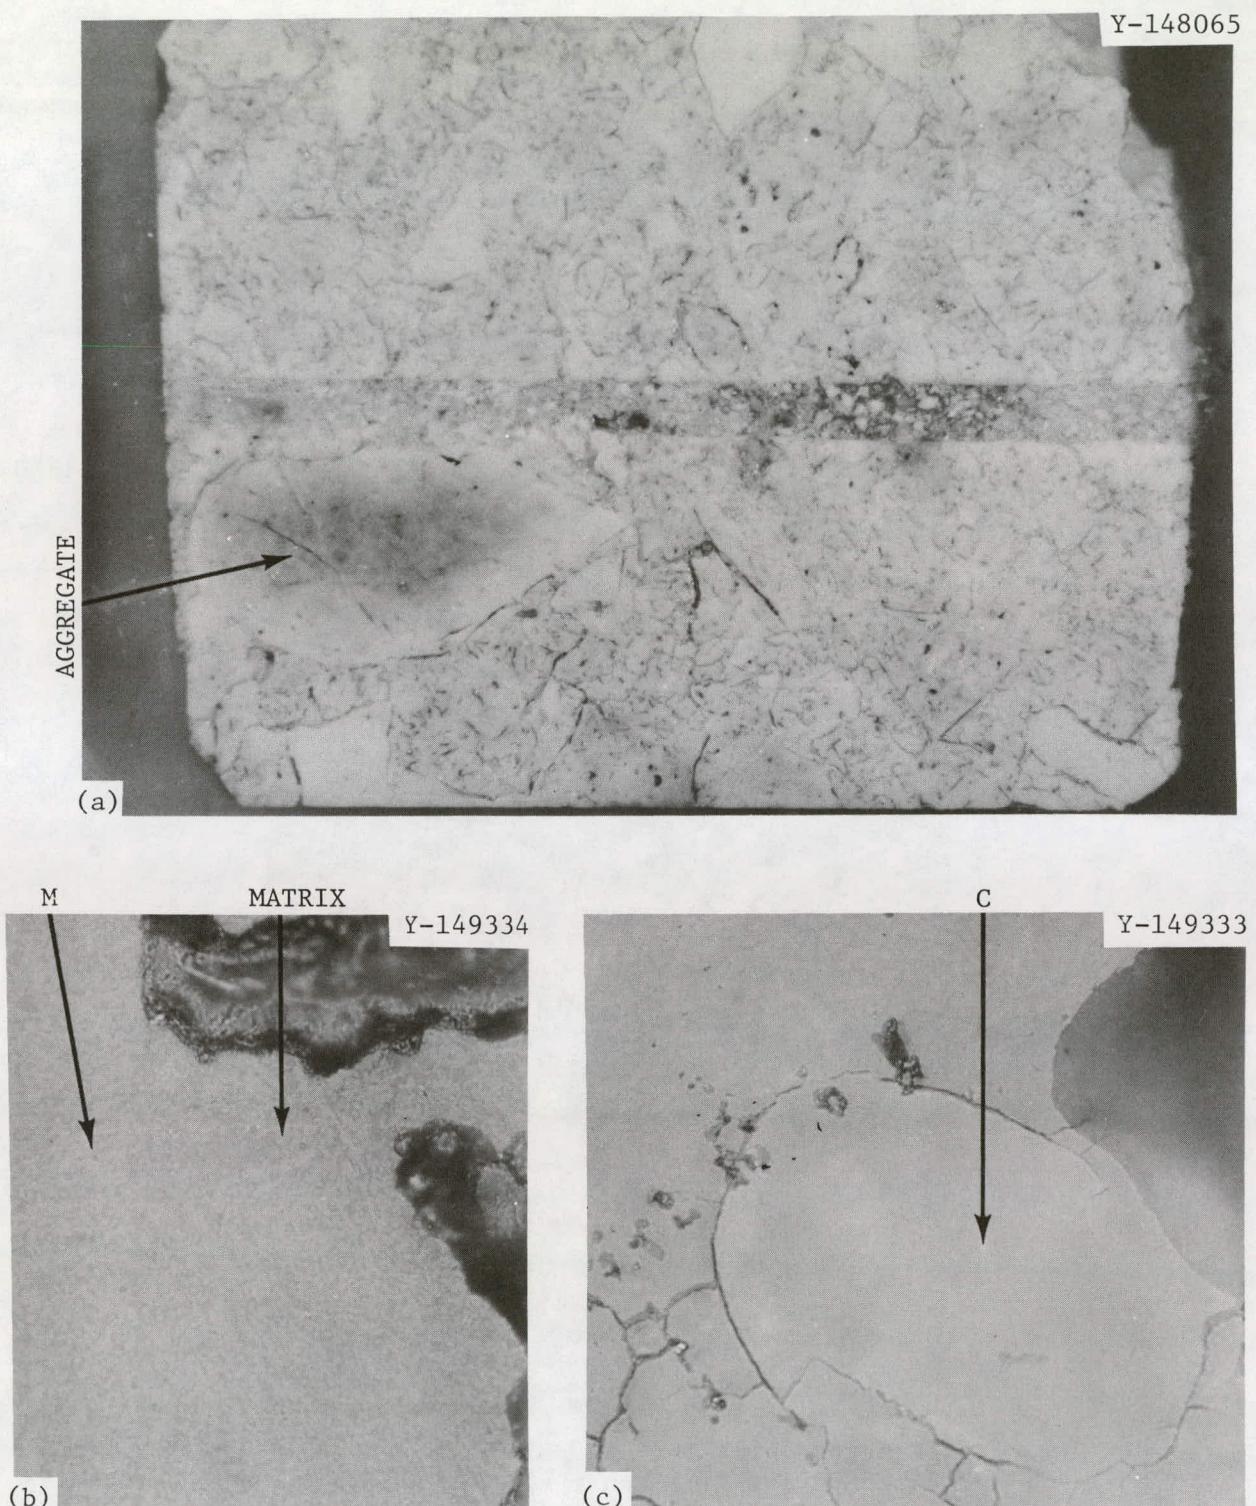
Ceramographic examination and electron microprobe results supported conclusions derived from the SEM data. Fig. 25(a) is a low magnification photograph of a polished section through the pretest MBB brick and MBM mortar. The large mullite aggregates and surrounding cracks are readily apparent. At higher magnification, in Figs. 25(b) and (c), the nature of the mullite and the cristobalite phase is illustrated. Figure 26 illustrates the microstructure of the MBB specimen which faced the burner and includes the slag surface. The oxide crystals containing high levels of Fe, Zn, and Al observed in other specimens were present. The matrix material contains the same elements as observed for other specimens, notably high Al and Si, medium Ca and Fe, and small Zn and S. The highly reflective needle-shaped crystals apparent in Fig. 26(a) were unique to the MBB specimens. These crystals contain the same elements as the matrix plus a significant amount of Ti. They are present in insufficient quantity to analyze by x-ray diffraction. Fig. 26(b) is of the slag area immediately behind the area shown in Fig. 26(a). It contains a light gray phase containing major Al and Si and is therefore probably mullite. Lower concentrations of Fe, Ti, and Zn were also detected. The matrix material in this sample appears to be a glass and contains major concentrations of Al and Si, plus lesser levels

Fig. 25. Pretest MBB Specimens. M: mullite; C: cristobalite. (a) MBM joint between MBB brick specimens. 100 $\times$ . Mullite aggregates are surrounded by cracks. (b) Polished section of mullite aggregate in MBB specimen shows mullite crystals (light gray) in glassy matrix (darker gray). 500 $\times$ . Very dark areas are voids and mounting material. (c) Cristobalite remnant in contact with mullite aggregate. 500 $\times$ .

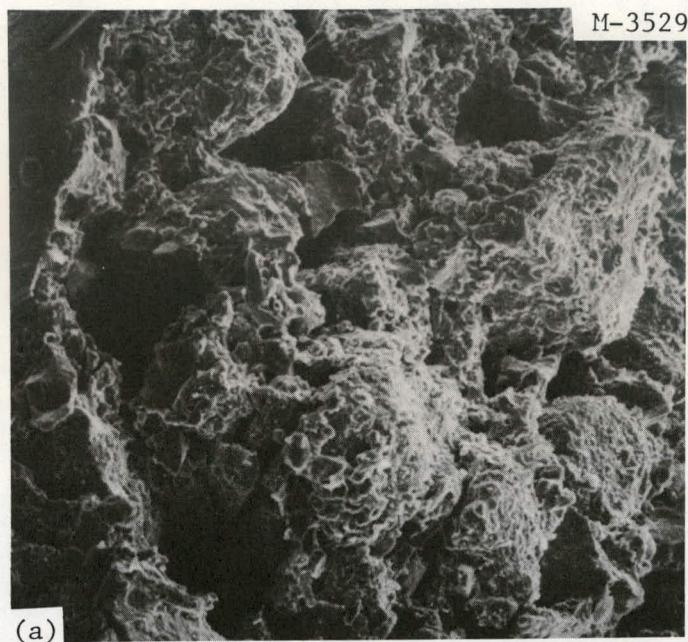
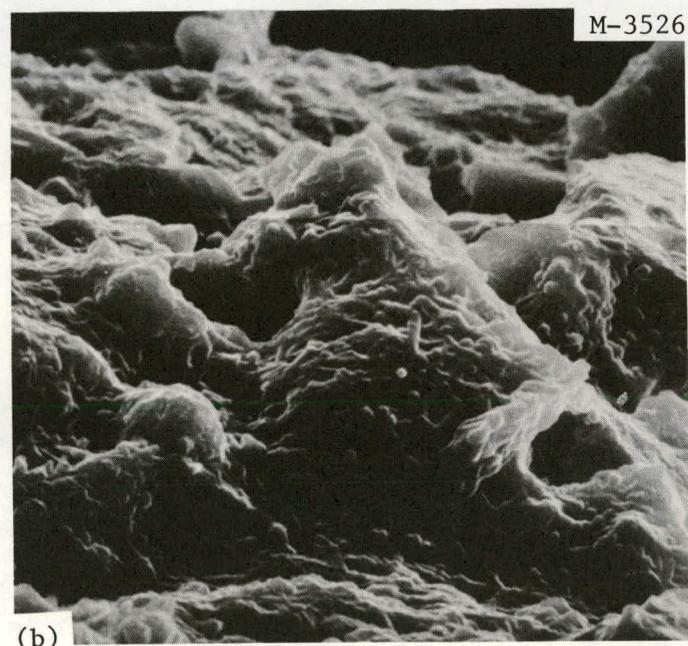
The mortar microstructure consists of aggregates of mullite and corundum grains. These are visible in Fig. 27(a), along with the large void volume fraction. At very high magnification, small needle-shaped mullite crystals can be seen in the fracture surface [Fig. 27(b)]. These needles contain significant amounts of Al and Si, and smaller amounts of Fe, K, Ca, and Ti.

Fig. 27. Scanning Electron Micrographs of Pretest MBM Specimens.  
(a) Fracture surface through mortar shows aggregates of mullite and  $\alpha\text{-Al}_2\text{O}_3$  along with voids. 100 $\times$ . (b) Same area at 3000 $\times$ , showing very fine mullite crystals.

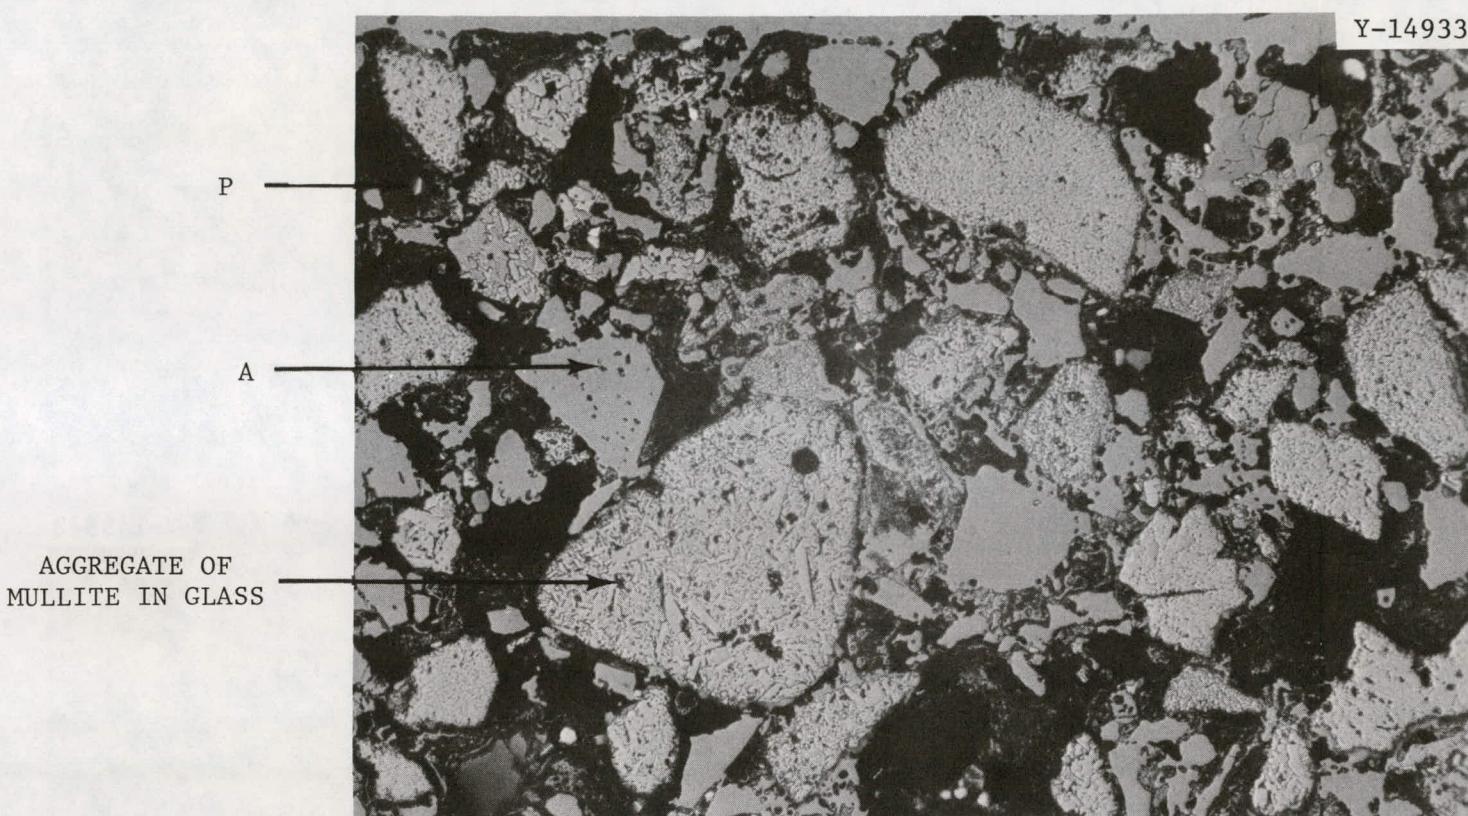
The microstructure of the pretest mortar as revealed by ceramography is shown in Fig. 29. This material is multiphase, containing aggregates of fine mullite in a very finely grained or glassy matrix, larger grains of corundum (large light areas in the figure), and porosity (black).

Fig. 29. Pretest Polished Section of Mullite-Based Mortar (MBM) Specimen. 100 $\times$ . A:  $\text{Al}_2\text{O}_3$ ; P: porosity.

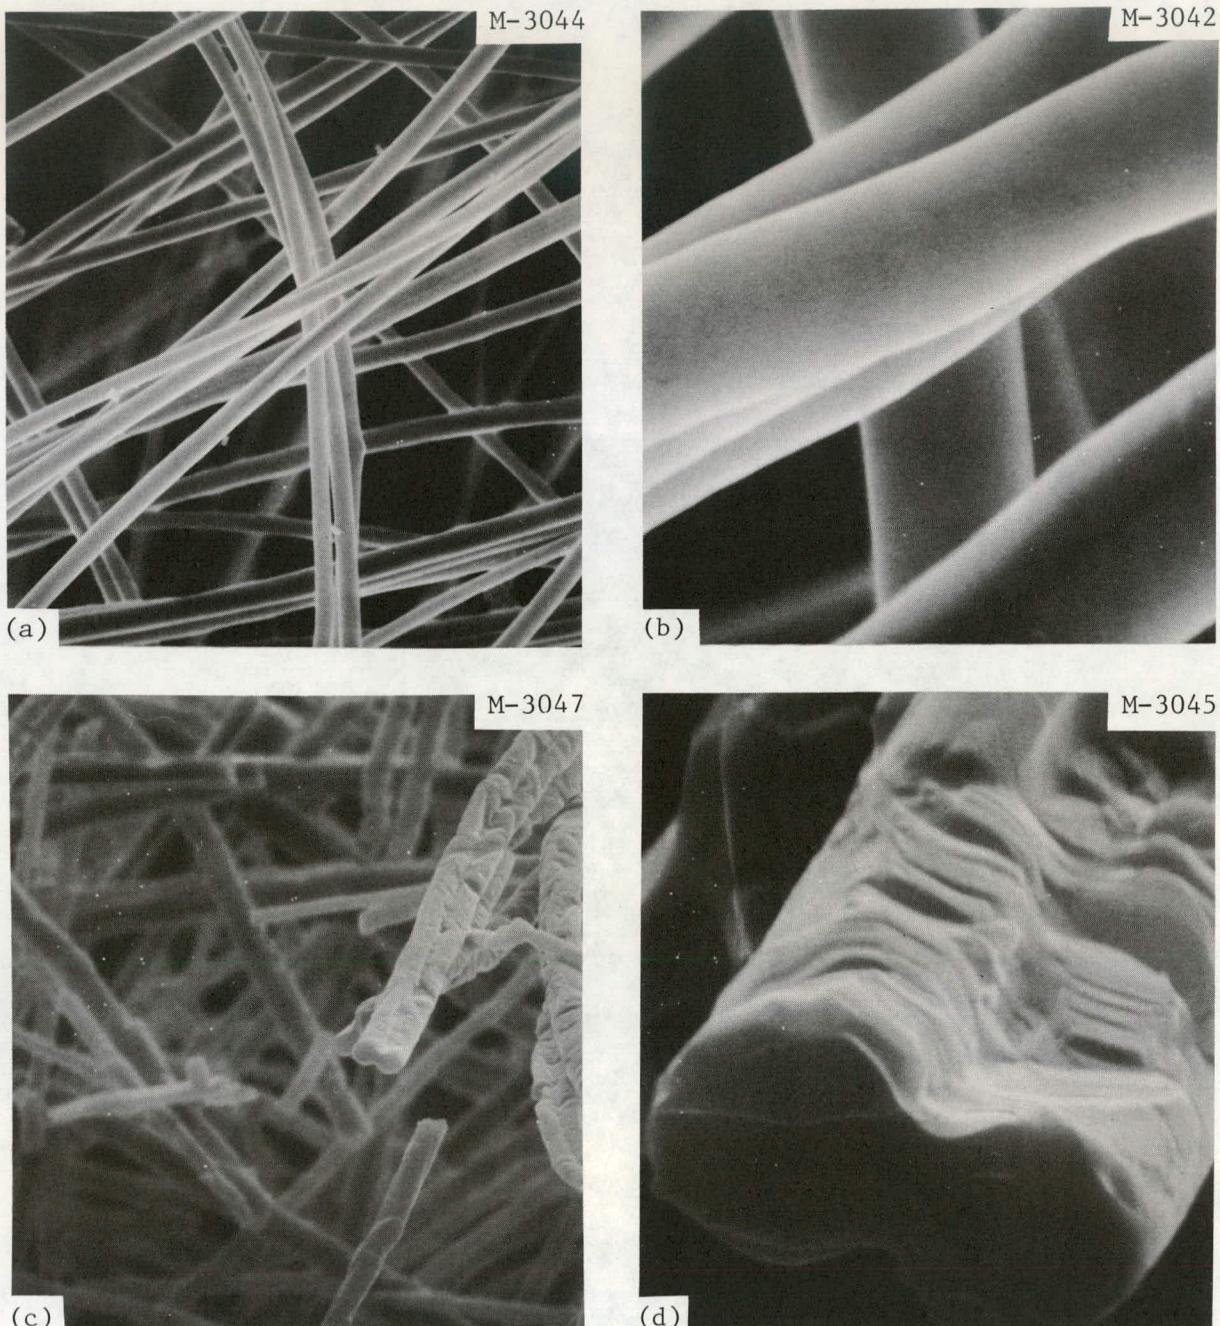
Fig. 32. Scanning Electron Micrographs of Pretest HAF Specimens.  
(a) and (b) As-received fiber blanket specimens showing smooth fibers.  
1000 and 10,000 $\times$ . (c) and (d) Grain growth and fiber sintering caused  
by heating to 1375°C (2500°F). 1000 and 10,000 $\times$ .

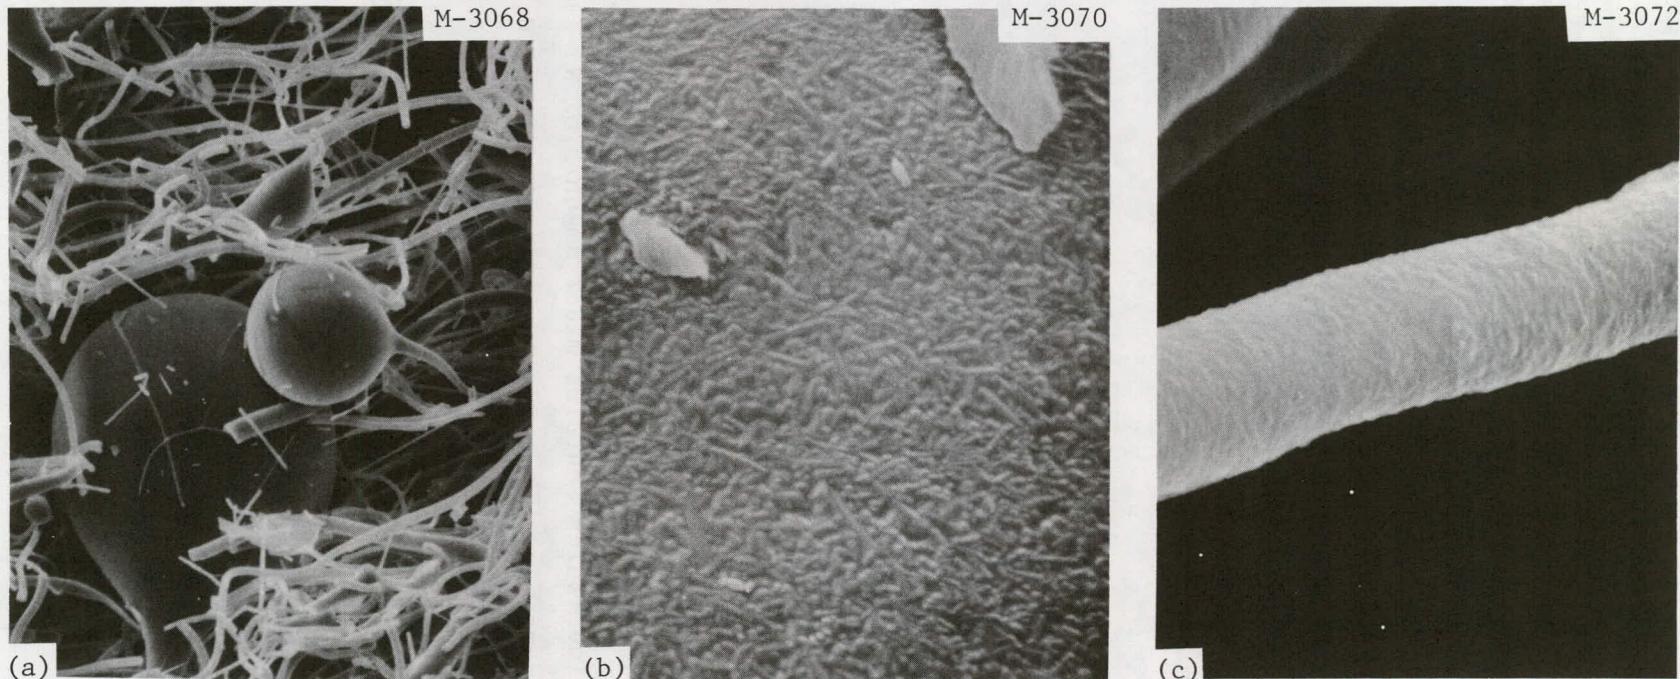
high magnification [Fig. 38(b)] which is similar to the morphology of needle-shaped mullite. EDX analysis of various fibers and shot inclusions indicate only Al and Si are present in major amounts, with trace levels of K occasionally detected.

Fig. 38. Scanning Electron Micrographs of Pretest MAF Specimen. (a) Representative area of as-received specimen showing varying fiber diameter, "shot" inclusions. 300 $\times$ . (b) Very high magnification of "shot" particle in (a) showing structure. 10,000 $\times$ . (c) Representative fiber after heating 115 hr in air at 1375°C (2500°F) showing essentially no change from as-received condition. 10,000 $\times$ .
