**Test of 6-in.-thick Pressure Vessels.
Series 3: Intermediate Test
Vessel V-7B**

OAK RIDGE NATIONAL LABORATORY
OPERATED BY UNION CARBIDE CORPORATION • FOR THE DEPARTMENT OF ENERGY

Engineering Technology Division

Manuscript Completed — October 6, 1978

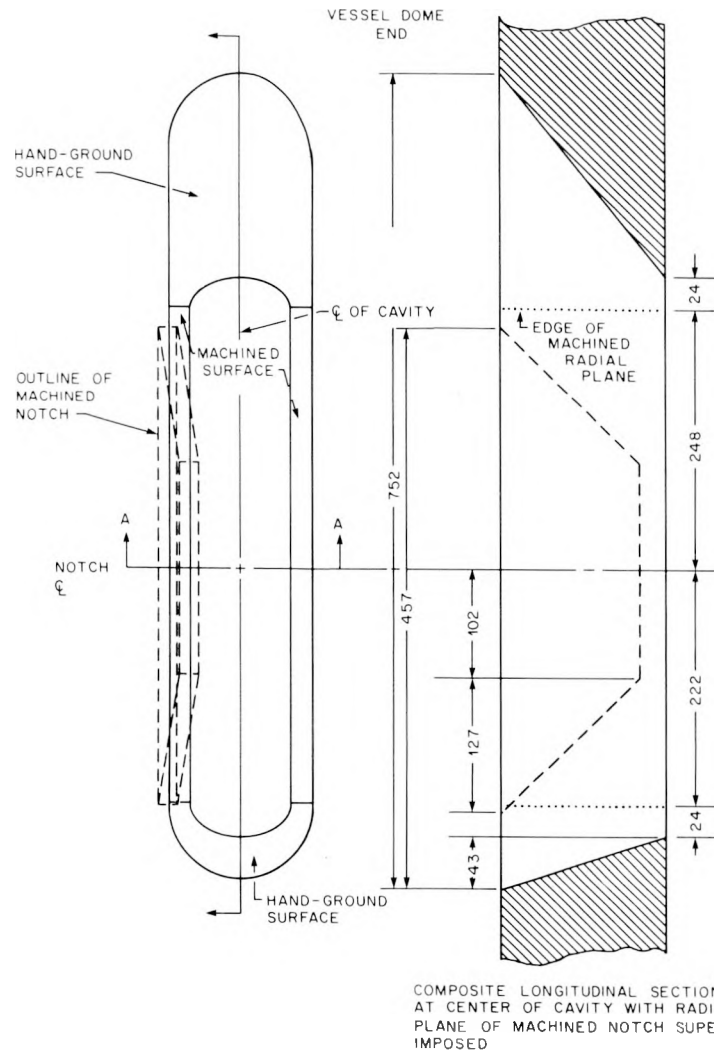
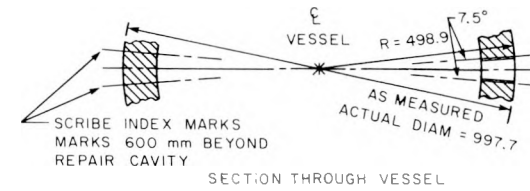
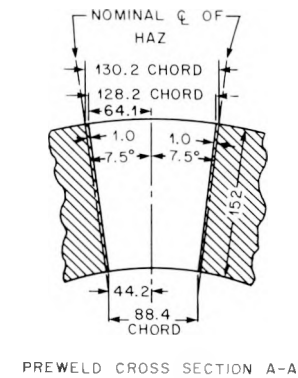
Fig. 2.33. Vessel V-7B as-built repair cavity and machined notch details.

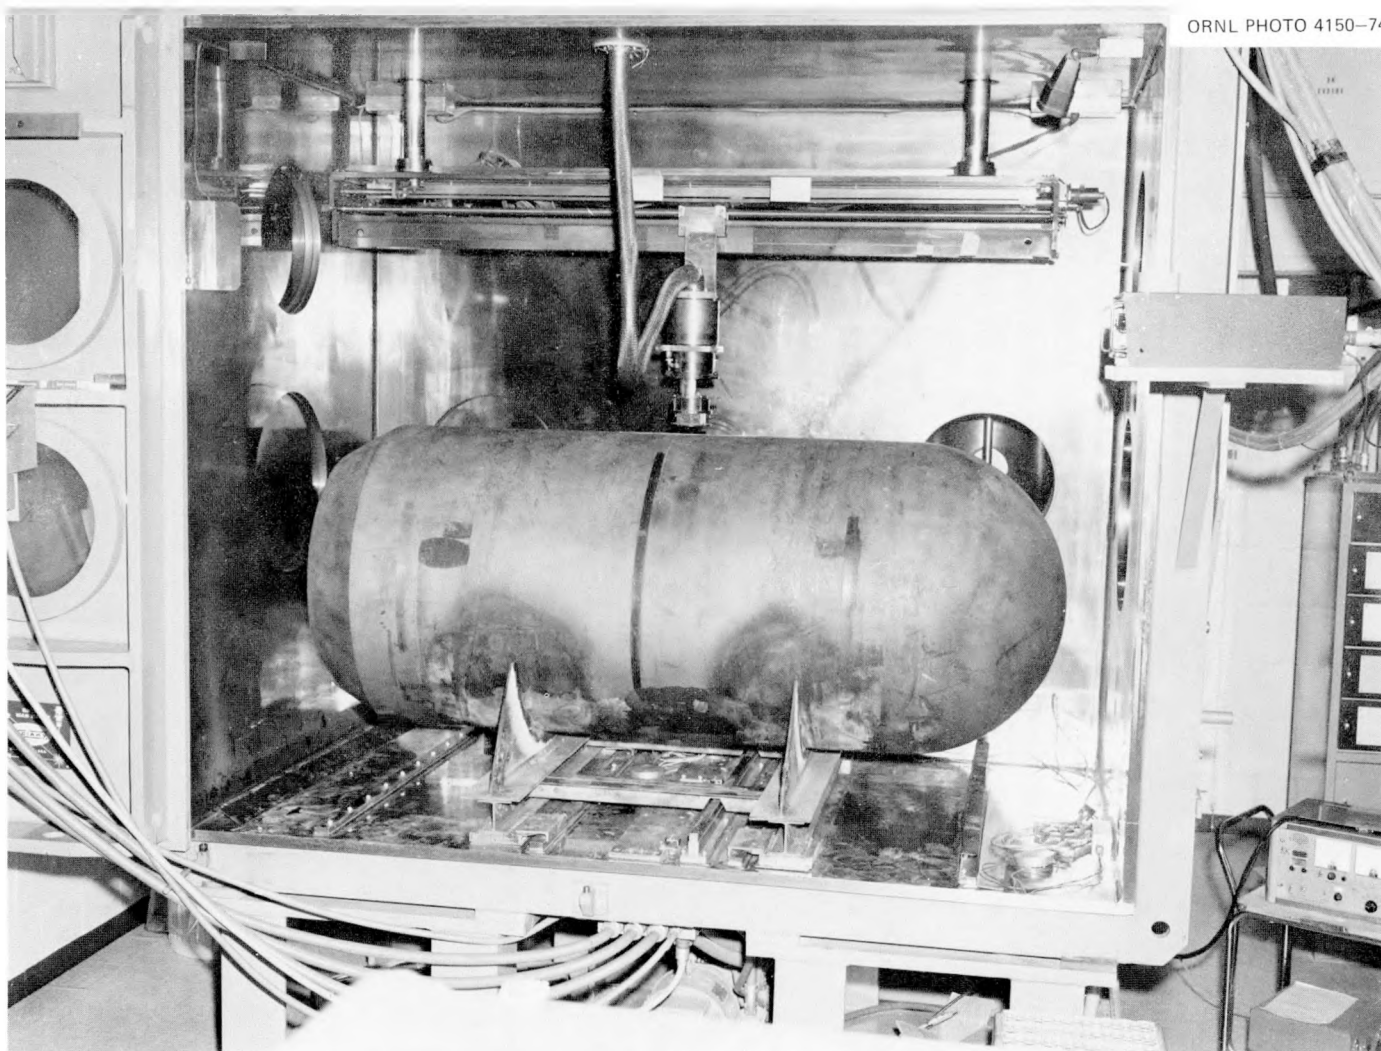
Electron-beam welding was again performed in a large Sciaky weld chamber in the Y-12 Plant. Figure 2.34 shows the vessel in the chamber positioned for the flaw welding. Weld programming was essentially the same as used before for the V-7 and V-7A notches: energy density, 190 J/mm; beam potential and current, 40.5 kV with 178 mA on the horizontal surface (deepest portion of the notch) and 182 mA on the two slopes; beam speed, 2.3 m/min (90 in./min); and vacuum chamber pressure, 0.67×10^{-3} Pa (5×10^{-6} torr).

Fig. 2.34. Vessel V-7B in EB weld chamber positioned for flaw welding.

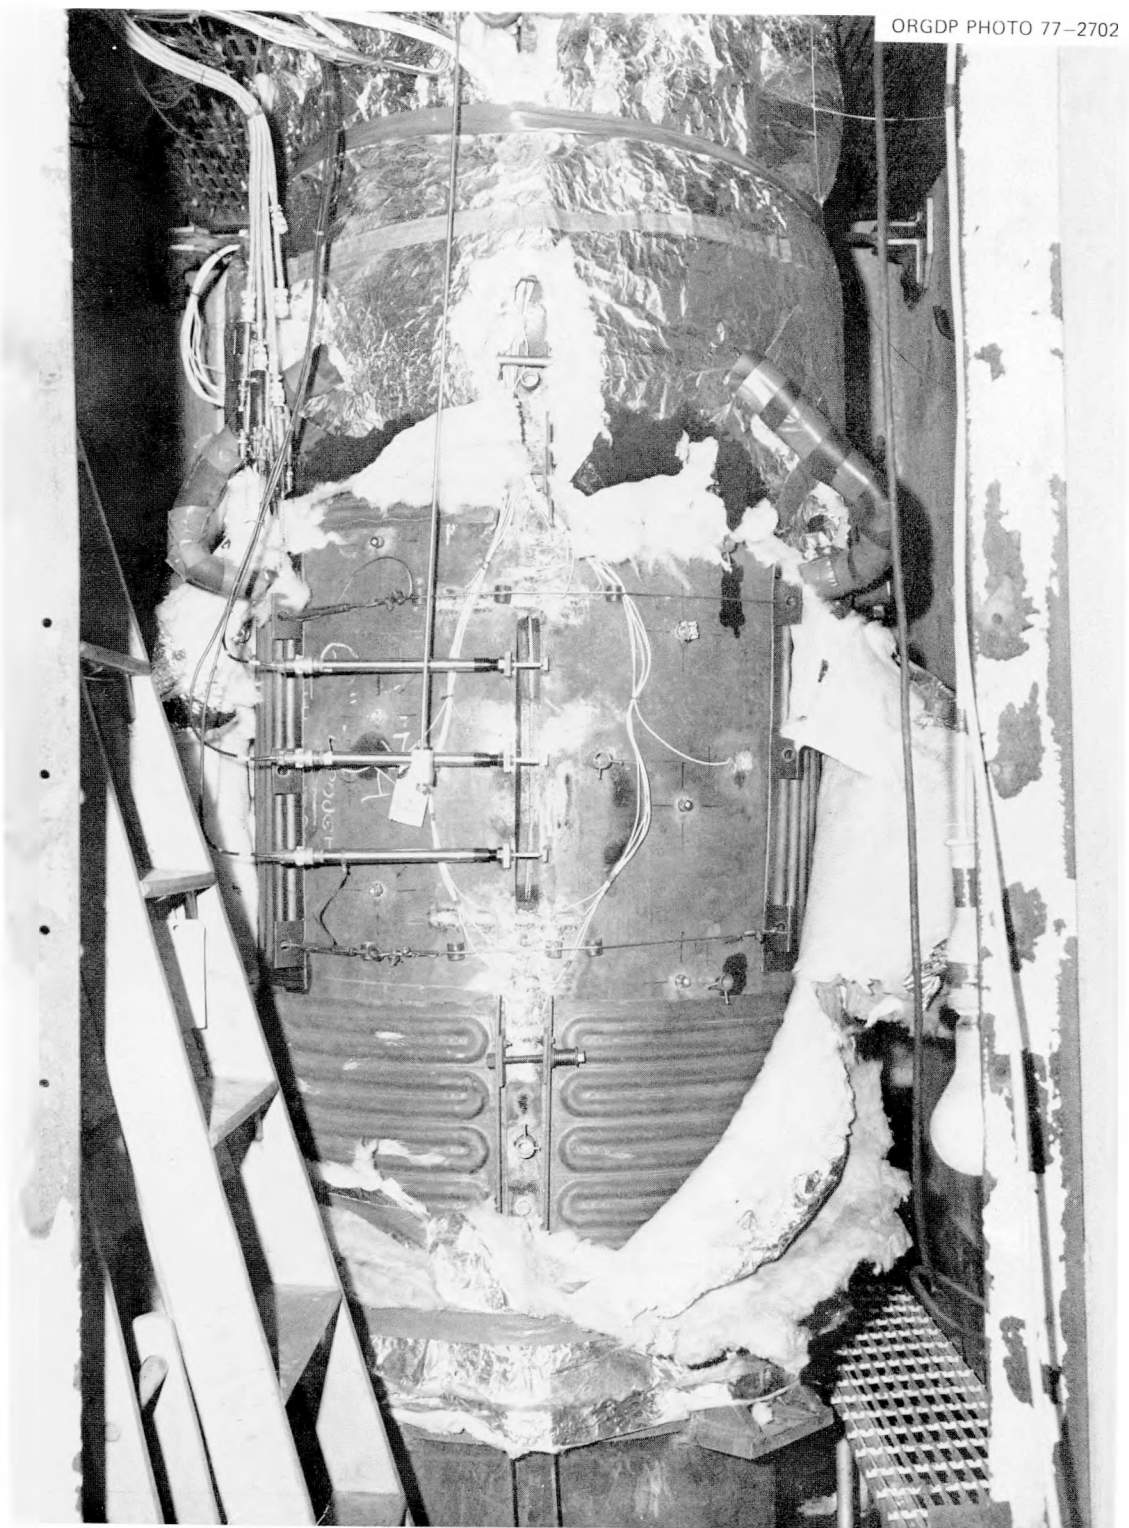
A posttest view of vessel V-7B is given in Fig. 3.10. Permanent deformation of the flaw can be detected along with crack extension at the ends of the machined notch. Complete data from the CCDAS are shown via microfiche described in Appendix A and attached to the inside back cover.

Fig. 3.10. Test vessel V-7B in pit after test.

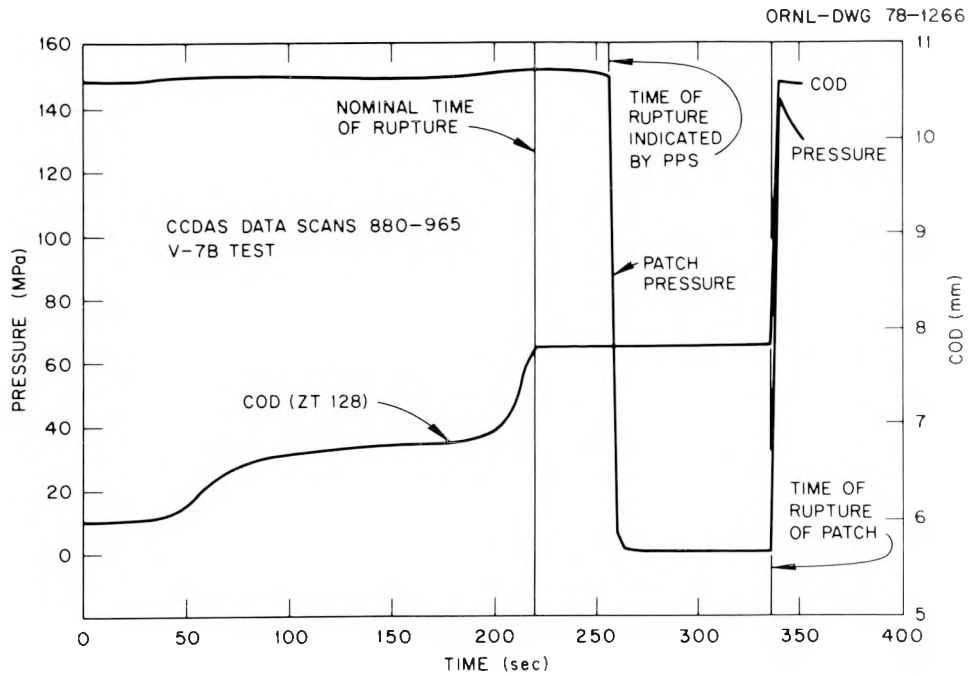
The development of this apparent instability and its relationship to the actual time of rupture are seen more clearly in Figs. 4.18 and 4.19. Figure 4.18 shows that the center COD gage (ZT 128) was subjected to

an extraneous force twice within about 120 sec; the second occasion occurred coincident with the patch rupture, which released a hard stream of water against the center COD probe. The earlier perturbation in ZT 128 is believed to have been caused by a similar impact during the rupture of the vessel. Thus we consider the time of this perturbation to be the nominal time of rupture, although leakage may have started a few seconds earlier.

Fig. 4.18. Patch pressure and central COD (ZT 128) vs time during development of vessel rupture. Time origin at scan 880.

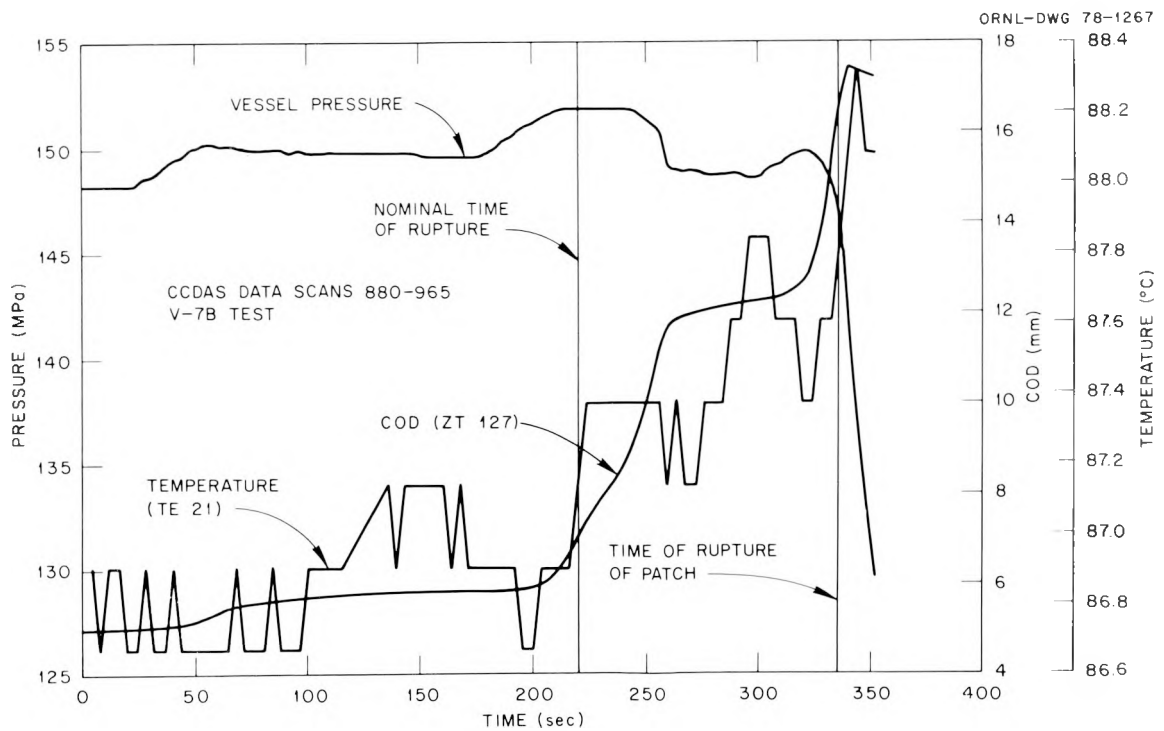
With this definition of nominal time of rupture as a reference point, the concurrent behavior of several variables is as shown in Fig. 4.19. The CODs were accelerating during the times after nominal rupture when vessel pressure was steady or increasing. This indicates that axial tearing of the flaw was probably taking place after rupture; this type of behavior did not occur during earlier pressurization steps or in the pneumatic V-7A test. A small temperature excursion of about 1 K (2°F) was observed near both ends of the flaw and in the ligament, as shown for one of these locations in Fig. 4.19. This occurrence is also unique to the rupture phase of the test and is consistent with the supposition that deformation and tearing at this time heated the metal. If this is the case, the ligament may have ruptured initially near one end rather than in the center since the central ligament temperature continued to increase after the nominal time of rupture until the rupture became large enough to affect the patch pressurization system. At that time the escaping fluid, chilled by expansion, cooled the notch as shown in Fig. 4.20.

Fig. 4.19. Vessel pressure, COD (ZT 127), and metal temperature near flaw (TE 21) vs time during development of vessel rupture. Time origin at scan 880.

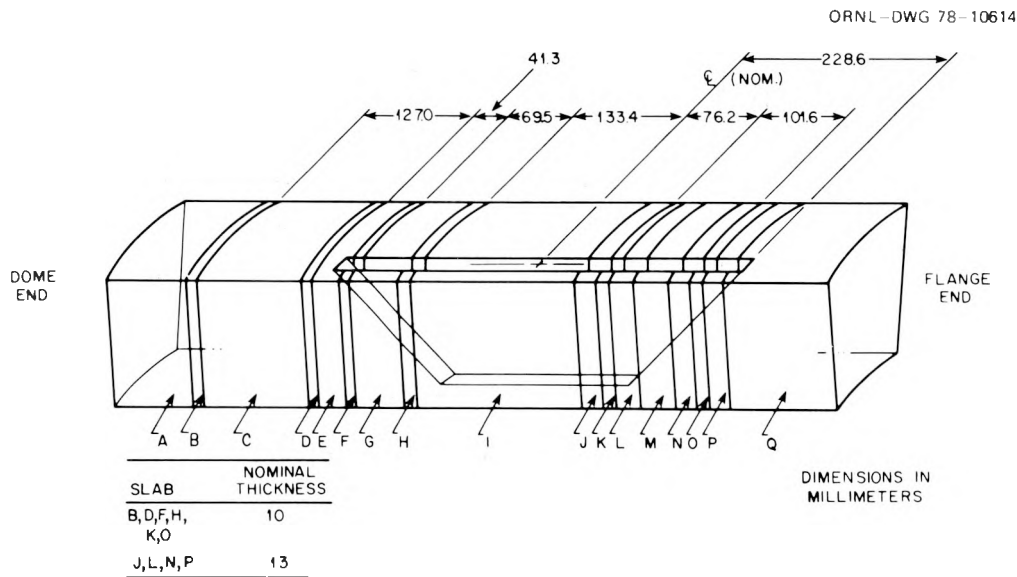
The block containing the flaw was saw cut transversely in 16 places as shown in Fig. 4.25. These cuts exposed cross-sectional views of the initial crack and the crack extension at 14 planes (28 faces). The etched faces of these cross sections show that the initial EB weld crack lay entirely within the heat-affected zone (HAZ) in the base metal adjacent to the weld repair, as had been desired (see Fig. 4.26).

Fig. 4.25. Block cut from intermediate test vessel V-7B containing entire repair weld and fracture zone. Slabs A through Q were cut after all ultrasonic examinations were completed.

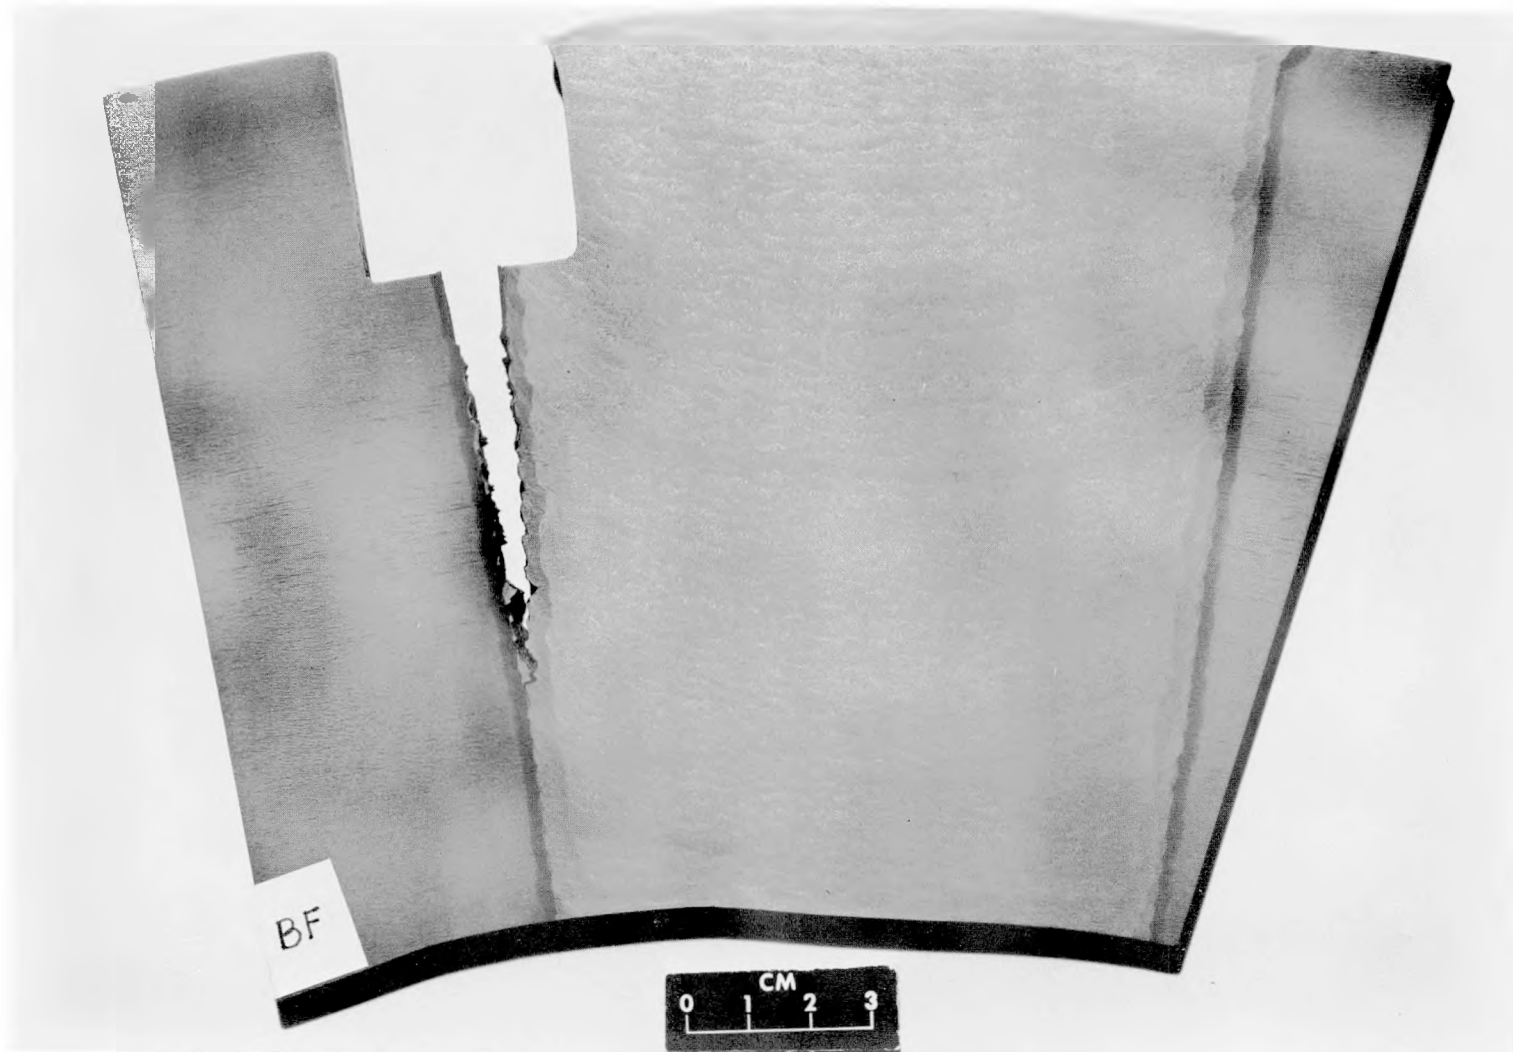
The etched cross sections at several locations show the crack extension relative to the HAZ. As indicated in Figs. 4.27 and 4.28, the crack extension was entirely in the base metal in some regions, in weld metal in others, and in the HAZ only at crossover points (as in Fig. 4.27).

Fig. 4.28. Etched face O_f (slab O, flange side) of cross section of the flaw near the flange end of the notch in V-7B. See Fig. 4.25 for definition of cross sections.

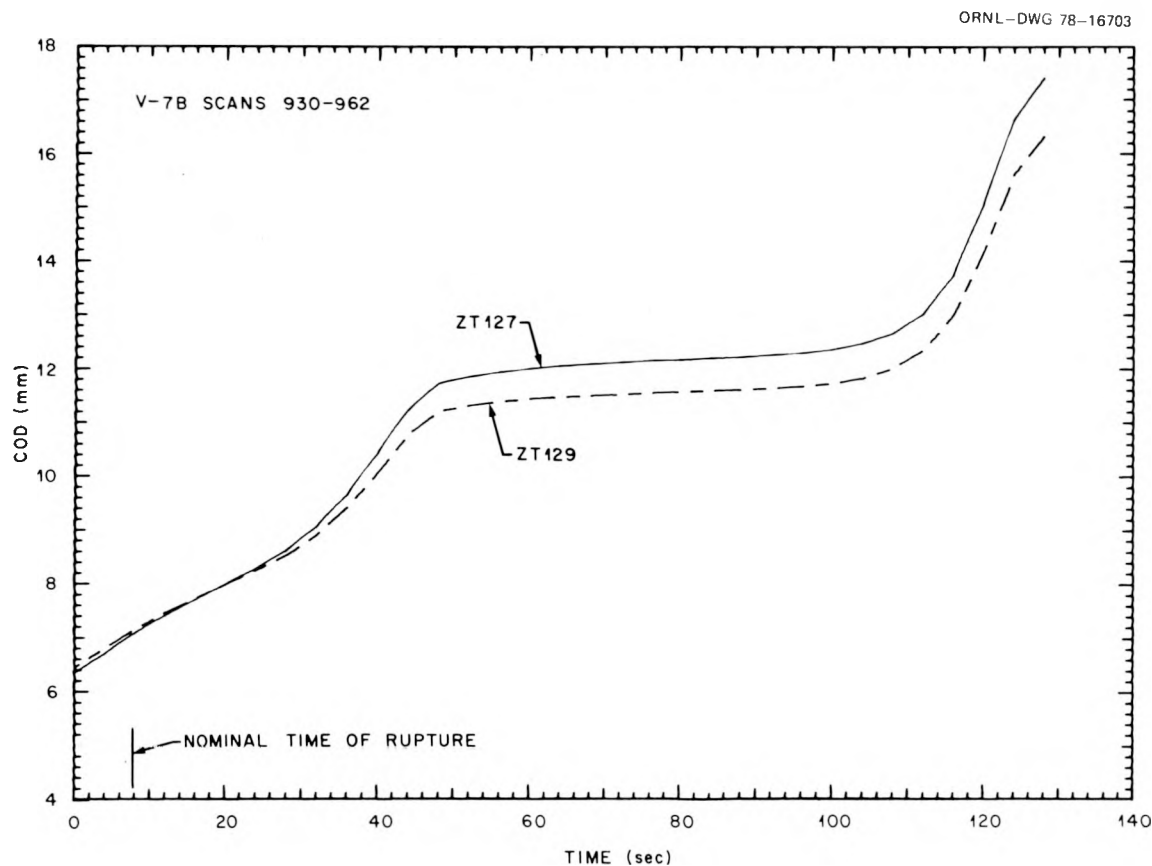
The continuing deformation of V-7B during constant load is shown in the strain and COD vs time plots of Figs. 4.31 and 4.32. Pressure changes during this interval are shown in Fig. 4.33. This behavior suggests that the structure as a whole was unstable at the maximum test pressure although the crack itself had not reached a condition conducive to fast fracture.

Fig. 4.31. COD near ends of flaw (ZT 127 and ZT 129) vs time in V-7B during final sustained loading (scans 930-962). Time origin is a 8 sec before nominal time of rupture.

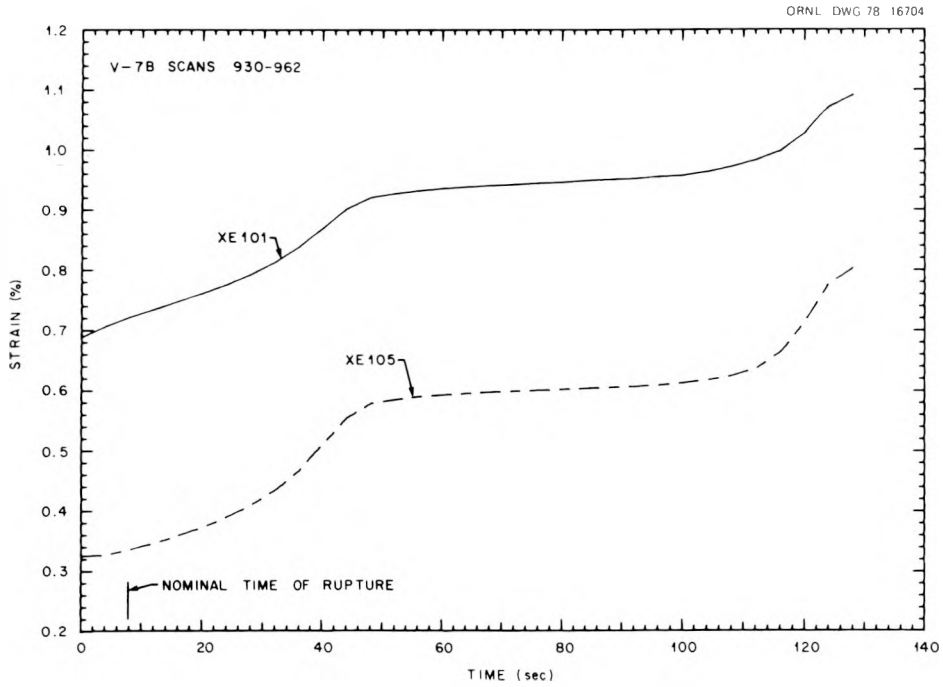
Fig. 4.32. Strain near ends of flaw (XE 101 and XE 105) vs time in V-7B during final sustained loading (scans 930–962).

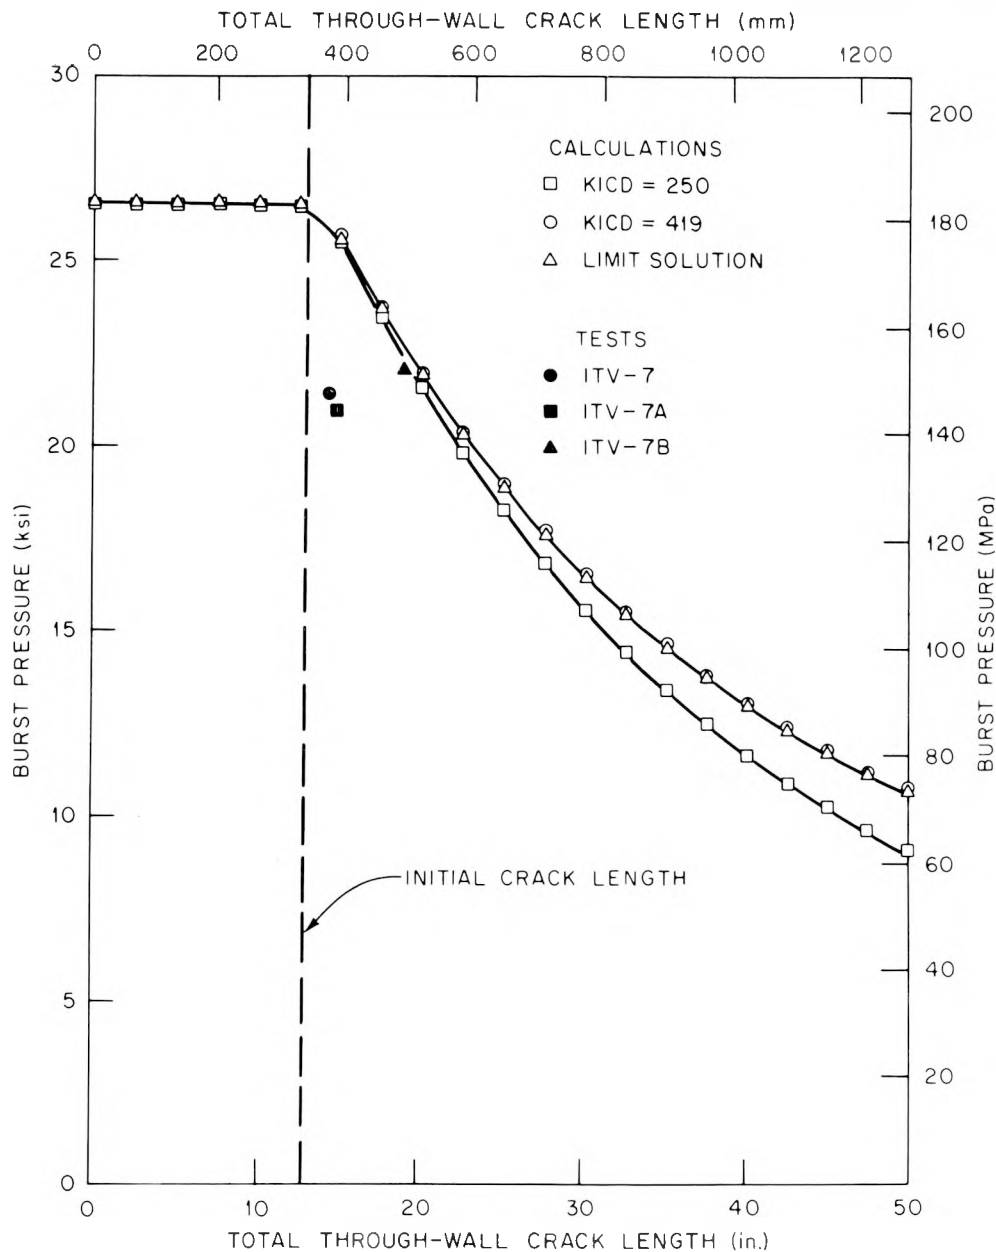
As indicated by pretest analyses, a burst was not expected in vessel V-7B with the initial crack length; results are shown in Fig. 4.34. Burst pressures for through-the-wall flaws in intermediate test vessels are shown by this figure to be very sensitive to the crack length for cracks at least as long as the V-7 series flaws; but variations in material toughness do not significantly affect the results. The final results of the V-7, V-7A, and V-7B tests are shown in this figure. The estimated burst conditions are consistent with the test results.

Fig. 4.34 Estimated burst pressures of an intermediate test vessel with a through-the-wall axial crack with results of tests V-7, V-7A, and V-7B.

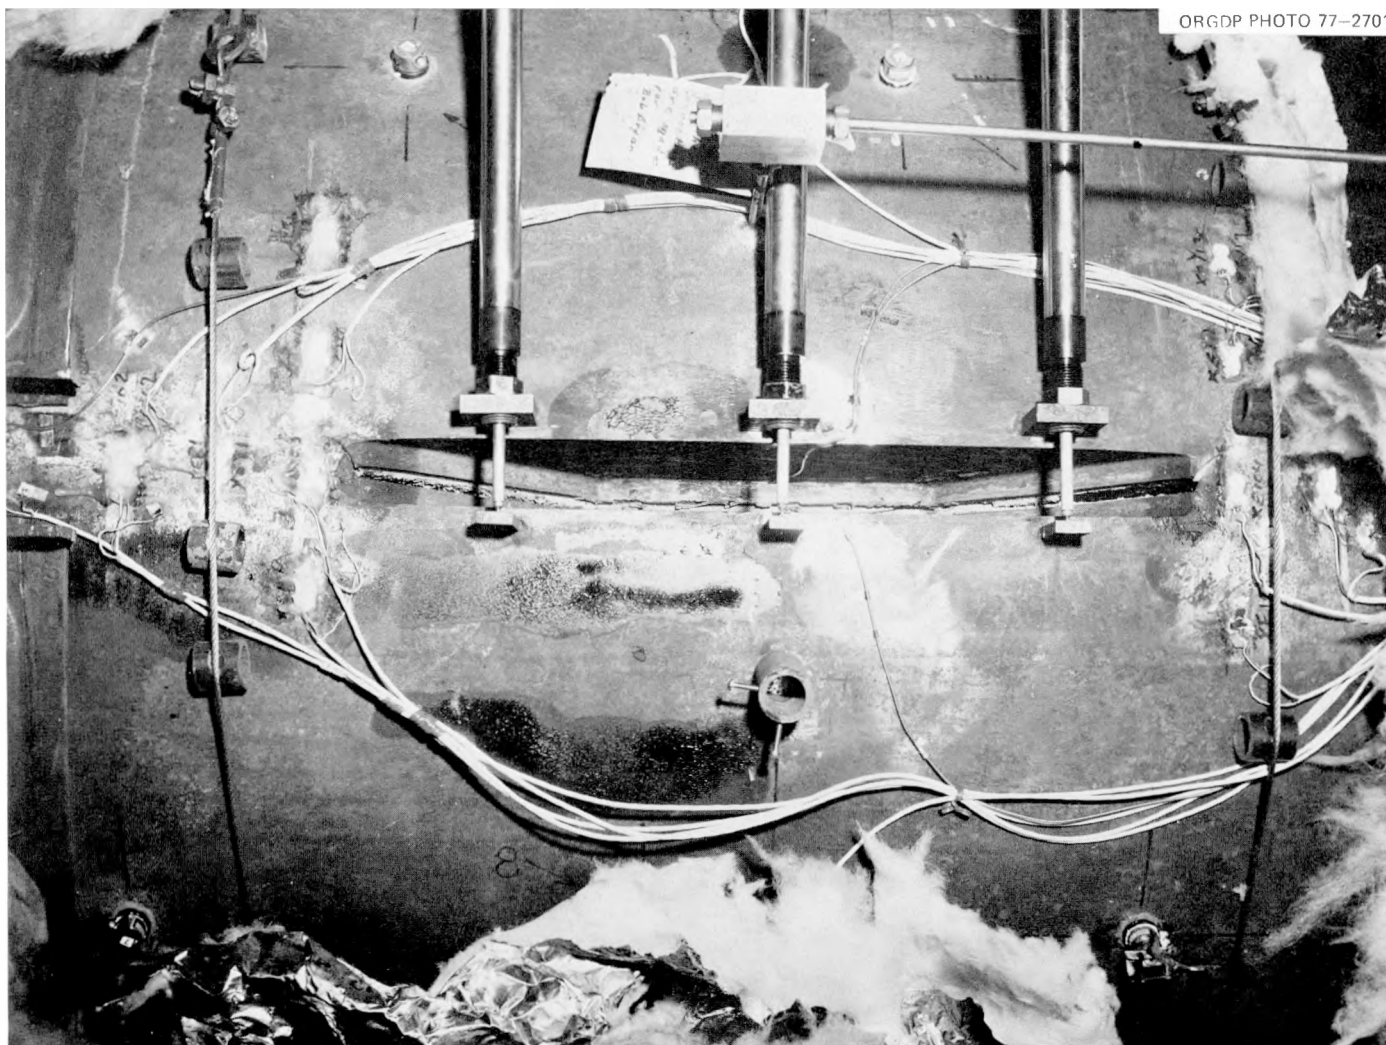
The primary significance of Figs. B.9–B.16 is to demonstrate AE response to flaw development. Up to 18,000 psig, most of the AE comes from the center section of the flaw. As the pressure increases above 18,000 psig, the AE indications begin to move to the outer ends of the flaw. The last two photographs (21,000 to 21,750 psig and 21,750 psig to failure) show evidence of potential crack extension from the ends of the flaw. Figure B.17 shows that this did occur.

Fig. B.17. HSST V-7B vessel failure at machined flaw.

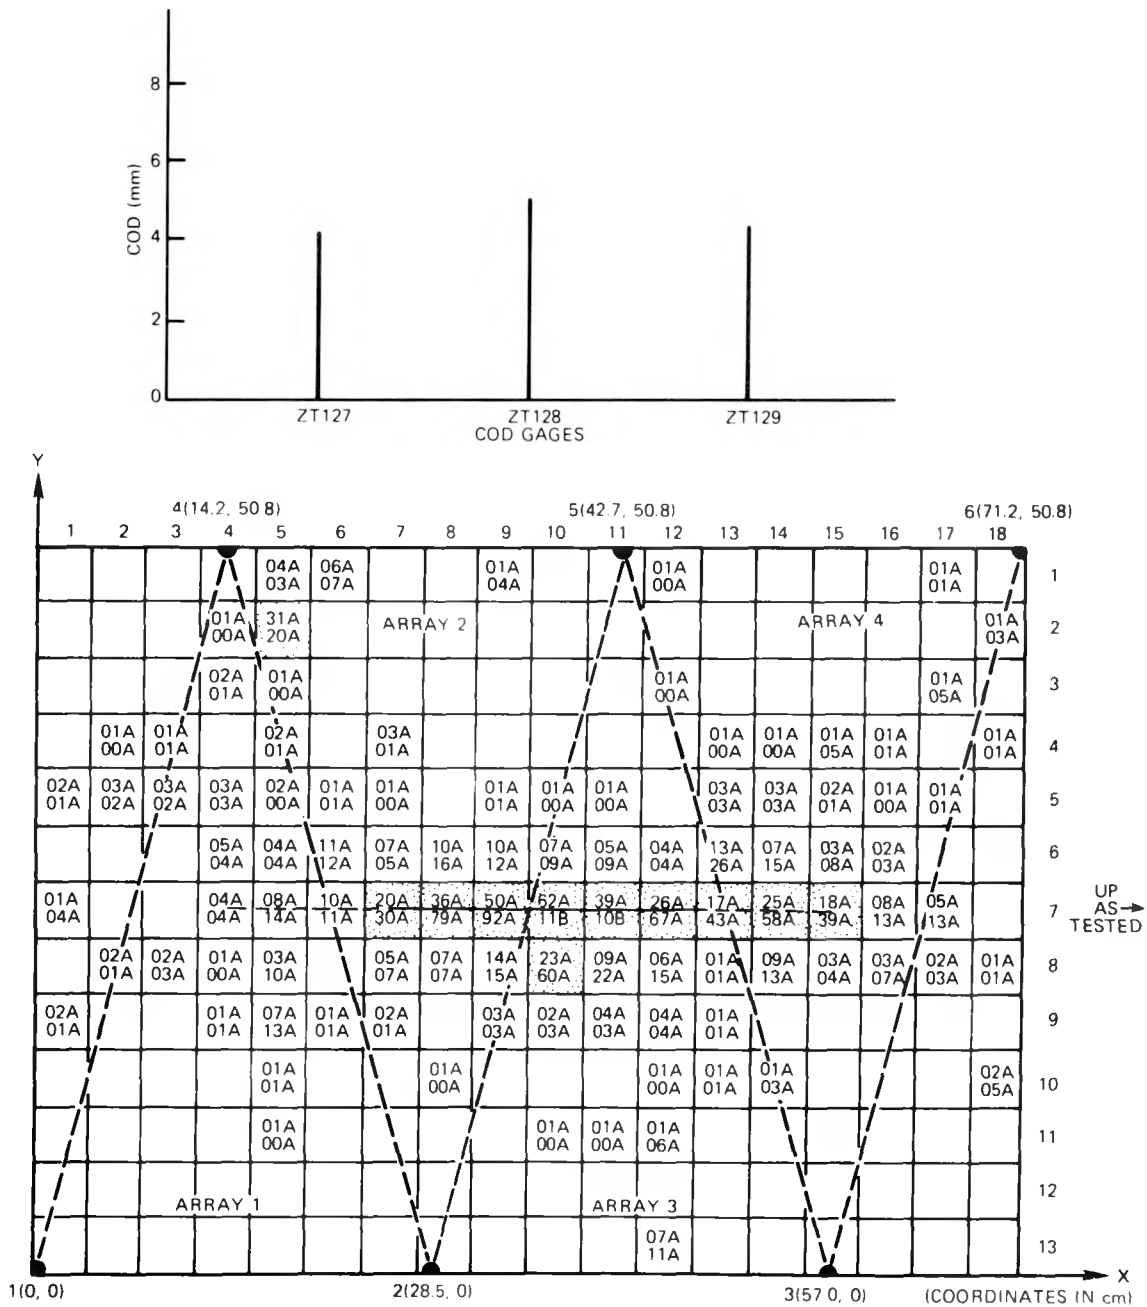
Two-dimensional grid displays were obtained for the second pressurization cycle both during and after completion of the test. Figures C.14 to C.19 present displays of events and voltage magnitudes as a function of location for pressures corresponding to 124.1, 144.8, 146.5, 148.2, 150 MPa, and at the conclusion of the test, respectively. Notations in these figures are the same as for Fig. C.10. Significant event occurrence by location* as a function of pressure interval is presented in Fig. C.20. As noted in the figures, regions of primary activity were adjacent to the flaw.

Fig. C.16. Grid display pressure cycle 2: P = 146.5 MPa, 644 events.

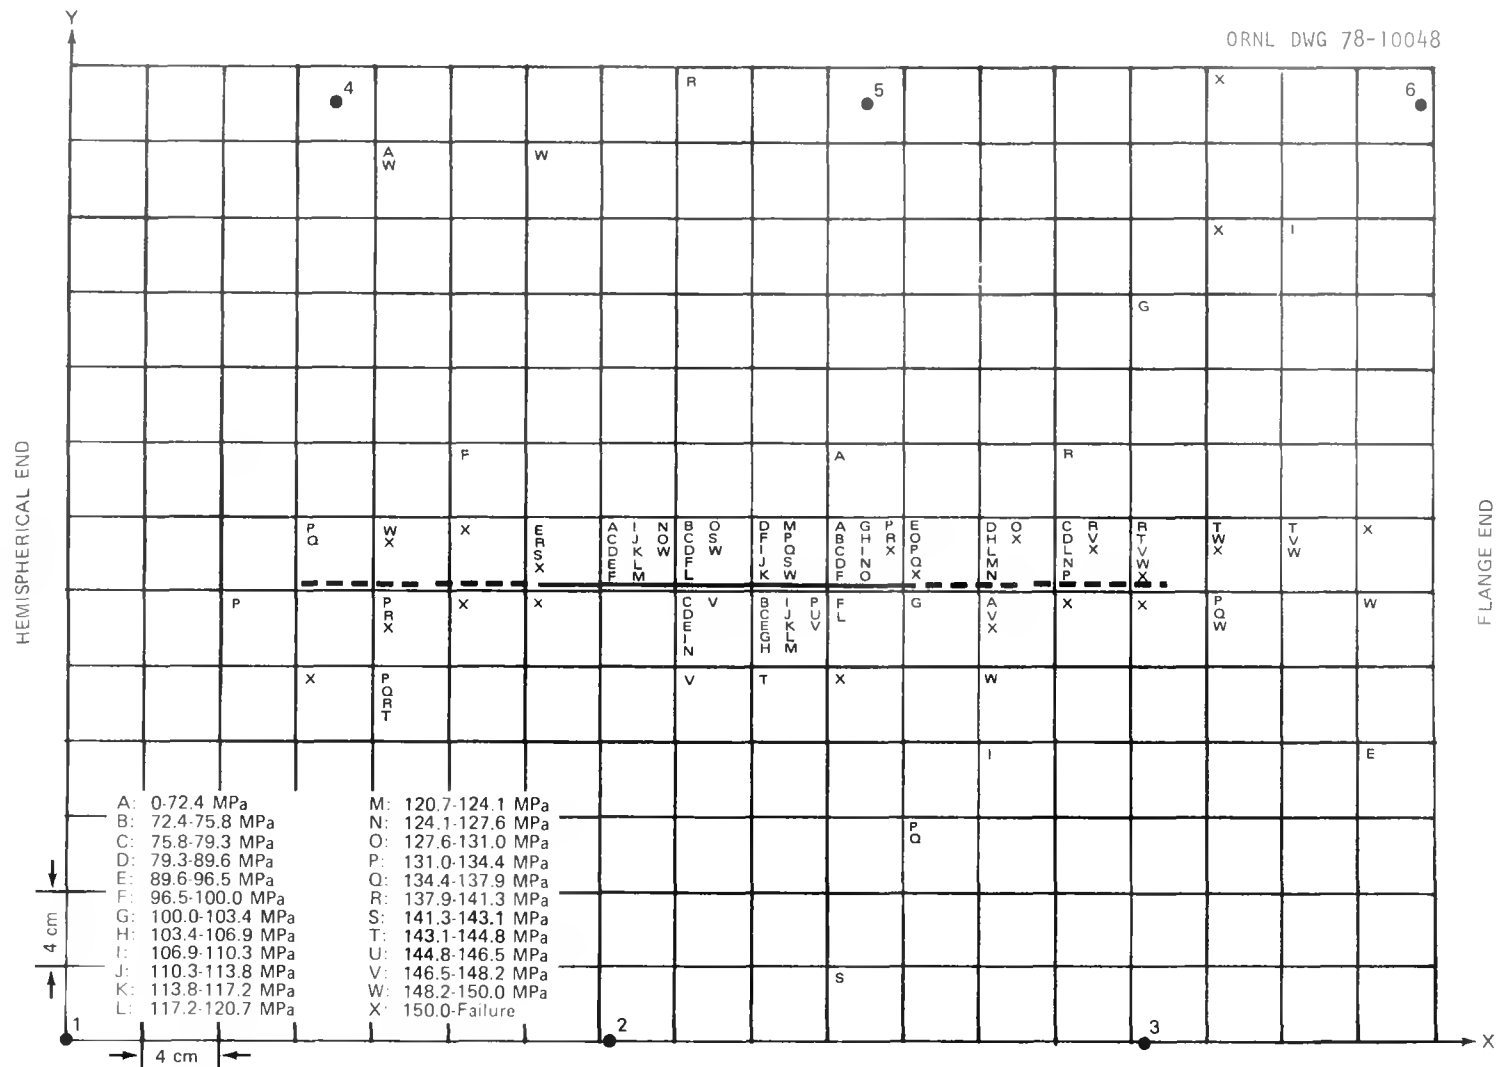
2. Plots of COD gages and summation of events as a function of pressure were geometrically similar.
3. At impending failure, the slope of the summation of events as a function of pressure changed drastically. This provides a possible technique for monitoring the vessel so that pressurization may be halted prior to failure. Also, as failure was approached, the magnitude of the emissions increased.

Fig. C.20. Significant event occurrence as a function of loading interval.
