LA-9512-HDR

Issued: August 1982

## Drilling of Hot-Dry-Rock Geothermal- Energy Extraction Well EE-3

John C. Rowley  
Richard S. Carden\*

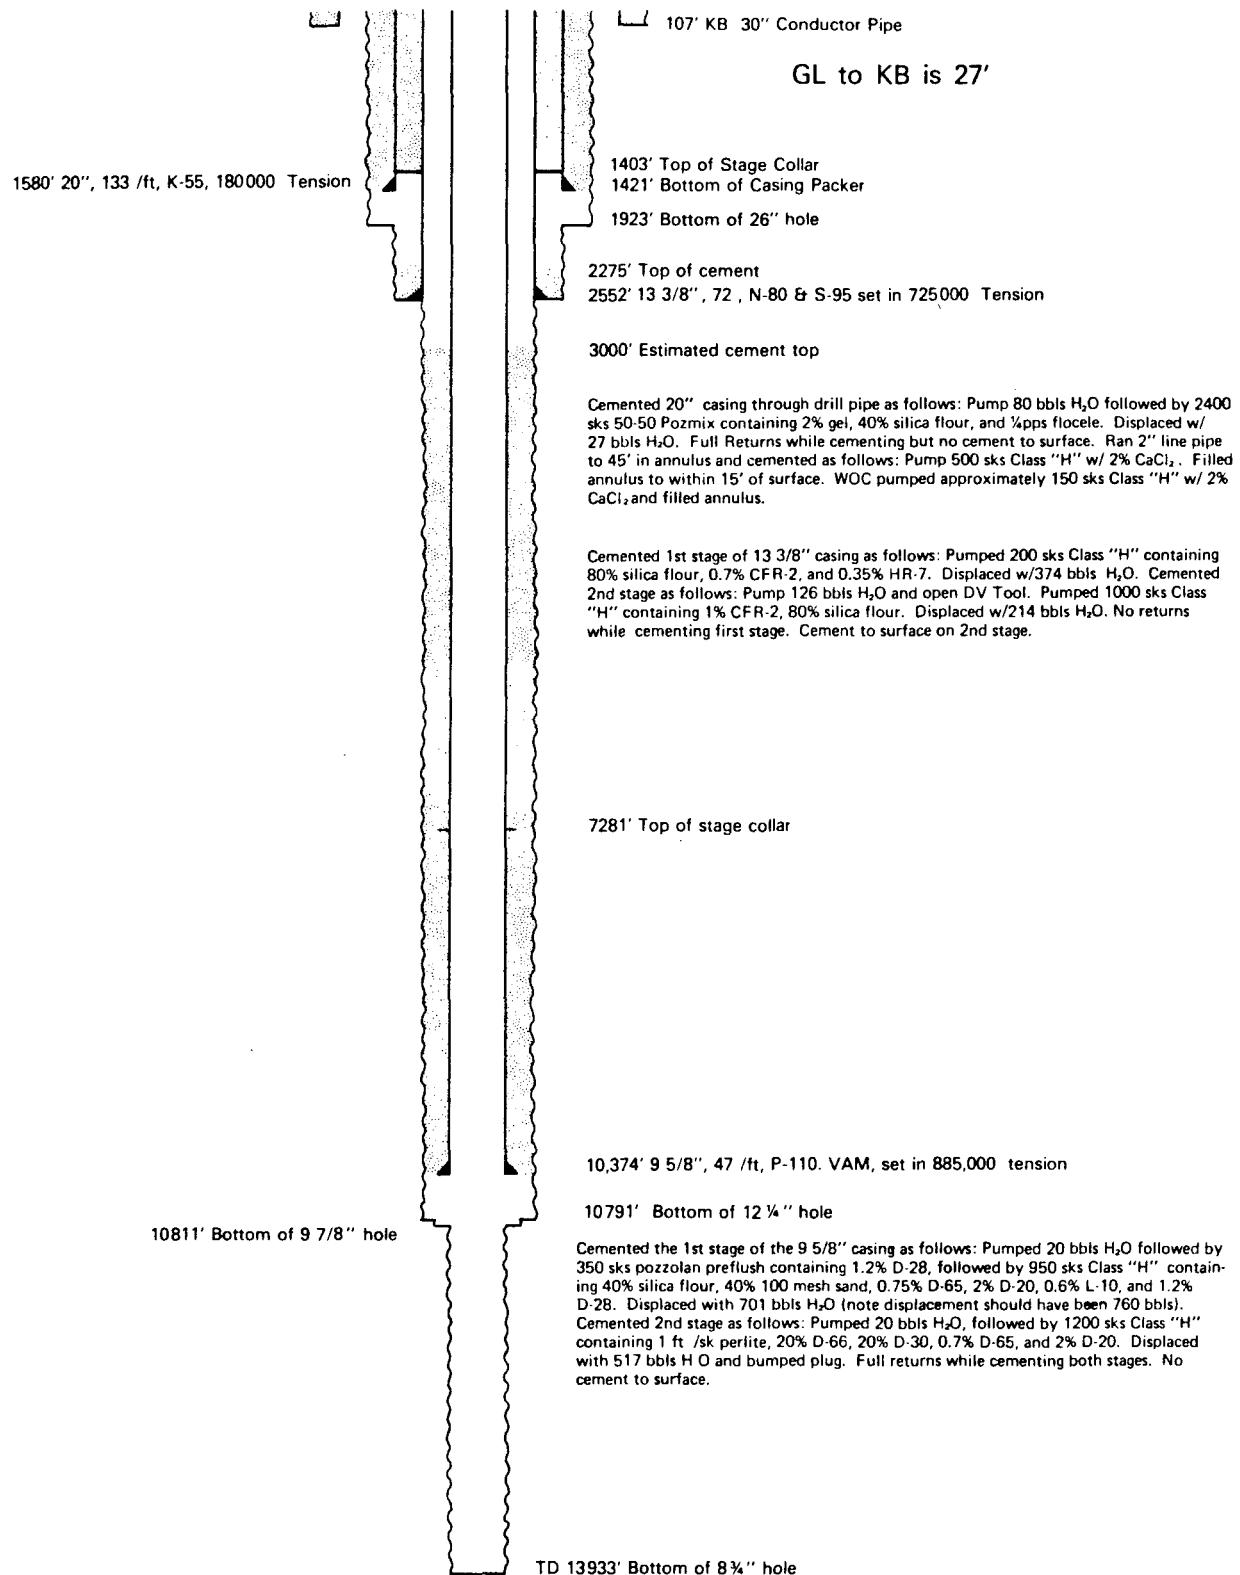
Fig. 7.  
Wellbore diagram for EE-3.

No totally problem-free method has been devised to overcome the loss of circulation in this cavernous zone. The plan to drill EE-3 without returns was successful, but was costly due to the necessity of hauling water. The local, nearby source at La Cueva was used up and delays occurred when water hauling from Los Alamos was necessary. The intermediate casing was successfully run and cemented in a two-stage procedure that assured a 45-m (150-ft) anchor into the granite and, after tensioning, provided a cement sheath behind the casing from 428 m (1403 ft) to the surface. However the zone from 428 m to 693 m (1403 to 2275 ft) was uncemented (see Fig. 7) and no solution has as yet been perfected to avoid this situation.

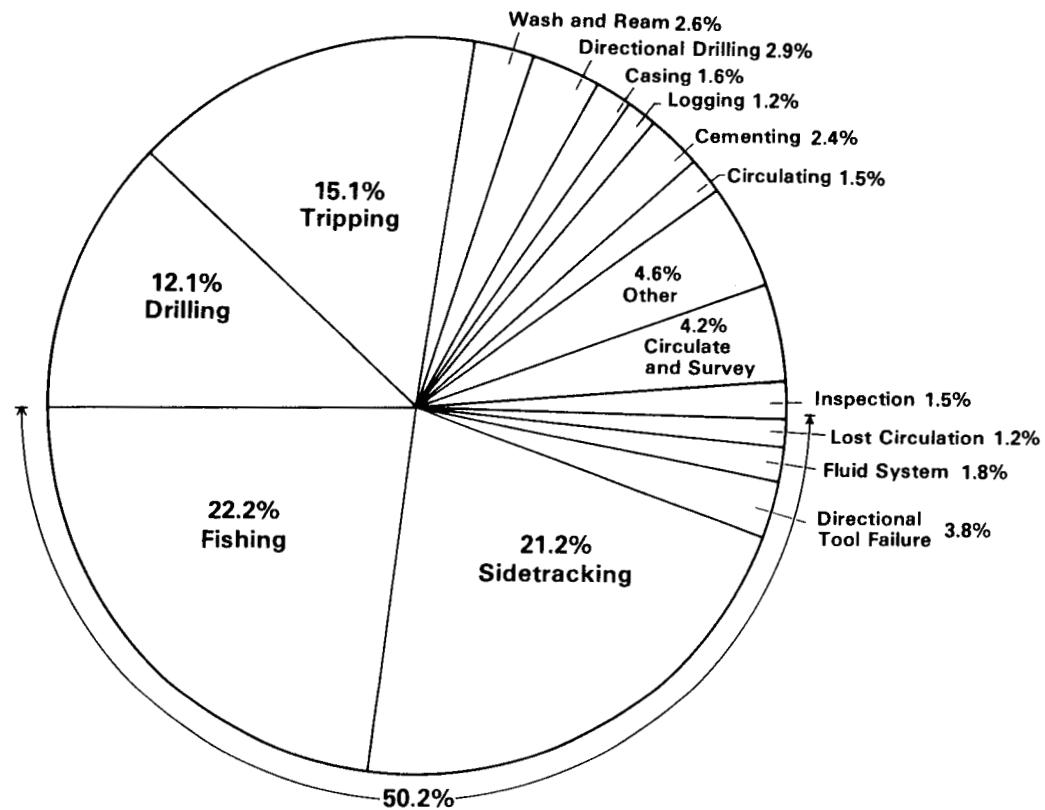
Fig. 10.  
Percentage of EE-3 time spent in drilling operations and solving problems.

The problems encountered in the drilling of EE-3 were severe but not abnormal for such a high-temperature deep-drilling operation. The drilling history of Fig. 3 is laid out in the diagram in Fig. 10. Two major and three minor problem areas are identified. These problems and their solutions represented over 50% of the time required to drill EE-3--about 235 days of the 461 total. Two major time-increments for fishing and sidetracking are shown and represent 86% of the problems that plagued the drilling campaign. The fishing episodes derive from twist-offs or washouts of the BHA or drill

string. These failures required in turn that the BHA and drill string remaining downhole must be removed or retrieved (fished) from the well. (Note: fishing can also occur when an object falls into the well.)

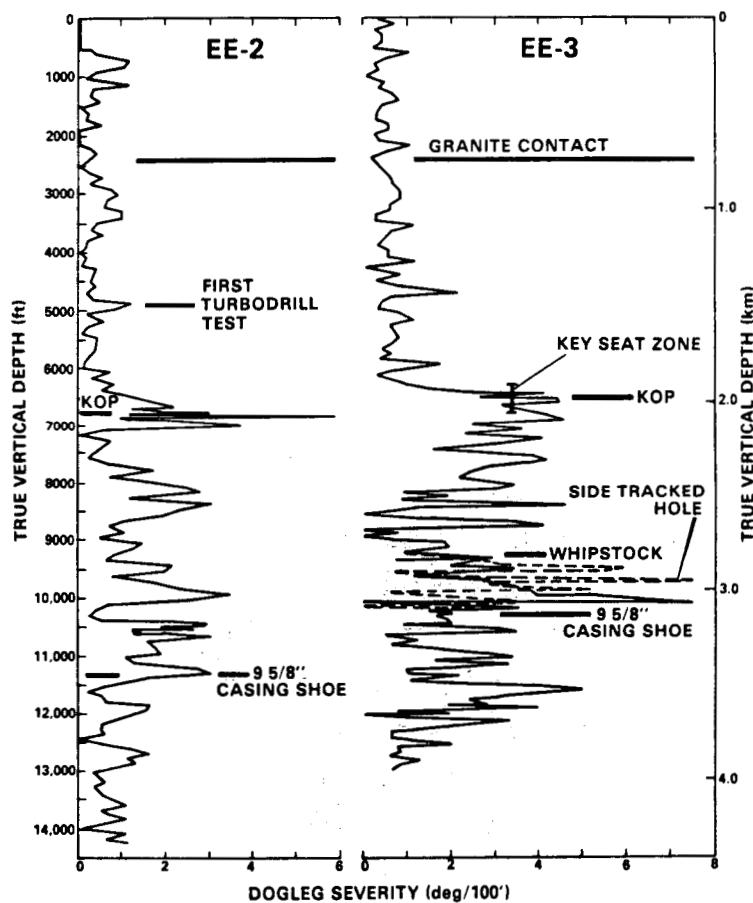
Fig. 11.  
Comparison of EE-2 and EE-3 DLS.

An attempt was then made to run a 30.5-cm (12-in.)-o.d. whipstock, but the whipstock started to drag at about 2070 m (6800 ft) and would not go past the DLS portion of the hole near 2195 m (7200 ft). To avoid shearing the shear pin holding the whipstock to the drill string [set for  $111 \times 10^3$  N (25 000 lb<sub>f</sub>)], the whipstock was not forced and was subsequently pulled from the hole.

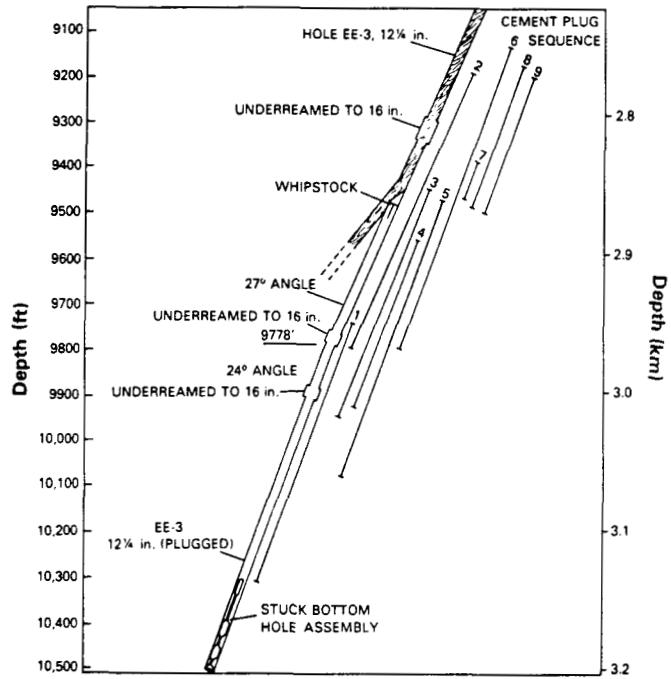
Fig. 12.  
Diagram of EE-3 sidetracking operations (see Table I).

On October 28, 1980, day 160, a twist-off occurred in EE-3 while drilling the 31.1-cm (12-1/4-in.) hole at a depth of 3200 m (10 528 ft). Fishing continued until December 15, when the sidetracking operation was initiated to bypass the stuck BHA. Figure 12 records the EE-3 configuration for the sidetracking operations. The hole was underreamed to a 40.6-cm (16-in.)-diam from 2975 to 2979 m (9760 to 9774 ft) and from 3013 to 3016 m (9885 to 9900 ft).

Six cement plugs were set before a plug with satisfactory hardness was placed. The penetration rate while facing off the first five plugs was about 0.3 m/min (1 ft/min) at  $22 \times 10^3$  N (5 000 lb<sub>f</sub>) bit load; the sixth plug was drilled at 0.1 m/min (0.3 ft/min) with  $45 \times 10^3$  N (10 000 lb<sub>f</sub>) bit load (see Table I).

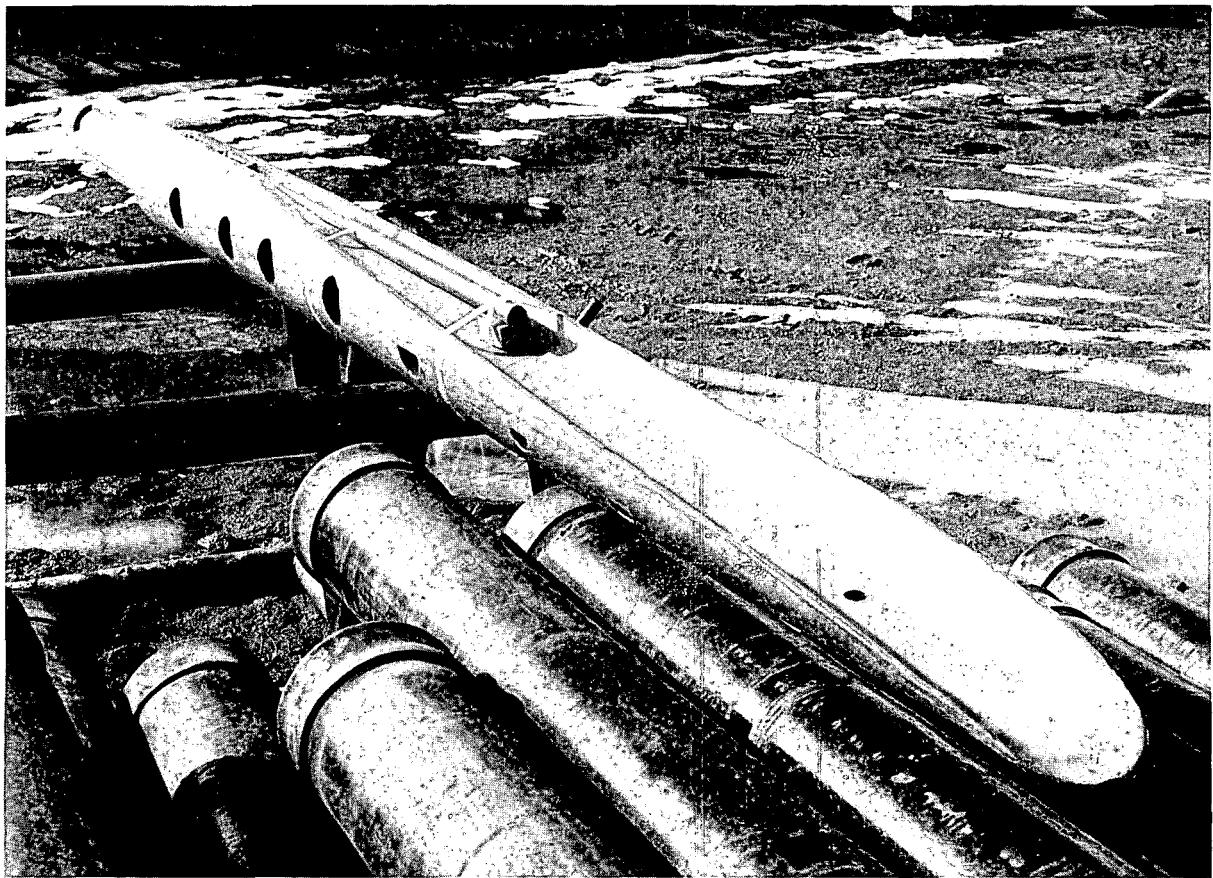
Fig. 13.  
Photograph of 10-3/4-in.-diam whipstock.

A 27-cm (10-1/2-in.)-o.d. whipstock, Fig. 13, with a 3-m (10-ft) slide designed with curvature to accommodate a 31.1-cm (12-1/4-in.) bit was run in with 10 m (30 ft) of tailpipe below, and was oriented and cemented with the ninth cement plug. The top of the whipstock was set at 2879 m (9444 ft). The top of the whipstock-anchoring plug was at 2804 m (9200 ft) to allow another chance at sidetracking in the underreamed section. Various slow time-drilling penetration rates were tried at the underreamed zone in drilling down to the whipstock using button bits on a Dyna-Drill PDM, but sidetracking was not accomplished.

Junk was encountered at 2875 m (9432 ft), about 3 m (10 ft) above the top of the whipstock while drilling cement down to the whipstock located at 2879 m (9444 ft). The junk was cleaned up through a series of bit, mill, and magnet runs\*. The junk was determined to be a high-chrome steel piece perhaps 1- to 1.2-m (3- to 4-ft) long, and not the cast steel of the whipstock. A BHA consisting of a 31.1-cm (12-1/4-in.) Q9JL bit, one 17.1-cm (6-3/4-in.) drill collar, jars, and 15 joints of HWDP was used to drill off the whipstock.

The bit drilled 5 m (15 ft) in 15.5 h with  $22 \times 10^3$  to  $67 \times 10^3$  N (5000 to 15 000 lb<sub>f</sub>) bit load. As the amount of granitic chips in the cuttings was increasing steadily, an angle-building assembly was made up and 30 m (97 ft) of new hole were drilled, which definitely established the successful sidetrack on March 22, after three months of attempts.
