1976 HANFORD AMERICIUM-EXPOSURE INCIDENT:

ACCIDENT DESCRIPTION

B. J. McMurray\*

Pacific Northwest Laboratory\*\*

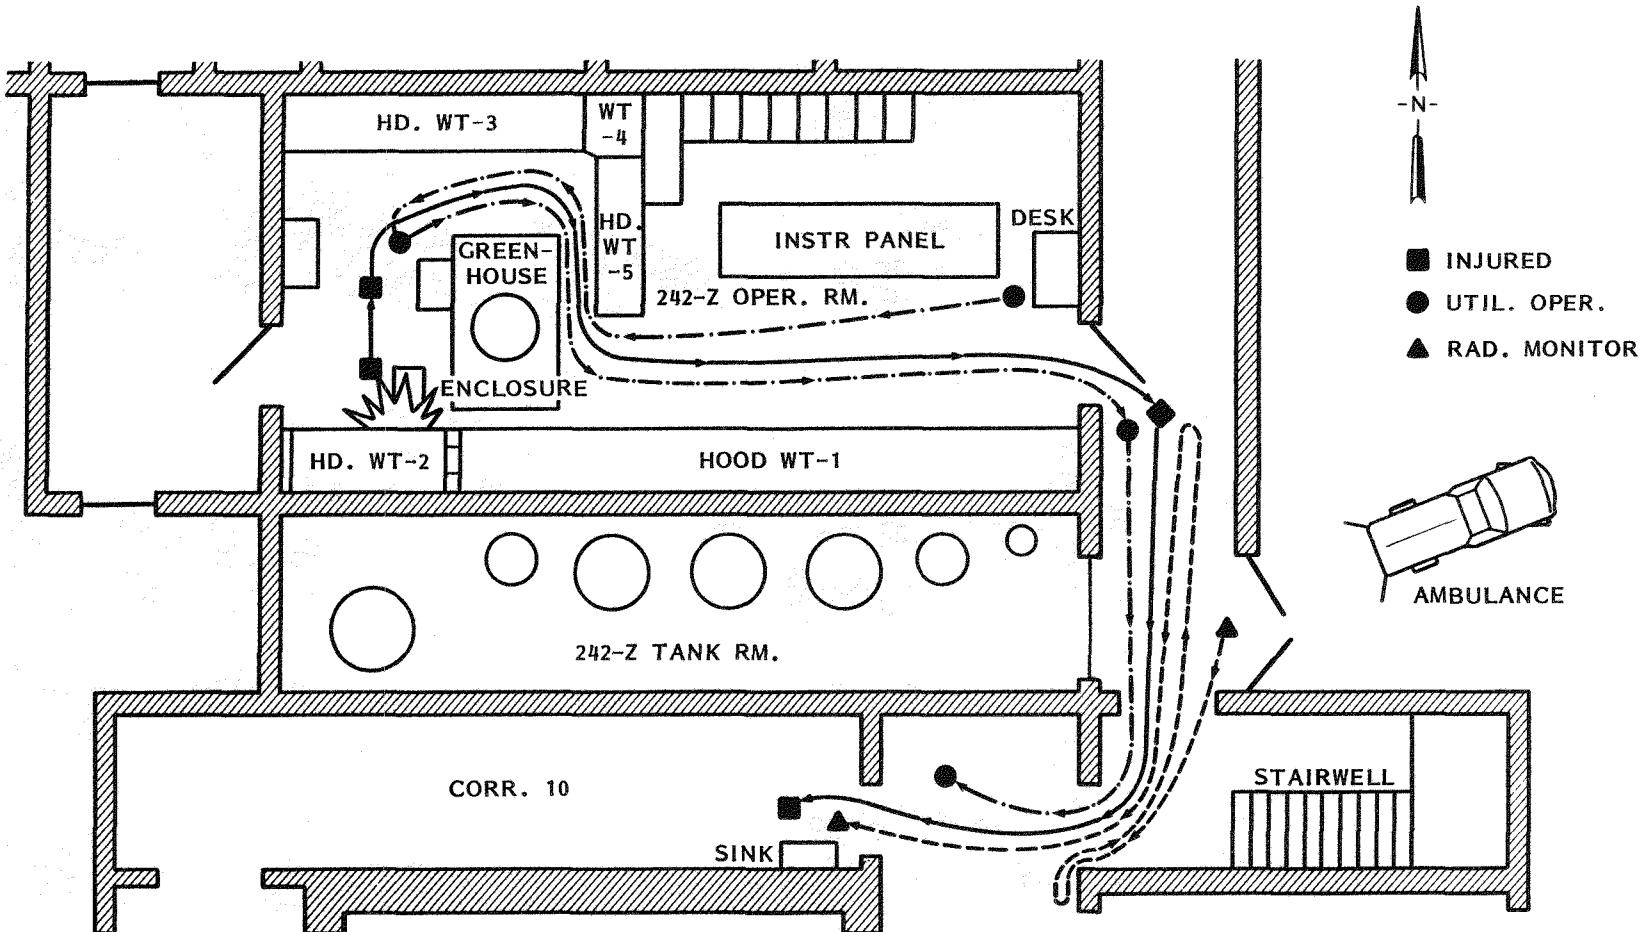
Figure 1

The general plan of the room is shown in Fig. 1. The long dimension of the room was about 50 feet. The americium recovery glove box was located on the south wall at the west end of the room. Just inside the normal (east) entry to the room was a desk and two chairs. Several instruments were nearby on the north wall, from which temperature, pressure and flow measurements were periodically monitored and recorded on record sheets and log books kept at this desk. A telephone and an intercom connected with the main control room on the fourth floor of the building and to other points in the plant were also located at the desk.

Fig. 1 Floorplan of a portion of the 242-Z Building, showing movements of affected personnel after the accident.
