# The Degradation of Steam-Generator Tubing and Components by Operation of Pressurized-Water Reactors\*

John R. Weeks and Carl J. Czajkowski

Corrosion Science Group  
Department of Nuclear Energy  
Brookhaven National Laboratory  
Upton, New York 11973

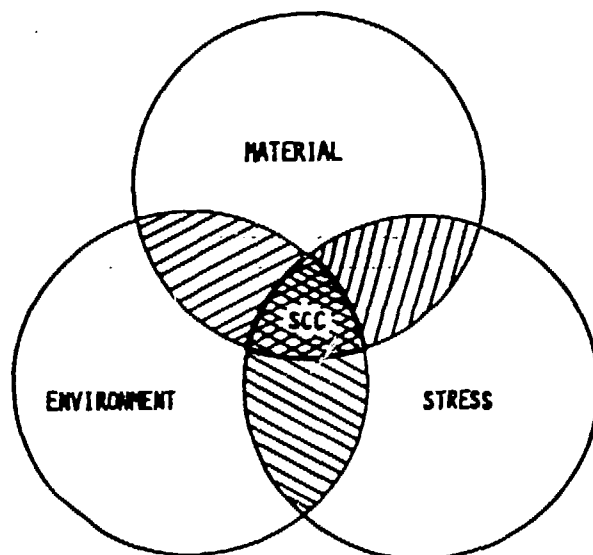
Figure 3 is an often repeated sketch (7) showing the synergistic interplay of environment, material composition, and stress that underly all SCC phenomena. An NRC sponsored research program is underway at BNL (8), the purpose of which is to develop a sufficient understanding of the degradation mechanisms and causative factors to permit an estimation of the lifetime of a steam generator tube. Results to date have been encouraging that these goals can be met, the principal observations are summarized in Table 4. It is anticipated that by the end of 1983, the program will be completed to a point where predictions of the life time of tubing under a variety of operating conditions can be made, including the situations where active deformation of the metal continues, where deformation has occurred but has been arrested, and where abnormal water chemistry might be encountered with or without active deformation.

FIGURE 3: SKETCH OF THE INTERPLAY OF STRESS, MATERIAL, AND ENVIRONMENTAL FACTORS THAT CAUSE SCC

With regard to solutions to the problem, returning again to Figure 3, the environment, at least on the primary side of a PWR steam generator, probably cannot be changed at the present time. The material can be changed only in new plants; for all SG's manufactured after approximately 1980, the Inconel 600 tubing has been given a heat treatment to improve its resistance to primary side SCC. On an existing generator, the only variable that can conceivably be modified is the stress pattern, and research is underway at the present time, under the auspices of the Electric Power Research Institute Steam Generators Owners Group (EPRI-SGOG), to develop techniques for in situ stress relief, particularly in those areas where the tube is expanded into the tube sheet.
