# **Minnesota Retrofit Insulation In Situ Test Program**

June 1978

The Minnesota Energy Agency

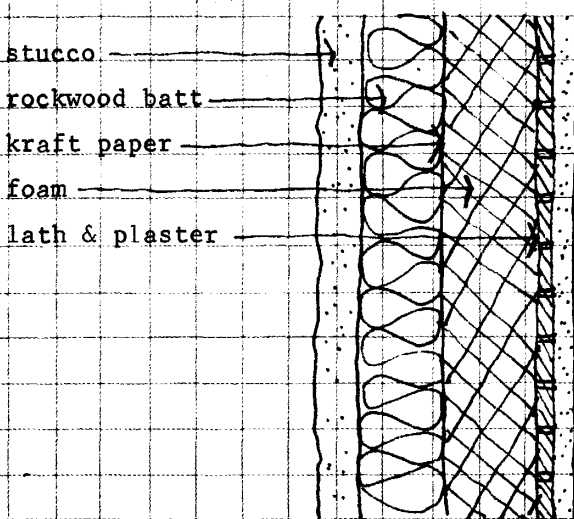
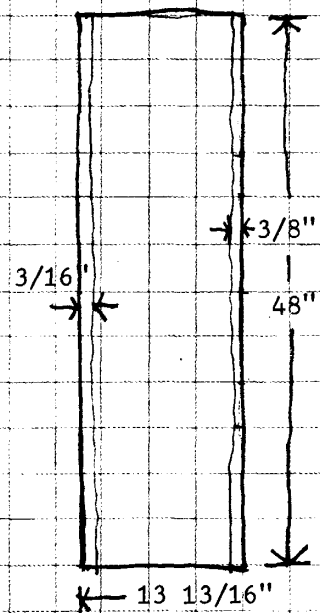
SHRINKAGE = 4%

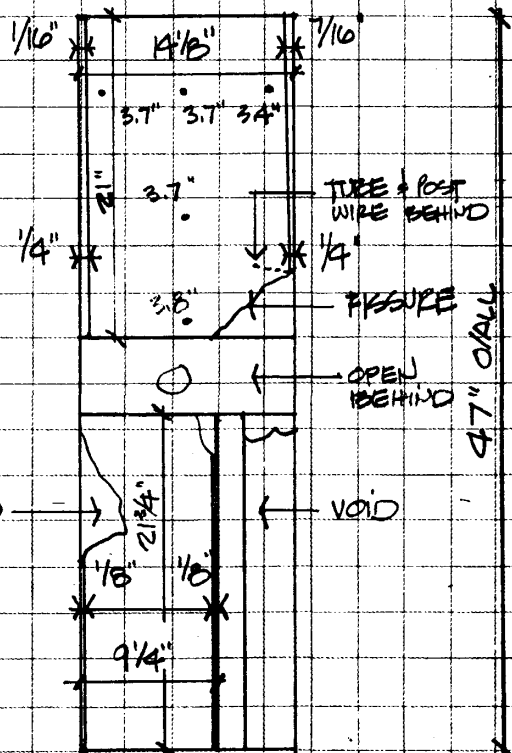
\*NOTE: presence of leak in general wall area.  
Small part of foam discolored & friable

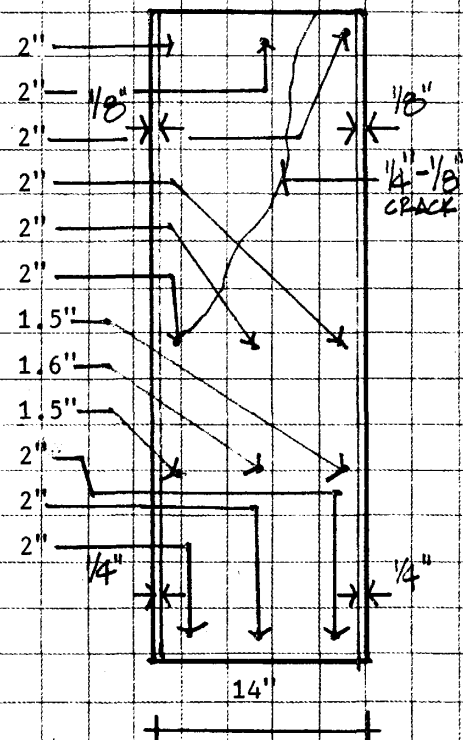
SHRINKAGE = 4%

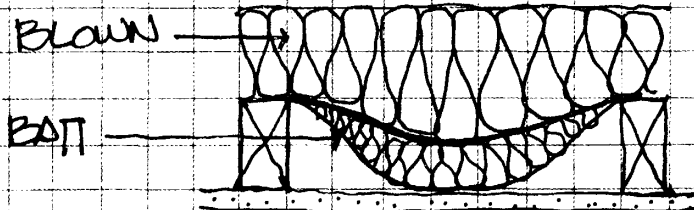
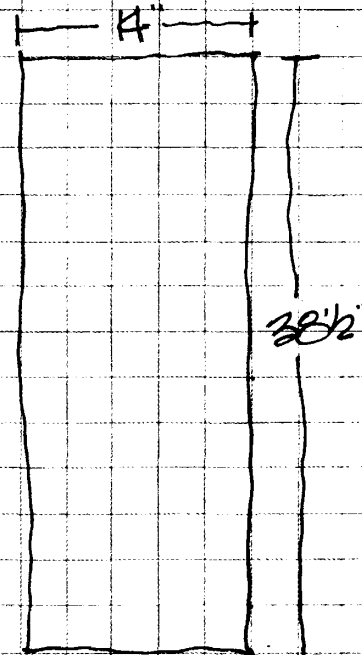
PLAN

plan location(s) dining area venting PRV + 2 10x10 gables  
framing type rafter & joist condition of structure excellent  
condition of wiring N/A  
ORIGINAL: insulation type mineral vapor barrier type paper-discont.  
RETROFIT: insulation type mineral vapor barrier type N/A  
retrofit installation procedures/problems none  
difficulty of opening/closing sample none

packing excellent friability N/A  
REPLACEMENT: insulation f glass vapor barrier original left intact

insulation thickness 9 1/2 + flame char, no burn

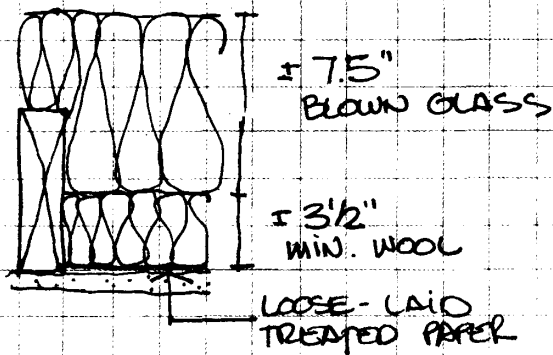
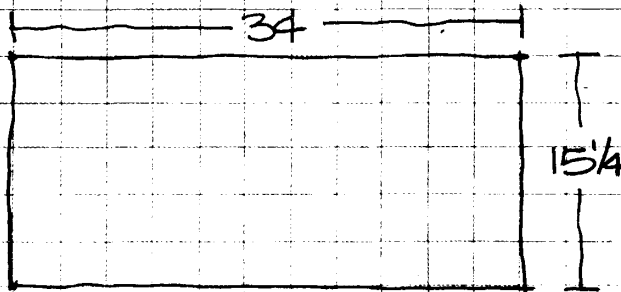
SECTION

plan location(s) bedroom venting 2 gables \*  
framing type joist & rafter condition of structure excellent  
condition of wiring N/A  
ORIGINAL: insulation type wool vapor barrier type paper- discount.  
RETROFIT: insulation type glass vapor barrier type N/A  
retrofit installation procedures/problems none

packing good friability N/A  
REPLACEMENT: insulation f glass batt vapor barrier orig. left in place

NOTE: Label 4"

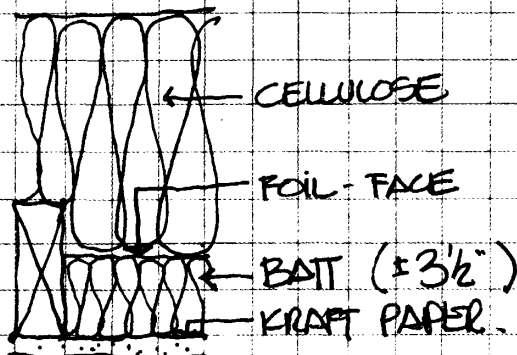
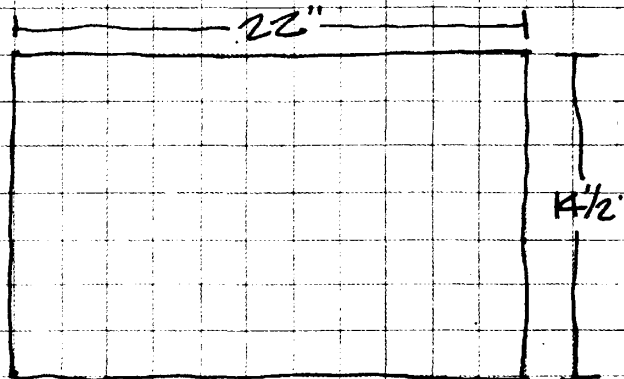
SECTION

plan location(s) bedroom venting 2 gable & 2 ridge \*  
framing type joist & rafter condition of structure excellent  
condition of wiring appears good  
ORIGINAL: insulation type foil faced batt vapor barrier type foil  
RETROFIT: insulation type cellulose vapor barrier type none  
retrofit installation procedures/problems tight space - uneven but deep

packing good friability N/A  
REPLACEMENT: insulation fiberglass vapor barrier left original batt in place

NOTE: Labeled R-22

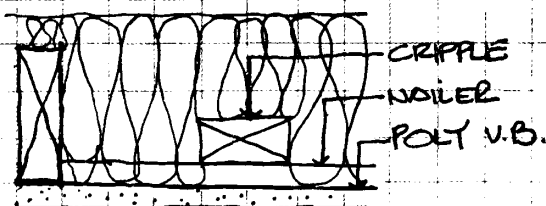
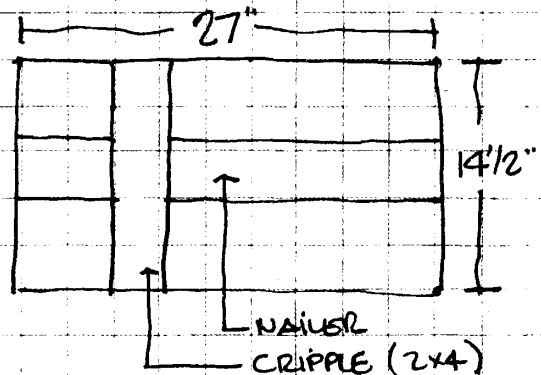
SECTION

plan location(s) stairway venting 3 gable vents - see below  
framing type joist & rafter condition of structure excellent  
condition of wiring N/A  
ORIGINAL: insulation type none vapor barrier type poly  
RETROFIT: insulation type blown vapor barrier type N/A  
retrofit installation procedures/problems none  
difficulty of opening/closing sample none

insulation thickness 7.35" flame char, no burn

NOTE: Original depth 10" - CONTRACT

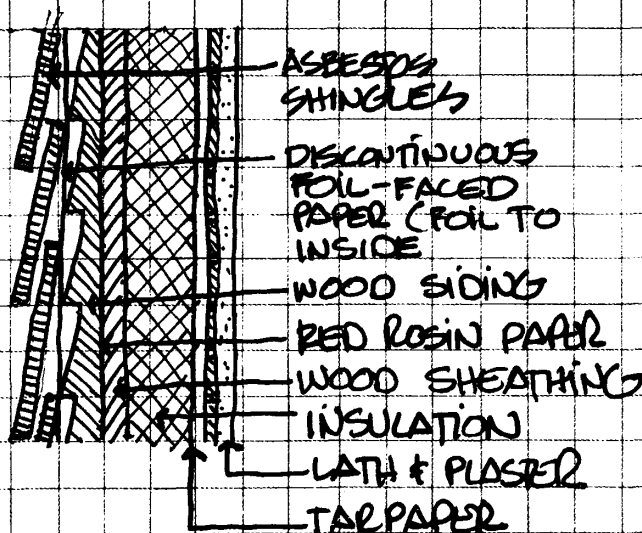
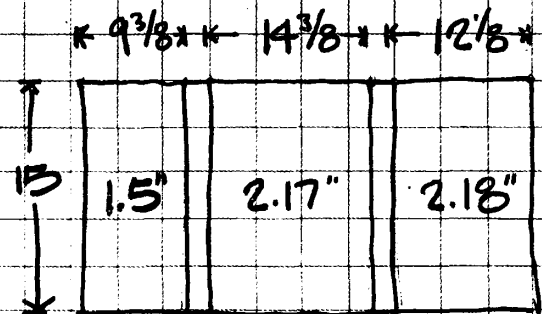
SECTION

plan location(s) kitchen venting N/A  
framing type 2X4 stud condition of structure good  
condition of wiring N/A

difficulty of opening/closing sample asbestos shingles very difficult to remove without damage

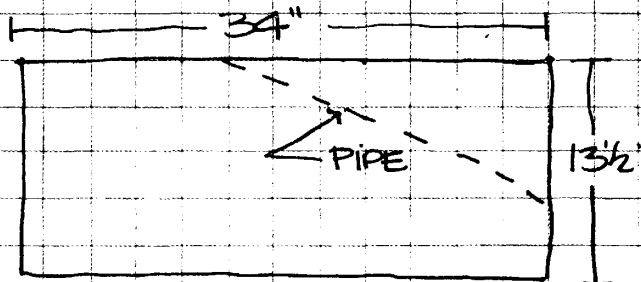
plan location(s) hall venting 2 gables 15X24 louvered  
framing type rafter & joist condition of structure good  
condition of wiring N/A  
ORIGINAL: insulation type none vapor barrier type none  
RETROFIT: insulation type cellulose vapor barrier type none  
retrofit installation procedures/problems none

insulation thickness 6" flame char, no burn

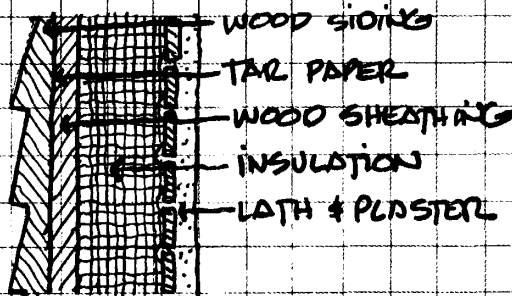
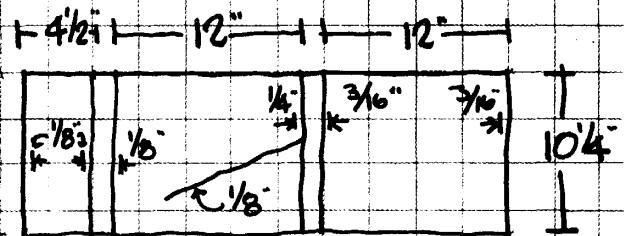
SECTION

plan location(s) dining room venting N/A  
framing type 2X4 stud condition of structure excellent  
condition of wiring N/A  
ORIGINAL: insulation type none vapor barrier type none  
RETROFIT: insulation type UF vapor barrier type none  
retrofit installation procedures/problems backplaster in certain areas  
difficulty of opening/closing sample none  
PRESENCE OF: moisture, corrosion, odor, vermin, fungus  
none  
packing N/A friability good  
REPLACEMENT: insulation UF vapor barrier none

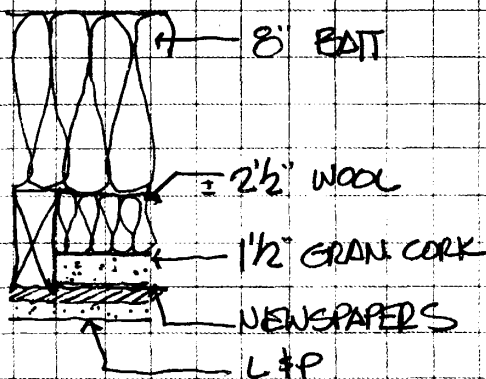
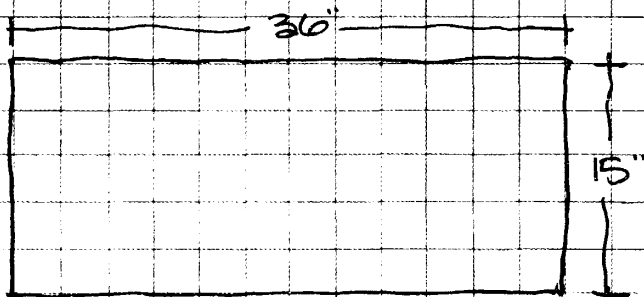
SECTION

plan location(s) living room venting 3 ridge, 1 gable  
framing type joist/rafter condition of structure excellent  
condition of wiring good  
ORIGINAL: insulation type cork/mineral wool vapor barrier type none  
RETROFIT: insulation type fiberglass batt vapor barrier type none  
retrofit installation procedures/problems none

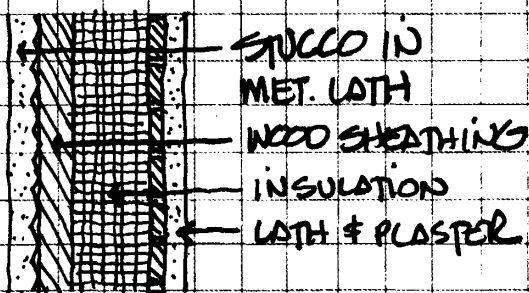
SECTION

PRESENCE OF: moisture, corrosion, odor, vermin, fungus possible corrosion at  
sheathing wet at corner due to downspout removal \* sheathing nails (see photo 9)  
packing N/A friability rather friable  
REPLACEMENT: insulation UF vapor barrier none

\* foam appeared to have different friability/density  
inner sfc to outer sfc; some yellow discoloration on  
exterior face near leakage corner.

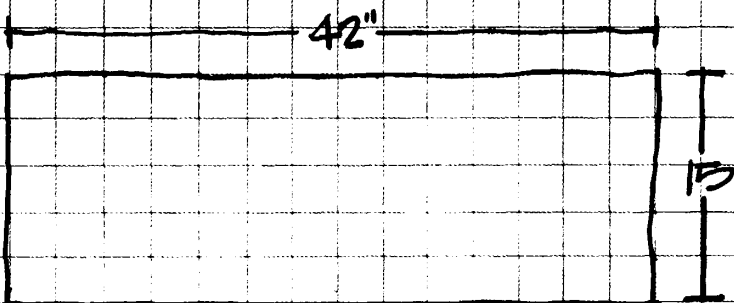
PLAN

plan location(s) bedroom venting 1 gable very small free area (perf alum.)  
framing type rafter/joist condition of structure excellent  
condition of wiring N/A  
ORIGINAL: insulation type none vapor barrier type none  
RETROFIT: insulation type fiberglass batt vapor barrier type none  
retrofit installation procedures/problems none - attic hot - ventilation minimal  
difficulty of opening/closing sample none

PRESENCE OF: moisture, corrosion, odor, vermin, fungus  
some sign of moisture stain @ ridge - may be old leakage

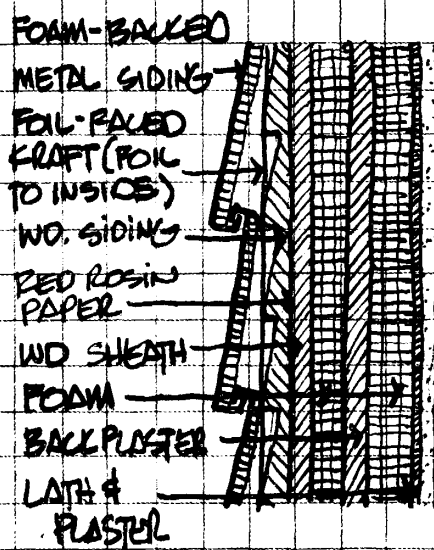
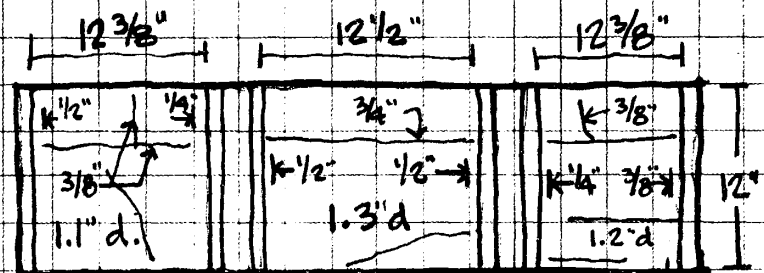
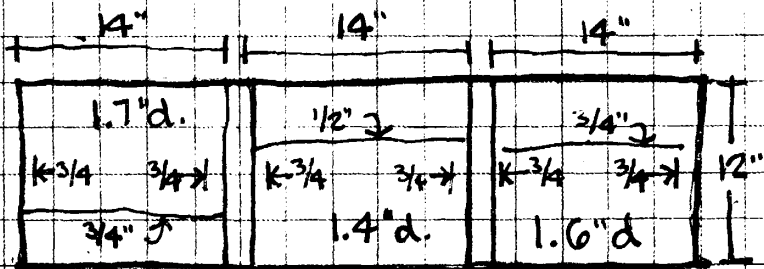
SECTION

plan location(s) bedroom venting N/A  
framing type 2X4 stud condition of structure good  
condition of wiring N/A  
ORIGINAL: insulation type none vapor barrier type none  
RETROFIT: insulation type UF vapor barrier type none  
retrofit installation procedures/problems backplaster  
difficulty of opening/closing sample aluminum siding, backplaster - several layers - 2 hours  
PRESENCE OF: moisture, corrosion, odor, vermin, fungus none  
packing N/A friability outer layer friable, inner rather intact  
REPLACEMENT: insulation UF vapor barrier none

insulation thickness see below flame char, no burn

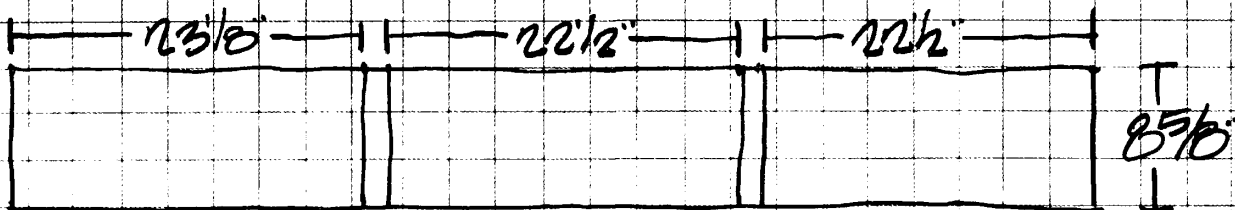
PLAN (TOT. CAVITY DEPTH 5 1/2")

plan location(s) entry venting N/A  
framing type rafter/joist condition of structure good  
condition of wiring N/A  
ORIGINAL: insulation type none vapor barrier type none  
RETROFIT: insulation type cellulose vapor barrier type none  
retrofit installation procedures/problems unevenness - problem due to blowby from loose floorboards  
difficulty of opening/closing sample floorboards

insulation thickness 4.5" flame chars, no burn

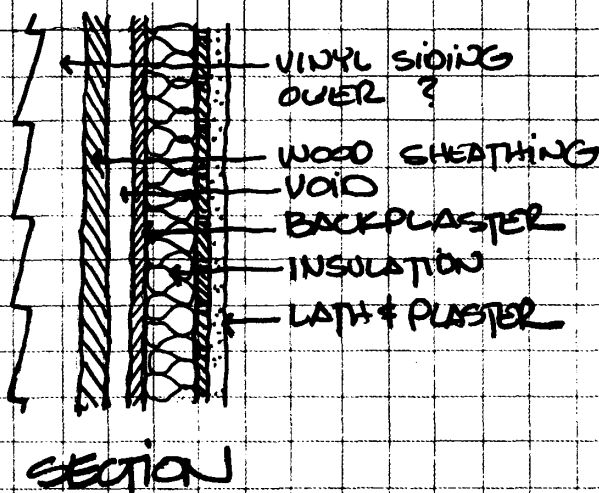
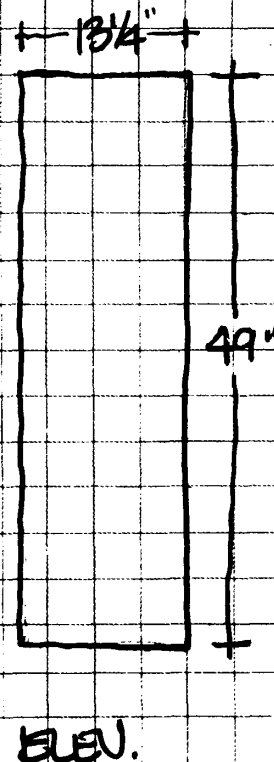
plan location(s) dining venting N/A  
framing type balloon - stops @ floor condition of structure good  
condition of wiring N/A  
ORIGINAL: insulation type none vapor barrier type none  
RETROFIT: insulation type cellulose vapor barrier type none  
retrofit installation procedures/problems backplaster

PRESENCE OF: moisture, corrosion, odor, vermin, fungus  
none  
packing excellent friability N/A  
REPLACEMENT: insulation fiberglass vapor barrier none

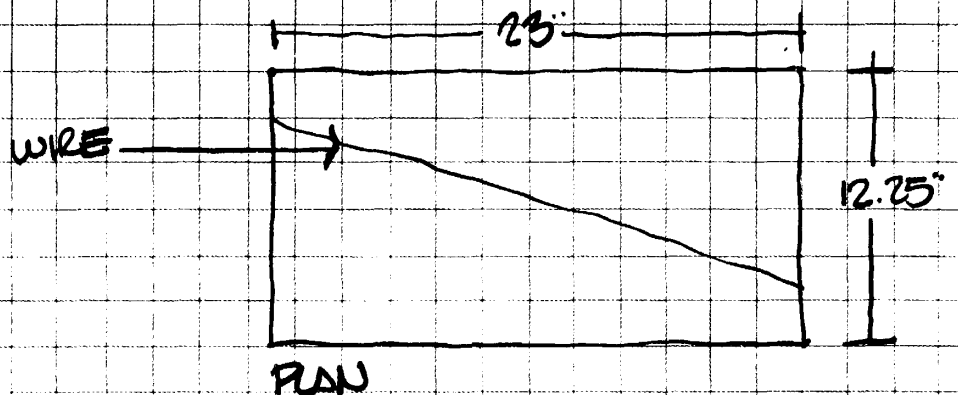
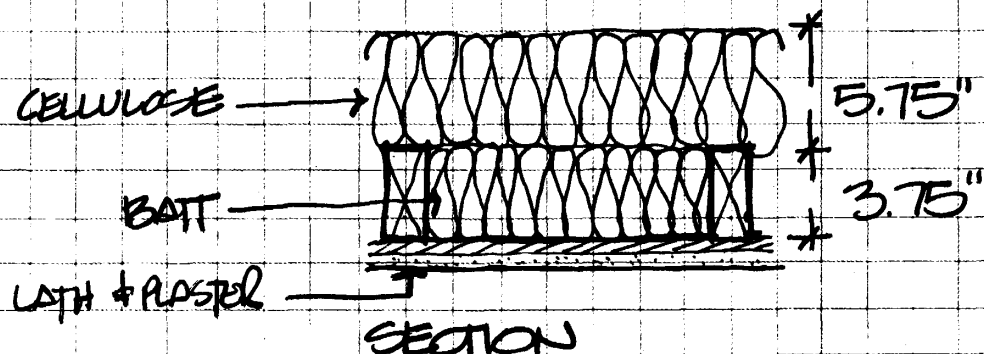
plan location(s) hallway venting 2 gables end + 18x24 each  
framing type rafter/joist condition of structure good  
condition of wiring good

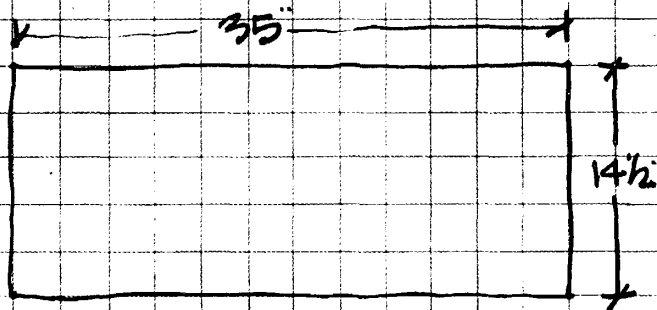
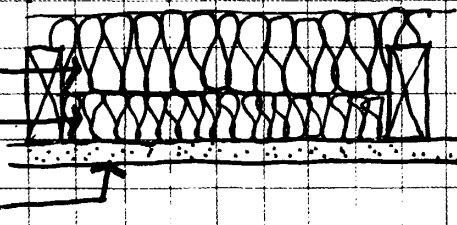
PLAN

plan location(s) kitchen venting 2, 9" ridge, 1 PRV, soffit vents  
framing type raft & joist condition of structure excellent  
condition of wiring N/A  
ORIGINAL: insulation type wood fiber batt vapor barrier type none  
RETROFIT: insulation type fiberglass batt vapor barrier type none  
retrofit installation procedures/problems tight space

\*soffit vents louvered

4@ 4X15  
2@ 6X16

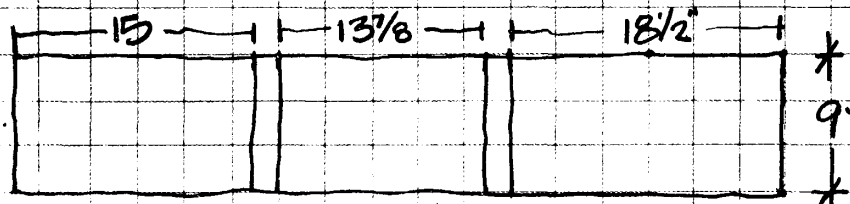
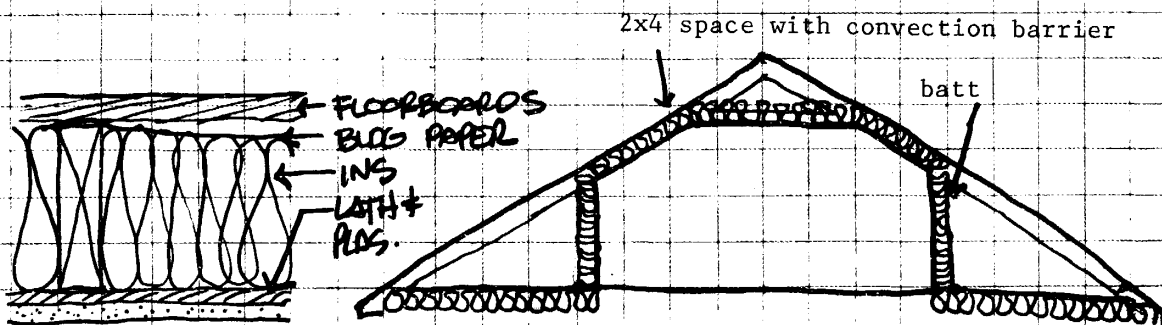
PLAN

plan location(s) bedroom venting 2, 9" dia. roof vents per gable  
framing type joist & rafter condition of structure good  
condition of wiring N/A  
ORIGINAL: insulation type none vapor barrier type none  
RETROFIT: insulation type blown glass vapor barrier type none  
retrofit installation procedures/problems floor boards, varied structural type, shallow roof rafters  
difficulty of opening/closing sample floor boards - long

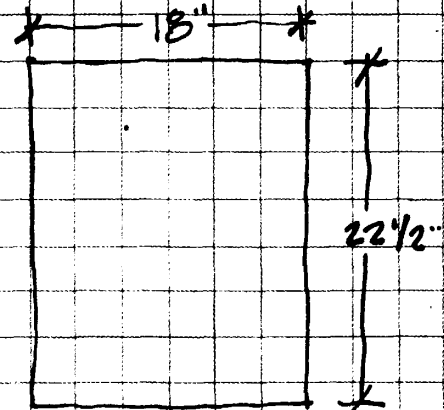
plan location(s) bedroom venting ridge vents, soffit vents  
framing type trusses condition of structure excellent  
condition of wiring good  
ORIGINAL: insulation type mineral wool vapor barrier type treated paper  
RETROFIT: insulation type fiberglass blown vapor barrier type N/A  
retrofit installation procedures/problems none  
difficulty of opening/closing sample none

NOTE: Avg. depth over ceiling total 8 1/2 - 9"  
label states original material 4"

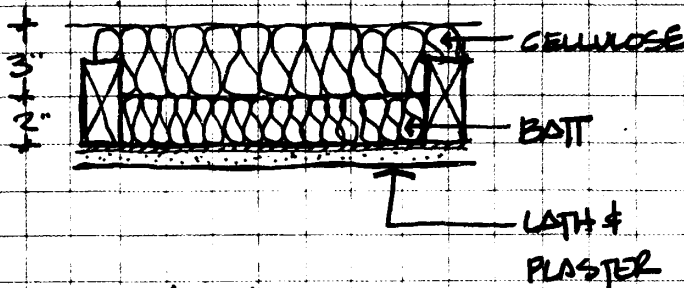
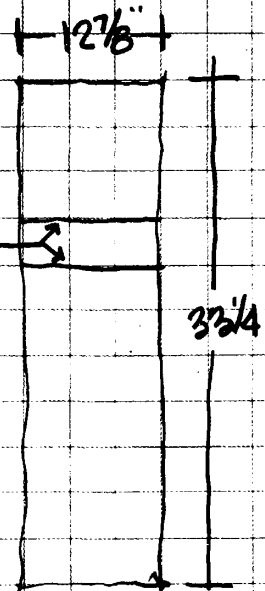
SECTION

\* Overall depth varies 5 - 9"

TUBE &  
POST  
WIRING

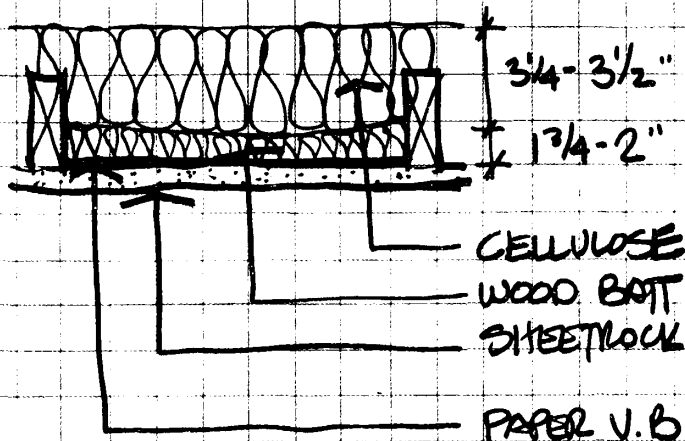
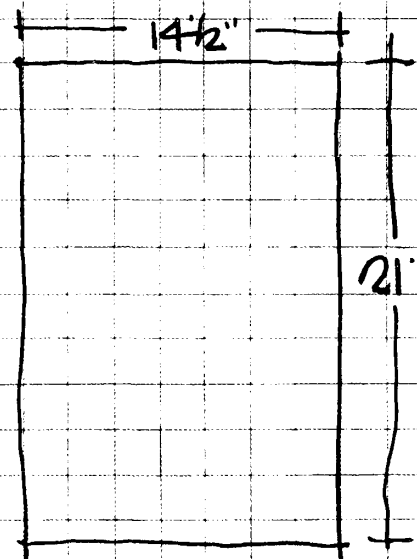
SECTION

NOTE: Sample area shallow Average depth  $\pm$  6"

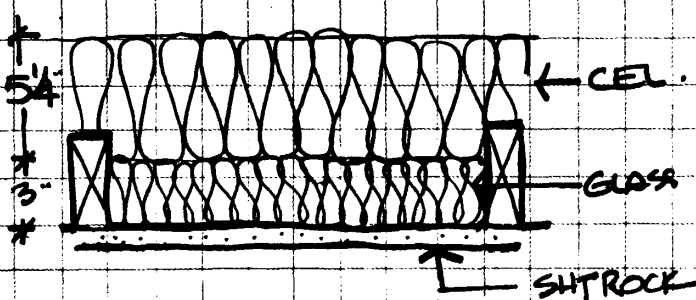
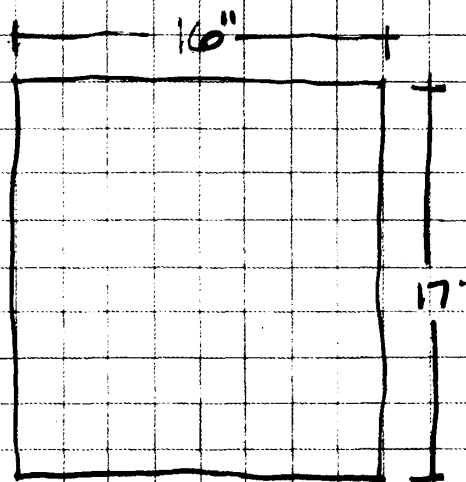
SECTION

\* Note: average ceiling depth 9" +

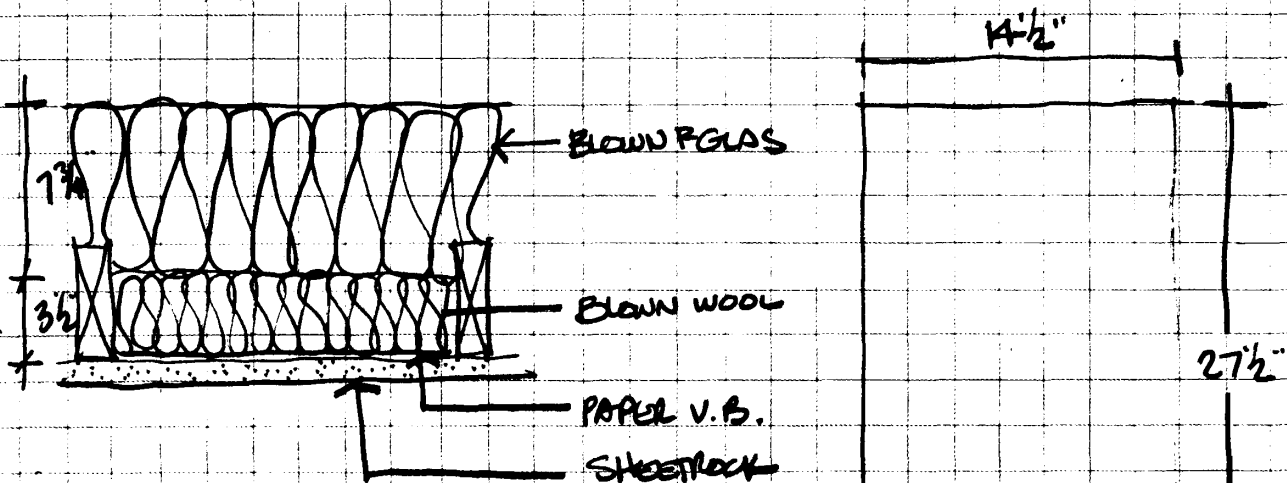
NOTE: 2 labels

19 bags 1232 sq.ft. area 6" reblow  
June 1975

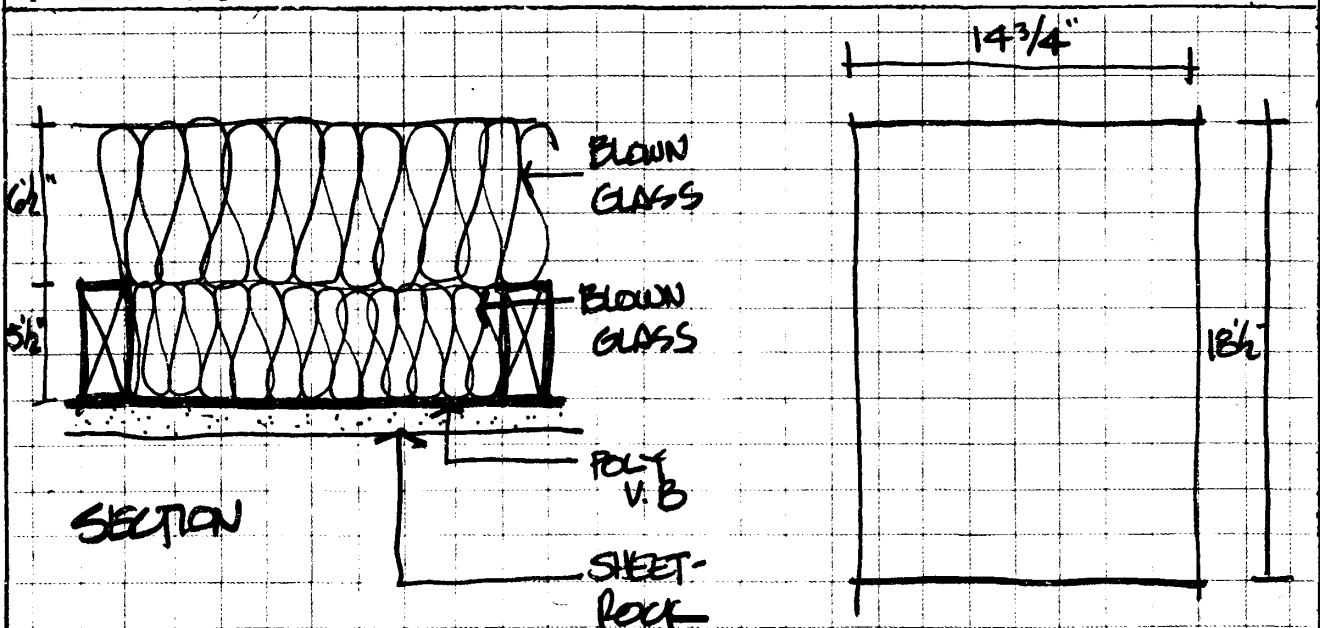
\* test taken @ minimum depth area -  
deepest insulation  $\pm 16\frac{1}{2}$ "

$16\frac{1}{2}$ " highspot, average minimum 12"

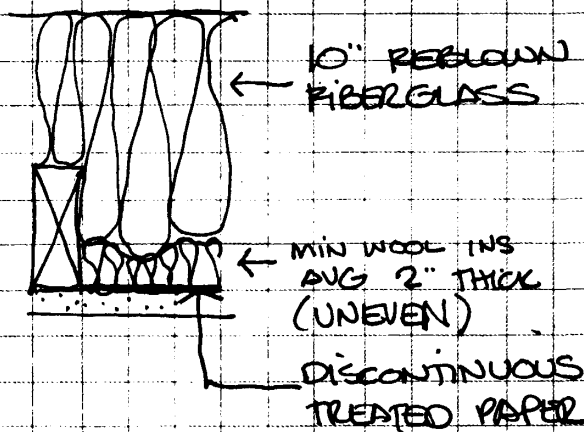
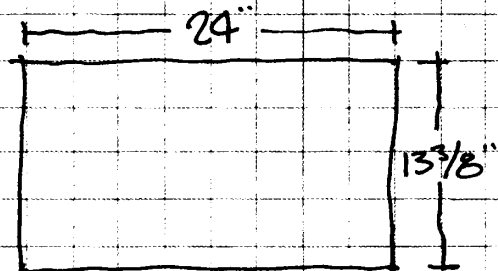
2" original insulation very uneven

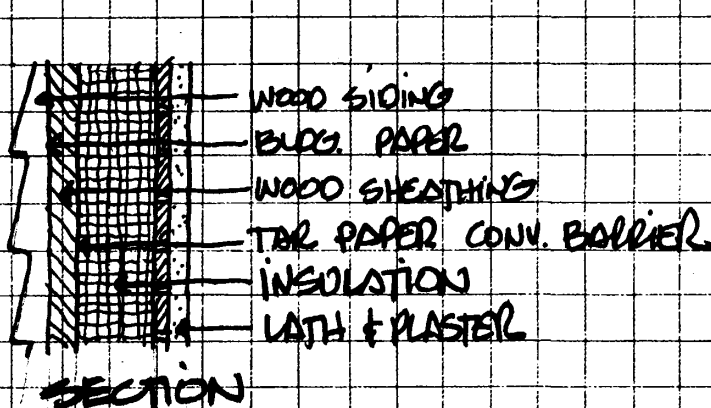
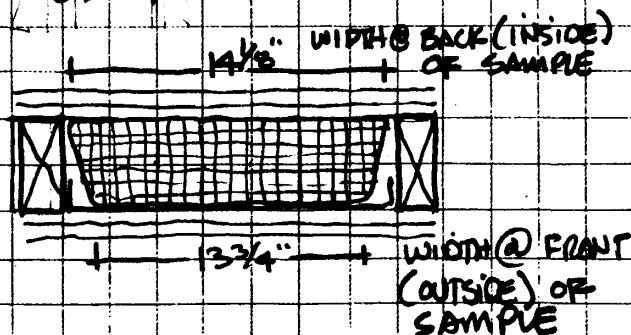
**ELEVATION**  
NOTE: ALL SHRINKAGE  
SHOWN @ OUTSIDE FACE

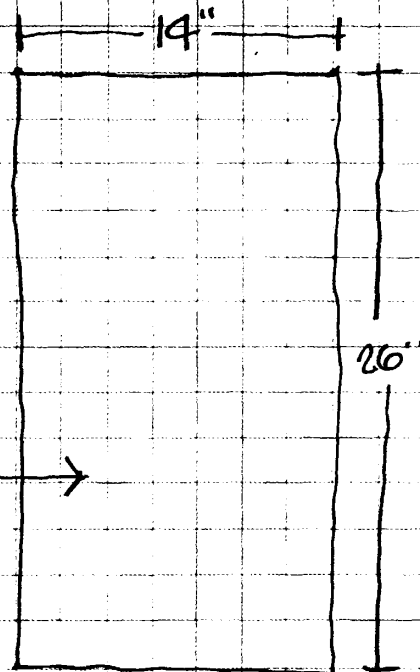
NOTE:  
SOME FRAMING  
BLOCKING A  
PORTION OF  
THE BOTTOM OF  
THE SAMPLE

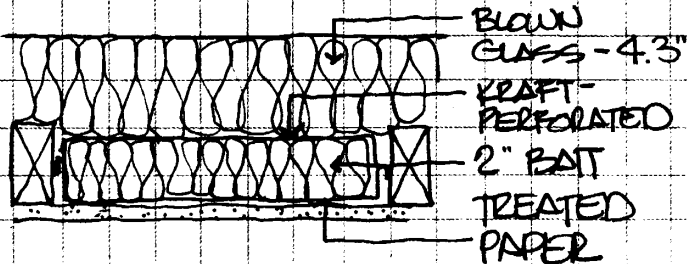
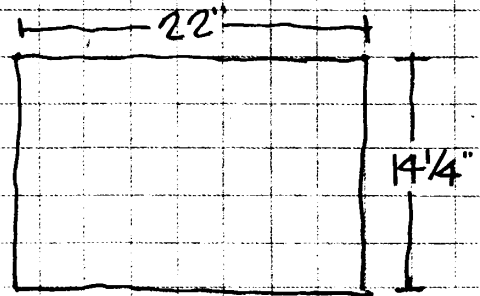
6" Reblown 7/16/74

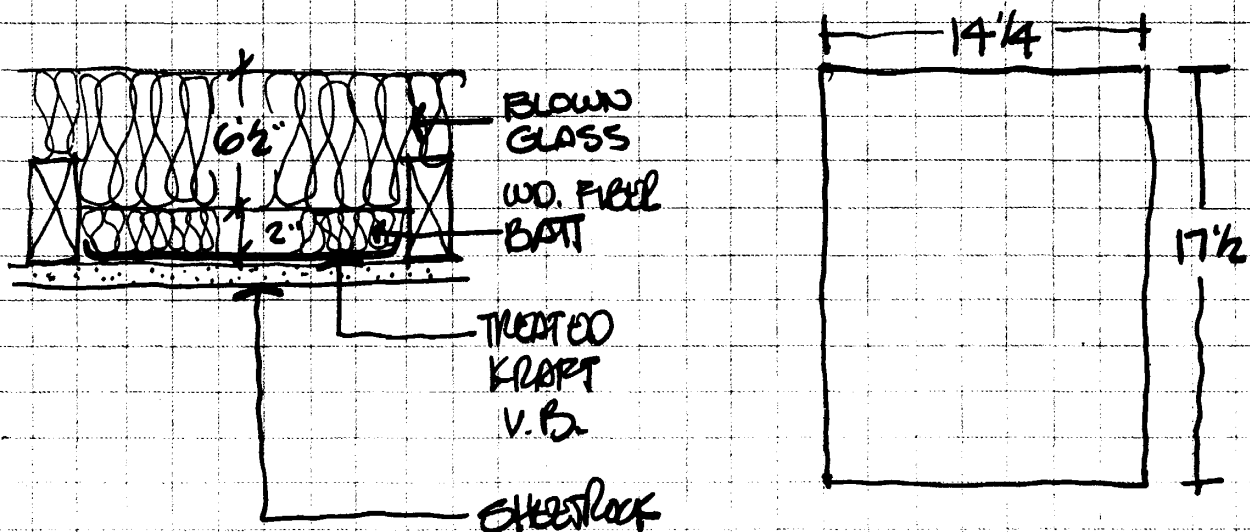
8 1/2" total thickness (2" wood fiber batt, 6 1/2" blown glass)

NOTE: label read - 6" blown fiberglass

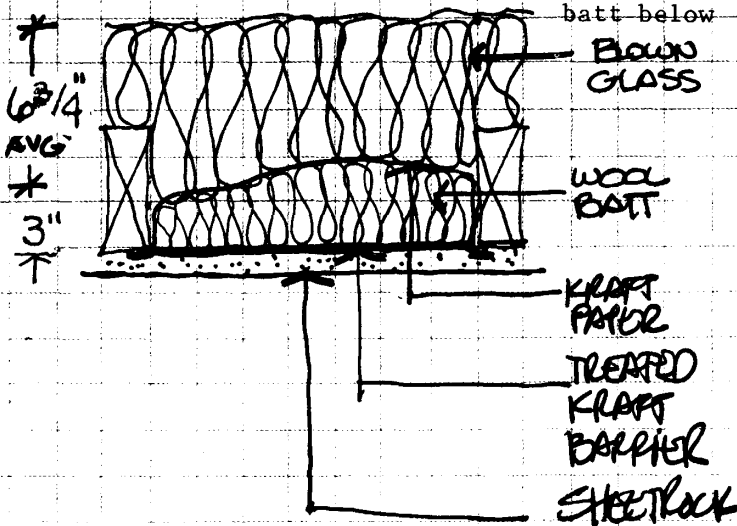
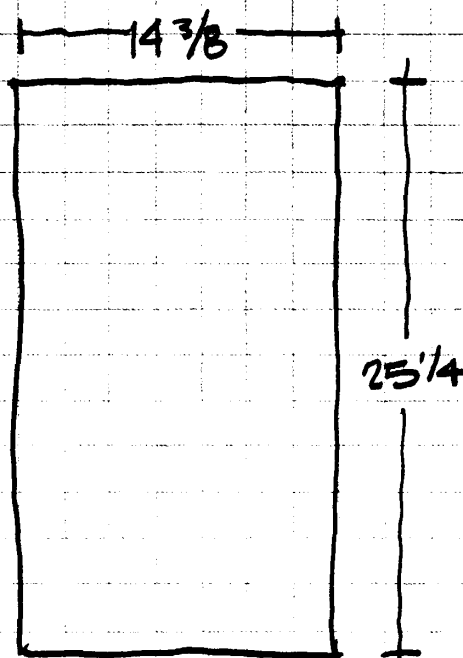
Label - 6" additional

Sample estimated 6" overall due to uneven batt below

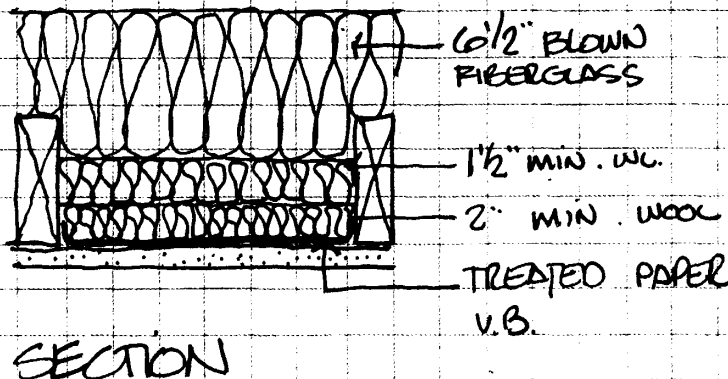
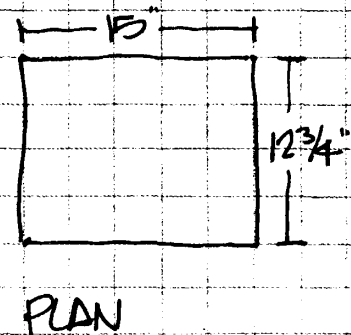
NOTE: depth under floor boards 5"

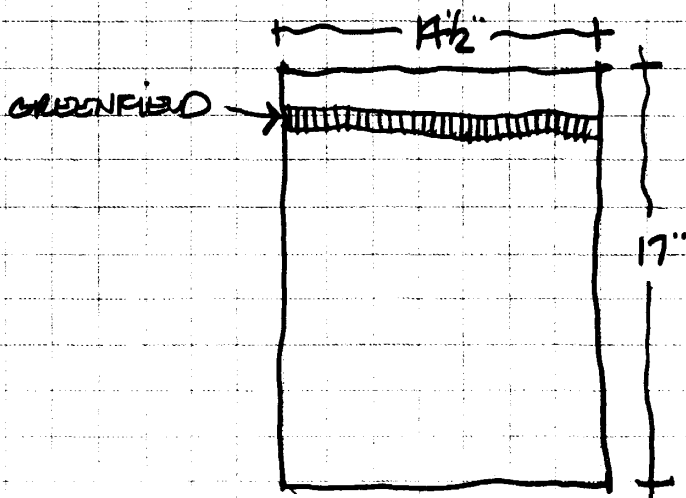
NOTE: \* average depth over attic  $8\frac{1}{2}$  -  $9\frac{1}{2}$ "

label - 8/1/74 4" reblow

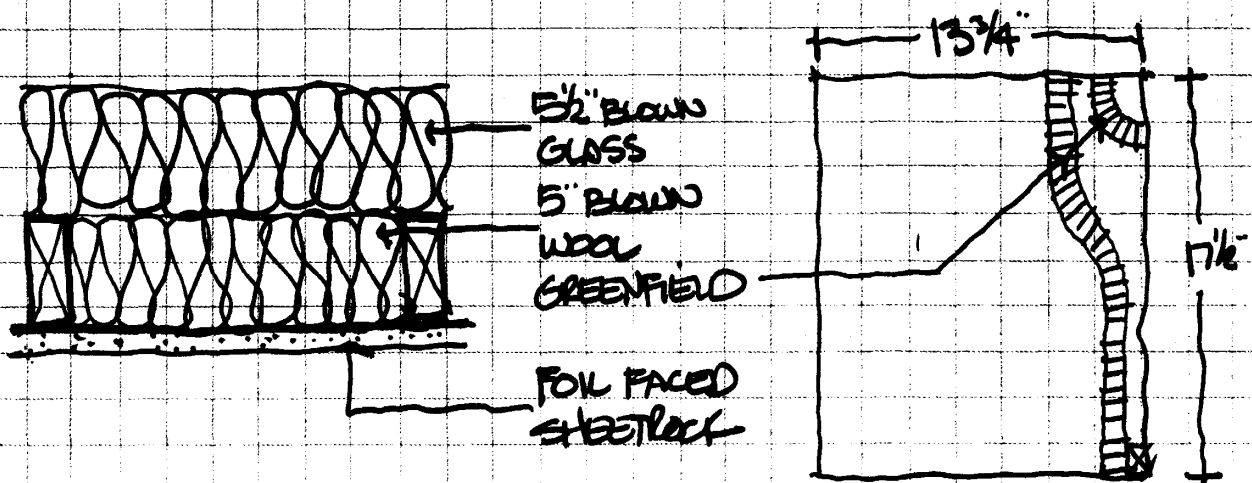
NOTE: labels - 8" @ density to maintain 90% thickness 7/27/64

6" reblow 6-74

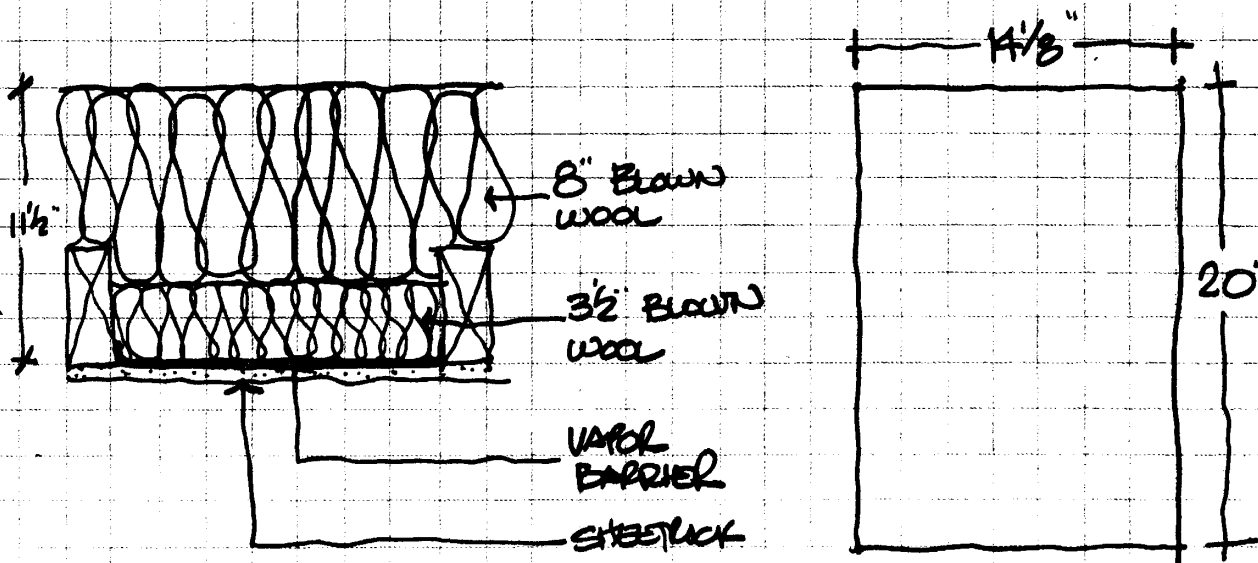
NOTE: label 8/7/74-6"

\* attic depth average 10-12 "
