WAPD-TM-628
AEC RESEARCH AND
DEVELOPMENT REPORT

**BEHAVIOR OF AN INTENTIONALLY
DEFECTED FUEL ROD WHICH
RUPTURED DURING IRRADIATION
(ROD BETT 79-64D)
(LWBR Development Program)**

JULY 1969

**BETTIS ATOMIC POWER LABORATORY, PITTSBURGH, PA.,
OPERATED FOR THE U. S. ATOMIC ENERGY COMMISSION
BY WESTINGHOUSE ELECTRIC CORPORATION**

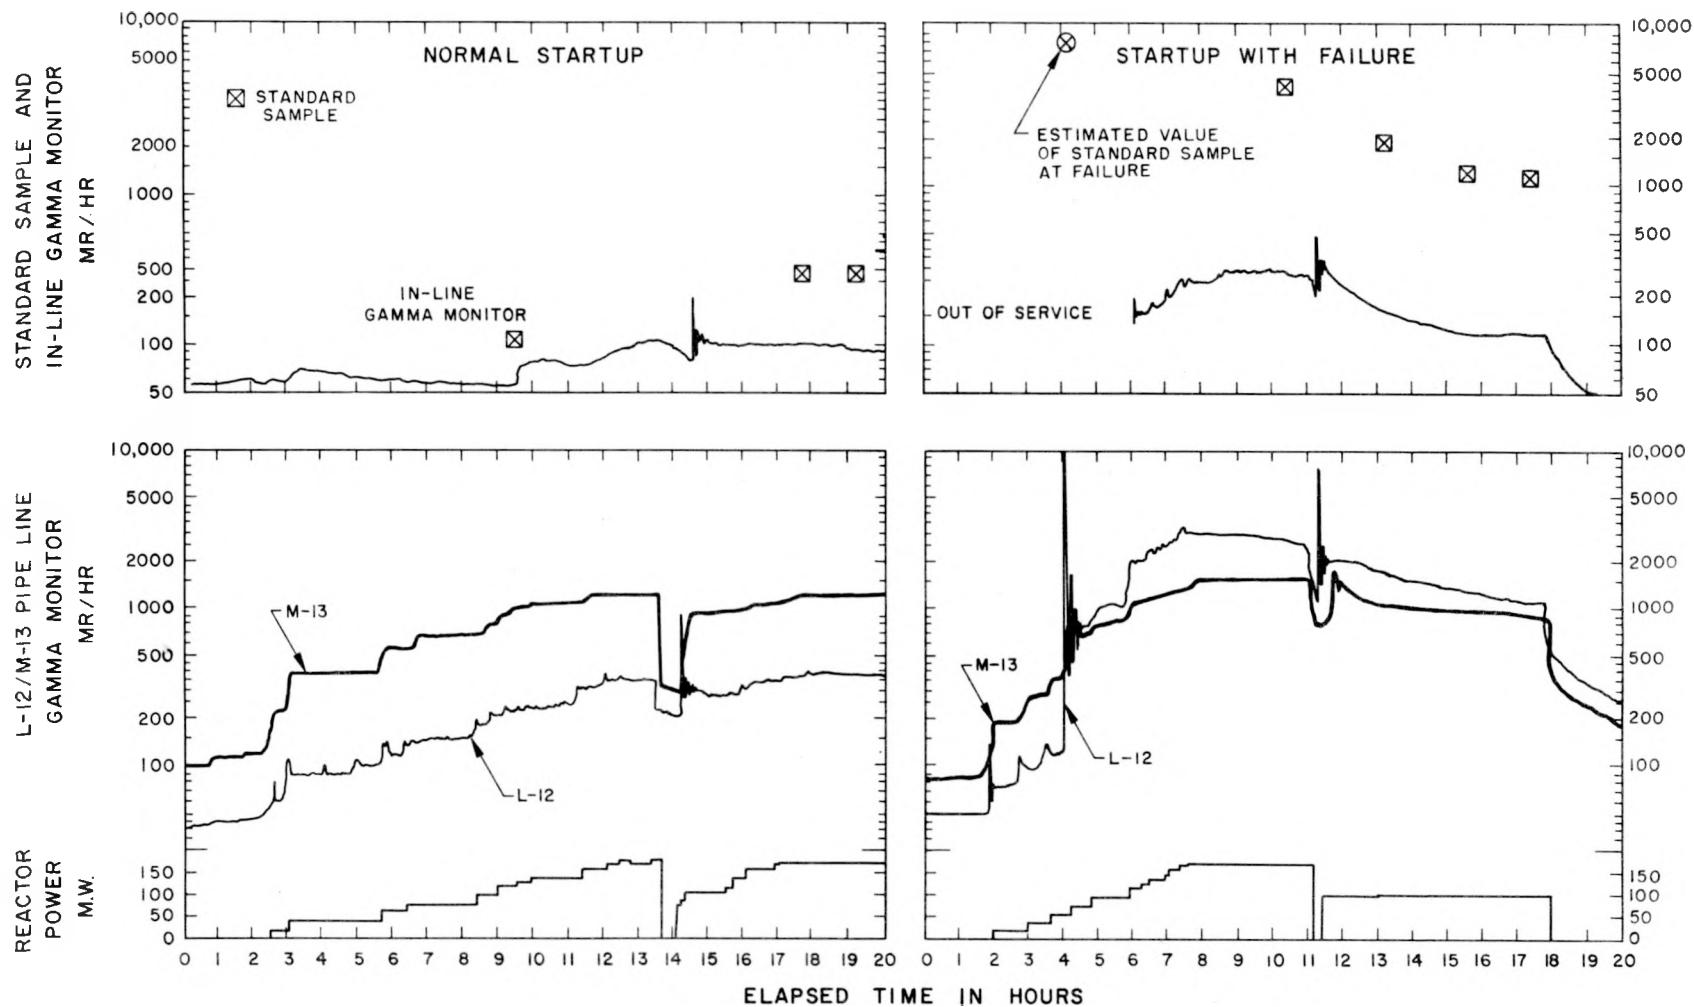
Figure 7. Comparison between Normal Startup and Startup with a Failure on L-12/M-13

examinations. It is postulated that such a mechanism was occurring but, as the internal pressure built up, the small pieces of fuel wedged in the defect became dislodged and permitted relief of the internal pressure of the rod. Figure 7, which is a comparison of a normal reactor startup in which a failure occurred, shows that during a normal startup a brief burst of activity has been recorded as the reactor power transients occur. These activity bursts have been attributed to the release of fuel particles and/or fission products from defected samples. Consequently, it is possible that the defect hole in rod BETT 79-64D periodically became plugged, the clad was deformed (as indicated by dimensional surveys), the hole cleared itself of the fuel particles (as indicated by the activity bursts noted on gamma monitoring devices), and the rod continued to operate normally until the next shutdown-startup cycle occurred. As the clad deforms and as the wall becomes thin, it would take less internal pressure to cause additional deformation. It is then not surprising that the rod diameter increased by 0.022 inch in the plenum region in the short exposure time of 24 EFPD after its third and prior to its fourth interim examination. Upon returning the rod to the L-12 loop test it only took an additional 8.8 EFPD to finally plug the hole to a diameter of less than 0.0001 inch (maximum diameter for hole if a waterlogging type failure were to occur) and rupture the already weakened cladding. Figure 9 indicates that there were eight shutdowns during the last cycle. Since the failure occurred on the seventh startup (Figure 7), there were seven chances for the above postulated mechanism to cause deformation of the clad to the point of failure.

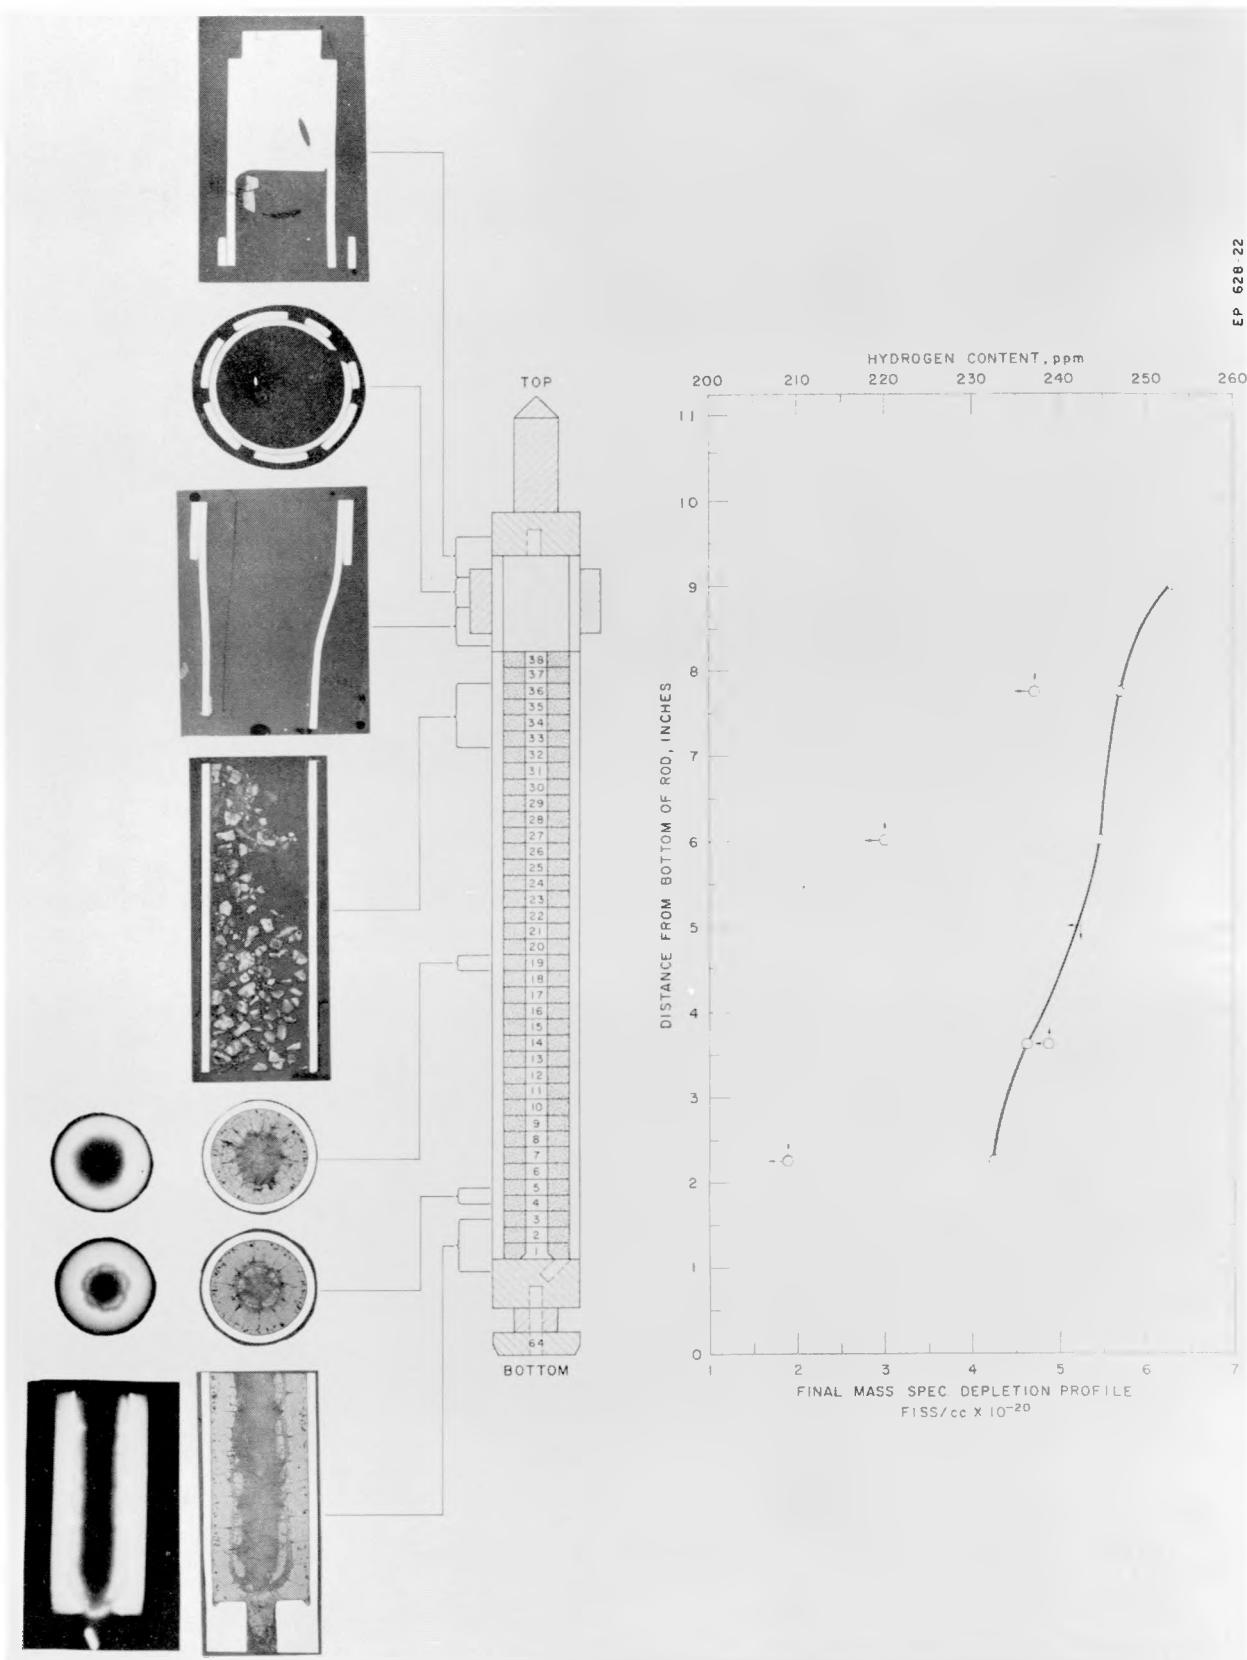
Figure 22. Fuel Structure Profile, Fission Product Concentrations
Fuel Depletion Profile, and Cladding Hydride Analysis Profile
for Rod BETT 79-64D

A transverse section taken through the cladding crack is illustrated in Figure 22 (Sample TE-T). The diameter increase (bulge) and clad thinning are both observed. The clad thickness varied from 0.013 to 0.016 inch with the thinner clad sections found near the fracture (the original clad wall thickness was 0.0177 inch). The resultant radial strains were up to 27 percent. The hydride precipitates were uniformly distributed around the circumference of the sample, with no apparent increase noted near the point of fracture. Figure 28 illustrates typical clad structures and hydride concentrations found near the cladding fracture. The greatest hydride precipitate concentrations appeared at the outer diameter, the cooler region of the cladding. There does not appear to be any differential hydride precipitate concentration close to or away from the cladding adjacent to the Inconel-X spring collar.

The third metallographic section (Sample D-L) was taken below the failed region and illustrates the transition from normal diameter to the bulge (Figure 22). The cladding wall thickness ranged from 0.013 to 0.015 inch in this sample. A series of planes was examined in the rod until the crack was reached in the cladding. The etched structure of the clad in the region where the crack appeared is shown in Figure 29. Though the zirconium hydride concentration is high, there appear to be no solid hydride formations present near or adjacent to the ductile fracture. The heavier hydride concentrations were located in the bulged region rather than at the nonbulged ends of the sample. Little radial variation in the hydride concentrations was observed. Further grindings failed to reveal the progression of the crack towards the intentional defect hole which would have been located near the bottom of the sample.

Several samples were taken from the rod at various axial locations for hydrogen analysis (Figure 21). The results of these analyses are shown graphically in Figure 22 and indicate that concentrations of up to 239 ppm hydrogen were found away from the clad rupture. Metallographic estimates for the hydrogen (visual comparison of photomicrographs with those having known concentrations) in the failed region were approximately 400 to 500 ppm or almost double that analyzed from the rest of the rod.

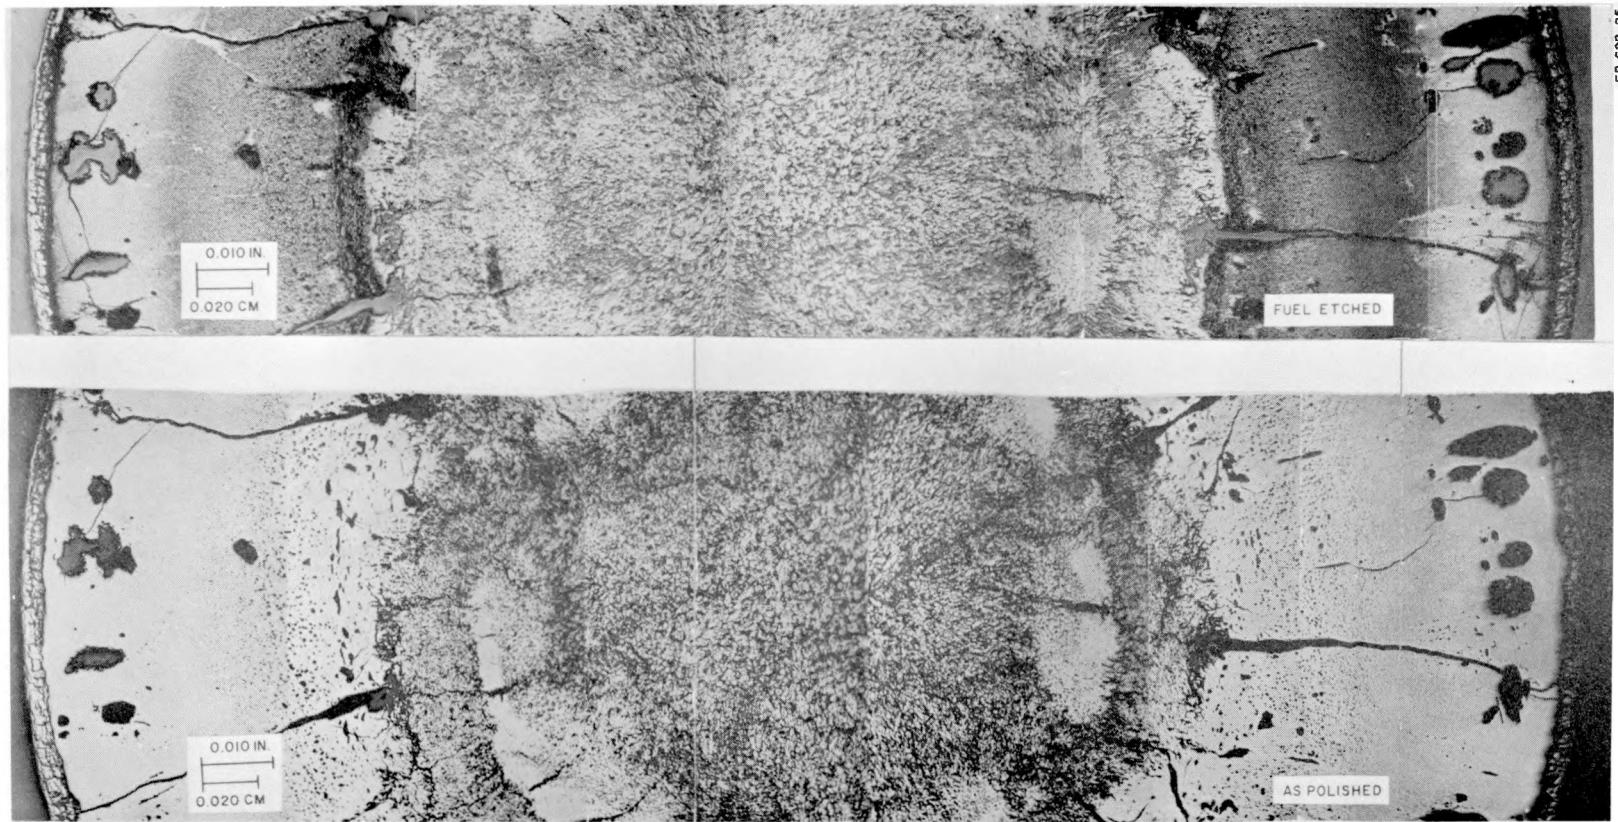
Figure 25. Fuel Structure from Pellet 5. Cladding Removed to Prepare Sample for Etching

Pellet 5 revealed structure similar to that seen in pellet 19 (Figure 25). However, due to lower fluxes in this region the postulated limits of melting were not as near to the pellet surface as in pellet 19.

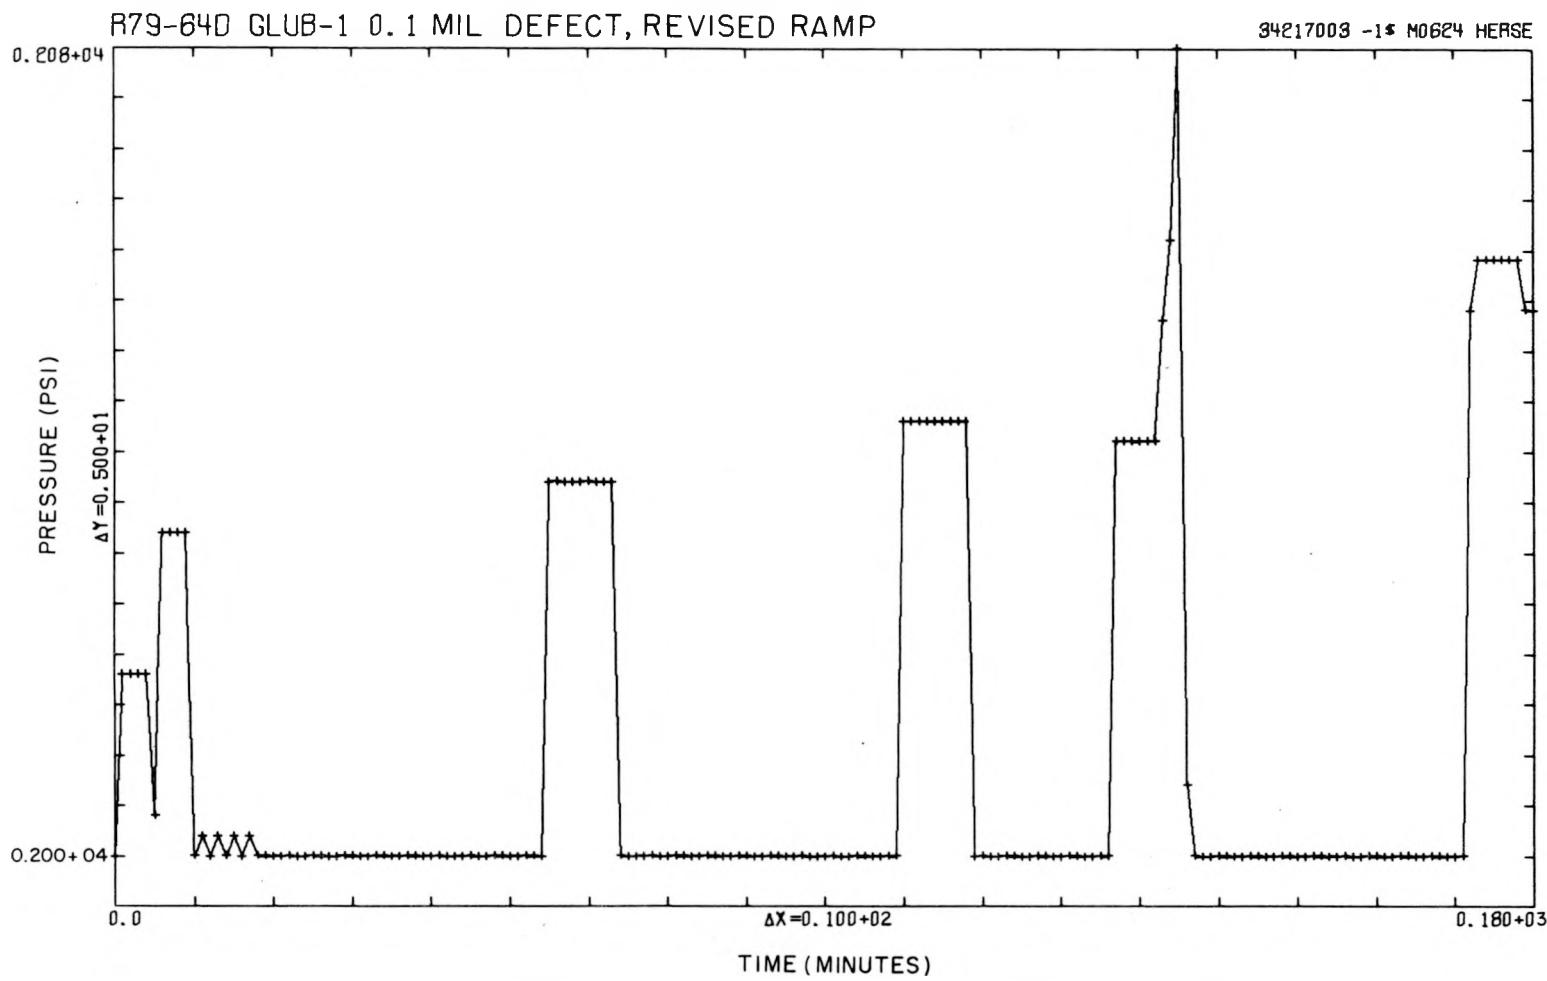
Figure 35. Internal Pressures in Rod BETT 79-64D with a 0.0001 Inch Diameter Defect Hole Calculated with GLUB-1 Computer Program

the fuel rod is made up of four subvolumes: (1) the hollow core of the fuel pellets, (2) the internal volume of the plenum, (3) the gap between fuel pellets and clad, and (4) the lumped volume representing the porosity of the fuel pellets. The clad may contain a defect of arbitrary size (including zero) located in either the fuel section (gap defect) or the plenum section (plenum defect). A plenum defect was considered in the case of the subject rod, and the reactor power history encountered by rod BETT 79-64D during its last day of irradiation was programmed into GLUB-1. It was calculated that internal pressures and corresponding clad rupture stresses would be produced if the defect hole were closed to a diameter of less than 0.0001 inch. Figures 35 and 36 illustrate the resultant internal pressures generated within an intentionally defected rod during a simulated reactor startup (from zero power) and in which the defect hole is partially plugged (0.0001-inch hole) or completely plugged (0.0-inch hole). In the former case there is a sufficient hole size and time for the steam to escape after each power transient. In the second case the internal pressures continue to build up after each power transient until there is a sufficient stress to cause clad rupture.
