NUREG/CR-5280
BNL-NUREG-52178
Vol. 1

Age-Related Degradation of Westinghouse 480-Volt Circuit Breakers

Aging Assessment and Recommendations
for Improving Breaker Reliability

Brookhaven National Laboratory

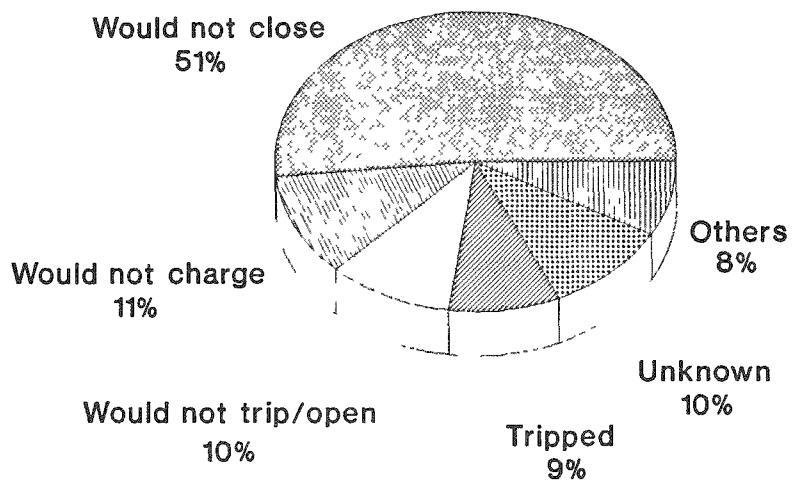
Figure 4.1 DS Breaker Failure Modes - NPRDS

The mode of failure for each of these circuit breaker events was analyzed (Figure 4.1). This figure shows that the failure of the breaker to close on demand is the dominant failure mode, contributing to more than 50% of the failures. The remaining modes all contribute a low (8% to 11%) number of the reported failures.

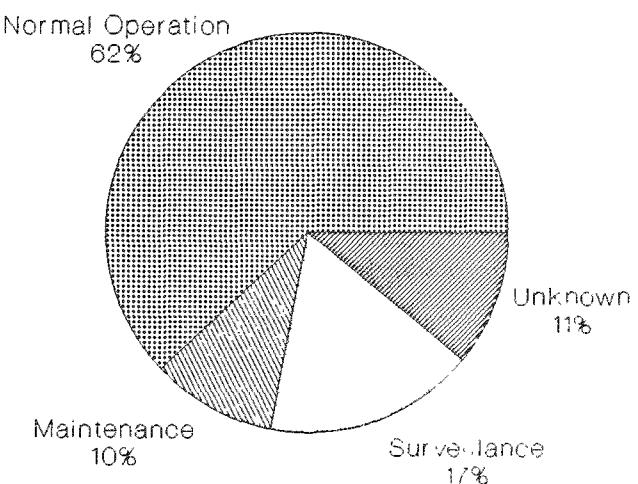
Figure 4.5 System Operating Status When DS Breaker Failure Occurred

3. System Operating Status: The analysis of the operating status of the system at the time the breaker failure was detected is summarized in Figure 4.5. These results indicate that only a small percentage of the failures (27%) were identified during surveillance and maintenance and suggest that modifications to the frequency and implementation of these procedures could improve the reliability of the effected systems.

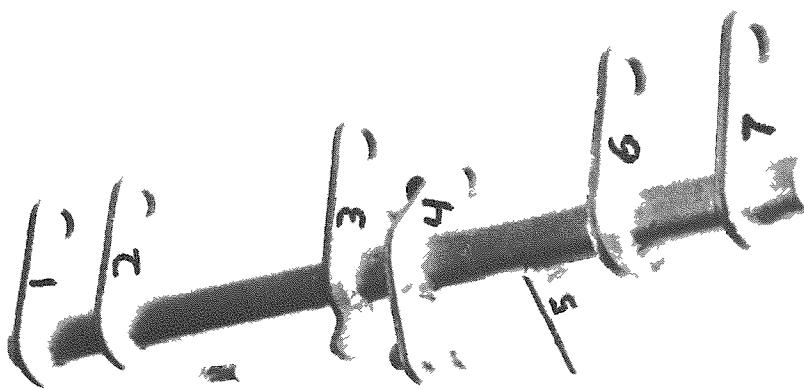
Figure 5-1 Pole Shaft With Levers (a-g)

- Manufacturing - The welding of pole levers to the shaft is inconsistent. These inconsistencies are evident from Figures 5-1 (a-g) which illustrate each of seven welds of a shaft acquired by BNL.

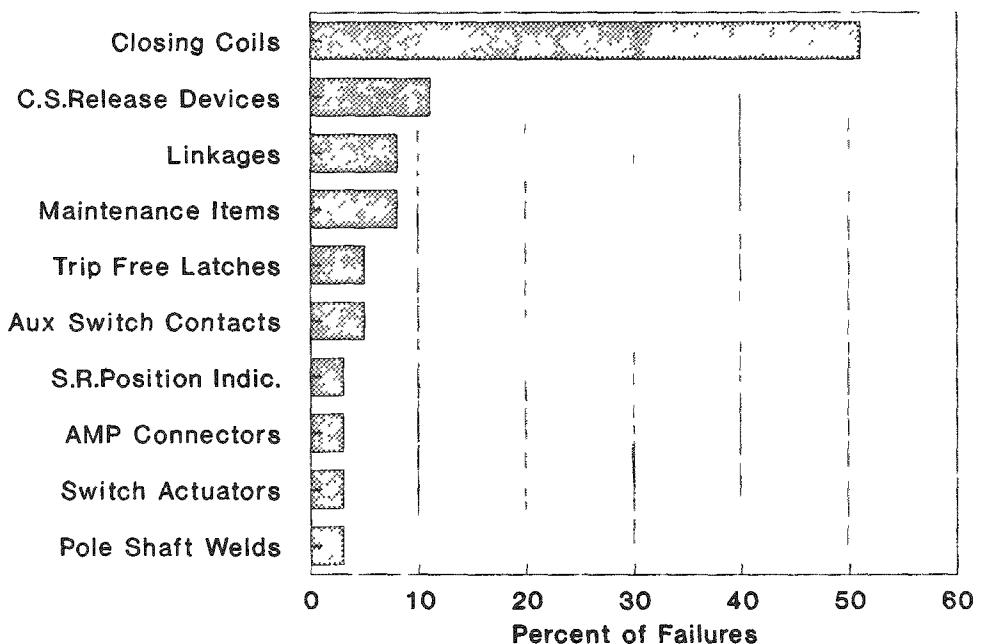
Figure 5.2 Maintenance History for Four Charging Pump-Motor Breakers
 (6/77-12/88) Total Number of Failures - 37

We obtained the maintenance work requests (MWRs) for the four charging pumps at this plant; the data, summarized in Figure 5-2, covers 10 years in which there were 37 incidents. Closing coils and the closing spring release devices account for 62% of the total failures. It seems that under severe service conditions, this particular mechanism has a finite life and needs to be closely monitored for frequent replacement or service. In most cases, the coil was replaced; however, often the root cause of these failures was not identified.
