ORNL/TM-6067

HTGR Fuel Development: Investigations of Breakages of Uranium-Loaded Weak Acid Resin Microspheres

METALS AND CERAMICS DIVISION

HTGR FUEL DEVELOPMENT: INVESTIGATIONS OF BREAKAGES OF
URANIUM-LOADED WEAK ACID RESIN MICROSPHERES

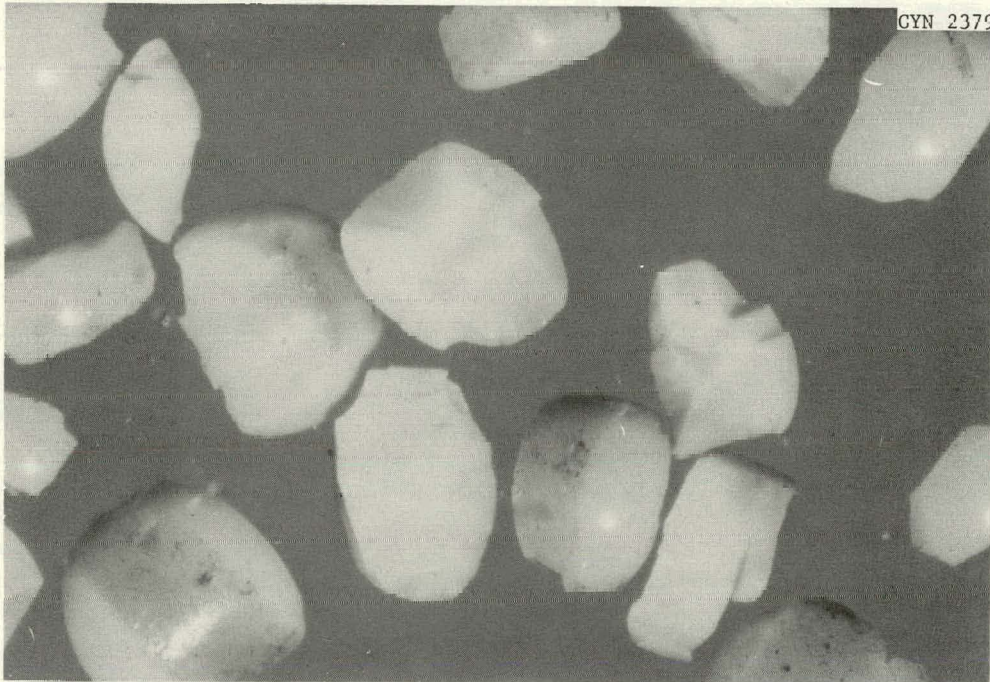
Fig. 4. Bits and Pieces of Uranium-Loaded Amberlite IRC-72 Weak Acid Resin Microspheres Selected at Random from a Normal Batch and Deliberately Crushed. 60 \times . Reduced 24%.

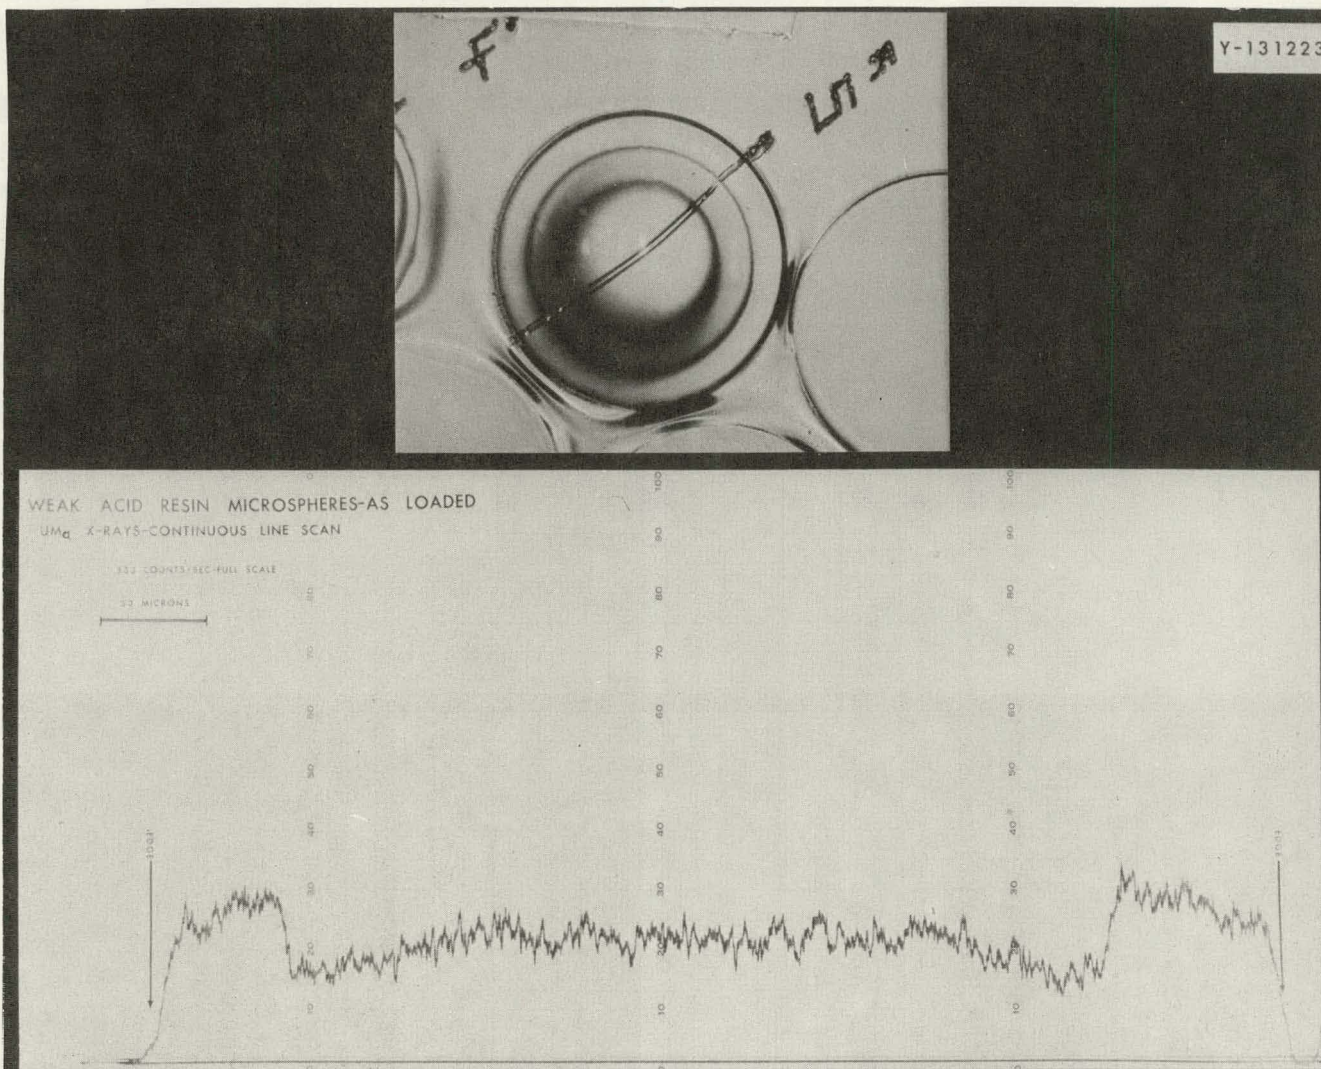
Fig. 14. Photomicrograph and Electron Beam Microprobe Scan of the Cross-Section of a Uranium-Loaded Amberlite IRC-72 Weak Acid Resin Microsphere from the Batch that Exhibited Breakage During Pneumatic Transfer, Carbonization, and Conversion. 100 \times . Reduced 32%.

Figs. 11 and 12 shows that this particle also has a thin outer shell of material, which appears similar to the glassy material, under polarized light (Fig. 12), only darker. The microprobe scan of this particle (Fig. 14) shows that the white center and the glassy material around it have lower uranium concentrations than the outer translucent material. The thin outer shell of glassy material seems to have about the same uranium concentration (perhaps a bit less) as the translucent material.

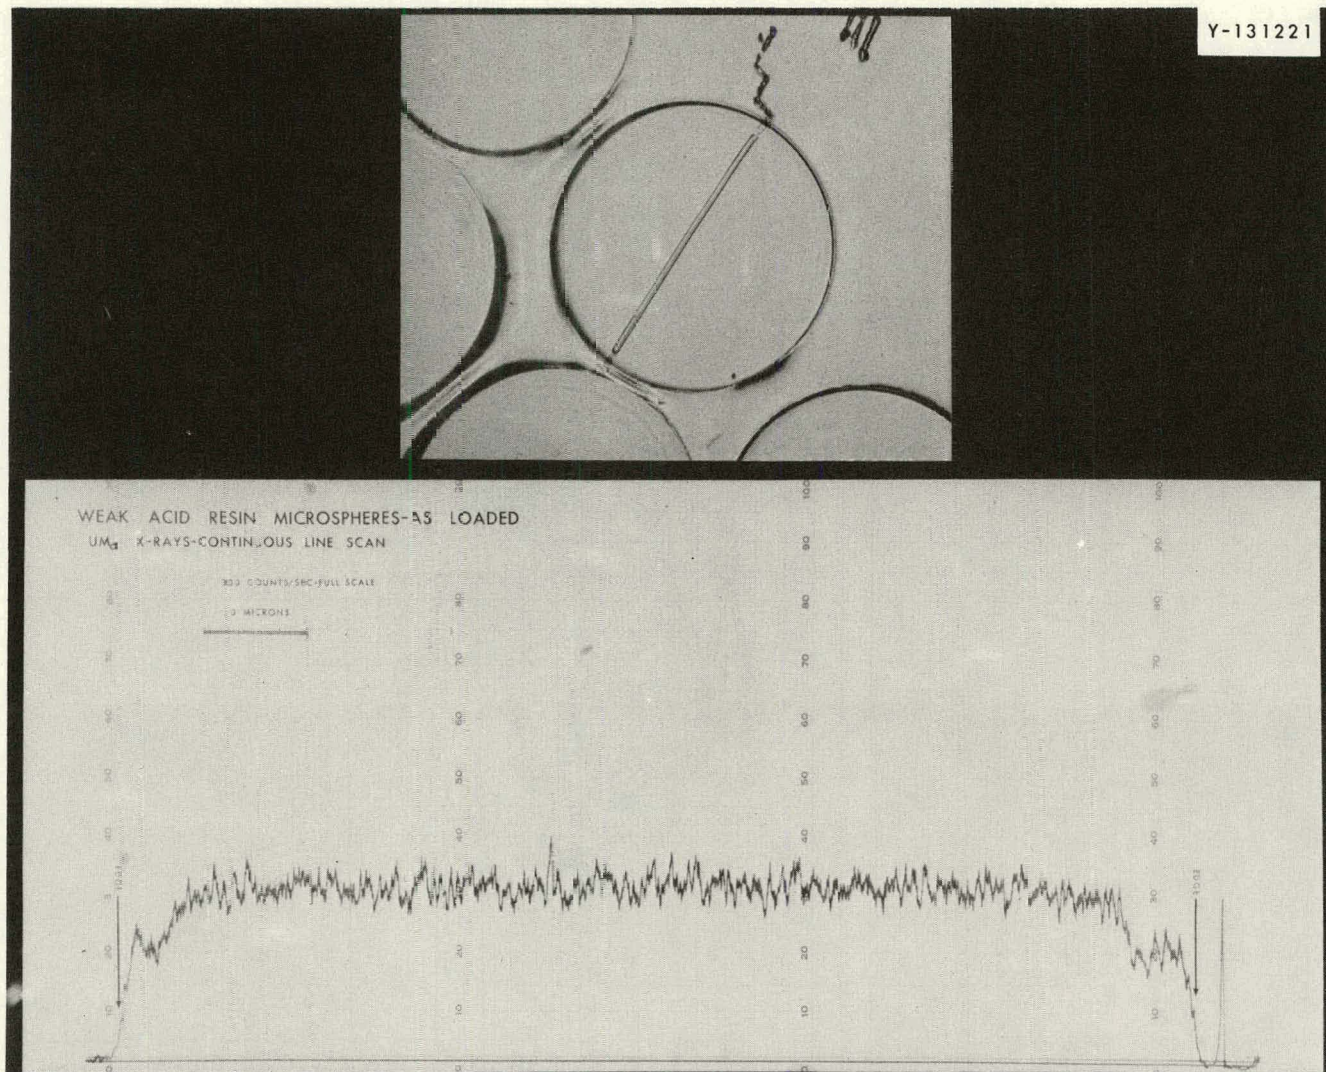
Fig. 15. Photomicrograph and Electron Beam Microprobe Scan of the Cross-Section of a "Normal" Uranium-Loaded Amberlite IRC-72 Weak Acid Resin Microsphere from the Batch that Exhibited Breakage During Pneumatic Transfer, Carbonization, and Converter. 100 \times . Reduced 32%.

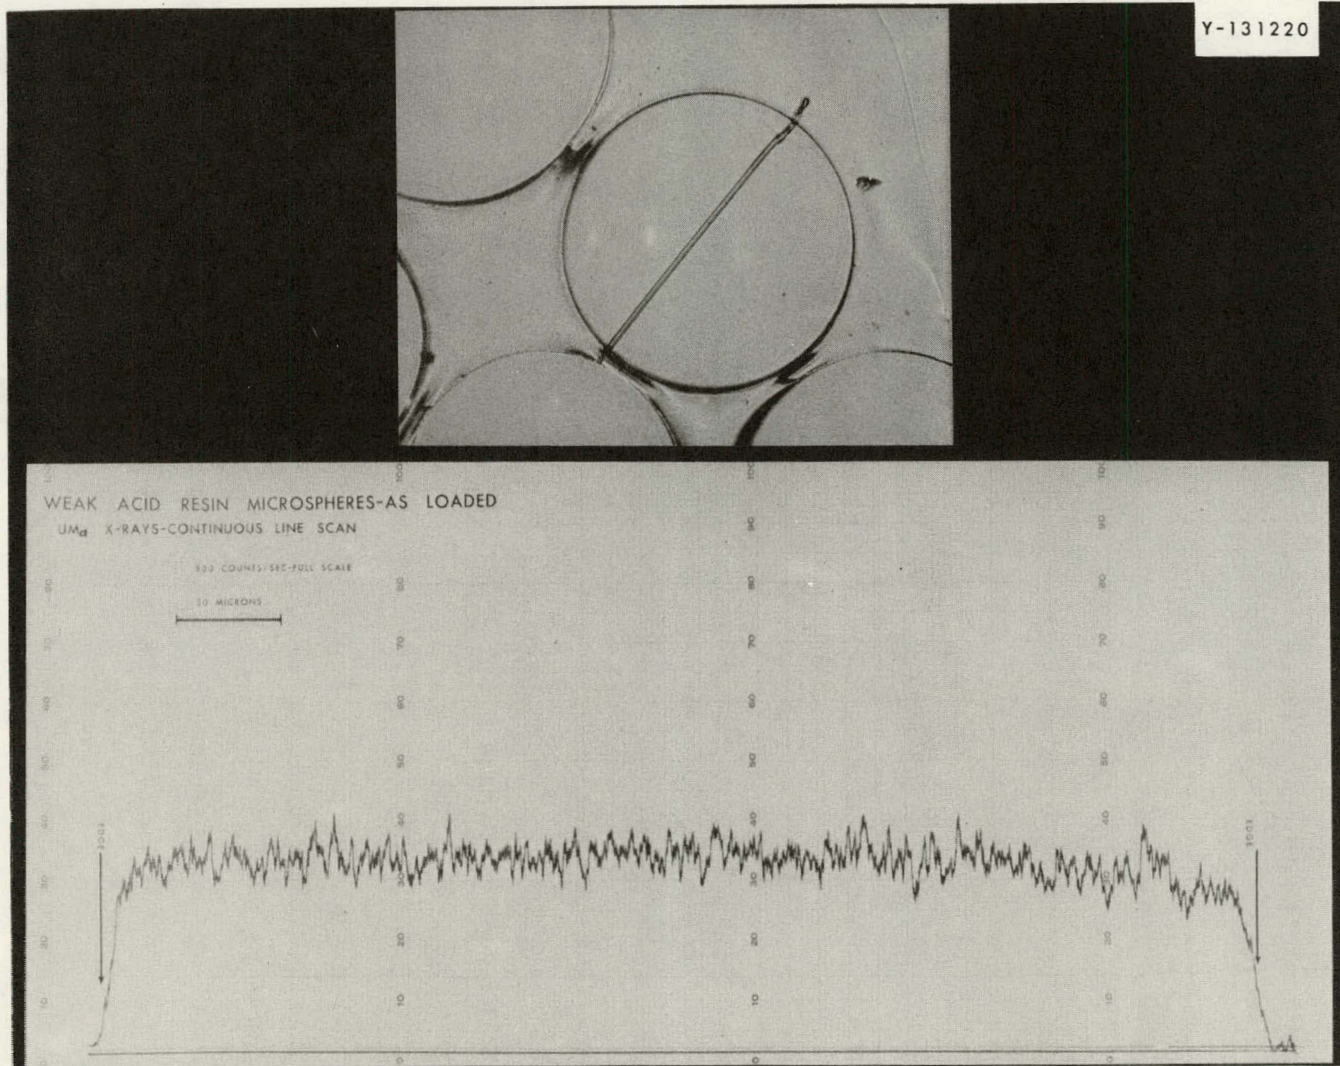
Fig. 16. Photomicrograph and Electron Beam Microprobe Scan of the Cross-Section of a "Normal" Uranium-Loaded Amberlite IRC-72 Weak Acid Resin Microsphere from the Batch that Exhibited Breakage During Pneumatic Transfer, Carbonization, and Conversion. 100 \times . Reduced 32%.

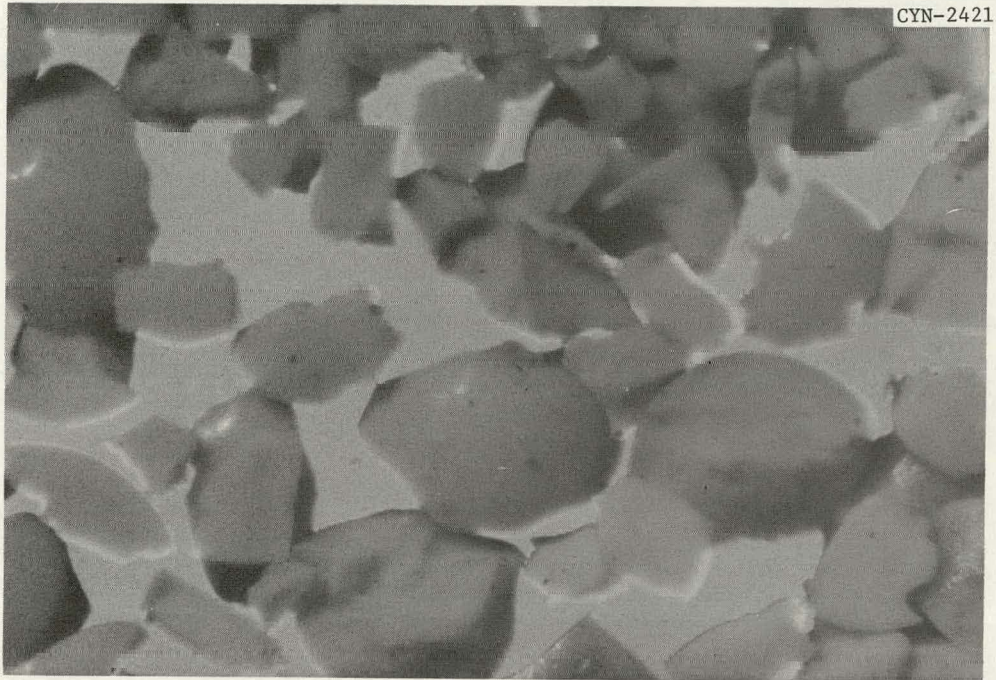
For comparison, Duolite C-464 resin loaded by the UO_3 method³ was also cracked open for inspection (Fig. 19). In these particles no center-to-edge color gradation can be seen.

Fig. 19. Duolite C-464 Weak Acid Resin Microspheres Loaded via the UO_3 Method and Deliberately Cracked Open for Inspection. 100 \times . Reduced 24%.

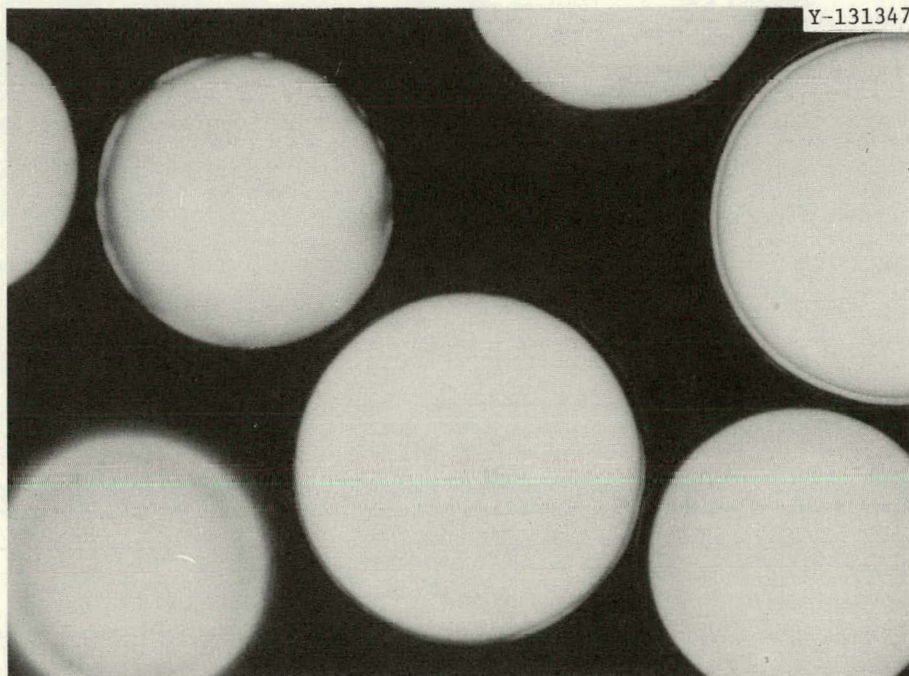
Fig. 23. Polarized Light Photomicrograph of Duolite C-464 Weak Acid Resin Microspheres Uranium-Loaded by the Ammonia Neutralization Method, Sectioned for Electron Beam Microprobe Examination. Same field as Fig. 22. 100 \times . Reduced 19%.

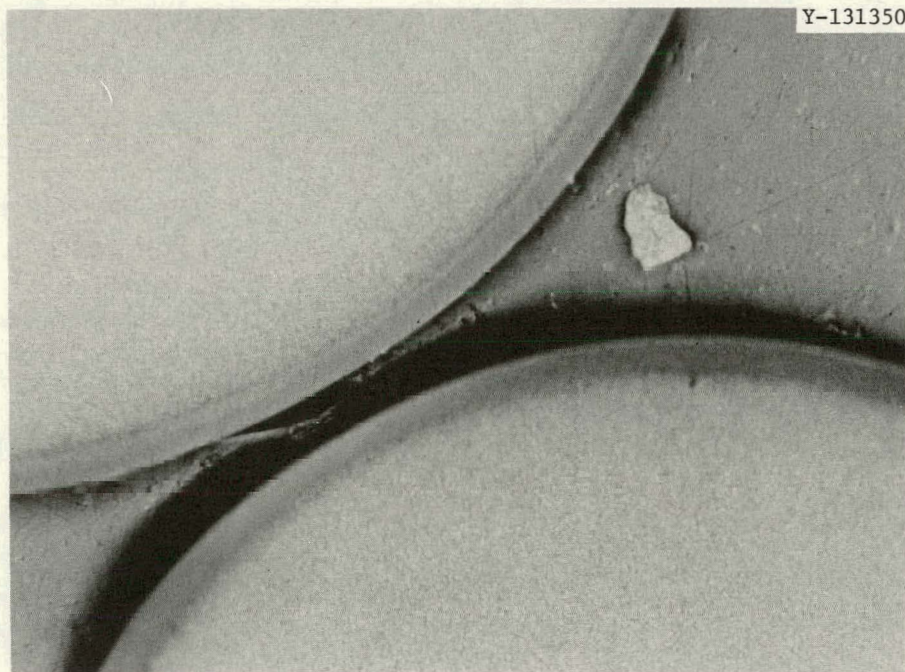
Fig. 24. Photomicrograph of Edges of Duolite C-464 Weak Acid Resin Microspheres Uranium-Loaded by the Ammonia Neutralization Method, Sectioned for Electron Beam Microprobe Examination. 500 \times . Reduced 19%.

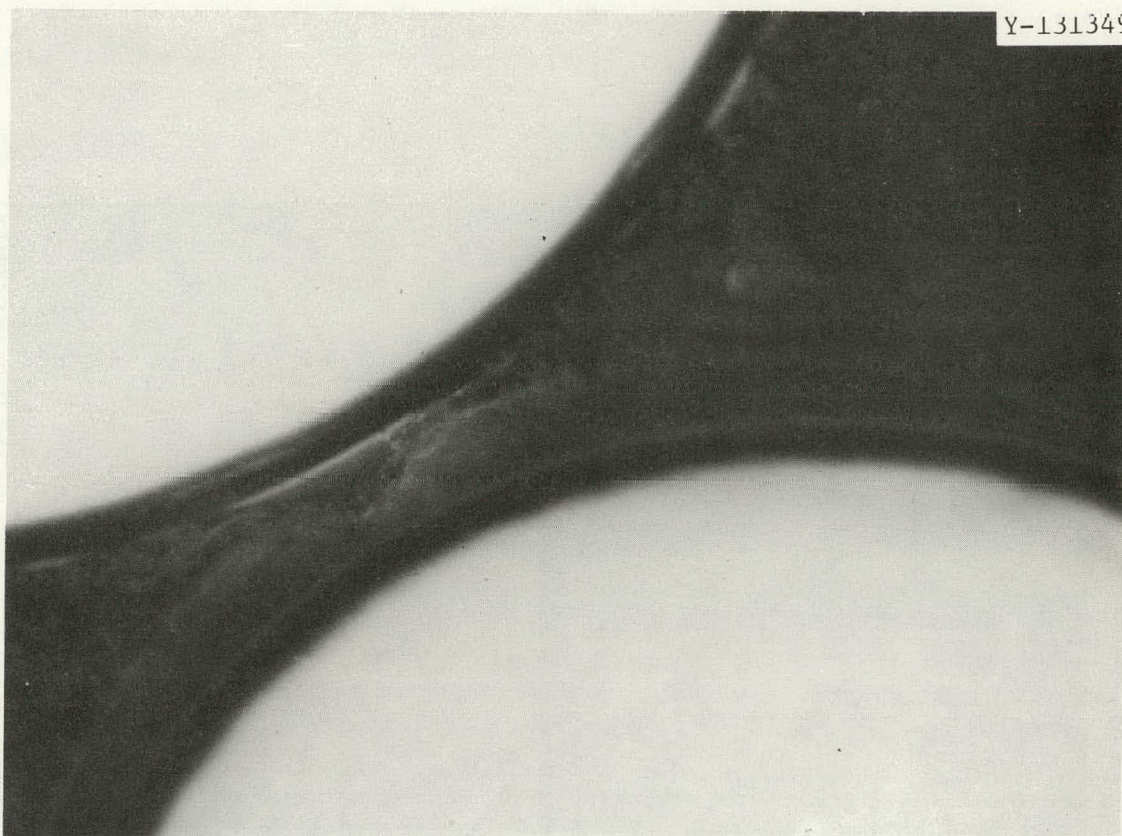
Fig. 25. Polarized Light Photomicrograph of Edges of Duolite C-464 Weak Acid Resin Microspheres Uranium-Loaded by the Ammonia Neutralization Method, Sectioned for Electron Beam Microprobe Examination. Same field as Fig. 24. 500 \times .
