# **A STUDY OF IN-SERVICE ULTRASONIC INSPECTION PRACTICE FOR BWR PIPING WELDS**

**EPRI NP-436-SR  
(Technical Planning Study 75-609)**

**Special Report**

**August 1977**

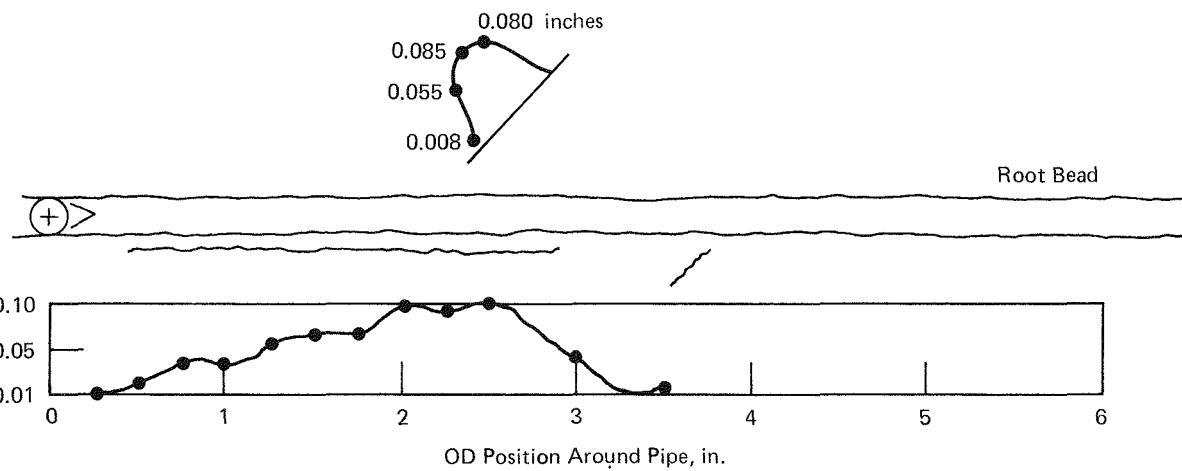
Figure 5-1 Electric Resistance Gauge (ERG) Data Plots for Specimen 1024A

- b. Electric Resistance Gaging (ERG). The depth of cracks was assessed with electrical resistance measurement techniques. Where possible, at least four sets of readings were made at each crack location, one set orthogonal to the other three. Thus, the effective resistivity in the immediate vicinity of the crack was measured, and then the deviation from this reading caused by the interruption of the current flow by the transverse orientation of the crack was determined (Figure 5-1).

Figure 5-1 shows the electric resistance gauge (ERG) readings for specimen 1024A. These readings are not corrected for differences between ERG and visual metallographic measurements.

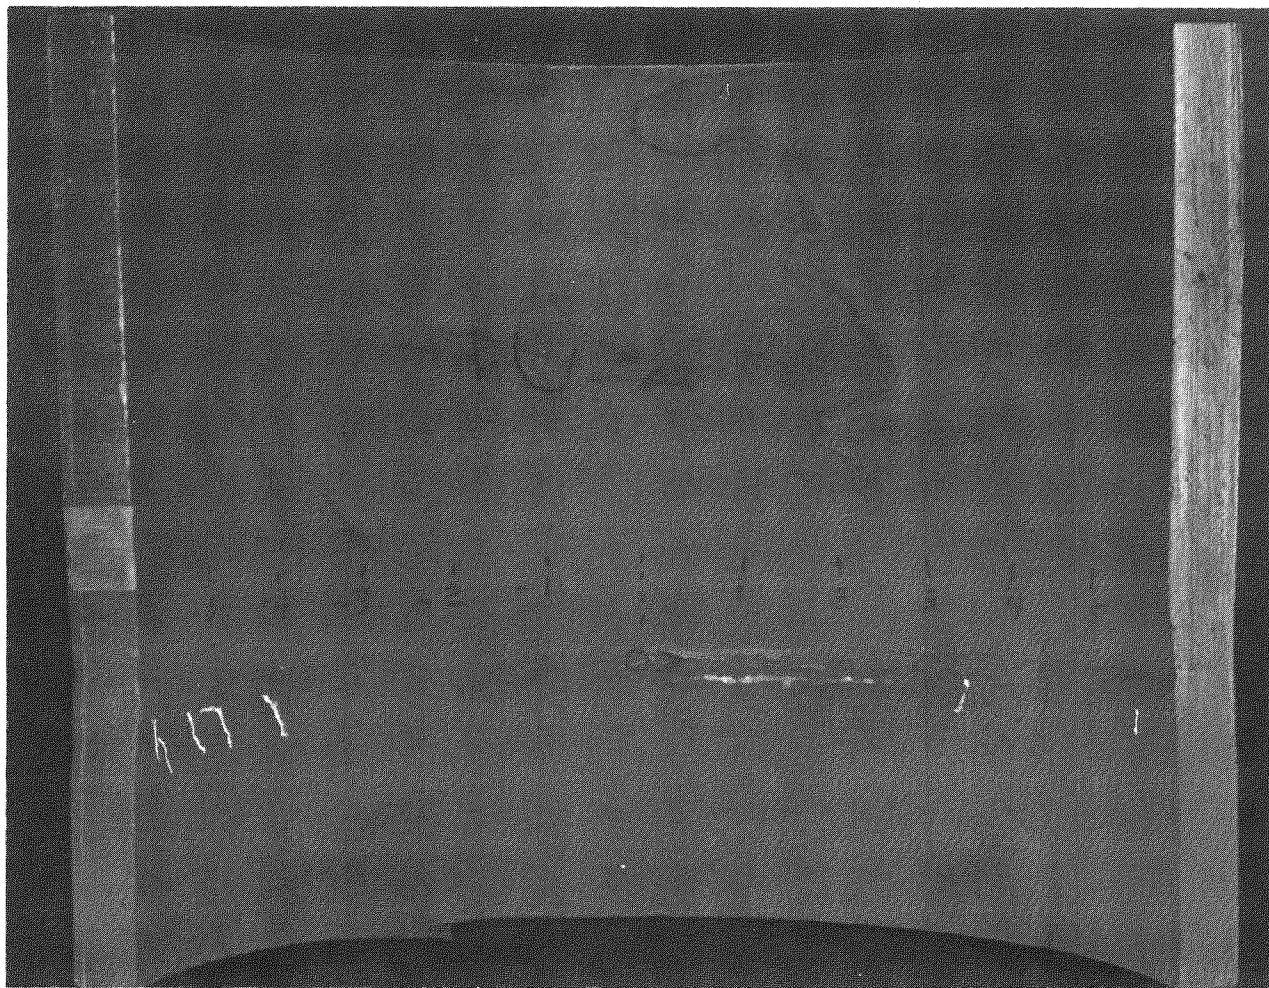
Figure 5-3 Fluorescent Dye Penetrant Indications, Specimen 1024A

- c. Liquid Penetrant Examination. The surface contour of the cracks was recorded by photographing the liquid penetrant indications present after the descaling operations. This was done because previous experience with detection of IGSCCs by the penetrant method has indicated a strong possibility that flaws may be masked by scale on the pipe. This indication proved accurate in the case of specimen 1024A, in which additional flaws were found after the descaling operation (figures 5-2 to 5-6).

The destructive examination of specimen 1024A may be described as typical. Fluorescent penetrant indications are shown in figures 5-2 through 5-6. Note that the dimensions shown on the part are ID measurements and do not conform to the outside diameter measurements usually discussed in ultrasonic results. A 2.5-in. indication can be seen from +0.25 in. to +2.8 in. (figures 5-4 and 5-5). Several other indications can be seen in Figure 5-6 in the area of -4 in. to -6 in. These cracks are angled with respect to the "normal" anticipated orientation of stress-induced cracks. The small indications shown in Figure 5-5 at +3 in. and +5.5 in. had not been reported by any previous investigators. The descaling operations probably made these flaws visible.

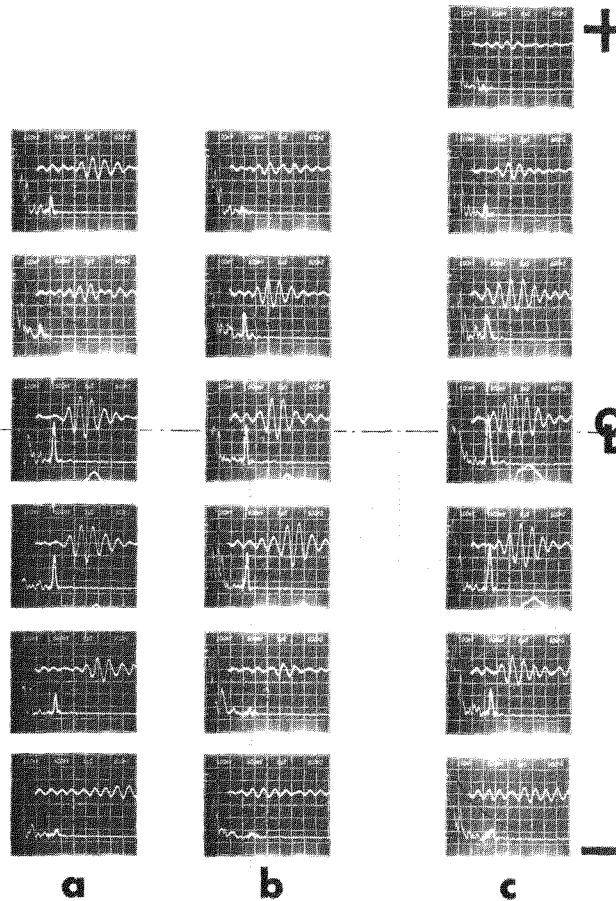
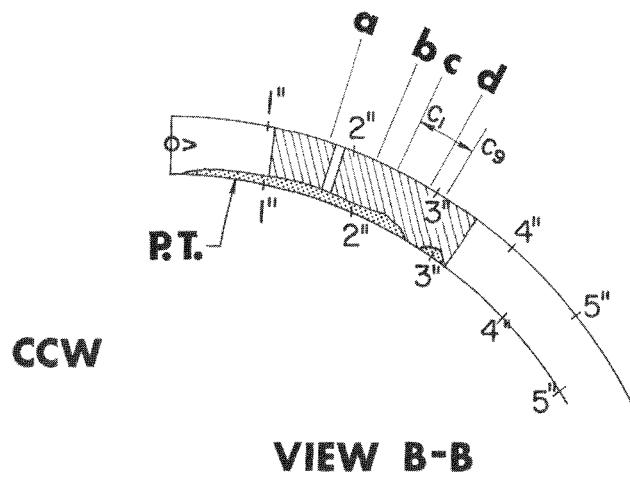
Figure 5-8 Ultrasonic Data From Scans a-c of Radial IGSCC in Specimen 1024A

Figure 5-7 describes the method of scanning the specimen. Figures 5-8 to 5-10 indicate the extensive ultrasonic recording of data. Ultrasonic data were taken by scanning toward the weld to obtain a peak signal and then past this position until the signal disappeared. Data were also taken at various points around the specimen, in both clockwise (CW) and counterclockwise (CCW) directions from the area that was eventually sectioned. In addition to photographs taken of the CRT screen, video tape recordings of the screen were obtained for all scans. With this data, a complete three-dimensional reconstruction of ultrasonic response from the flawed area can be made.

Figure 5-10 is a detailed presentation of the CRT originally seen in Figure 5-8. The signal trace presented at the bottom of the screen is the "normal" video signal seen by an ultrasonic inspector. The signal from the flaw is shown at three divisions from the left-hand edge of the screen grid. The amplitude from the flaw is approximately 150% of inspection sensitivity specified in ASME Code Section XI.

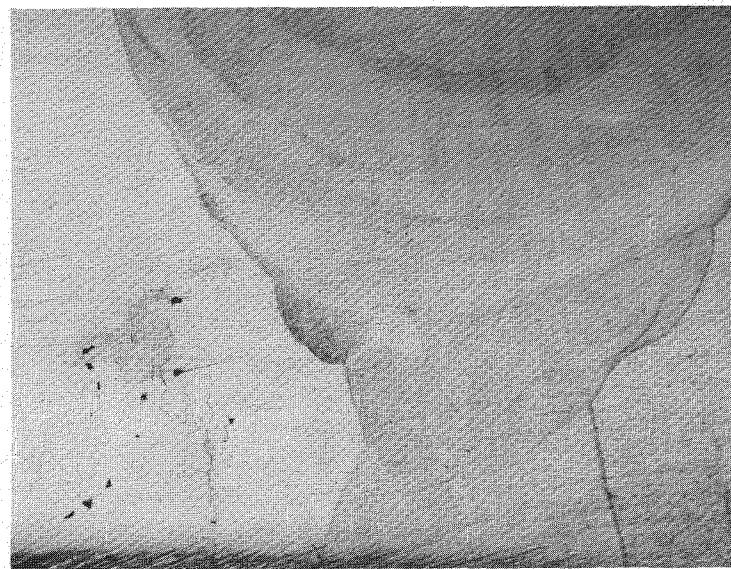
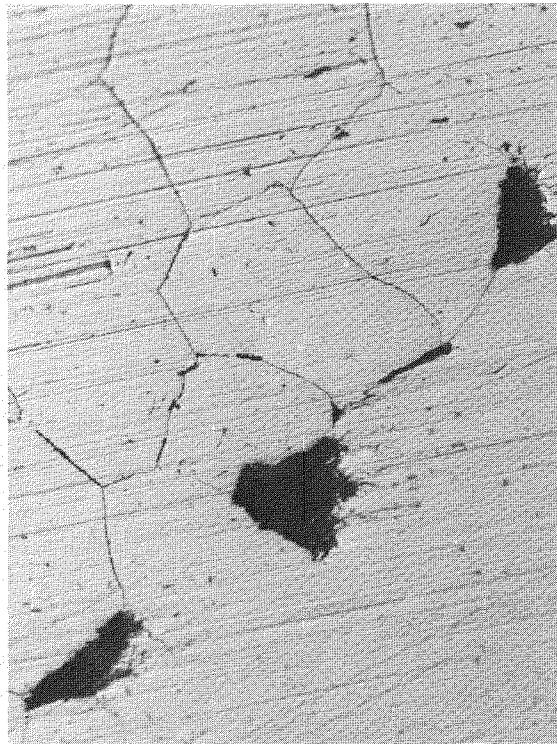
Figure 5-11 Photomicrographs of Radial IGSCC in Specimen 1024A

(a) 8x MAGNIFICATION

(b) 100x MAGNIFICATION OF LOWER LEFT HAND  
AREA OF FIGURE 5-11a

Figure 5-11 shows two photomicrographs of an area cut from specimen 1024A at +1.7 in. (refer to figures 5-2 and 5-3). About two-thirds of the defective area is identifiable as a given crack. The last one-third is more like a region of general stress corrosion attack. Using the best radiographic practices (0.7%), the film did show this area, but the indications were not so distinct as those typical of a more clearly defined crack such as a fatigue crack.

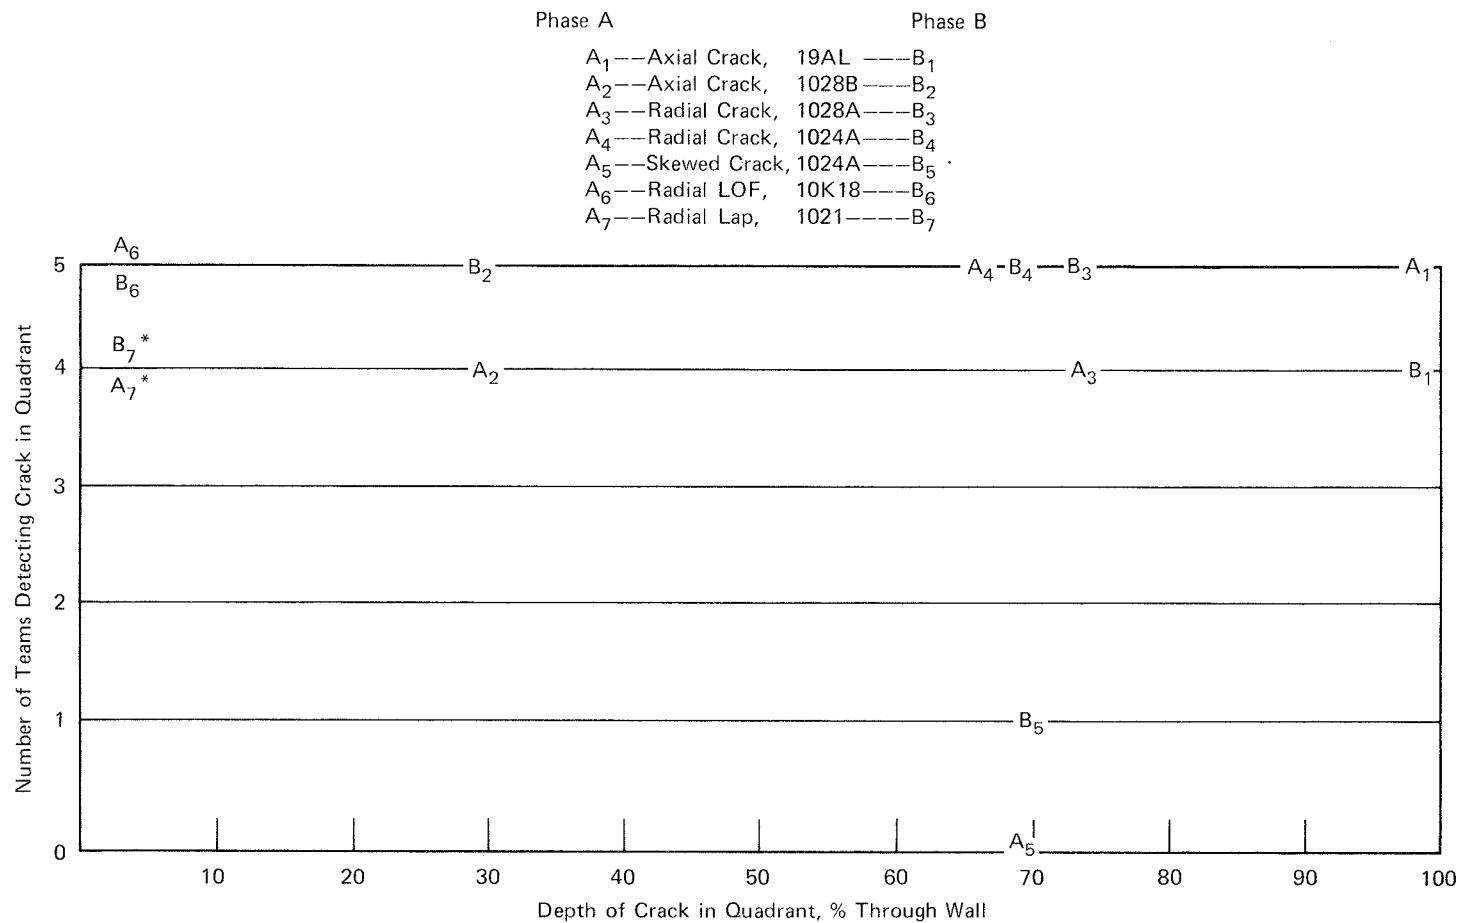
Figure 7-1 Detection of Flaws by Inspection Team vs. Flaw Depth

Using the data from Table 7-1, the number of teams successfully detecting a flaw is plotted as a function of flaw depth in Figure 7-1. In a similar manner, the number of teams successfully analyzing a detected flaw is plotted against flaw depth in Figure 7-2. As would be expected, the successful analysis of a crack tended to fall with decreasing wall penetration, with the significant exception of the skewed crack in sample 1024A. In all cases, the teams had considerable difficulty in detecting and analyzing skewed cracks. To further emphasize the effect of flaw orientation, the analysis performance of the inspection teams is plotted as a function of flaw orientation in Figure 7-3.

As these figures show, the orientation of an IGSCC flaw rather than its depth appears to be the controlling factor in successful detection. The shape of the flaw (high depth-to-length ratio) may also contribute to its difficulty of detection. As previously discussed, the skewed cracks were extremely difficult to detect in the laboratory evaluations using the normal field inspection procedures.

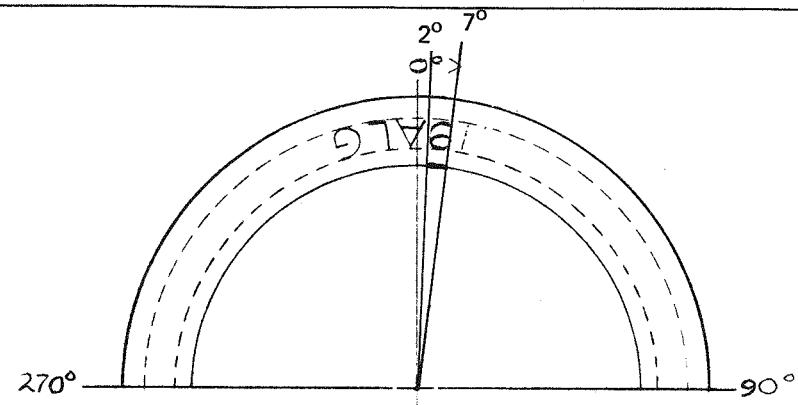
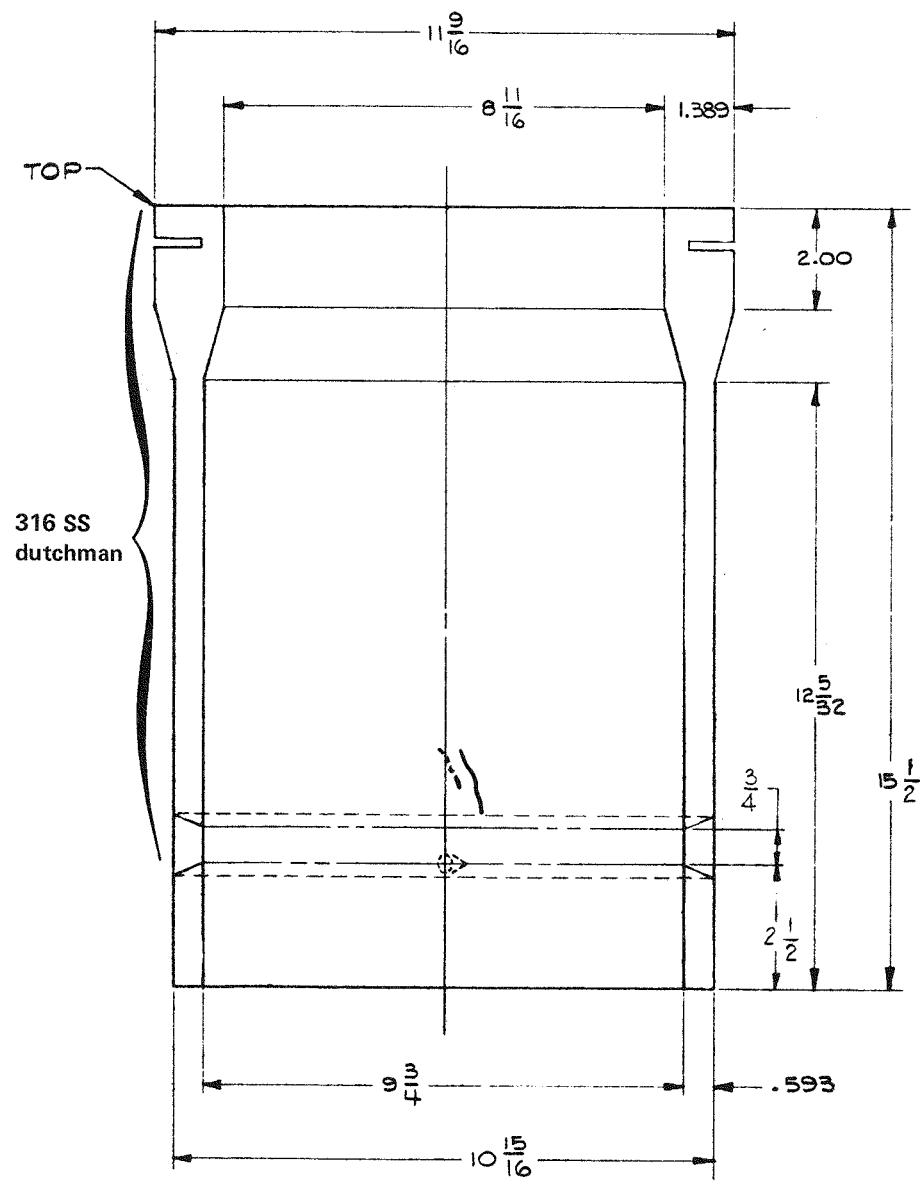
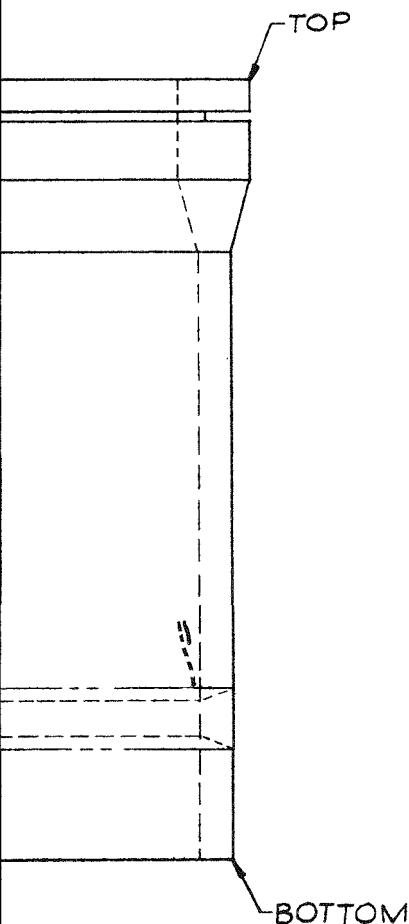
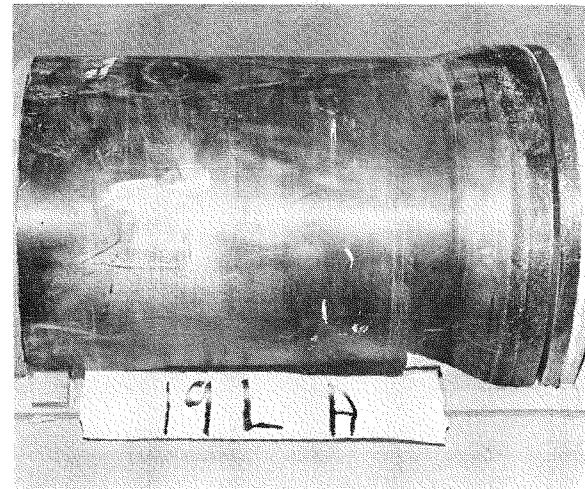
Figure A-1 Sample 19AL

Nozzle section with a weld that is difficult to find since both inside and outside surfaces are flush. Two distinct series of UT indications, both high amplitudes and very similar. Only one DPT indication, through wall axial crack approximately 0.6 in. (1.52 cm) on outside diameter. In summary, one confirmed crack and one possible crack, moderately difficult to detect.

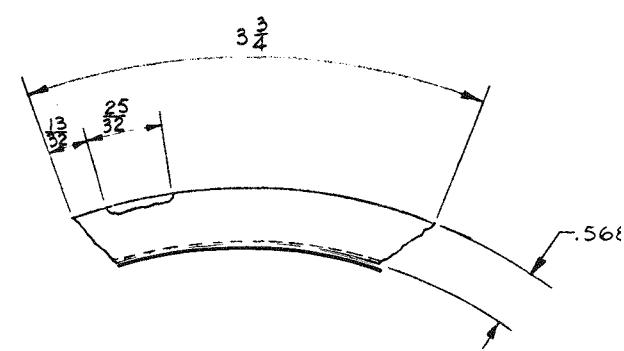
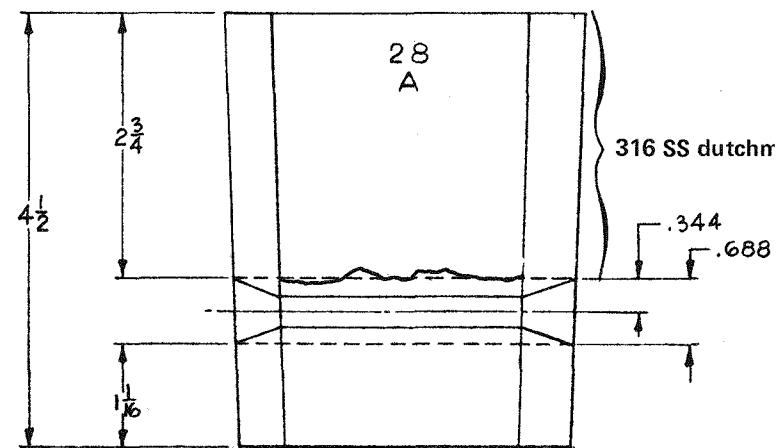
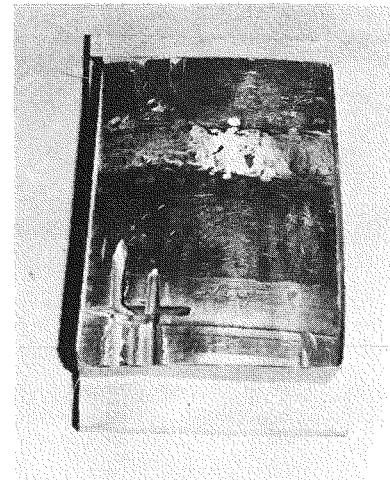
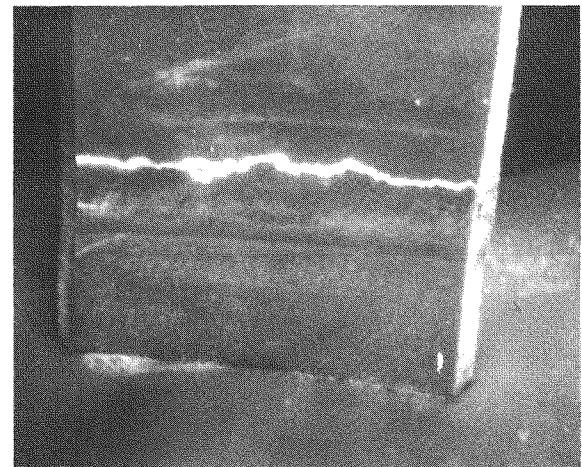
**SAMPLE IDENTIFICATION: 1028A**

Continuous high amplitude UT signals across sample. Confirmed full width crack by DPT.  
Depth of crack ranges from 0.12 in. to 0.5 in.  
(1.52-3.18 cm) by ERG measurements.  
Moderately easy to detect.

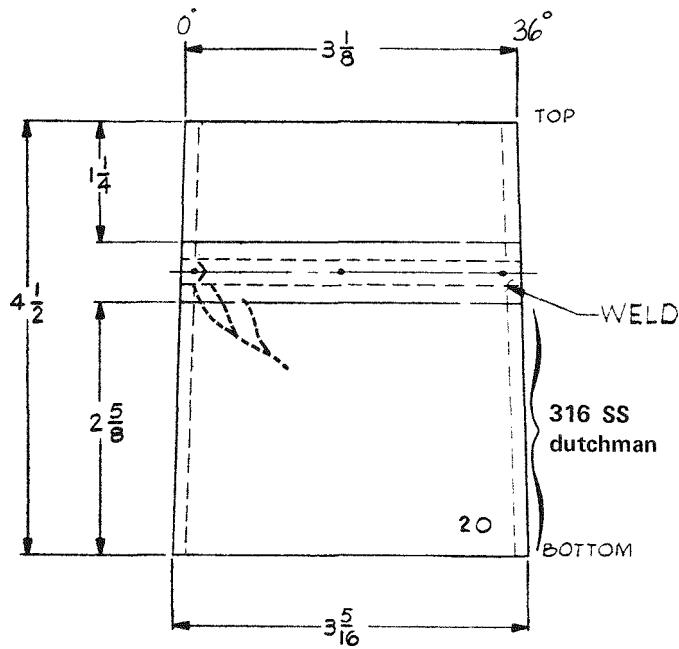
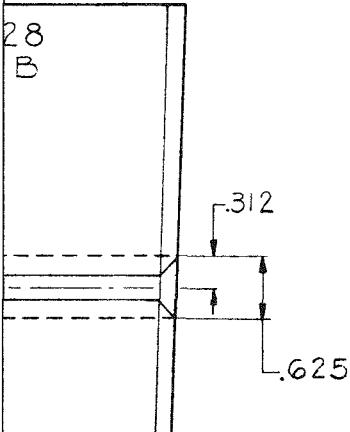
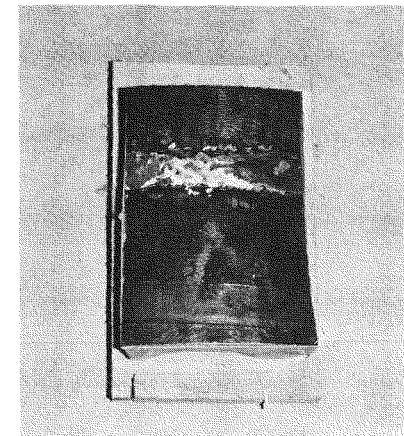
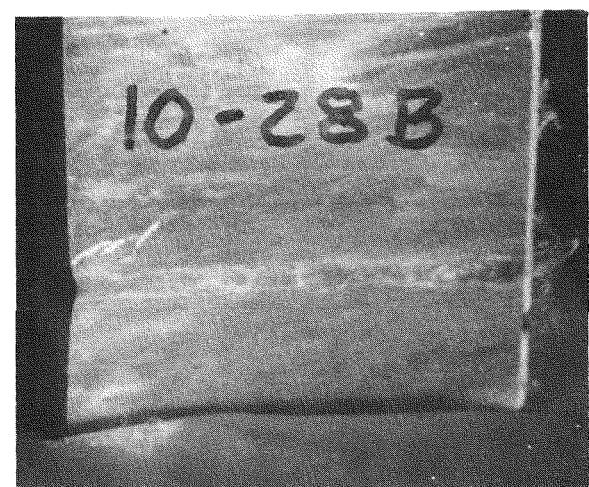
Figure A-3 Sample 1028B

Fairly continuous geometry signal on UT. One confirmed by DPT, a triple intersecting crack approximately 1 in. (2.54 cm) long (continuation of crack in sample 1028A). Depth of 0.12 in. to 0.5 in (0.3-1.27 cm) by ERG. Crack signal is relatively easy to find but difficult to determine characteristics. Overall, the specimen is difficult to inspect.

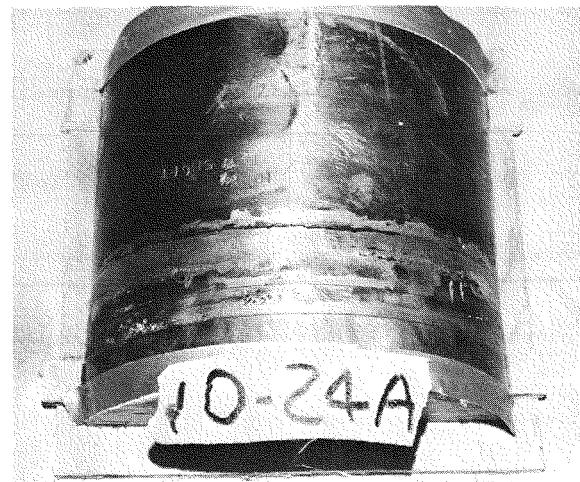
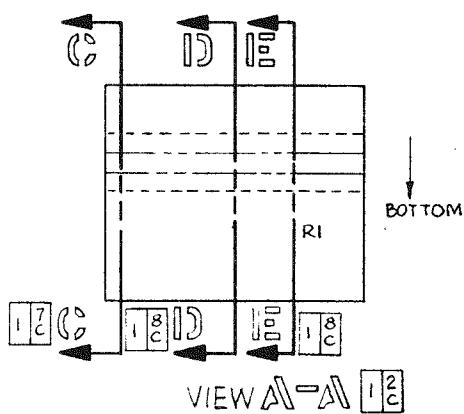
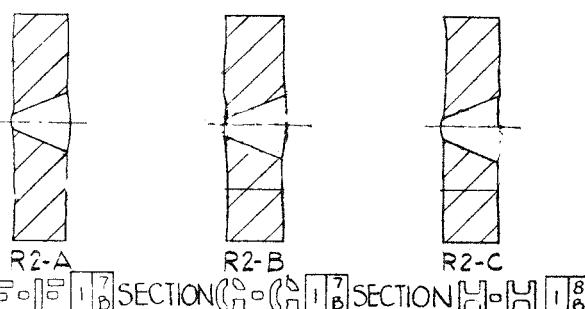
Figure A-4 Sample 1024A

Eight cracks on dutchman (short) side of weld, all SCC confirmed by DPT. One crack axial, one radial, and six skewed at 45°. Depth by ERG are 0.1 in. to 0.12 in. (0.25-0.48 cm) Skewed cracks are extremely difficult to find and characterize. Transducer must be oscillated  $\pm 45^\circ$  into weld to detect. Radial crack is relatively easy to find.

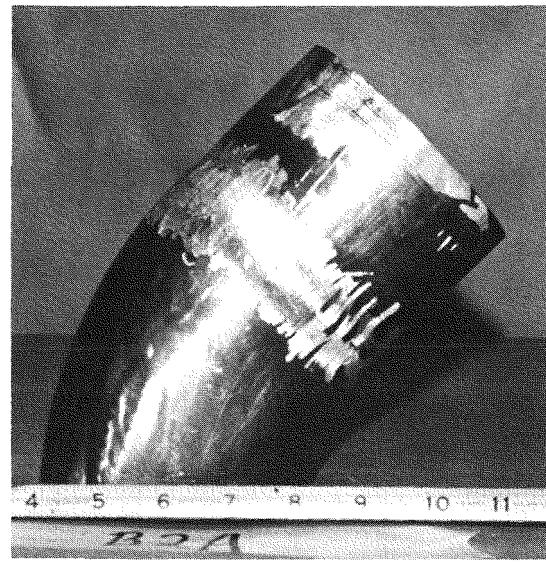
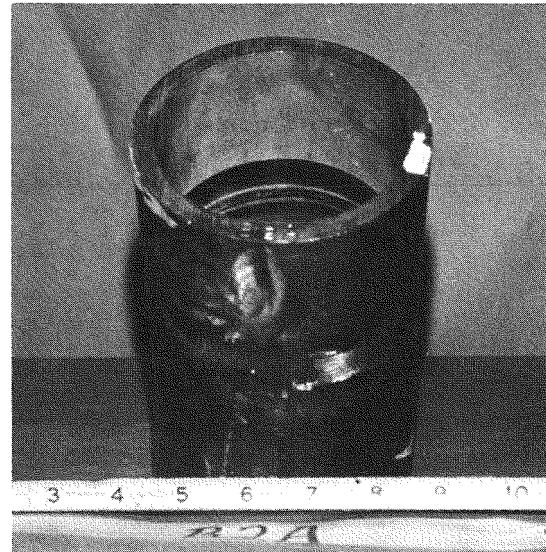
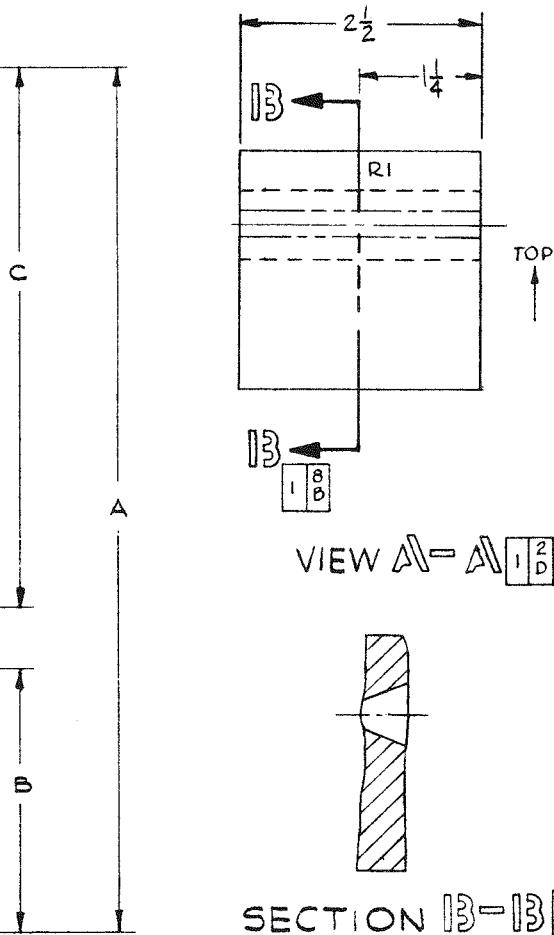
### SAMPLE IDENTIFICATION: B2A

Many UT geometry signals and low amplitude signals from flaws. Low amplitude signals confirmed as possible SCC by DPT.

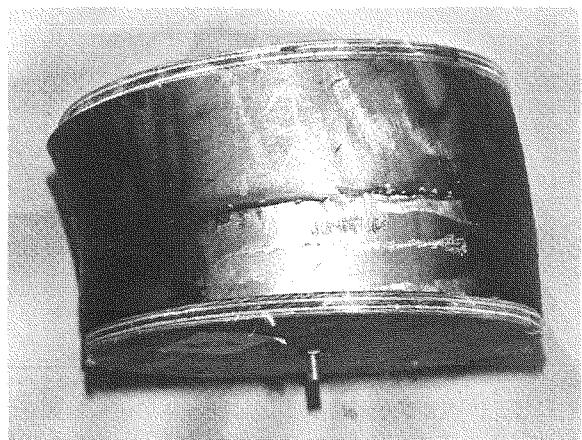
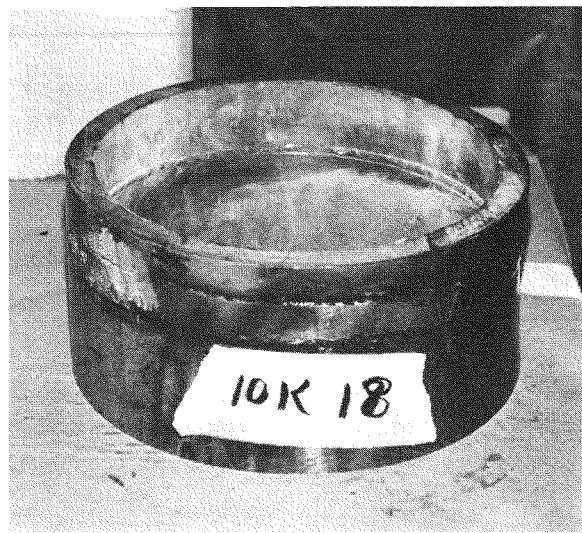
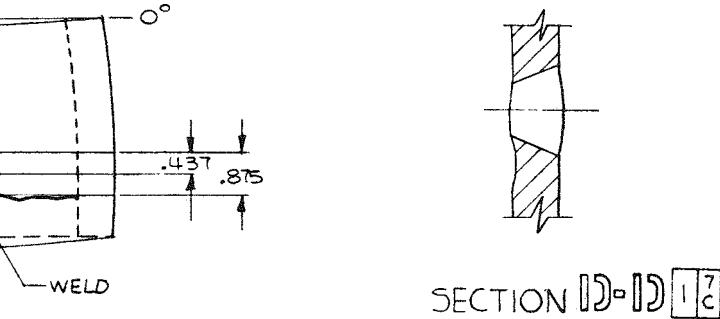
Figure A-6 Sample 10K18

Six intermittent UT signals spread over total 360° sample. Two evaluated as possible radial cracks, one approximately 5.0 in. long at approximately 180° and the other 0.375 in. (0.95 cm) long at 90°. DPT confirmed longer crack at 180° with ERG measurements of 0.03 in. to 0.06 in. (0.08 to 0.15 cm) depth over 1.75 in. (4.445 cm). Difficult to evaluate.

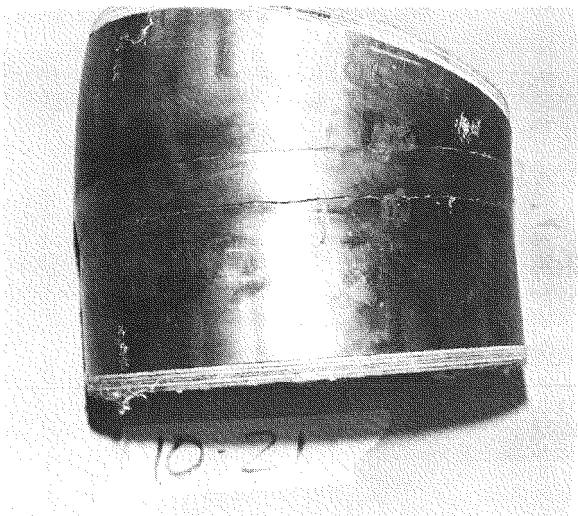
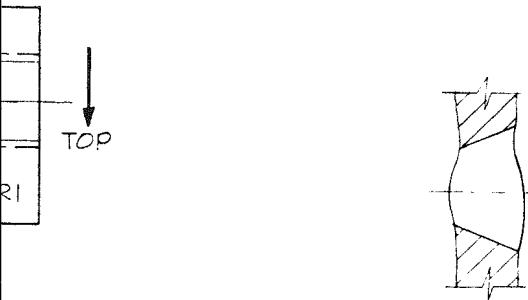
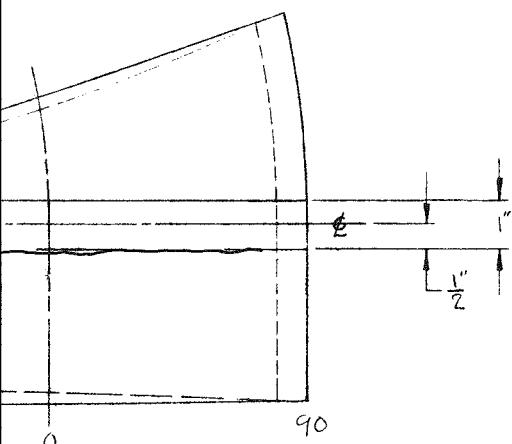
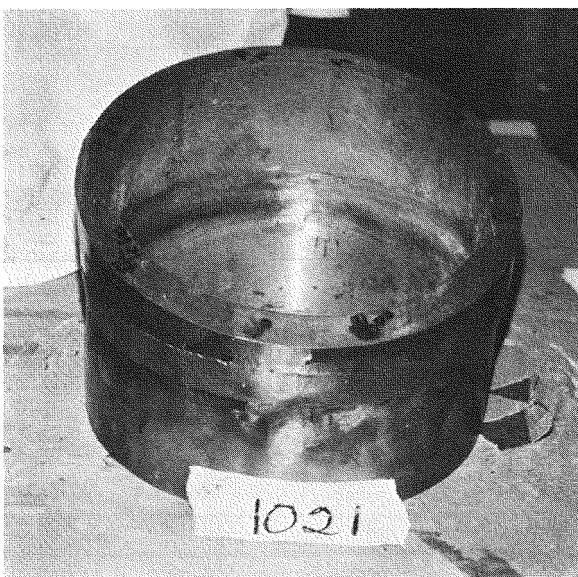
Figure A-7 Sample 1021

Six UT signals in two areas, one area confirmed by DPT 180° from reference, approximately 7.87 in. (20.0 cm) long, very straight and uniform indication defined as crack or lack of fusion. In summary, one confirmed crack or lack of fusion and one possible crack or lack of fusion. Moderately difficult to detect.

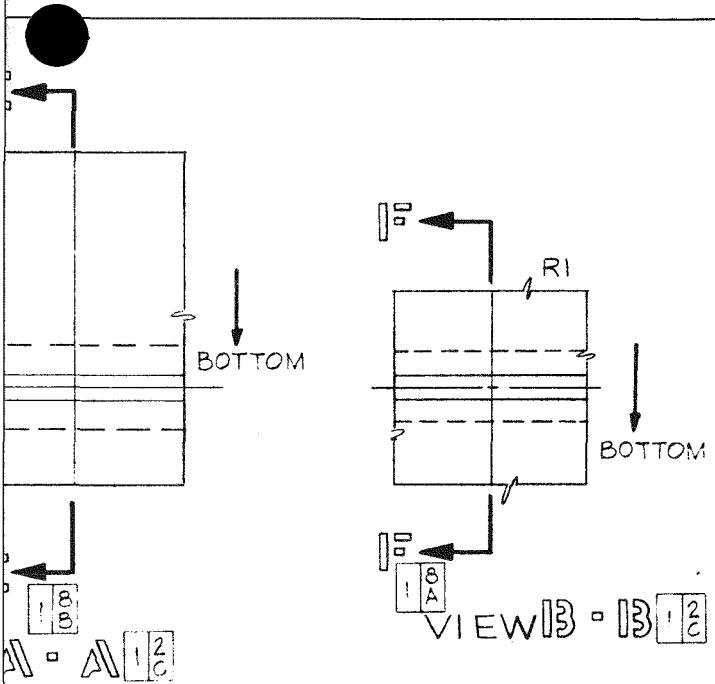
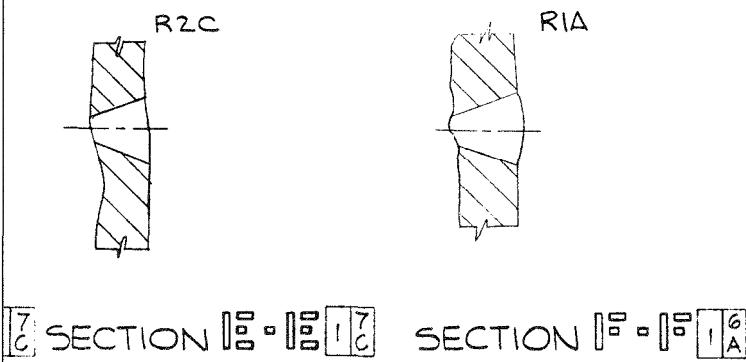
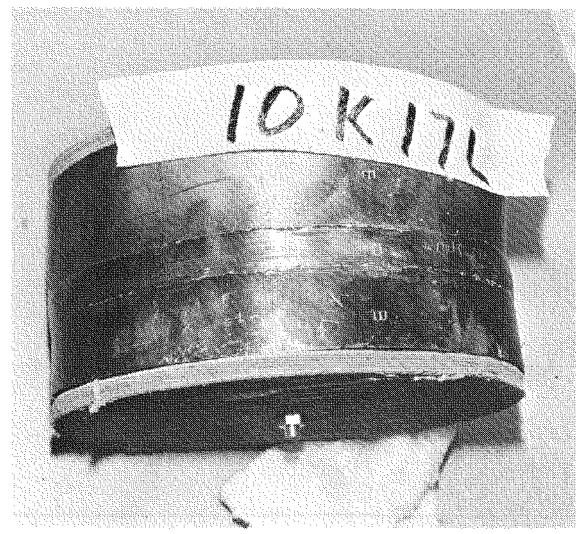
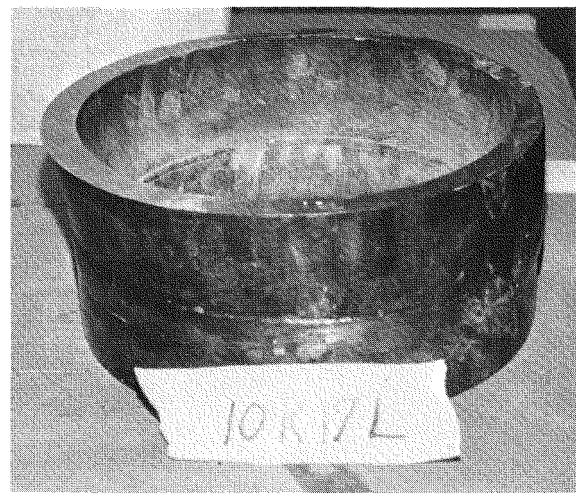
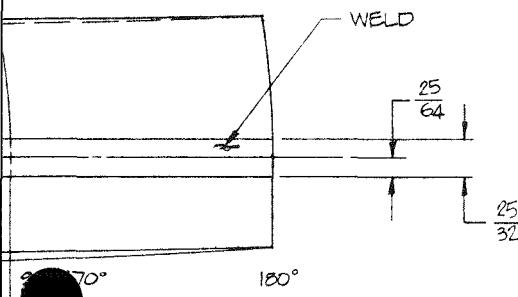
Figure A-8 Sample 10K17L

Nine geometric signals including one series approximately 1.5 in. (3.8 cm) long and 15 in. (38.1 cm) from B-B reference (stamp mark on sample) in an internally ground area approximately 180° from B-B reference. DPT indicates two spots with possible interconnecting crack in the ground area (Photo). In summary, one possible crack approximately 1.5 in. (3.8 cm) long and difficult to detect by UT.

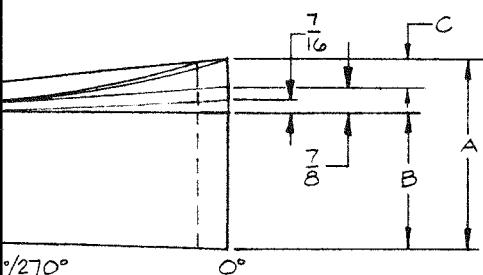
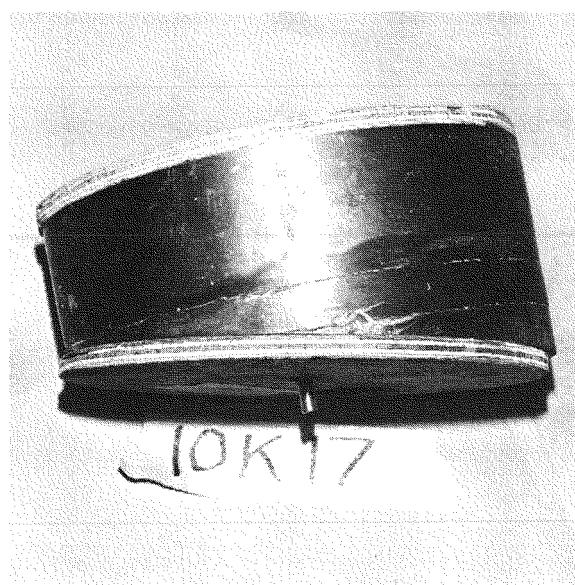
Figure A-9 Sample 10K17

No DPT indications. UT shows geometry signals completely around weld. No confirmed cracks.

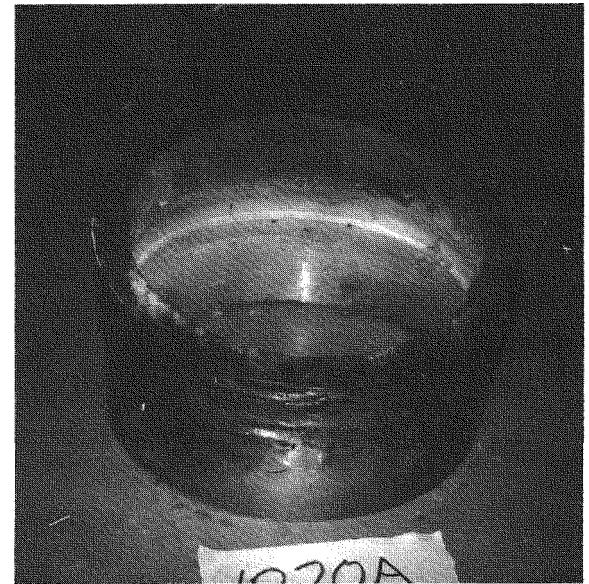
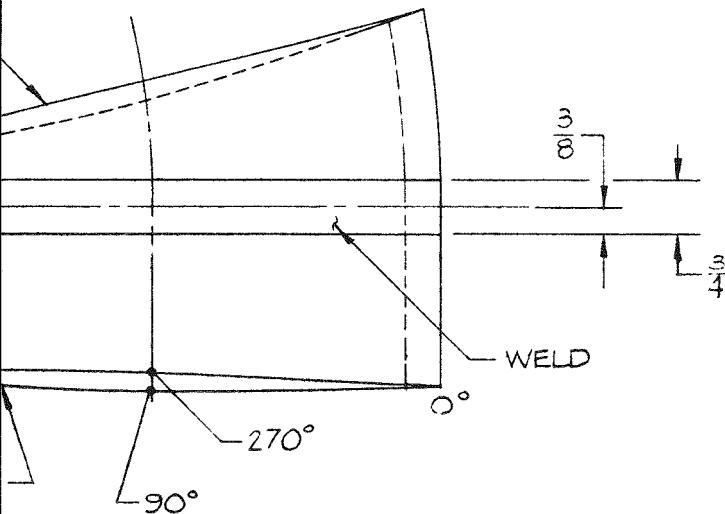
Figure A-10 Sample 1020A

No DPT indications and limited number of  
geometric signals. No cracks.

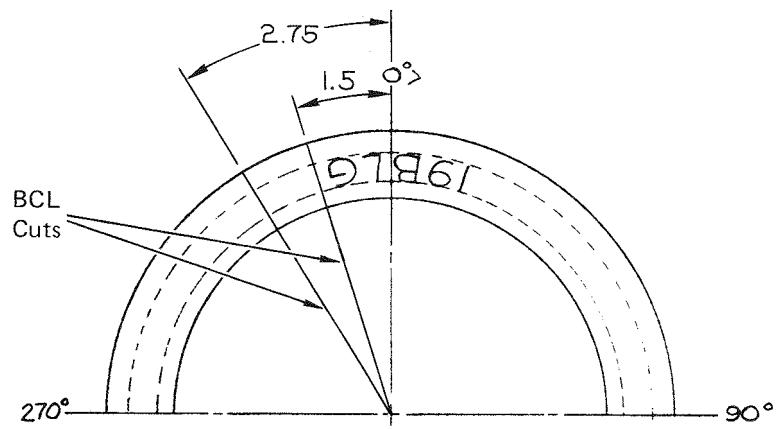
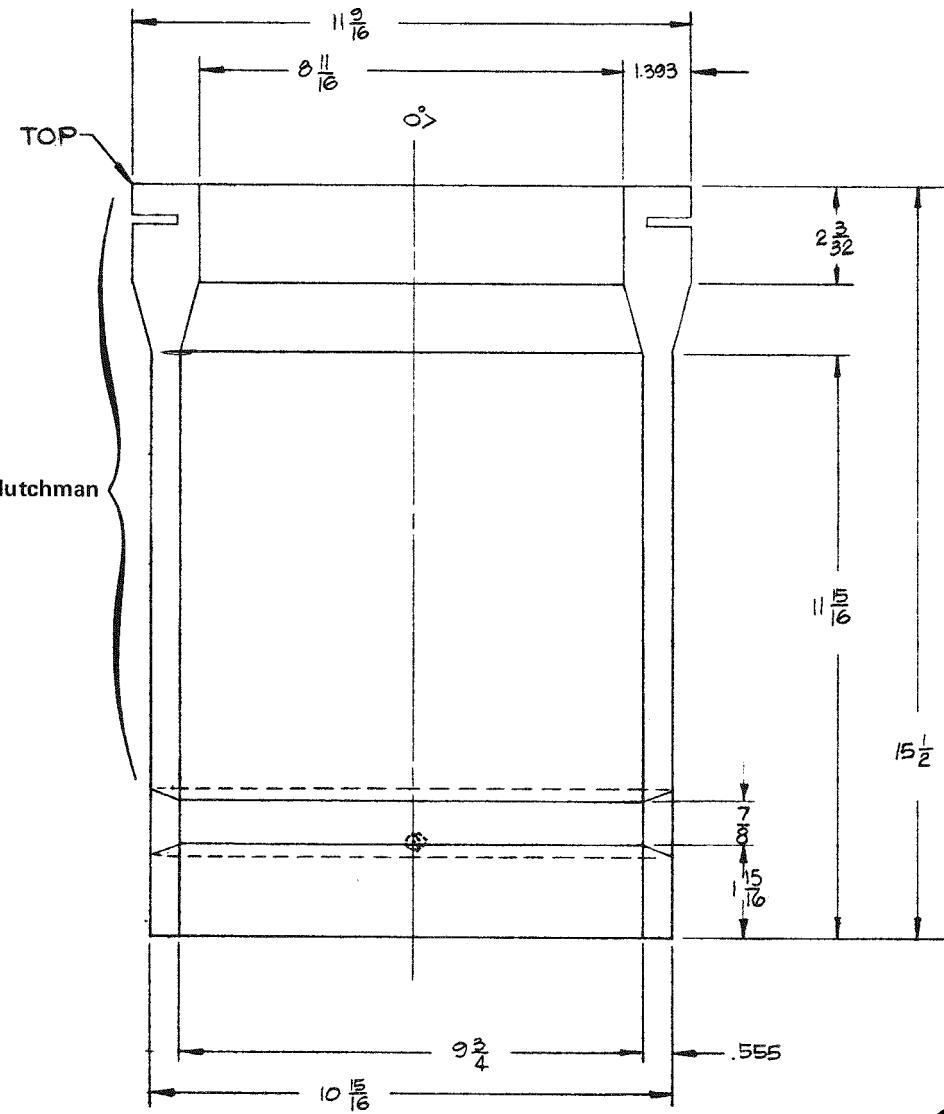
Figure A-14 Sample 1019A

Numerous geometric UT indications due to unground weld crowns and extreme suck-up on the inside of the pipe. No DPT indications. Difficult to inspect and time-consuming to record, plot, and evaluate. No cracks.

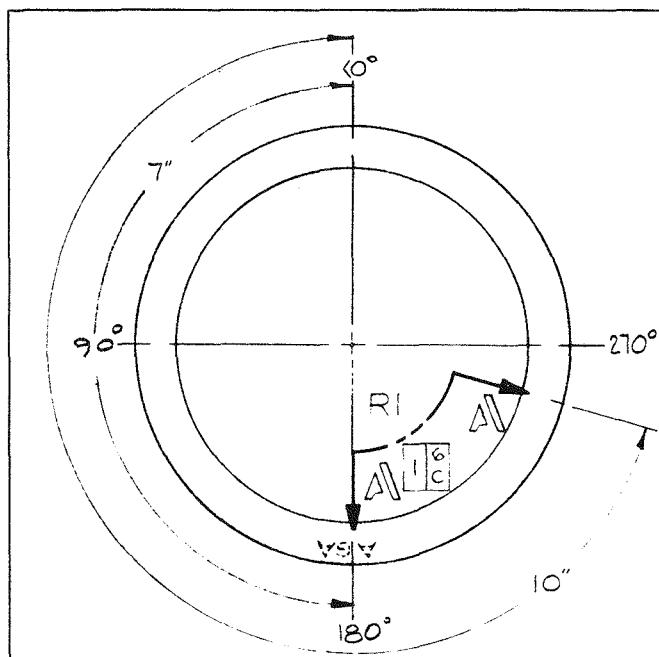
Figure A-15 Sample 19BL

Relatively clean UT signals and no indications  
with DPT. No cracks, easy to inspect. (This  
sample is the other half of samples 1028A,  
1028B, 1028C, and 1028D).

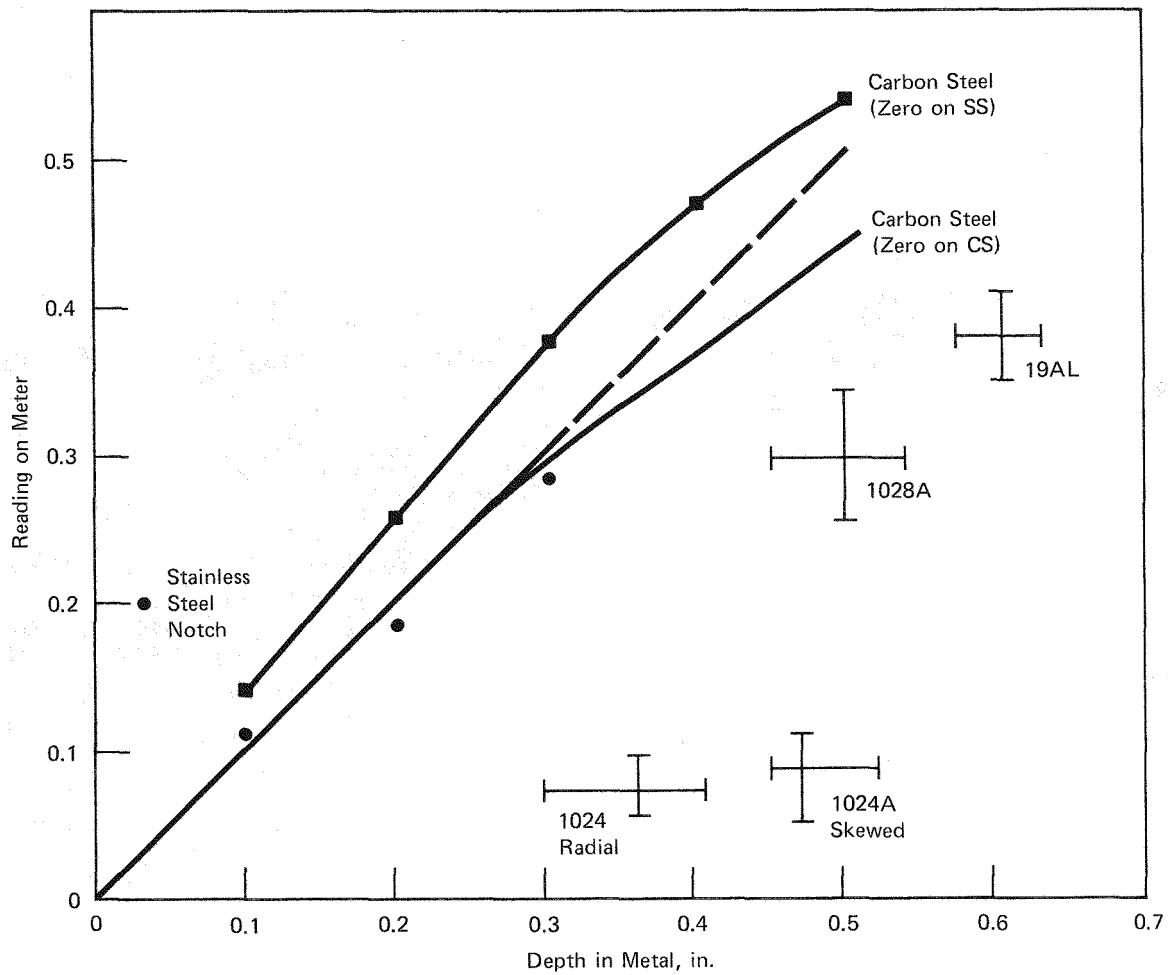
Figure D-1 ERG Calibration and IGSCC Correlation

The depths of known cracks were assessed using a Uresco electric resistance gauge. Several gauge calibration techniques were investigated, including (1) using the calibration notch provided by Uresco, (2) using the Uresco calibration notch and then rezeroing on the BWR pipe of interest, and (3) fabricating a notch in BWR pipe material. Calibration curves for the cases mentioned are shown in Figure D-1. Figure D-1 shows that little difference exists between the latter two calibration techniques; hence the URESCO notch was used for initial gauge calibration, followed by rezeroing on the BWR pipe being examined.

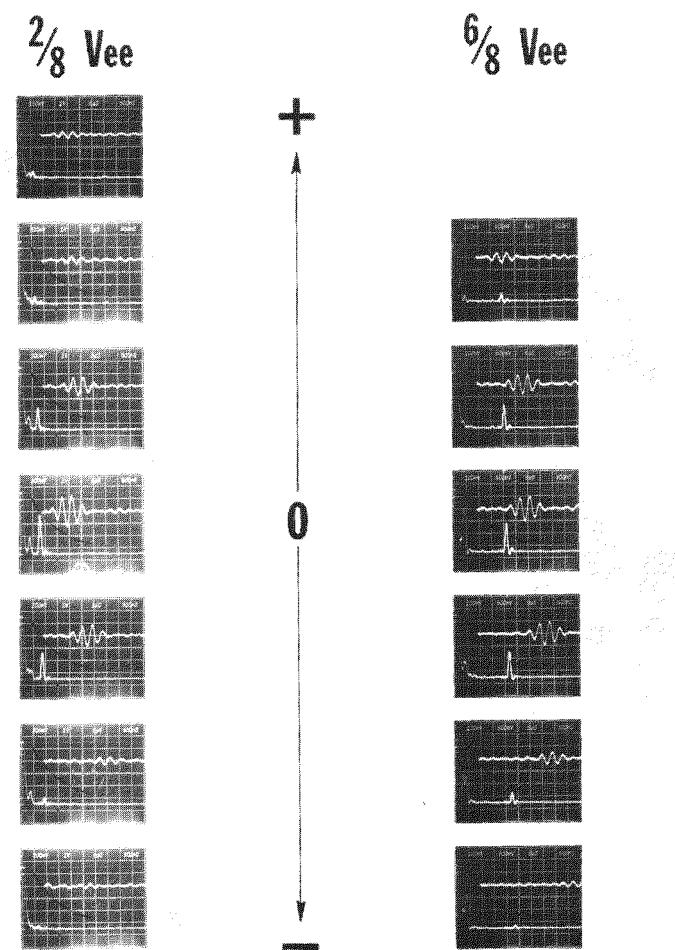
Figure D-3 UT Response From SDH

Beam spread characteristics of the 45° shear wave, 0.25-in. diameter 2.25 MHz transducer were determined by locating the 2/8 Vee and 6/8 Vee positions and incrementing the transducer at 1/16-in. intervals toward and away from the particular Vee position. Again, the EPRI 10-in. pipe calibration block was used. The results of the beam spread test are shown in Figure D-3.

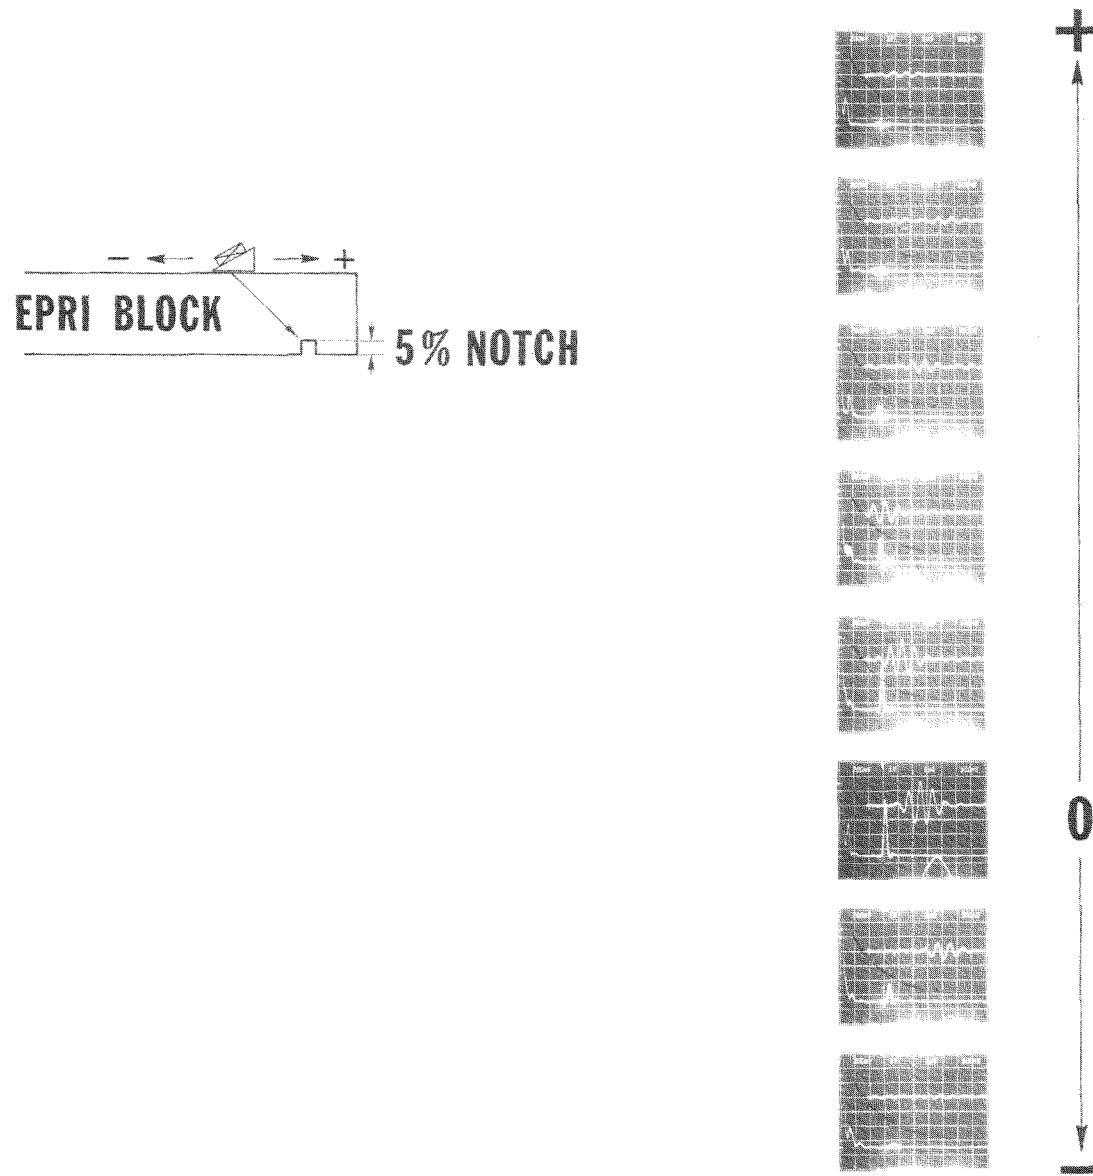
Figure D-4 UT Response From 5% Notch

A comparison of the 1/8-in. and SDH DAC curve with the response of a 5%T notch is shown in Figure D-4. Again, the transducer was incremented at  $\pm 1/16$ -in. increments about the 4/8 Vee notch/transducer position. As shown in Figure D-4, a lower effective sensitivity results when the notch is used for calibration purposes.
