# **A STUDY OF IN-SERVICE ULTRASONIC INSPECTION PRACTICE FOR BWR PIPING WELDS**

**EPRI NP-436-SR  
(Technical Planning Study 75-609)**

**Special Report**

**August 1977**

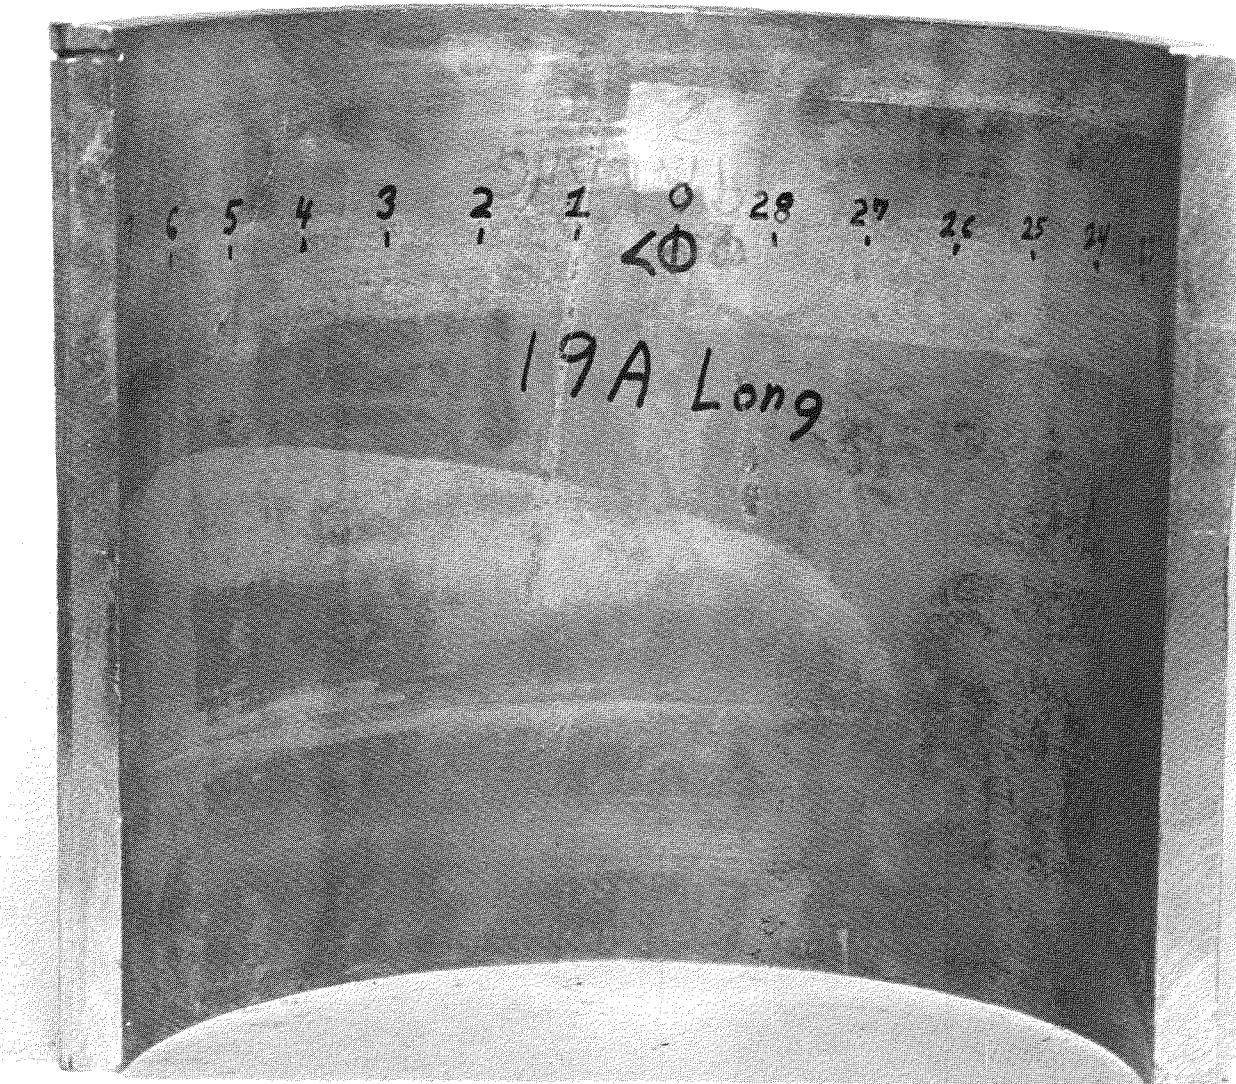
Figure D-7 Inside Surface, 19AL

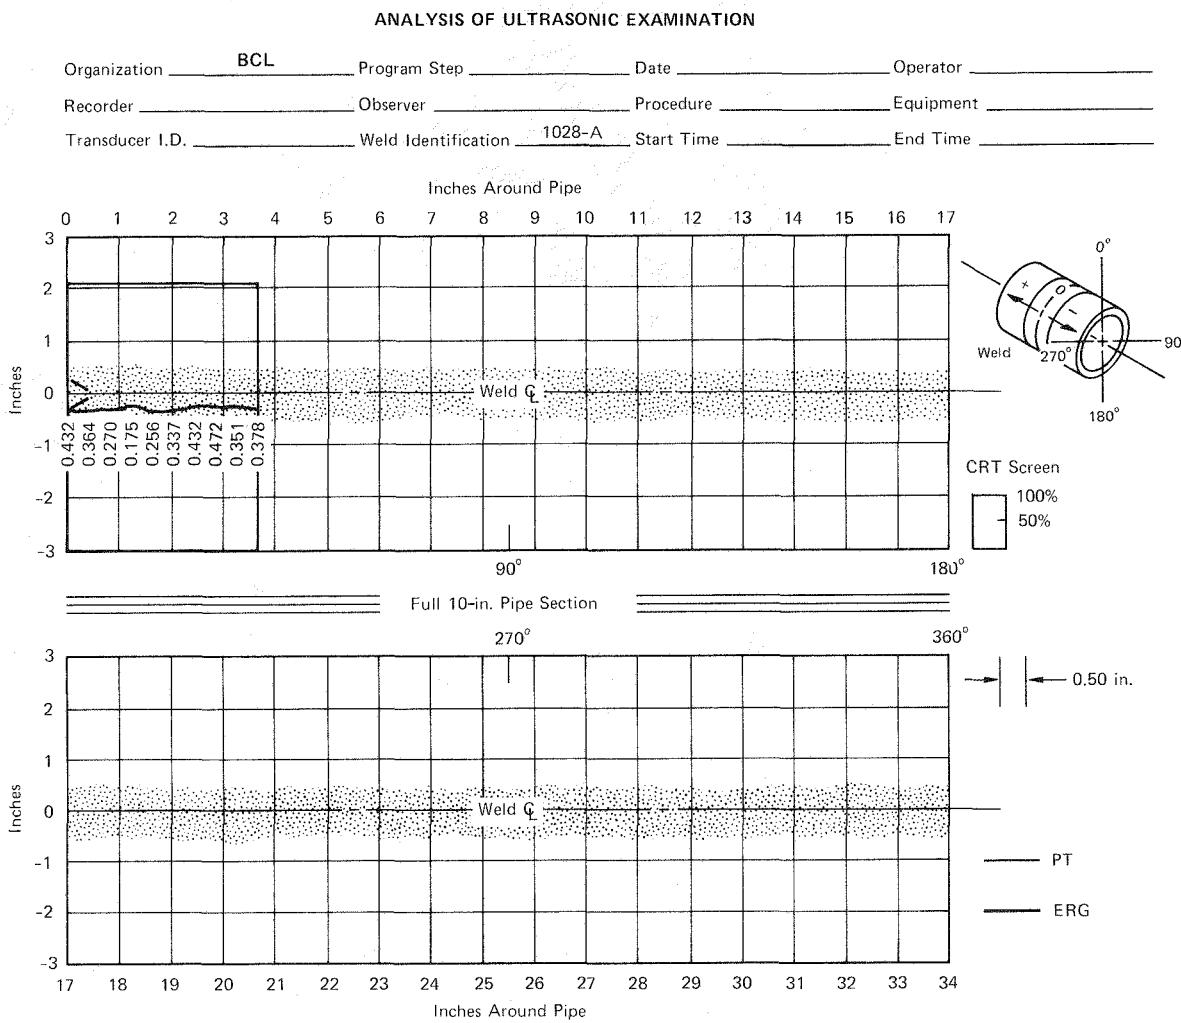
Figure D-10 ERG Readings, Sample 1028A

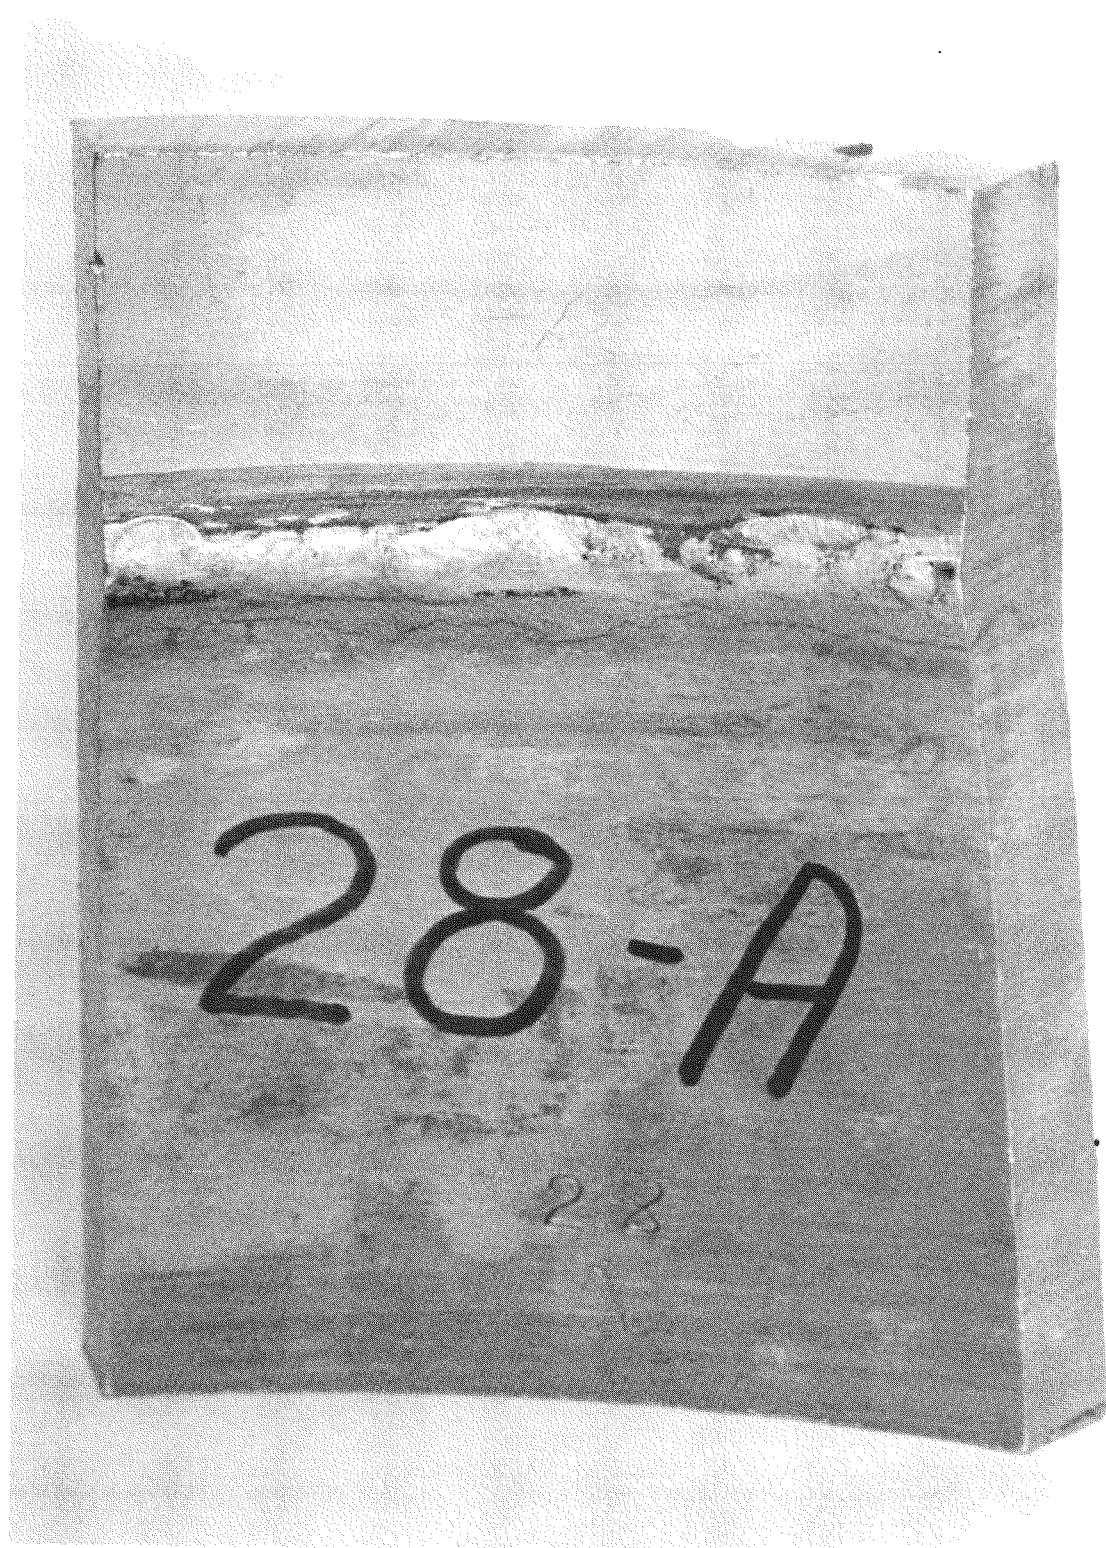
Figure D-11 Inside Surface, 1028A

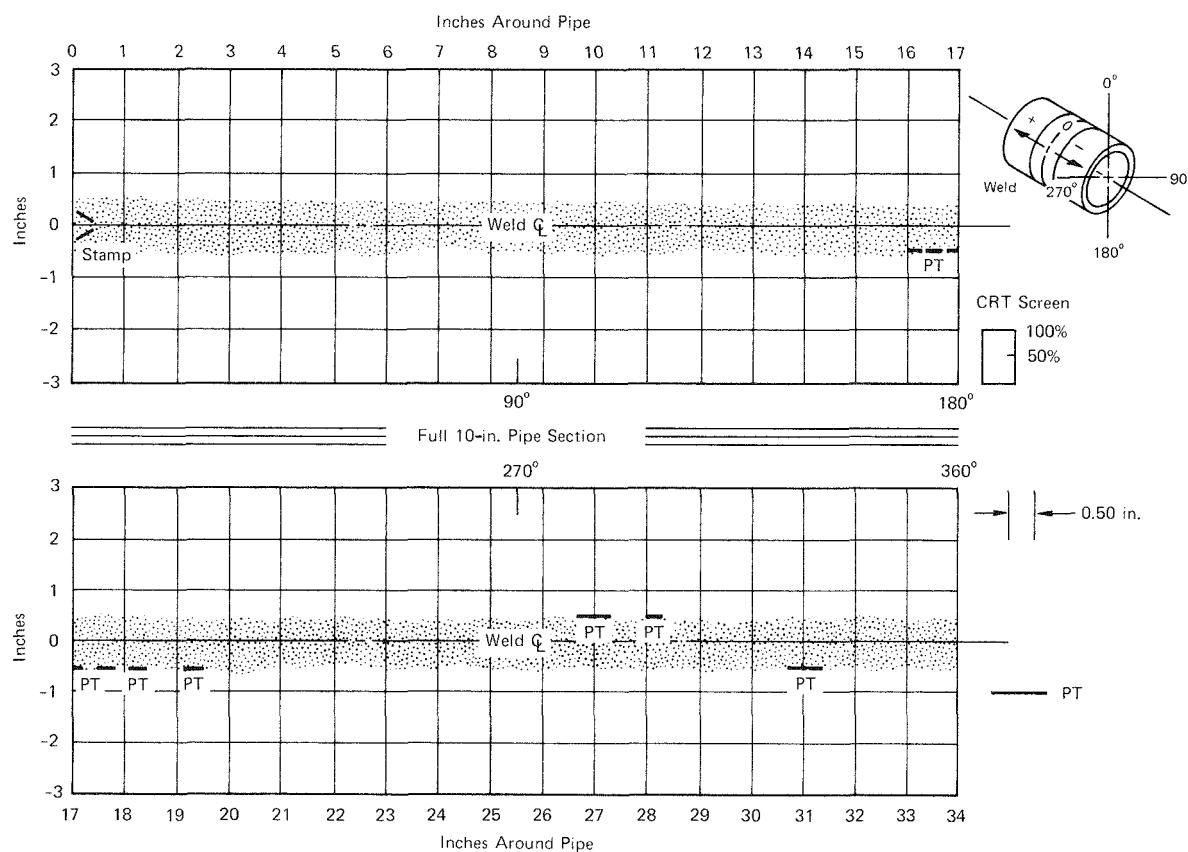
Specimen 1021 was interesting in that it was initially judged to contain a stress corrosion crack approximately 8-in. long as in Figure D-14. A white light photograph showing the condition of the pipe ID and the thickness mismatch between surfaces is shown in Figure D-15. The weld crown has been ground fairly smooth. The root area has been ground uniformly around the ID circumference of the pipe. An ID penetrant view is shown in Figure D-16. The close-up photograph shows the existence of a linear indication between ID locations 17 in. and 14 in.

Figure D-14 DPT Data for 1021

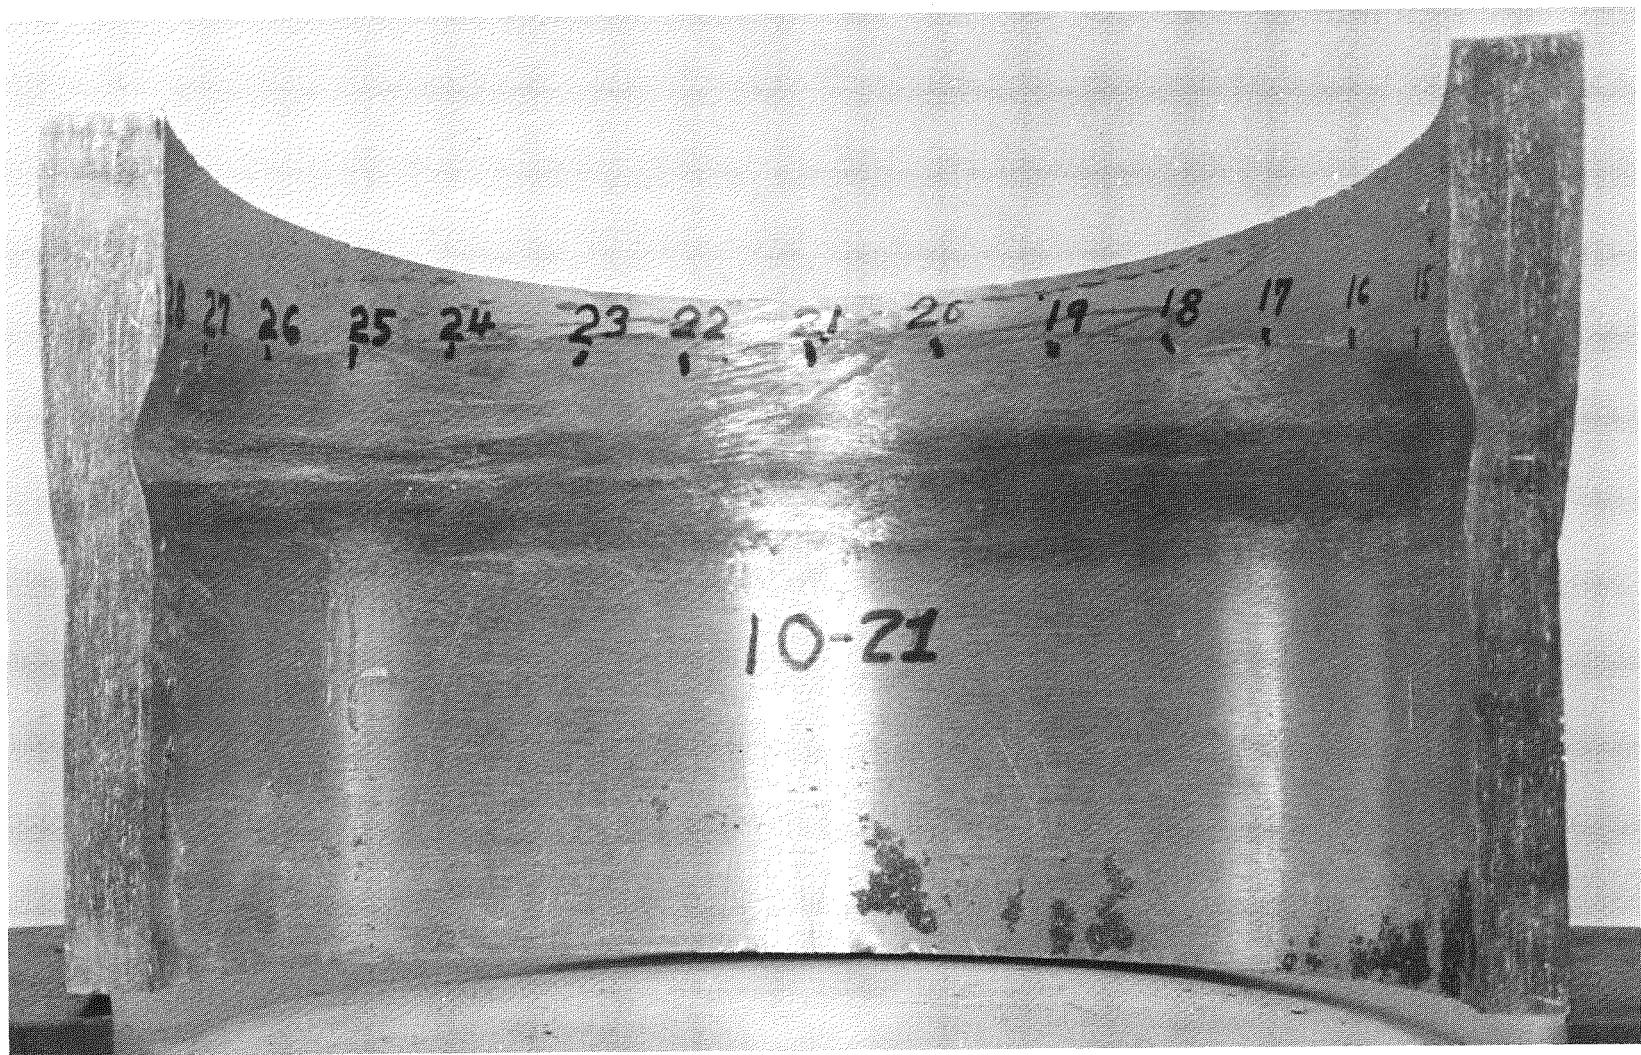
Figure D-15 Specimen 1021, Inside Surface

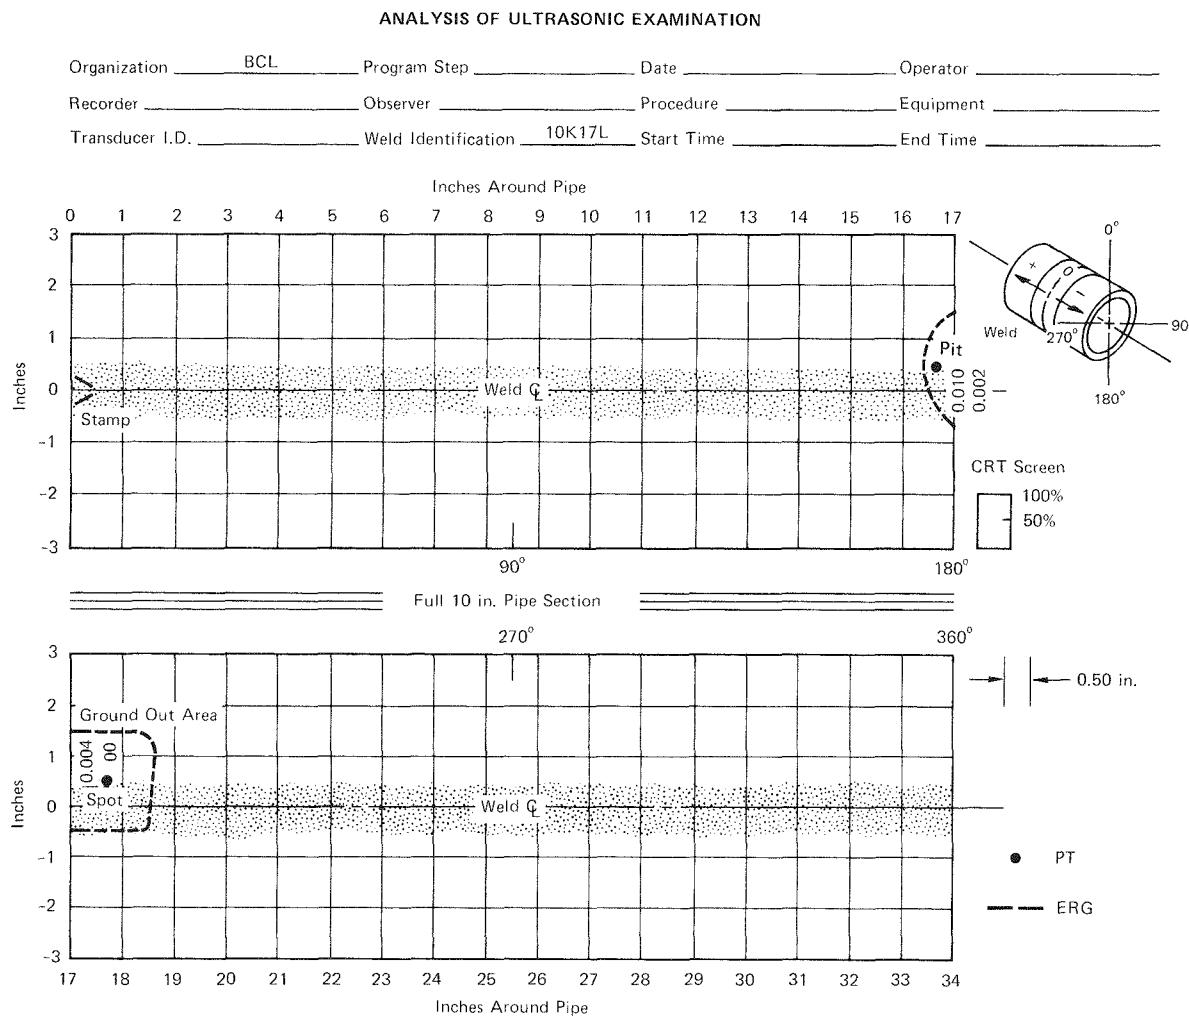
Figure D-18 ERG and DPT Data for 10K17L

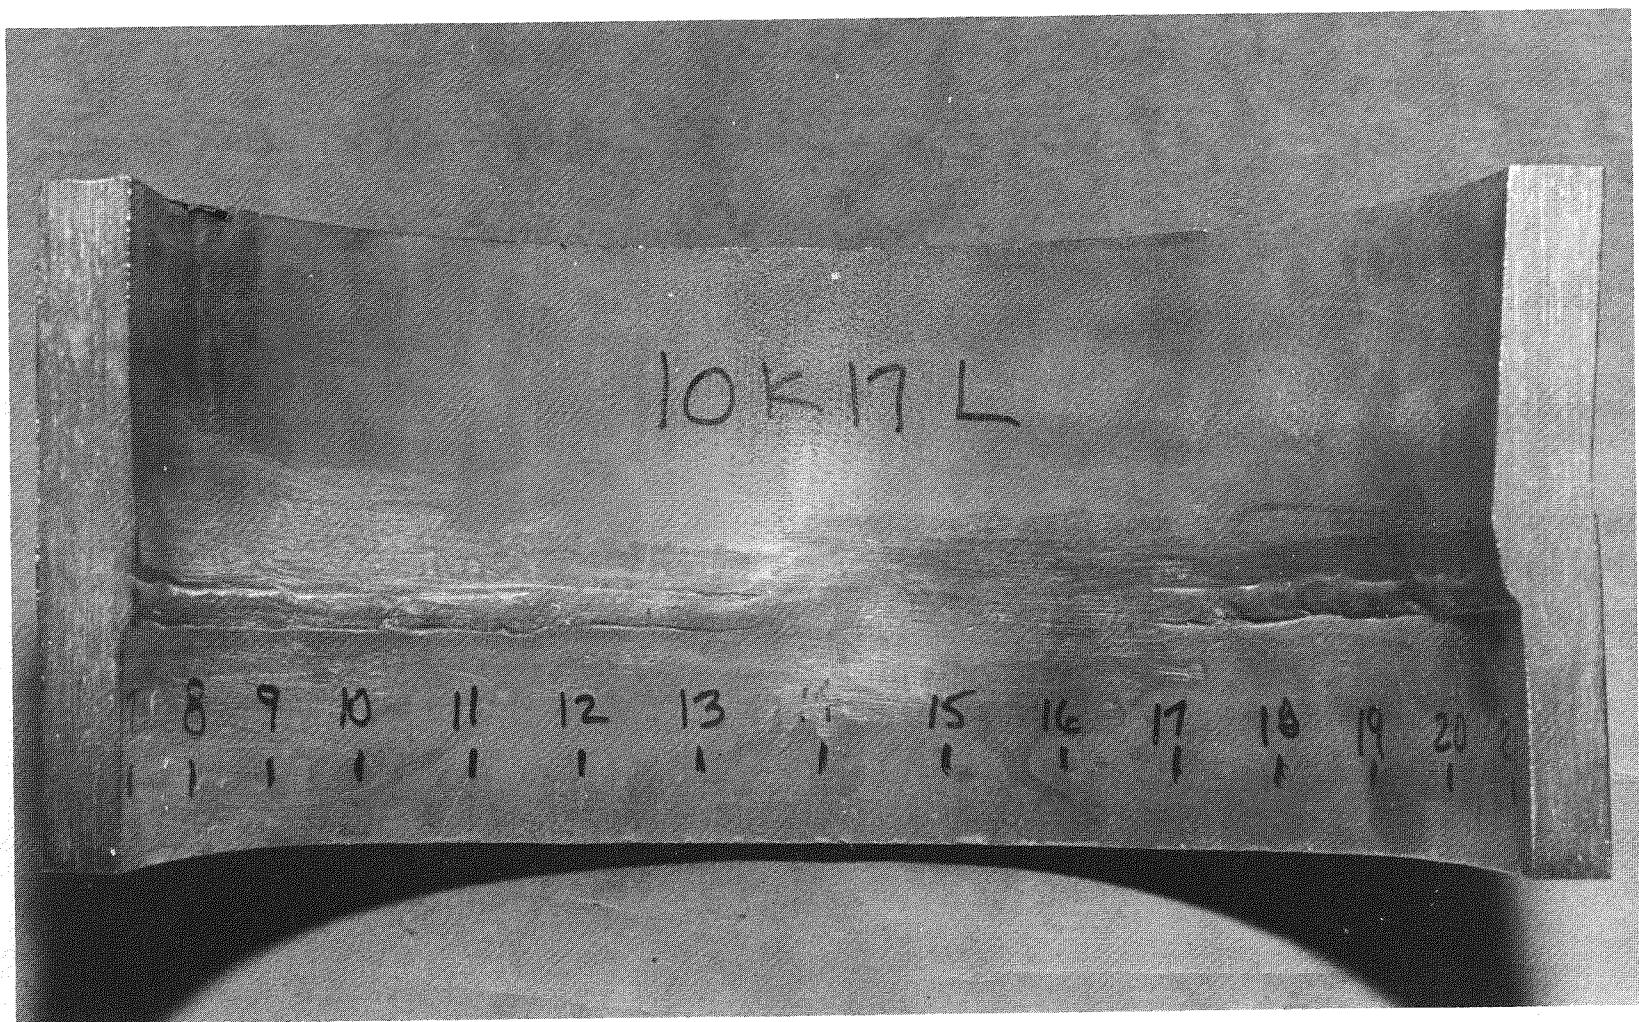
Figure D-19 Inside Surface of 10K17L

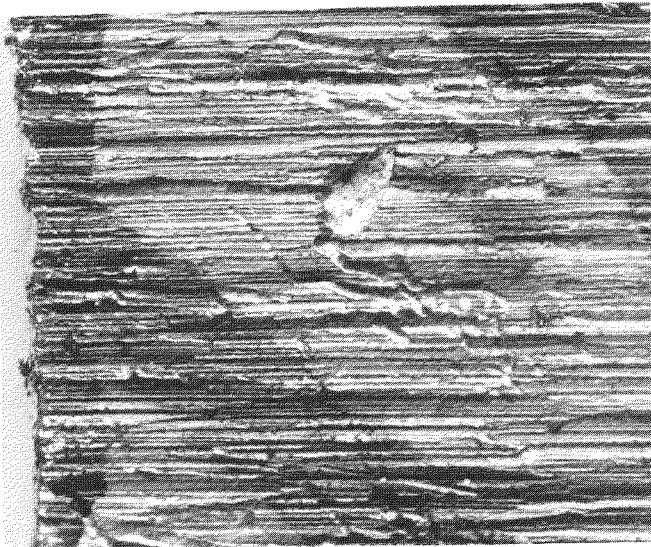
(a) 10K17L PIT AT 14.75 IN. ID, 15X

Figure D-21 Macrographs of Indications in 10K17L

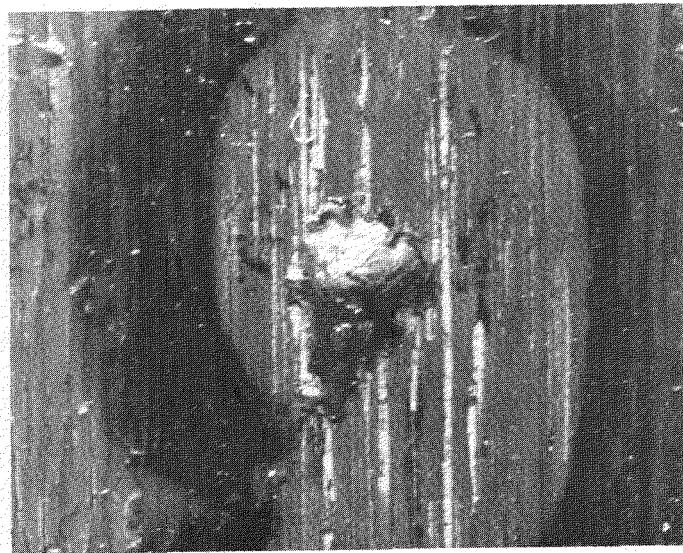
(b) 10K17L SPOT AT 15.5 IN. ID, 15X

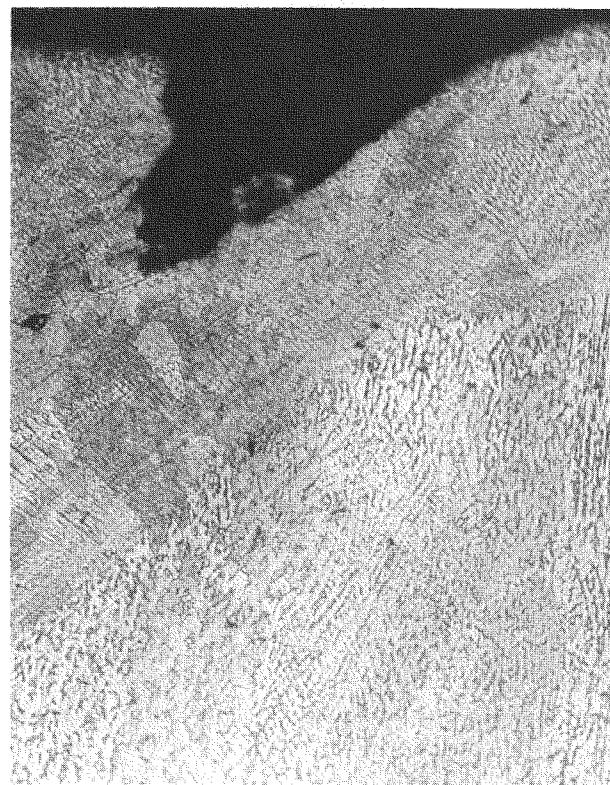
Figure D-22 Macrograph of Section Through Pore  
at 14.75 in. ID in 10K17L, 100x

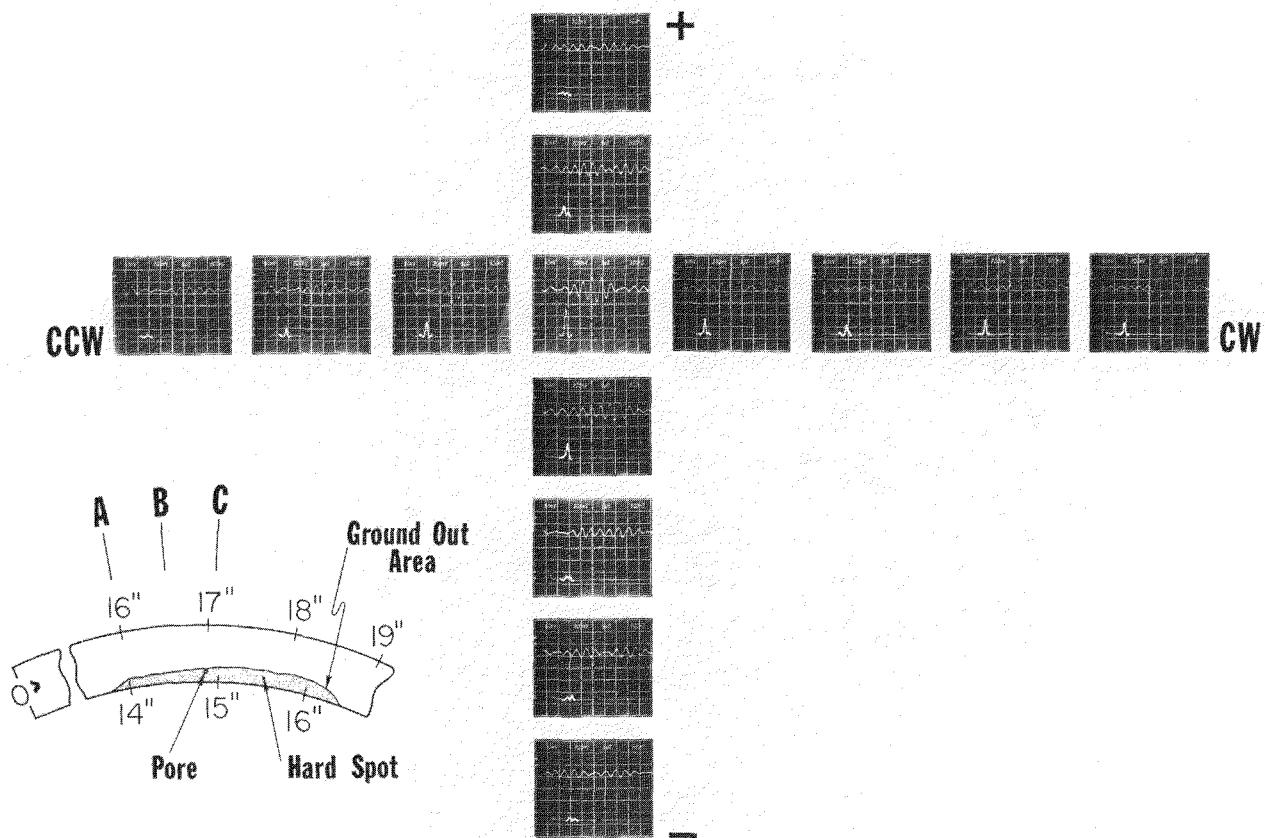
Figure D-23 UT Characterization of 10K17L

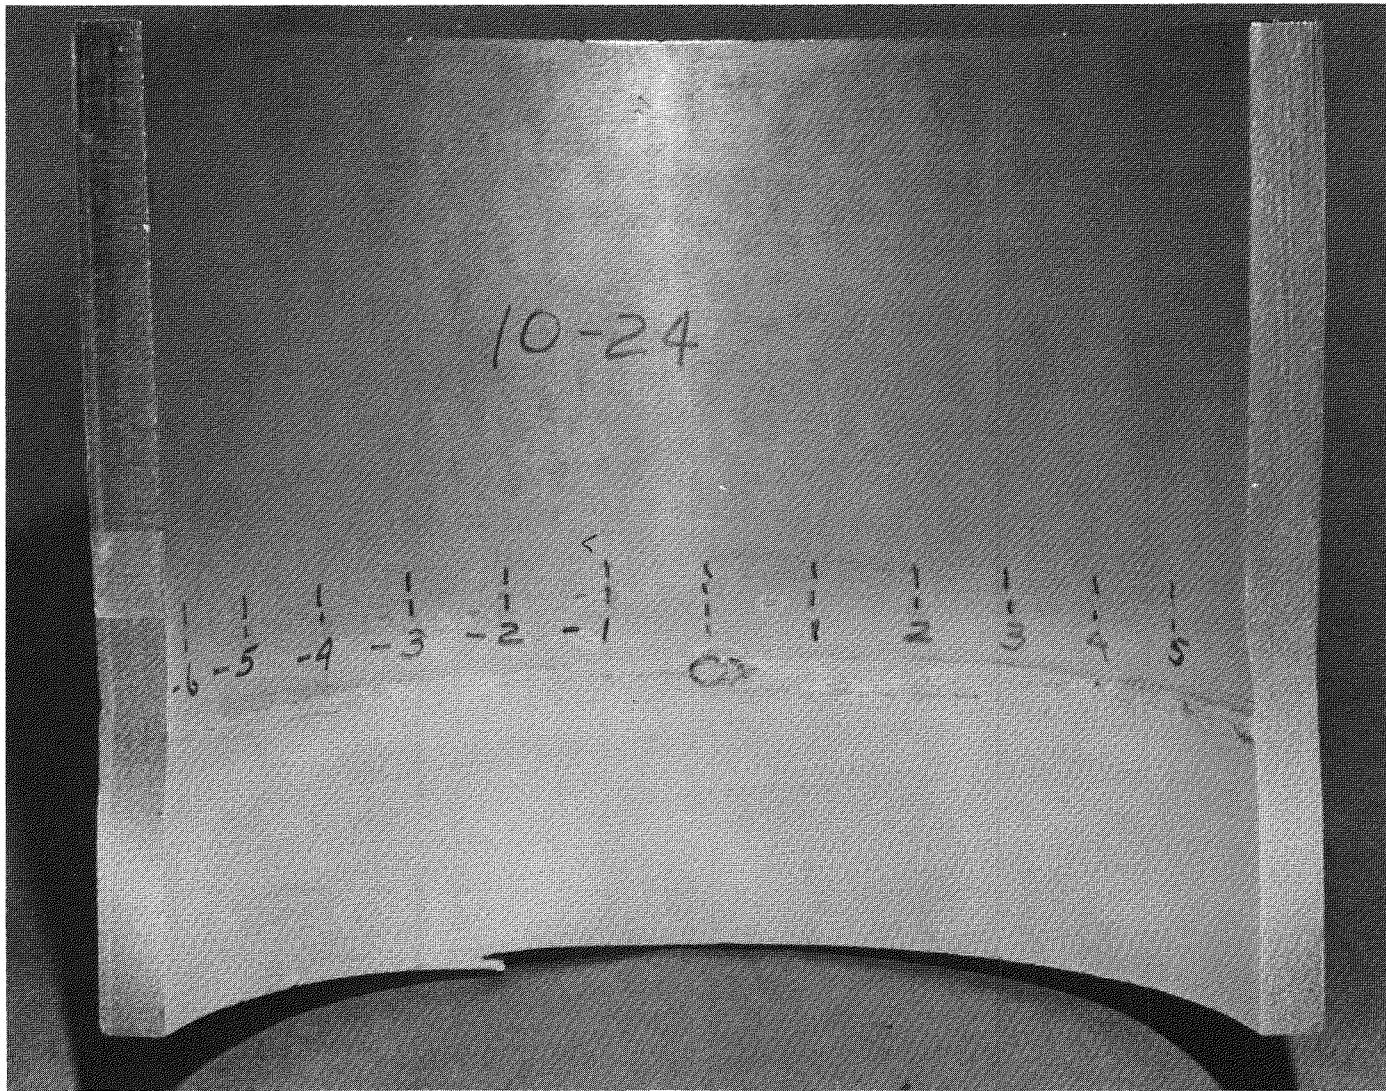
1024A contains a number of cracks, some of which had not been reported previously. The location and orientation of all cracks identified by penetrant testing are summarized in Figure D-24. A general white light ID view of 1024A is shown in Figure D-25. An ID penetrant view in Figure D-26 shows the longitudinal indication

Figure D-25 Inside Surface of 1024A

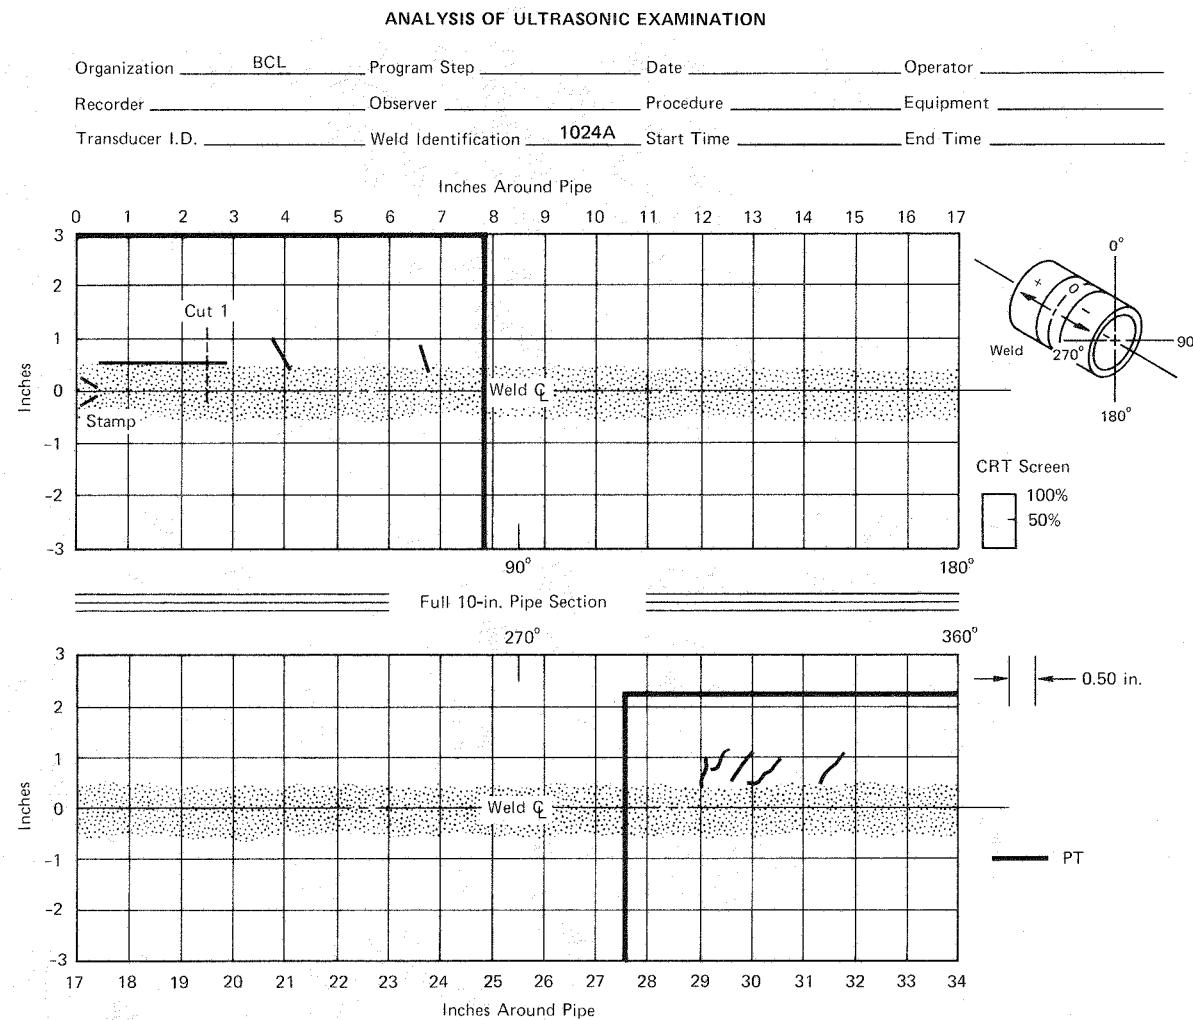
Figure D-24 DPT Results, 1024

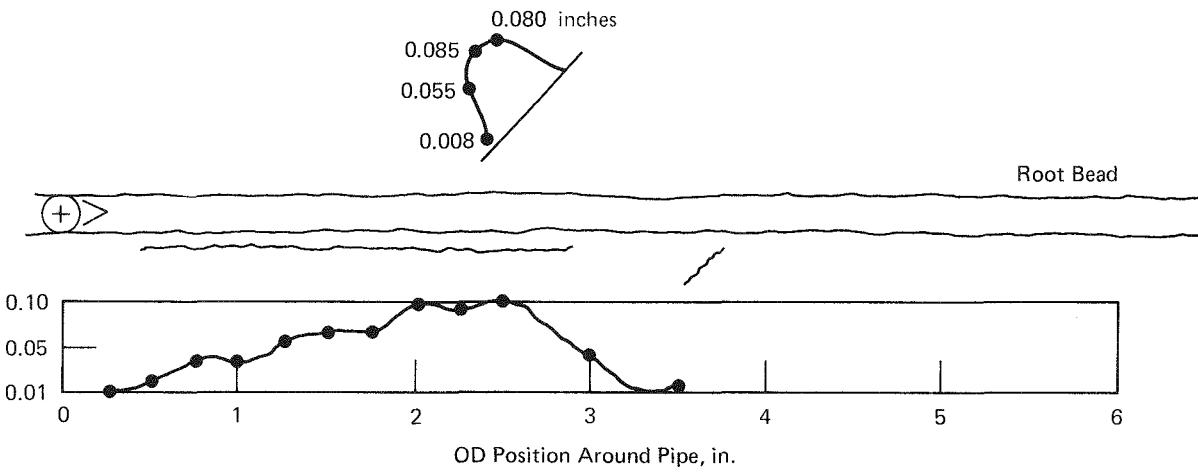
Figure D-29 ERG Data Plots for Cracks in 1024A

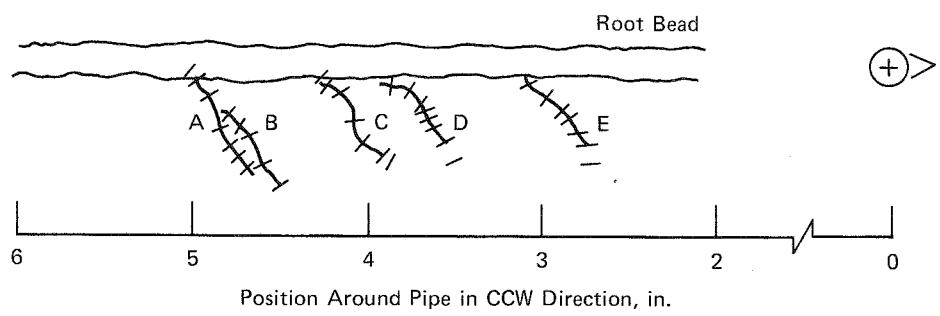
Figure D-30 ERG Depth Readings for 1024A Angled Cracks

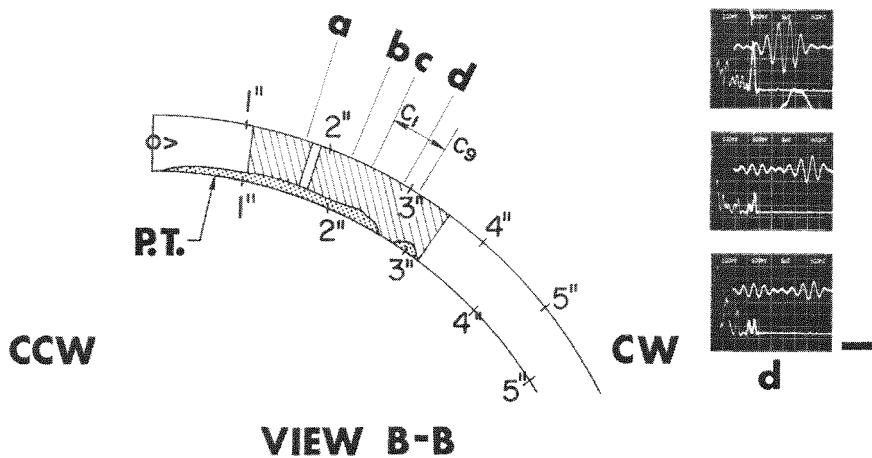
Ultrasonic scans in directions parallel and perpendicular to the weld for the circumferential crack are shown in figures D-31 and D-32. The transverse scanning ultrasonic signal responses, identified as the vertical columns a, b, c, and d, correspond to the locations a, b, c, and d shown on the adjacent view of the pipe cross section. The series of scope traces identified as  $c_1$  through  $c_9$  were obtained by scanning parallel to the weld; they again correspond to positions  $c_1$  through  $c_9$  shown on the adjacent sketch of the pipe. The ultrasonic scanning sensitivity was 6 db higher than that used to obtain the initial 1/8-in. SDH DAC curves.

Figure D-31 UT Characterization of 1024A

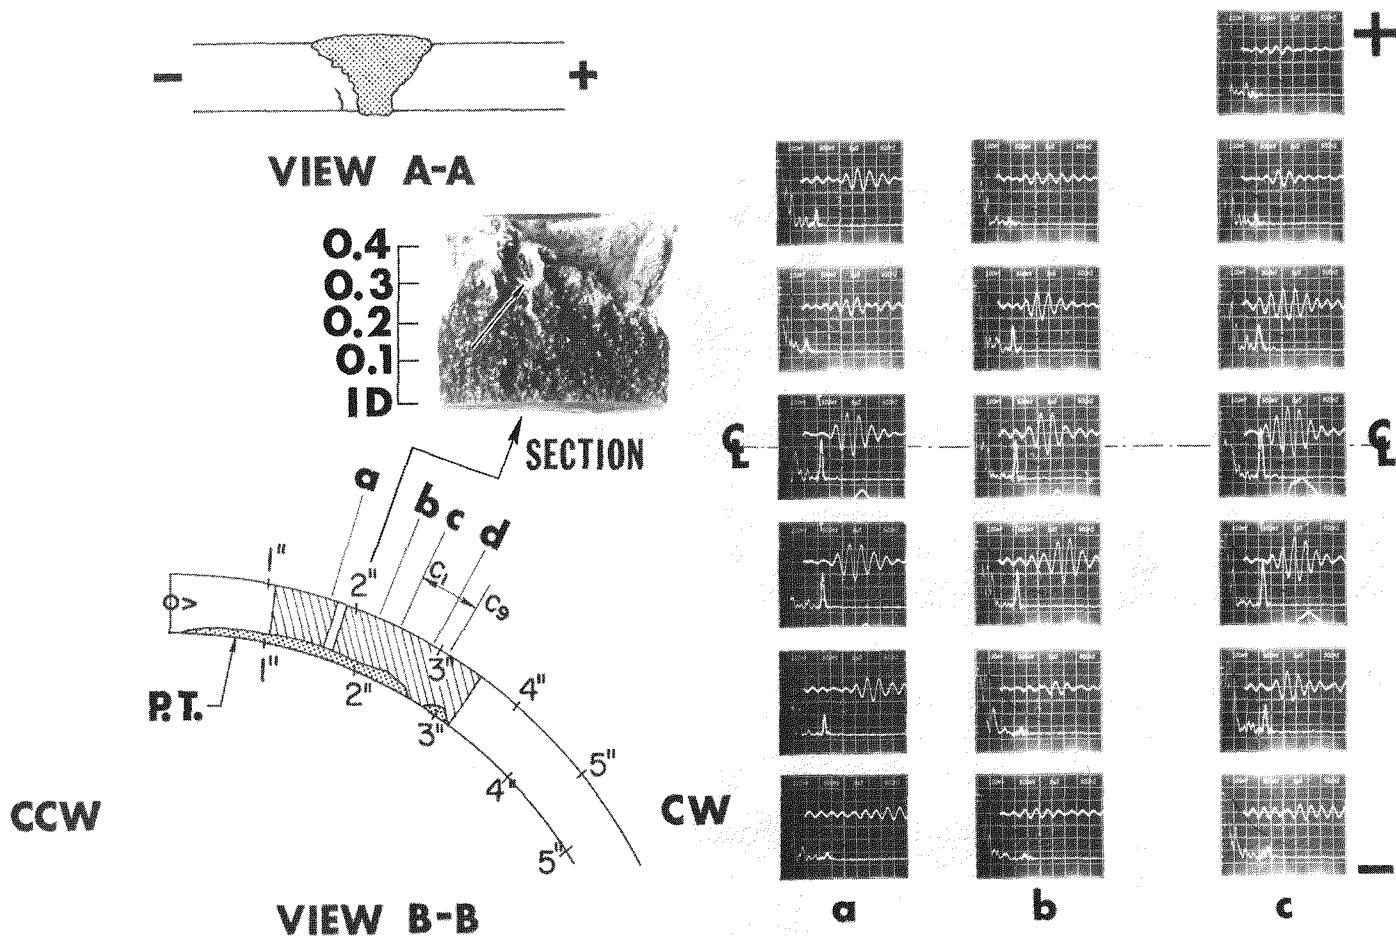
The broken crack surface shown in Figure D-32 was obtained by breaking the circumferential crack between the approximate OD locations 1.1 in. and 1.8 in. The crack photograph clearly shows the sugarlike texture of the region of intergranular attack. It is important to note that the crack photo is misleading in that the crack appears to run 90% through the wall. However, the entire thickness of the pipe wall is not shown; in reality the crack runs through approximately 65% of the wall. This crack runs circumferentially and is offset from the weld root by approximately 0.1 in. Scanning electron microscope (SEM) photographs of the area of the crack surface identified by an arrow in Figure D-32 are shown in Figure D-33. In Figure D-33, one can identify the region of attack (sugarlike texture) and regions of intergranular weakening from the existence of stress corrosion crack dendrites. Unattacked material exhibits a smoother texture than that shown by the attacked regions. View (b) is an enlargement of view (a) in essentially the same area.

Figure D-32 UT and Metallographic Characterization of 1024A

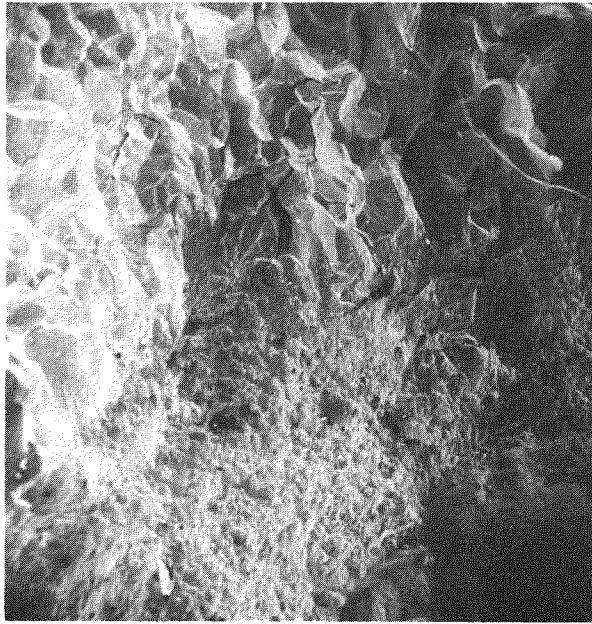
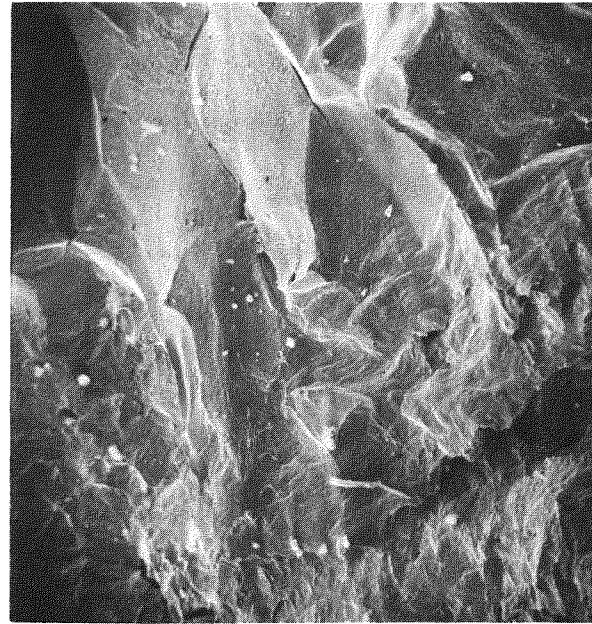
Figure D-33 SEM Characterization of IGSCC, 1024A

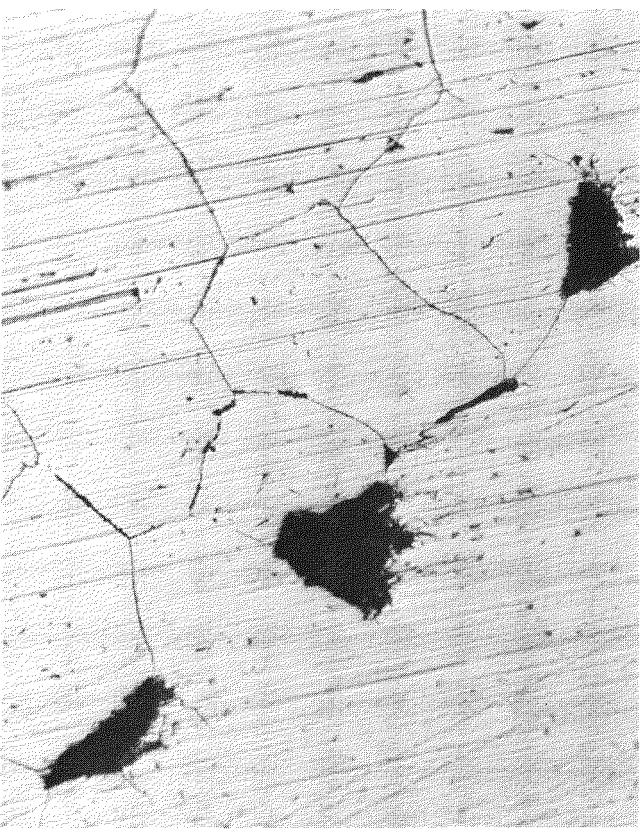
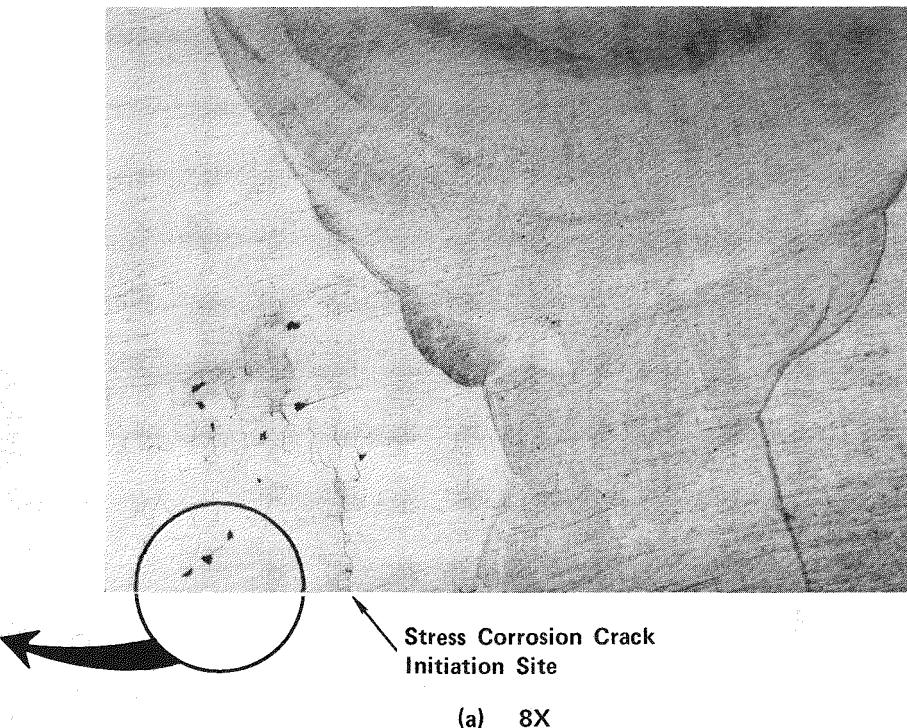
Another view of the circumferential crack sectioned transversely at approximately 1.9 in. OD is shown in Figure D-34. This figure clearly shows the general region of intergranular attack and depleted grain boundaries.

Enlarged Area Showing Region of Depleted Grain Boundaries

Figure D-34 Sectioned View of IGSCC at 1.9 in., 1024A

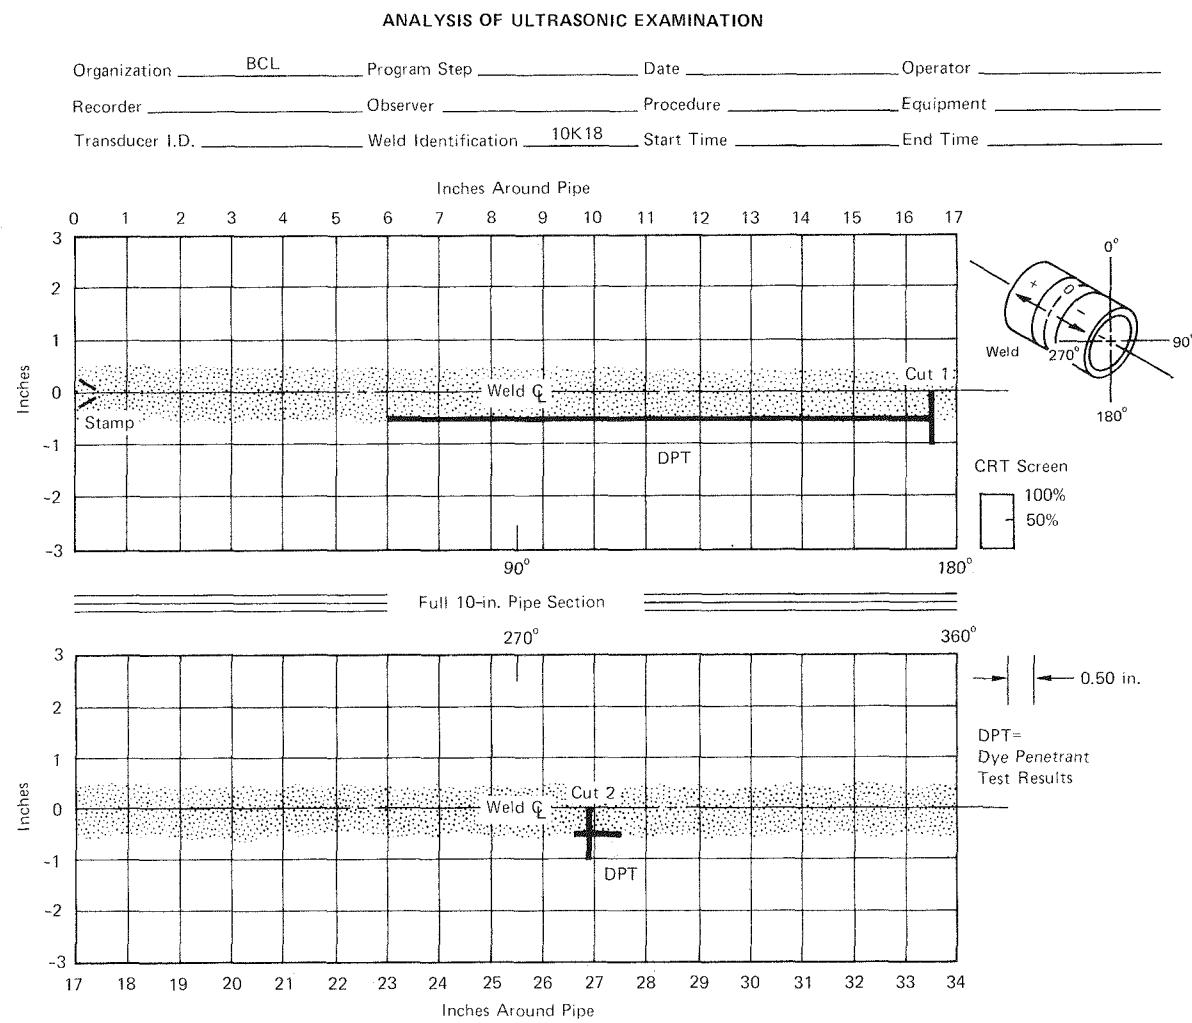
Figure D-37 DPT Characterization of Sample 10K18
