# **A STUDY OF IN-SERVICE ULTRASONIC INSPECTION PRACTICE FOR BWR PIPING WELDS**

**EPRI NP-436-SR  
(Technical Planning Study 75-609)**

**Special Report**

**August 1977**

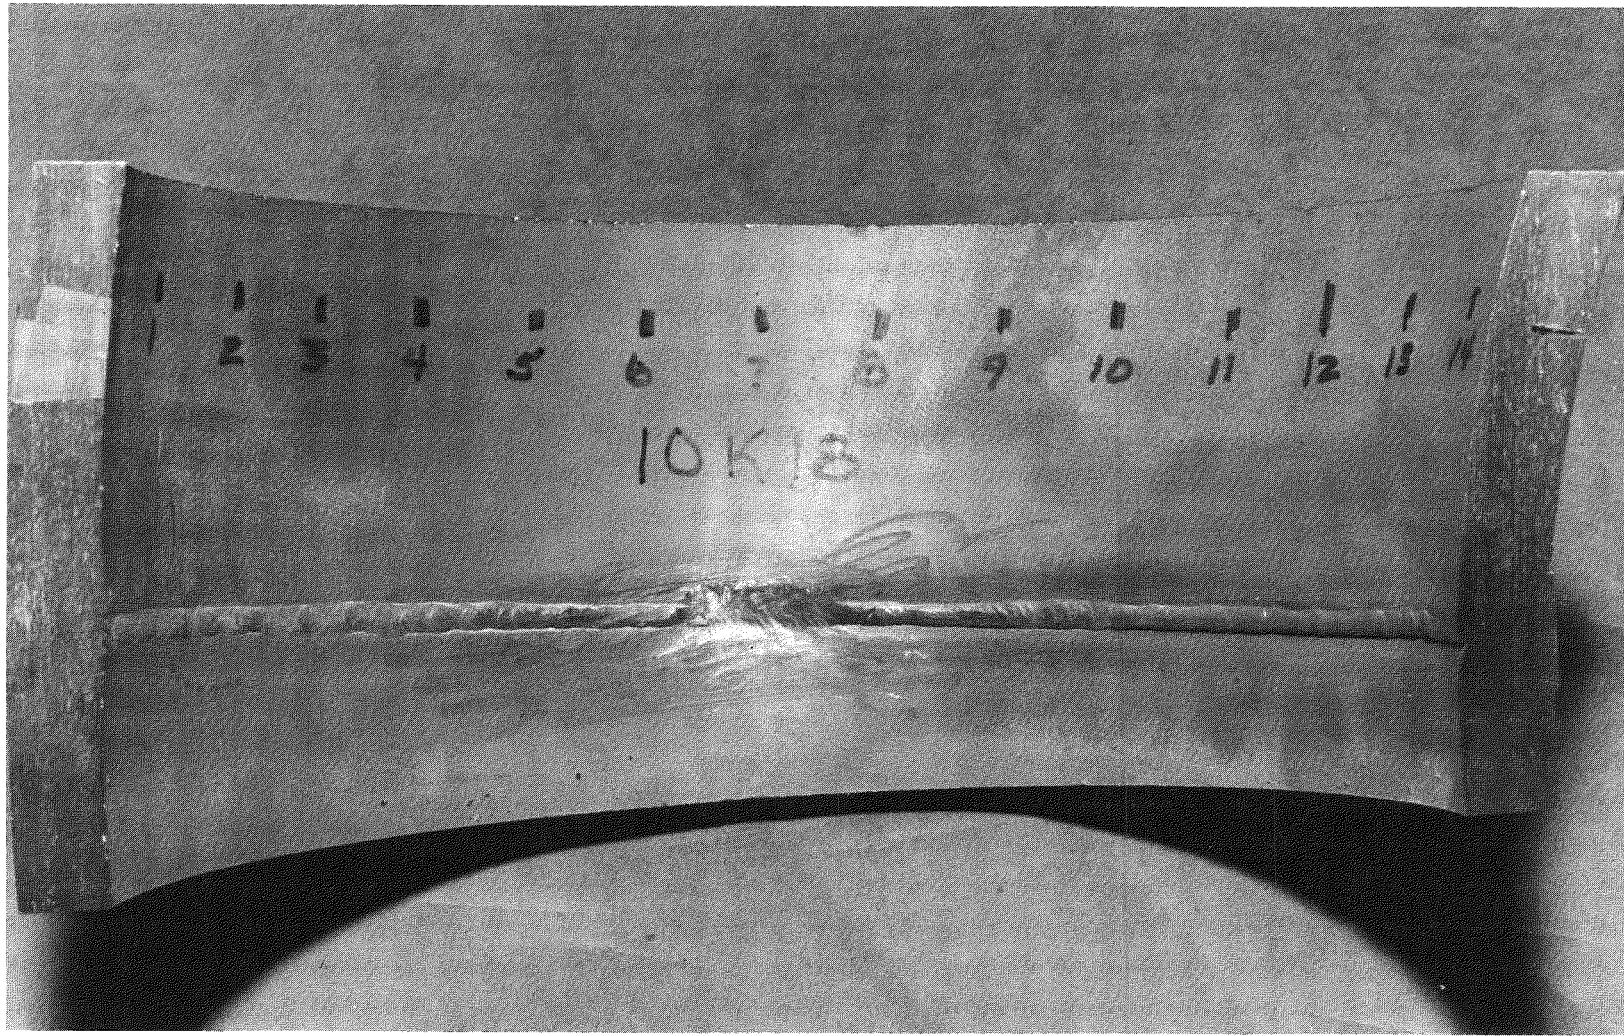
Figure D-38 Inside Surface, 10K18

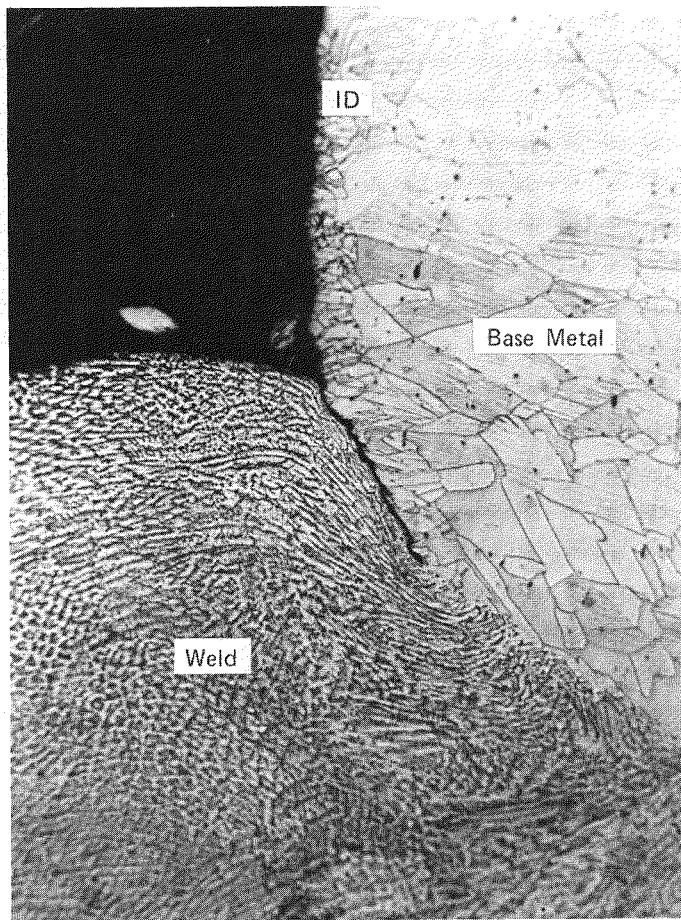
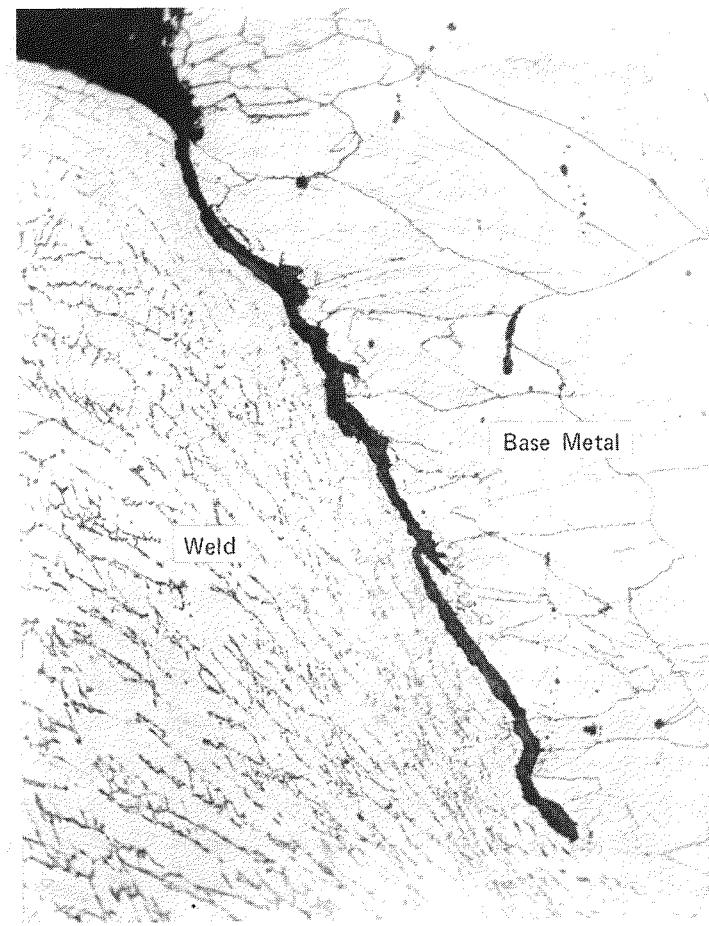
Figure D-41 Micrographs of Section Through 10K18 at 15.5 in. ID, Showing Lack of Fusion

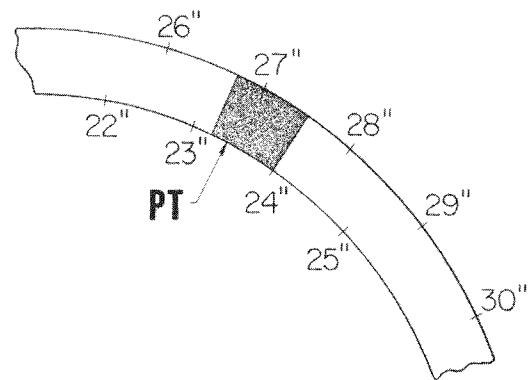
TRANSVERSE WELD  
SECTION AT 27.1" O.D.  
SHOWING LOF

Figure D-42 Ultrasonic Characterization of 10K18

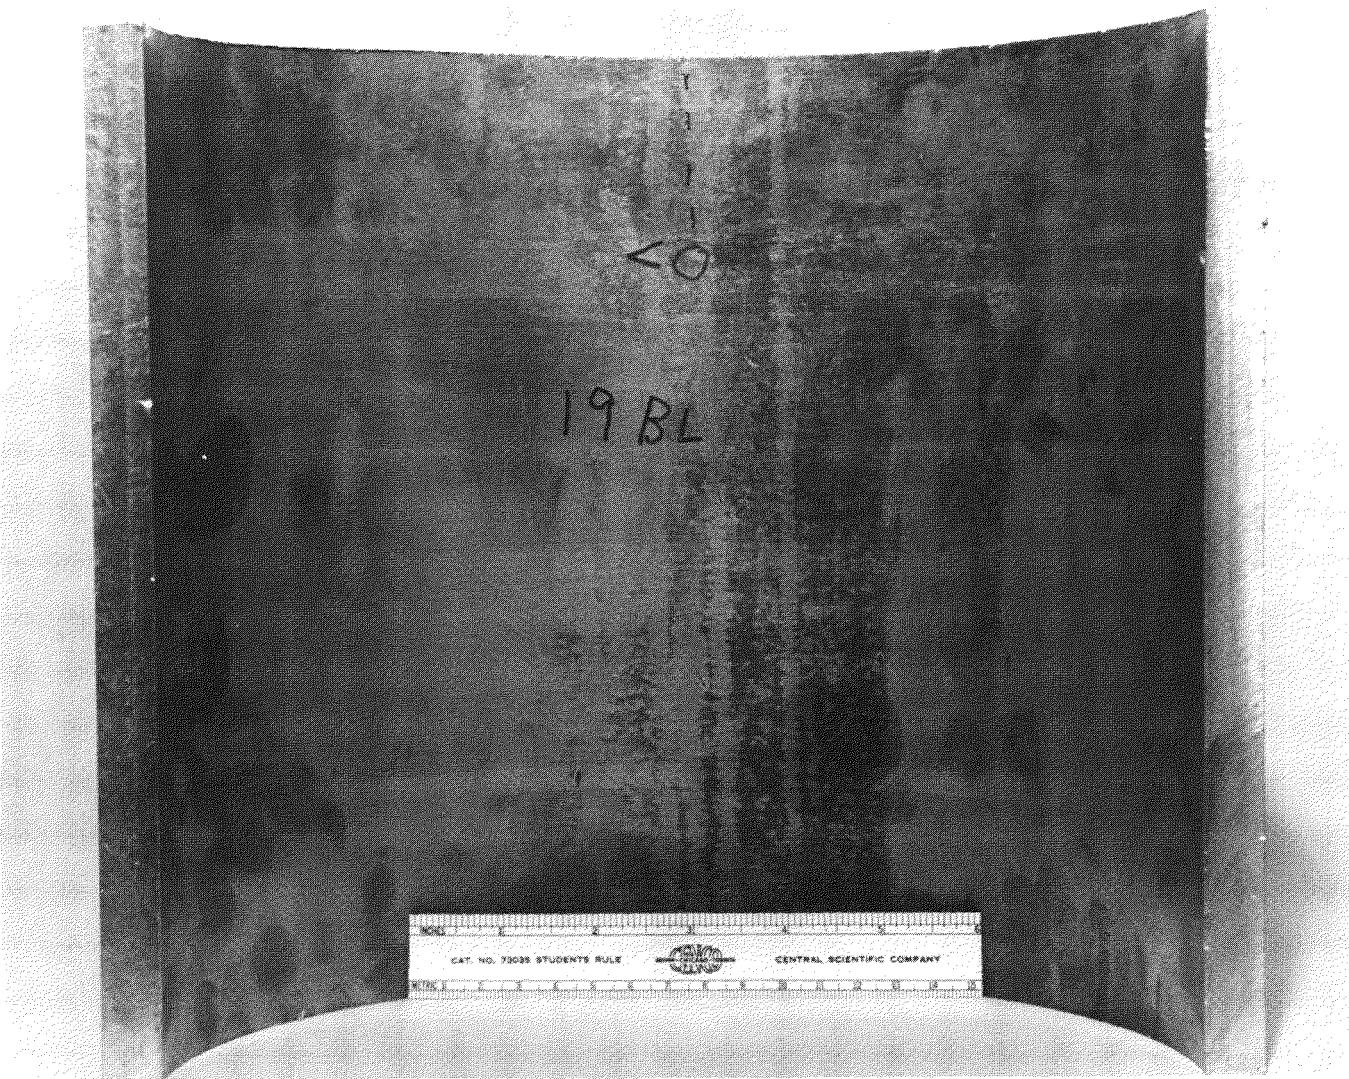
19BL is an infamous specimen in that it was the source of several rather strong ultrasonic indications, yet neither penetrant nor radiography shows the presence of any material discontinuities. The specimen represents a shop-fabricated weld with the overall surfaces in excellent condition for field ultrasonic testing. A general ID view of the pipe is shown in Figure D-43. Previous ultrasonic characterization had identified some "geometrical" reflectors, but based on the condition of the weld (ground), the basis for this conclusion is ill founded.

Figure D-43 Inside Surface of 19BL

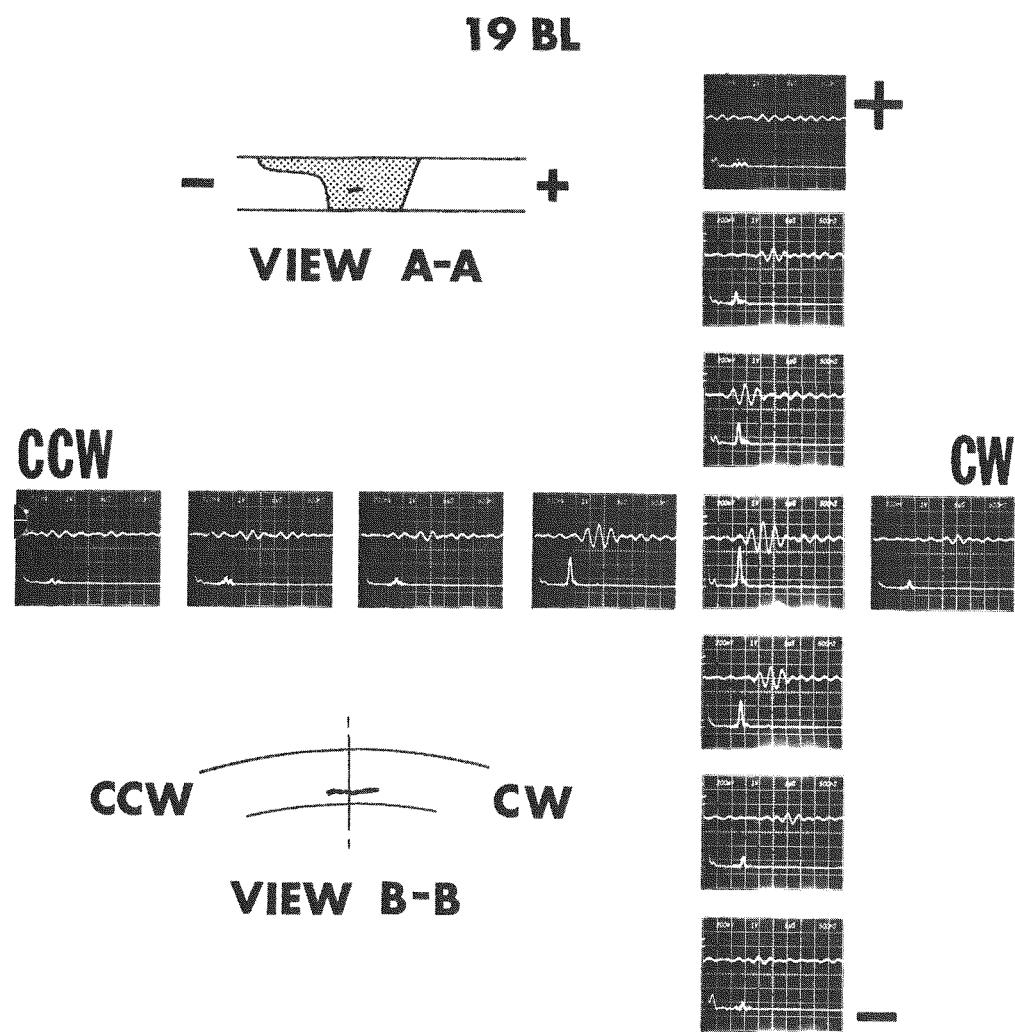
Figure D-44 UT Characterization of 19BL at 5 in. OD Location

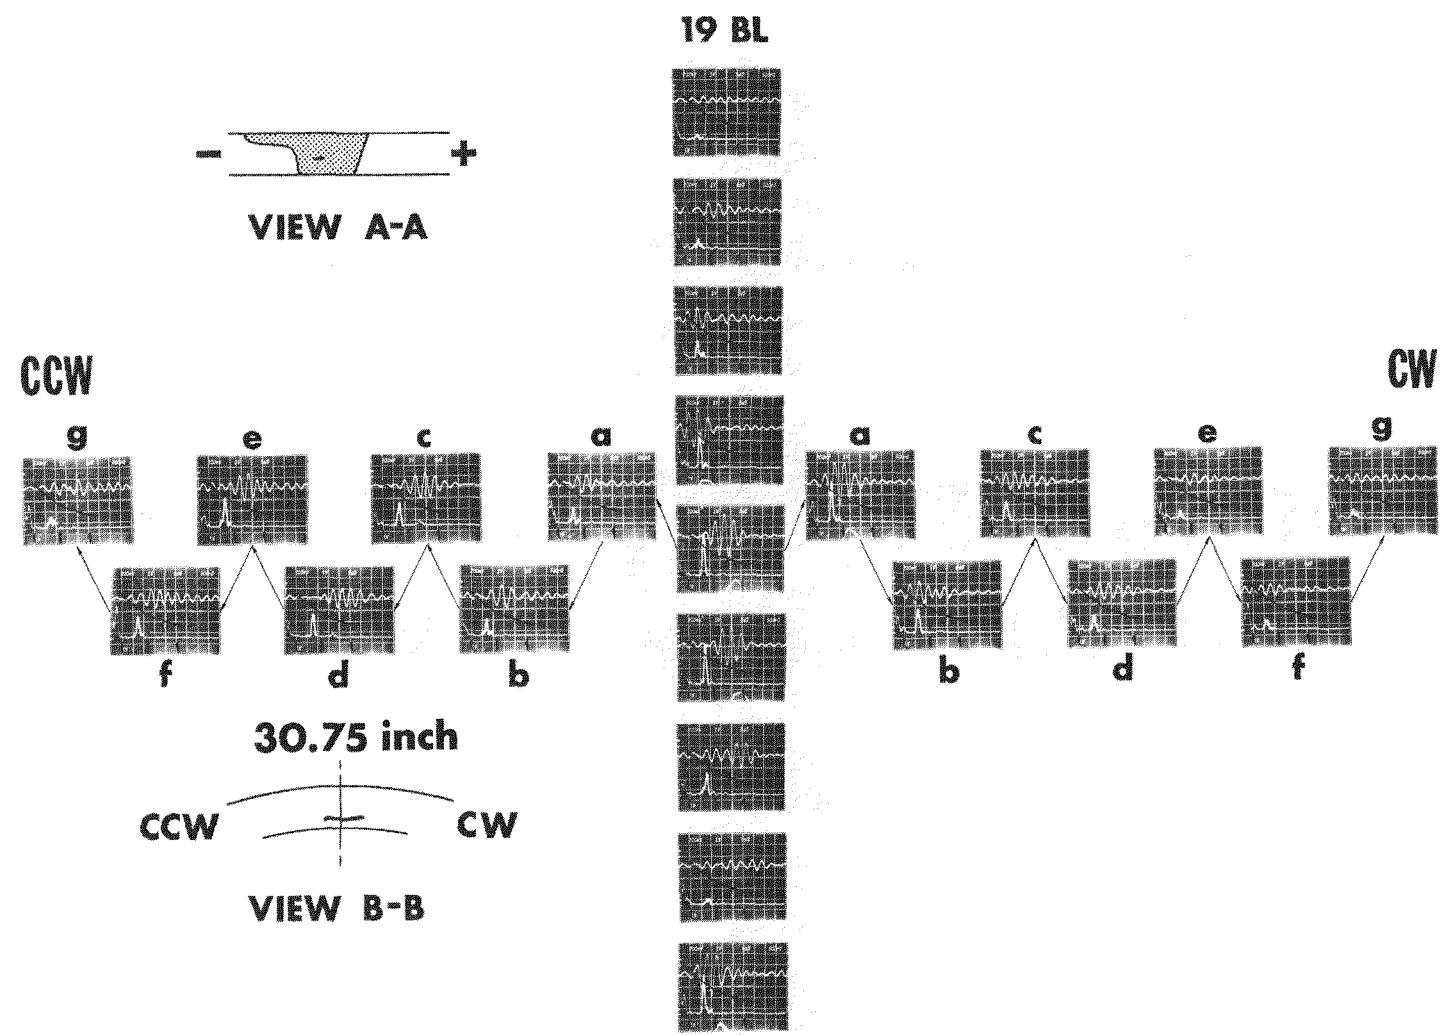
Figure D-45 UT Characterization of Specimen 19BL at OD Location of 30-3/4 in.
