HEDL-SA-902

MODE OF FAILURE OF LMFBR FUEL PINS

D. F. Washburn

For presentation at the meeting
of the American Nuclear Society
New Orleans, Louisiana, June 8-13, 1975

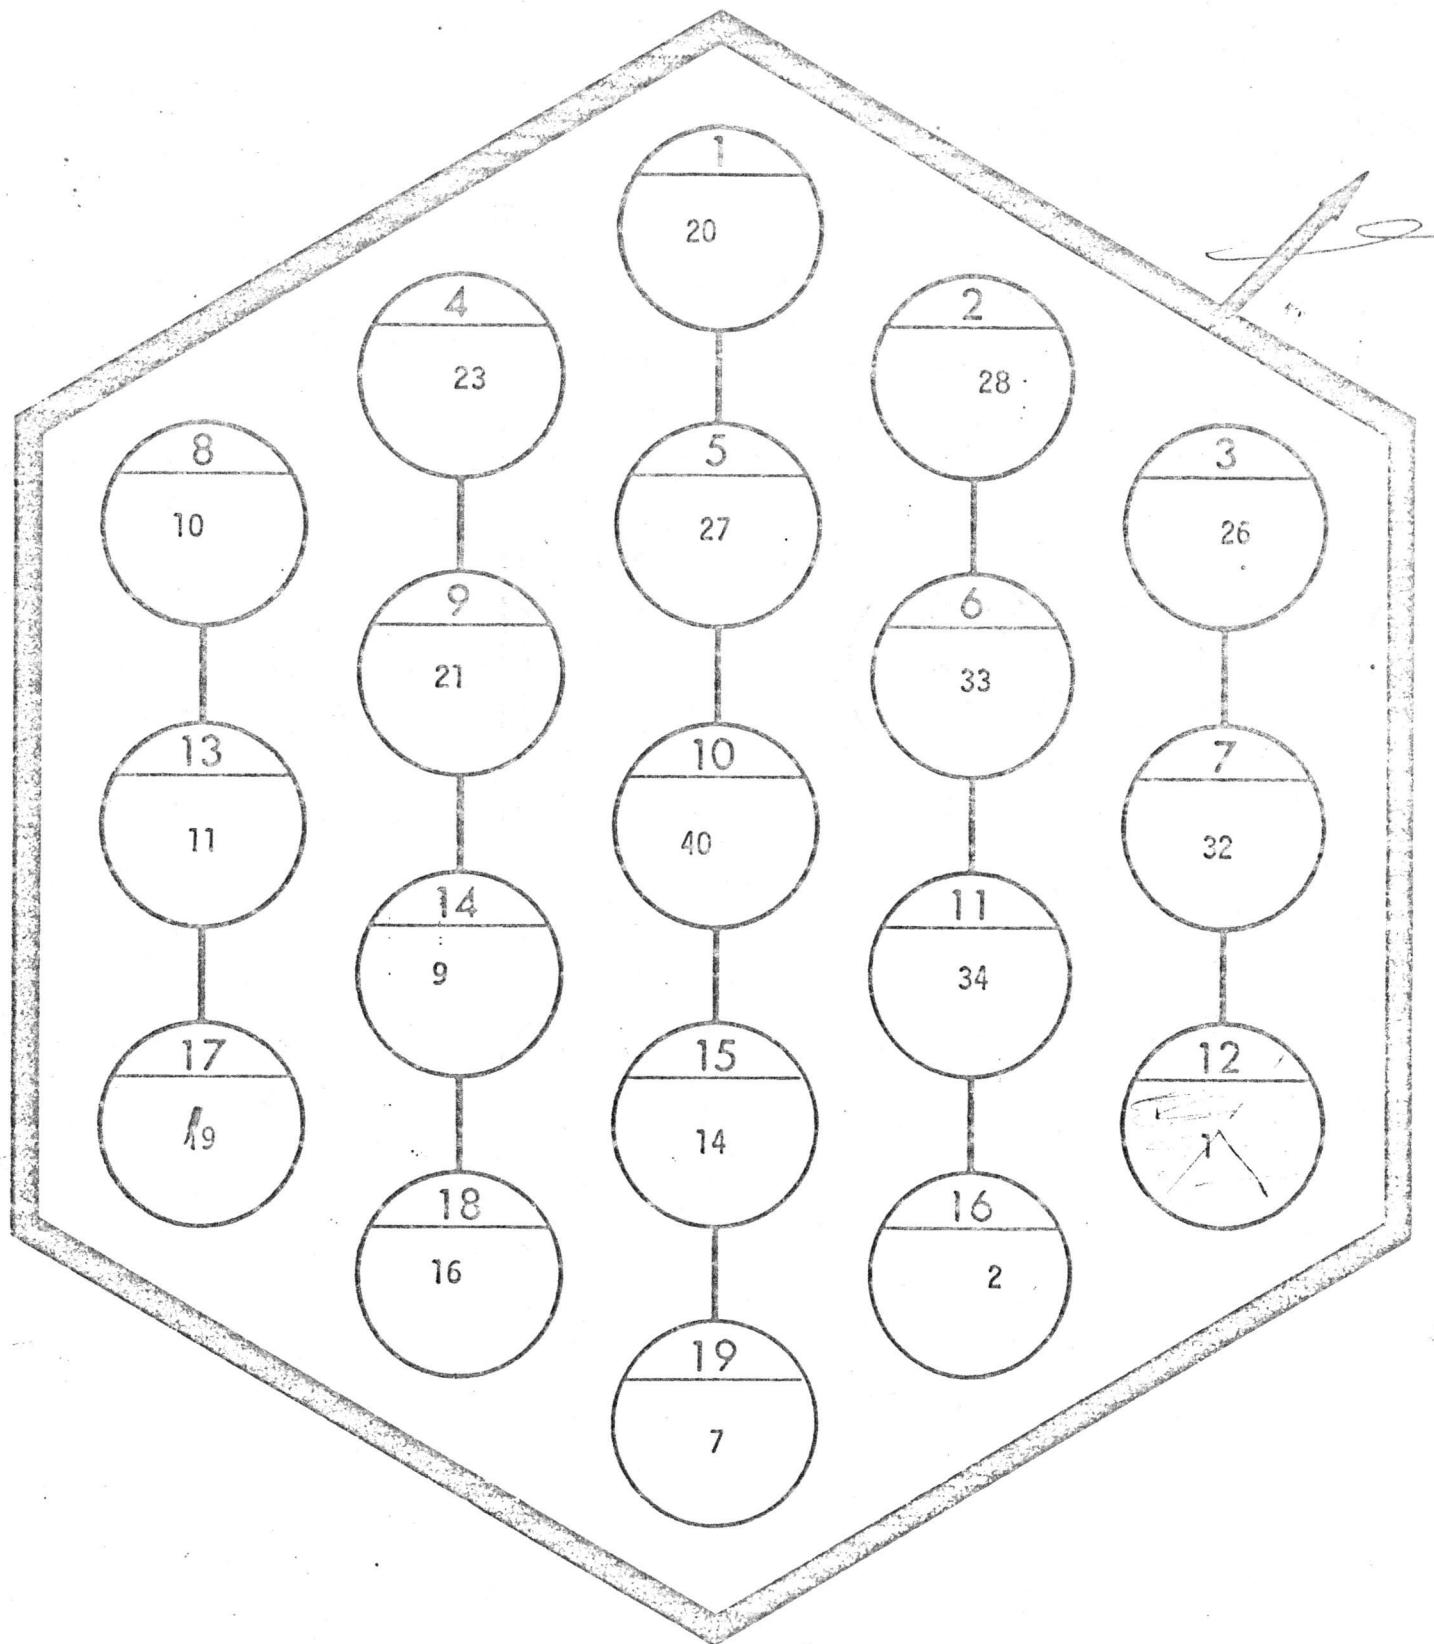
PNL 5A Subassembly Arrangement

Removal of the hex duct at HFEF showed several of the fuel pins along one edge of the bundle (including the breached pin) were severely distorted. The distortion was most severe just above the core midplane and is evident in the photograph shown in the fourth slide. This photograph (supplied by ANL) shows the pin in position 12 has been displaced to position 7 while the pin in position 11 is in position 12. The pin arrangement shown earlier clarifies this rearrangement, Slide 5. As a result of this distortion, conditions were favorable for pin-to-pin contact. The cause of the distortion was not evident from an examination of either the fuel pins or the subassembly hardware although the metallographic examination of PNL 5-2, a neighbor to the breached pin suggests it occurred during assembly of the PNL-5A subassembly.

Gamma-scanning and weight measurements at HFEF positively identified the breached fuel pin as PNL 5-1. This was one of the severely distorted pins observed earlier although there was no outward evidence of the cladding breach. No other breached pins were present in the subassembly.

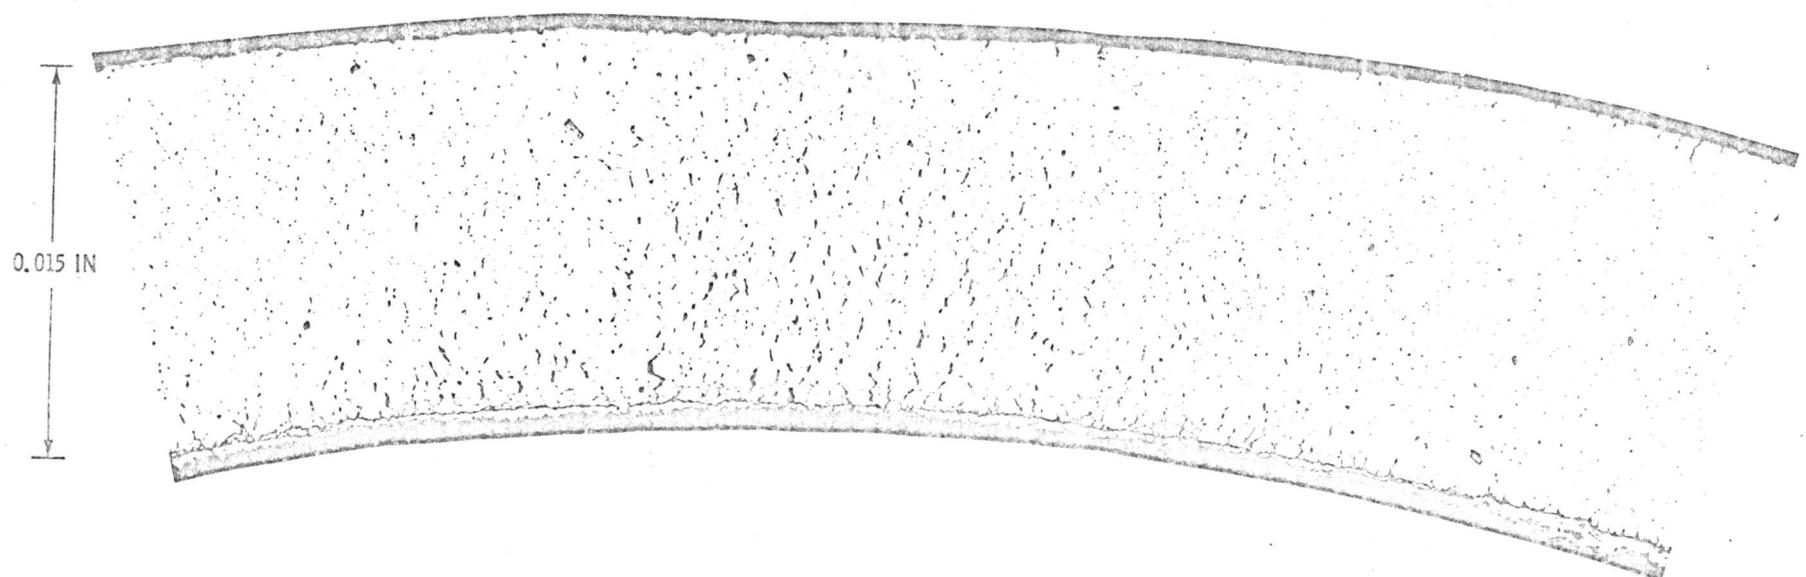
CLADDING BREACH
PNL 5-1

The mechanism of failure in the cladding was determined by incrementally polishing and examining numerous transverse surfaces in a section of the fuel pin known to contain the cladding breach. An area of cladding within an included angle of about 30° and extending axially for about 5/8-inch contained a high density of intergranular porosity and cracking. A typical example of these features is shown in Slide 9. There was no single surface which contained a continuous through crack; suggesting the cladding breach resulted from interconnection of the intergranular porosity. This intergranular porosity was not observed in any other area of the cladding of the breached pin or its sibling, PNL 5-2, or in the cladding of PNL 5-34 which was examined at the suspect axial height. The pin which is suspected of being in contact with the failed pin is now undergoing examination.

The intergranular porosity, local deformation of the cladding, and intergranular penetration of palladium at the cladding inner surface provides strong evidence that the cladding fissure resulted from thermal creep which was confined to a hot spot in the cladding. The 900°F nominal cladding temperature is too low for thermal creep. However, calculations by M. Parker showed that restricted coolant flow resulting from pin-to-pin contact could cause a cladding hot spot approaching 1200°F. A temperature increase of this magnitude is sufficient to result in thermal creep of the cladding. Under conditions of pin-to-pin contact at full power the pin survived 376 Equivalent Full Power Days (7.9 a/o burnup) before the occurrence of a benign cladding breach.
