Analysis of Ultrasonic Inspection Data for Pilgrim 1 Reactor Nozzle N-2B

ANALYSIS OF ULTRASONIC INSPECTION DATA FOR
PILGRIM 1 REACTOR NOZZLE N-2B

The ultrasonic examination data relative to the discontinuity located in the Pilgrim I Reactor Vessel Nozzle N-2B weld was reviewed. The data was obtained during the 1976 in-service inspection. The results of the review of several examinations are tabulated, test conditions discussed, and a conclusion made as to probable flaw size.

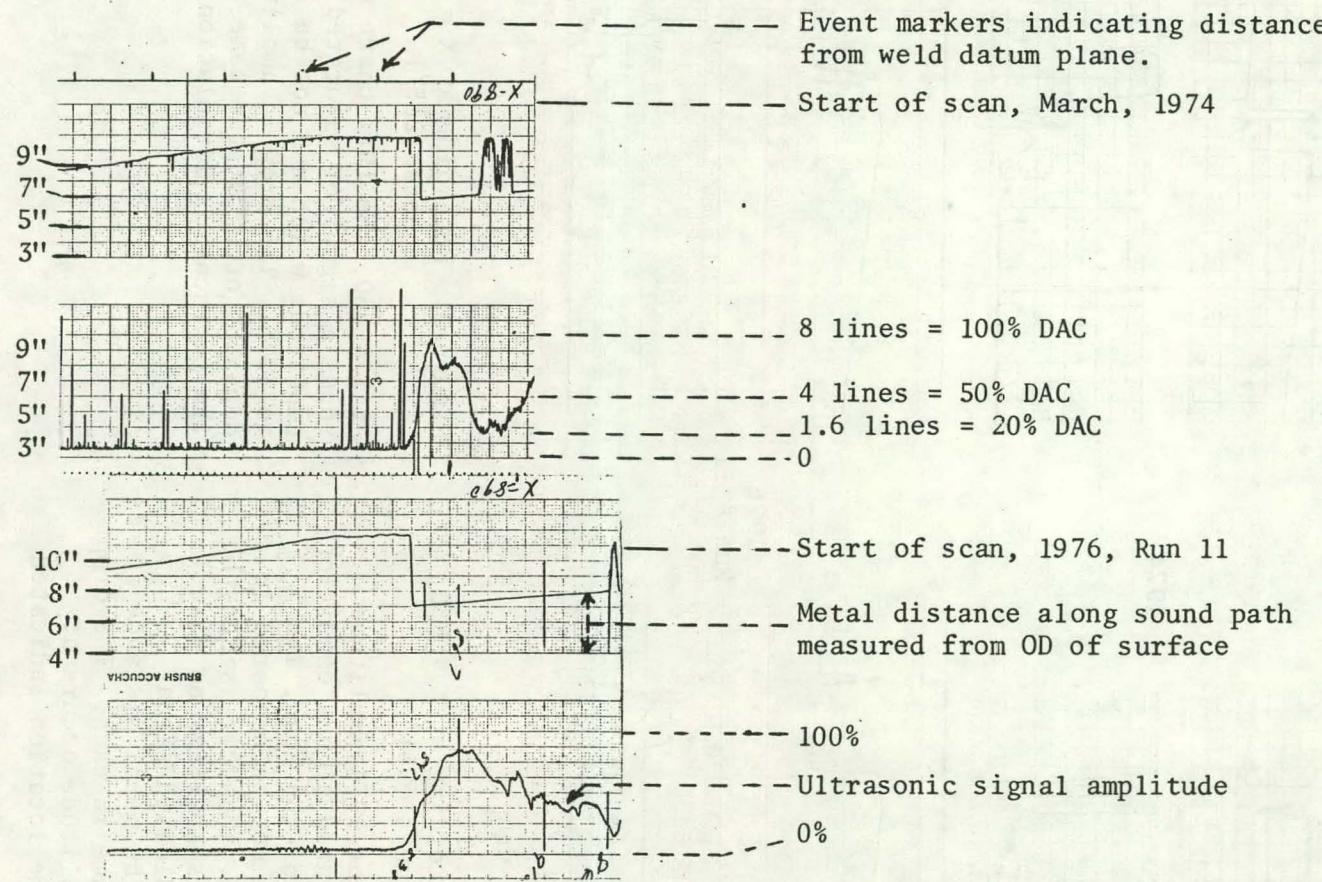
Figure 1. Identification of recorded information on the strip charts.

In Figure 1, the top chart is for 1974 and the bottom chart is for 1976. The bottom half of each chart is the recording of the ultrasonic signal amplitude. The system is calibrated such that eight lines on the amplitude signal represents 100% DAC which is the maximum response obtained from a 5/16 inch side drilled hole in the calibration block. The top half of each chart is the record of the distance between the transducer and the reflecting surface of the flaw (metal distance). The start point of the scan in 1976 was apparently 3/4 inch farther back from the weld than in 1974. Since, in both examinations, the flaw signal was already present at the start of the scan, only that part of the flaw

At $X = 820$, the 1974 amplitude shows a saturated signal condition at the start of the scan, and therefore can not be compared in shape to 1976. However, since the 1976 signal is smaller, no flaw growth is indicated signal amplitude. The metal distance is nearly the same in each. The drop in signal amplitude occurs at about the same location indicated by "A".
