A Chronology of the Beryllium-Replacement Shutdown at the High Flux Isotope Reactor

A CHRONOLOGY OF THE BERYLLIUM-REPLACEMENT SHUTDOWN
AT THE HIGH FLUX ISOTOPE REACTOR

W. H. Culbert

Date Published: December 1976

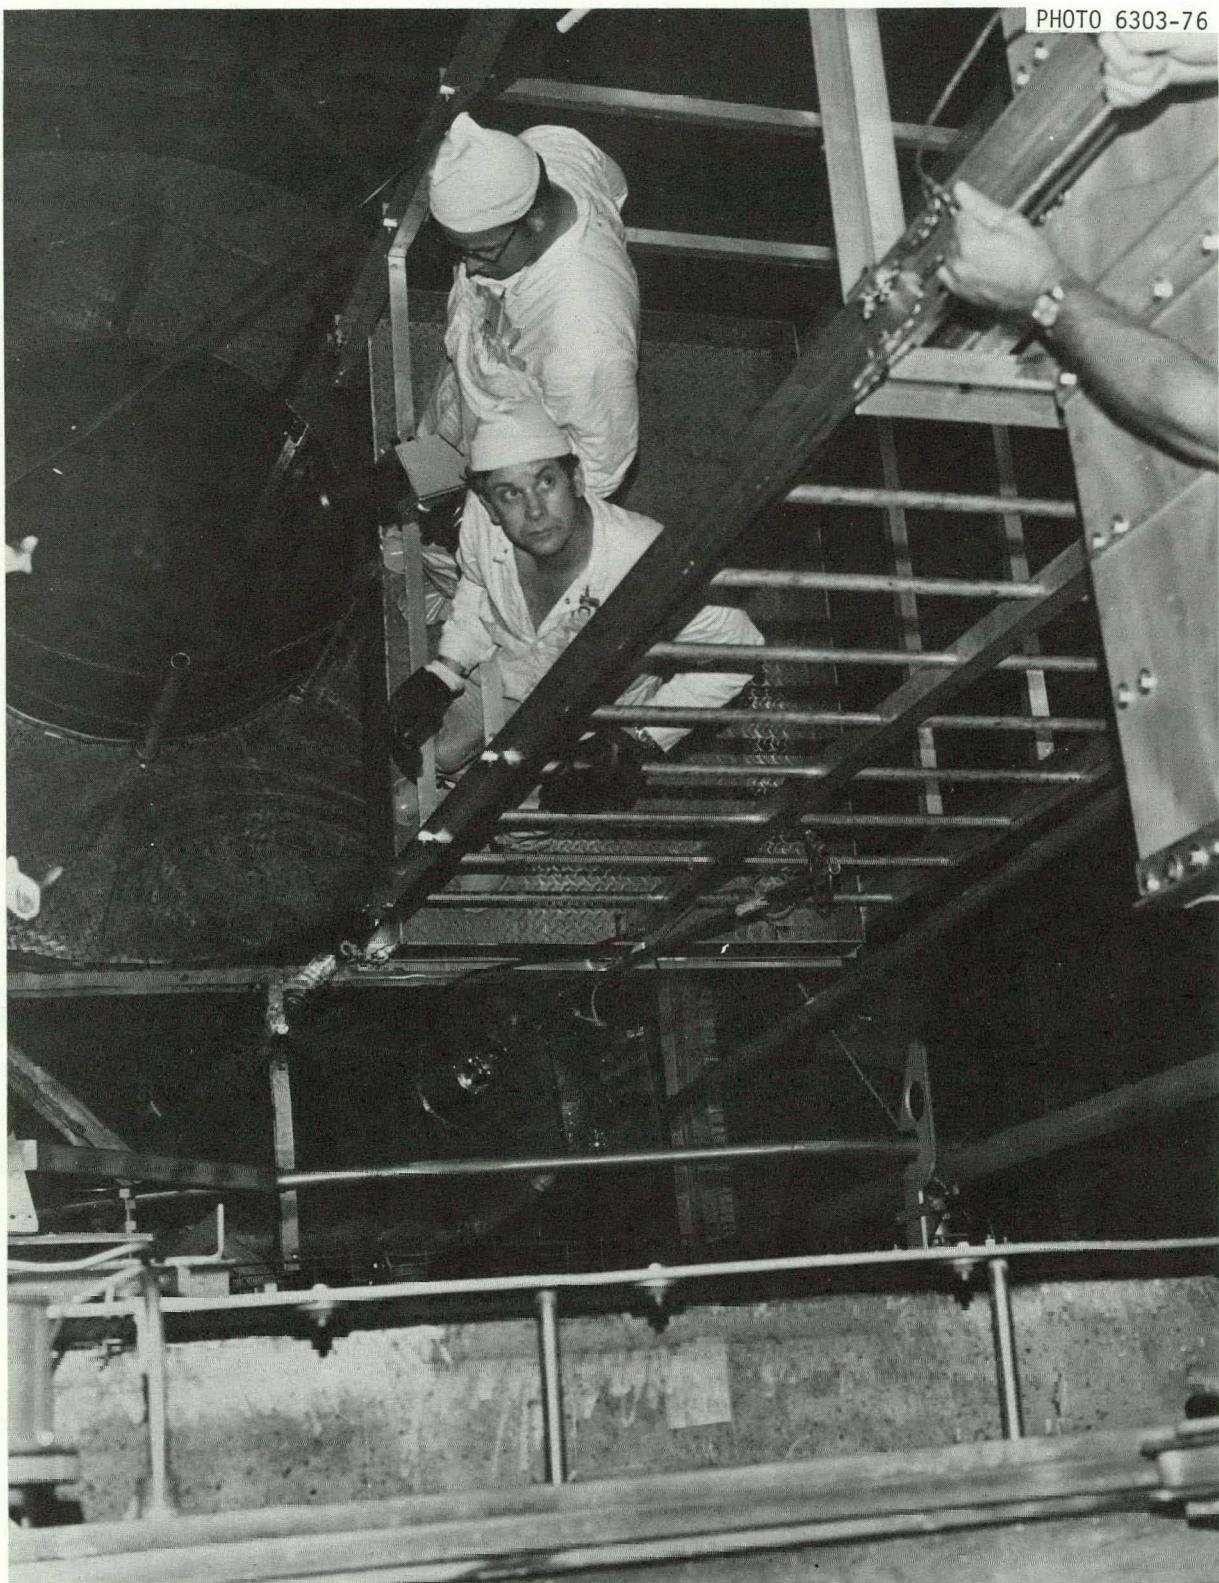
Figure 31. The Suspended, In-Pool Work Platform

The water-guide-sleeve tubes were removed from EF-1, 3, and 4; the EF-2 tube was removed on the following week. These tubes screw into a threaded connection which is welded to the bottom of the inside wall of the reactor vessel. The upper part of these 11 1/2-ft-long tubes terminates at the flange; the adaptor plug, used in EF-1, 3, and 4, fits inside the tube. To unscrew and subsequently disconnect the water-guide sleeve, a special 30-ft-long tool was designed to secure the inside of the tube using expandable rubber gaskets. To position this long tool, the two steel-plate panels were removed from the south and west walls of the reactor bay; and the "cherry picker" crane, positioned outside the building, was used to manipulate the tool. (See Figures 29 and 30.) A special in-pool work platform was made to allow the operators to manipulate the new tools for this operation. (See Figure 31.)

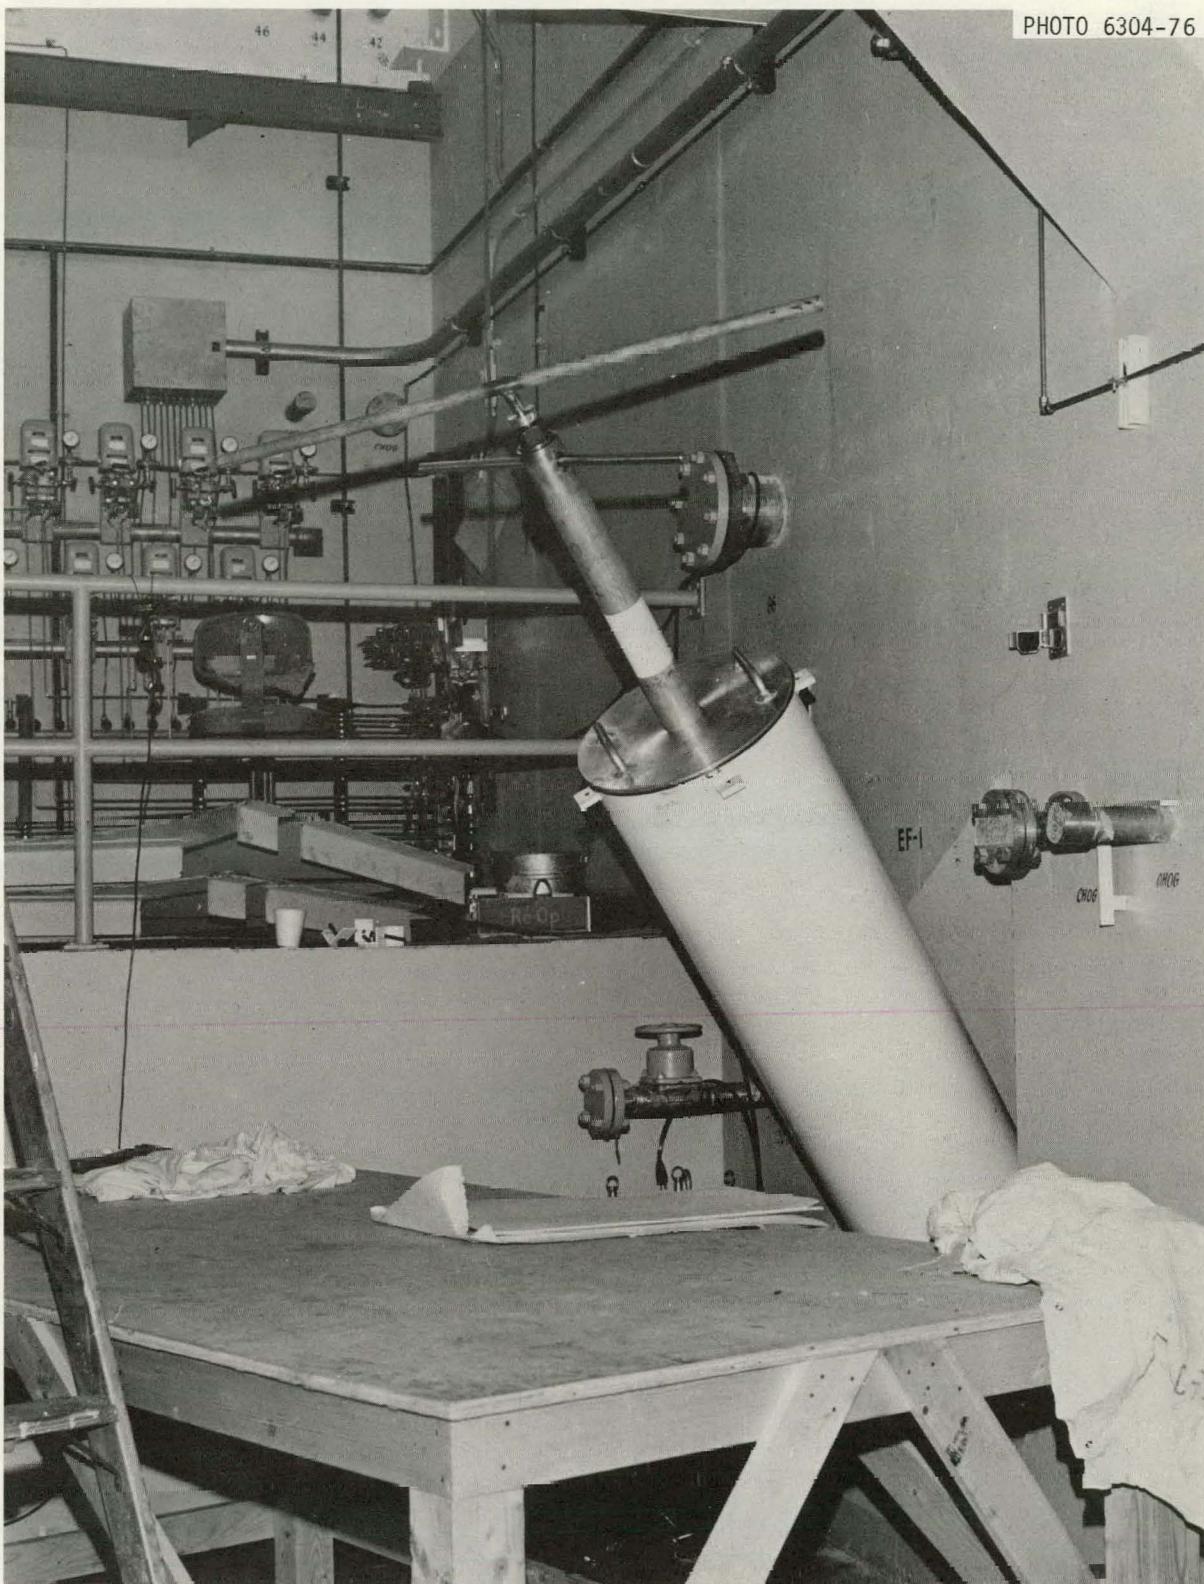
Figure 32. The Shield-Penetration Extension Tube with the Water-Guide-Sleeve Removal Tool Inserted (Used in the Disassembly of the EF Tubes in the Experiment Room)

After each withdrawal, the tubes were cut into ~4-ft sections by holding a special pipe-cutting tool, in the pool, stationary while rotating the water-guide sleeve with the special holding tool in the experiment room. (See Figure 32.)

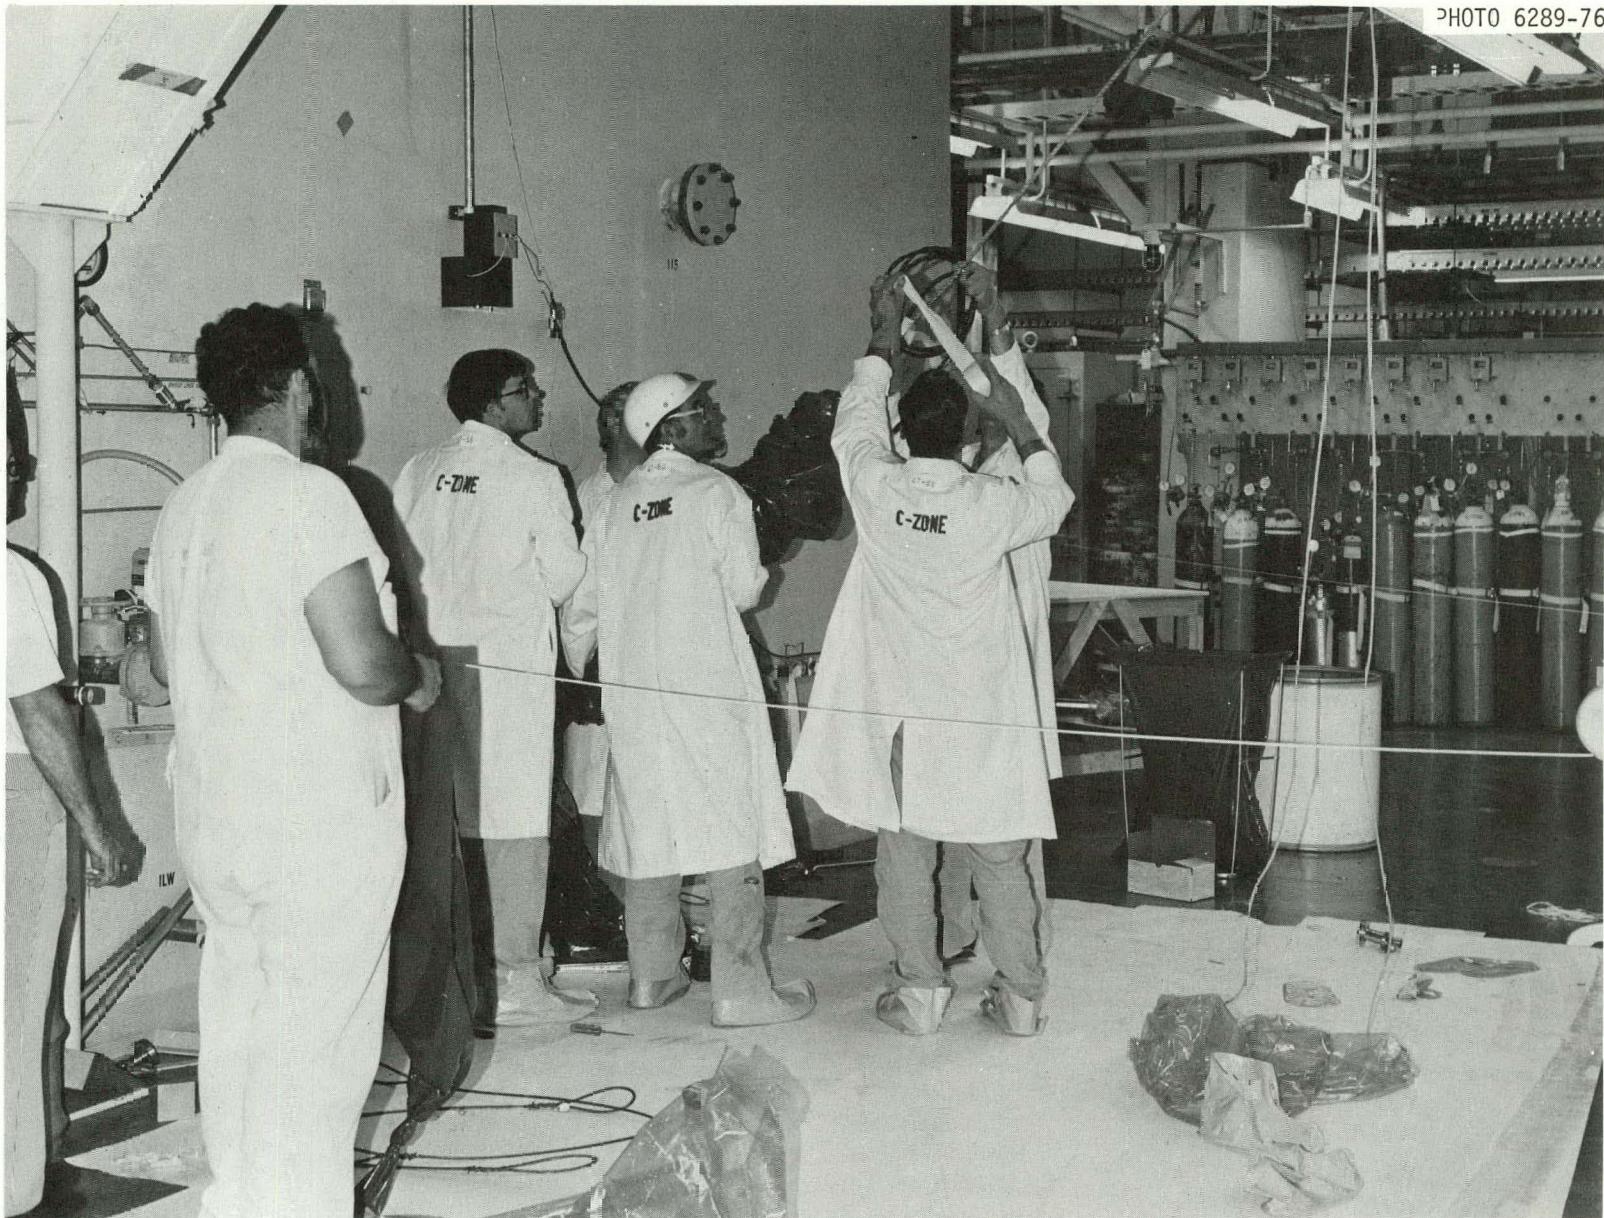
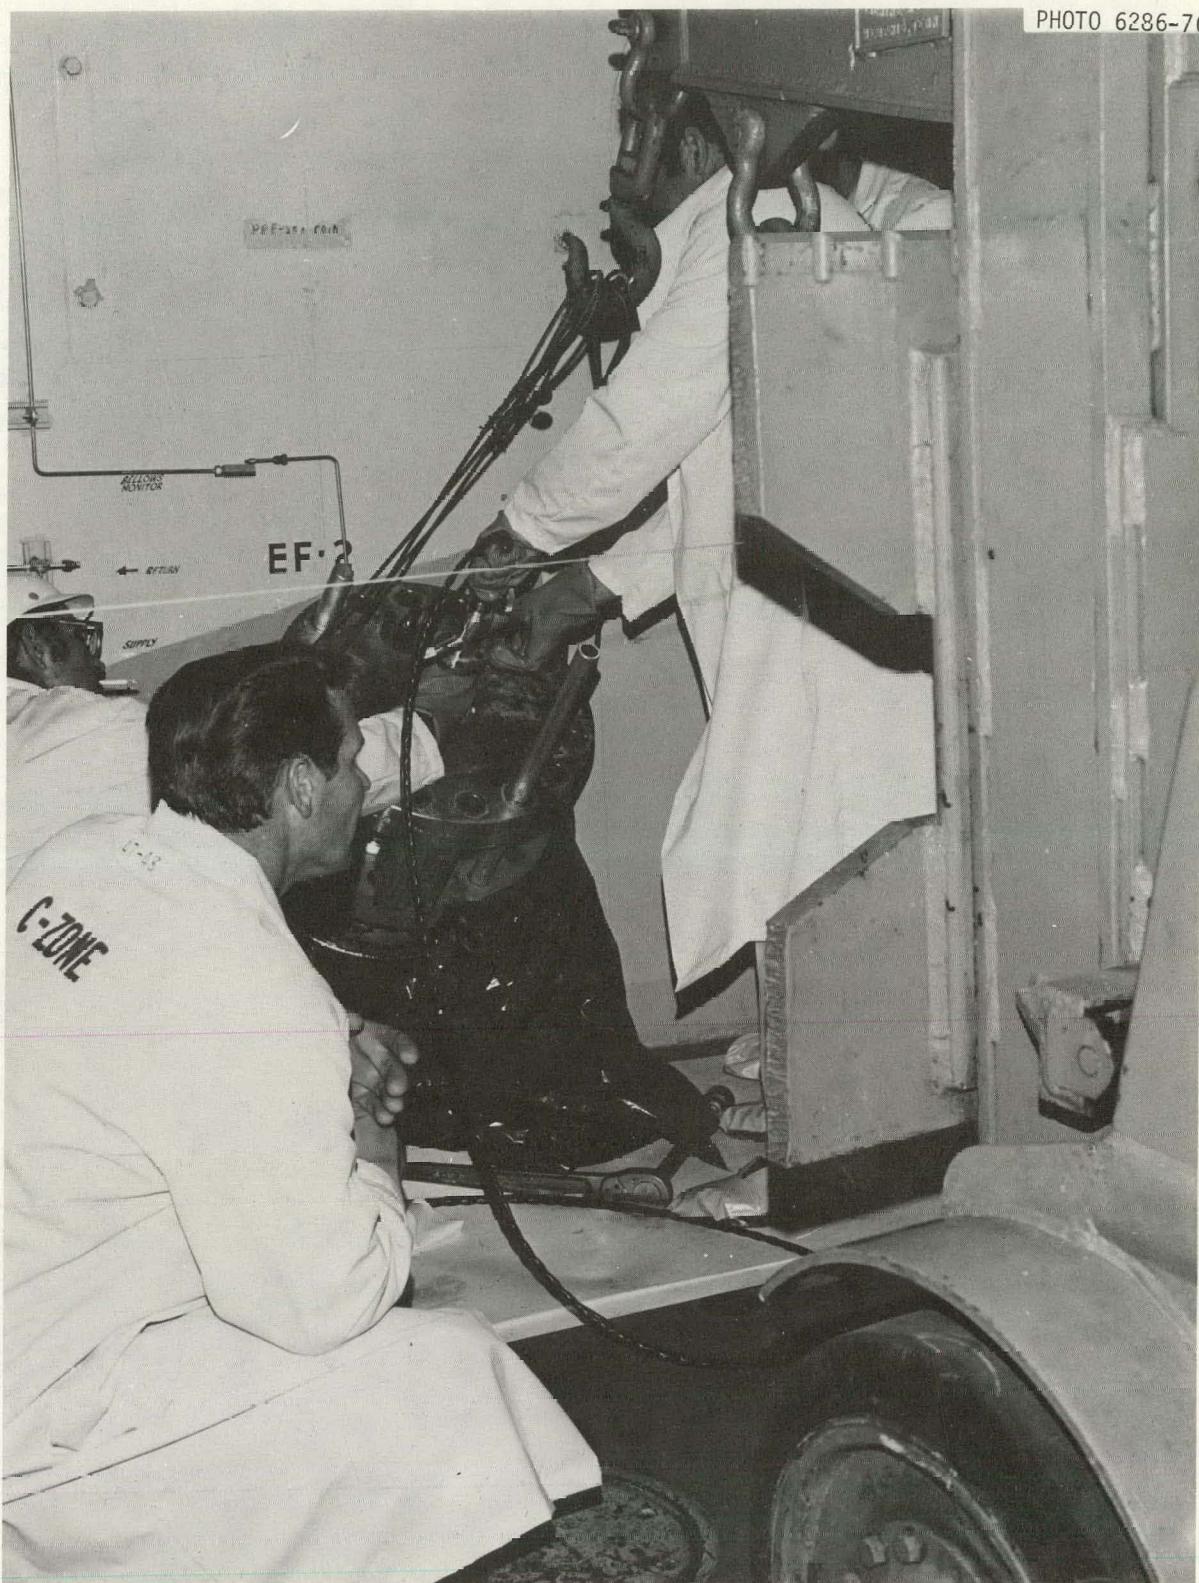
The EF-2 shield plug was removed from the EF-2 facility and stored in the experiment room. The ionization chamber in EF-2 was disconnected and removed to the vault for storage. (See Figures 33 and 34.) The radiation level of the chamber was ~2 R/hr. (Reiterating, the EF-2 facility was the only one of the four engineering-test facilities to contain a facility beam tube, an extension tube, a water-jacket tube, and an experiment.) The beam tube, which was fluted on the outside for cooling by reactor vessel water, fit inside the water-guide-sleeve tube. The extension tube was secured to a second adaptor flange and extended to the facility penetration in the experiment room. The experiment was an ionization chamber used by Instrumentation and Controls Division (I&C) personnel for noise analysis; the signal from this channel was sent to the computer.

Figure 33. Removing the Ionization Chamber from the EF-2 Facility

Figure 34. The EF-2 Facility Being Disassembled in the Experiment Room

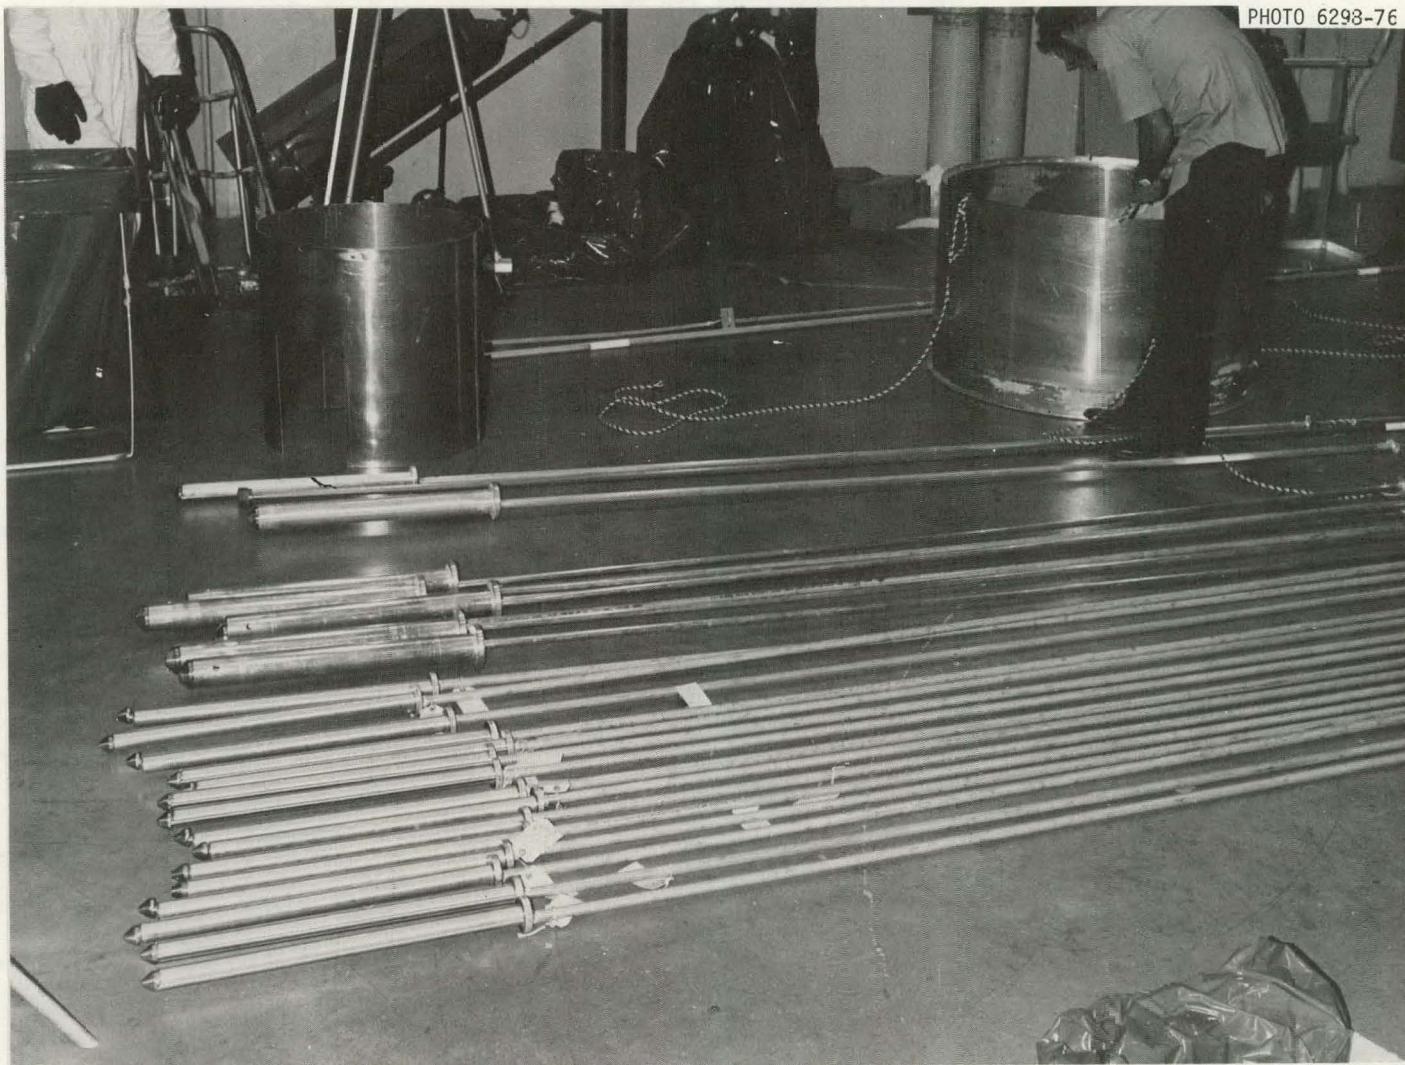
As part of the preparations for removing the damaged beryllium, measurements were made of the clearance between the six guide fingers on the reflector-container ribs (the "bird cage") and the beryllium reflector. Although the nominal clearance was 15 mils, the measurements made indicated that the clearance had been reduced to less than 3 mils due to the swelling of the beryllium. Special debris-collector pans and special inner and outer peripheral retainers were installed in the vessel to prevent particles or sections of beryllium from falling into the vessel in the event the beryllium fell apart during the removal procedure. (See Figure 42.)

Figure 42. Some of the Special Tools Used to Remove
the Cracked Beryllium
(One cylinder was placed inside the beryllium
and one was placed on the outside; the long
rods were placed through each of the VXF
holes and comprised the main lifting scheme)

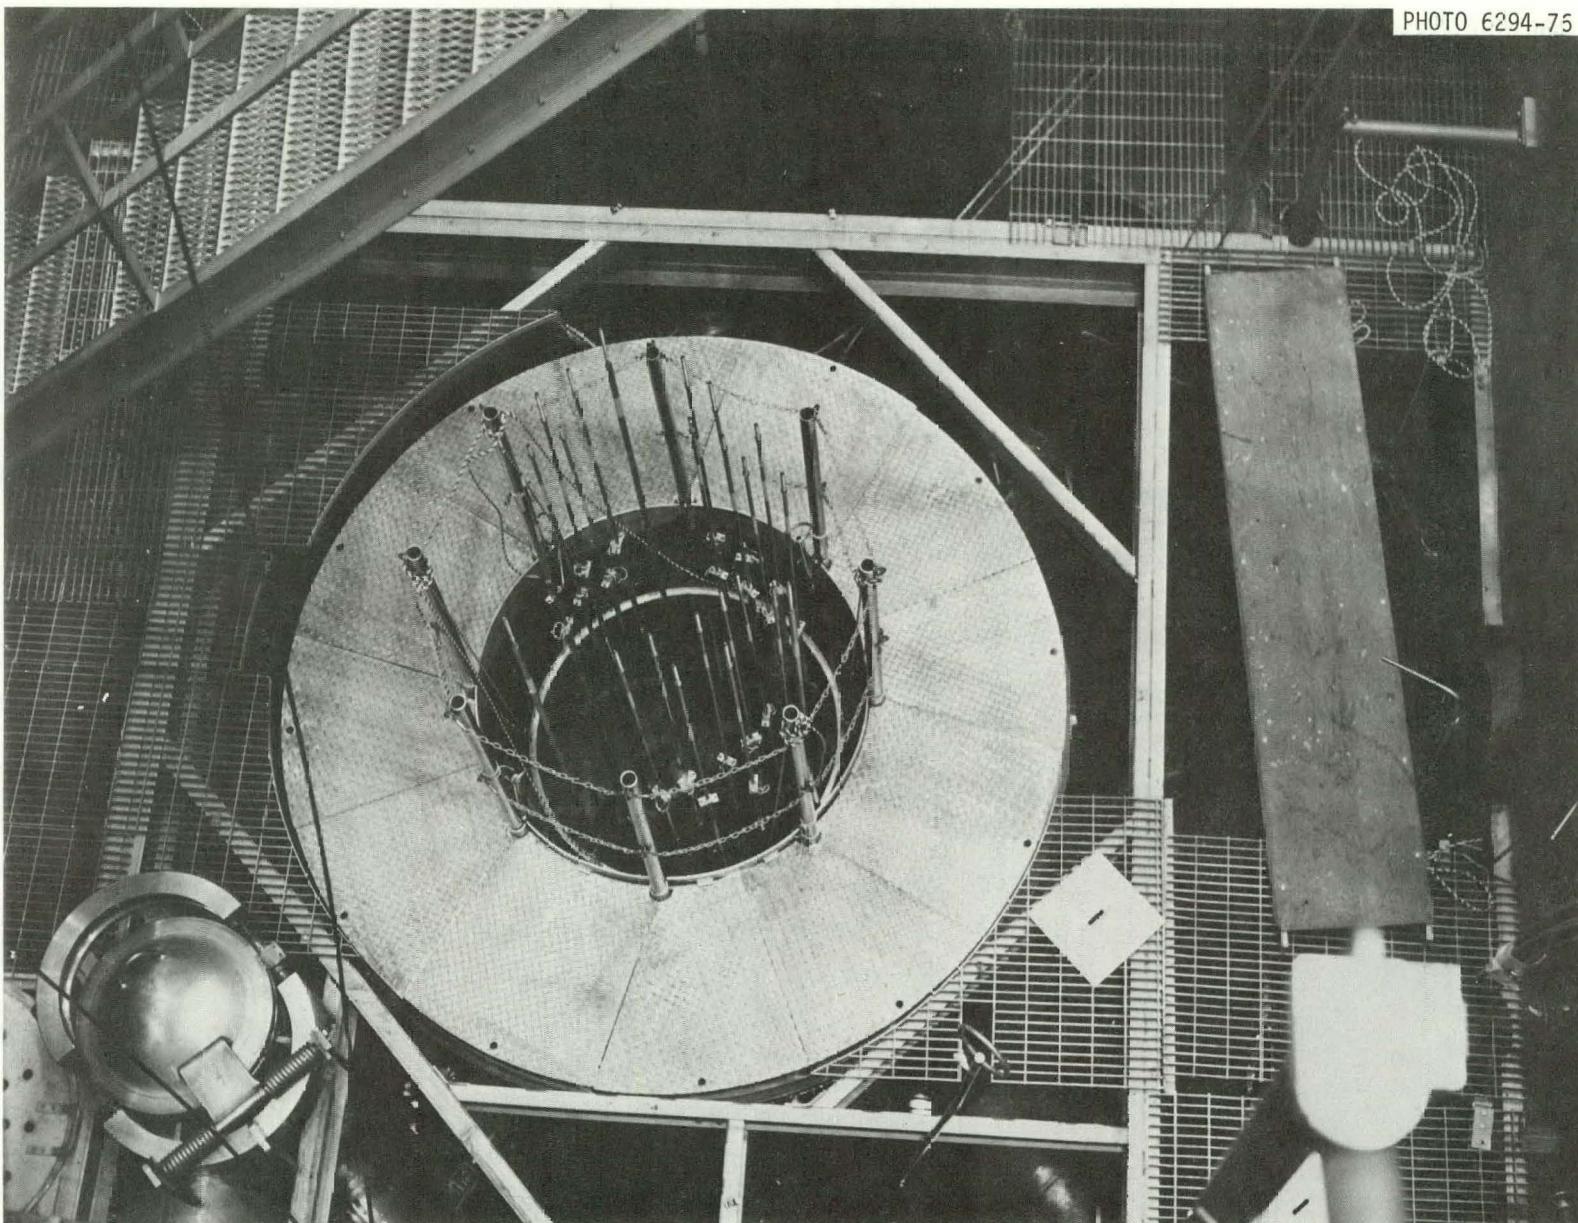
The scheme for lifting the beryllium consisted of inserting special tools into and through each of the twenty available VXF experiment holes; the bottom of each tool, when in the locked position, secured the beryllium from the bottom side. In addition, three threaded rods were inserted into the top surface of the beryllium. The 23 rods extended to a circular lifting plate above the surface of the water. The plate was leveled to ensure that a uniform lifting force would be applied on the beryllium from each lifting point. (See Figures 43 and 44.)

Figure 43. The Lifting Tools after Installation through
the VXF Holes in the Beryllium

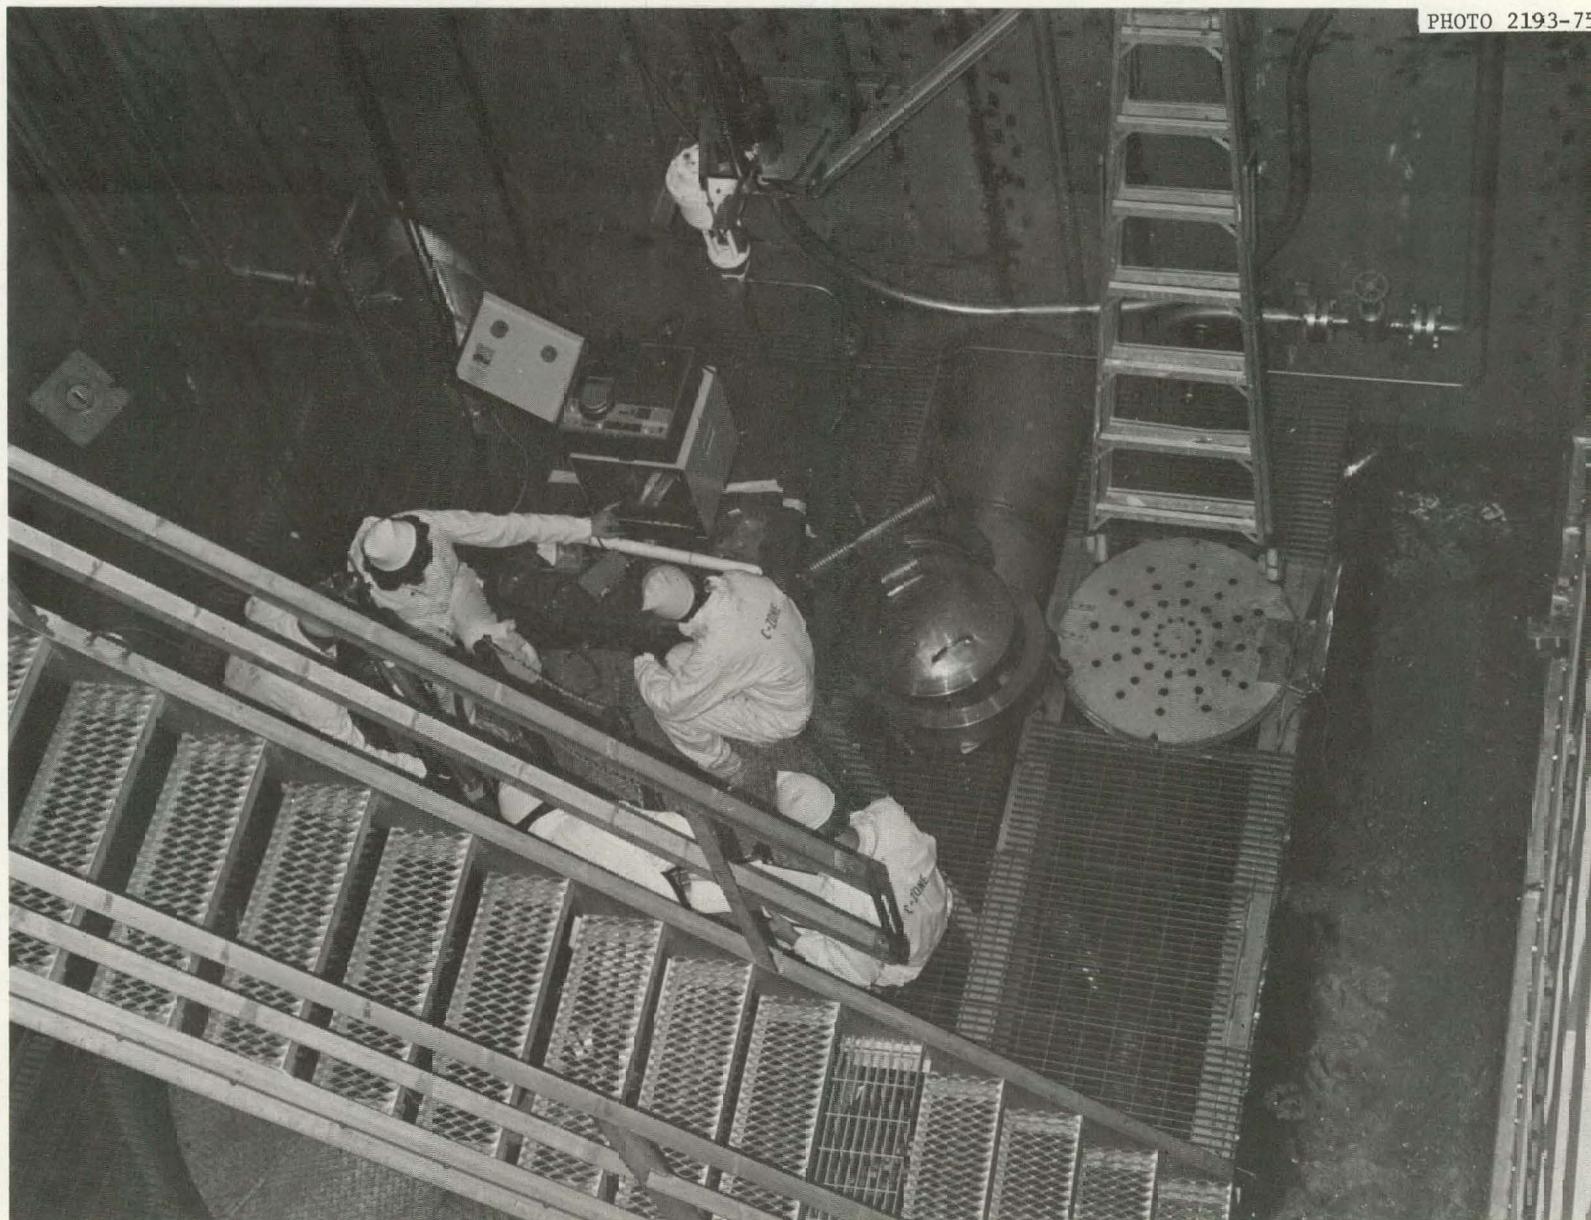
Personnel from the Inspection Engineering Department began an inspection of the reactor vessel and its components which lasted a few weeks. The purpose of the inspection was to determine the integrity of welds, cladding, and internal components. The equipment used during this work included an underwater TV camera and video-tape machine for indirect viewing and a boroscope, mirrors, and binoculars for direct viewing. Ultrasonic-testing equipment was used for a volumetric inspection. (See Figures 46 and 47.) To minimize possible conflicts with other in-pool work, the inspections were performed on the 12-8 shifts.

Figure 46. Inspection Engineering Personnel Videotaping
Underwater Reactor Components

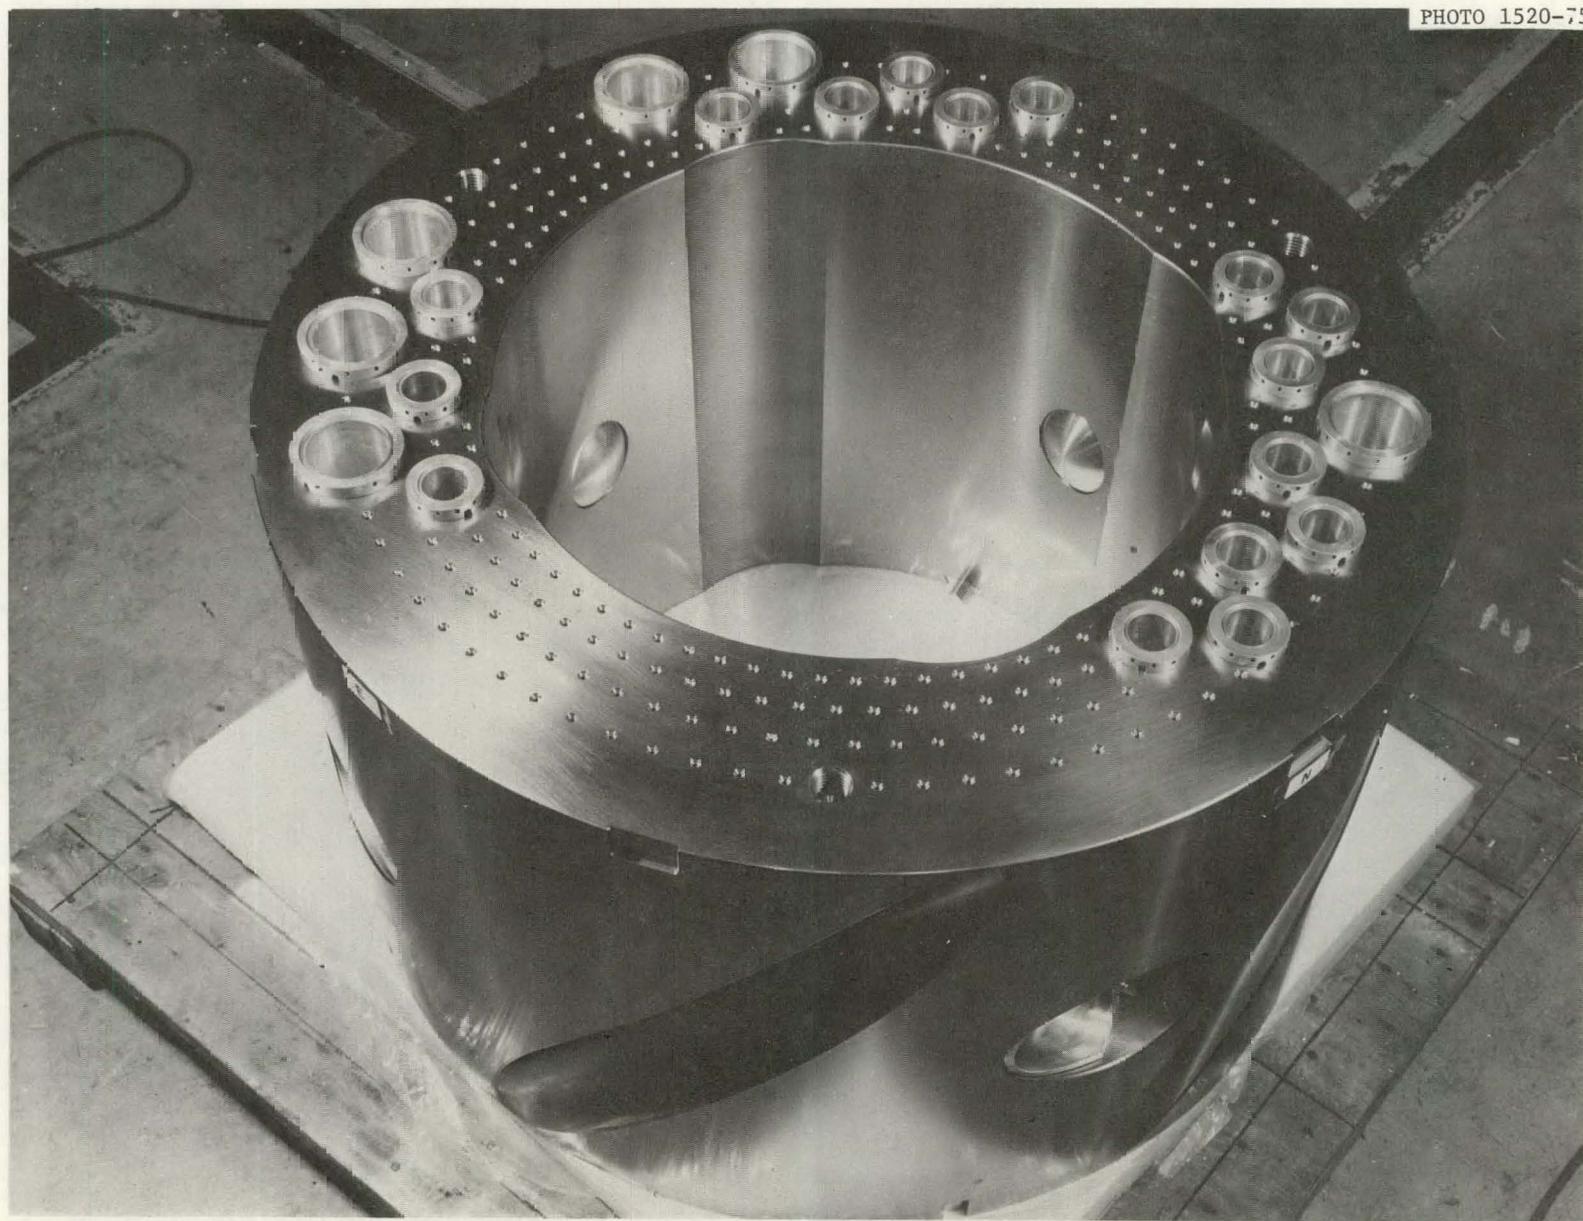
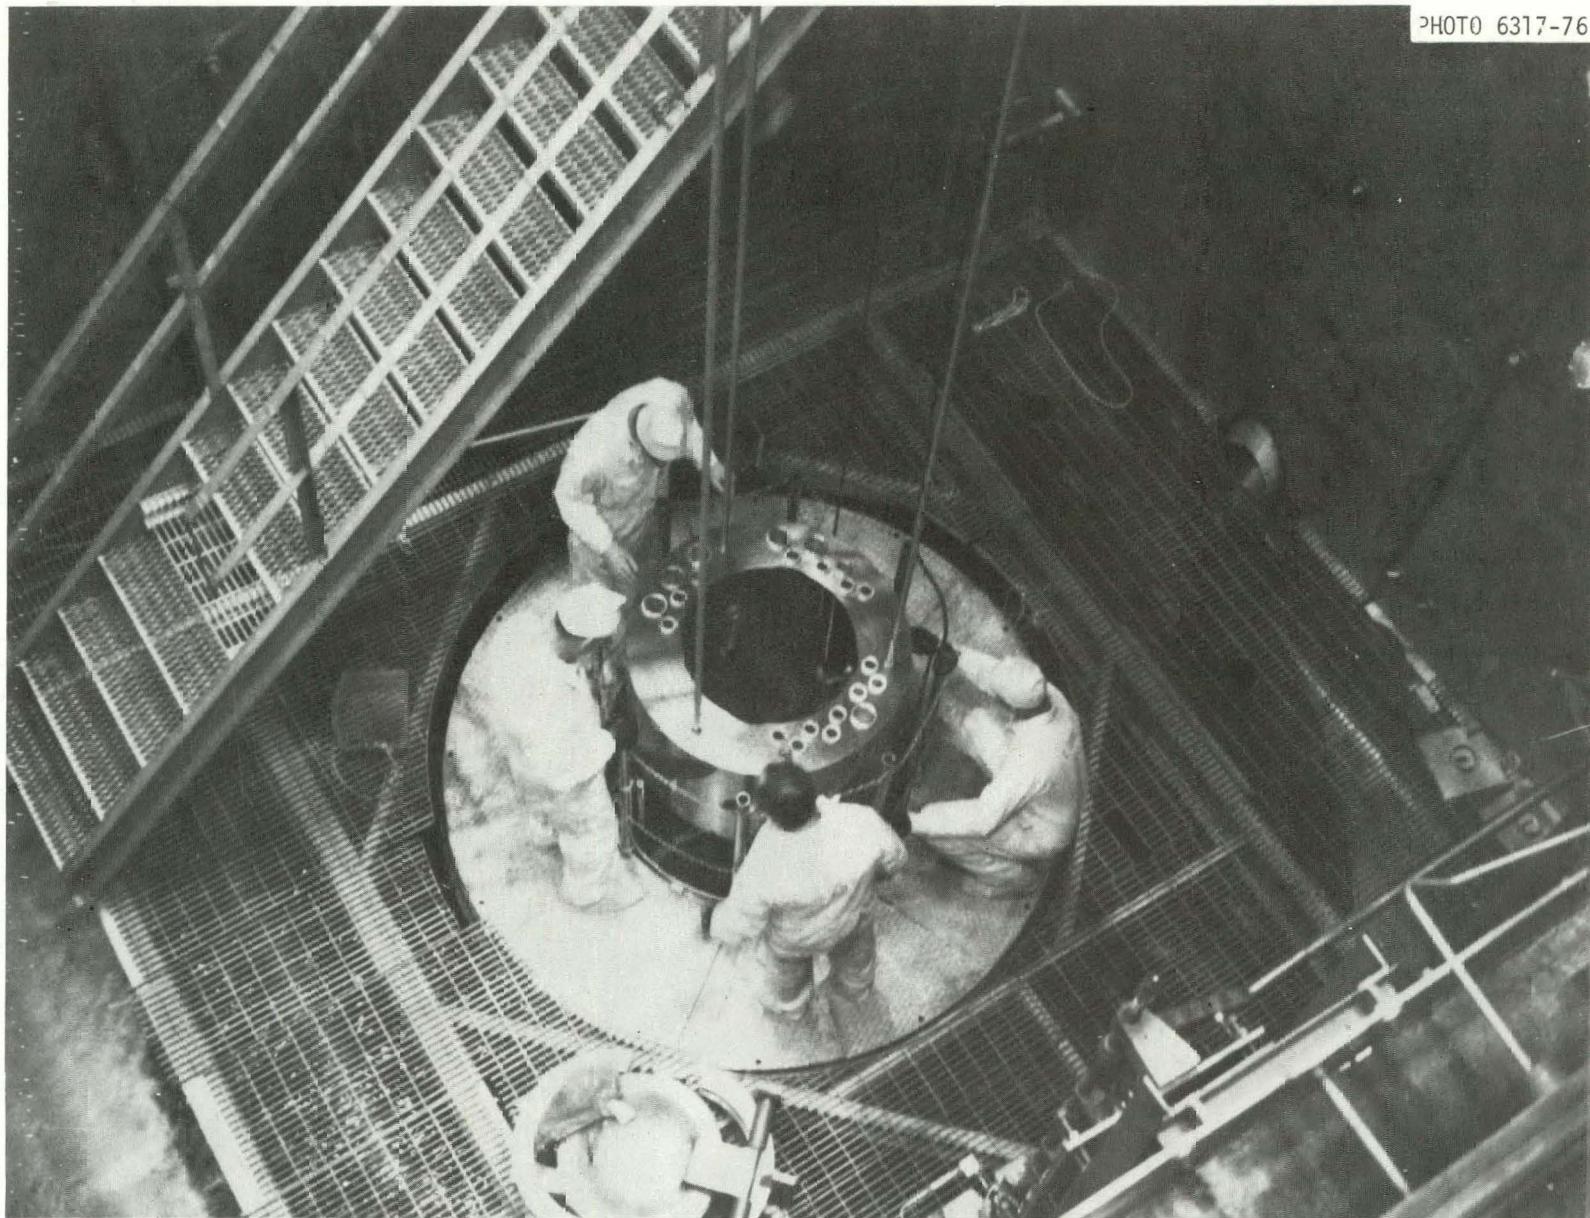
Figure 48. The New Permanent Beryllium

Figure 49. Installing the New Beryllium in the Reactor Vessel

The new permanent-beryllium reflector was installed in the reactor vessel; it was transferred using three new lifting rods that were inserted into the threaded holes in the top side of the beryllium. (See Figures 48 and 49.) When the lifting assembly was removed, mud washed out of one of the three new tools and settled atop the newly installed beryllium; the mud was later washed off using a water jet. A protection plate, which had been installed atop the beryllium after the problem with the mud, was removed.

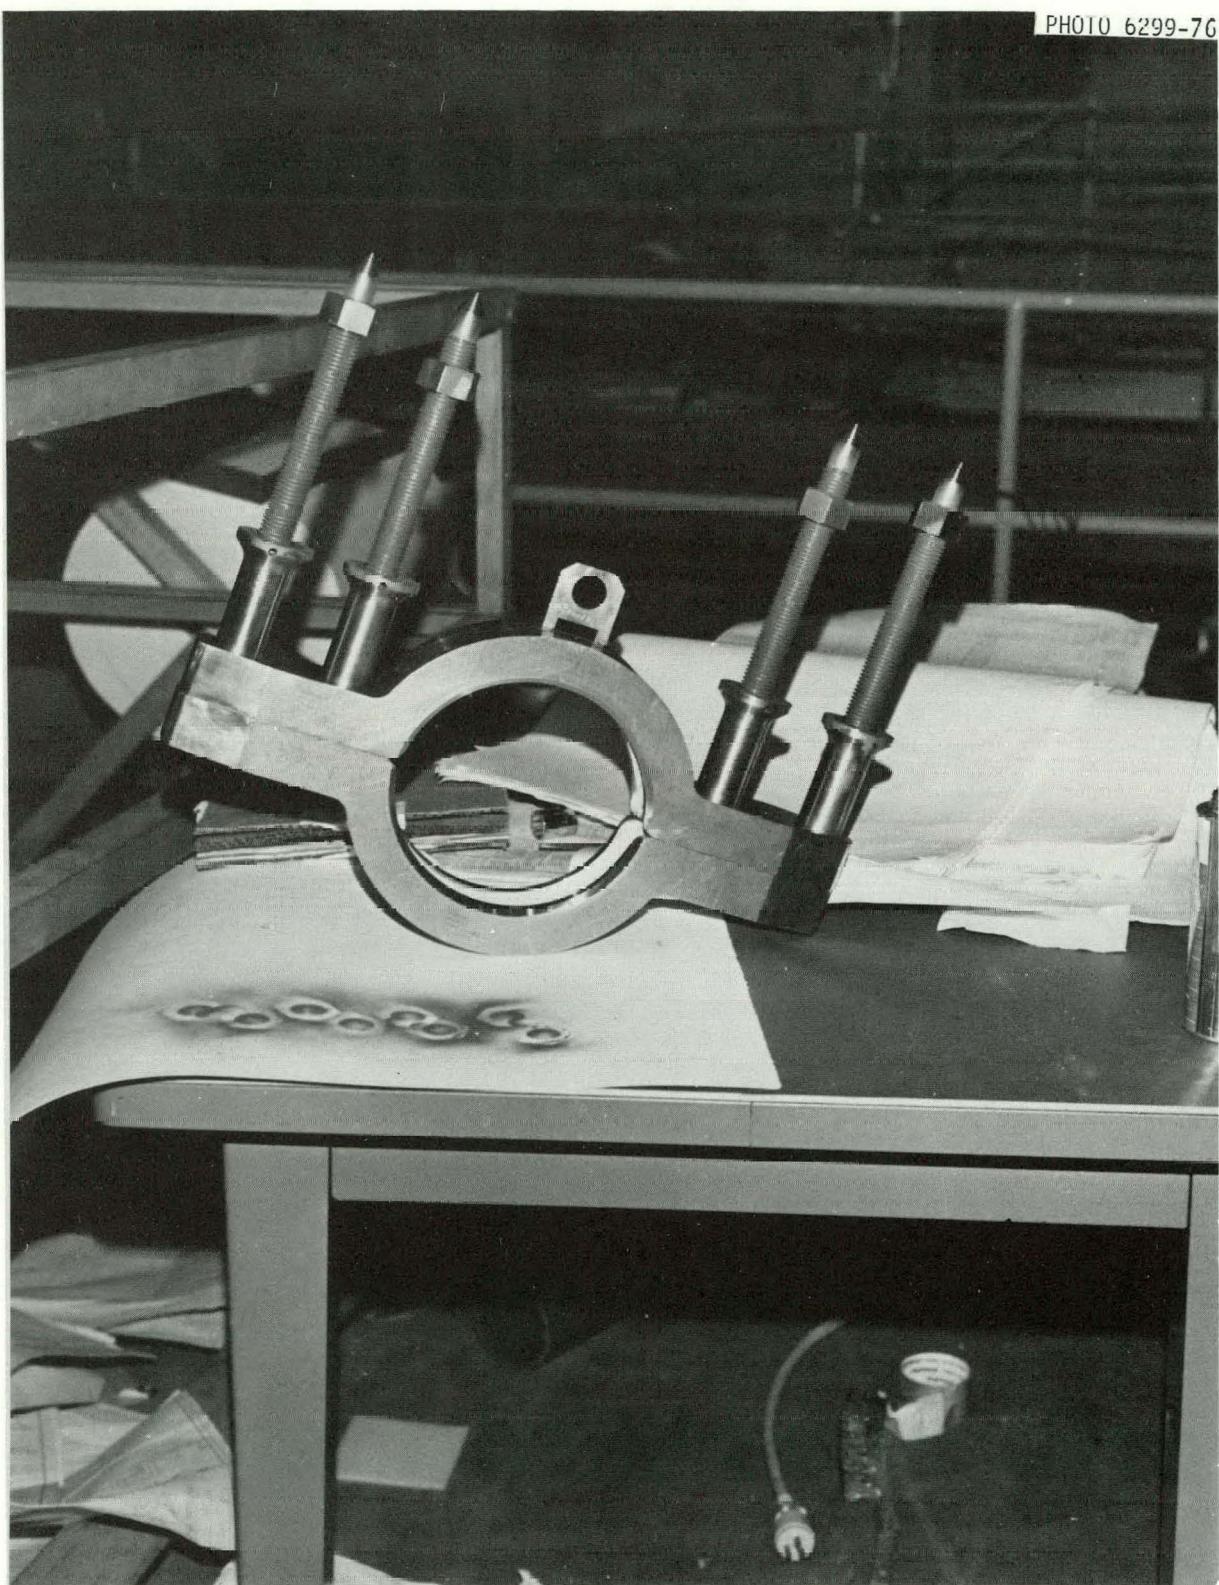
Figure 52. The Four-Bolt Variety of Marman Clamp

installation of the beam tube (which resulted in extensive contamination of the floor area in the beam room); however, these problems were resolved. The new four-bolt Marman clamp was installed on the HB-2 adaptor flange. (See Figure 52.) To ensure a uniform compression of the Conoseal gasket, impressions of the gap between the mating flanges were made (using Duct seal) after each 500-lb increase in hydraulic pressure of the bolt-tensioner tool. The HB-2 shield-liner cavity was filled with water to check for leaks; no abnormalities were detected.

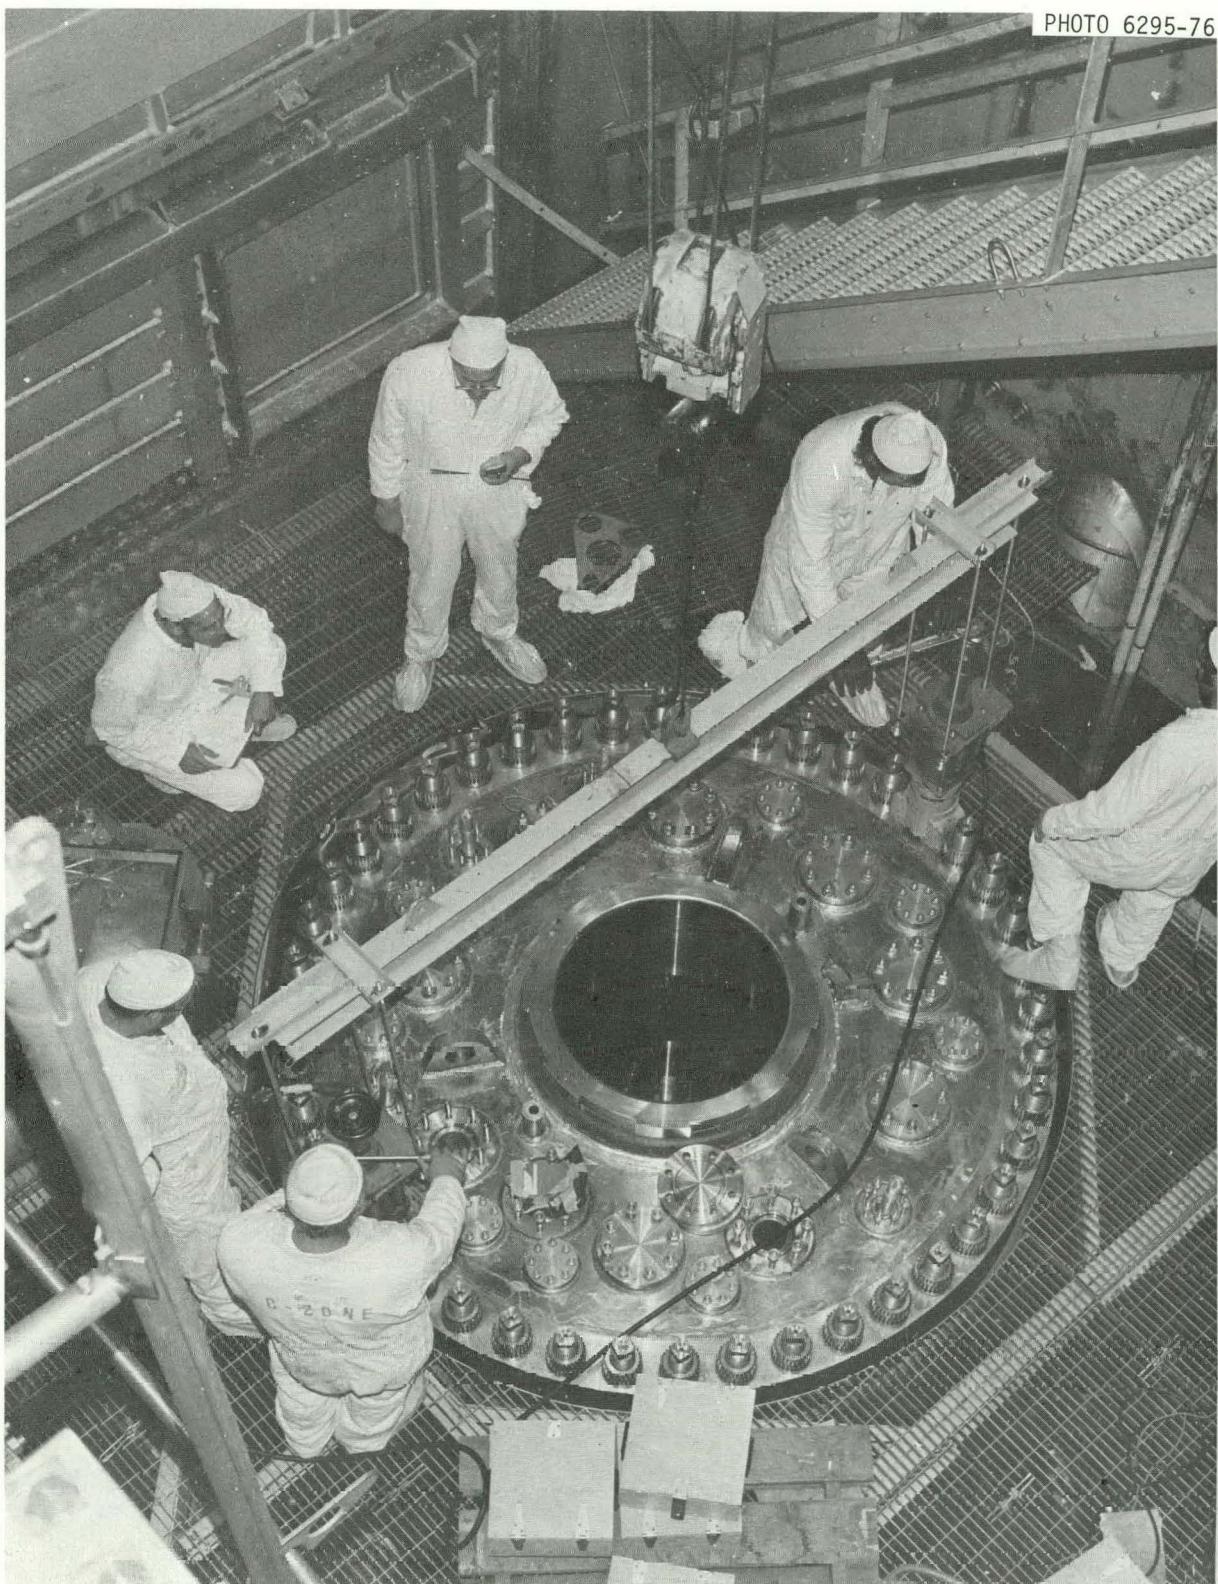
Figure 56. Inspecting the Studs for the Reactor Vessel Head

The vessel-head studs were delivered to the reactor bay from storage. On the following day they were gauged for length prior to installation in the vessel head. (See Figure 56.) After the studs were installed, the 14-ton vessel head was installed and secured. With a pressure of ~7,000 psig from the bolt-tensioner tool, the 3-in.-diameter bolts were stretched ~25 mils for this operation. (See Figure 57.)
