A Chronology of the Beryllium-Replacement Shutdown at the High Flux Isotope Reactor

A CHRONOLOGY OF THE BERYLLIUM-REPLACEMENT SHUTDOWN
AT THE HIGH FLUX ISOTOPE REACTOR

W. H. Culbert

Date Published: December 1976

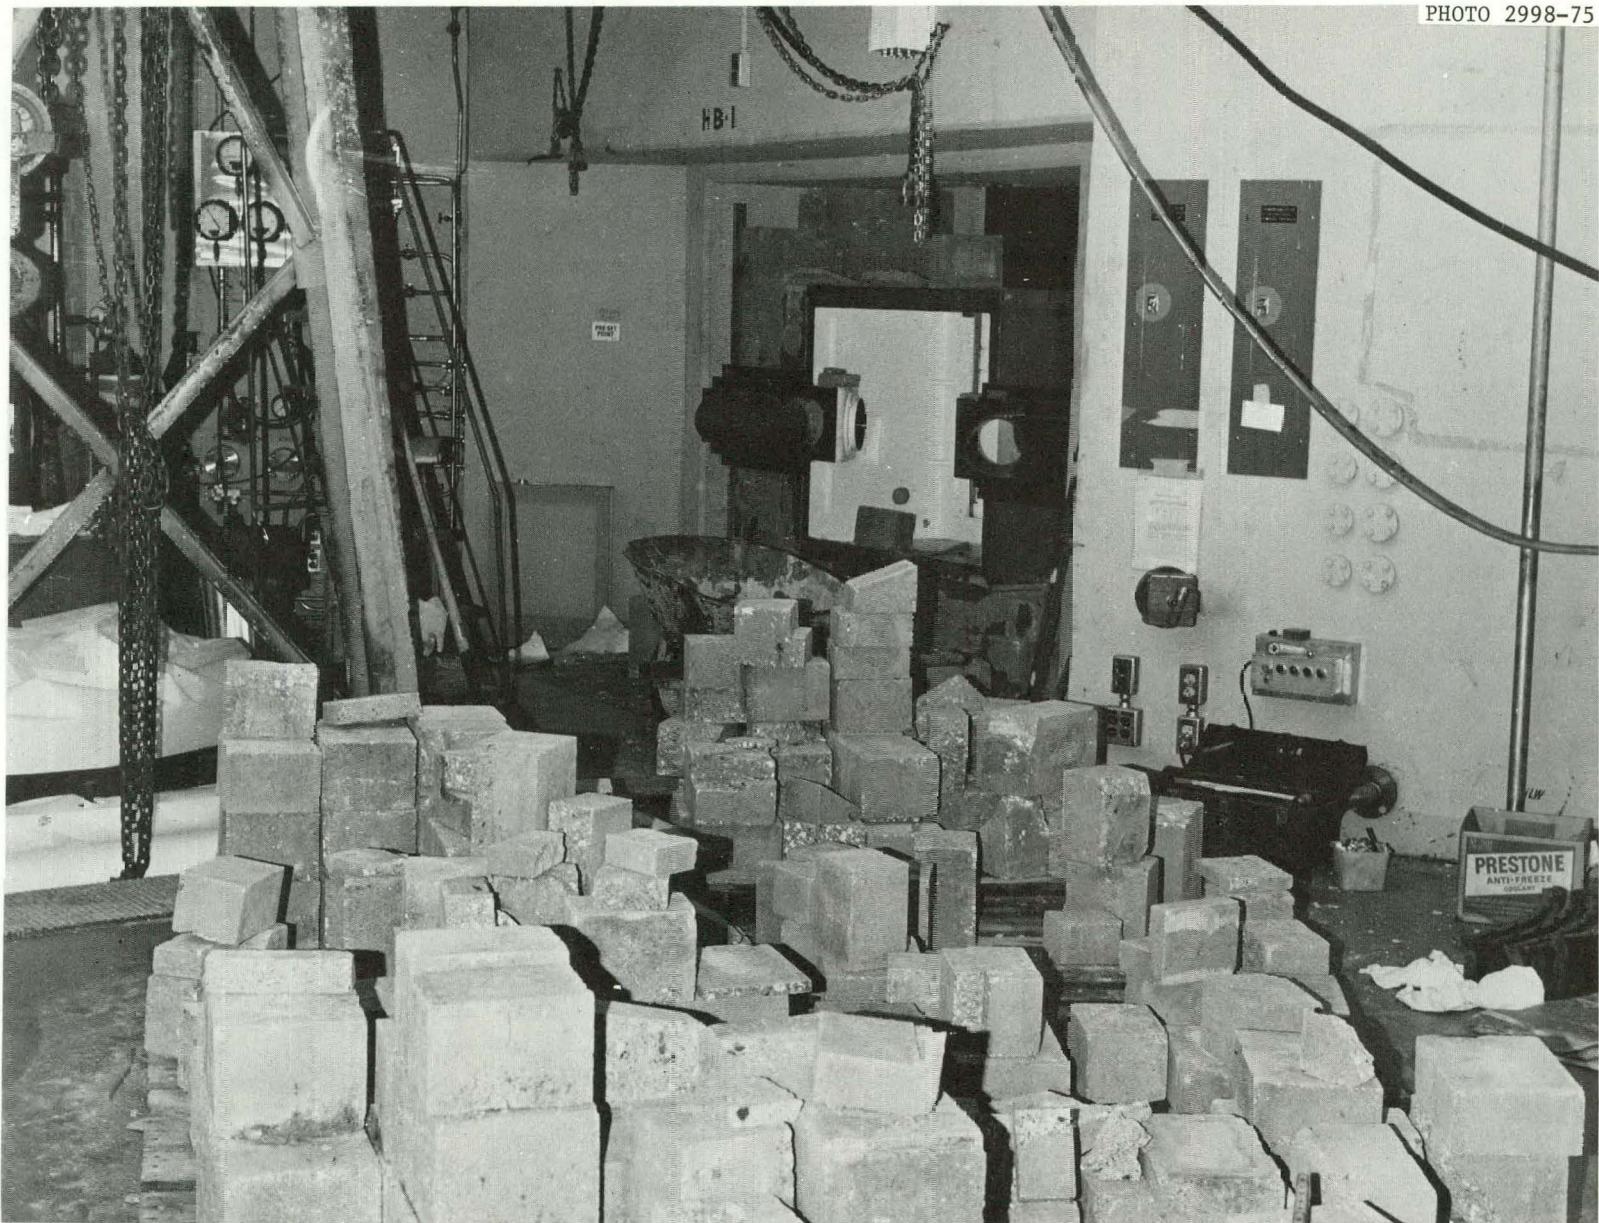
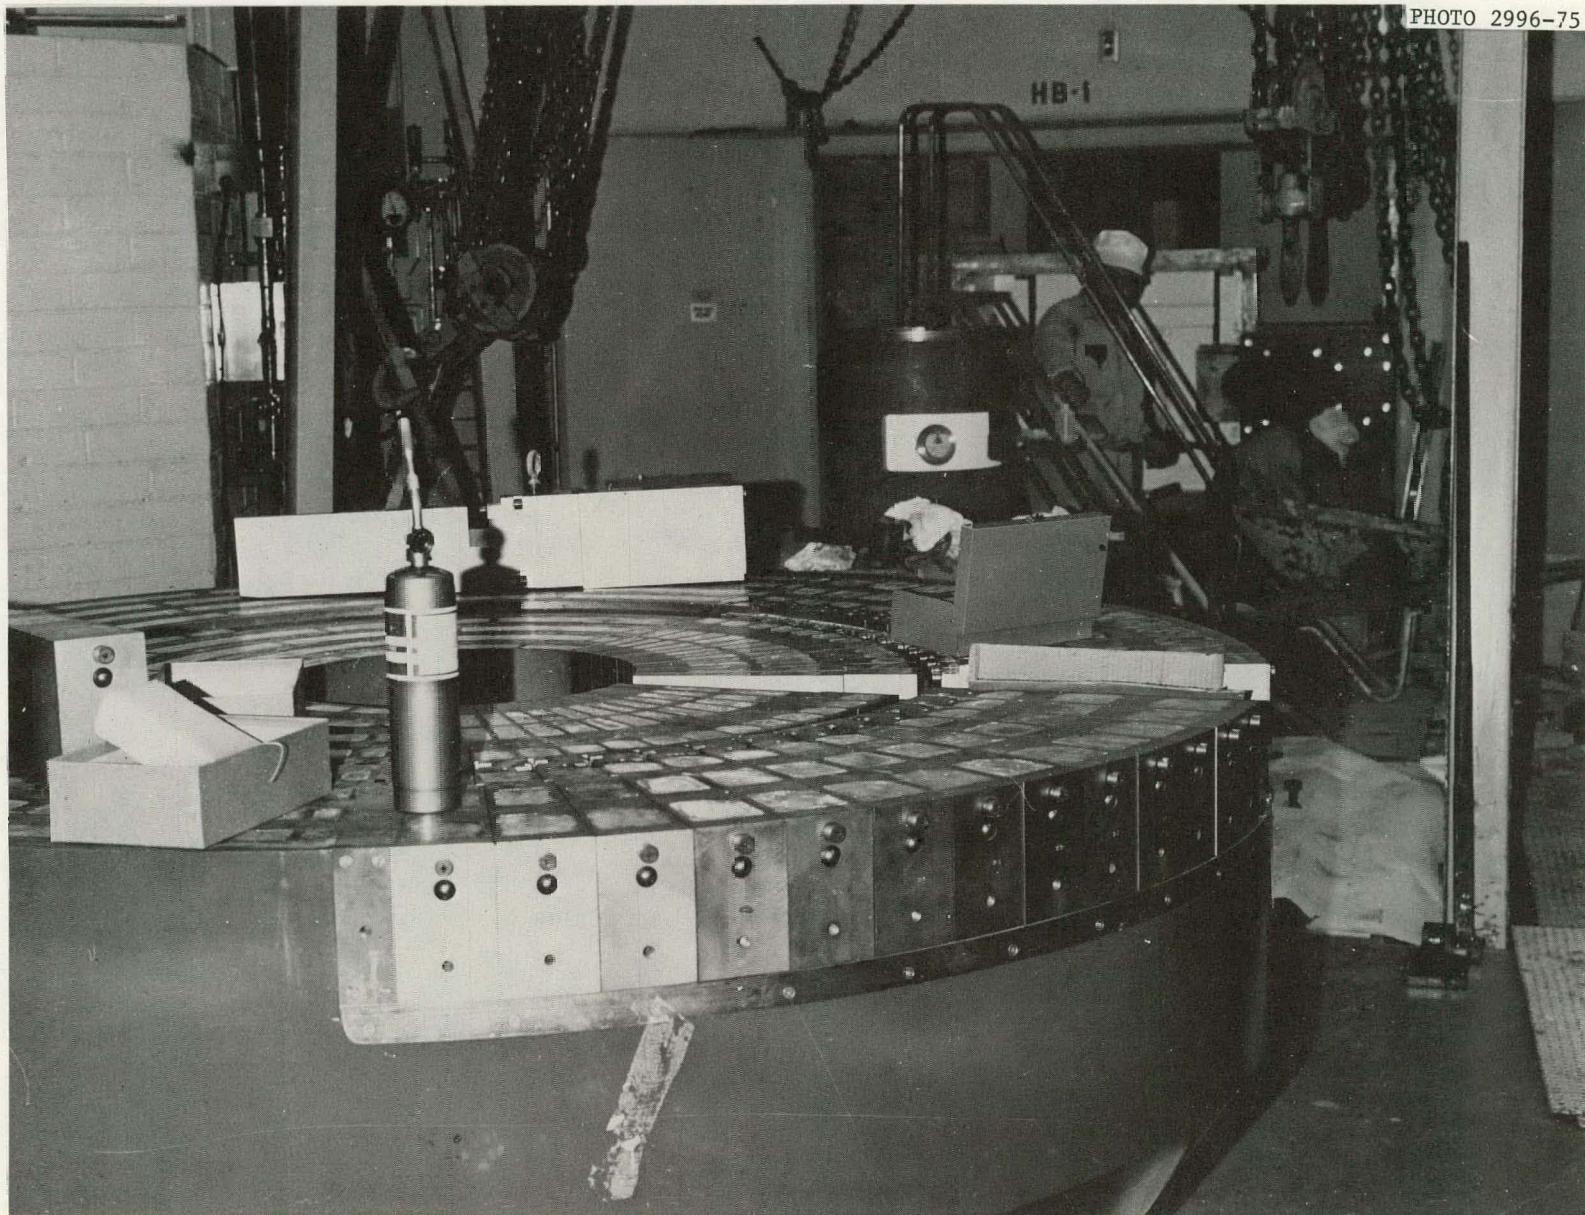
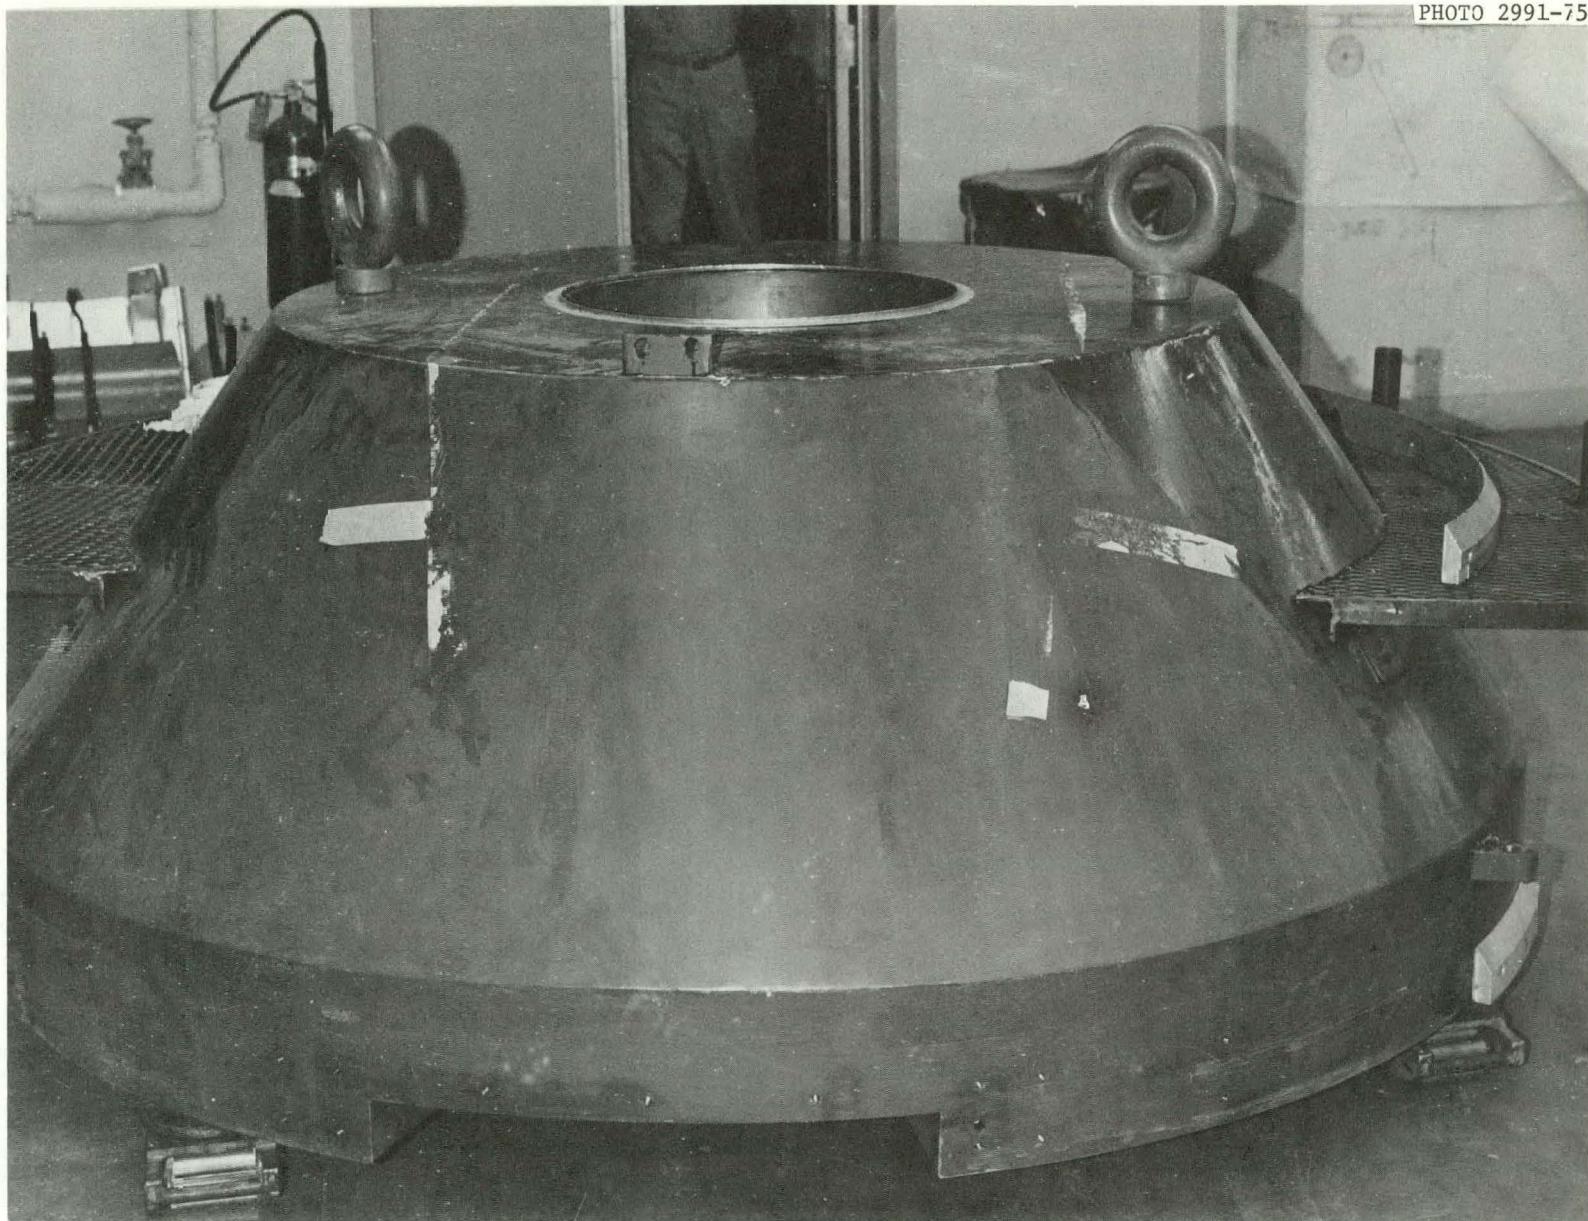
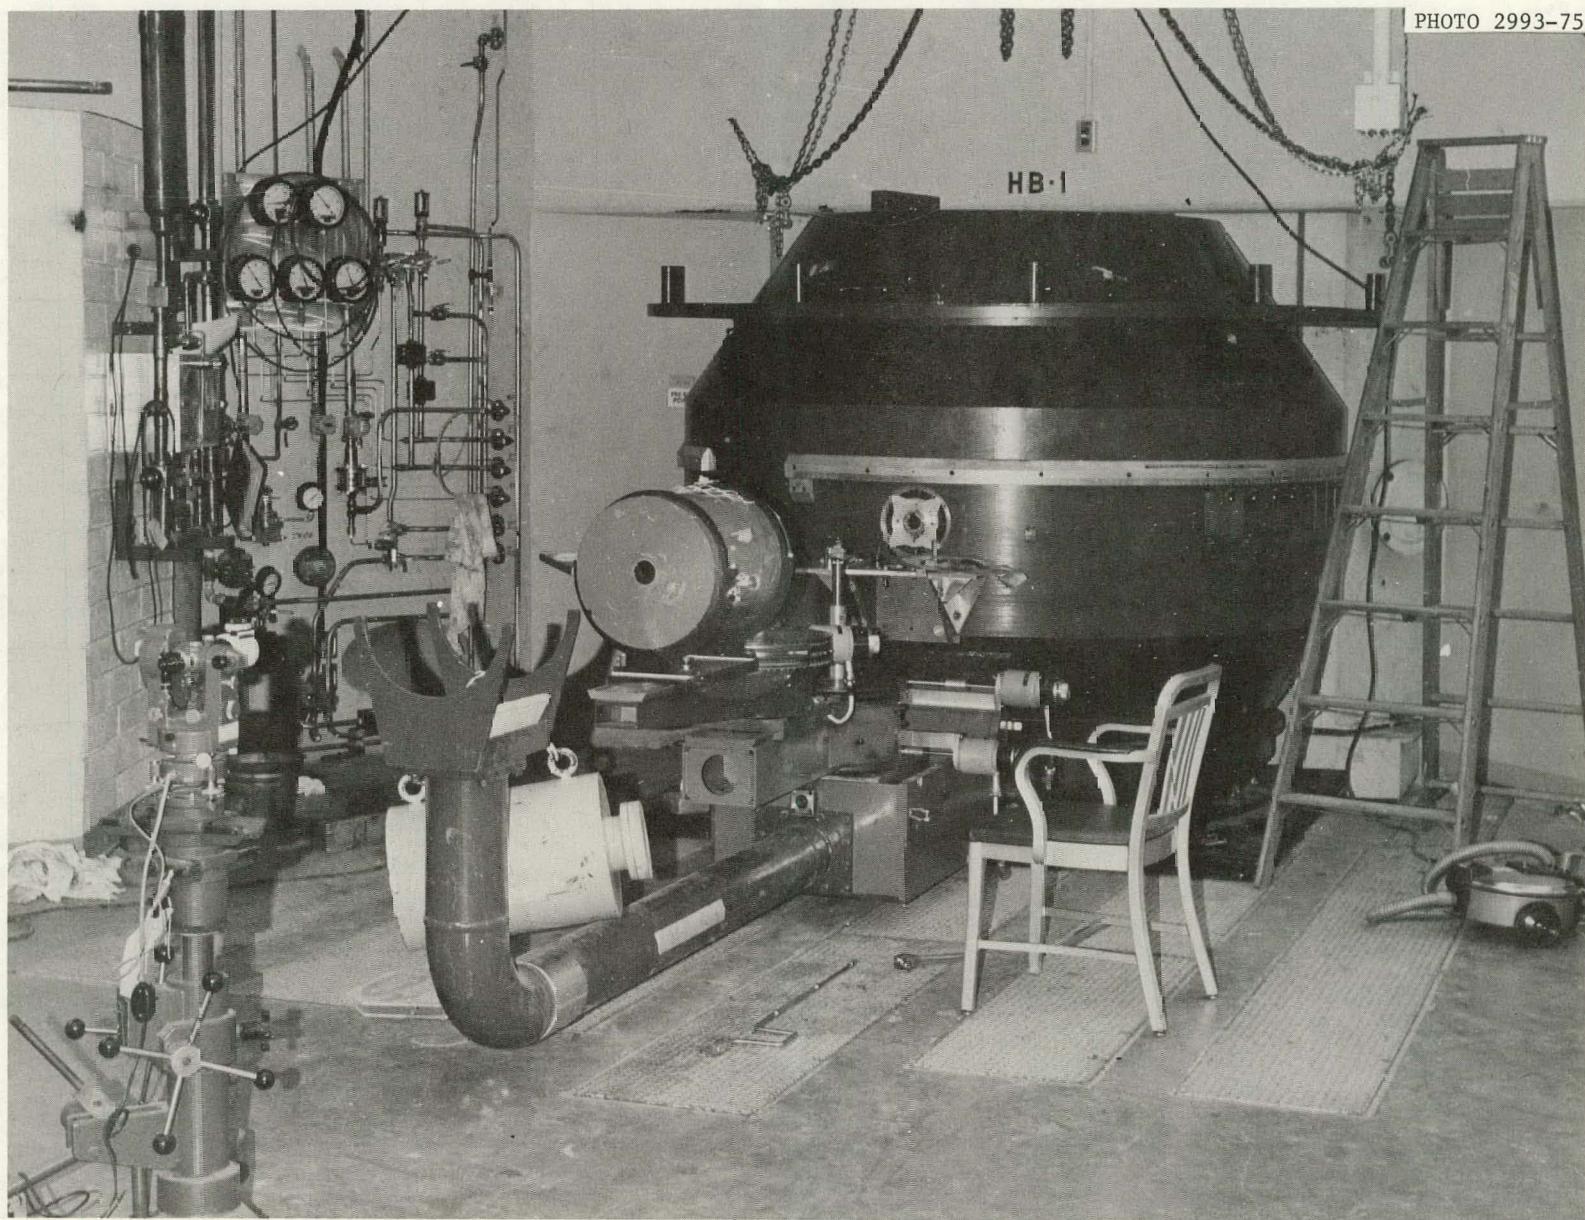
During the three months following the reactor startup, the work of reinstalling the shielding blocks, the rotating shutters, and the electronic equipment at the beam-tube facilities was continued. (See Figures 60, 61, 62, 63, and 64.)
