INEEL/EXT-99-01109

Corrosion Evaluation of INTEC Waste Storage Tank WM-182

Published November 15, 1999

**Idaho National Engineering and Environmental Laboratory
High Level Waste Program Division
Bechtel BWXT Idaho, LLC
Idaho Falls, Idaho 83415**

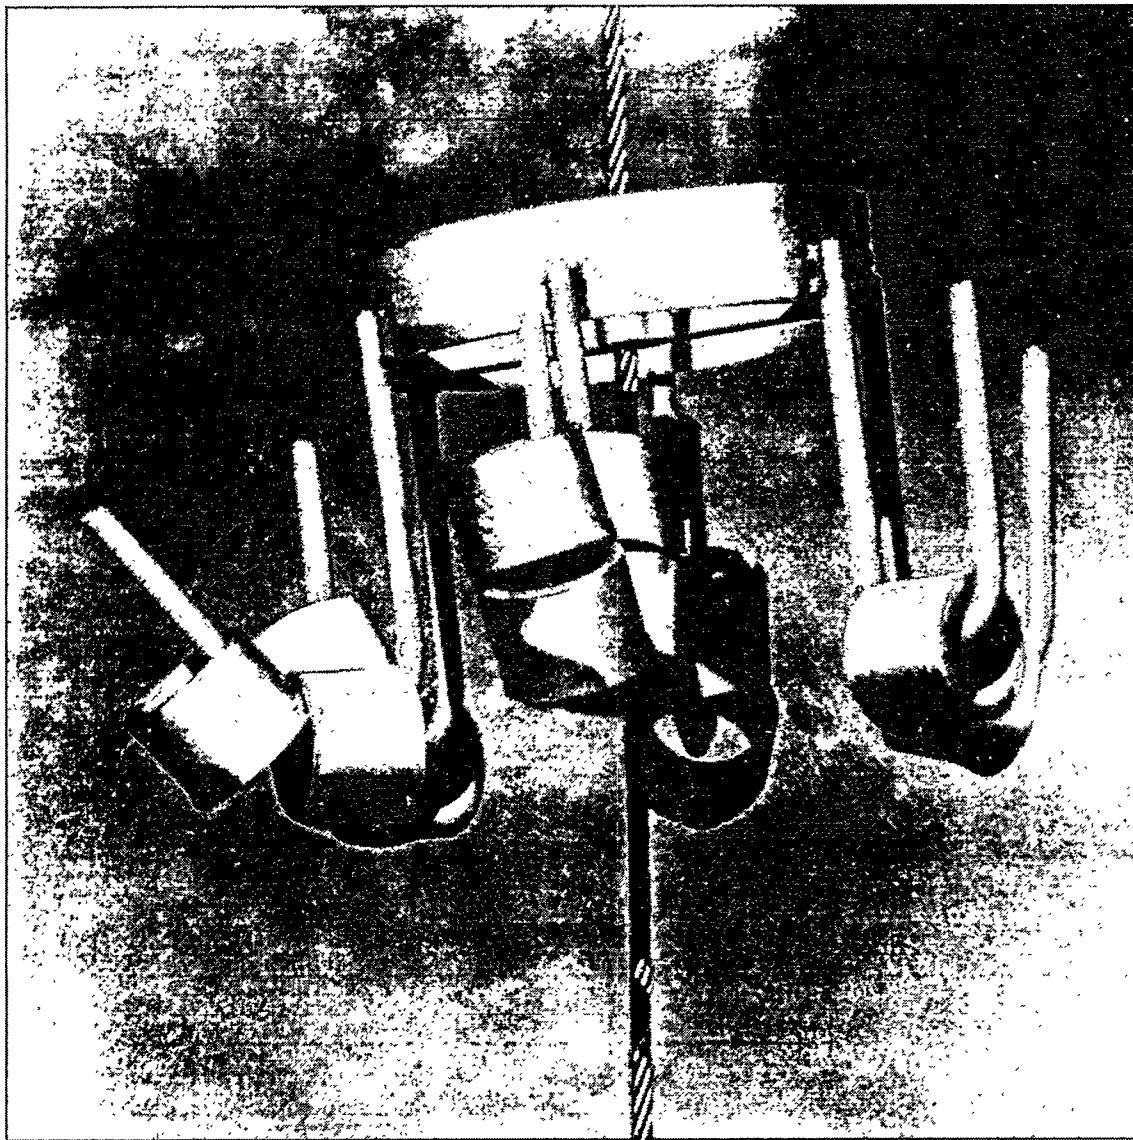
Figure 4. Corrosion Specimen Test Jig.

The corrosion test coupons in Tank WM-182 are round seamless pipe sections. These coupons are held on test jigs (Figure 4) which are fabricated of austenitic (Type 304L) stainless steel and suspended in the waste tanks by clamping onto stainless steel cables at the 18-inch, 36-inch, and 72-inch levels above the tank bottom. The test coupons are held on hooks welded to the support assembly. During the corrosion coupon recovery operation in 1987-1988 (Reference 4), additional welded corrosion coupons (Figure 5) were placed in all eleven waste tanks. These coupons are exposed on or near the tank bottom to measure the corrosion that is occurring in this previously unmonitored area. Corrosion coupons have been retrieved from the tanks and analyzed four times, in the past: 1962, 1976, 1983, and 1988 (References 1, 2, 3, 4).
