Degradation and Failure Characteristics of NPP Containment Protective Coating Systems

Preliminary Evaluation of Plant Coating Specimens

Division of Engineering Technology
Office of Nuclear Regulatory Research
U.S. Nuclear Regulatory Commission
Washington, DC 20555
NRC Job Code W6959

DOCUMENT: WSRC-TR-2001-00163

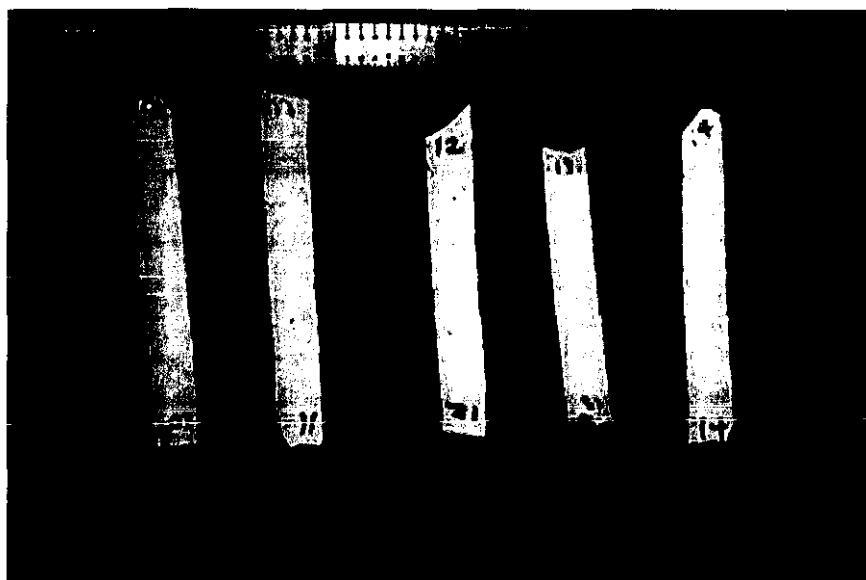
Free-film tensile tests were developed using fragments or chips of an epoxy-phenolic/IOZ coating system which failed in service. The strip specimens were die-cut in widths of 0.35 in. (Figure 2-11). Specimens were tested (Figure 2-12) in an Instron model 4507 mechanical testing machine at a crosshead speed of 0.05 inches per minute, using knurled, spring-loaded grips. Failure occurred outside the grips (Figure 2-13) in only one successful test, at 100°F. The maximum load was 2.7 lb and the resulting tensile strength 710 psi. Other tests resulted in failure within a grip. The 710-psi tensile strength is lower than that measured in an unirradiated, freshly applied epoxy phenolic coating (without any primer layer), but is within the range seen in the same coating irradiated to 10⁹ rad.

Figure 2-11. Tensile strip specimens cut from chips

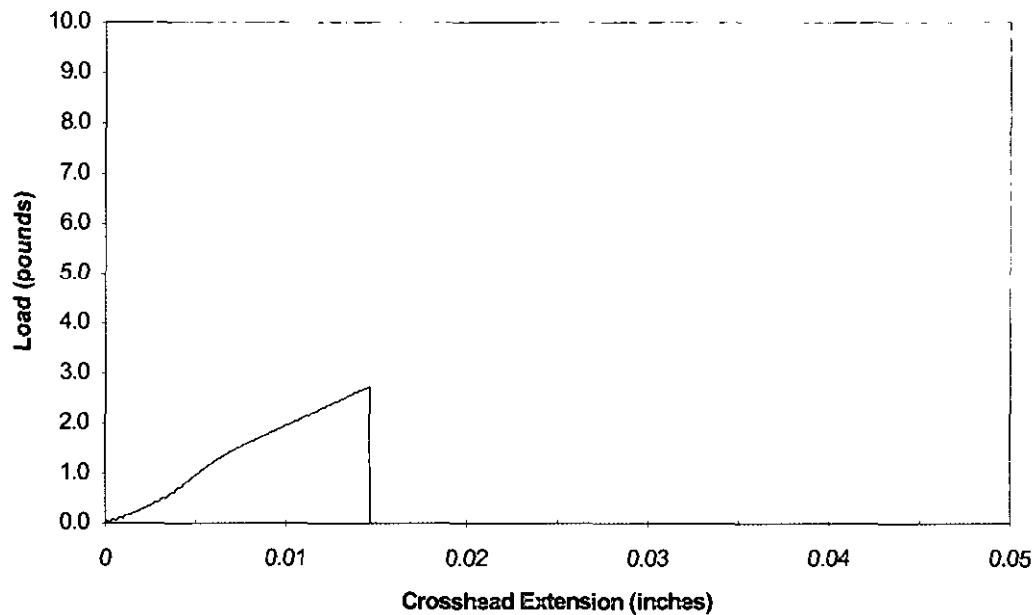
Plant Chip Tensile Test, Specimen 10 @ 38 deg C
failed outside grips

Figure 2-12. Tensile test of plant chip at 100°F (38°C)

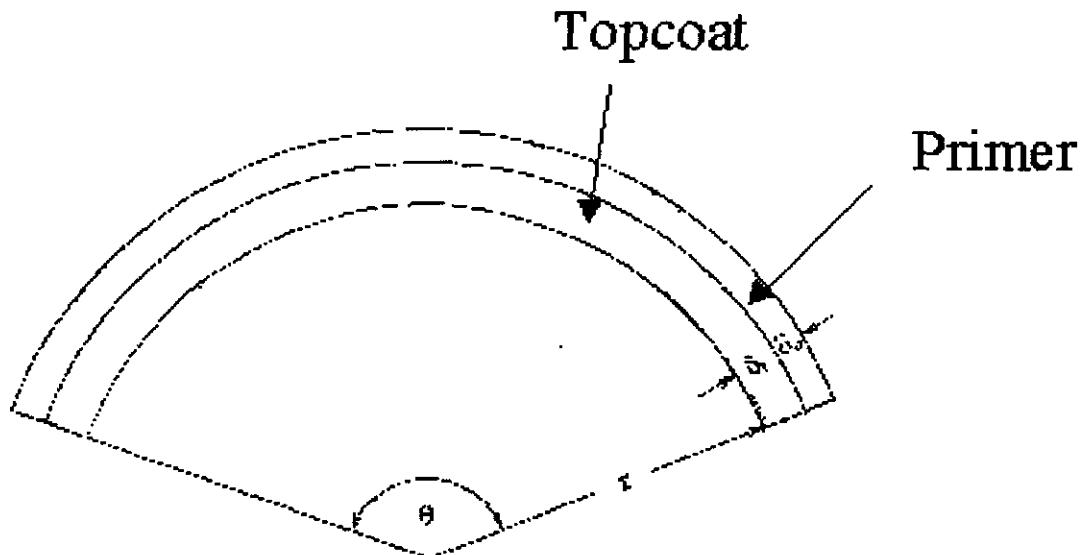
Figure 2-17. Analytical model of the radius of curvature of a two-layer chip

This model shows that, whatever the mechanisms causing the differential expansion or contraction, a difference in expansion/contraction must occur if the chips curl. The as-received chips had an initial radius of curvature of approximately 1 cm, consistent with a differential expansion/contraction of approximately one percent.

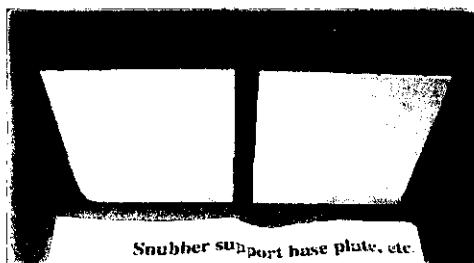
Figure 4-6. Overall view of the coated steel specimen provided from an operating nuclear power plant. The specimen was coated on the two main surfaces with two coats of Mobil 78-W-300.

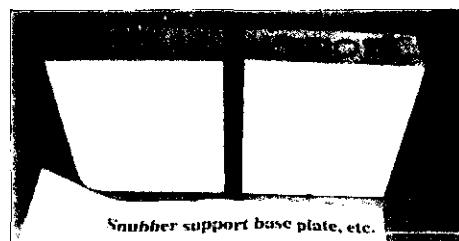
Figure 4-7. Overall view of the snubber support specimen following irradiation aging of the left half to 1×10^9 rads at 1×10^6 rad/hr and 120°F in the SRTC gamma cell.

Design-basis accident/LOCA testing was performed on the specimens according to ASTM D3911-95, except the bottoms of each specimen were allowed to become immersed during the spray-cooling portion of the test. During testing, the irradiation-aged specimen exhibited extensive blistering of the coating, including the intra-coating delamination of a significant portion of one face. The non-irradiated specimen exhibited only minor, localized surface blistering. No significant debris was released from the specimens; however, no effort was made to collect debris particles that may have been released.

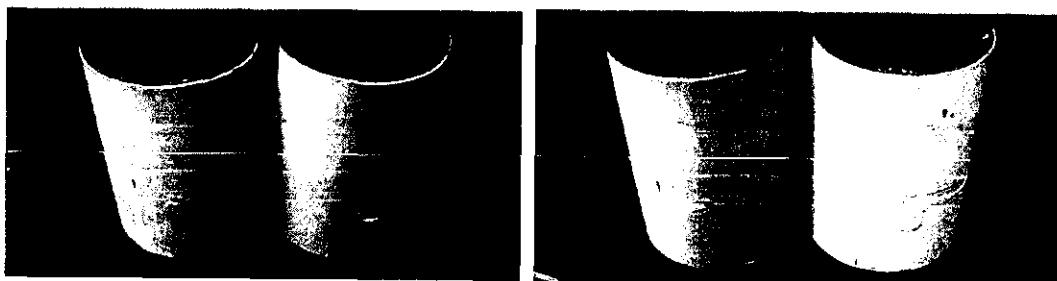
A DBA-LOCA test was performed, according to ASTM D3911-95, on a section of coated steel handrail provided by a commercial nuclear generating station. The coating system consisted of two coats of Mobil/Valspar amine-cured epoxy (78W300). The specimen was divided, with half tested in the as-received condition, and half tested after irradiation-aging to 1×10^9 rad at 1×10^6 rad/hour at 120° F (Figure 4-16).

Figure 4-16. Overall views of the handrail specimen as it appeared as-received and after dividing in half (left), and after irradiation-aging of half of the specimen (right).

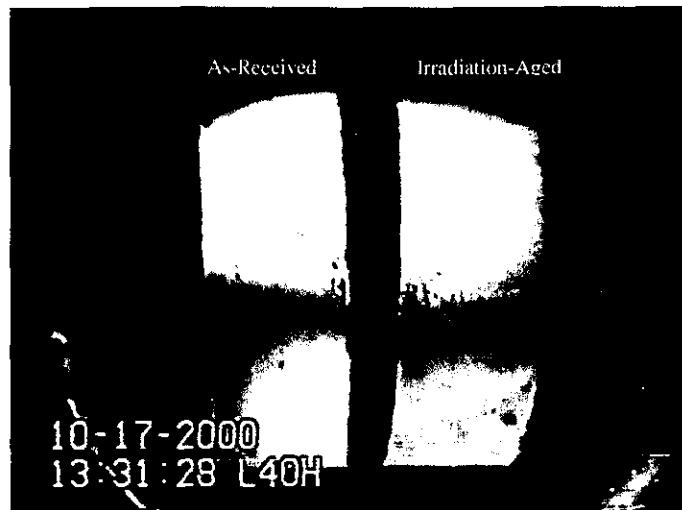
Figure 4-20. Handrail specimens immediately after immersion in water preheated to 200° F.

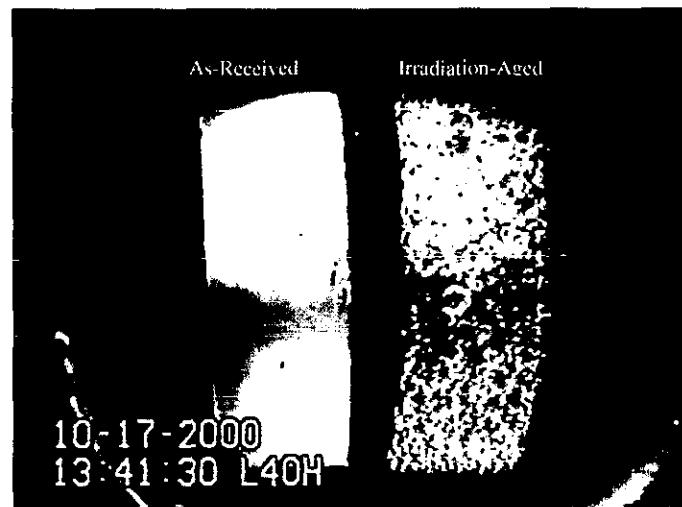
The first image (Figure 4-20) illustrates the condition of the specimens immediately after immersing them into water, preheated to 200° F. The next image (Figure 4-21) illustrates the appearance of the specimens after 10 minutes. Note the formation of a uniform layer of bubbles and blisters on the surface of the irradiated specimen. The rapid formation and release of bubbles is consistent with the hypothesis of gas formation within an epoxy topcoat during the irradiation of the specimen.

Figure 4-21. Handrail specimens 10 minutes after immersion in water preheated to 200° F.

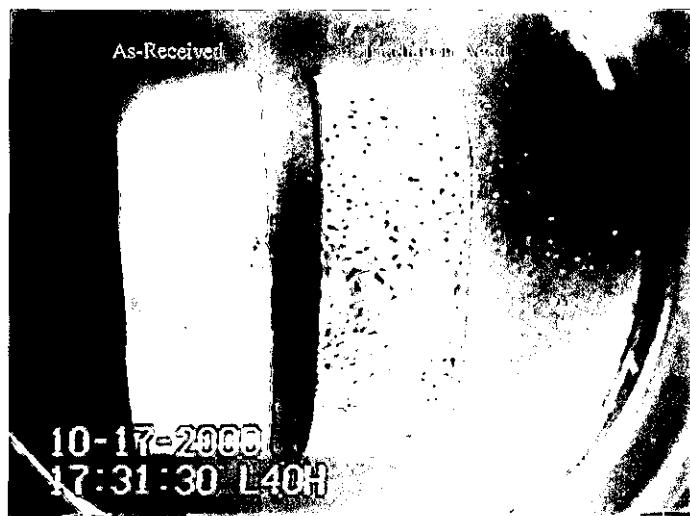
The addition of heat was terminated after approximately 2.5 hours and the specimens were allowed to cool under water. Figure 4-22 shows the appearance of the specimens after cooling for approximately 1.5 hours.

Figure 4-22. Handrail specimens at the end of the immersion tests.

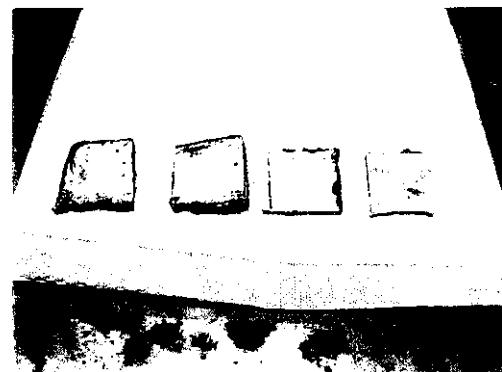
Figure 5-1 Overall view of coated steel plate specimens. The specimens are approximately 2 inches square, each, and were saw-cut from a plate which appeared to have been removed from service with a cutting torch.
