**INTEGRITY ASSESSMENT REPORT
OF
TANKS TK-101 AND TK-102**

**PROJECT W-178
219-S SECONDARY CONTAINMENT UPGRADE**

Prepared for
Waste Management Hanford

Prepared by
David S. McShane P.E.
Fluor Daniel Northwest

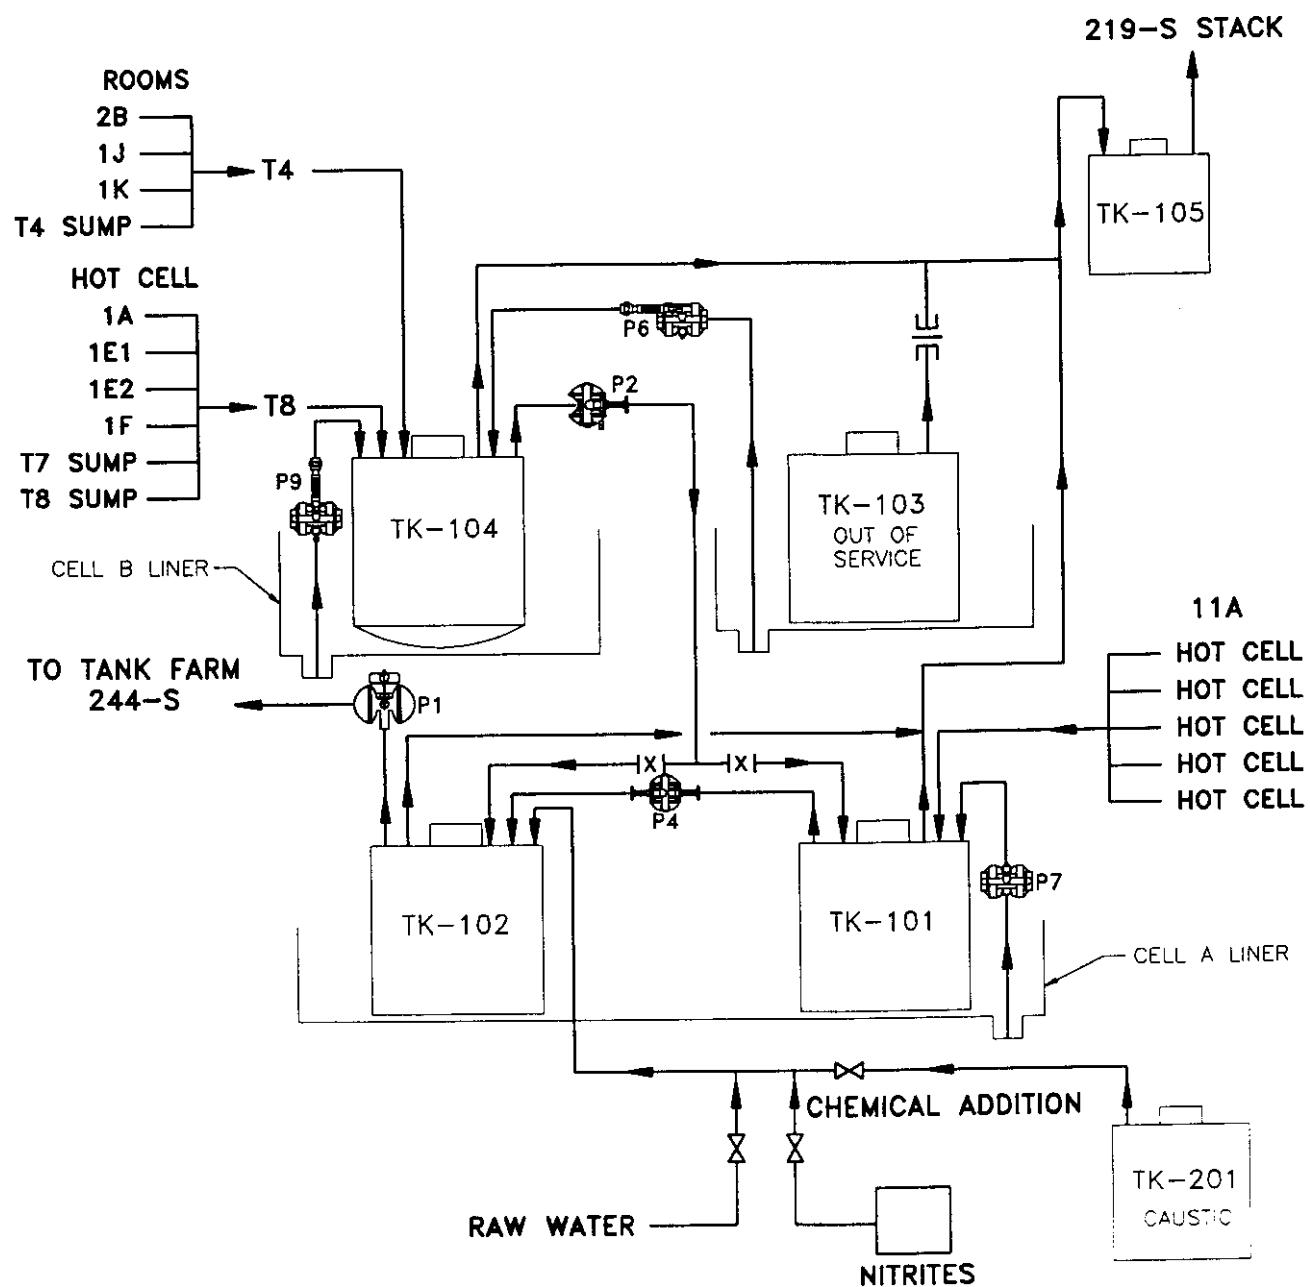
Figure 2,
Waste Transfer System

Radioactive liquid waste generated in the 222-S Laboratory enters into the collection system in the laboratory (i.e. hot cells, hoods, sumps, etc). The collection system is connected to a transfer system, which moves the waste to the 219-S Facility. There are four main transfer lines connected to the 219-S Facility. Two lines originate in the 11A hot cells and were installed by project W-041H. The other two lines were installed by project W-087; one line originates in the T8 tunnel and one line originates in the T4 tunnel. The collection and transfer lines are encased (pipe in pipe) piping equipped with leak detection. Waste from the 11A hot cells is collected in Tank 101 and waste from T8 and T4 is collected in Tank 104. Tank 104 was added by Project W-178, 219-S Secondary Containment Upgrade. Once enough waste has accumulated in the collection tanks, the waste is transferred to Tank 102 for treatment. In Tank 102, the pH and nitrite levels of the waste are adjusted to meet tank farms waste acceptance criteria. The waste is transferred to tank farms by an air-operated pump and an underground transfer line (project W-087). The tanks are operated at a slight negative and vented through a HEPA filter. A sketch of the system is shown in Figure 2. The waste characteristics and tank operating parameters are shown in Table 1.
