Structural Integrity Program for the 300,000-Gallon Radioactive Liquid Waste Storage Tanks at the Idaho Nuclear Technology and Engineering Center

April 2003

*Idaho National Engineering and Environmental Laboratory
Bechtel BWXT Idaho, LLC*

The conclusion of this report is that the Tank Farm Facility tanks, vaults, and transfer systems that remain in service for storage are structurally adequate, and are expected to remain structurally adequate over the remainder of their planned service life through 2012.

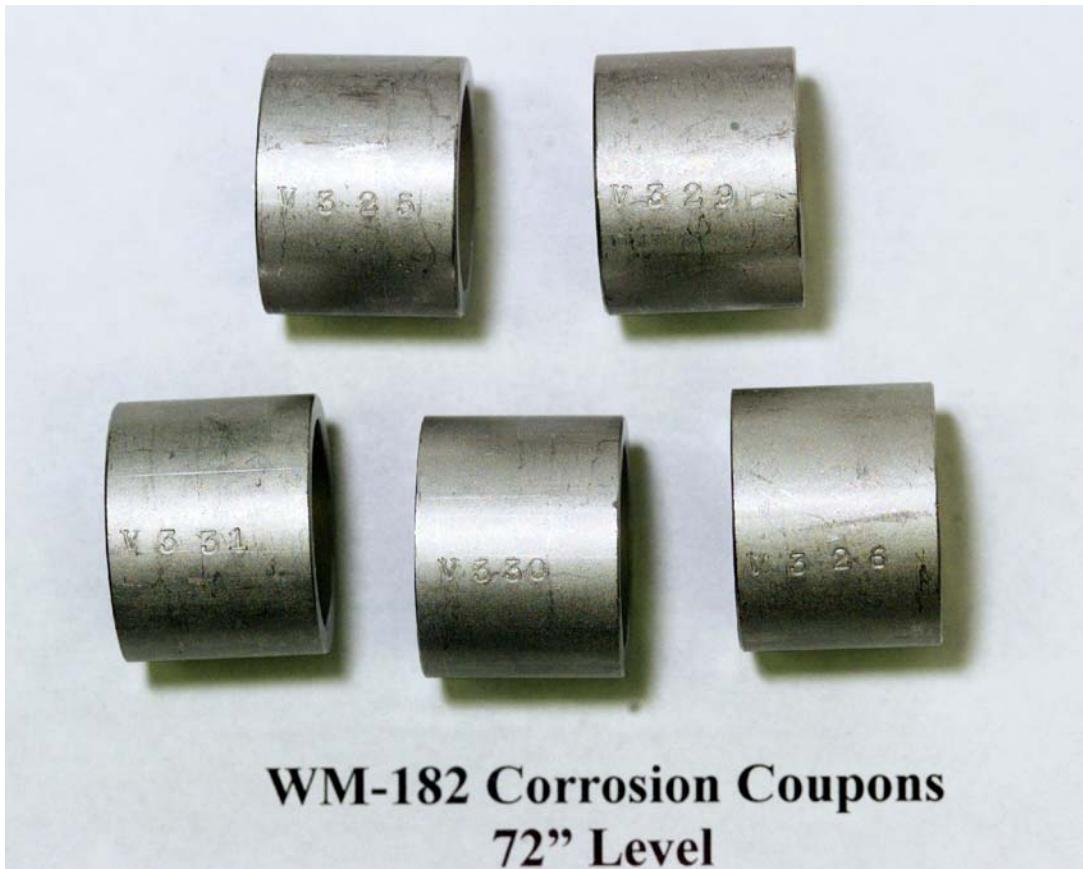
WM-182 Corrosion Coupons 72" Level

Figure C-7. Tank WM-182 coupons at the 183-cm (72-in.) level after 26.5 years of exposure (PD01-0406-10).

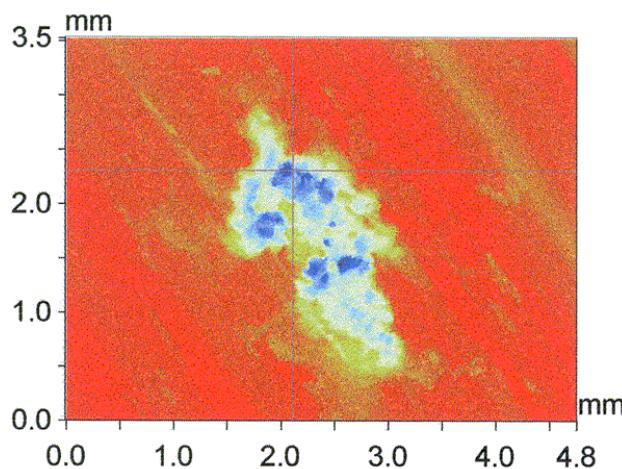
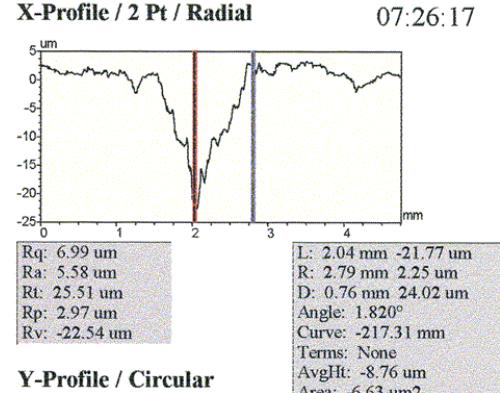
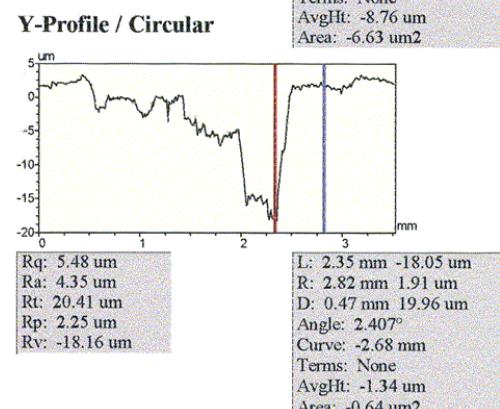
Title: W893

Note: Bottom Level WM-183 Coupon

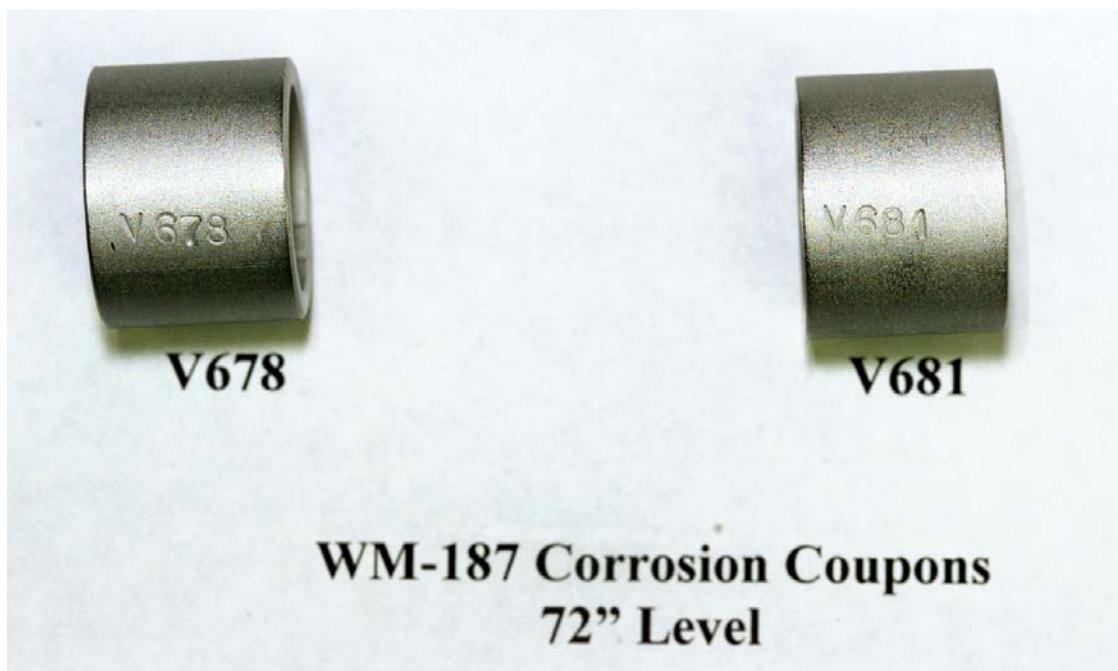
WM-187 Corrosion Coupons 72" Level

Figure C-25. Tank WM-187 coupons at the 183-cm (72-in.) level after 28.4 years of exposure (PD01-0406-12).

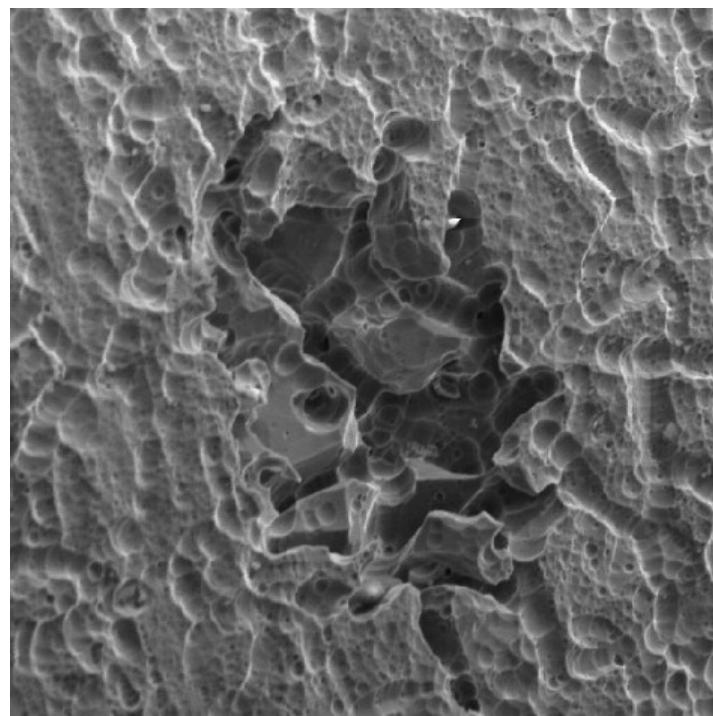
Figure C-30. Scanning electron microscope photograph (680 \times) of heat-affected zone attack on Coupon VV1867 in Tank WM-189 (PD03-0029-28).⁹

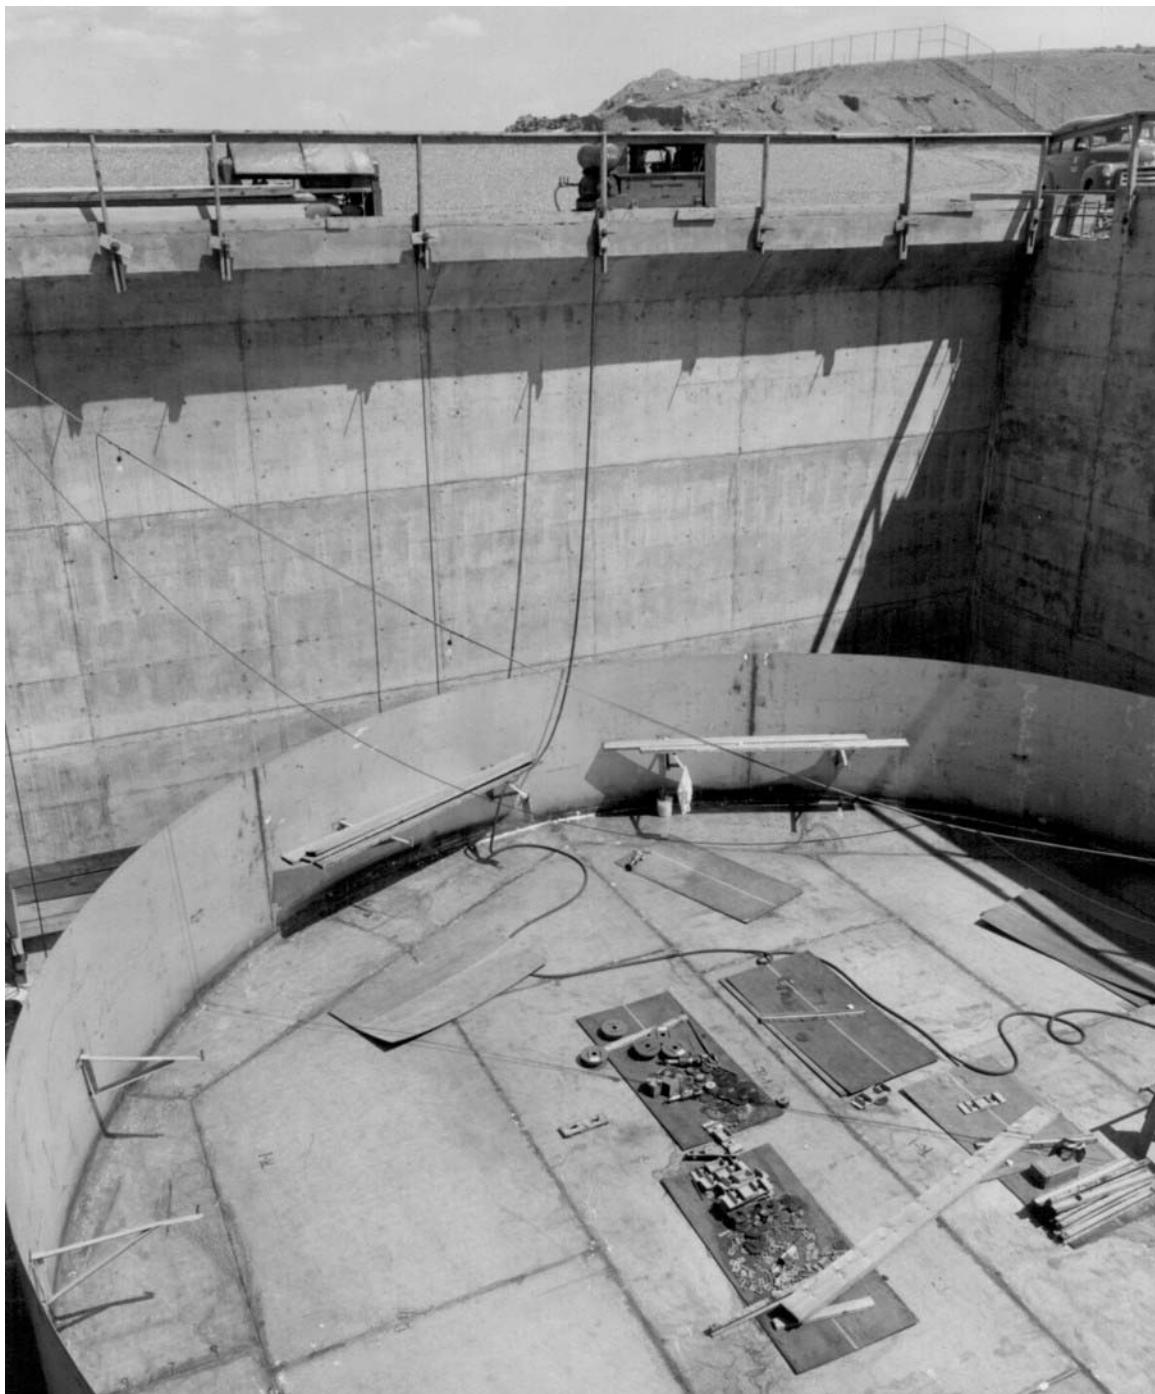
Figure D-1. Construction of Tank WM-188 (58-3473).

To facilitate understanding of the images captured from the video 1999 inspection, the construction practices followed for the tanks are reviewed below. All of the 300,000-gal tanks were fabricated out of rolled stainless steel plates that were welded together. Figure D-1 shows an early construction view of Tank WM-188, in which the tank bottom and one row of the wall shell course have been installed. The horizontal and vertical edges of the plates where they were welded together are an obvious feature. Support structures for work platforms were welded to the tank wall, but these supports were later removed. Figure D-2 shows the process at a later stage, with grinding marks visible on the metal surfaces of the first row of metal plates where the supports were removed. Figure D-3 shows the installation of cooling coils in Tank WM-187. All of the supports that were attached to the walls have been removed. Extensive grinding marks are evident on the tank walls.⁴

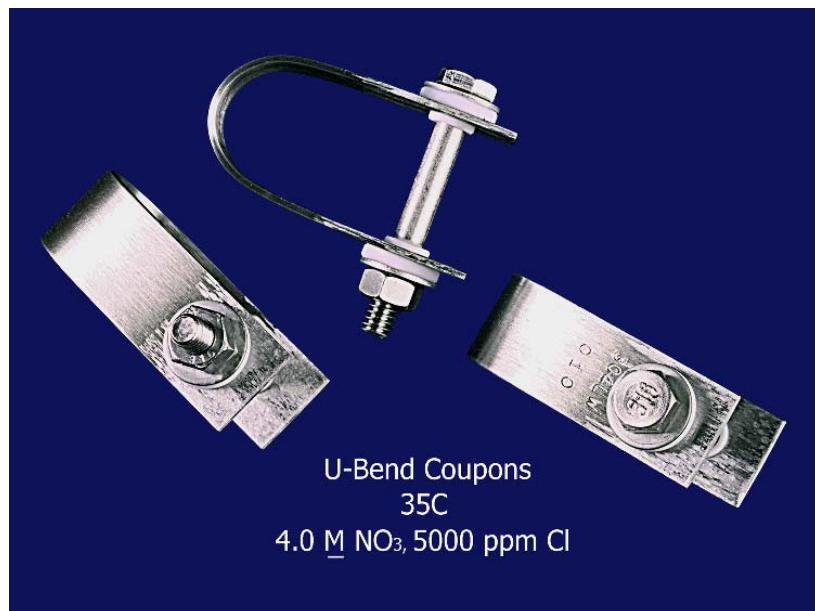
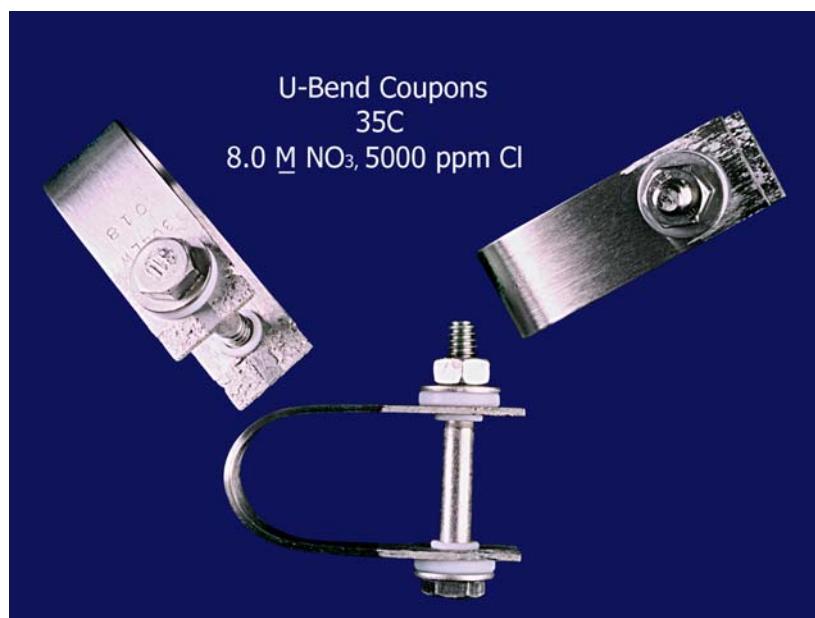
Figure E-1. U-bend coupons from first phase of 2001 corrosion testing (PD010403-2-15 and PD010403-3-15).⁸

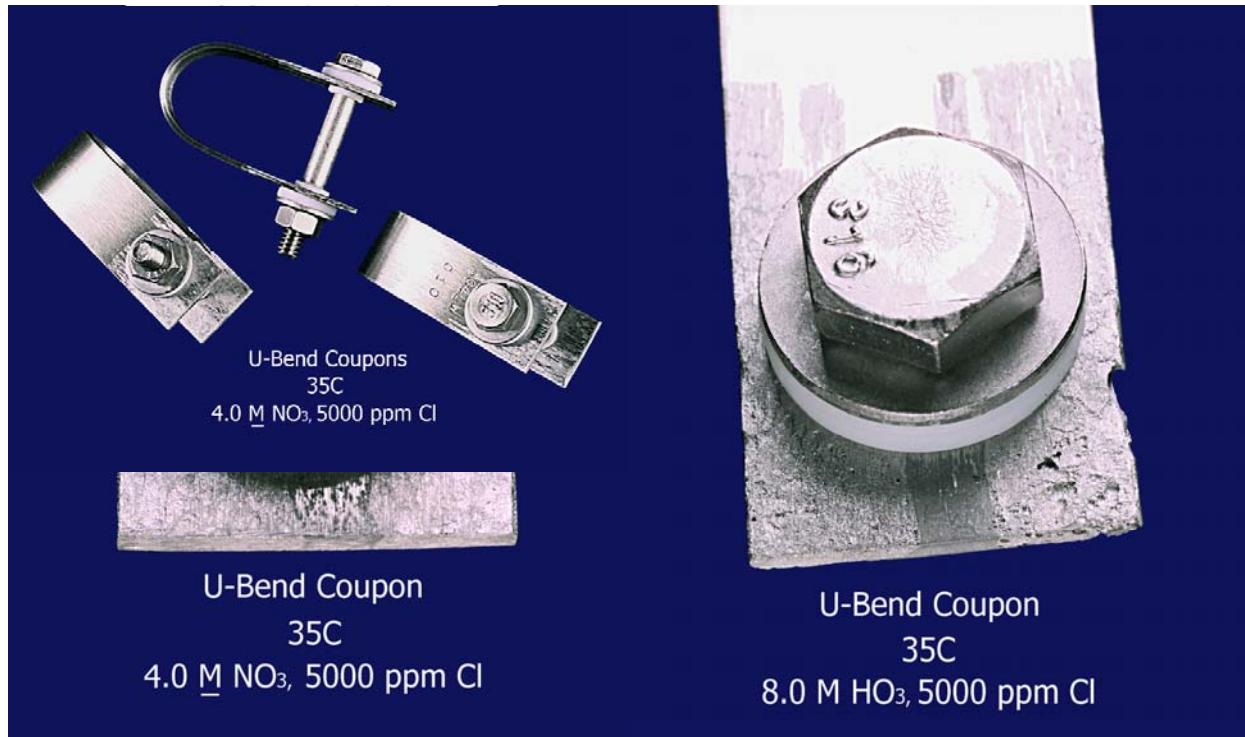
Figure E-2. Close-up of U-bend coupons from first phase of 2001 corrosion testing (PD010403-4-22 and PD010403-4-25).⁸

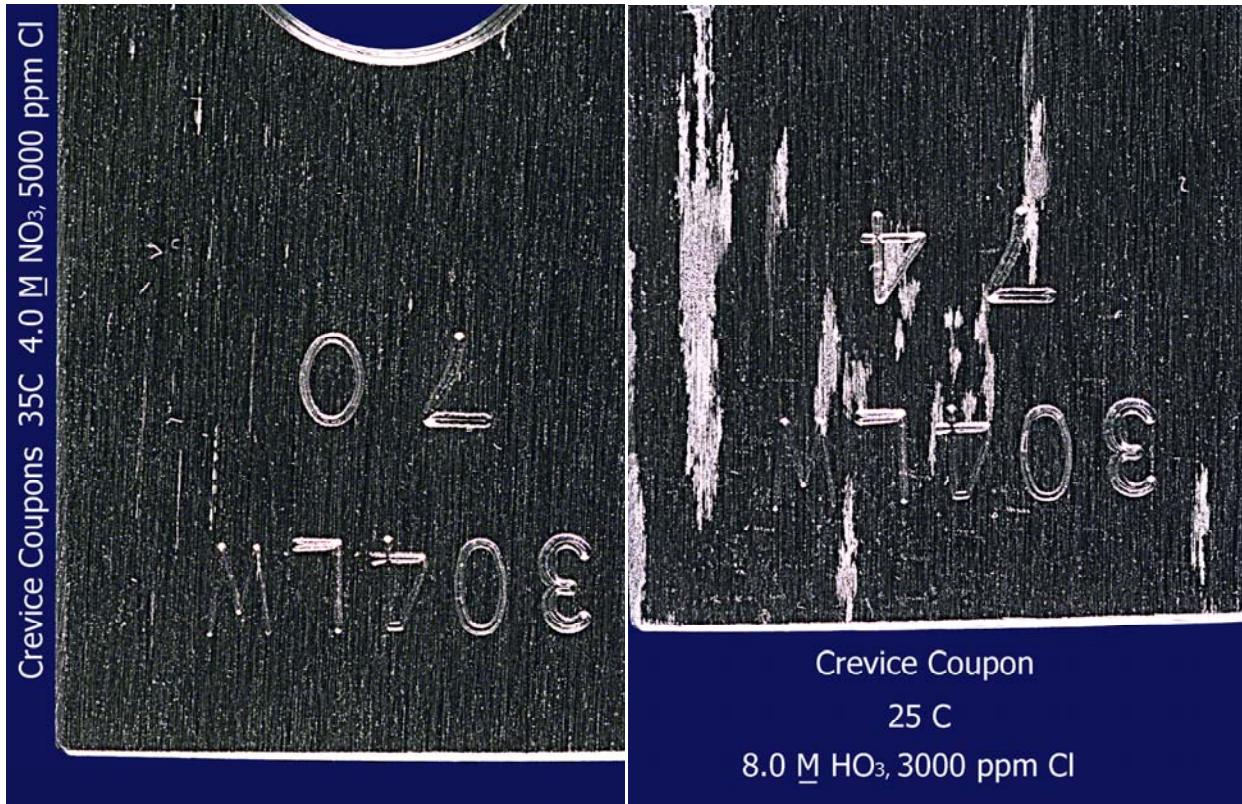
Figure E-3. Crevice coupons suspended above solution noted (PD010403-3-20 and PD010403-4-21).
