DOE/NV--898-REV 1

Tonopah Test Range Post-Closure
Inspection Annual Report,
Tonopah Test Range, Nevada
Calendar Year 2002

August 2003

Environmental Restoration
Division

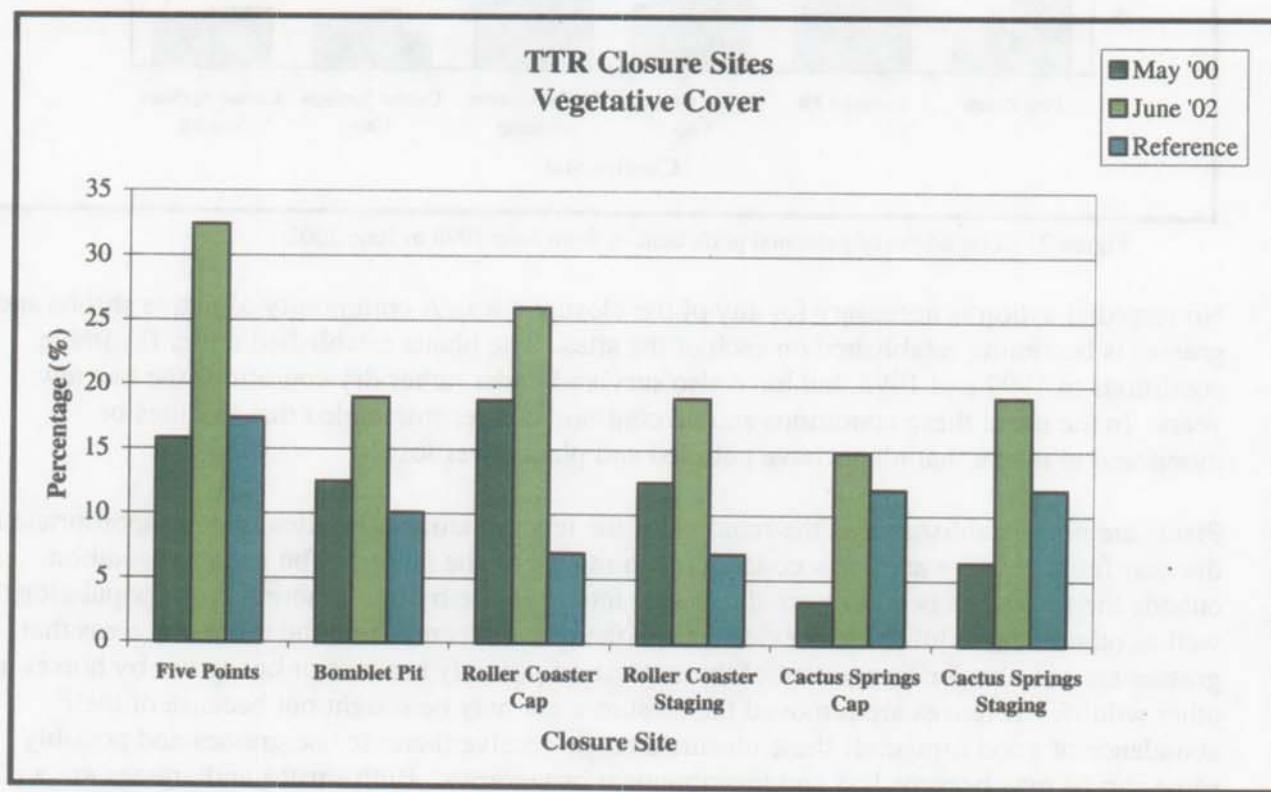
Figure 1. Comparison of plant cover on TTR closure sites from May 2000 to June 2002.

The following two figures summarize plant density data and plant cover data collected over the past five years from the four closure sites. As shown in Figure 1, plant cover at all of the sites exceeded the amount of plant cover found on their corresponding reference area. Plant cover increased at all sites from 2000 to 2002. After five years plant cover at Five Points Landfill was the highest of any of the sites and was about twice what is found on the reference area. Whereas at Roller Coaster Sewage Lagoon, plant cover was just over 25%, but it was almost four times higher than the plant cover on the associated reference area.

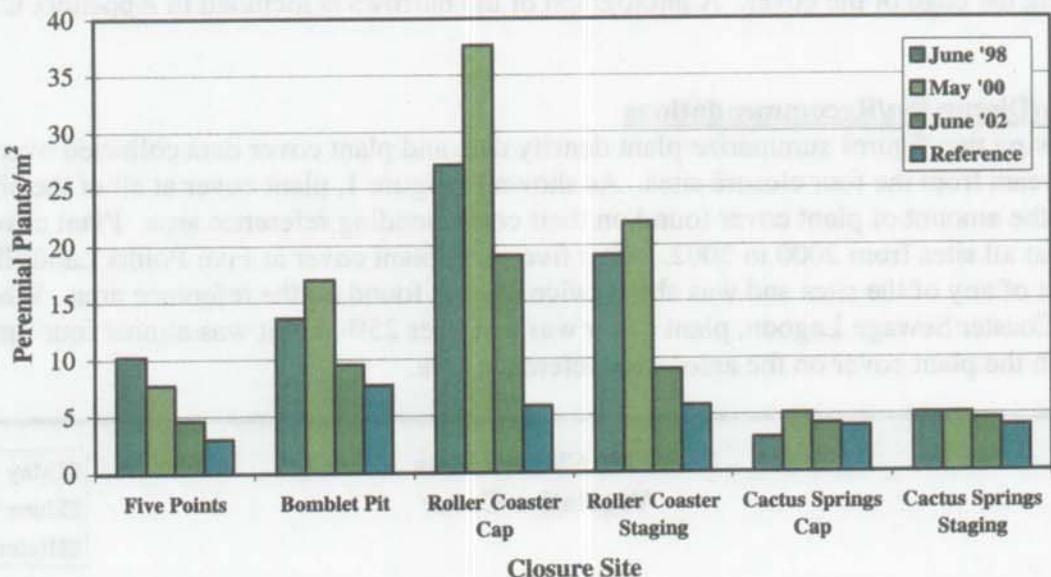
Figure 2. Comparison of perennial plant density from June 1998 to June 2002.

Plant density increased from 1998 to 2000, but overall has decreased the last two years. Plant density is the highest at Roller Coaster Sewage Lagoons, and overall plant density is higher on the revegetated areas than on the adjacent reference areas.

No remedial action is necessary for any of the closure sites. A community of native shrubs and grasses is becoming established on each of the sites. The plants established under favorable conditions in 1997 and 1998, but have also survived under rather dry conditions the last few years. In the event these conditions should continue it is recommended that the sites be monitored to insure that plants have not died and plant cover lost.

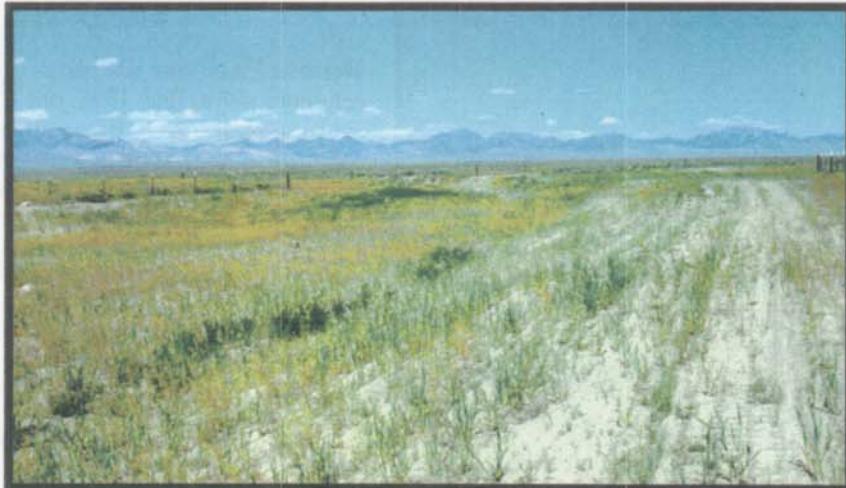
Five Points Landfill photo reference point, June 1998, one growing season after revegetation. Much of vegetation is wheat as a result of straw mulch.

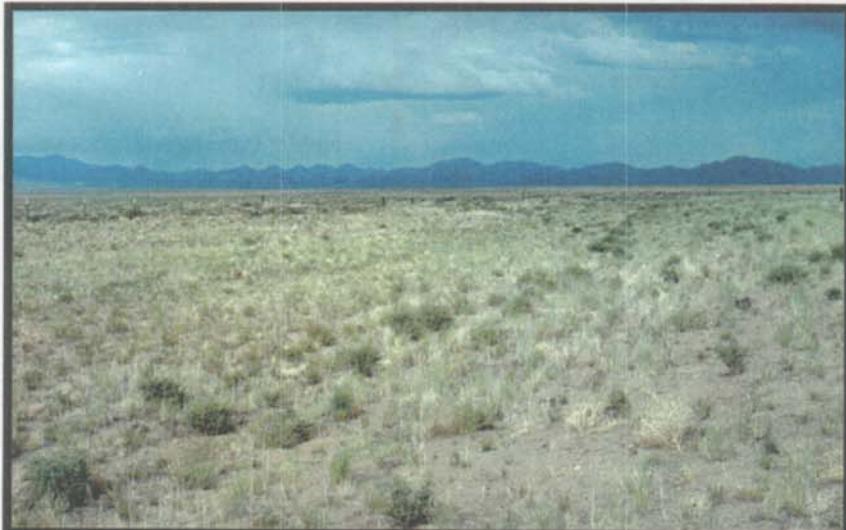
Five Points Landfill photo reference point, June 2000, three growing seasons after revegetation. Grasses, primarily Indian Ricegrass and some bottlebrush squirreltail are becoming well established. Shrubs are primarily fourwing saltbush.

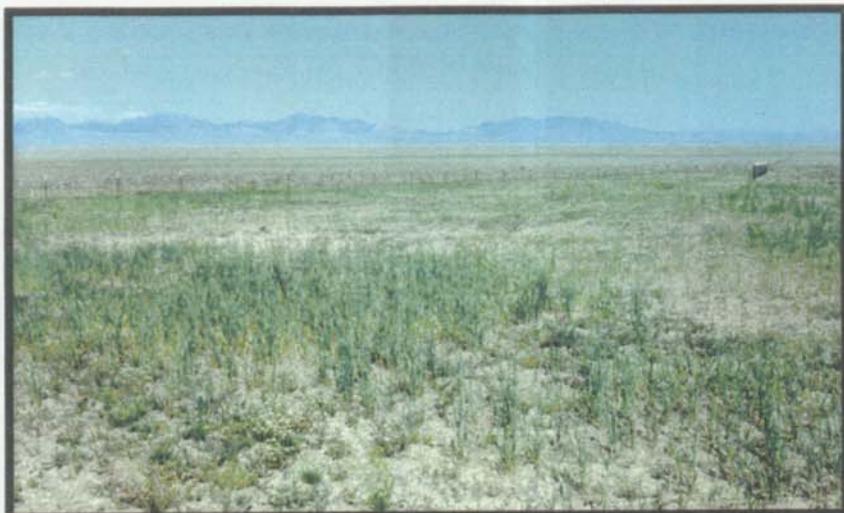
Bomblet Pit closure site photo reference point, June 1998, one growing season after revegetation. Majority of vegetation is wheat that germinated from wheat straw used during mulching.

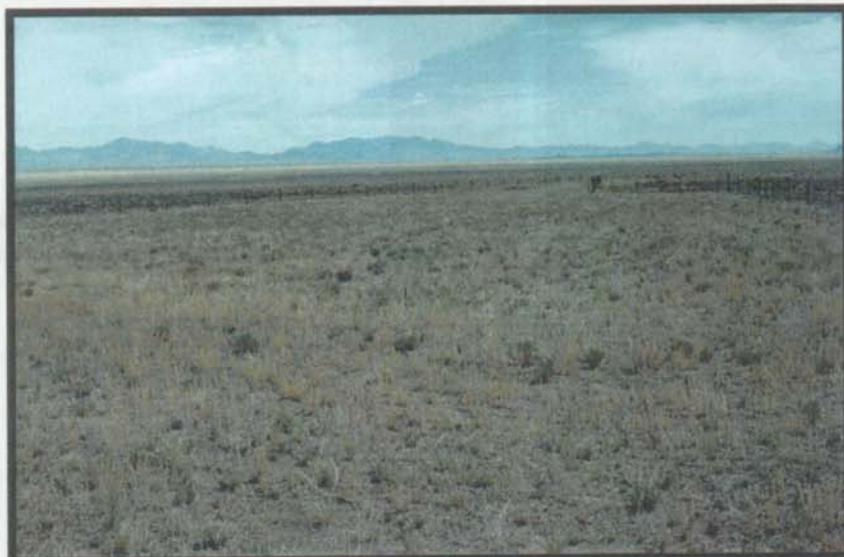
Bomblet Pit reference photo point, June 2000, three growing seasons after revegetation. Vegetation appears dry because photo taken late in growing season and wheat is no longer present on the site.

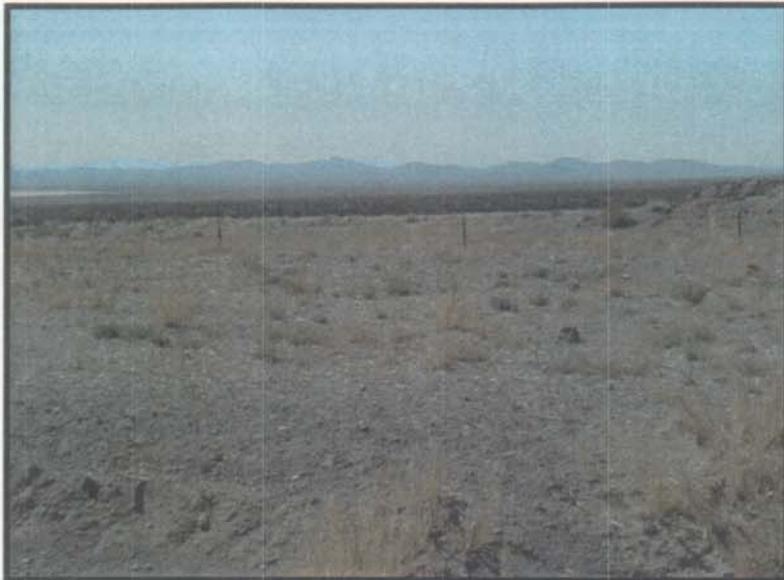
Roller Coaster RADSAFE site photograph taken June 2002. Some shrubs are established on the site as are annual weeds, primarily halogeton.

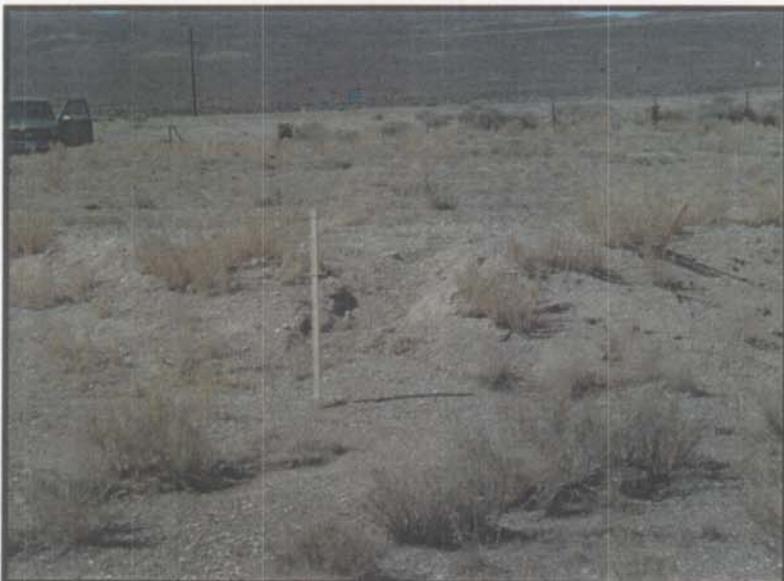
Roller Coaster RADSAFE area showing erosion channel off east edge of cover cap. Some remedial action may be necessary if erosion channel deepens. Some protection from erosion may occur as plant cover increases over the next few years.

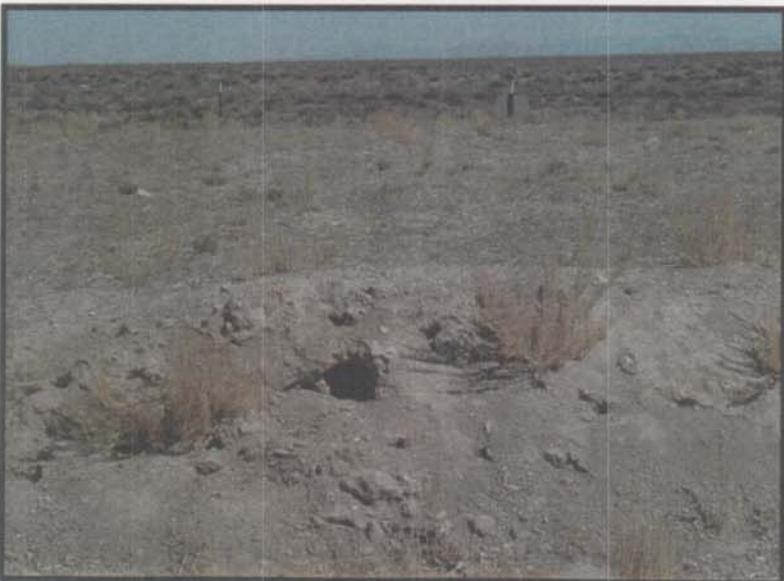
Animal burrows along edge of cover cap at the Roller Coaster RADSAFE area.

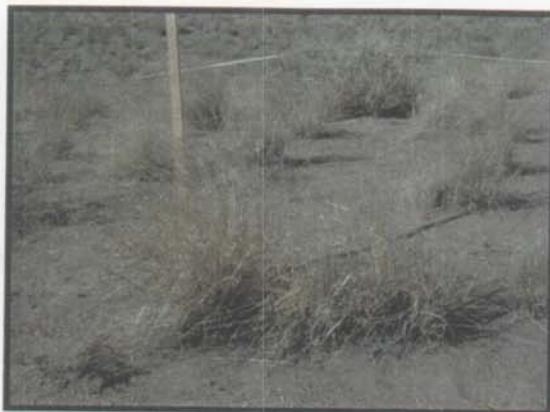
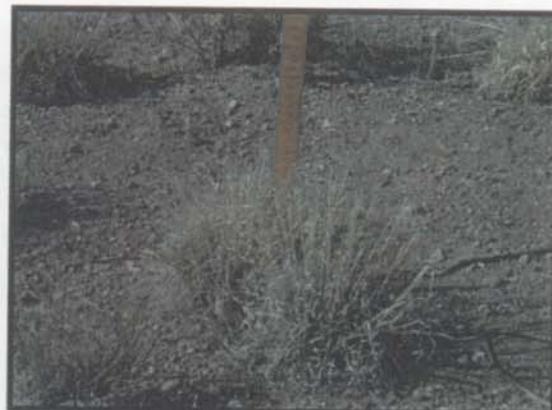
Indian ricegrass (left) and bottlebrush squirreltail (right) were the two most common grasses encountered on the closure sites. They most common and showed the greatest growth at the Five Points Landfill site.

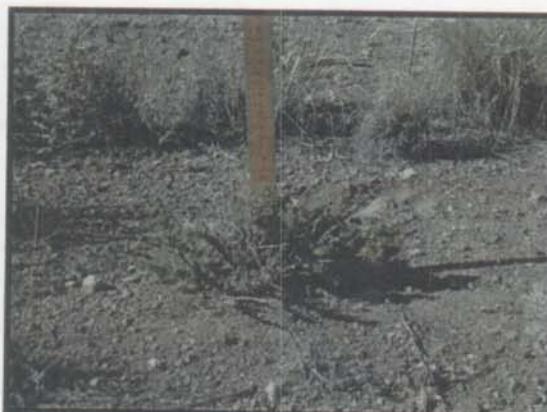
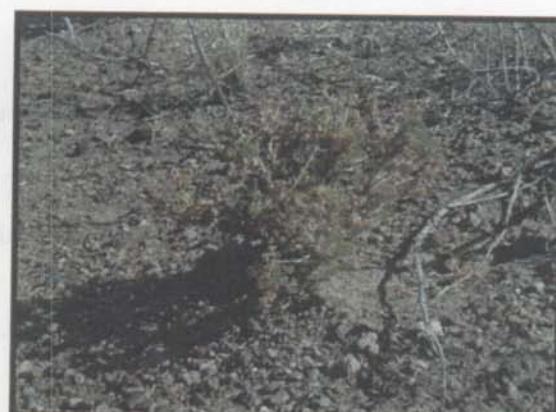
Budsage seed is not available commercially so it was custom collected from the immediate vicinity of the closure sites and used with great success in the seed mix. Budsage was well established at Five Points Landfill (left), Bomblet Pit (right) and Roller Coaster Sewage Lagoons and many individuals flowered and produced seed.

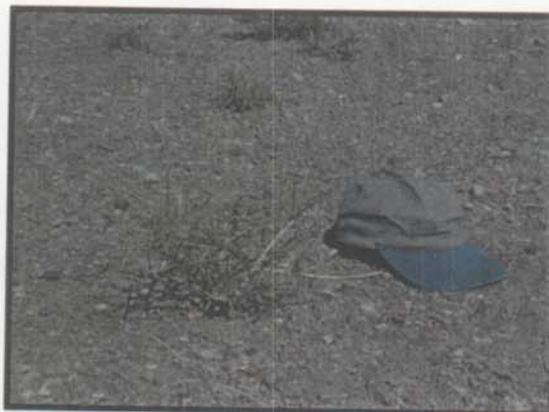
Nevada jointfir was a prominent component of the vegetation on the Cactus Springs closure site. Plant density was excellent, as was the growth of the plants over the last five years as noted in this photograph. Nevada jointfir is common in the immediate vicinity of the Cactus Springs closure site.

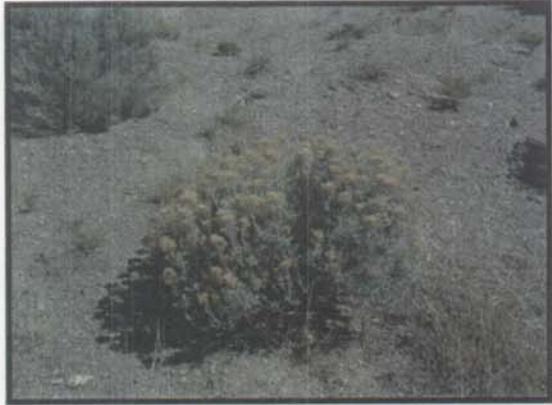
Another common component of the vegetation at the Cactus Springs closure site is rubber rabbitbrush. The site occurs close to a natural drainage and rabbitbrush is a major component of the vegetation along the drainage. It is establishing well on the site in spite of the the pressure from browsers, such as rabbits. This particular individual on the Cactus Springs staging area flowered last season and has shown very good growth in just five years.

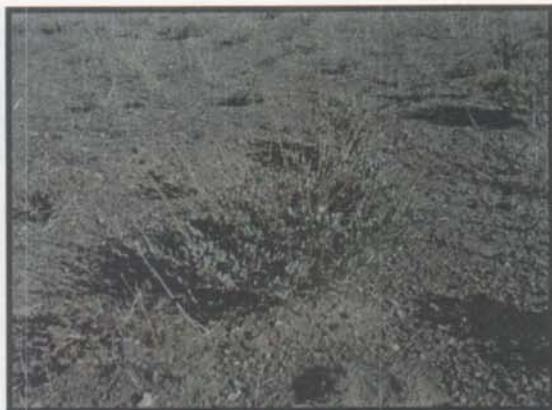
One of the most common shrubs found at all of the closure sites is shadscale. It germinates well, is resistant to dry conditions and to browsing. The first couple years the density of shadscale was were high, but as plants mature and competition for resources (water) increases density has decreased. At the same time the amount of cover from this species and others has increased, indicated good plant growth and apparent plant establishment on the sites.
