Materials Reliability Program: Environmental Fatigue Testing of Type 304L Stainless Steel U-Bends in Simulated PWR Primary Water (MRP-137)

1008207

Technical Update, December 2004

Framatome ANP GmbH

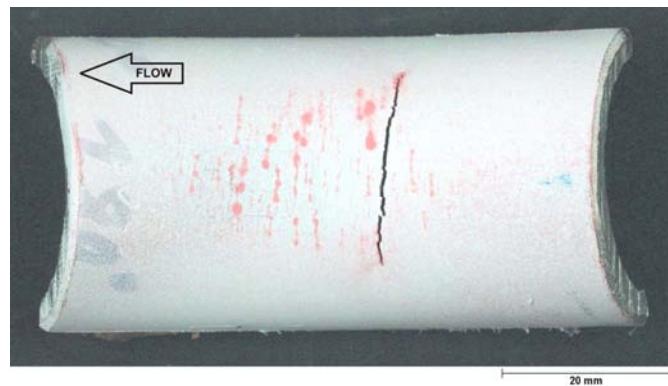
A narrow piece with an approximate length of 60 mm containing the bend apex was sectioned from the bend and split in two half shells for further inspection with dye penetrant. The external surface of the intrados exhibited an array of multiple circumferential crack indications as displayed in Figure 4-8. The internal surface of the intrados was free of indications with the exception of the primary failure formed by the circumferential through wall crack (see Figure 4-9).

Figure 4-8
DPI of external surface at intrados revealing an array of circumferential cracks in the intrados area

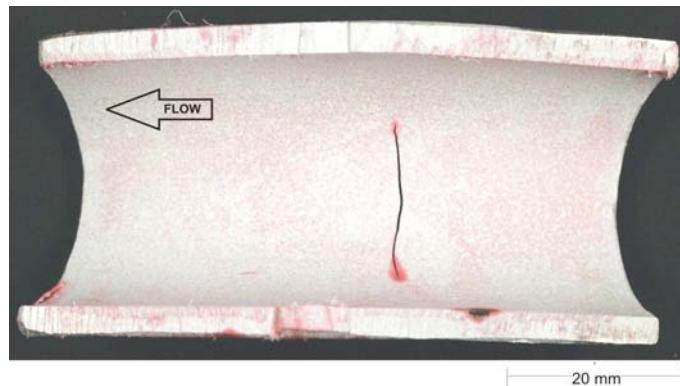
Figure 4-9
DPI of internal surface at intrados showing that the primary circumferential crack had developed into a through wall defect.

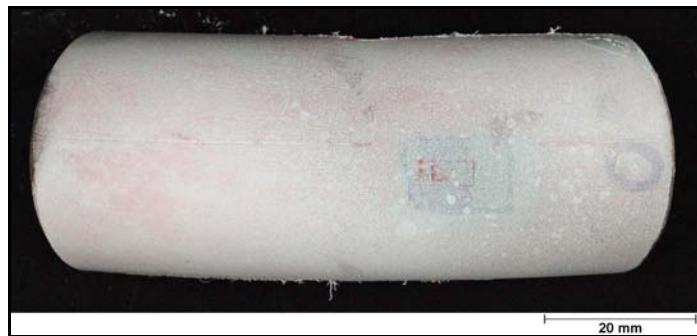
Both the internal and external surface of the extrados were free from indications as displayed in Figure 4-10 and Figure 4-11.

Figure 4-10
DPI of external surface of extrados free of indications

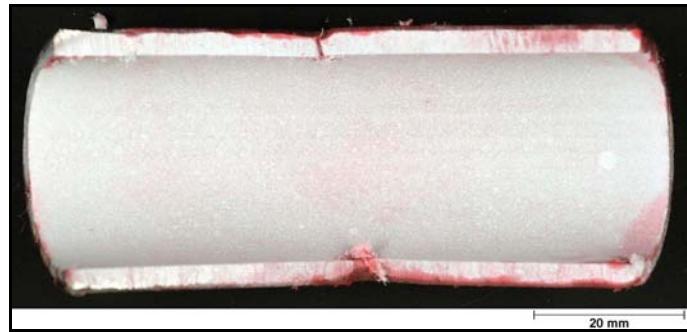
Figure 4-11
DPI of internal surface of extrados free of indications

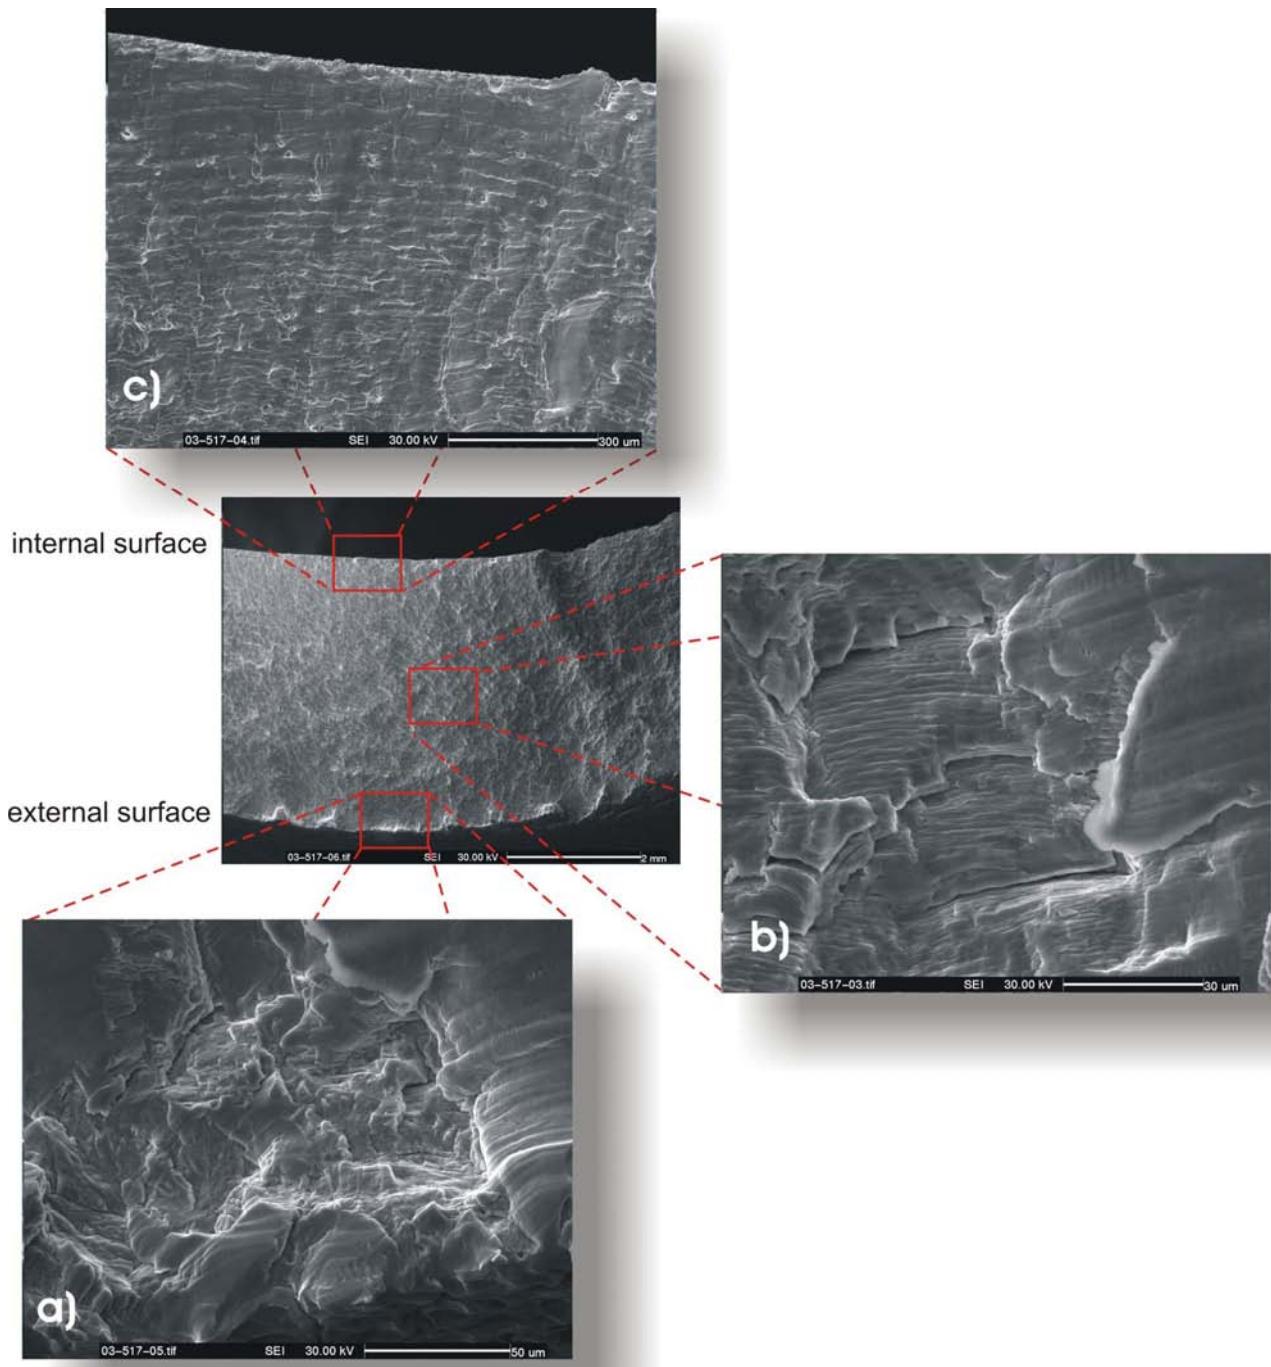
Figure 4-12

The failure mechanism was confirmed as mechanical fatigue, indicated by striations as a result of step-wise crack progression under cyclic loading. As expected, the striation spacing increased with further propagation, since the decreasing wall thickness resulted in higher local loading. With the exception of pickling attack along grain boundaries, no other potential fracture initiating features were found. The initiation area and the mid section of the wall thickness exhibited striations with an average spacing of 1 μm and 2 μm , respectively. In the last stages of the fracture however, the striations exhibited an average spacing of 20 μm .

Views obtained during SEM examination; a) typical crack initiation site found along the external surface with average striation spacing of 1 μm ; b) typical fracture appearance found in mid-section of fracture with average striation spacing of 2 μm ; c) typical fracture appearance adjacent to internal surface with average striation spacing of 20 μm

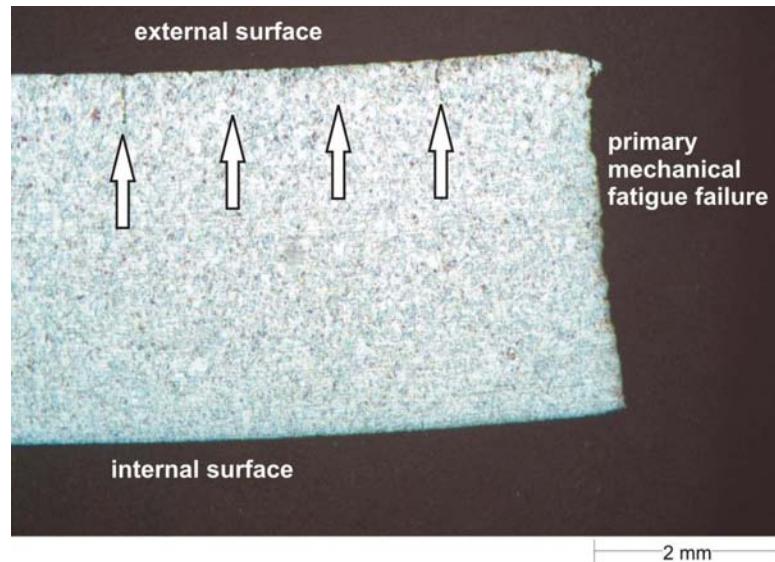
Similar to all previously examined U-bends, metallography showed a generally sound austenitic microstructure. No anomalies were found. The examination confirmed the findings from visual and dye penetrant inspection. The intrados area exhibited multiple cracks all initiating from the external surface progressing towards the internal surface. All examined locations showed, that the crack progression was more or less perpendicular to the tube surface and exhibited a non-branched, transgranular mode indicating a purely mechanical driven failure mechanism (see Figure 4-14 to Figure 4-16).

Figure 4-14
Overall view of prepared specimen; the white arrows indicate some of the multiple crack initiations on the external surface.

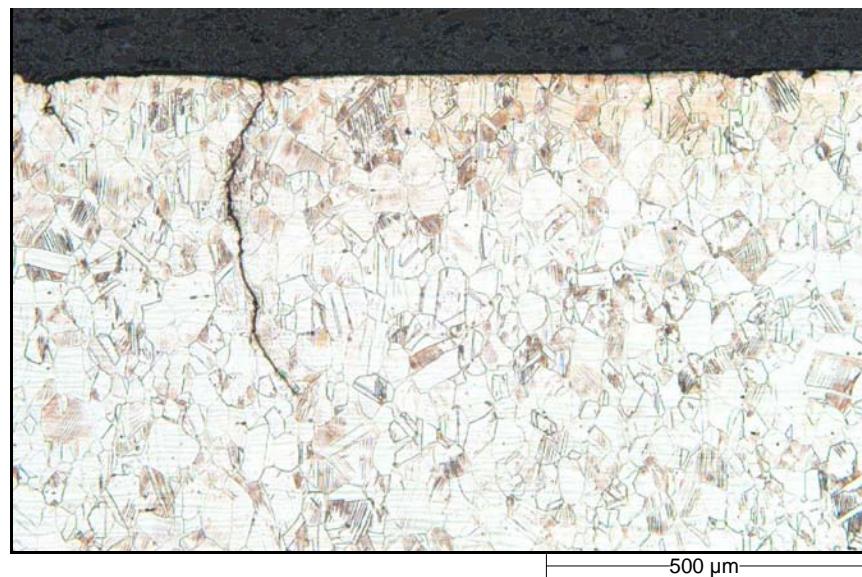
Figure 4-15
Typical view of microstructure with transgranular crack originating from external surface.

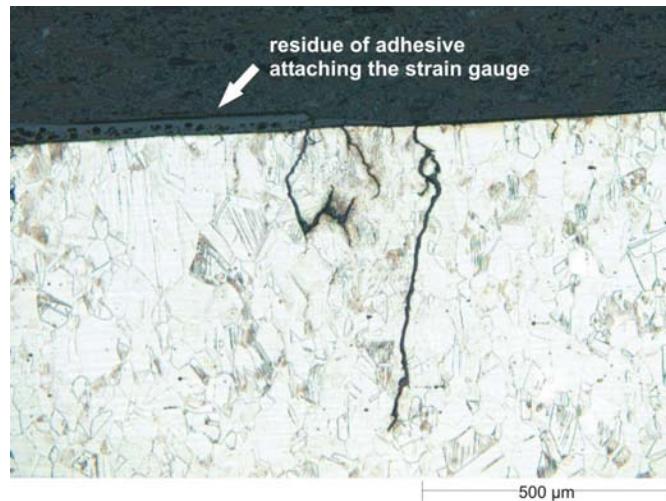
Cracking also occurred immediately underneath the intrados strain gauge, which was positioned centrally within the array of circumferential indications. In the course of examination, it was observed that the intrados strain gauge had fractured and disbanded from the tube's surface as shown in Figure 4-17.

Figure 4-16
Transgranular cracking in area where strain gauge was positioned.

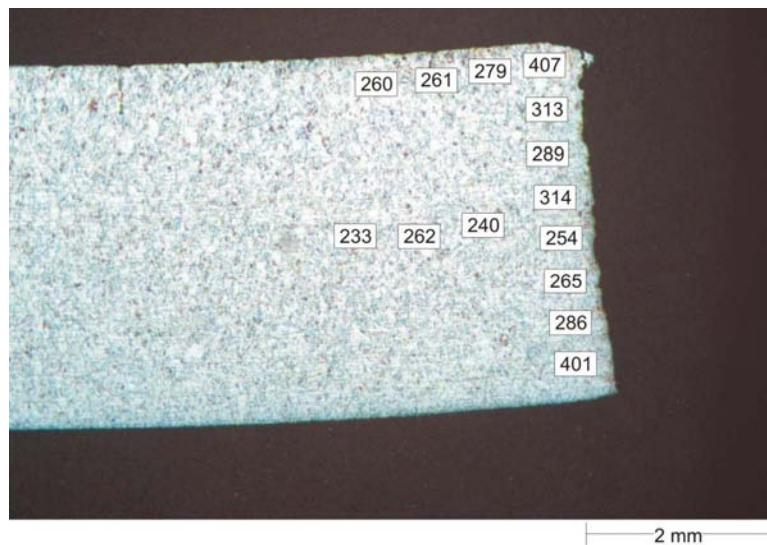
Figure 4-18
Hardness readings obtained.

Vickers micro hardness (100g load) measurements were conducted along the primary fracture and in the base metal of the prepared metallographic specimen, as displayed in Figure 4-18. Generally the readings ranged from 233 HV to 314 HV and corresponded with previously obtained results. However, the readings adjacent to the edges at the internal and external surface exhibited higher numbers with 401 HV and 407 HV, respectively.

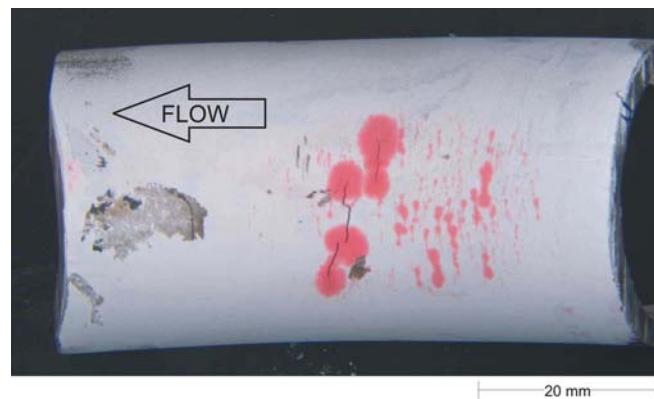
Similar to BLT 2, the external surface of the intrados exhibited an array of multiple circumferential crack indications as displayed in Figure 5-10. The internal surface of the intrados disclosed the through wall defect as well as multiple axial indications shown in Figure 5-11. The 90°, 270° position were free of cracking on the external surface, but revealed multiple axial indications on the internal surface as displayed in Figure 5-12 and Figure 5-13. The indications appeared to follow wear marks that most likely originated from the bending mandrel used during manufacturing. The extrados showed similar characteristics, since it was free of cracking on the external surface Figure 5-14 but revealed some weak axial indications as displayed in Figure 5-15.

Figure 5-10
DPI of external surface of intrados exhibiting array of circumferential indications.

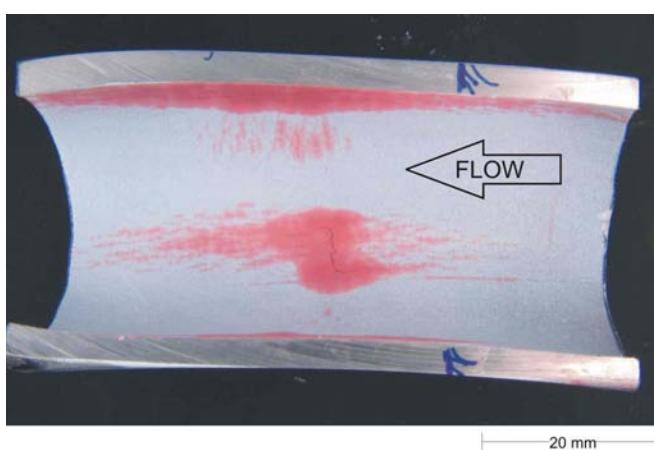
Figure 5-11
DPI of internal surface of intrados.

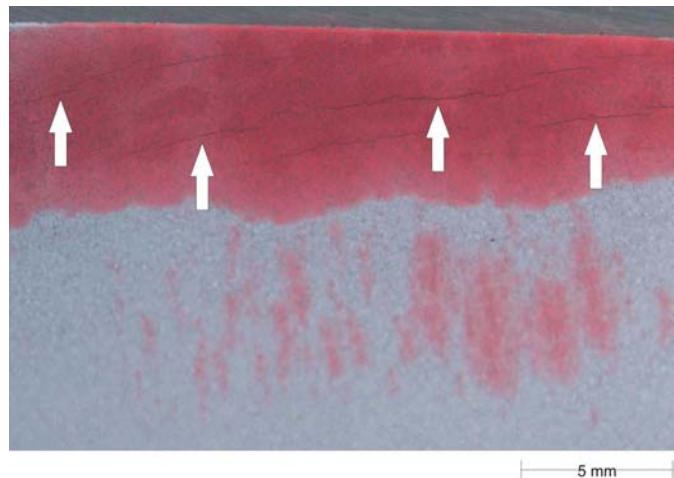
Figure 5-12
Axial crack indications found at the 90° position; some of which are indicated by white arrows.

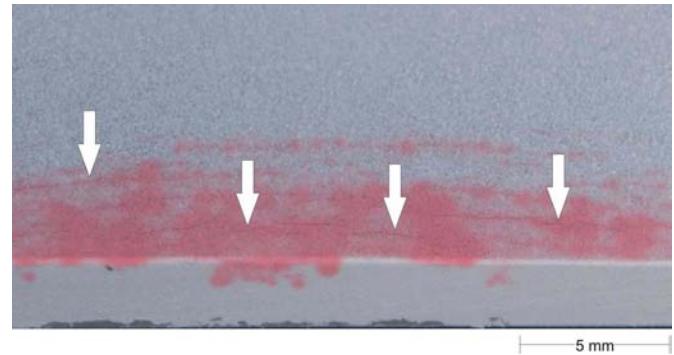
Figure 5-13
Axial crack indications found at the 270° location; some of which are indicated by white arrows.

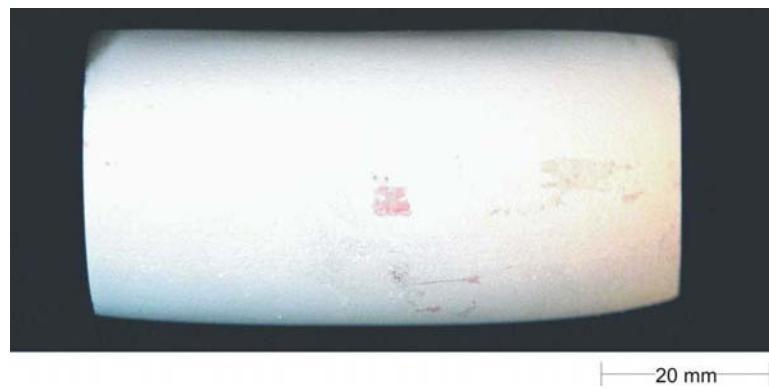
Figure 5-14
No indications found on external surface of the extrados.

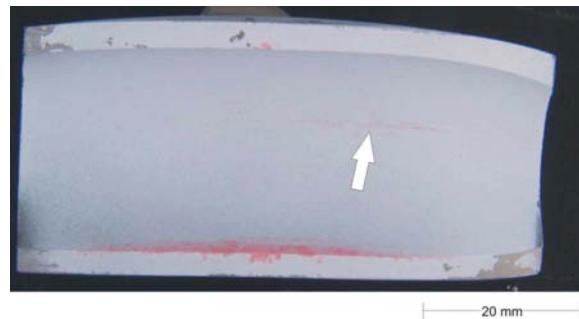
Figure 5-15
Axial crack found on internal surface of extrados as indicated by the white arrow.

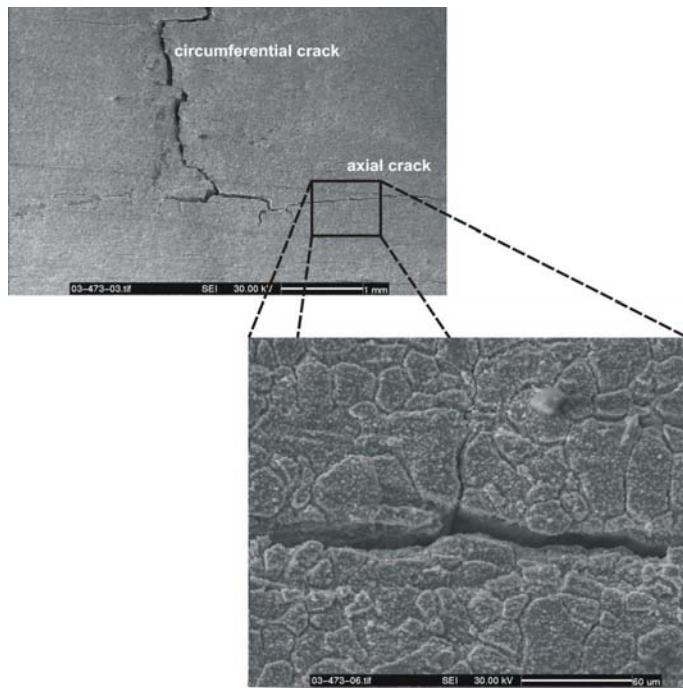
The internal surface of the intrados containing the circumferential through-wall crack was examined with the scanning electron microscope (SEM). The analysis confirmed the findings from visual inspection and DPI by revealing a predominantly circumferential crack. Smaller axial crack indications were found also. It appeared that all three crack indications followed a “given” path along grain boundaries provided by the texture from the picking attack (see Figure 5-16)

Figure 5-16
SEM examination of internal surface of intrados revealing circumferential and axial cracking.

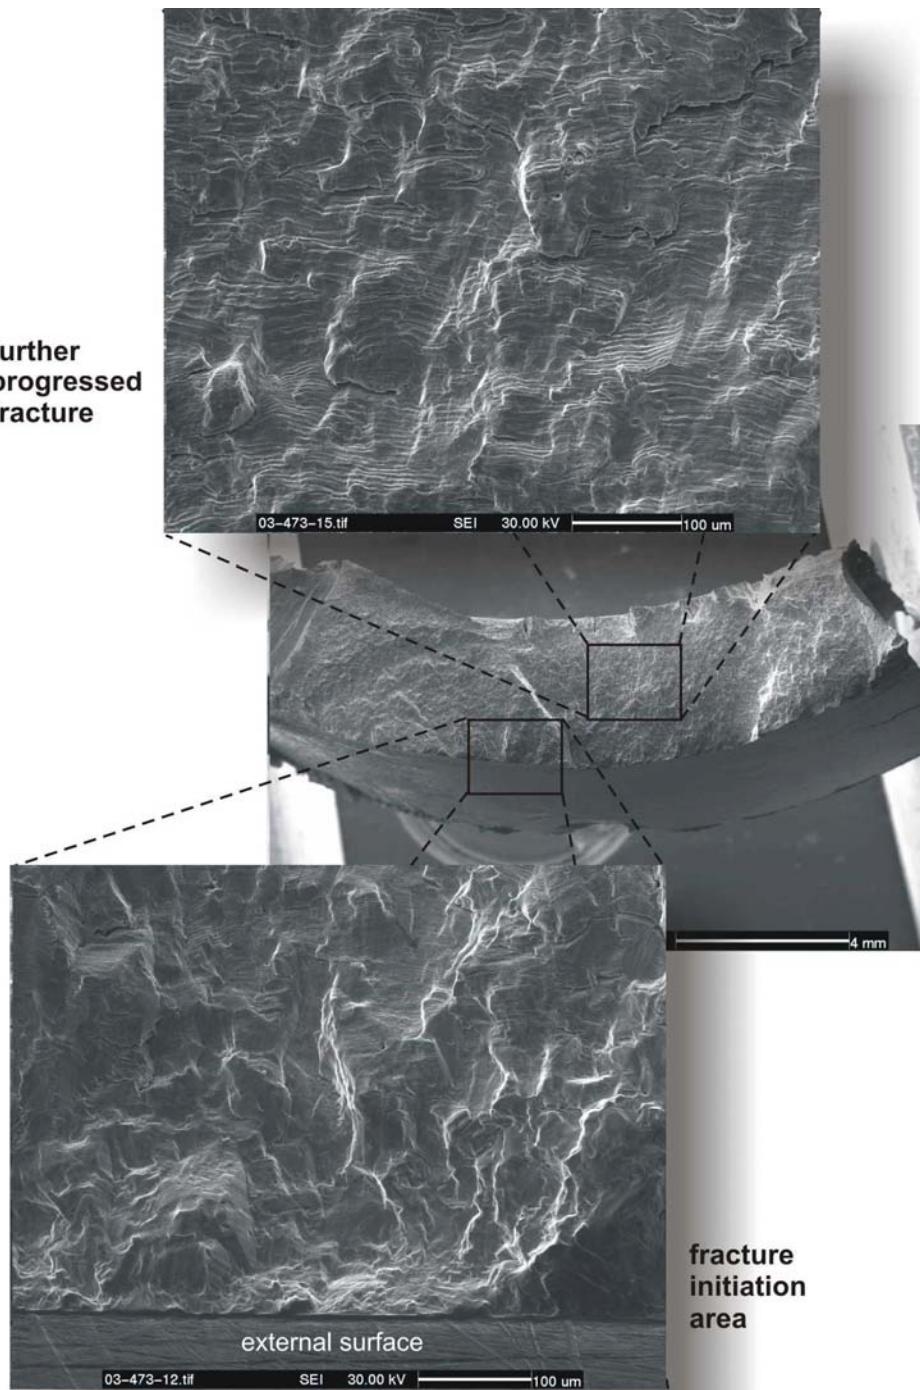
The findings from visual inspection were confirmed, since the fracture surface was dominated by one primary circumferential crack progressing from the external to the internal surface of the intrados. The entire fracture surface exhibited evidence of mechanical fatigue, since striations as a result of step-wise crack propagation during cyclic loading of the bend were found. The initiation area exhibited a striation spacing of approximately 1 μm . With further progression of the crack front, the spacing increased to approximately 5 μm in the mid fracture area and to approximately 20 μm at the last stages of failure. Various stages of the failure are illustrated in Figure 5-18.

Figure 5-18
Broken open primary fracture used for SEM examination.

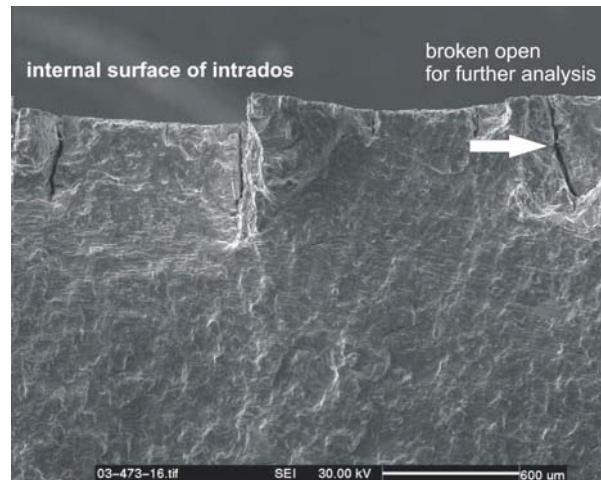
The internal surface of the intrados also disclosed multiple axial fissures as displayed in Figure 5-19. One representative axial fissure was broken open and analyzed with the SEM. The fracture surface also revealed a striation pattern indicating a step-wise crack progression under cyclic loading. However, the spacing was determined as 0.5 μm to 1 μm and thus found to be finer if compared to the primary mechanical driven fracture. The crack progression of this axial fissure occurred from the internal towards the external surface. The fracture surface was partly altered by the HT water during testing, but the morphology still indicated a combined environmental and mechanical effect as to be expected during corrosion fatigue (see Figure 5-20).

Figure 5-19
Axial cracking found on the internal surface of intrados.

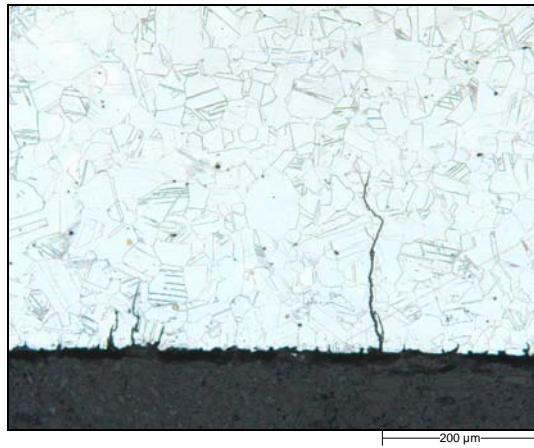
The extrados (Specimen S4) exhibited axial cracking that propagated in a transgranular manner from the internal towards the external surface as displayed in Figure 5-25. The maximum crack depth was determined as approximately $200\text{ }\mu\text{m}$ (approximately 6 % of the tube's nominal wall thickness). At this location, too, the attacked grain boundaries appeared to have influenced the crack initiation process.

Figure 5-25
Typical view of cross-section at the extrados (Specimen S4) showing transgranular axial cracking progressing from the internal towards the external surface.

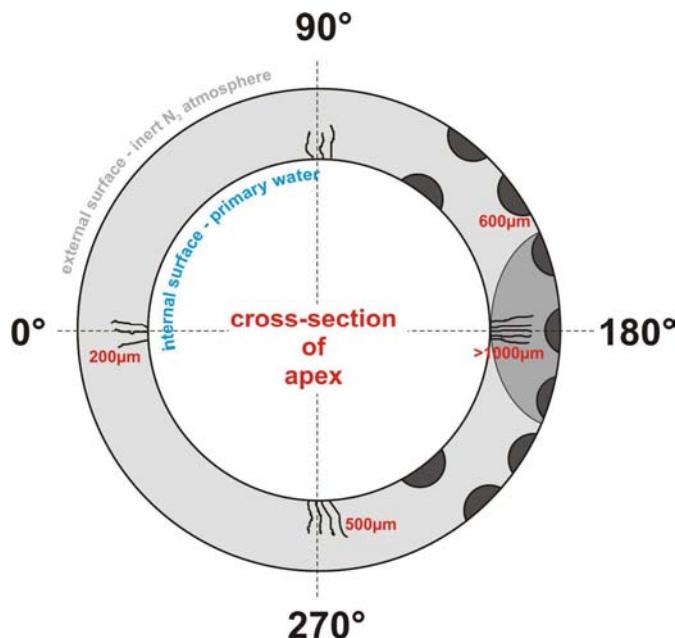
Figure 5-26
Cross-sectional sketch of apex schematically showing all crack indications and their depths (if available); please note that sketch is not to scale.

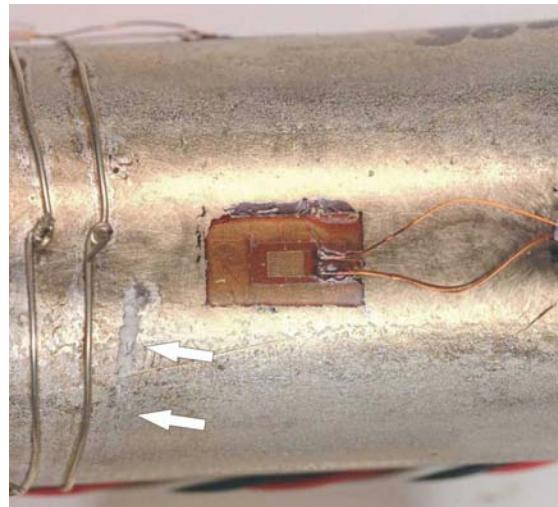
Visual inspection revealed one primary circumferential crack with an approximate length of 10 mm to 12 mm as displayed in Figure 6-9 and Figure 6-10. This defect was located in the intrados area (approximate 200° position) and had developed into a through-wall defect causing leakage of the simulated primary water as also indicated by some boric acid that had crystallized along this fracture. The crack had initiated from the external surface at a circumferential scratch present on the bend. No other primary defects visible to the naked eye were found on the external surface during visual inspection.

Figure 6-9
Circumferential intrados defect as observed after test termination; the white remnants originated from crystallized boric acid.

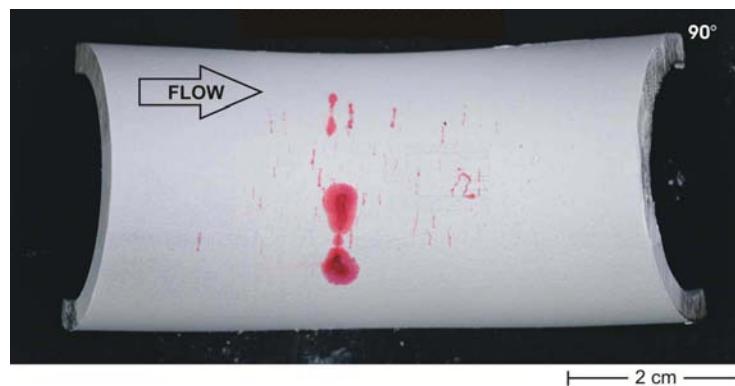
The external surface of the intrados area exhibited an array of circumferential cracks including the defect causing leakage similar to previously tested bends (see Figure 6-11). No further indications were found on all other external positions of the bend.

Figure 6-11
External surface of intrados showing array of circumferential cracks.

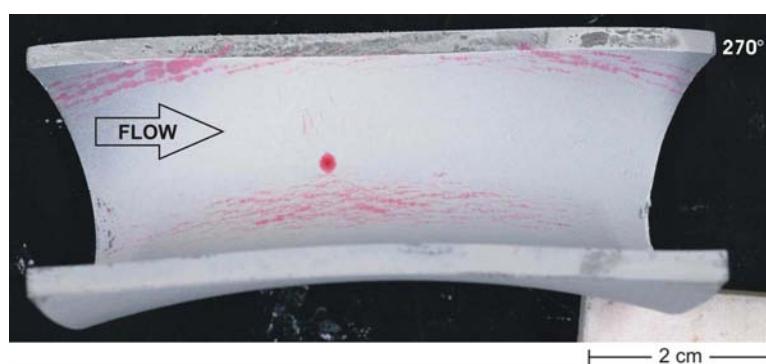
DPI of the internal intrados surface showed multiple axial cracking and the through wall defect formed by the one circumferential fissure mentioned above (see Figure 6-12). Also fine circumferential cracking was found on the internal surface of the intrados. The internal surfaces of the extrados, the 90° and the 270° position all showed axial cracking to varying degrees as displayed in Figure 6-13 to Figure 6-15.

Figure 6-12
Internal surface of intrados showing multiple axial cracking and the defect causing leakage in the form of a spot-like indentation in the middle of the halfshell.

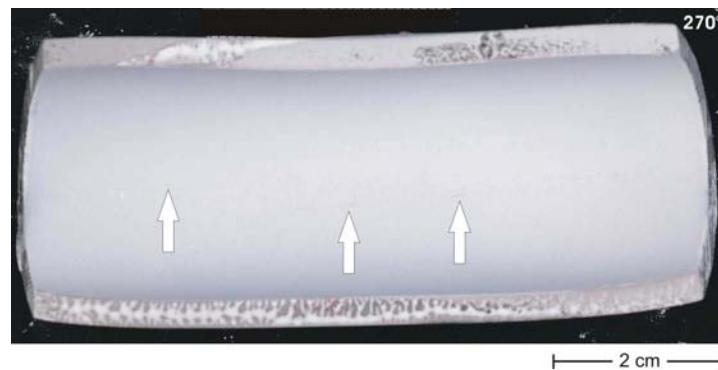
Figure 6-13
Internal surface of extrados showing very fine axial cracking.

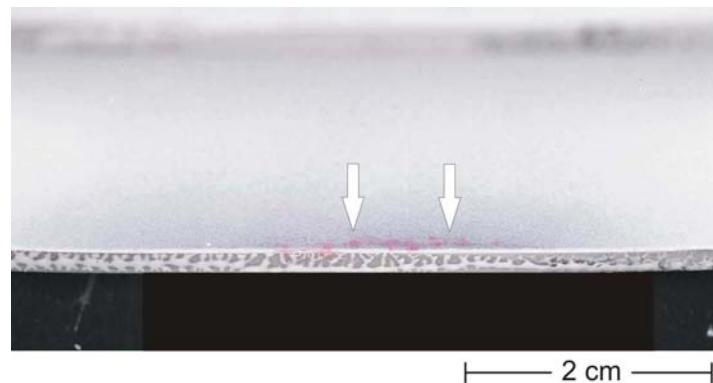
Figure 6-14p
Internal surface of 90° position showing axial cracking.

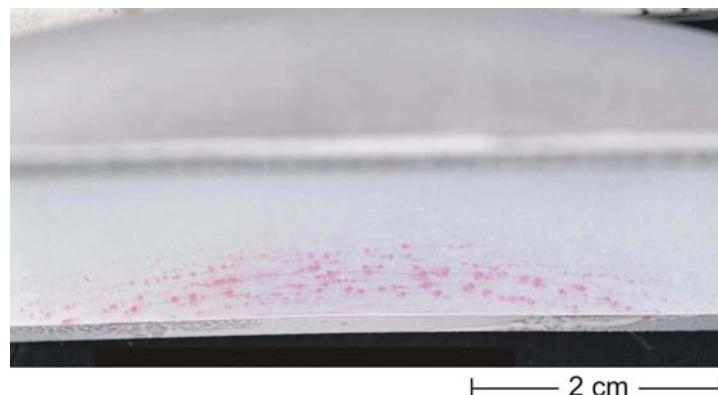
Figure 6-15
Internal surface of 270° position showing axial cracking.

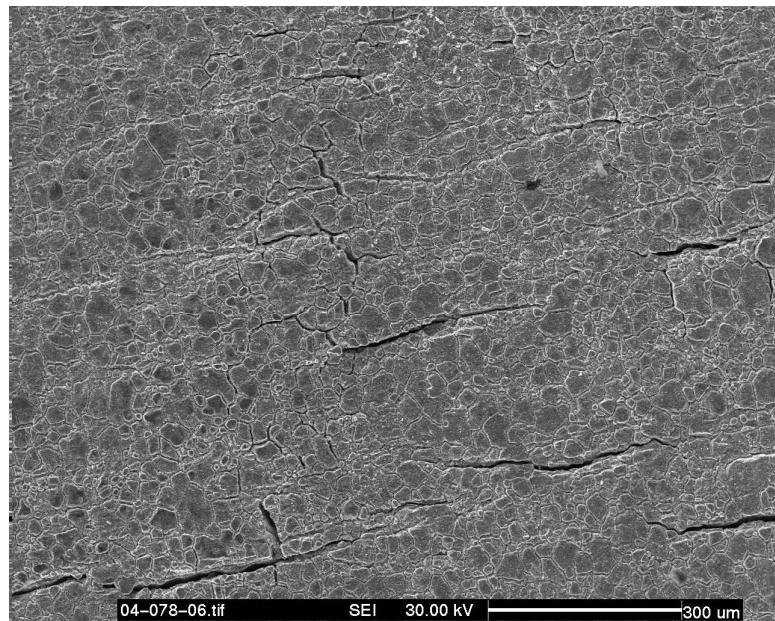
Figure 6-19
SEM of internal intrados surface also showing circumferential cracking to a certain degree.

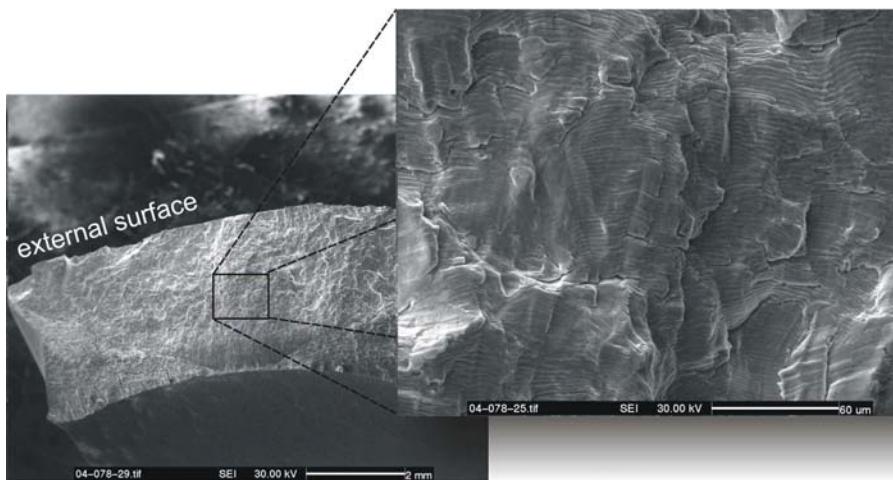
The primary circumferential crack was broken open for fractography. Figure 6-20 displays the specimen used for analysis. The defect causing leakage was characterized as mechanical fatigue indicated by striations typical for step-wise crack progression under cyclic loading as displayed in Figure 6-21. The crack progression occurred from the external towards the internal surface. The area typically considered a mid fracture area revealed a striation spacing of approximately $2.5 \mu\text{m}$, whereas the final stages of this fracture exhibited numbers greater than $20 \mu\text{m}$.

Figure 6-21
Typical view of circumferential mid fracture area; the striations clearly indicate step-wise crack progression typical for mechanical fatigue.

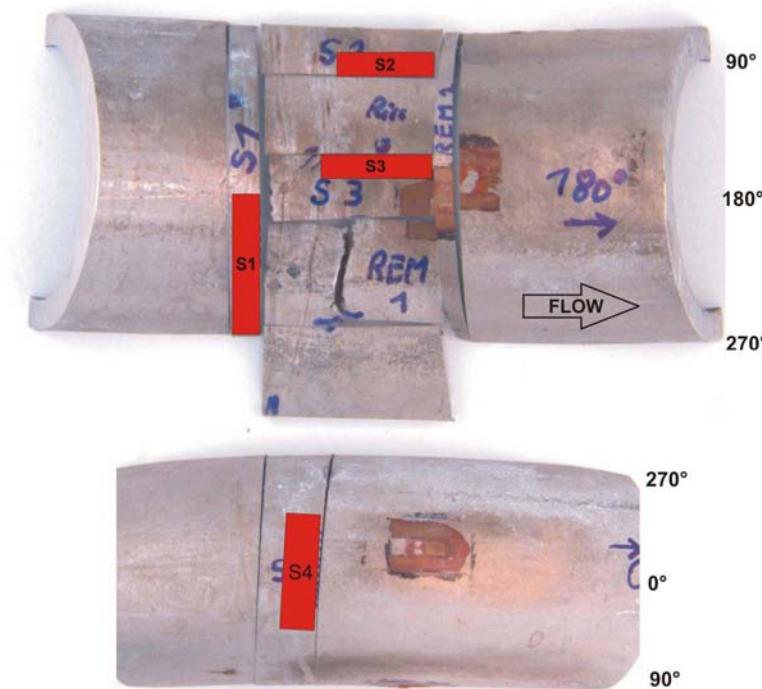
Figure 6-25
Specimen removal for metallographic examination; the red squares numbered from S1 to S4 indicate the locations of specimen extraction.

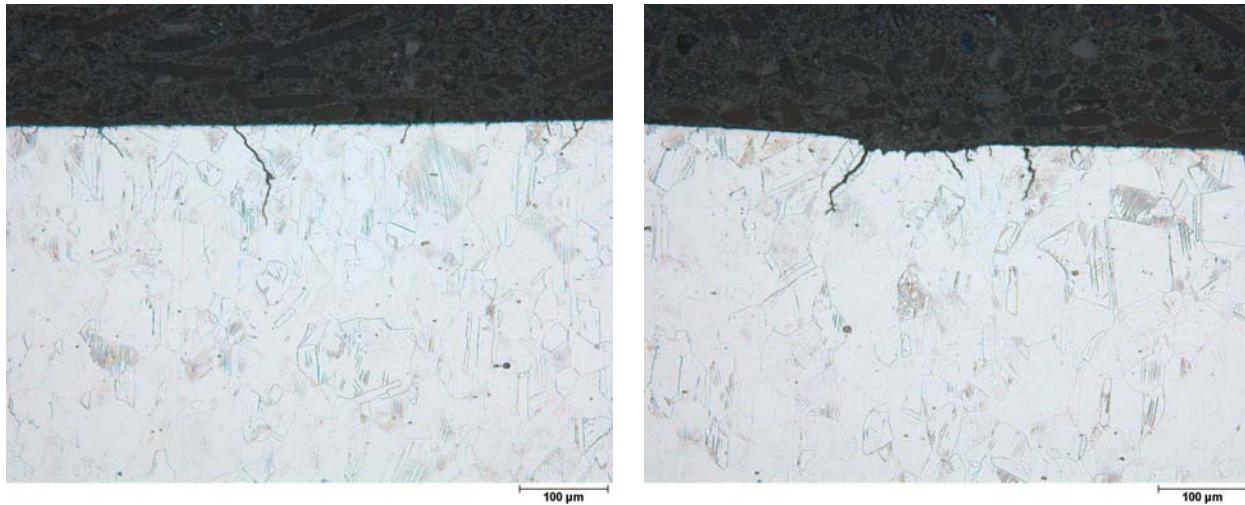
Figure 6-26

The external 180° intrados position exhibited circumferential cracking, propagating in a transgranular manner from the external to the internal surface (see Figure 6-26). At this particular location, the crack depth was determined to be approximately 100 μm (about 3 % of the nominal wall thickness). The internal 180° intrados position also exhibited circumferential cracking as displayed in Figure 6-27. There the maximum observed crack depth was approximately 250 μm (approx. 7 % of the nominal wall thickness).

Typical views of cross section of the external 180° intrados position (Specimen S3); transgranular, circumferential cracks propagating from the external towards the internal surface.

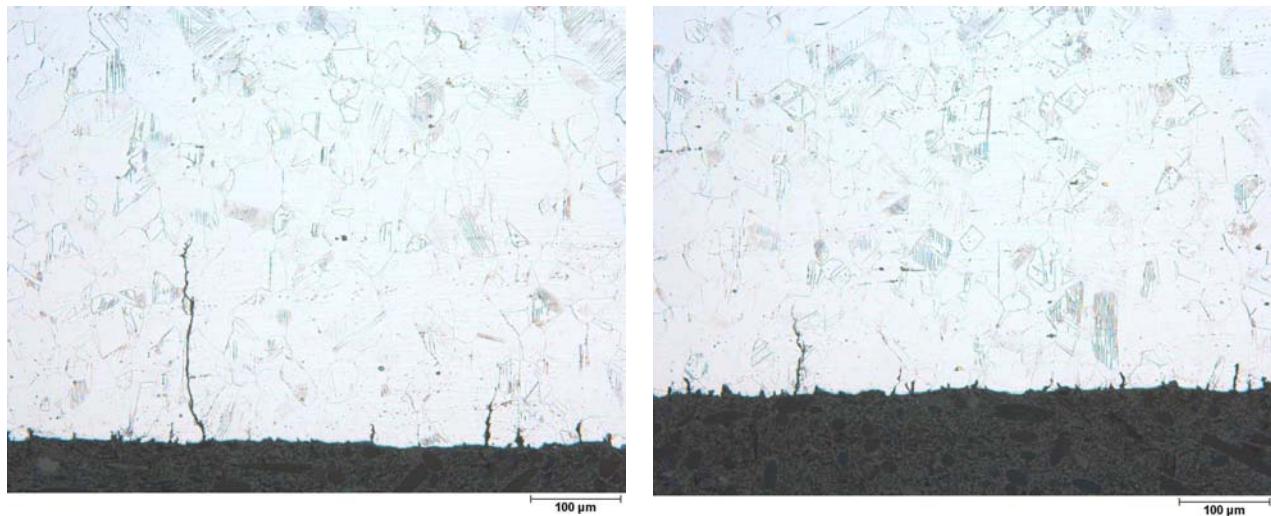
Figure 6-27

Typical views of cross section of the internal 180° intrados position (Specimen S3); transgranular, circumferential cracks propagating from the internal towards the external surface.

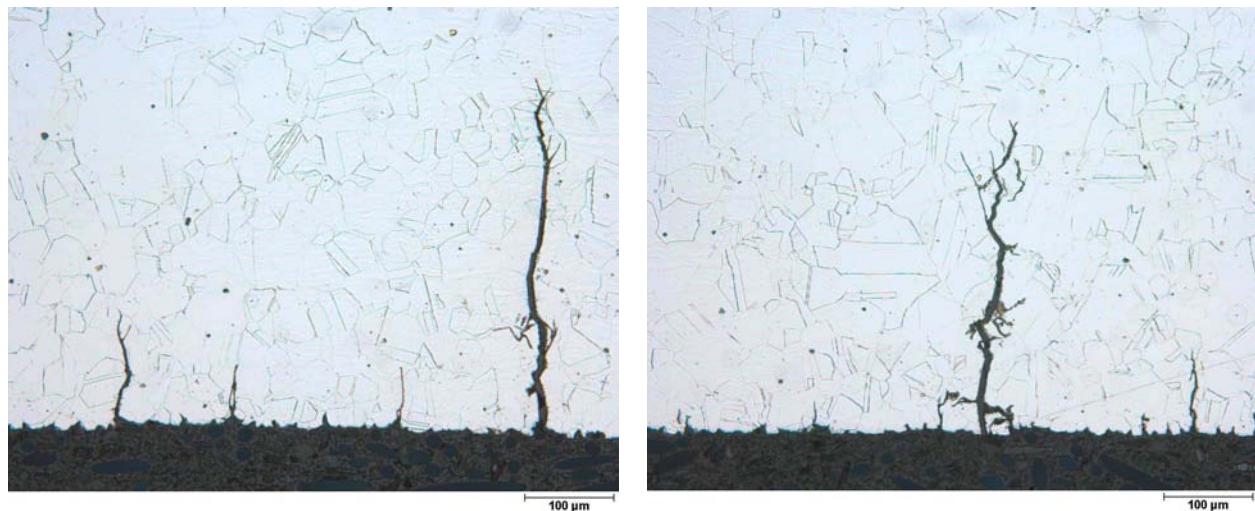
Figure 6-28

The 270° position exhibited slightly branched transgranular axial cracking that progressed from the internal towards the external surface as shown in Figure 6-28. The crack appearance suggested an environmental effect on the failure mechanism, confirming the results from SEM

examination. This cross-section showed a maximum crack depth of approximately 400 μm representing about 12 % of the nominal wall thickness.

Typical views of cross section of the internal 270° position (Specimen S1); environmental, axial cracks propagating from the internal towards the external surface in a transgranular manner; crack initiation appeared to have occurred at attacked grain boundaries from pickling treatment.

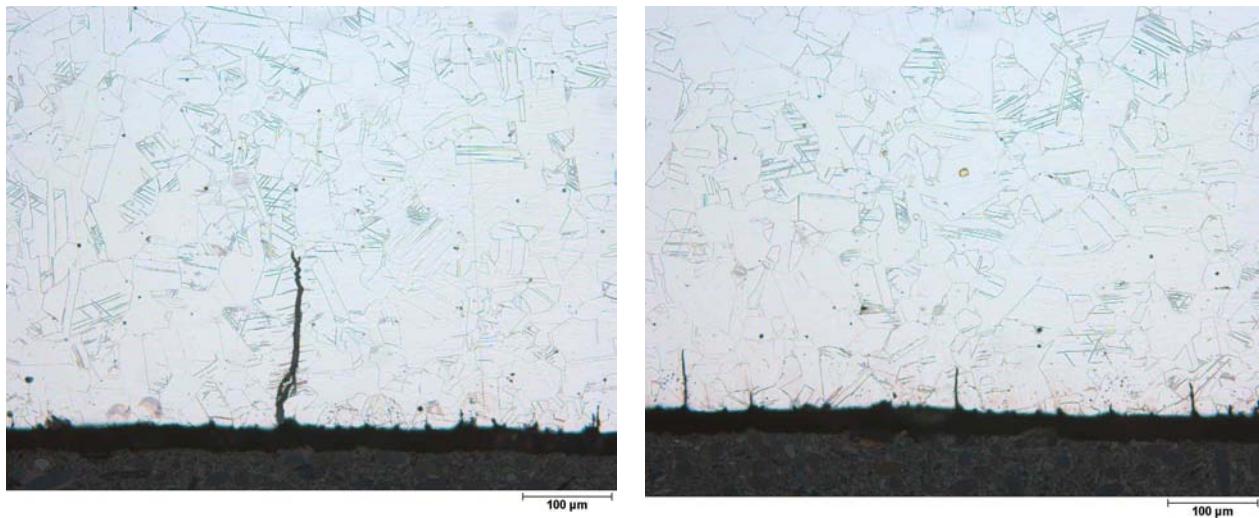
**Figure 6-31**

The 0° extrados position revealed axial, transgranular cracking propagating from the internal towards the external surface as shown in Figure 6-31. The crack appearance also suggested an environmental effect on the propagation, with initiation predominantly occurring at attacked grain boundaries. The approximate crack depth was determined to be 200 μm , representing about 6 % of the nominal wall thickness.

Typical views of the internal 0° extrados position (Specimen S4); environmental, axial cracks propagating from the internal towards the external surface in a transgranular manner; crack initiation appeared to have occurred at attacked grain boundaries from pickling treatment.

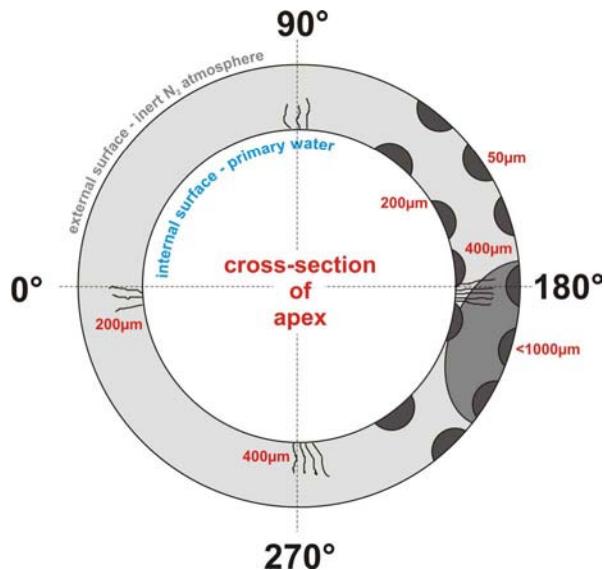
Figure 6-32
Schematic summary of crack locations, orientation and approximate crack depths (if available); schematic provides a cross-sectional view of the apex looking down-stream; please note that schematic is not to scale.

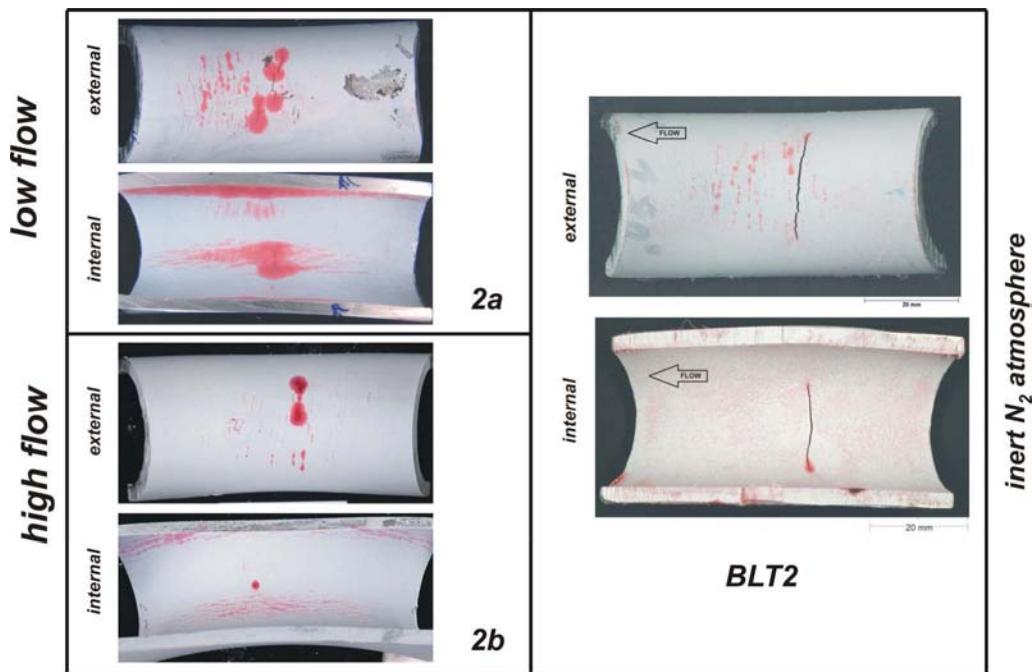
Figure 7-1
Summary of DPI results.

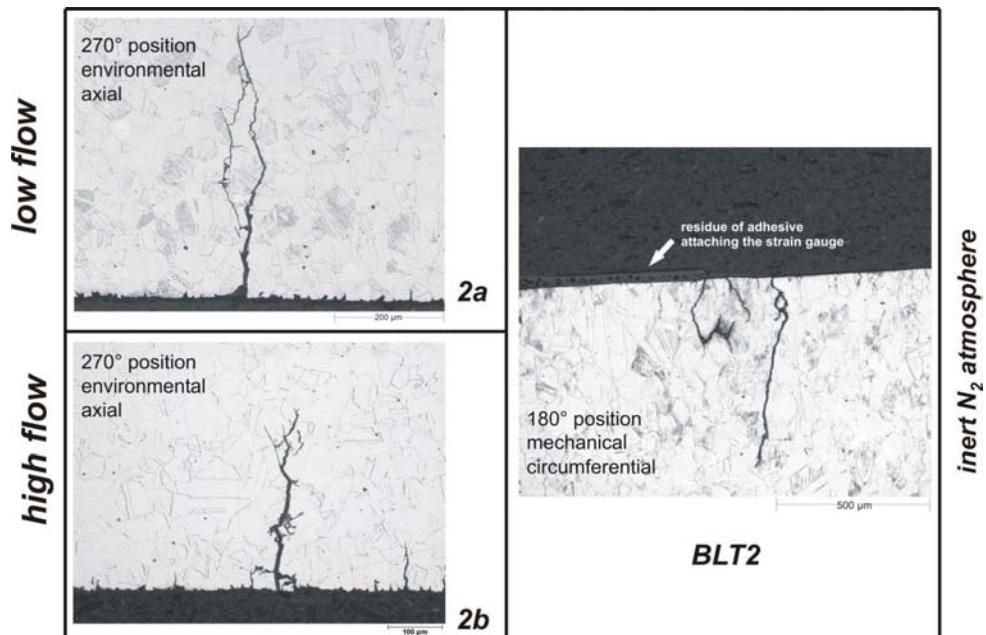
Figure 7-2
Summary of metallographic examination.

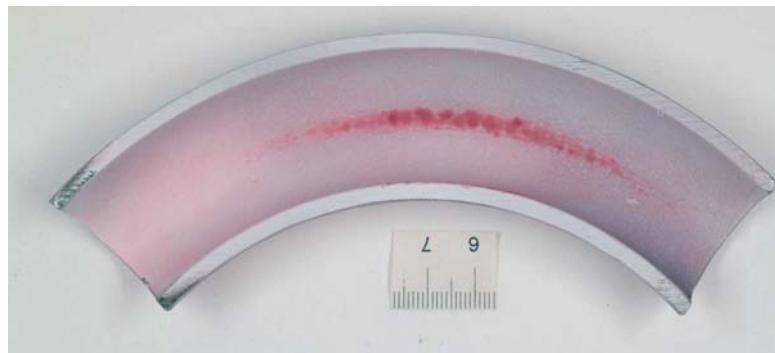
The 90° Position disclosed a similar failure appearance with a narrow band of multiple axial cracking on the internal surface, as shown in Figure 8-13. However, the cracking at this bend location had not developed into a through-wall defect, since the external surface was free of indications.

Figure 8-13
Internal surface of 90° position showing multiple axial cracking.

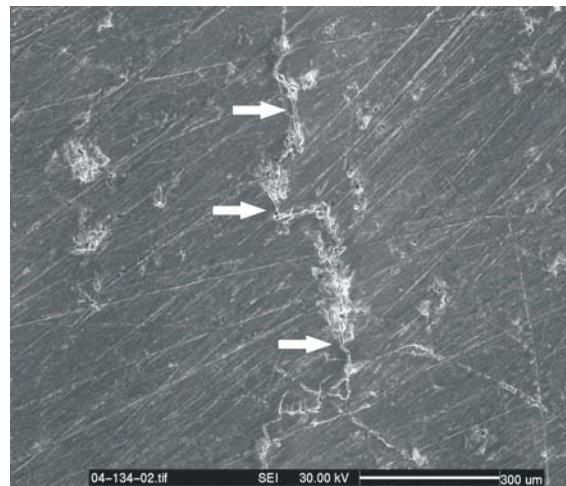
Figure 8-15
External surface of intrados showing fine circumferential cracking.

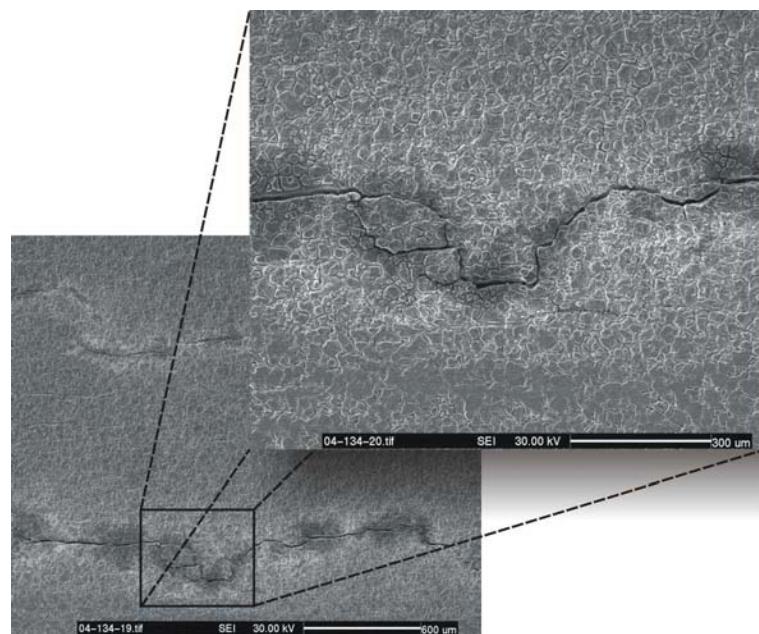
Figure 8-17
Internal surface of 90° position showing axial cracking following attacked grain boundaries from pickling attack.

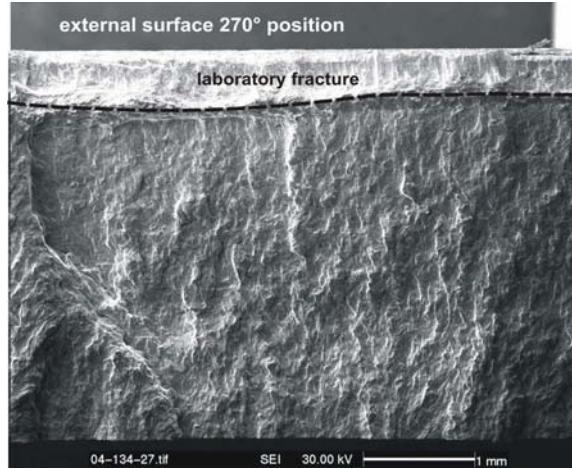
As a next step, one representative axial crack found in the 270° position was broken open for analysis. Figure 8-21 illustrates the laboratory fracture as well as the actual fracture surface to be investigated. Similar to the 180° circumferential crack, this location also revealed a fracture appearance with striations indicating a step-wise crack progression under cyclic loading. However, the generally flatten morphology and the fact of the multiple crack presence at this location indicated corrosion fatigue. Additionally, this is confirmed by the fact that the fracture progressed from the internal towards the external surface.

The striation spacing was then determined by evaluating corresponding images of the fracture surface. The spacing in the area associated to crack initiation was determined as approximately 1 μm. The mid fracture area showed a spacing of approximately 3 μm. The final stages of the crack revealed a striation spacing of approximately 7 μm.

Figure 8-21
Broken open axial crack at 270° position.

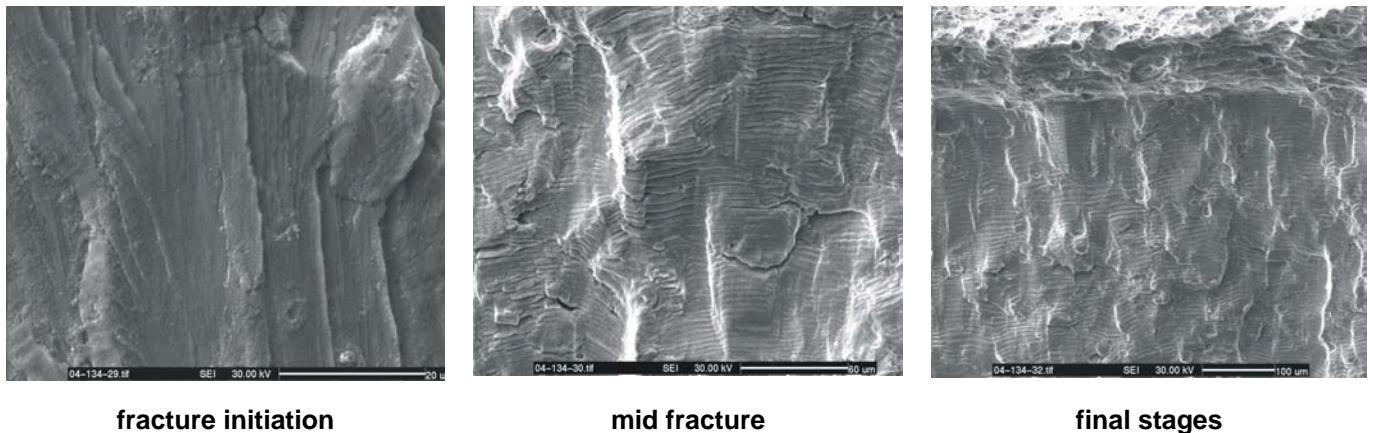
Typical views of fracture surface found at the 270° position; the morphology indicates step-wise crack progression under the combined influence of mechanical loading and environment.

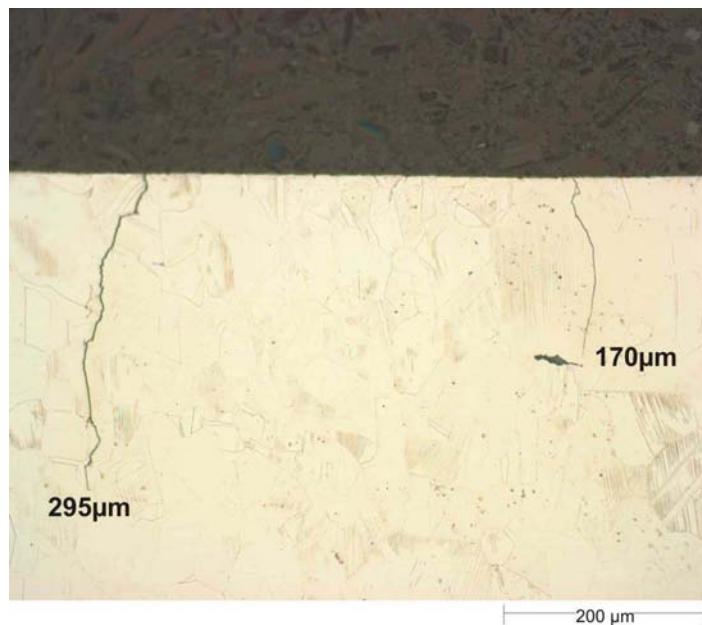
The 180° position exhibited circumferentially oriented cracking, originating on the external surface. The propagation mode was transgranular and the maximum depth within this prepared cross-section was determined to be 295 μm, representing approximately 9 % of the tube's nominal wall thickness. A typical view of this circumferential cracking is displayed in Figure 8-26.

Figure 8-26
Typical views from the 180° position showing circumferential cracking progressing from the external towards the internal surface.
