Materials Reliability Program: Environmental Fatigue Testing of Type 304L Stainless Steel U-Bends in Simulated PWR Primary Water (MRP-137)

1008207

Technical Update, December 2004

Framatome ANP GmbH

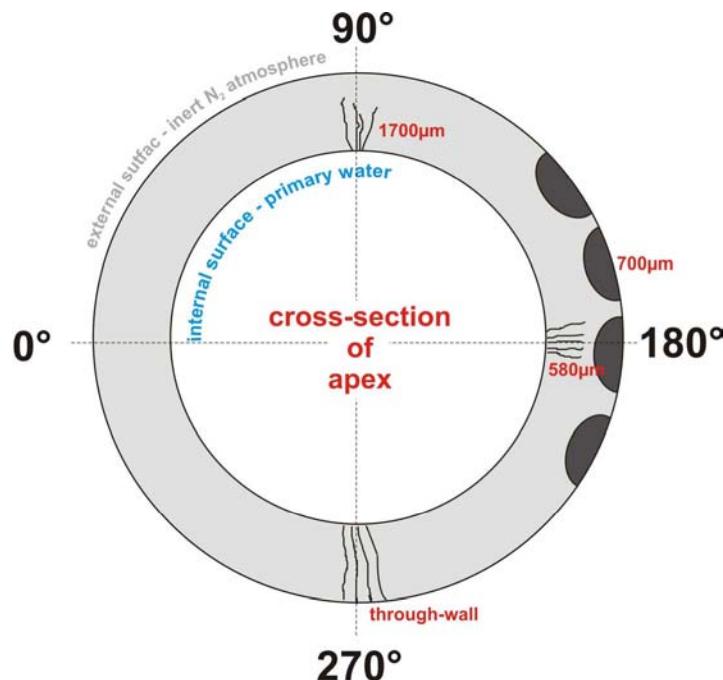
Figure 8-28

- Leakage due to internally initiated axial through-wall cracking in the 270° position;
- At 90°, 180° and position axial cracking on internal surface
- Array of multiple circumferential cracks on the external surface of intrados (180° position)

- No circumferential internal cracking
- The extrados position was free of cracking both internally and externally
- All cracks were transgranular and showed features typical of fatigue; all internal axially initiated cracks showed evidence of environmental assisted progression (corrosion fatigue)

Schematic summary of crack locations, orientation and approximate crack depths (if available) of Test 4a; schematic provides a cross-sectional view of the apex looking downstream; please note that schematic is not to scale.

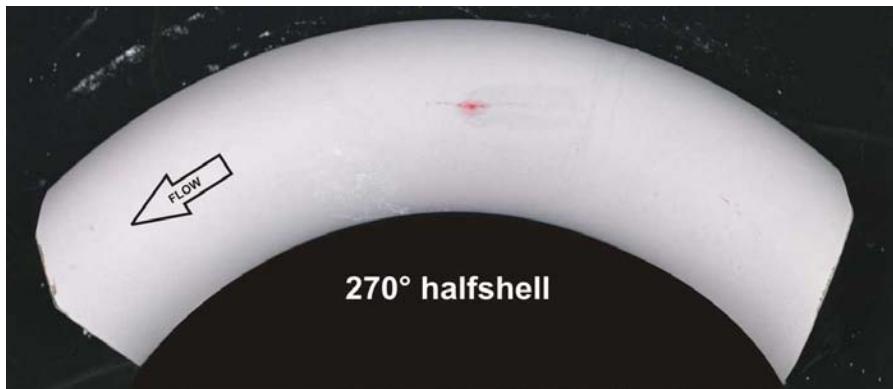
The findings from visual inspection were confirmed, since the 270° position exhibited an axial fissure on the external surface as shown in Figure 8-12. The internal surface of the same location exhibited a narrow band of multiple axial cracking, which extended over a length of approximately 70 mm as displayed in Figure 9-13.

Figure 9-12
External surface at 270° position revealing axial through-wall defect.

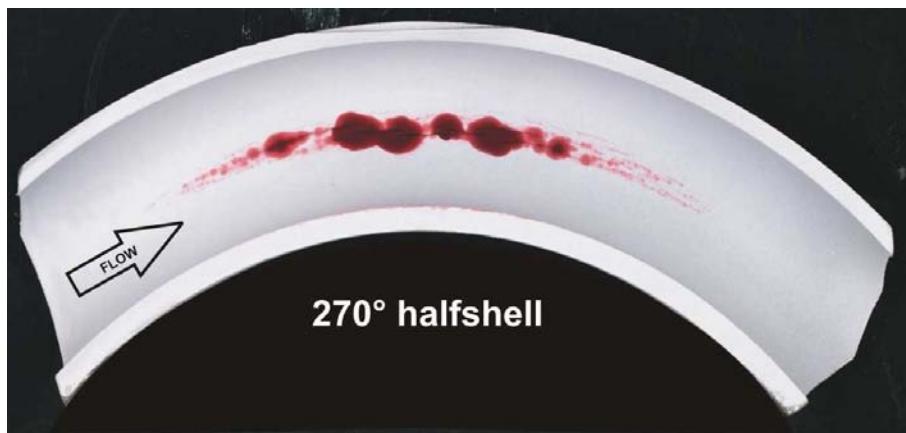
Figure 9-13
Internal surface at 270° position revealing multiple axial cracking.

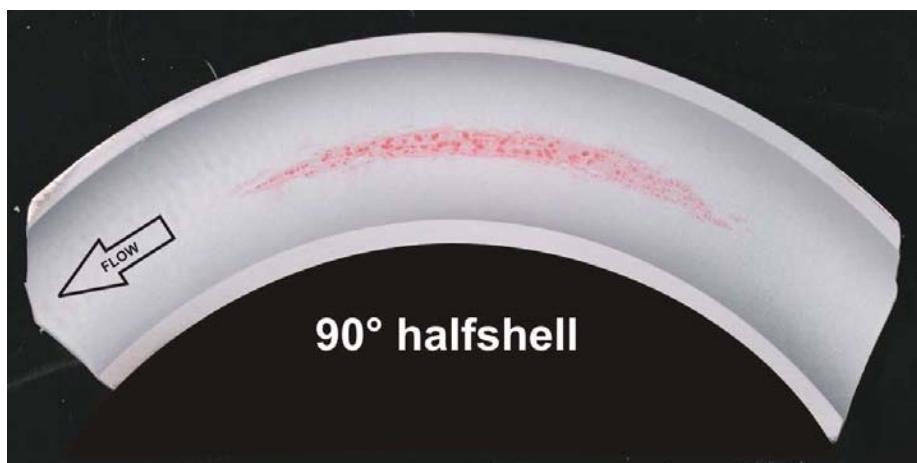
Also, the internal surface at the 90° position revealed a narrow band of axial cracking showing similar extensions. However, the cracking was less pronounced if compared to the 270° position (see Figure 9-14). The external surface at the 90° position was free of indications.

Figure 9-14
Internal surface at 90° position revealing multiple axial cracking.

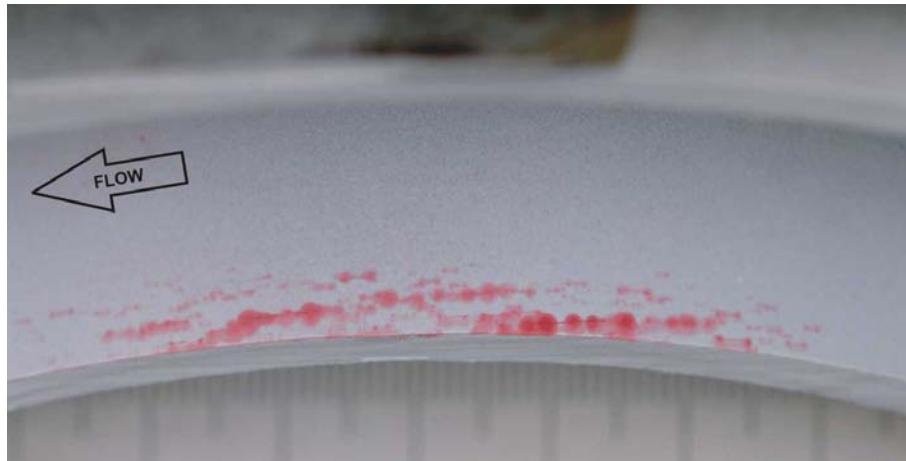
The 180° intrados position also revealed a narrow band of multiple axial cracking on the internal surface as shown in Figure 9-15. The external surface of this location was free of cracking. The 0° extrados position was free of cracking both on the internal and external surfaces.

Figure 9-15
Internal surface at 180° intrados position revealing multiple axial cracking.

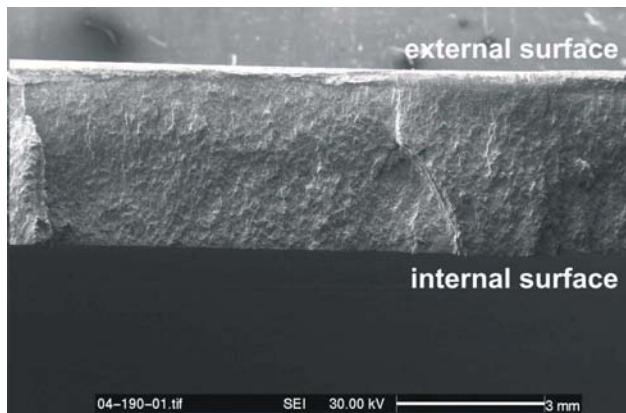
One representative crack of the primary defect causing leakage was broken open to allow fractography at higher magnifications. Figure 9-19 displays the specimen used for SEM examination. This location revealed a fracture appearance with striations indicating a step-wise crack progression under cyclic loading. The fact that the fracture progressed from the internal towards the external surface, the general morphology and the multiple crack presence at this location indicated corrosion fatigue. The striation spacing was then determined by evaluating corresponding images of the fracture surface. The spacing in the area associated with crack initiation was determined as approximately 1.5 μm . The mid fracture area showed a spacing of approximately 1.2 μm . The final stages of the crack disclosed a striation spacing of approximately 3.5 μm . Typical views of the different zones of the opened fracture are shown in Figure 9-20.

Figure 9-19
Opened axial fracture of 270° position.

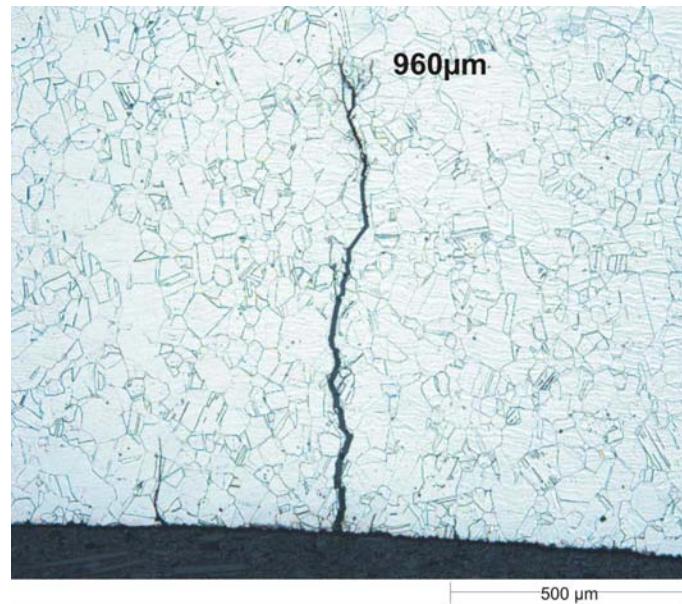
Also, the 180° position exhibited transgranular axial cracking propagating from the internal towards the external surface. The approximate crack depth within this prepared cross-section was determined as 960 μm , representing about 28 % of the tube's wall thickness. Figure 9-23 displays a typical example of cracking found in this position.

Figure 9-23
Cross-sectional view of 180° position showing multiple transgranular cracks propagating from the internal towards the external surface (Specimen S1); the numbers represent approximate crack depths.

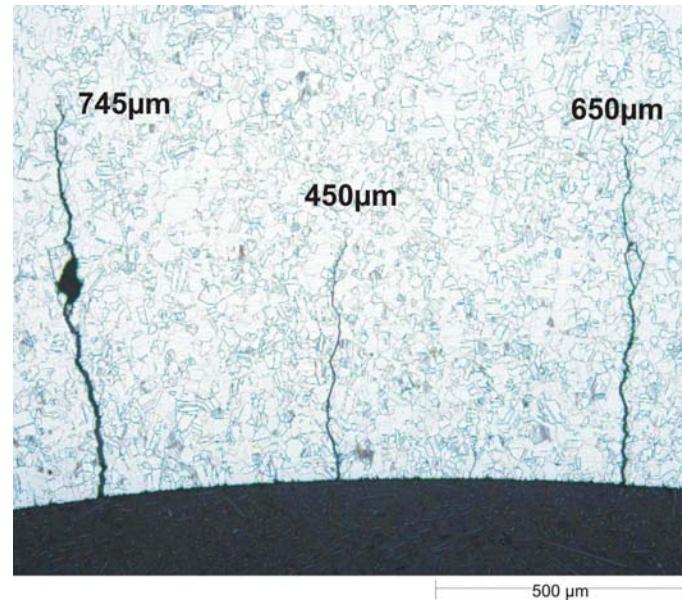
The 90° position presented very similar findings with multiple axially oriented, transgranular cracking that had initiated on the internal surface and propagated towards the external surface. The maximum crack depth within this prepared cross-section was determined as 745 μm , representing about 22 % of the tube's wall thickness. Figure 9-24 displays a typical example of cracking found in the 90° position.

Figure 9-24
Cross-sectional view of 90° position showing multiple transgranular cracks propagating from the internal towards the external surface (Specimen S2); the numbers represent approximate crack depths.

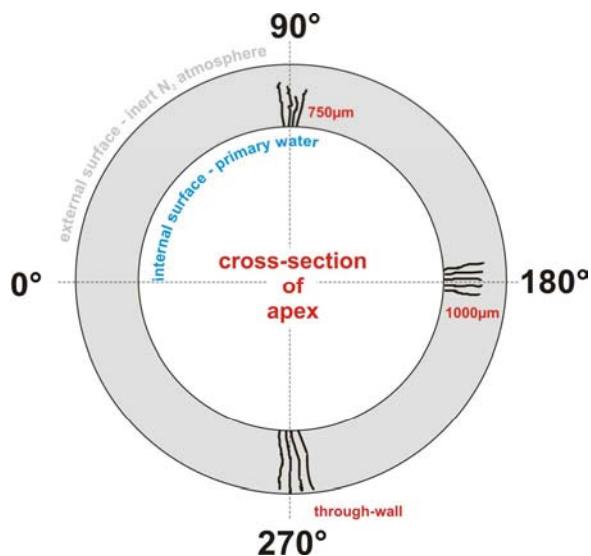
Figure 9-25

- Water chemistry within the range of specified values
- ECP -550 mV_{H,T}, Redox Pot. -450 mV_{H,T} for high flow rate (≈ 2.1 m/s)
- Total number of cycles: 3616
- Leakage due to internally initiated axial through-wall defect in the 270° position
- Polishing of external surface resulted in no external crack initiation in this test
- All internal defects at 90°, 180° and 270° were axial, environmentally assisted cracks; Initiation appeared to have occurred predominantly along surface texture caused by pickling
- Location 0° was free of cracking
- No internal circumferential cracking was observed
- No microstructural anomalies were observed

Schematic summary of crack locations, orientation and approximate crack depths (if available) of Test 4b; schematic provides a cross-sectional view of the apex looking downstream; please note that schematic is not to scale.

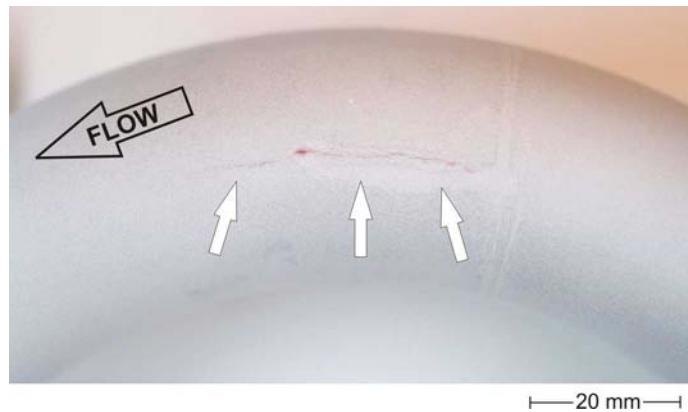
The findings from visual inspection were confirmed since the 270° position exhibited an axial fissure on the external surface as shown in Figure 10-14. The internal surface of the same location exhibited a narrow band of multiple axial cracking, which extended over a length of approximately 60 mm as displayed in Figure 10-15.

Figure 10-14
External 270° position confirming an axial fissure (approximate length 40 mm).

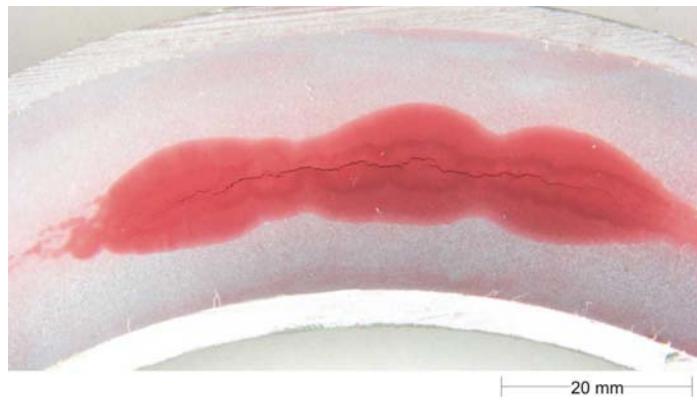
Figure 10-15
Internal 270° position confirming multiple axial cracking (approximate length 60 mm).

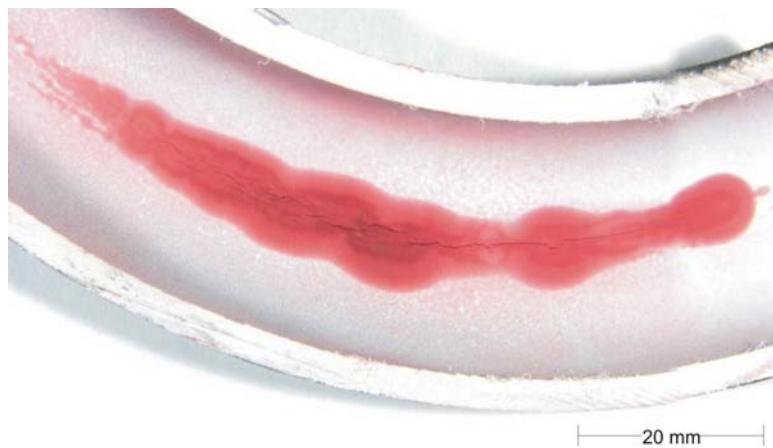
Also, the internal surface at the 90° position revealed a narrow band of axial cracking showing similar extensions as displayed in Figure 10-16. The external surface at the 90° position was free of indications.

Figure 10-16
Internal 90° position confirming multiple axial cracking (approximate length 60 mm).

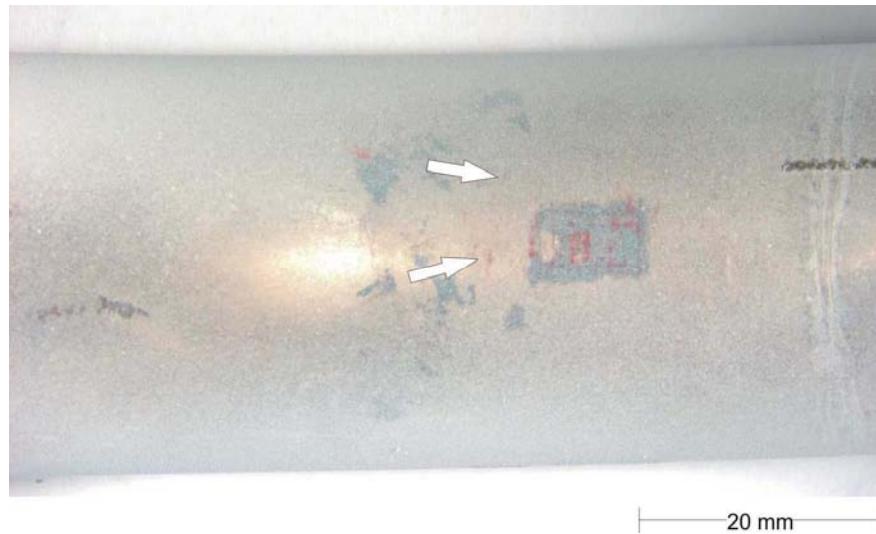
Despite the external surface polishing, which successfully prevented cracking in the previous test (Test 4b), this test again suffered from a small amount of very fine circumferential cracking at the 180° intrados position as displayed in Figure 10-17. The internal surface at the 180° intrados position revealed multiple axial indications. The internal defects at the 180° position were much finer and less pronounced if compared to the 270° and 90° positions, respectively. The extrados position was free of cracking on both the internal and external surfaces.

Figure 10-17
External surface of intrados showing fine circumferential cracking as indicated by white arrows.

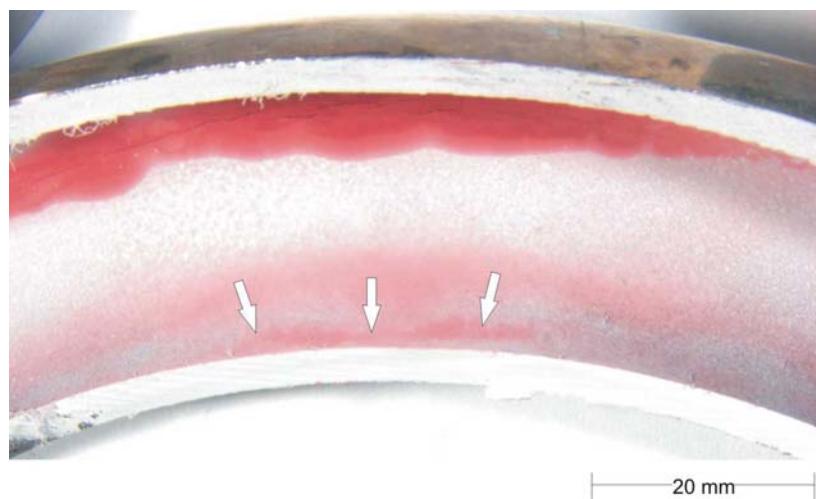
Figure 10-18
Internal 180° intrados position showing axial indications as indicated by white arrows.

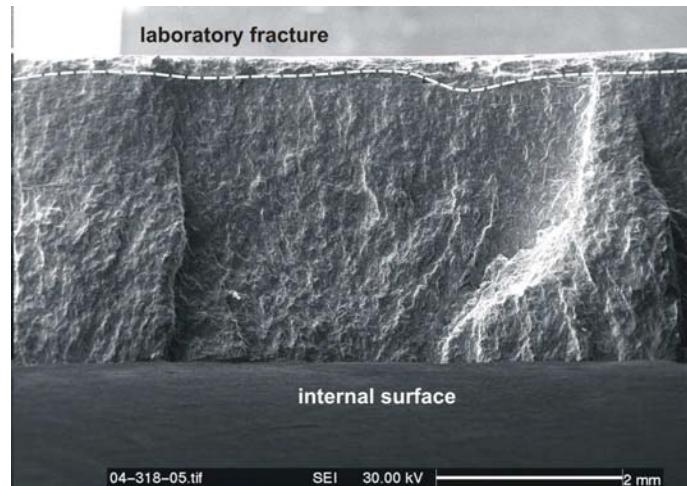
One representative crack from the primary defect causing leakage(270° position) was broken open to allow fractography at higher magnifications. Figure 10-20 displays the specimen used for SEM examination. Figure 10-21 shows close-ups of two areas that were under investigation. These locations revealed a fracture appearance with striations indicating a step-wise crack progression under cyclic loading. The fact that the fracture progressed from the internal towards the external surface, the general morphology and the multiple crack presence at this location indicated corrosion fatigue. The striation spacing was then determined by evaluating corresponding images of the fracture surface. The spacing in the area associated with crack initiation was determined as approximately 0.5 μ m. The mid- fracture area showed a spacing of approximately 1 μ m. The final stages of the crack disclosed a striation spacing of approximately 5 μ m. Typical views of the different zones of the opened fracture are shown in Figure 10-22.

Figure 10-20
Broken open fracture at 270° position used for SEM.

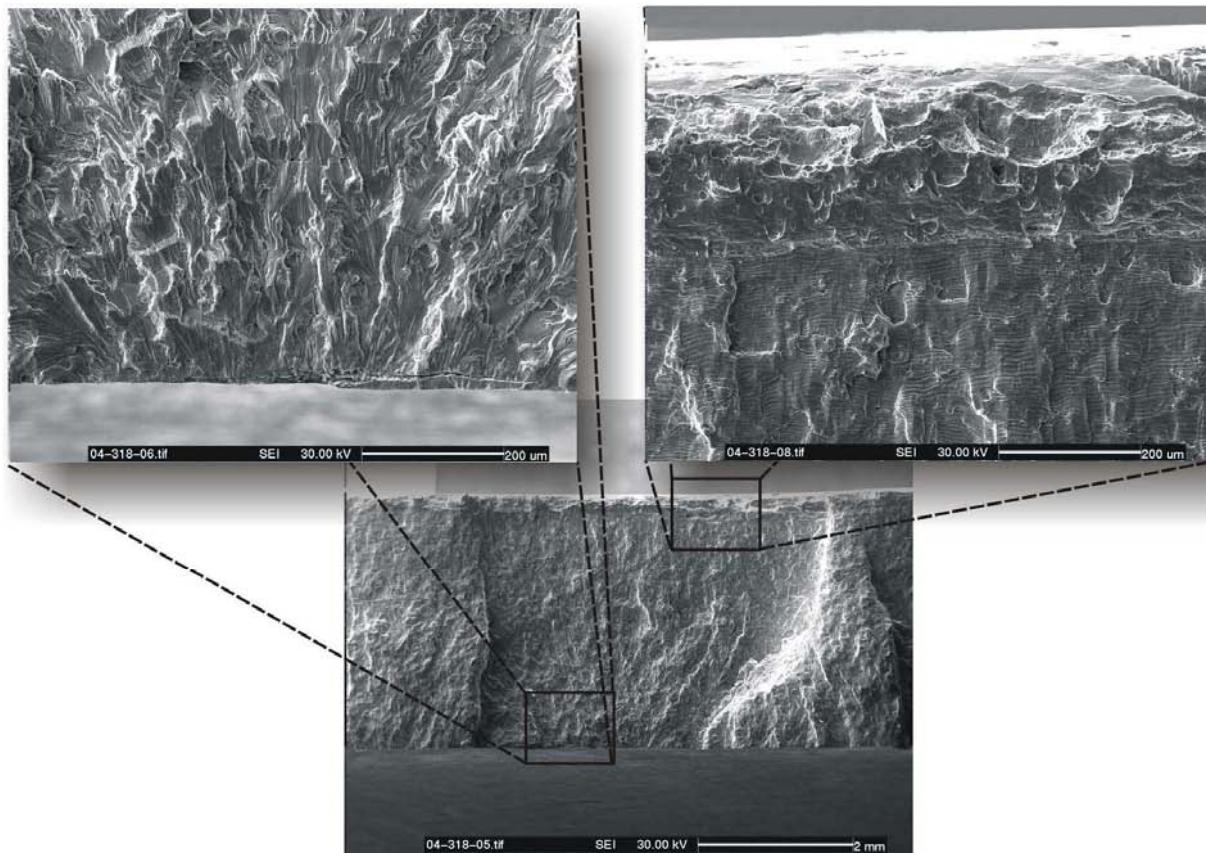
Figure 10-21
Areas examined at the 270° position.

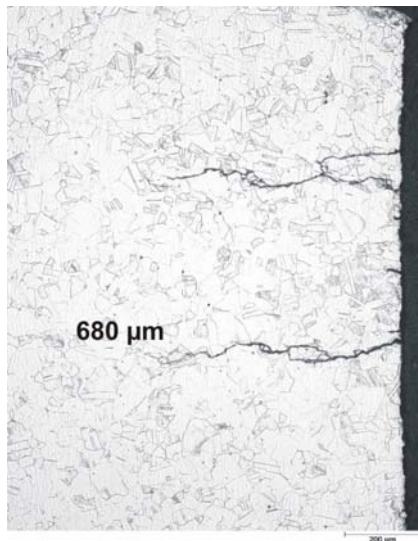
internal axial cracking (specimen S1)

Also, the 180° position exhibited transgranular axial cracking propagating from the internal towards the external surface. The approximate crack depth within this prepared cross-section was determined as 680 µm, representing about 20 % of the tube's nominal wall thickness. Despite the externally polished surface, circumferential cracking was found with a maximum depth of approximately 200 µm, representing about 6 % of the tube's nominal wall thickness. Figure 10-25 displays a typical example of cracking found in this position.

Figure 10-25
Metallography of the 180° position confirmed both axial and circumferential cracking on the internal and external surface, respectively. The numbers represent approximate crack depths.

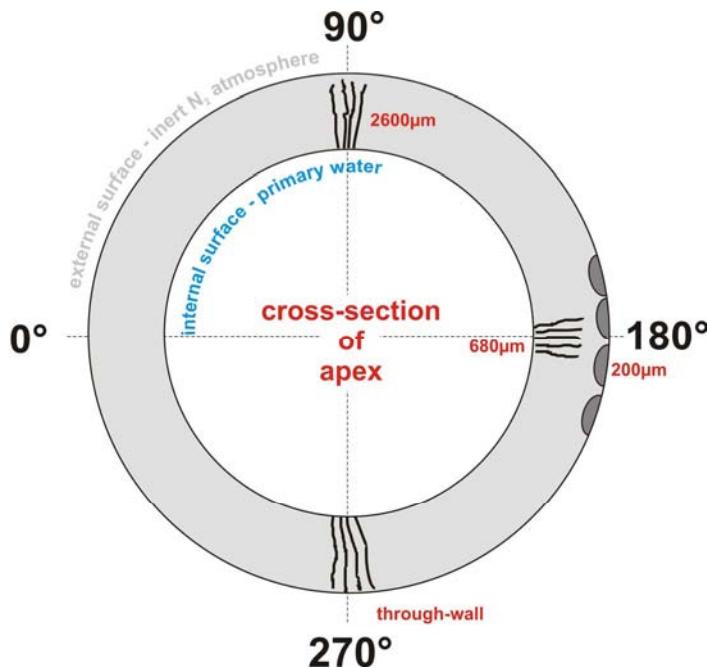
- Water chemistry within the range of specified values
- ECP: $-550 \text{ mV}_{\text{H,T}}$, Redox Potential: $-500 \text{ mV}_{\text{H,T}}$ for high flow rate ($\approx 2.1 \text{ m/s}$)
- Total number of achieved cycles: 3835
- Leakage due to internally initiated through-wall, axial cracking in the 270° position
- Polishing of external surface could not prevent external crack initiation entirely; observed circumferential cracking had an approximate depth of 200 μm
- All internal defects at 90°, 180° and 270° were axial, environmentally assisted cracking
- Location 0° was free of cracking
- No internal circumferential cracking was observed
- No microstructural anomalies were observed

Figure 10-26
Schematic summary of crack locations, orientation and approximate crack depths (if available) of Test 4d; schematic provides a cross-sectional view of the apex looking downstream; please note that schematic is not to scale.

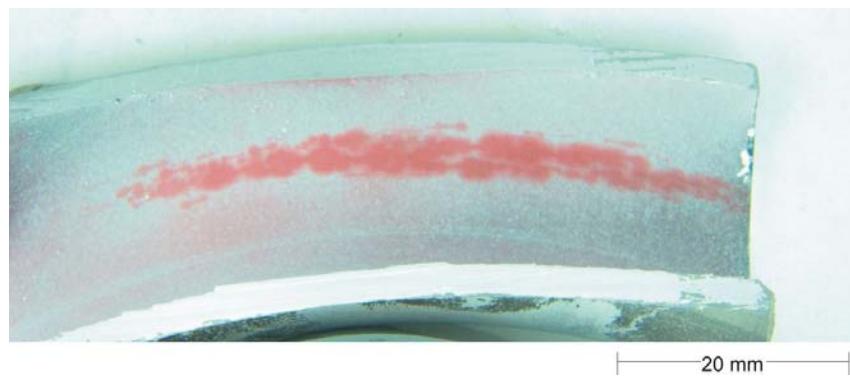
The 90° position disclosed a similar failure appearance with a narrow band of multiple axial cracking on the internal surface, as shown in Figure 11-13. However, the cracking at this bend location had not developed into a through-wall defect, since the external surface was free of indications.

Figure 11-13
DPI at 90° position showing multiple axial cracking.

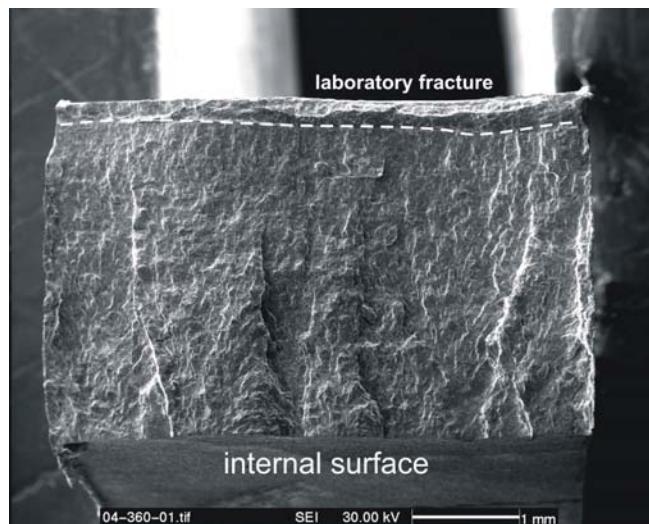
One representative axial crack found at the 270° position was broken open for detailed fractography at higher magnifications. Figure 11-16 illustrates the specimen with the laboratory fracture as well as the actual fracture surface to be investigated. The morphology revealed a striation pattern with varying spacing indicating a step wise crack progression under cyclic loading as displayed in Figure 11-17. The appearance indicated the combined efforts of mechanical loading and environment typical for corrosion fatigue. This is consolidated by the fact that the fracture progressed from the internal towards the external surface, by the flatter pronounced morphology and the multiple crack presence at this location.

Figure 11-16
Broken open crack at 270° position that was used for fractography.

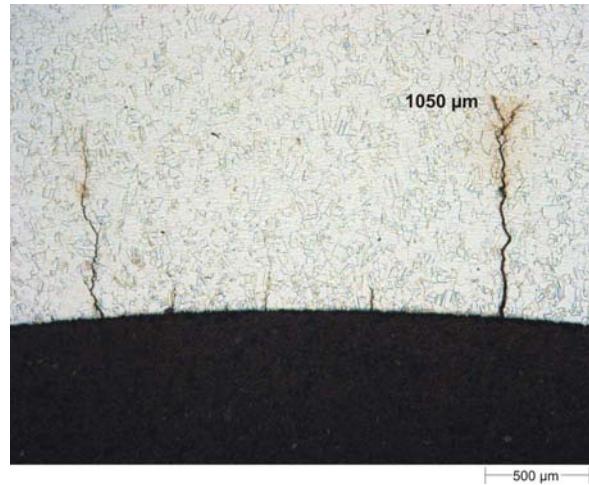
The 90° position exhibited a very similar appearance with multiple axially oriented cracks propagating from the internal towards the external surface in a transgranular manner. Identical to previous examined locations, crack initiation had occurred at attacked grain boundaries. The maximum crack depth within this prepared specimen was determined to be 1050 μm, representing approximately 30 % of the tube's nominal wall thickness as shown in Figure 11-1.

Figure 11-1
Metallography of 90° position confirmed multiple axial cracking propagating in a transgranular manner from the internal towards the external surface.

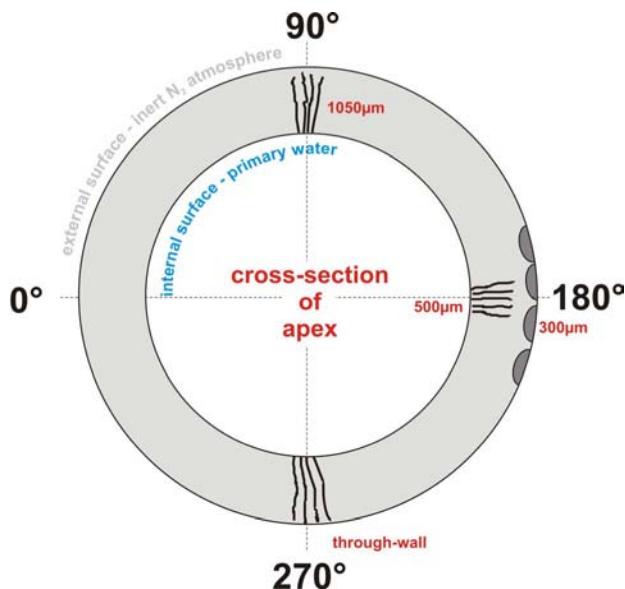
- Water chemistry within the range of specified values
- ECP -550 mV_{H,T}, Redox Pot. -500 mV_{H,T} for low flow rate (≈ 0.005 m/s)
- Total number of cycles: 3437
- Leakage due to internally initiated axial through-wall cracking in the 270° position;
- At 270°, 90° and 180° and positions, axial cracking on internal surface
- The 0° position was free of cracking
- No internal circumferential cracking was observed

- External polishing did not entirely prevent external crack initiation; Small array of multiple circumferential cracks on the external surface of intrados (180° position)
- All cracks were transgranular and showed features typical of fatigue; all internal axially initiated cracks showed evidence of environmental assisted progression (corrosion fatigue)
- No metallurgical anomalies were observed

Figure 11-3
Schematic summary of crack locations, orientation and approximate crack depths (if available) of Test 4a'; schematic provides a cross-sectional view of the apex looking down-stream; please note that schematic is not to scale.

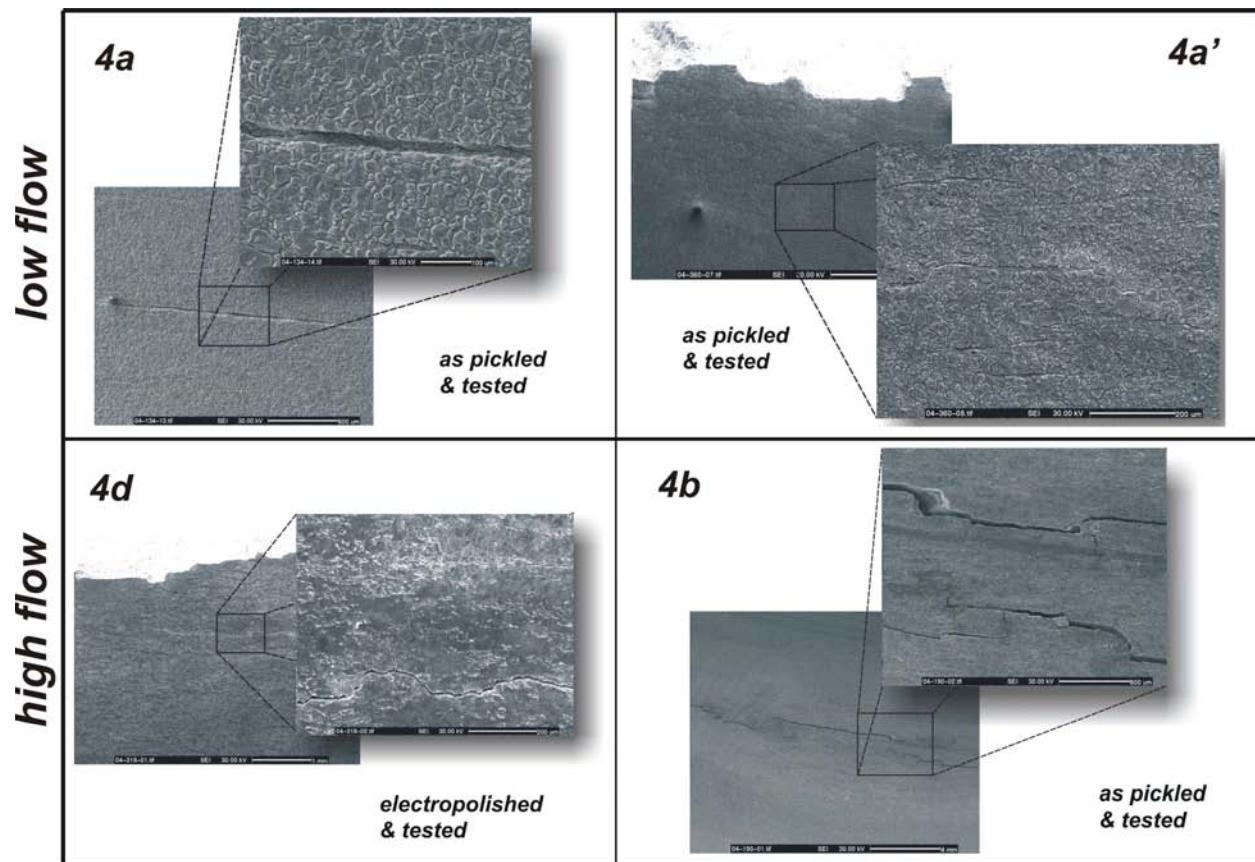
Figure 12-2
Summary of SEM surface examination during Test Series 4.

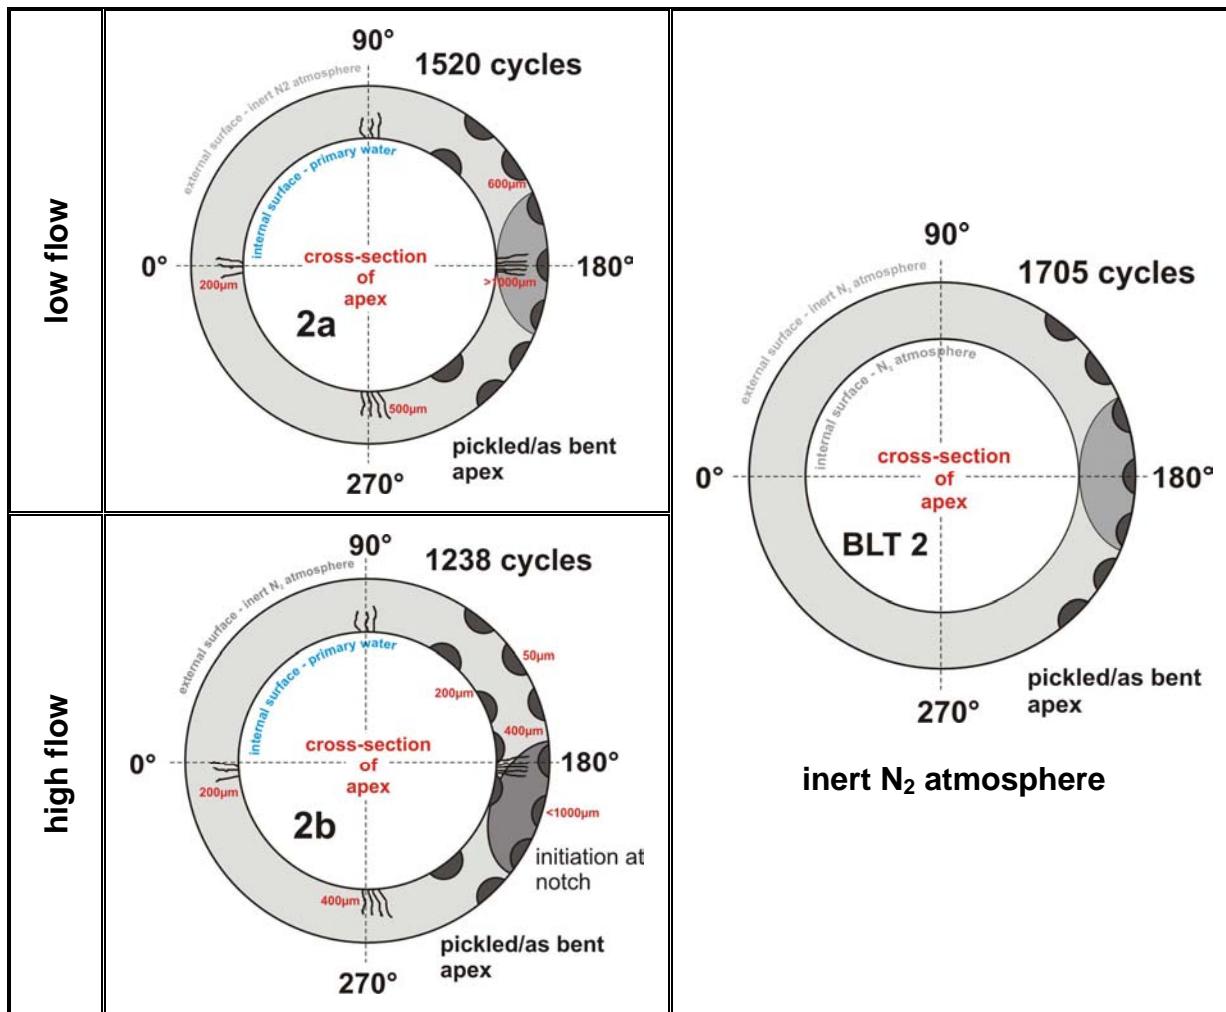
Figure 13-1 graphically summarizes the results from test series 2 and BLT2, both tested within one strain amplitude domain. In contrast to BLT2, the effects of a simulated PWR environment are clearly revealed by the presence of axial, internally initiated cracking in tests 2a and 2b.

Figure 13-1
Summary of results obtained during Test Series 2 and BLT 2 (Strain amplitude: $\pm 0.6\%$; strain rate: $1 \times 10^{-4} \text{ s}^{-1}$).

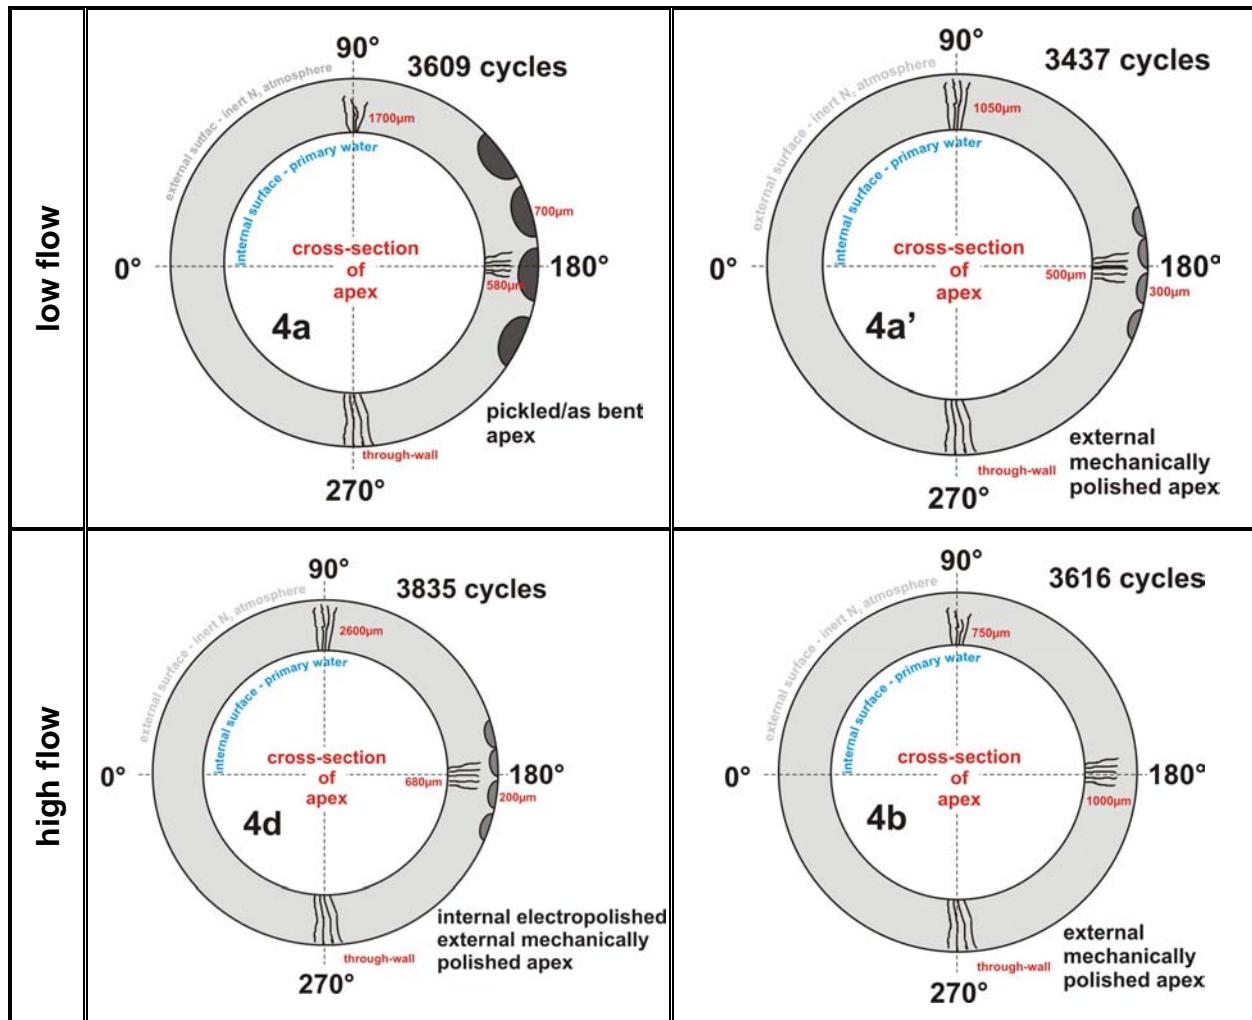
Again, the beneficial effect of higher flow rates could not be observed within the test series 4. A direct comparison is provided by the low flow test 4a' and the high flow test 4b, both exhibiting identical test parameters. Test 4a' yielded a total number 3437 cycles and test 4b yielded a total of 3616 cycles. This increase in achieved cycles of the high flow test 4b corresponds to approximately 5 % increase in lifetime. Considering the statistical variations during fatigue testing (easily containing scatter of $\pm 30\%$) this increase cannot be considered a clear effect.

Figure 13-2
Summary of results obtained during Test Series 4 (strain amplitude: $\pm 0.4\%$; strain rate: $1 \times 10^{-4} \text{ s}^{-1}$).
