FINAL TECHNICAL REPORT
MATERIALS FOR INDUSTRIAL HEAT RECOVERY SYSTEMS

MATERIALS FOR HEAT RECOVERY IN BLACK LIQUOR RECOVERY BOILERS

DOE Award Number
DE-FC36-04GO14035

December 31, 2007

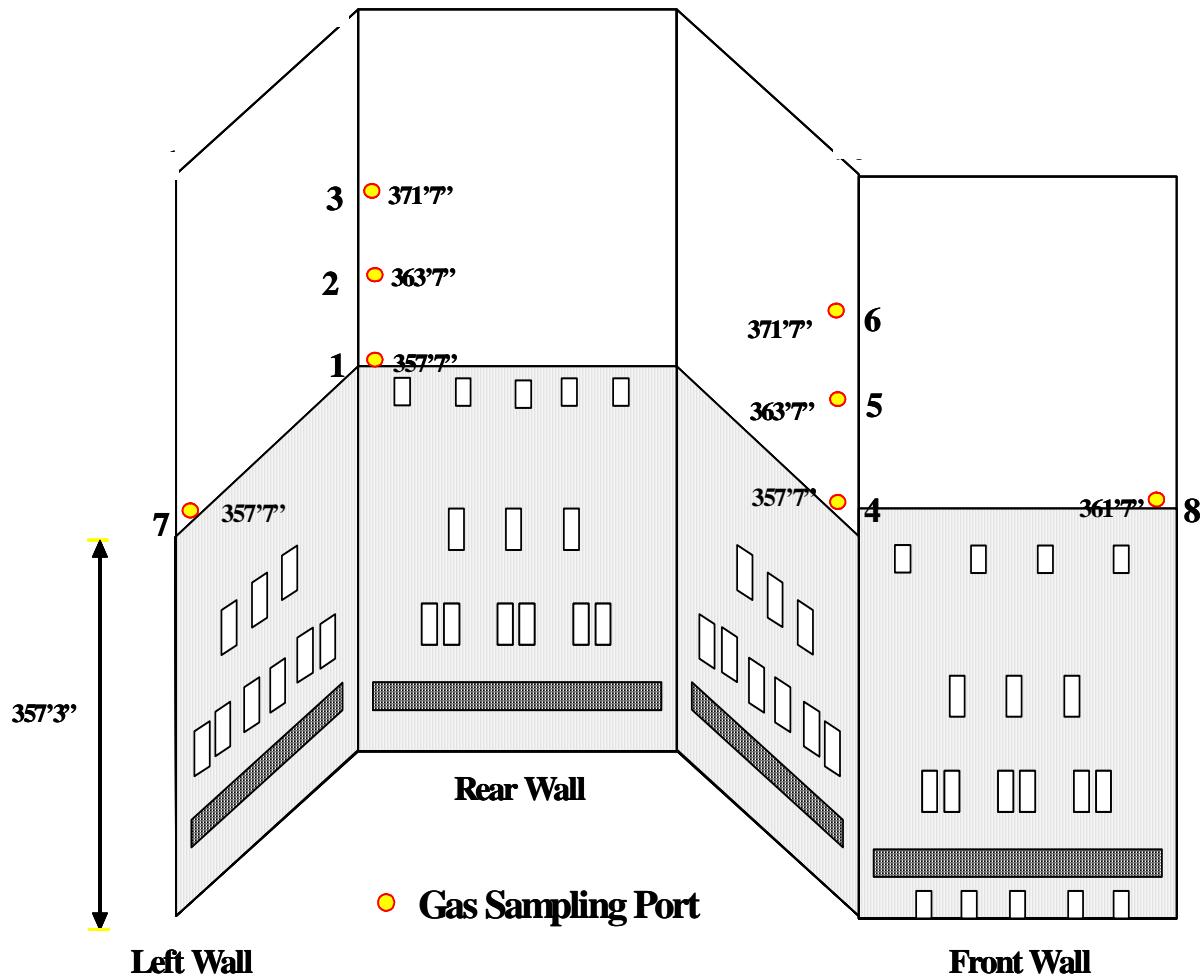
10.3 MPa (1500 psig) and a saturated steam temperature of around 320°C. Composite tubes were used to construct the lower-furnace section, ending at the tertiary airport elevation. This boiler experienced significant corrosion of the carbon steel waterwalls in three corners of the boiler. The front-wall and the rear-wall exhibited accelerated corrosion on the carbon steel tubes extending almost 12 feet above the cut-line, as is shown in Fig. 2.

Figure 2. Schematic of the boiler showing the port locations in mid-furnace area (above the cut-line). Heights (above sea level) are given to define relative positions.

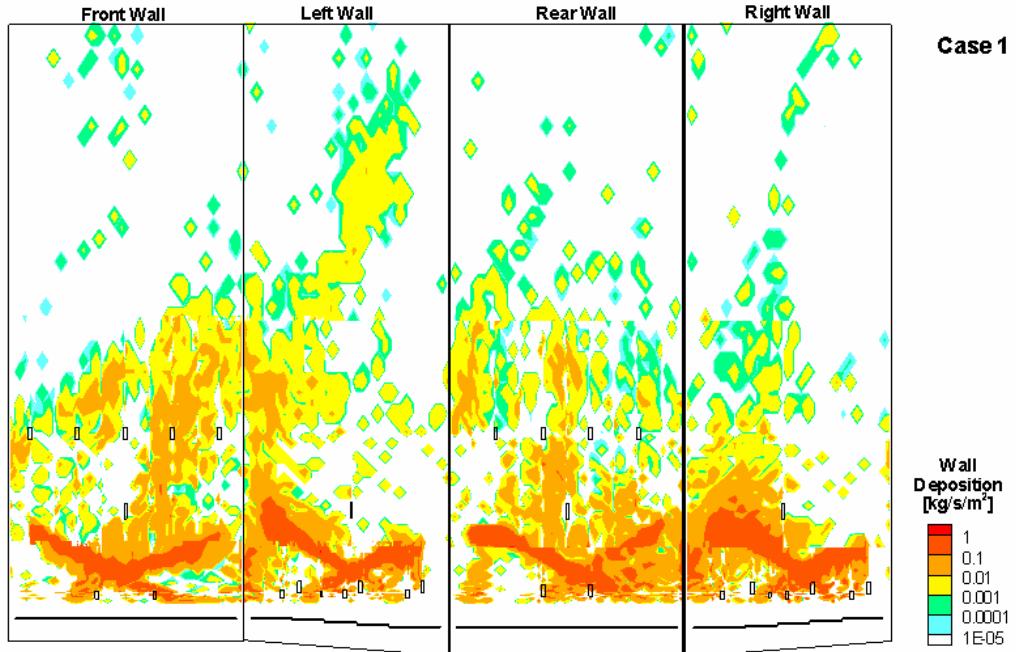
A computational fluid dynamics (CFD) model was developed for this particular boiler by Process Simulations Limited. Results from this model have predicted that some liquor could contact the waterwall surface in certain areas of the mid-furnace (see Figures 10 and 11), depending on the air flow pattern, as well as on liquor spray parameters and properties. Due to liquor contacting the waterwall surface, the local environments in these areas can be very different. Release of sulfur-bearing and reducing gases during pyrolysis can lead to higher partial pressures of S_2 in these areas. Figures 10 and 11 show some of the predictions for the model run with a set of normal boiler operating parameters. These figures show there are significant variations in the distribution of black liquor on the walls as well as in the H_2S concentration in the mid-furnace area. Changes in operating parameters and gas flow in the boiler likely cause these variations, and they are one indication of how much conditions change in some parts of the mid-furnace area of the boiler. The model also calculated the local heat flux differences in the mid-furnace section, near the waterwall surface. Local environment near the waterwall will change locally if the boiler operations are altered. The model is capable of calculating these effects, but this model needs to be validated with the actual data obtained from the boiler. Laboratory tests have shown that temperature significantly influences the corrosion rates of carbon steel in the simulated recovery boiler gaseous environments. An increase in test temperature from 320°C to 400°C increased the corrosion rate of SA-210 carbon steel from 0.320 mm/year to 14.66 mm/year in an environment simulating lower-furnace area with low

Figure 10. CFD model results showing black liquor spray pattern on waterwall surface in the mid-furnace. Note the differences on the same wall and on different walls.

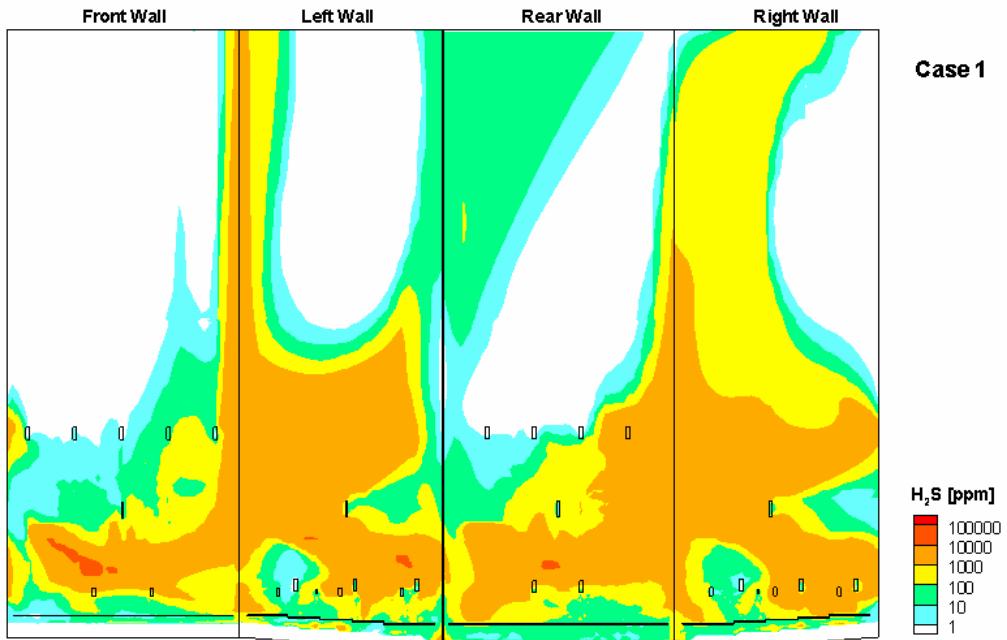
Figure 11. CFD model results showing H_2S concentration on the waterwall surface in the mid-furnace section. Some areas on the waterwalls have a higher concentration of sulfur-bearing and reducing gases compared to other areas at the same elevation. These trends match with the general corrosion patterns found in this boiler.

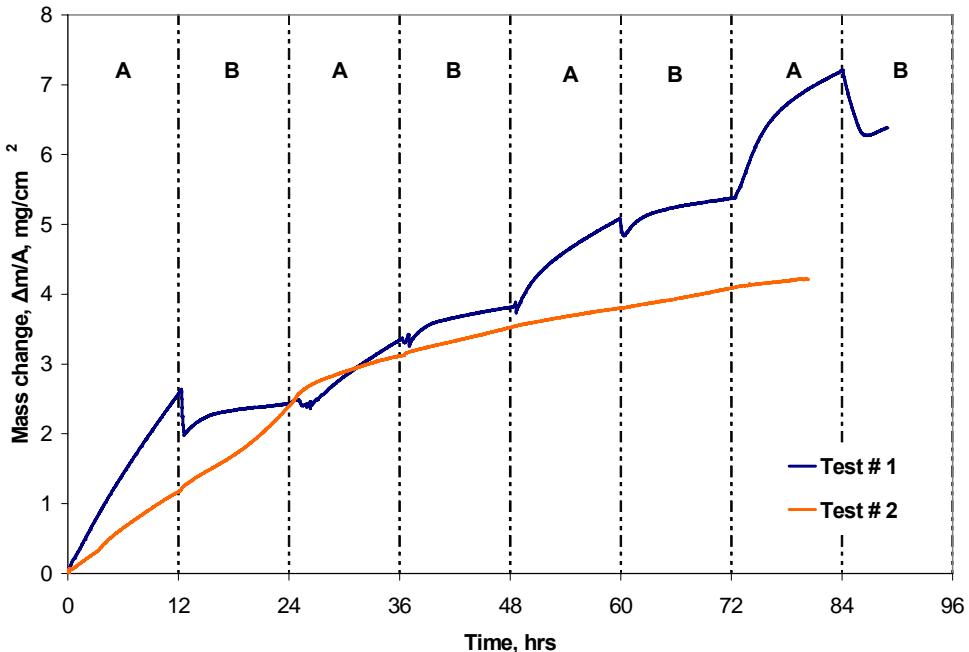
Results from the corrosion tests are shown in Fig. 12. The alternating 12-hour zones, marked as A and B, represent different gas compositions during that time. For Test #1 a sharp mass loss was observed after each environmental cycle, which indicates spallation of scale. Figure 13 shows a cross-sectional view of the surface scale after 100 hours of exposure in Test #1 at 300°C. The scale shows a layered structure, which was due to the formation of different oxides/sulfides during each environment change. During the first sulfidizing period, a sulfide scale formed. As the environment changed to an oxidizing one, an oxide scale subsequently formed. This caused the formation of a layered structure as the environments were cycled. The large mismatch between corrosion products can cause the composite scale to crack and spall, thus exposing the metal to corrosive gases [25,26]. The weight change during each period was used to determine if the reaction rate were linear or parabolic during that stage of test. During the first two sulfidation cycles, corrosion showed linear behavior and oxidation showed parabolic behavior. As the scale grows, the sulfidation rate showed a dependence on diffusion of sulfur species through unspalled/adherent scale, as indicated by the transition to parabolic behavior. The qualitative composition of different layers of the surface scale was determined by an EDS line spectra. A sulfur peak indicated a sulfide layer, whereas the absence of a sulfur peak was assumed correspond to an oxide layer. The results are shown in Figs. 13 and 14, and indicate that even a small amount of O₂ introduced during environmental cycling can promote the formation of a stable oxide layer and thus provide protection.

For Test #2, sulfide scales on the SA-210 carbon steel coupons did not show any significant spallation, as evident from TGA plot in Fig. 12. The scale was adherent to the substrate after removal from the TGA apparatus. Results show that the sample tested in Test #2 showed lower mass gain than Test #1, as the scale was adherent and the reaction kinetics were primarily governed by the diffusion of gaseous species through the scale with parabolic rate constant of 0.25 mg²/cm⁴sec. Figure 14 shows the cross-sectional view of the scale after 100 hours of exposure at 300°C in Test #2. The scale morphology suggests the formation of laminated structure of oxides/sulfides. Although the scale looks continuous in cross-section, it exhibited some cracking at the scale/alloy interface. This cracking was likely a result of the large CTE mismatch between the scale and the steel substrate. The scale thickness was roughly 60-80 µm with a dense outer layer (layer #1) of ~50-60 µm thickness, which consists primarily of sulfides, and a highly porous inner layer (layer #2) of ~10-20 µm thickness, which consists primarily of oxide at the scale/alloy interface. Perhaps the presence of a thin oxide layer and its interdiffusion in the sulfide layer provided the good scale adherence observed during Test #2.

Figure 12. Effect of fluctuating sulfidizing/oxidizing atmosphere on corrosion behavior of SA210; A and B denote gas atmosphere as follows: Test # 1: (A) 1% H_2S in N_2 , (B) 1% O_2 in N_2 , Test # 2: (A) (1% H_2S + 1% O_2) in N_2 , (B) 1% H_2S in N_2

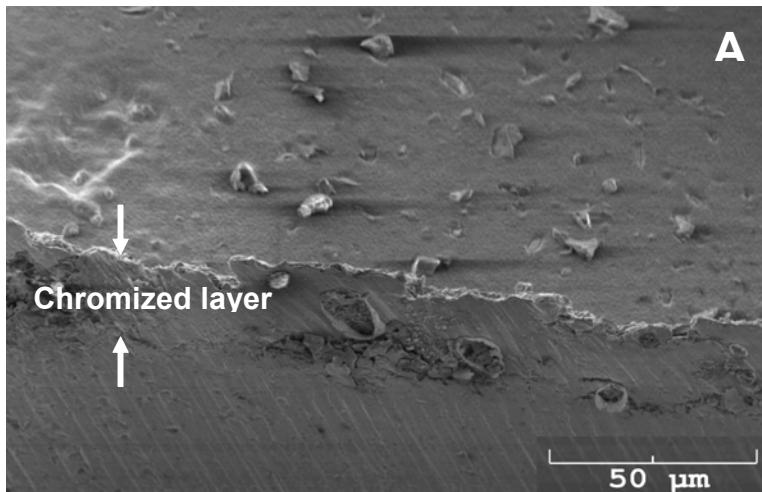
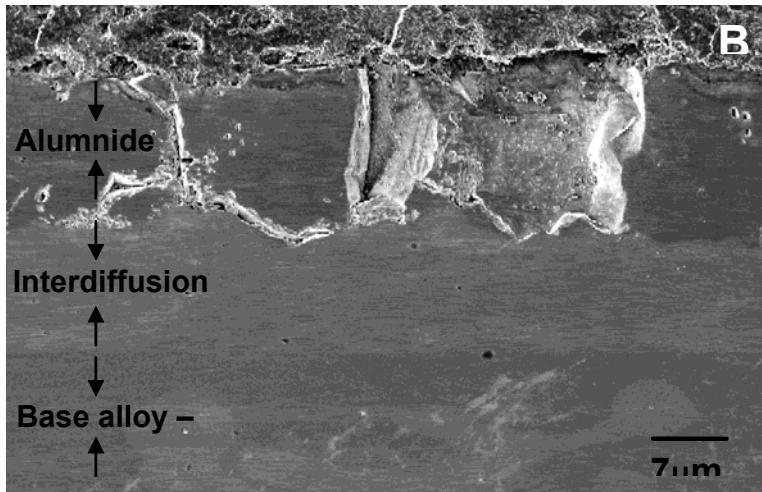
The resulting pack cementation coatings applied to SA-210 carbon steel samples were characterized using XRD and SEM. As Fig. 15A shows, the chromized layer formed on the SA-210 carbon steel substrate was $\sim 60\text{-}70\ \mu\text{m}$ thick and it consisted of $(\text{Cr,Fe})_{23}\text{C}_6$ and $(\text{Cr,Fe})_7\text{C}_3$ as the major components. The aluminized layer formed on the SA-210 carbon steel substrate was found to be $\sim 70\text{-}80\ \mu\text{m}$ thick (Fig. 15B), and it consisted of FeAl as the major component. Note that the chromium carbide formed during the chromizing treatment was likely due to the outward diffusion of carbon and strong affinity of chromium towards carbon.

Figure 15. SEM micrographs showing cross-sectional view of pack cemented chromized coating (A) and aluminized coating (B) on carbon steel sample treated for 8 hours at 800°C.

of an Al_2O_3 scale. On the chromized sample, the scale was found by XRD to consist of chromium sulfide with minor amount of Cr_2O_3 on the surface. These preliminary results indicate that these diffusion coatings could be used to protect the carbon steel boiler tubes against sulfidation attack.

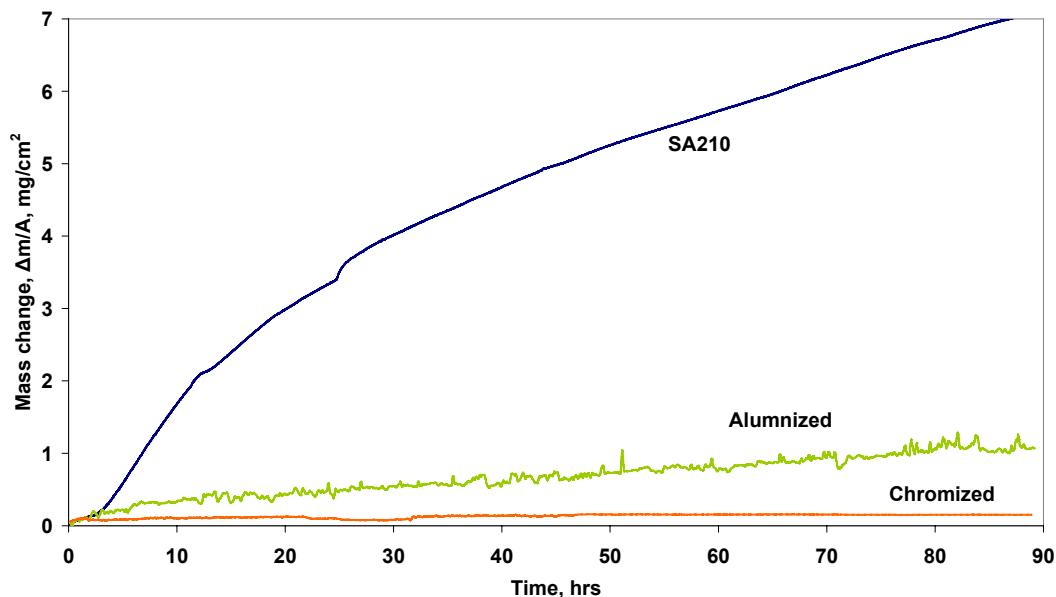
Chromized and aluminized SA-210 carbon steel samples were tested for 100 hours in 1% H_2S in a N_2 mixture to compare their sulfidizing resistance to uncoated SA-210 carbon steel samples. Figure 16 shows the weight change versus time curves at 300°C of the chromized and aluminized SA-210 carbon steel samples compared to that of the uncoated SA-210 carbon steel sample. Both diffusion coatings significantly improved the sulfidation resistance exhibited by the SA-210 carbon steel. The aluminized and chromized SA-210 carbon steel sample exhibited an overall mass gain of $\sim 1\ \text{mg}/\text{cm}^2$ and $\sim 0.5\ \text{mg}/\text{cm}^2$ respectively. In contrast, the uncoated SA-210 carbon

Figure 16. Thermogravimetric analysis (TGA) of aluminized, chromized and uncoated SA-210 carbon steel samples tested in a 1% H_2S in N_2 gas mixture at 300°C. The parabolic reaction rate constants tabulated in Table 2 show the benefits of chromizing and aluminizing for controlling corrosion.

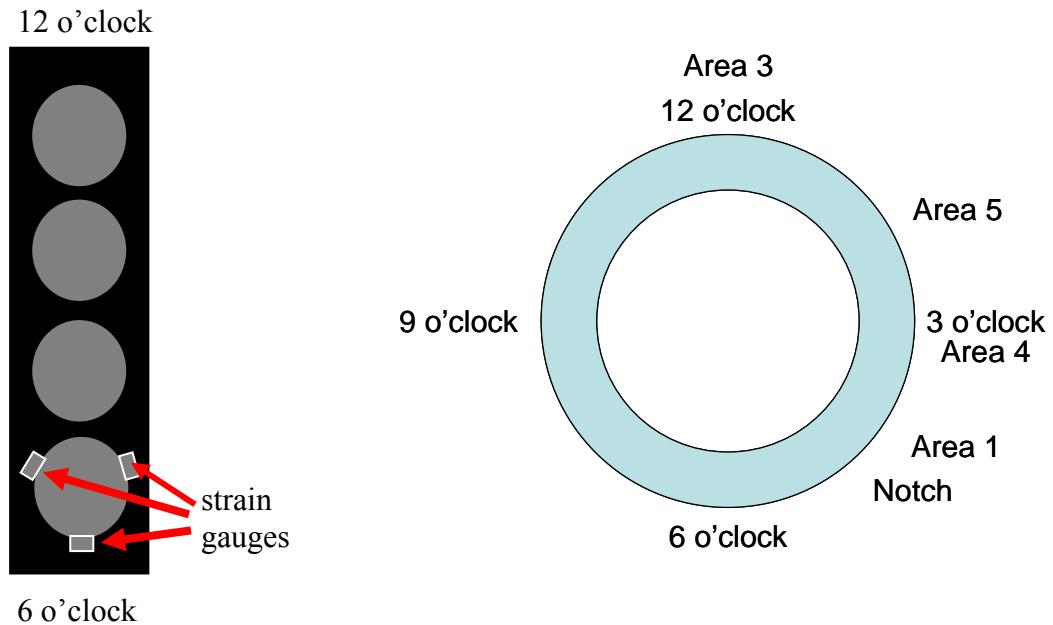
A sketch of the fracture surface examined is shown on the right side of Fig. 19, and distinctive features as well as the original orientation of the tube are indicated. Because of the damage done to the surface during prolonged operation in a partially cracked condition as well as during removal from the boiler, it is not easy to identify the crack initiation sites or the direction of crack propagation. The section of this tube between areas 1 and 4 is shown in the collection of SEM micrographs assembled in Fig. 20. A higher magnification view of the area on the left side of Fig. 20 is shown in Fig. 21, and, based on the "steps" in the center and right side of this

Figure 19. Sketches showing the arrangement of superheater tubes in the platen, the position of strain gauges on the first tubes in platen 5 and 14 and the SEM operator's sketch of the fracture surface of the superheater tube showing the areas examined and their relative position.

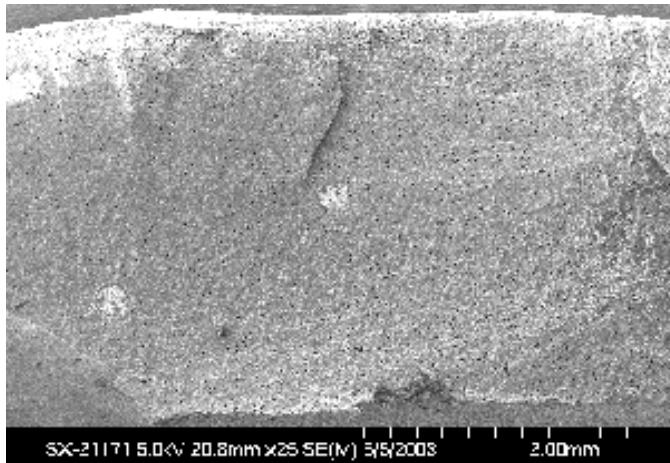
micrograph, it appears this is possibly an area where multiple cracks initiated on the outer surface and advanced toward the ID. Figure 22 shows two higher magnification micrographs of areas in the center and upper right of Fig. 20, and the many small cracks on these surfaces suggest the progression of a crack toward the left. Other areas of the fracture surface have microstructural features that suggest a certain direction of crack motion, but the evidence is not sufficient to unequivocally define the crack path.

Figure 22. SEM micrographs showing areas to the right and right center in Fig. 20. Both micrographs appear to have secondary cracks advancing into the fracture surface. This type of cracking can be an indicator of fatigue. The arrow indicates the likely direction of crack advance.

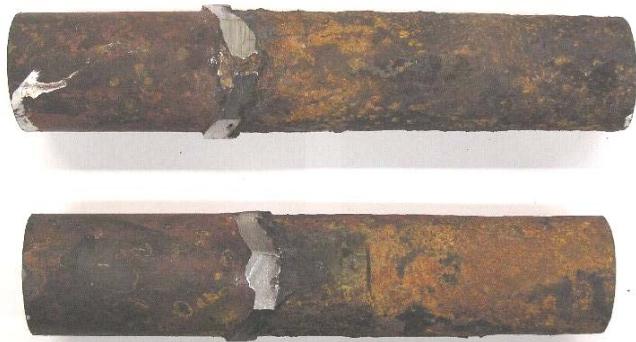
Two other tubes were submitted for examination when leaks were found after a November 2004 shutdown. These tubes are shown in Fig. 24. The remainder of the metal from the high crown seal was ground off these tubes and the tubes were then cleaned in inhibited acid to remove the scale. Dye penetrant examination of both tubes showed strong crack indications (see Fig. 25) along the bottom edge of what had been the weld attaching the tube to the high crown seal. As

Figure 24. Sections of two failed intermediate superheater tubes removed during Fall, 2004.

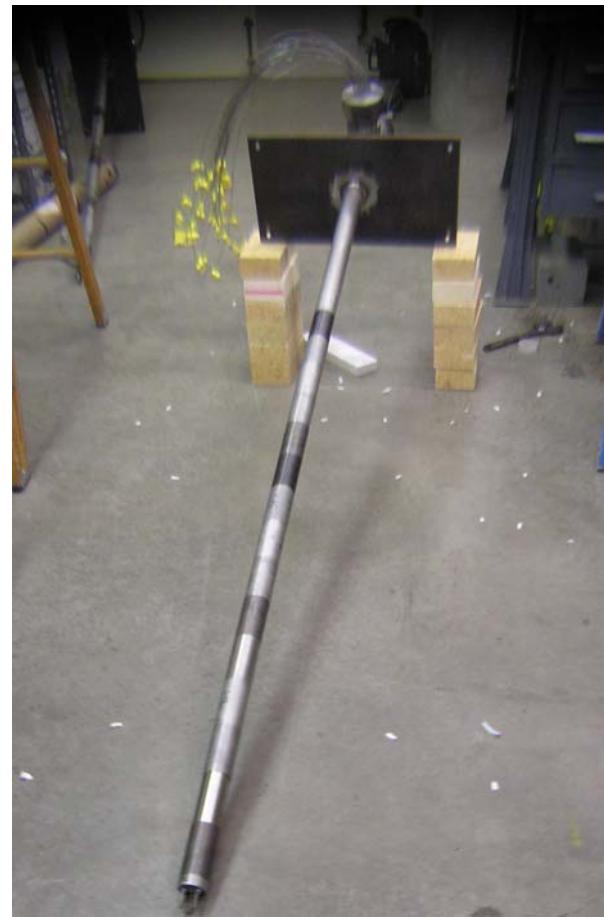
Figure 57. Assembled superheater corrosion probe.

For the field exposure, 15 interlocking, air-cooled samples were assembled in a spring loaded assembly that provided for two thermocouples per sample. The samples were arranged in a repeating pattern based somewhat on the anticipated corrosion rate. The exception was the omission of T91 and the addition of weld overlaid alloy 33 in the set of five samples exposed at the hottest end of the probes. Using the abbreviated descriptions listed in Table 10, the order of the samples, from the coolest to hottest positions, was: T91, 347, 310, 28, 693, T91, 347, 310, 28, 693, 347, 310, 28, 33, 693. Figures 52 to 57 show the components and the assembly of one of the two identical probes. Figure 52 shows a schematic of the corrosion probe, and in Fig. 53 the base of the probe with the thermocouples in place can be seen along with most of the samples sitting on the cart on the right side of the figure. Figure 54 shows the probe being assembled. Four of the samples are in place, and the thermocouples for the remaining samples along with the support rods can be seen extending above the samples. The arrangement of the spacer inserted inside the sample along with the support rods and thermocouples are shown in Fig. 55. Figure 56 shows how two thermocouples per sample were held in place by a snap ring. One snap ring was used in each sample to hold the thermocouples in shallow holes that were drilled on the ID of each tubular sample (top and bottom of the horizontally inserted probe) so the effects on metal temperature of such things as radiant heating and deposit accumulation could be determined. An assembled probe is shown in Fig. 57.

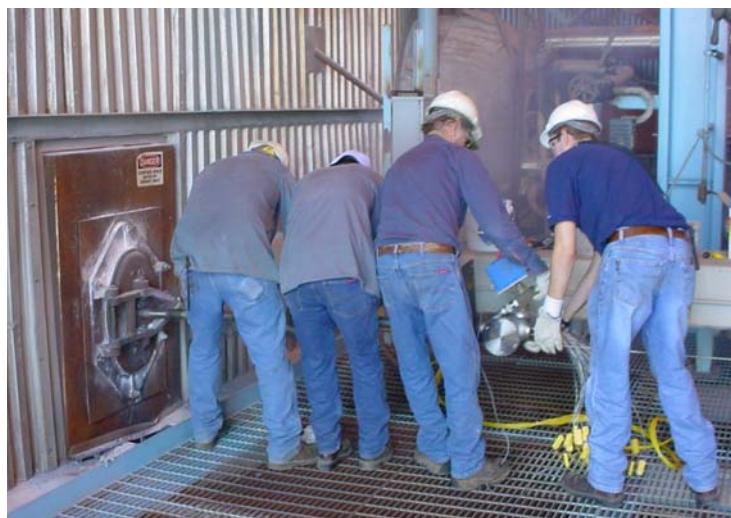
Figure 58. Corrosion probe being inserted through hole in manway door.

The probe was inserted horizontally into the superheater section of the recovery boiler under study through an inspection door modified to accommodate the probe. Figure 58 shows the

probe being inserted, and Fig. 59 shows the probe after installation was completed. In this figure, the air supply line and the remotely-controlled, variable flow valve are on the right side of the probe, and the 30 thermocouples that were attached to the samples can be seen coming into the bottom of the probe. The probe was aligned so that, for each sample, one thermocouple was at the 12 o'clock or top position and the other thermocouple was 180° away in the bottom position where it was subject to radiant as well as convective heating. The flue gas temperature in the vicinity of the probe was estimated to be about 650°C, and a temperature gradient along the probe ranging from 650°C to 316°C was expected. The probe was removed just before the boiler was water washed, and the exposure period was almost exactly 1000 hours. Because of deposits that had accumulated on the probe, removal of the probe through the small opening in the manway was difficult. Figure 60 shows the probe after removal.

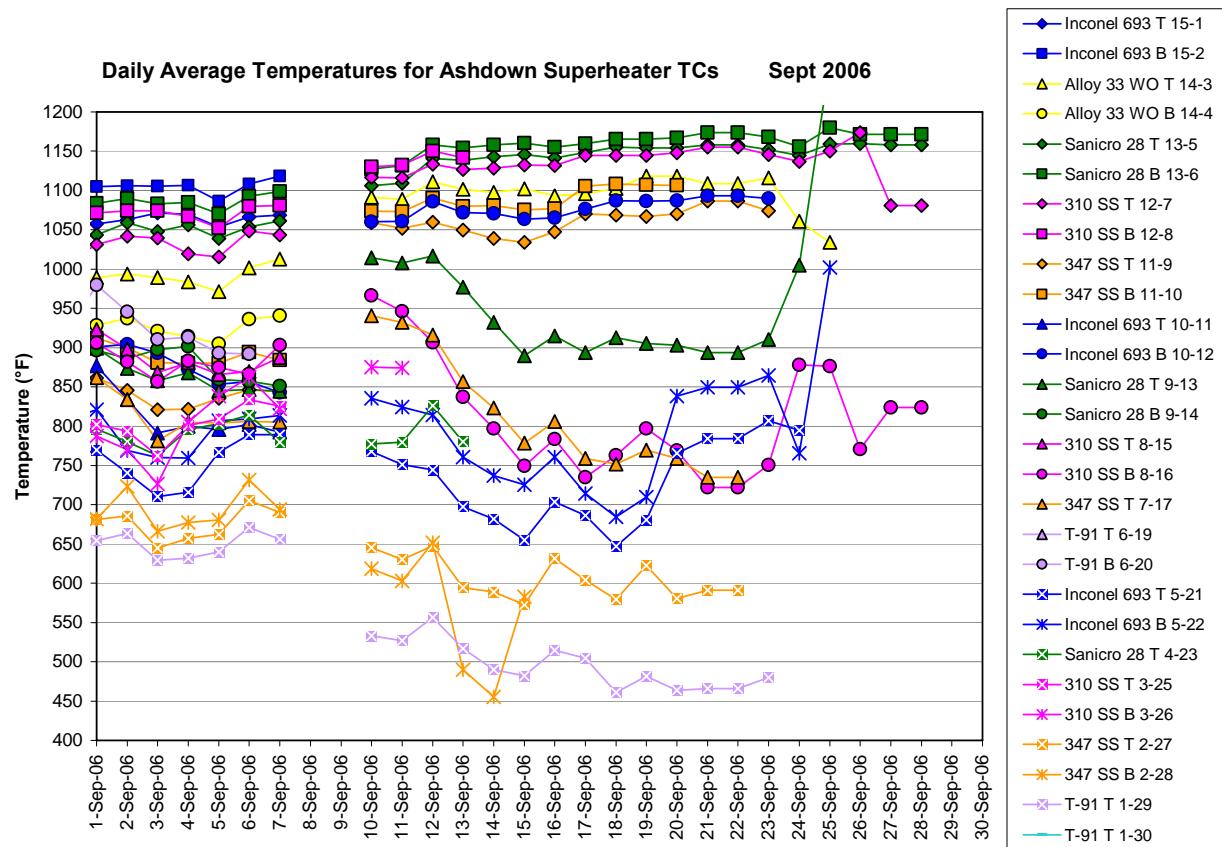
Figure 61. Daily average (measured) metal temperatures for the 30 thermocouples vs. date.

computer at ORNL through a phone line. Unfortunately, many of the thermocouples stopped working before the 1000 hour exposure was completed. Nevertheless, enough data were collected to provide a good indication of the top and bottom temperatures for each of the samples. The daily average measured metal temperatures are shown in Fig. 61, and the average temperatures for all 30 thermocouples are shown in Fig. 62. Because the thermocouples were a short distance below the surface of the tubular samples, it was assumed that the actual surface temperatures were about 17°C (30°F) higher than the measured temperatures.

Because some thermocouples failed and stopped providing data at random times throughout the exposure, a direct comparison between the top or bottom surface temperatures of the samples was not always possible. However, the data collected does provide useful information. With a first melting temperature (FMT) of the superheater deposits of about 547°C (1017°F), it is clear from Fig. 61 that samples #11 through #15 (Alloy 693, Alloy 33, Alloy 28, 310H and 347H) were exposed at temperatures above the FMT, while #1 through #10 (Alloy 693, Alloy 28, 310H, 347H, T91) were exposed at temperatures below this FMT for the majority of the exposure.

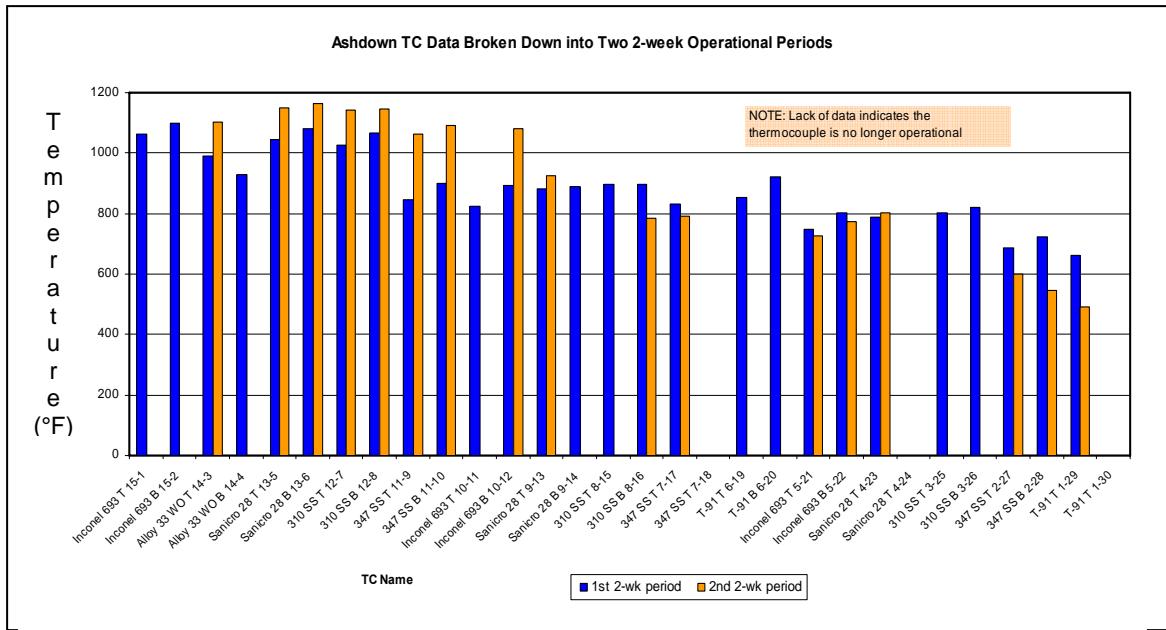
Figure 62. Thermocouple data for initial two week and later two week operating periods.

Considering that the external surface should be hotter than the internal surface, Alloy 33 was considered to have been exposed at temperatures above the FMT for the majority of the exposure. The increased variation in temperature observed in the second half coincides with changes made to the cooling air flow rate in order to maintain the temperatures at the tip of the probe. These changes were made in response to the loosening of samples in the probe and the subsequent leaking of air from the probe.

The results shown in Fig. 62 indicate the measured temperatures (not accounting for the difference between the inner and outer surface temperatures) for the thermocouples on the top and bottom of each sample and for the first two weeks and two weeks during the latter part of the

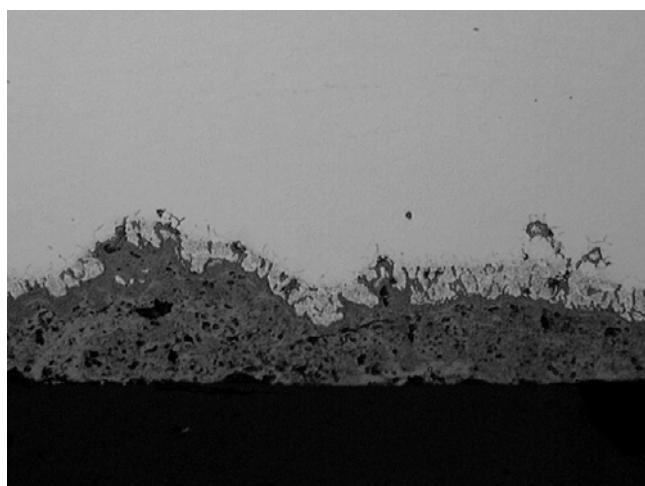
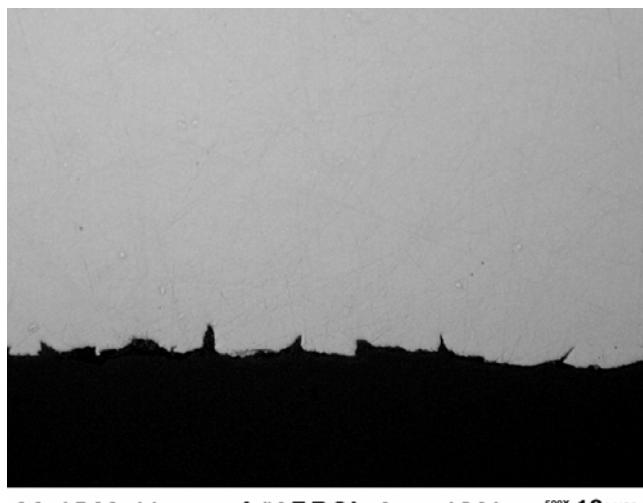
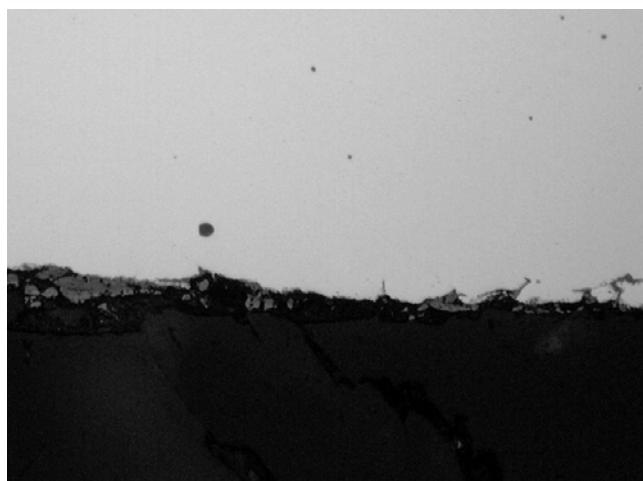
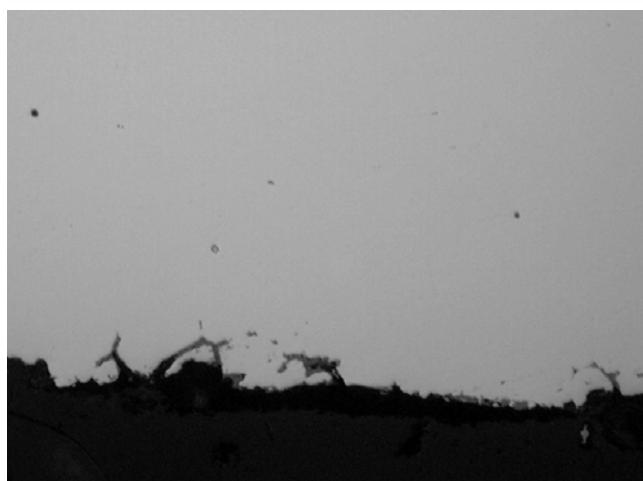
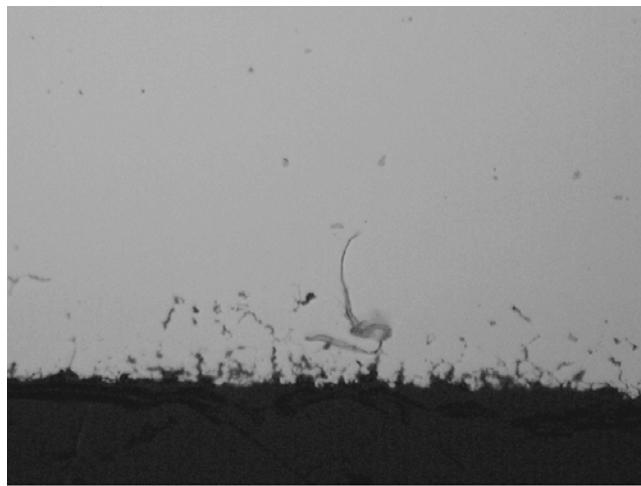
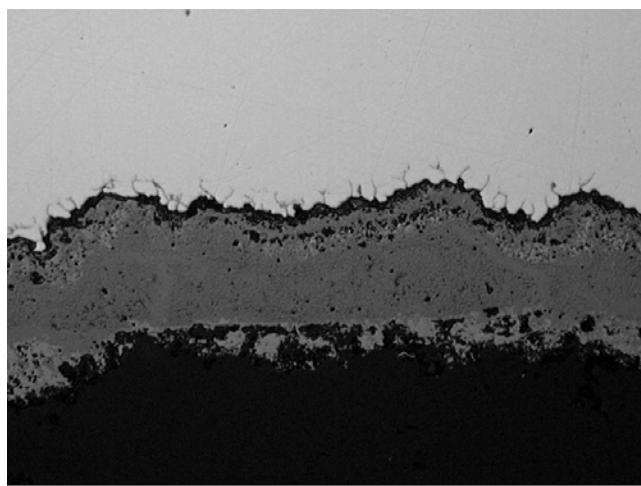
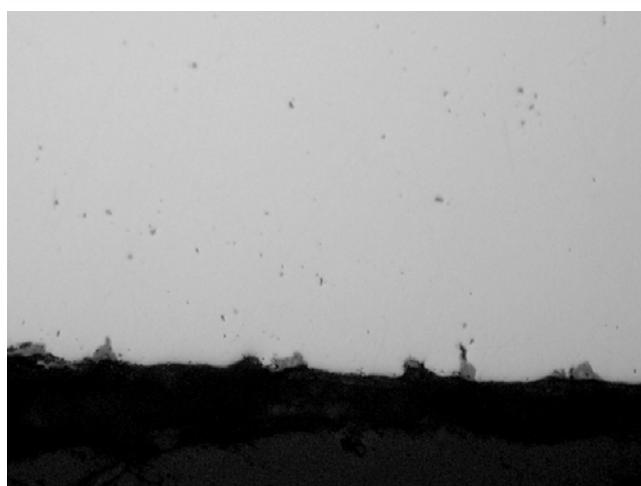
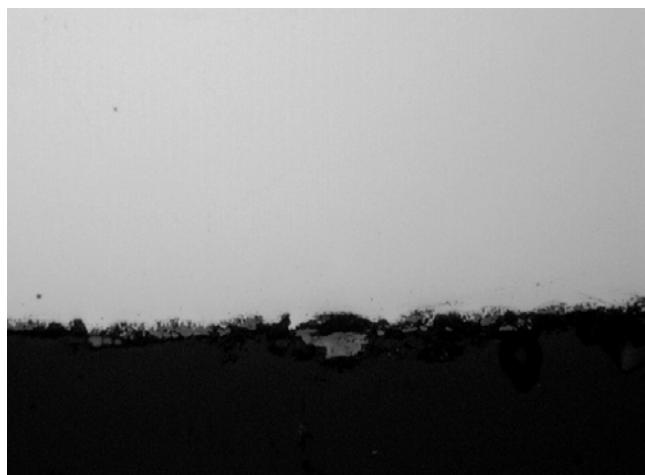
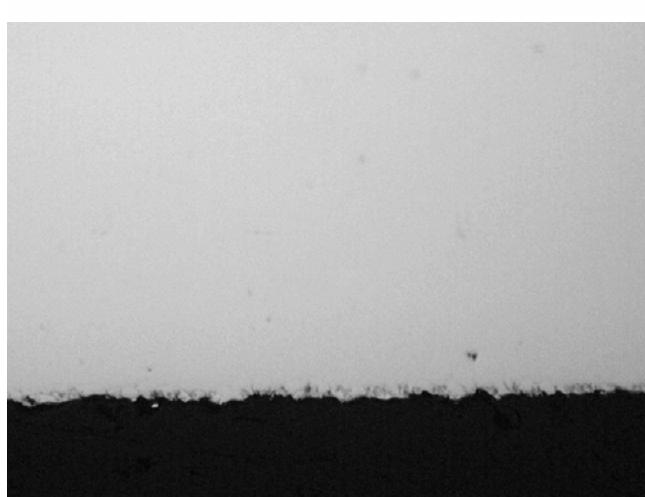
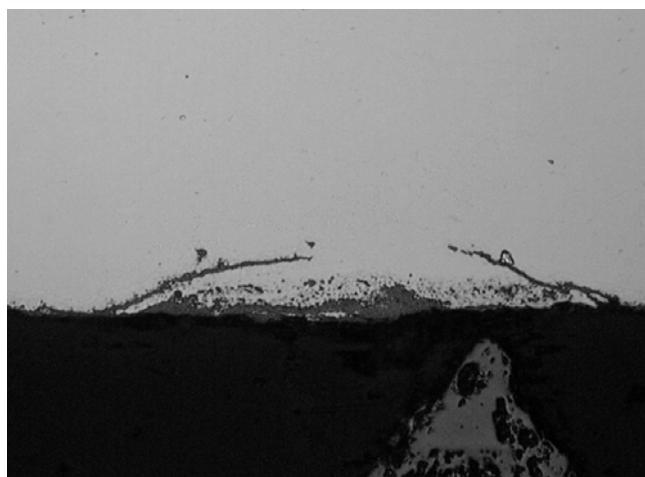
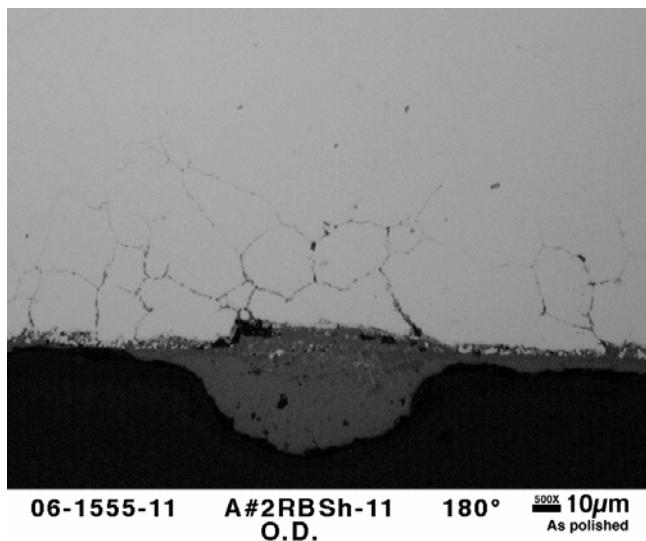
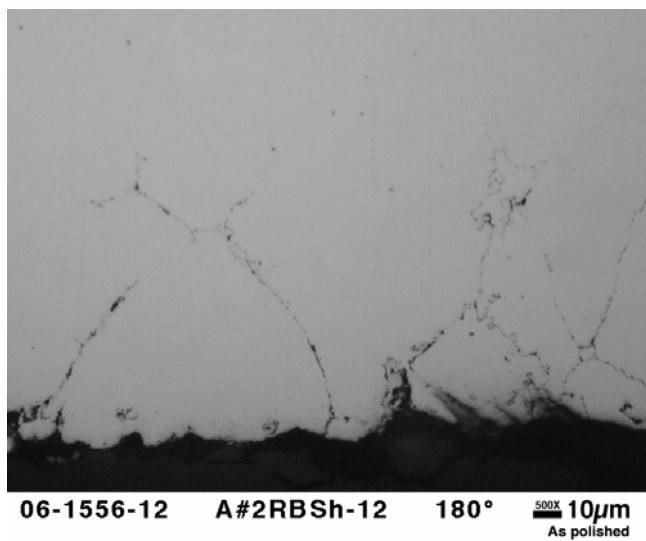
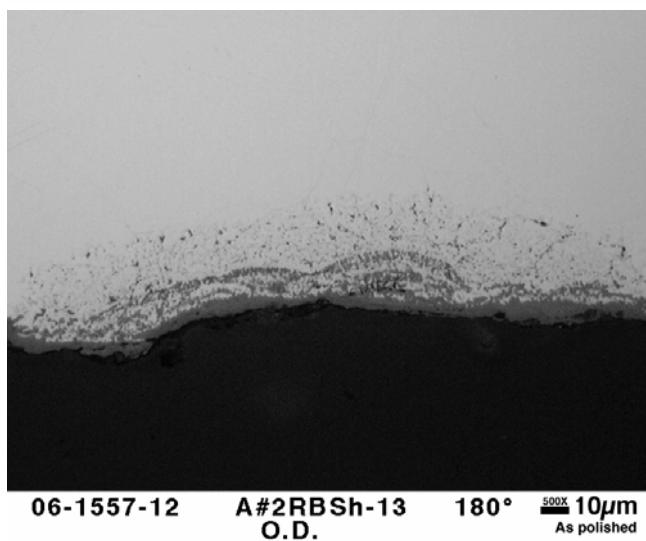
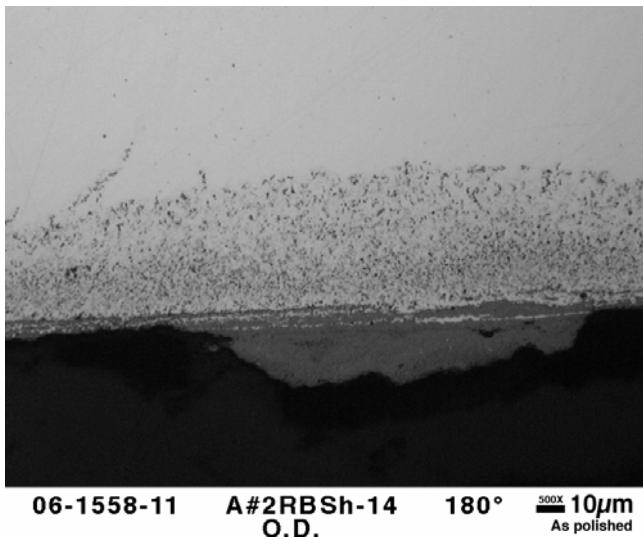
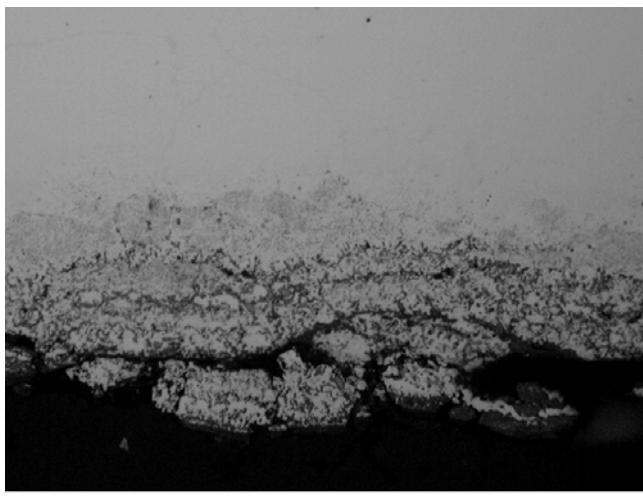
The six coolest samples showed no significant wall thickness changes. Stainless steel samples #7, #8, #11, and #12 as well as samples #14 and #15 all showed meaningful thickness losses. These measurements did not differentiate between unaffected metal and metal that suffered sub-surface attack, and as can be seen from the micrographs in Fig. 63, many of the samples exposed at the higher temperatures experienced sub-surface degradation.

The collection of micrographs in Fig. 63 shows the outer surface on the “bottom” side (180° position) of the tubular samples at an original magnification of 500X; additional micrographs are shown in Appendix 2. These micrographs show that for each alloy, the higher the temperature, the more extensive the degradation, particularly when the temperature exceeded the FMT. In addition, as a general rule, the lower the chromium content the more extensive was the degradation. Of the five samples at the highest temperature, the two stainless steels experienced external corrosion and some subsurface, probably intergranular attack. The other three samples had a more uniform subsurface degradation; the electron microprobe studies provided more information about the nature of this degradation. The more extensive collection of micrographs in Appendix 2 shows attack was generally worse on the bottom of the samples than on the top.

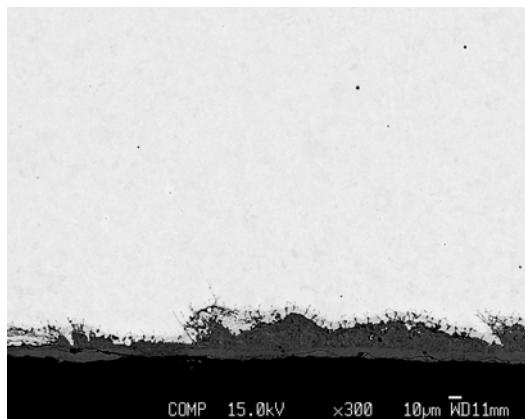
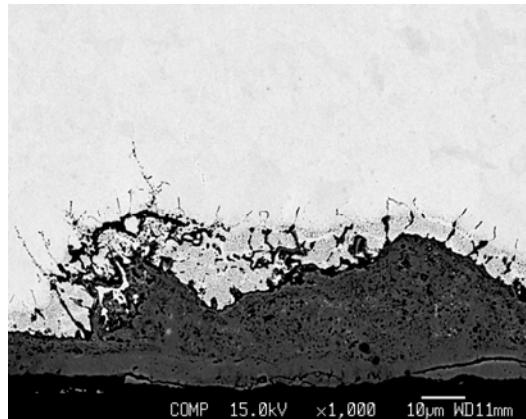
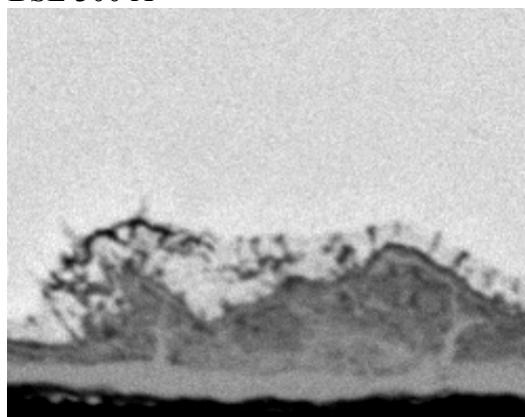
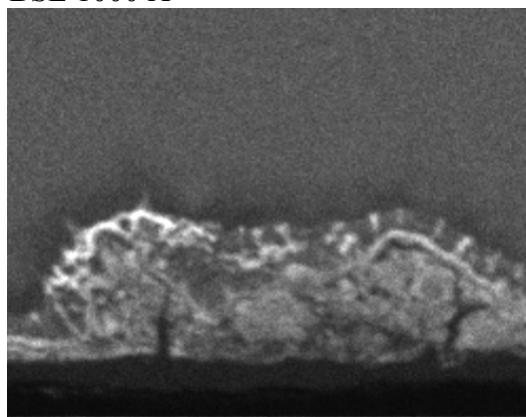
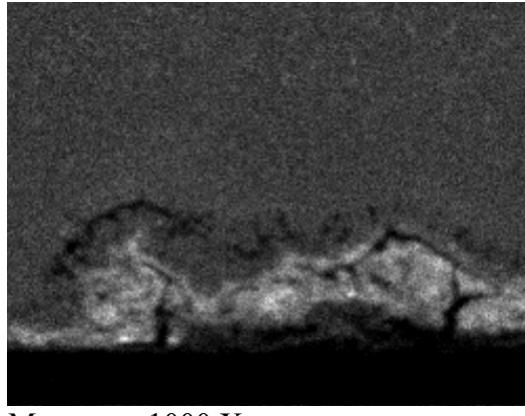
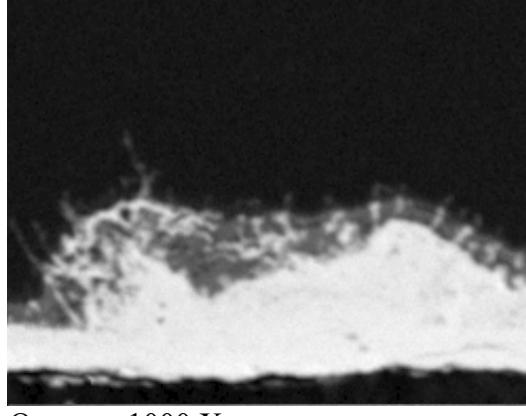
Figure 64. Electron microprobe images from T-91 sample #6.

Figure 64 contains a series of micrographs that show the distribution of iron, chromium, molybdenum and oxygen in the sample that was exposed in the superheater at temperatures no higher than 510°C (950°F). This sample has a significant corrosion product layer on the surface, and the maps indicate the corrosion product is depleted in iron (compared to the base metal), enriched in chromium and molybdenum and contains a significant amount of oxide. This leads to the conclusion that the layer contains iron and chromium oxide.

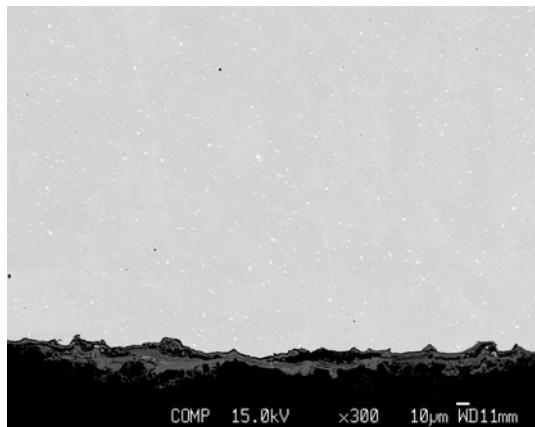
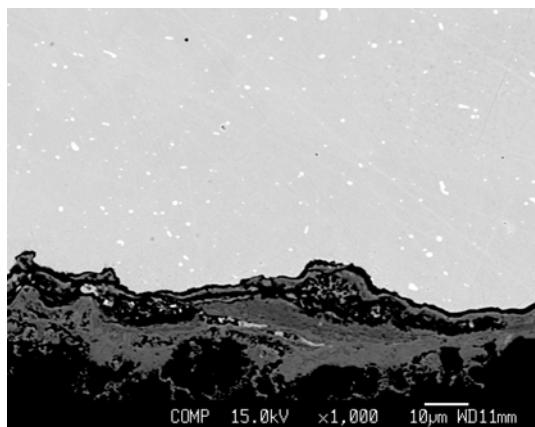
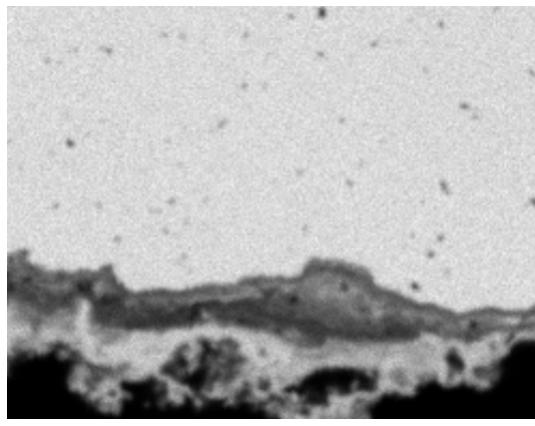
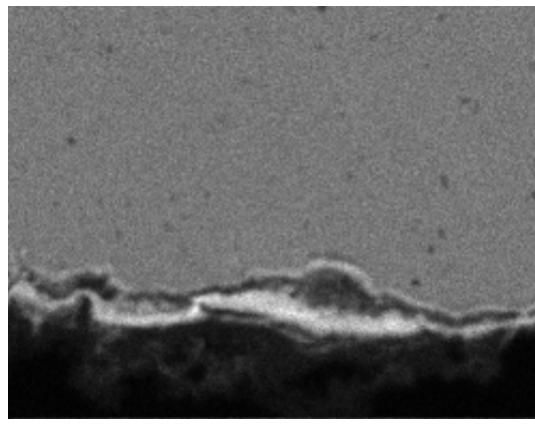
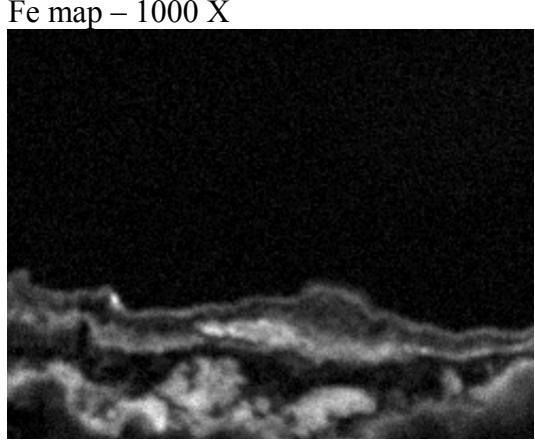
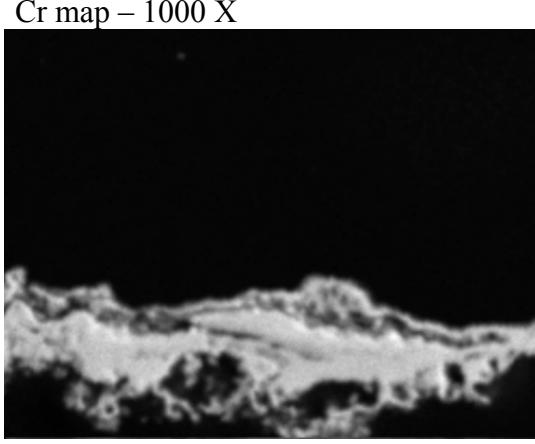
Figure 65. Electron microprobe images from 347H stainless steel sample #7

The micrographs in Fig. 65 show the reaction product on the 347H stainless steel sample exposed at temperatures definitely below the FMT of the superheater deposits. The corrosion product on the surface contains an outer layer richer in iron oxide and an inner layer containing primarily chromium oxide. The chlorine map shows appreciable chlorine content associated with the chromium oxide layer as well as the boiler material deposits that accumulated on the probe during operation.

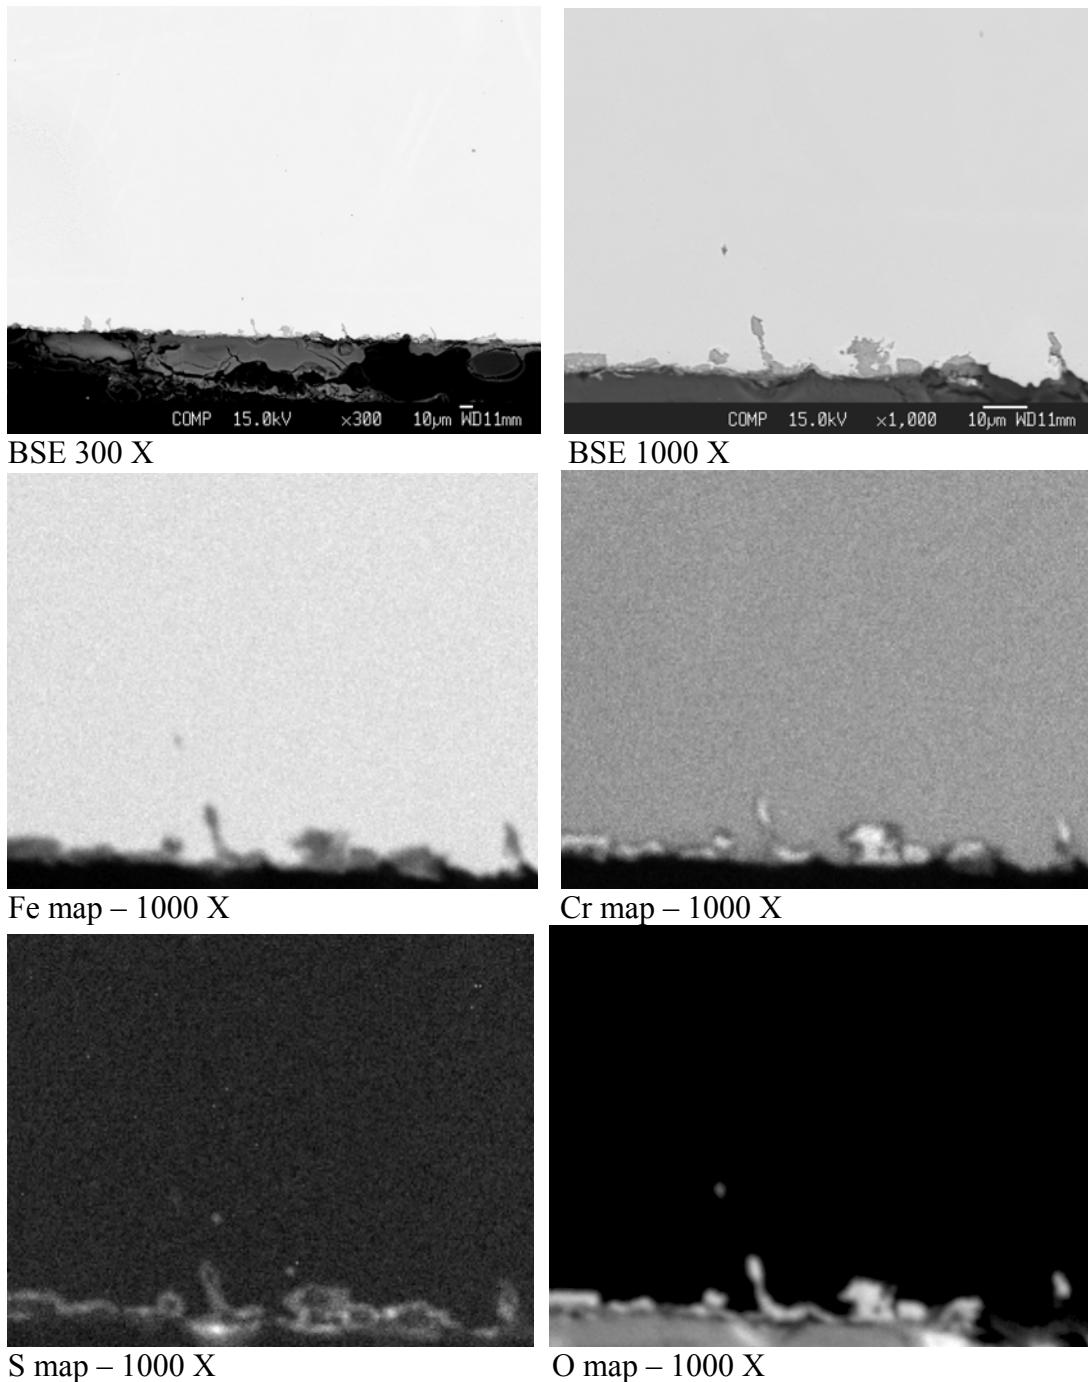
Figure 66. Electron microprobe images from 310H stainless steel sample #8

This stainless sample, as shown in Fig. 66, also has surface deposits of boiler material that contain oxygen but little or no iron and chromium. However, there are pits and subsurface penetrations that contain chromium oxide. There is a sulfur-containing layer on the metal surface and the surface deposits are enriched in sodium and oxygen.
