FINAL TECHNICAL REPORT
MATERIALS FOR INDUSTRIAL HEAT RECOVERY SYSTEMS

MATERIALS FOR HEAT RECOVERY IN BLACK LIQUOR RECOVERY BOILERS

DOE Award Number
DE-FC36-04GO14035

December 31, 2007

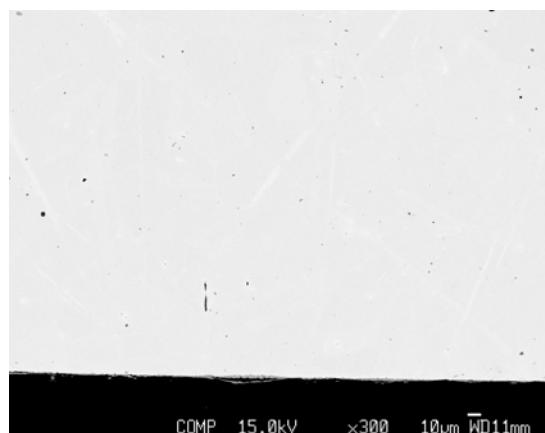
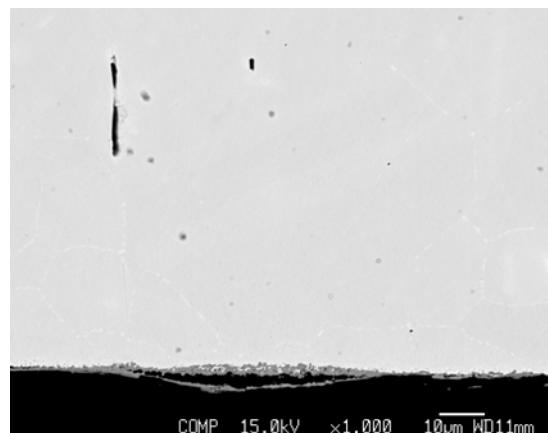
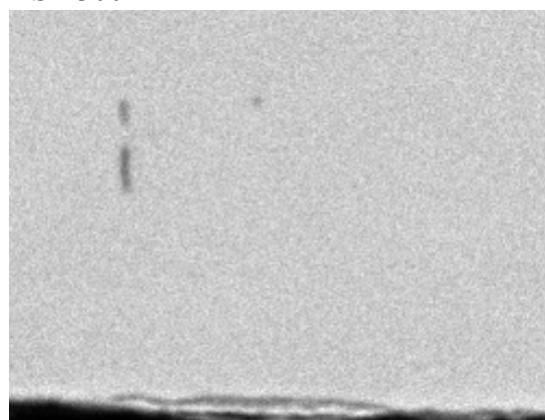
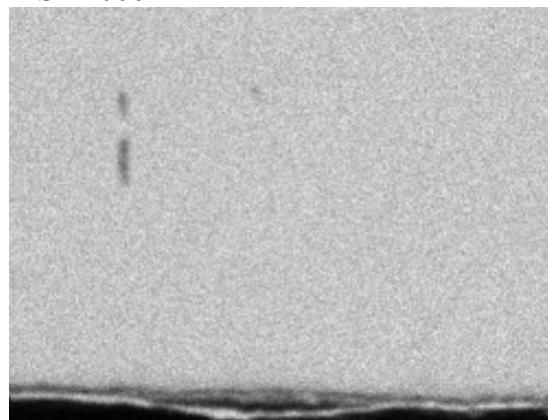
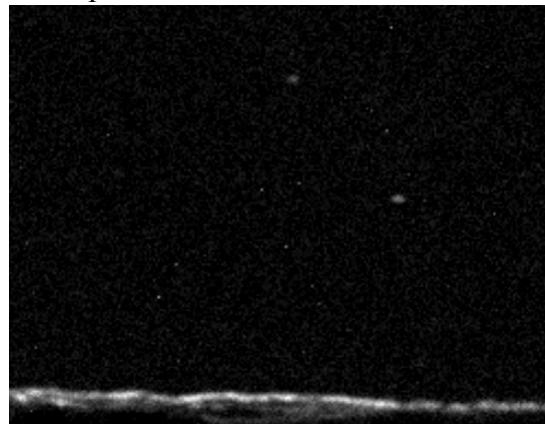
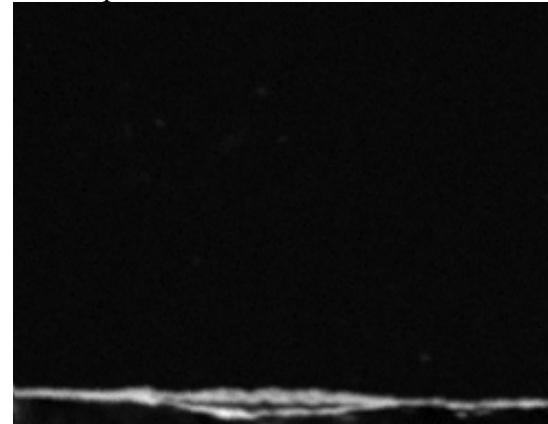
Figure 67. Electron microprobe images from Sanicro 28 sample #9

Although the thermocouples on this sample failed fairly early, based on temperatures reached by adjacent samples it appears the surface temperature of this sample probably did not exceed 538°C (1000°F). The micrographs in Fig. 67 show a thin oxygen-containing surface layer, primarily chromium oxide but with some iron oxide particularly where the chromium oxide appears to have separated from the surface of the sample. A layer of sulfur also appears to be present on the surface of the sample.

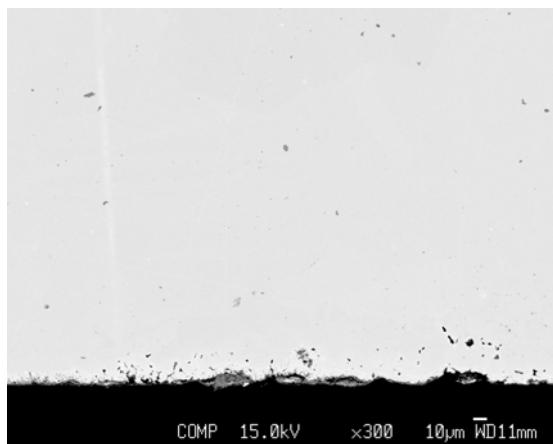
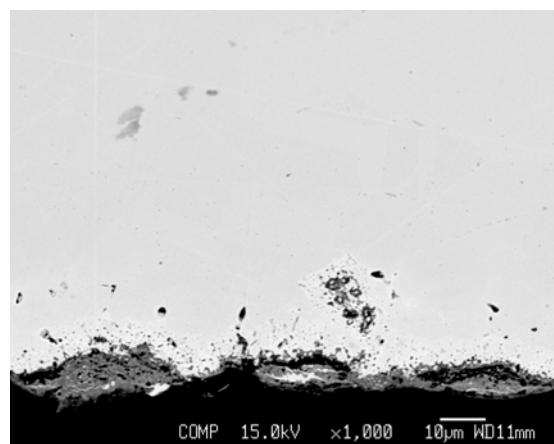
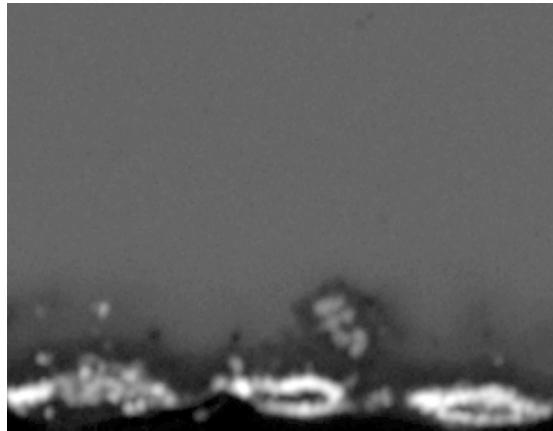
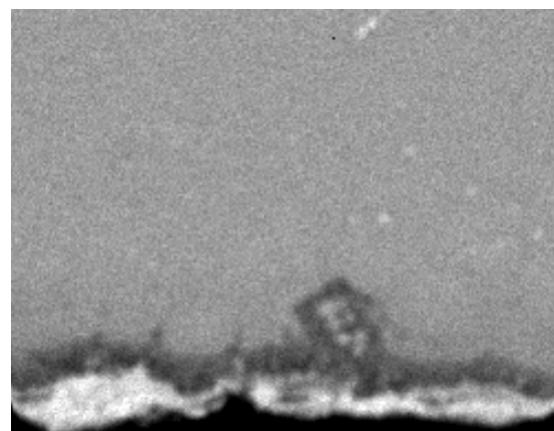
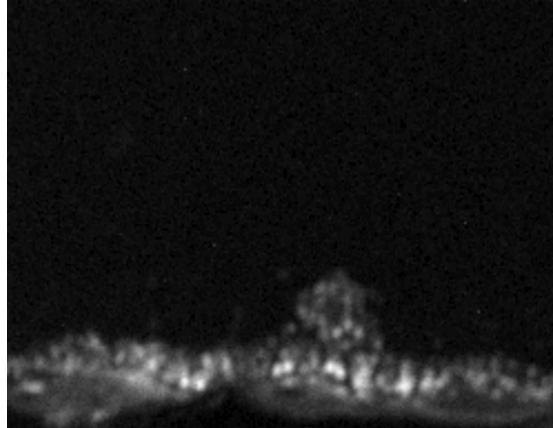
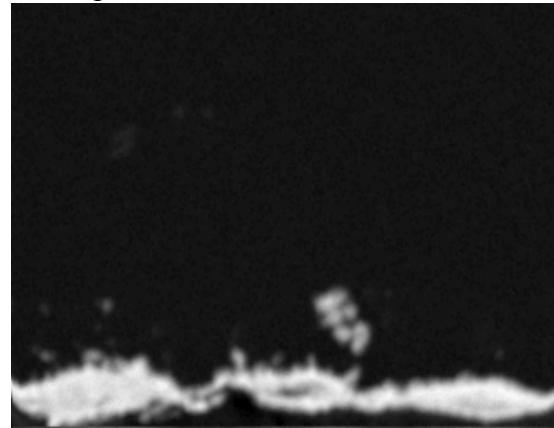
Figure 68. Electron microprobe images from Inconel 693 sample #10

This alloy was included in the test series because of an interest in determining if a protective alumina layer would be formed on the surface of the alloy. It is generally thought that exposure to an oxidizing environment at temperatures of 900-1000°C is necessary to form the alumina layer, and this sample only reached about 600°C. The micrographs in Fig. 68 show this sample experienced a significant amount of subsurface attack. Some subsurface regions were depleted in chromium and aluminum while other areas had elevated concentrations. Oxygen was present in these regions of elevated chromium and aluminum indicating the presence of chromium and aluminum oxides. Scattered regions of increased sulfur concentration were also present, and these regions included areas where subsurface oxides were observed.

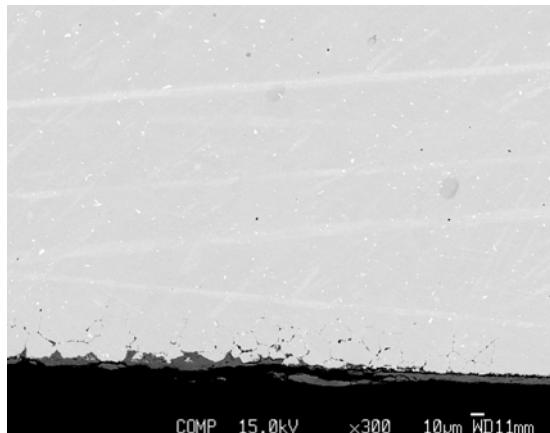
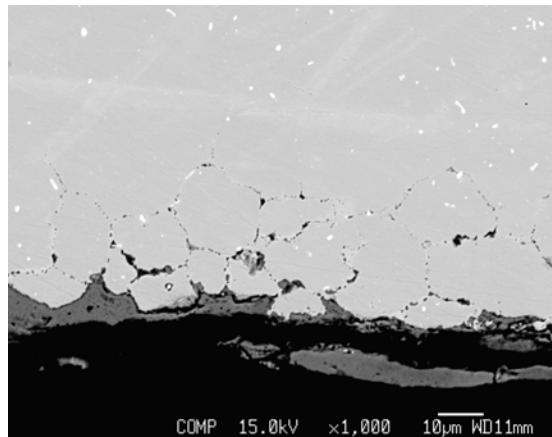
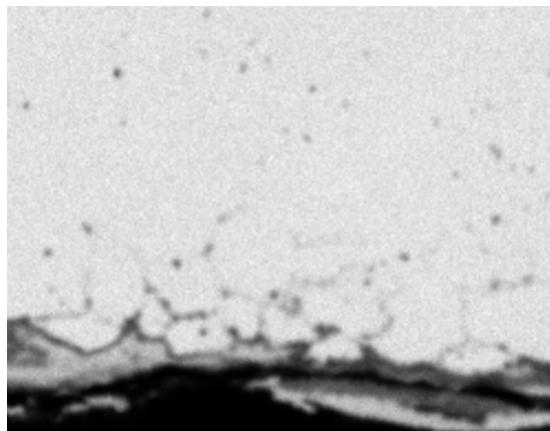
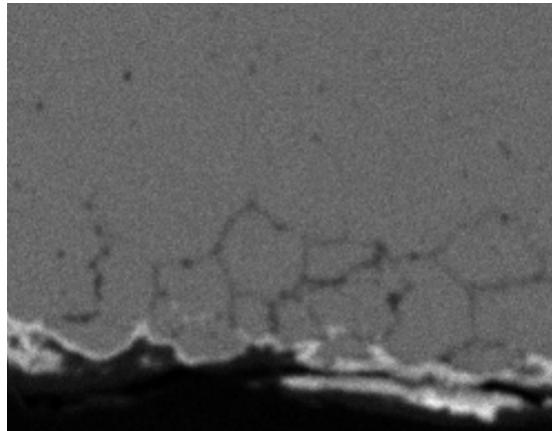
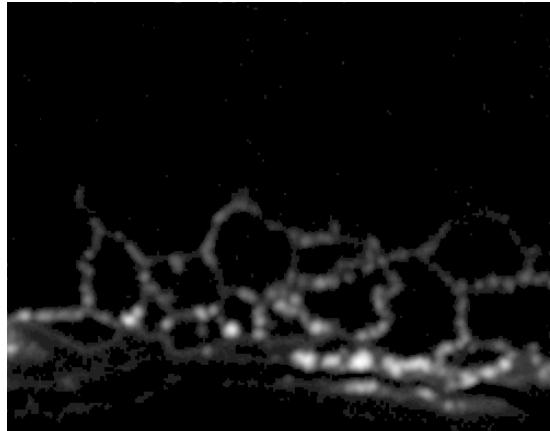
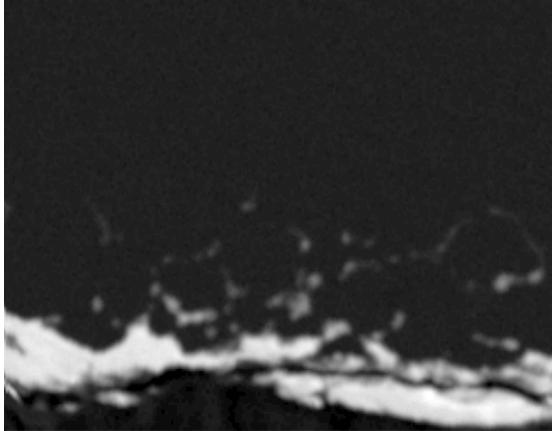
Figure 69 Electron microprobe images from 347H stainless steel sample #11

The microprobe images in Fig. 69 show this sample suffered considerable intergranular attack as well as having some surface corrosion products. Sulfur was particularly evident on the grain boundaries while no evidence of grain boundary enrichment of chromium was found. A thin chromium layer was present on the outer surface, and some enrichment of iron and chromium was also seen in the surface layers. The surface enrichment of iron and chromium corresponded to areas of high oxygen concentration, and oxygen was also seen on some of the grain boundaries.

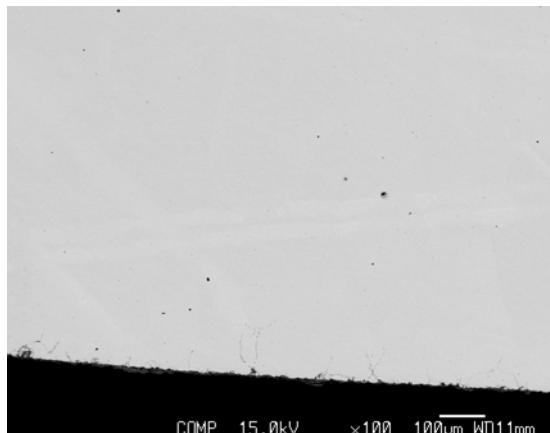
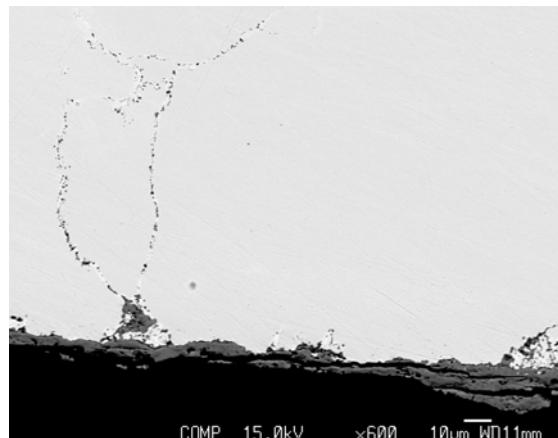
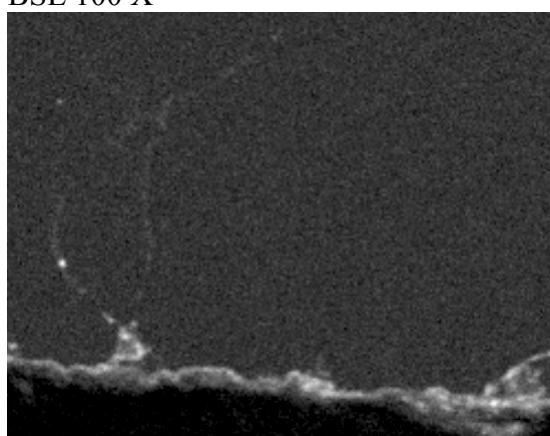
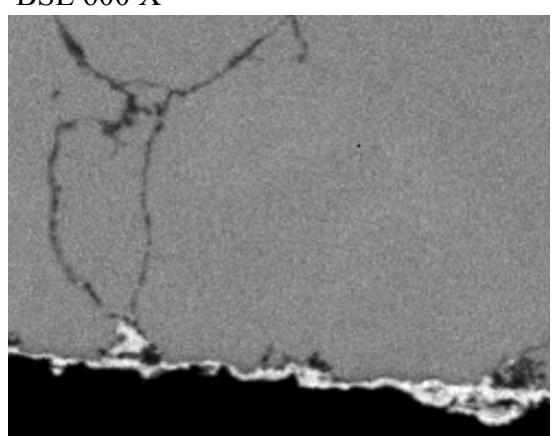
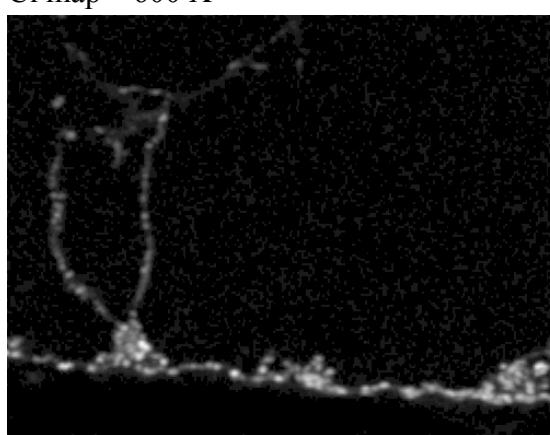
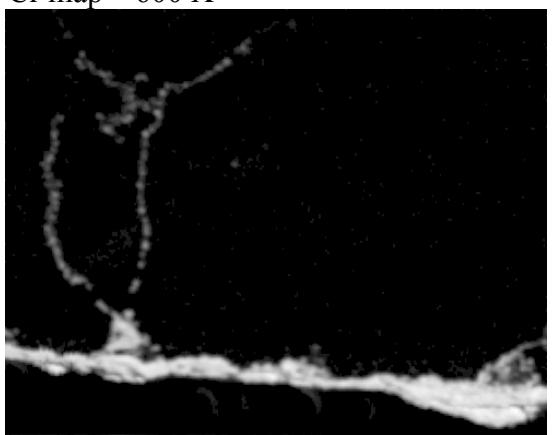
Figure 70 Electron microprobe images from 310H stainless steel sample #12

Like the 347H sample #11, this stainless steel sample suffered subsurface attack of the base metal. The micrographs in Fig. 70 show what are likely transgranular cracks that originate at the surface and advance a significant distance into the sample. A chromium oxide layer is present on the surface, and this layer appears to be continuous. Chlorine and sulfur are also present in this layer, and oxygen, sulfur and chlorine are concentrated on the cracks that advance into the

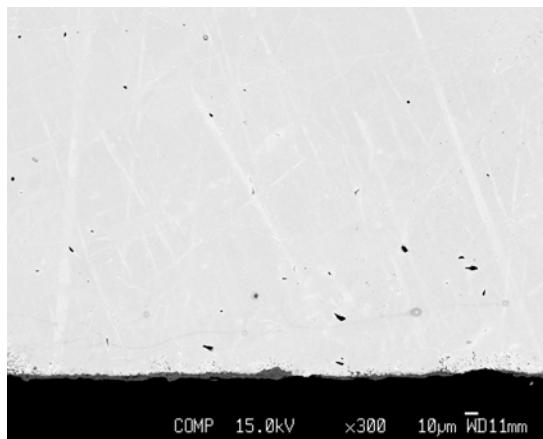
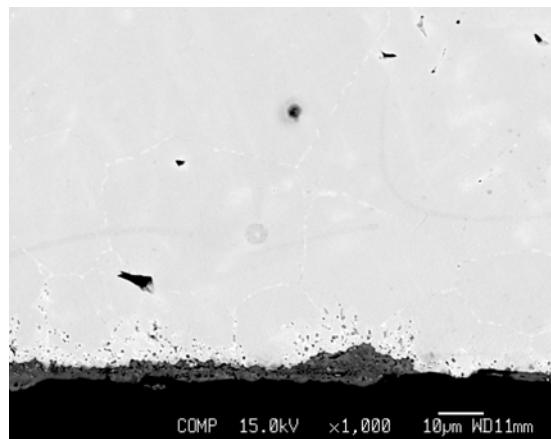
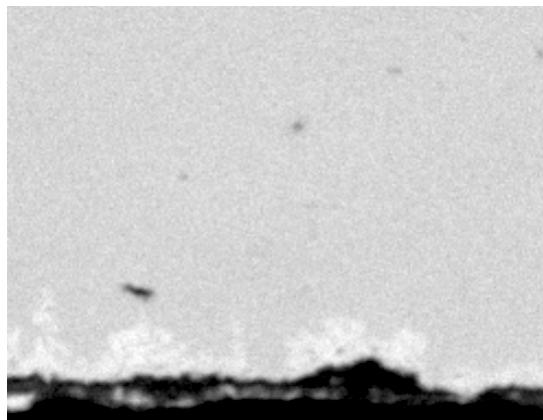
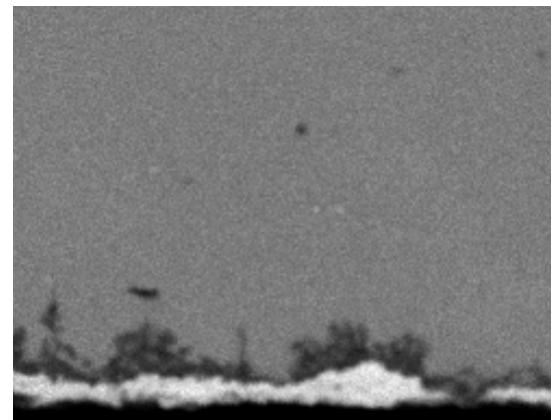
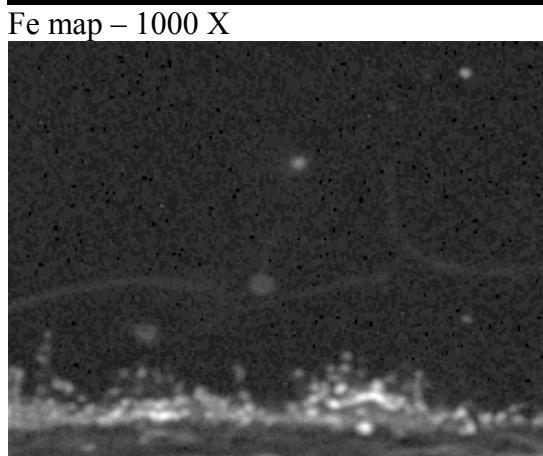
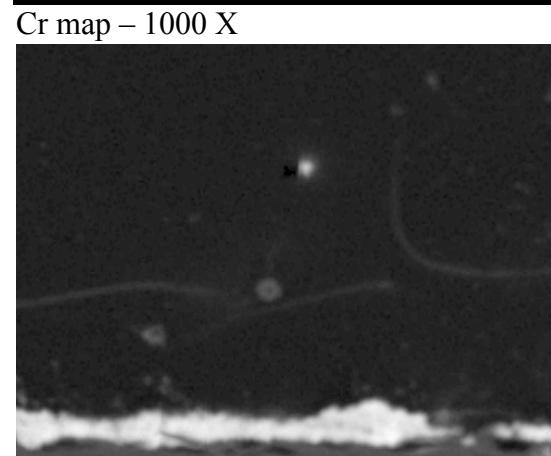
Figure 71 Electron microprobe images from Sanicro 28 sample #13

This sample was exposed at temperatures as high as 645°C (1193°F) which is well above the FMT. The sample shows evidence of subsurface attack, but the extent is less than on the adjacent type 310H stainless steel sample and, as shown in Figs 72 and 73, than the two samples exposed at higher temperature. The elemental maps for this sample, which are given in Fig. 71,

show there is a nearly continuous enrichment of chromium and oxygen along the surface indicating the presence of a chromium oxide layer. There is depletion of chromium in the sample just below the surface and a corresponding increase of iron in the area where chromium is depleted. In these subsurface, chromium-depleted regions, some sulfur and, to a lesser extent, chlorine, is present.

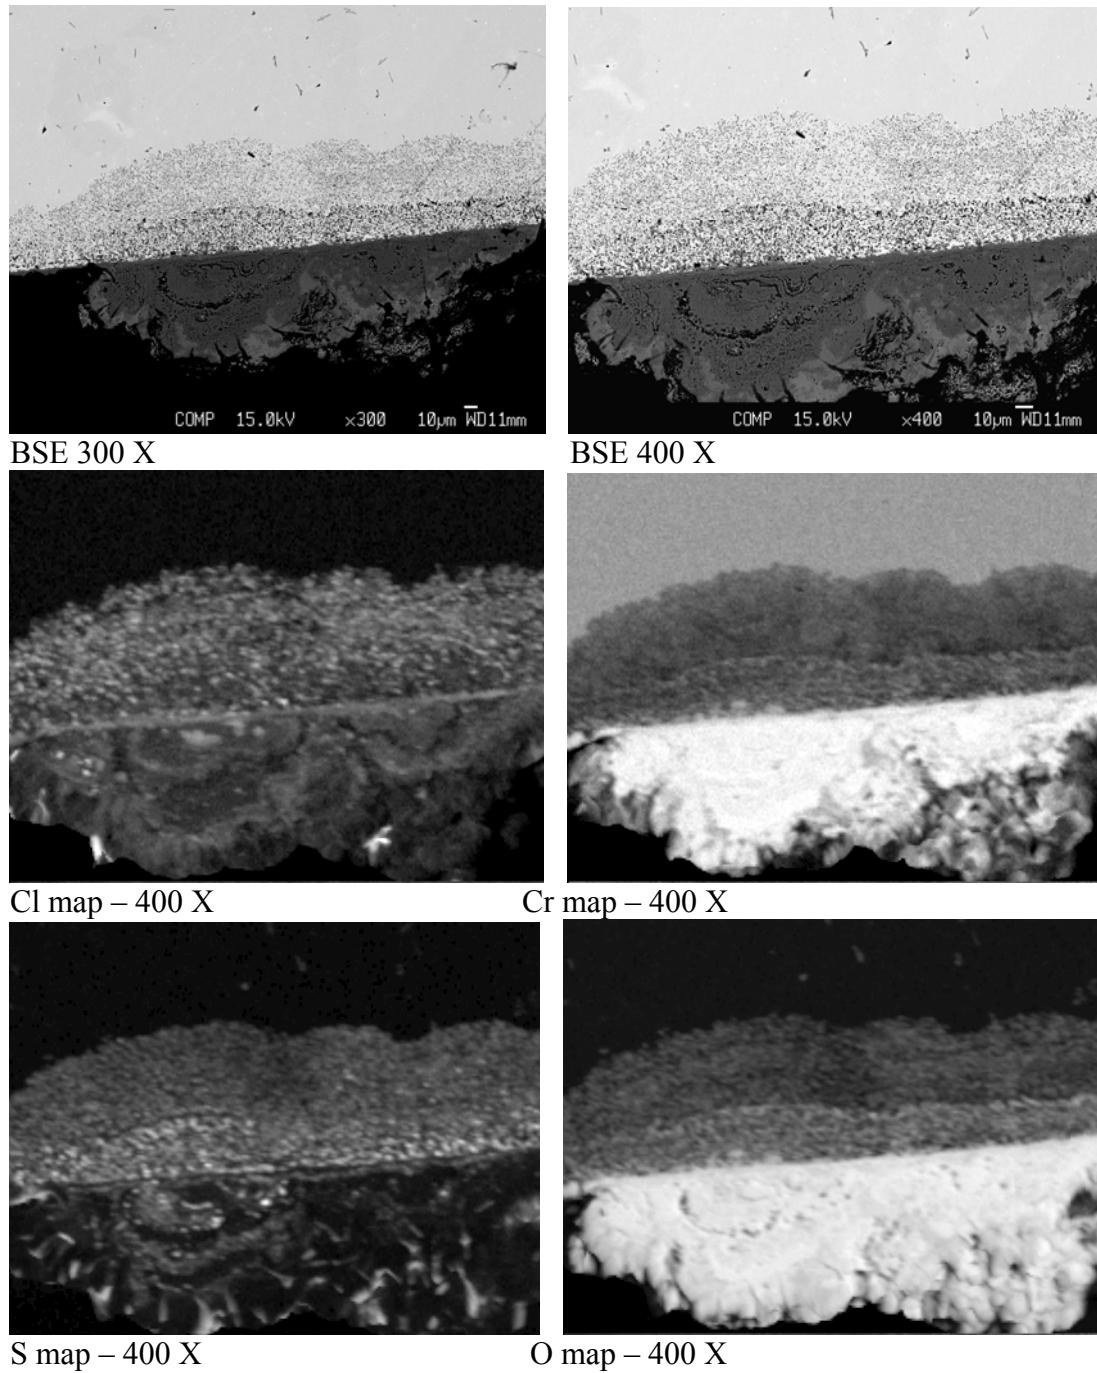
Figure 72 Electron microprobe images from Alloy 33 weld overlay sample #14

Figure 72 shows micrographs taken with the electron microprobe of the carbon steel sample that had an Alloy 33 weld overlay. Note that the elemental maps are shown at 400 X because of the size of the corrosion product on the surface and the volume of the affected subsurface region. The corrosion product on the surface is primarily chromium oxide, but there are detectable

amounts of chlorine and sulfur in the corrosion product. Sodium and potassium are also present in the corrosion product. In the subsurface area, there appear to be at least two distinct layers where the chromium, iron and nickel content vary. The sulfur content seems to be higher in the outermost of the subsurface layers and this may be due to development of some porosity in this sample. Clearly, this sample has undergone significant degradation.

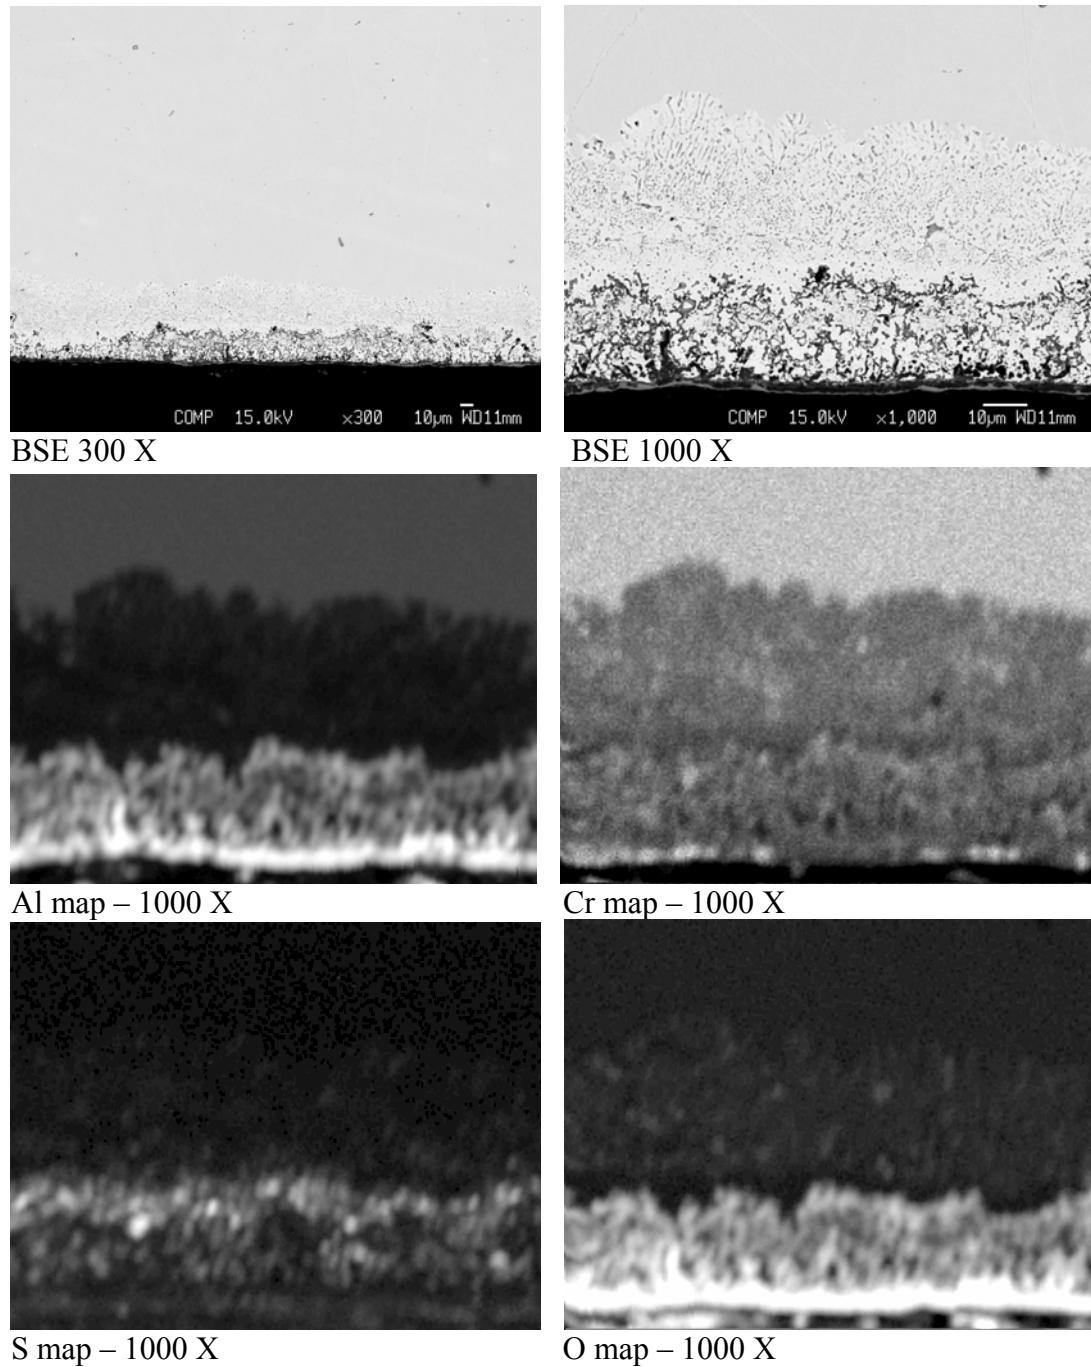
Figure 73 Electron microprobe images from Inconel 693 sample #15

As noted previously in this report, this alloy was chosen because of its ability to form a protective layer of alumina when exposed in an oxidizing environment at a sufficiently high temperature. Even though the surface of this sample probably reached temperatures in excess of 650°C (1200°F), it is very likely the temperature did not reach the level where a continuous and protective alumina layer could form. The elemental maps show the presence of a nearly

continuous aluminum layer on the surface with an aluminum-enriched layer just below the surface. This same region appears depleted in chromium. Significant oxygen is present in this aluminum enriched region, but there apparently is not a continuous, protective layer developed. There is also sulfur present in this first subsurface, aluminum-enriched layer suggesting this may be a porous layer. However, potassium and sodium do not appear to be particularly enriched in this layer. The extent of degradation of this sample is not as extensive as on sample #14, but it is significant enough that this alloy does not have enough corrosion resistance for this application.

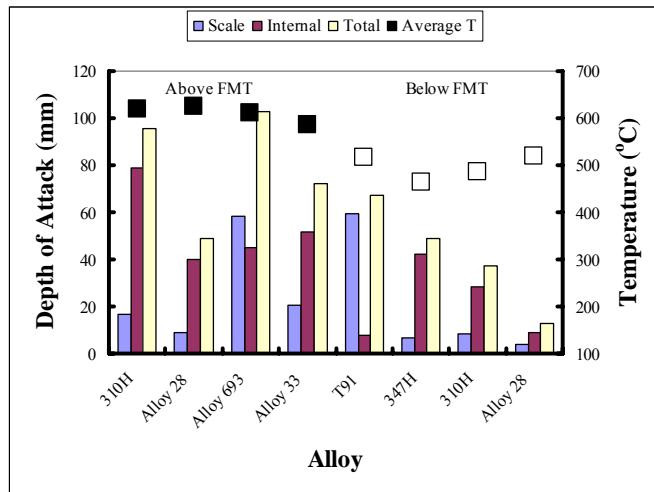
An attempt was made to quantify the extent of corrosion by measuring the scale thickness and the depth of internal penetration observed on each sample at one of the four documented positions. Figure 74 shows the results of that attempt. Superimposed onto the bar chart is an estimated average exposure temperature for the outside surface of each sample. This estimated average is simply the average inside surface temperature, calculated from the data plotted in Fig. 61, plus an allowance to compensate for the expected temperature drop across the sample tube wall. Of the four alloys exposed at temperatures above the FMT, which includes the alumina-forming Alloy 693, Alloy 28 exhibited the lowest scale thickness and the lowest depth of internal penetration. Alloy 28 also exhibits the smallest total depth of attack of the four alloys exposed at temperatures just below the FMT. It exhibited the lowest scale thickness and the second lowest depth of internal penetration. Interestingly, this lowest total depth of attack exhibited by Alloy 28 occurred at the highest relative exposure temperature below the FMT.

Figure 74. Depth of attack for alloys tested. Superimposed (as squares) is the estimated average exposure temperature for the outside surface of each sample.

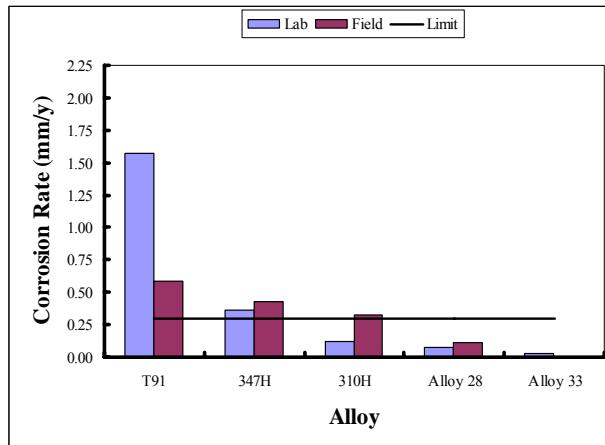
A plot comparing the extrapolated annual corrosion rate for the various alloys exposed at temperatures below the FMT in the lab (reactive cover gas mixture) and field exposure is shown in Fig. 75. superimposed on this plot, as a limit, is the minimum corrosion rate (0.3 mm/y) reported for corroded 347H tube bends in existing HT recovery boilers.[49] With the exception of T91, the field exposure appeared to be slightly more aggressive to the alloys than the lab exposure with the reactive cover gas mixture. Interestingly, both exposures yield the same relative ranking of alloys in terms of increasing corrosion rate at temperatures below the FMT, namely,

Figure 75. Annual corrosion rate extrapolated from lab (reactive cover gas mixture) and field exposure for alloys tested at temperatures below the FMT. Superimposed, as a limit, is the minimum corrosion rate (0.3 mm/y) reported for corroded 347H tube bends in existing HT recovery boilers.[49] Lab exposure based on 336 h and field exposure based on 1000 h.

The discussion of alloy suitability needs to take the corrosion resistance design criterion into consideration. If the criterion is acceptable corrosion resistance at temperatures below the FMT of the deposit, then, from Fig. 75, it appears as though 347H would be the minimum alloy (of those tested) suitable, albeit marginal, for use as superheater tubes in HT/ HP recovery boilers. A better choice would appear to be 310H or Alloy 28 (Note Alloy 33 was not tested under these conditions). To minimize the risk of corrosion in practice, removal of non-process elements (potassium and chlorine) would become a critical part of corrosion control to assure that the FMT of the superheater tube deposit is well above the tube temperature and the associated expected degree of variation.

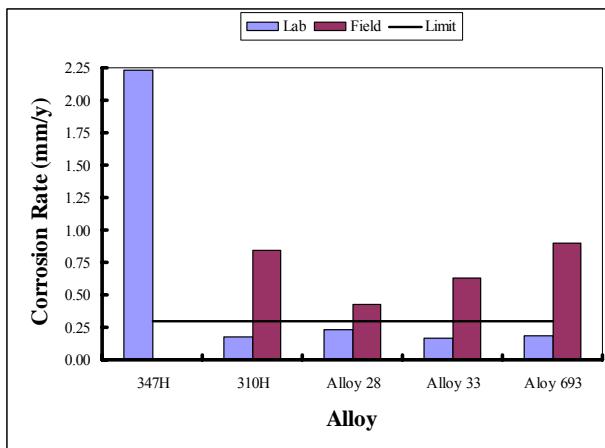
A plot comparing the extrapolated annual corrosion rate for the various alloys exposed at temperatures above the FMT in the lab (reactive cover gas mixture) and field exposure is shown in Fig. 76. Also superimposed on this plot, as a limit, is the minimum corrosion rate (0.3 mm/y) reported for corroded 347H tube bends in existing HT recovery boilers.[49] The field exposure appeared to be moderately more aggressive to the alloys than the lab exposure using the reactive cover gas mixture. Unlike the trend in corrosion rate observed for the lab exposure below the FMT (Fig. 75), the corrosion rate did not vary much among the alloys, with the obvious exception of 347H, which had a significantly higher rate. Note that the corrosion rate of the alumina-forming Alloy 693 was similar to that of the chromia-forming 310H, Alloy 28 and Alloy 33 in the lab test environment. The corrosion rate of 347H was significantly greater than the minimum rate of 0.3 mm/y (12 mpy) reported for cases involving accelerated corrosion in HP recovery boilers. The lab exposure corrosion rates of the other four alloys were lower than this rate, ranging from 0.17 mm/y (6.8 mpy) for 310H to 0.23 mm/y (9.2 mpy) for Alloy 28. In contrast, the field exposure corrosion rates for 310H, Alloy 28, Alloy 33 and Alloy 693 were all greater than this limiting rate. Of the alloys tested at temperatures above the FMT in the field, which includes the alumina-forming Alloy 693, Alloy 28 exhibited the lowest corrosion rate. Based on the field exposure, the relative ranking of alloys in terms of increasing corrosion rate at temperatures above the FMT is,

Fig. 76. Annual corrosion rate extrapolated from lab (reactive cover gas mixture) and field exposure for alloys tested above the FMT. Superimposed, as a limit, is the minimum corrosion rate (0.3 mm/y) reported for corroded 347H tube bends in existing HT recovery boilers.[49] Laboratory exposure is based on 336 h and field exposure is based on 1000 h.

If the criterion is acceptable corrosion resistance at temperatures above FMT of the deposit, then, from Fig. 76, it appears as though Alloy 28 would be the minimum alloy (of those tested) suitable to control corrosion of superheater tubes in HT/HP recovery boilers. For this to be realized in practice, tight control of tube temperature would become critical to corrosion control to assure that the time at temperature above the FMT of the deposit is minimized. Based on the various resistances to heat transfer, the surface temperature of a superheater tube is expected to be about 30 to 50C° hotter, or higher if affected by direct radiation, than the steam temperature inside the tube.[50,51] In addition, the tube temperature may be 20C° hotter on the windward side than on the leeward side.[43] Note also that the individual tube steam temperature can vary another $\pm 23\text{C}^\circ$ from the average across the steam manifold.[52]

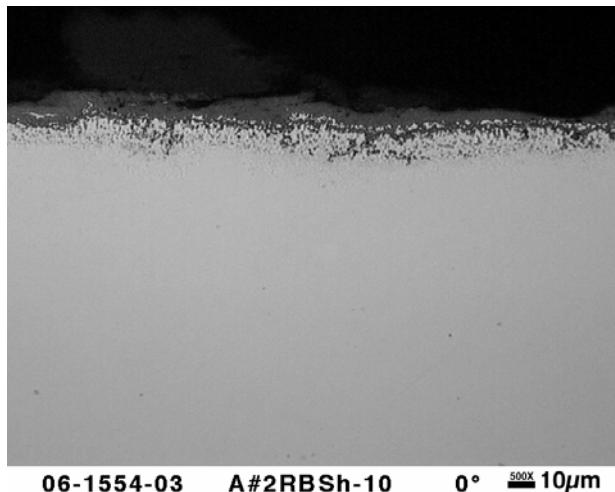
06-1554-03 A#2RBSh-10 0° 500X 10µm
O.D. As polished

Inconel 693 – sample #10

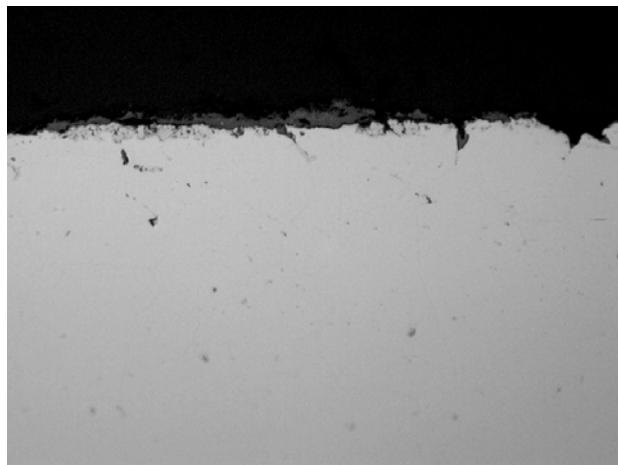
06-1555-03 A#2RBSh-11 0° 500X 10µm
O.D. As polished

347H stainless steel – sample #11

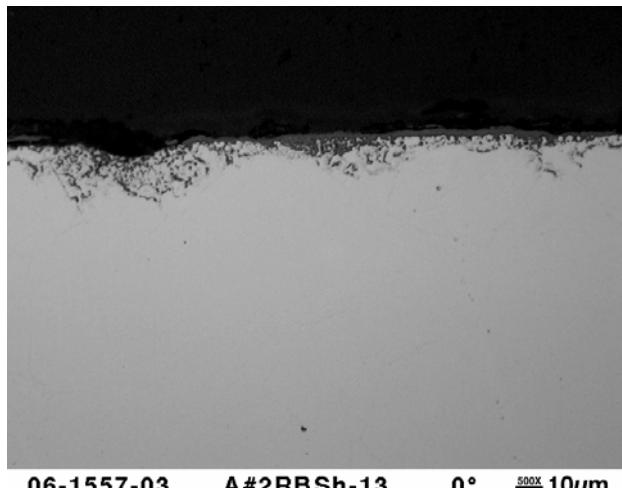
06-1557-03 A#2RBSh-13 0° 500X 10µm
O.D. As polished

Sanicro 28 – sample #13
