Nevada
Environmental
Restoration
Project

DOE/NV-974

Tonopah Test Range Post-Closure
Inspection Annual Report, Tonopah
Test Range, Nevada
Calendar Year 2003

April 2004

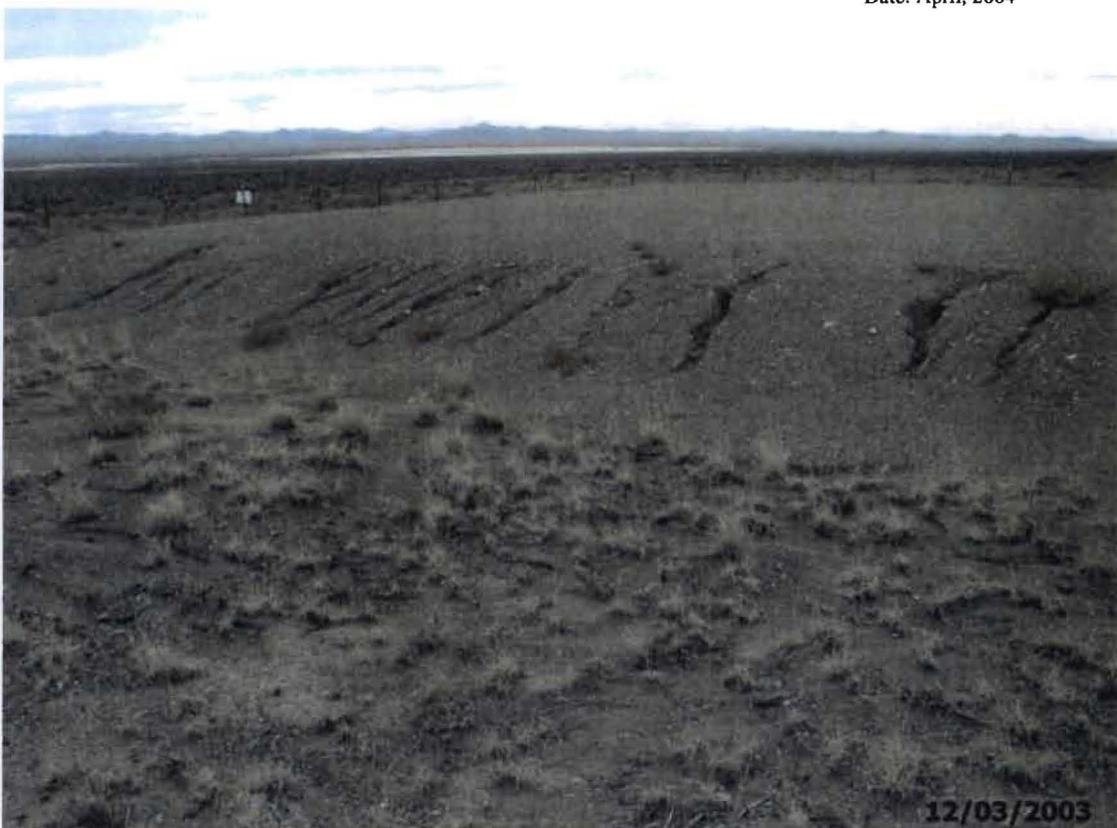
9. CAU 407 Roller Coaster RadSafe Area, looking south showing erosion on cover

Repair activities for CAU 407 consisted of fence and minor cover repair completed on July 16, 2003. The southeast corner fence post was repaired and the attached fencing tension was tightened. Additional clean fill was added to repair the areas of erosion on the cover side slopes, and faded radiological posting signs were replaced with new signs.

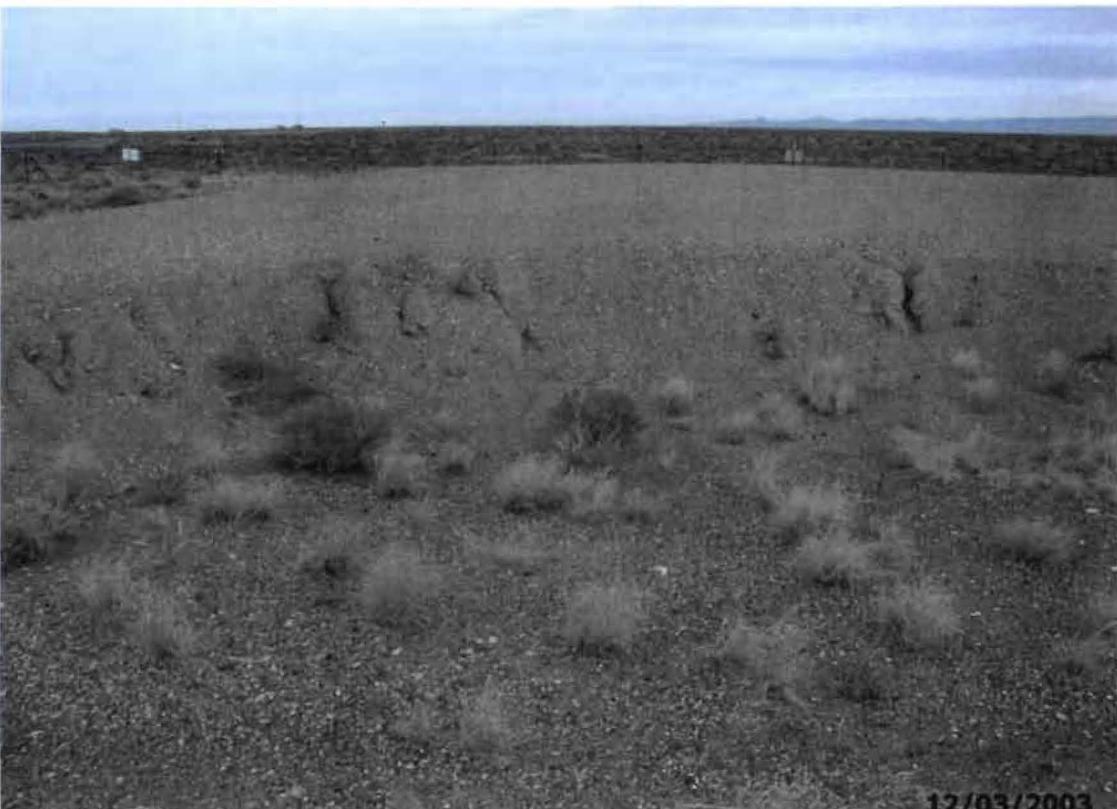
10. CAU 407 Roller Coaster RadSafe Area, looking north showing erosion on cover

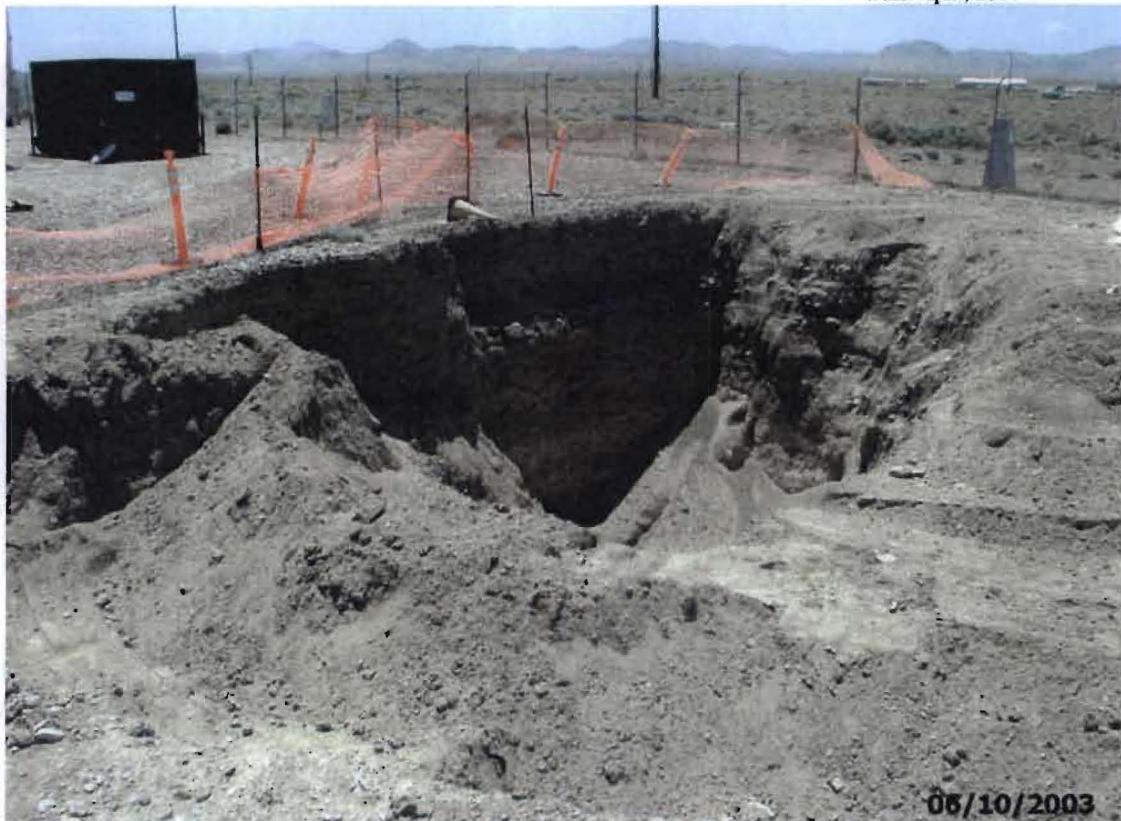
17. CAU 424 Area 3 Landfill Complexes Landfill Cell A3-3 (monument marked by orange cone), looking west (CAU 410 excavation in foreground)

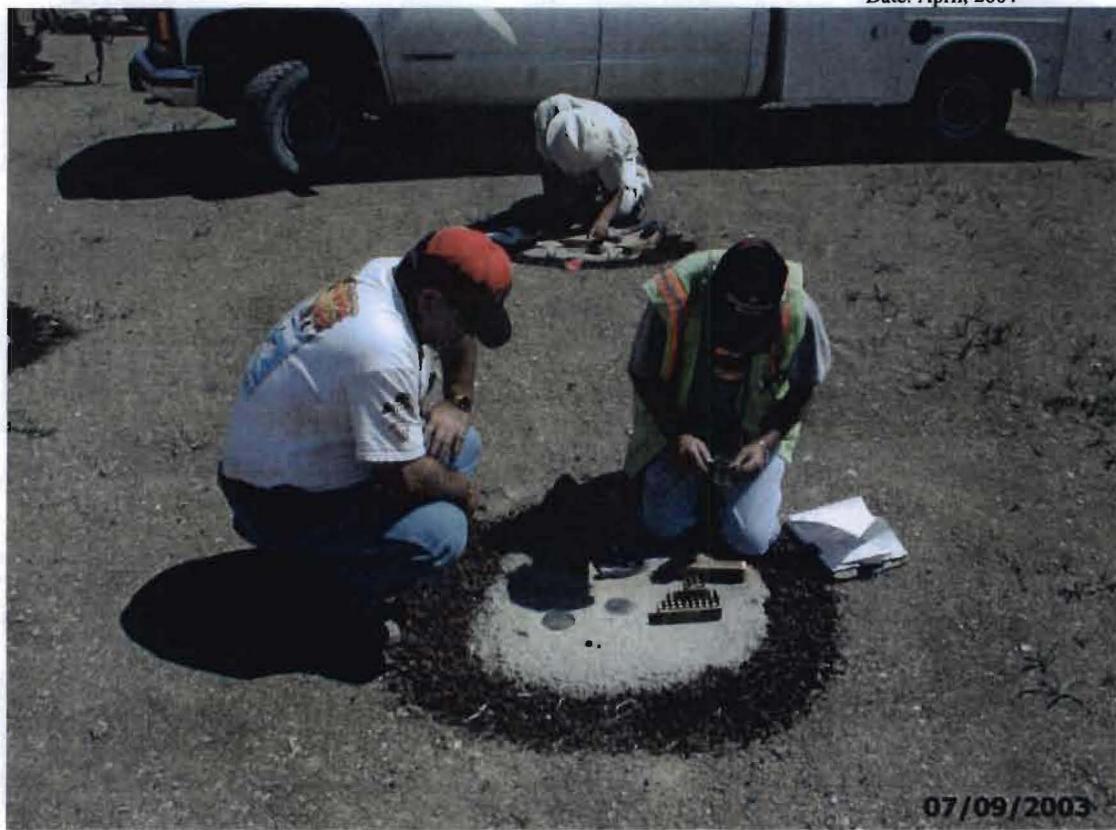
29. CAU 424 Area 3 Landfill Complexes Landfill Cell A3-3, July 2003 repairs
(stamping land-use restriction coordinates on monument)

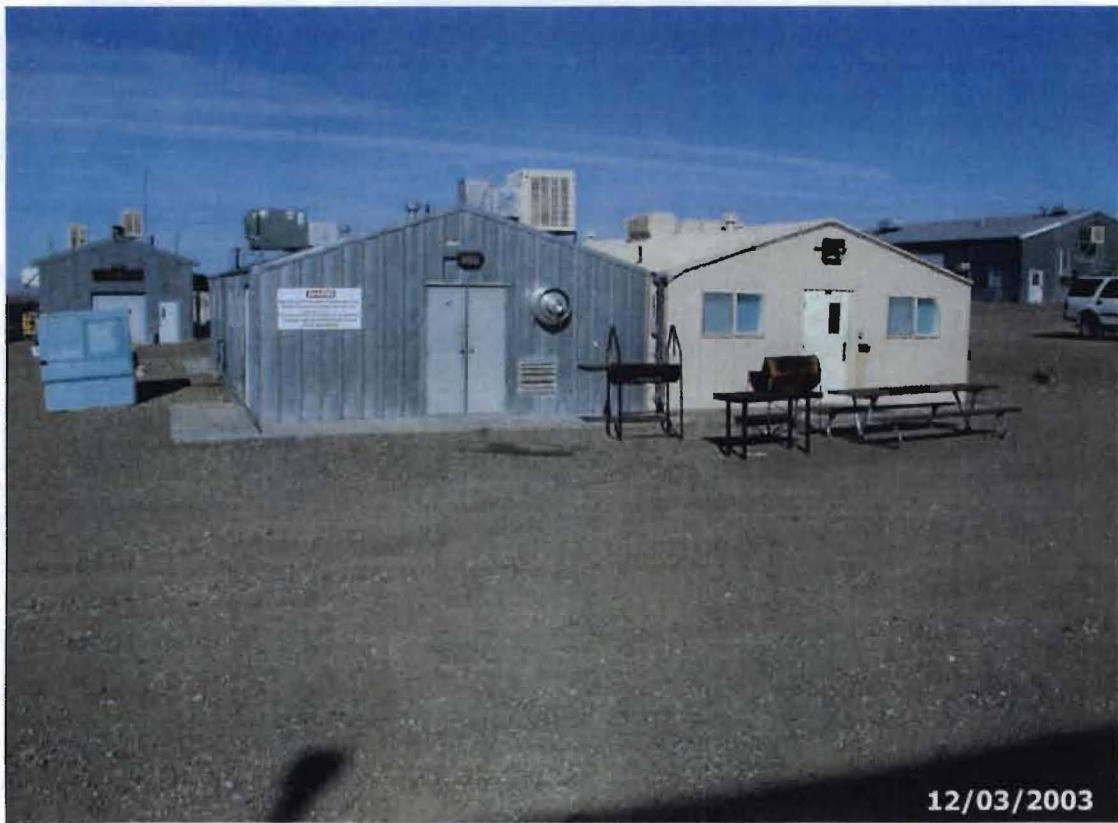
34. CAU 427 Area 3 Septic Waste Systems 2, 6, looking north (monuments are in foreground shadow)

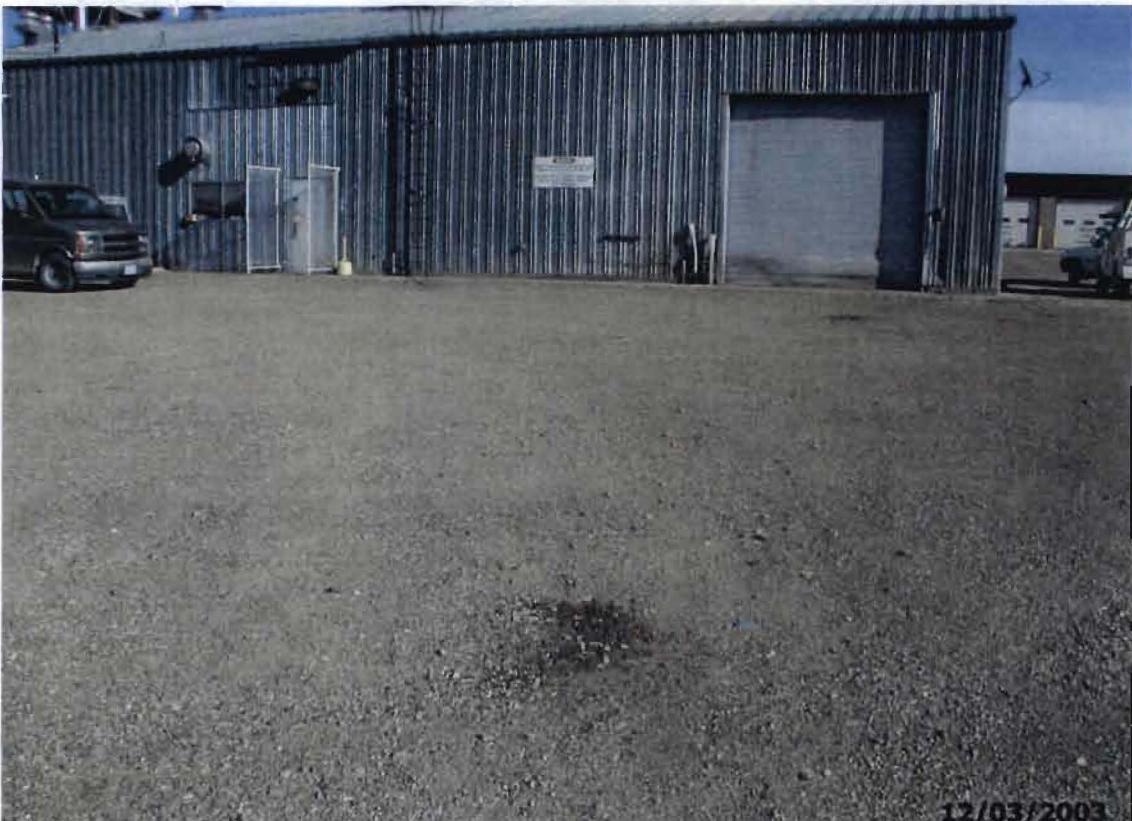
38. CAU 427 Area 3 Septic Waste Systems 2, 6, looking east

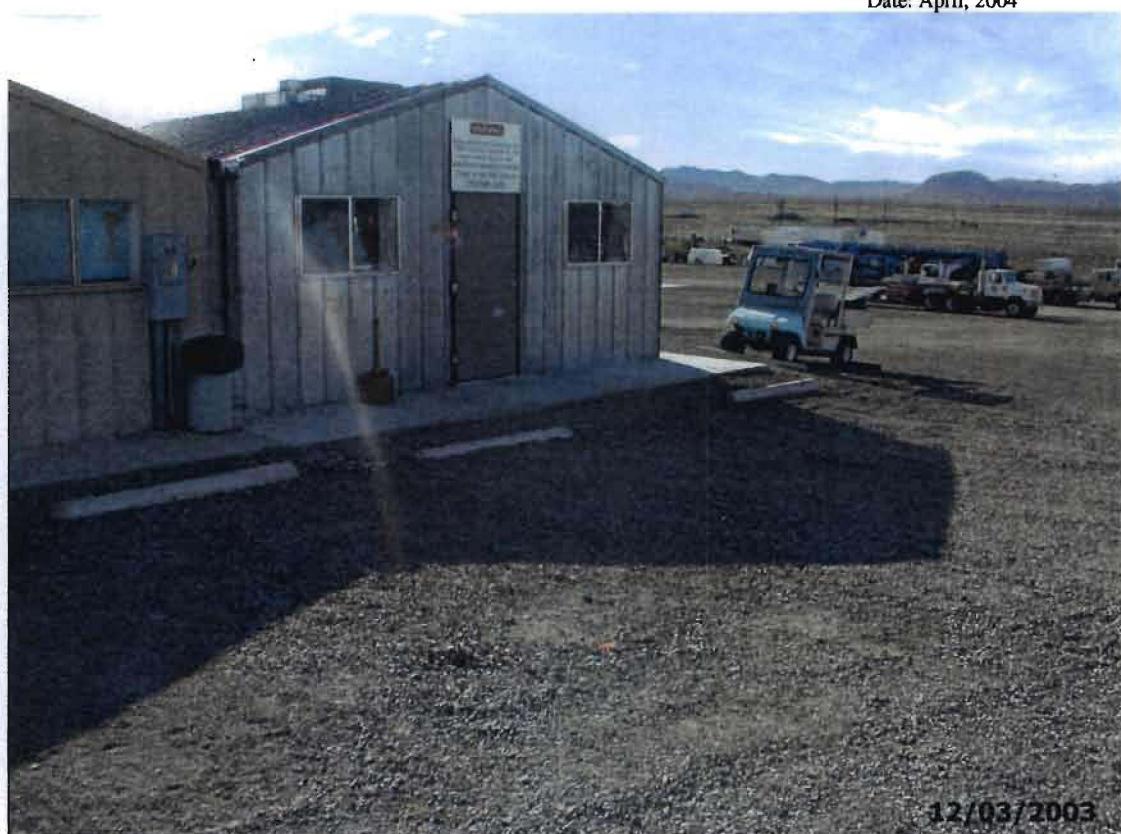
39. CAU 427 Area 3 Septic Waste Systems 2, 6, looking west (new use restriction sign on Bldg 0307T)

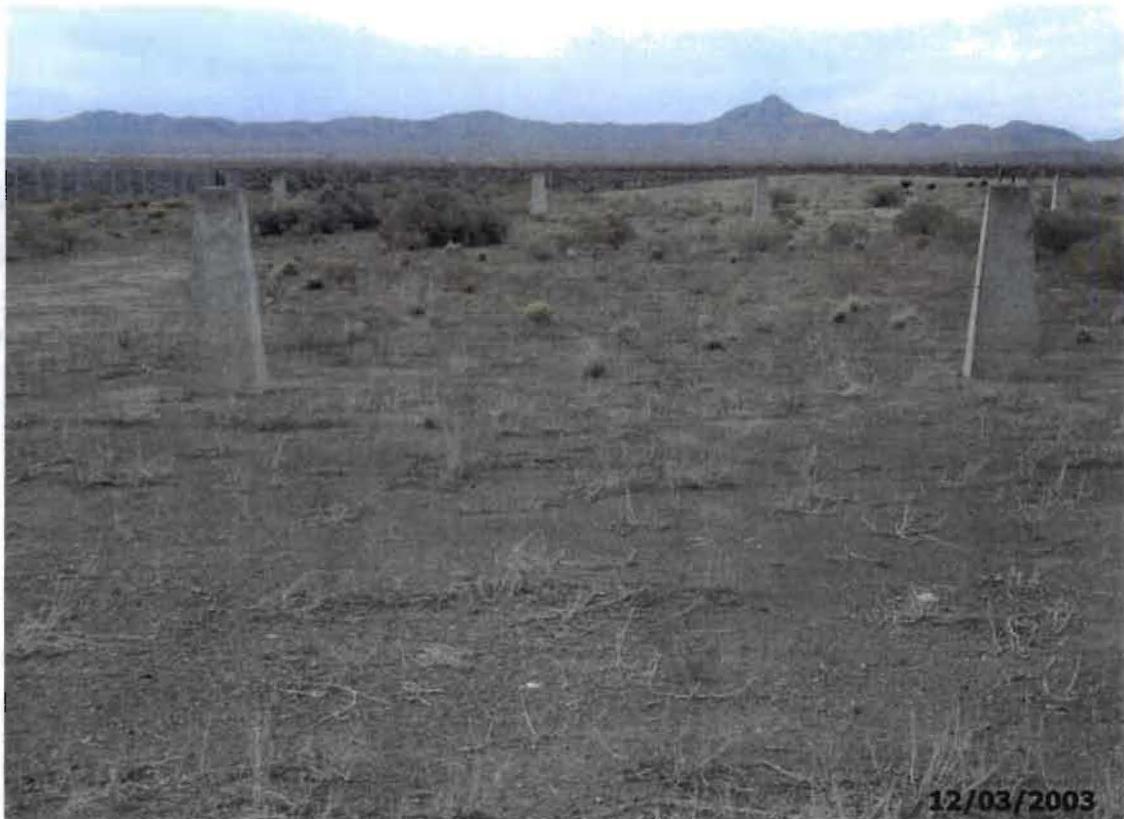
42. CAU 453 Area 9 UXO Landfill, looking west

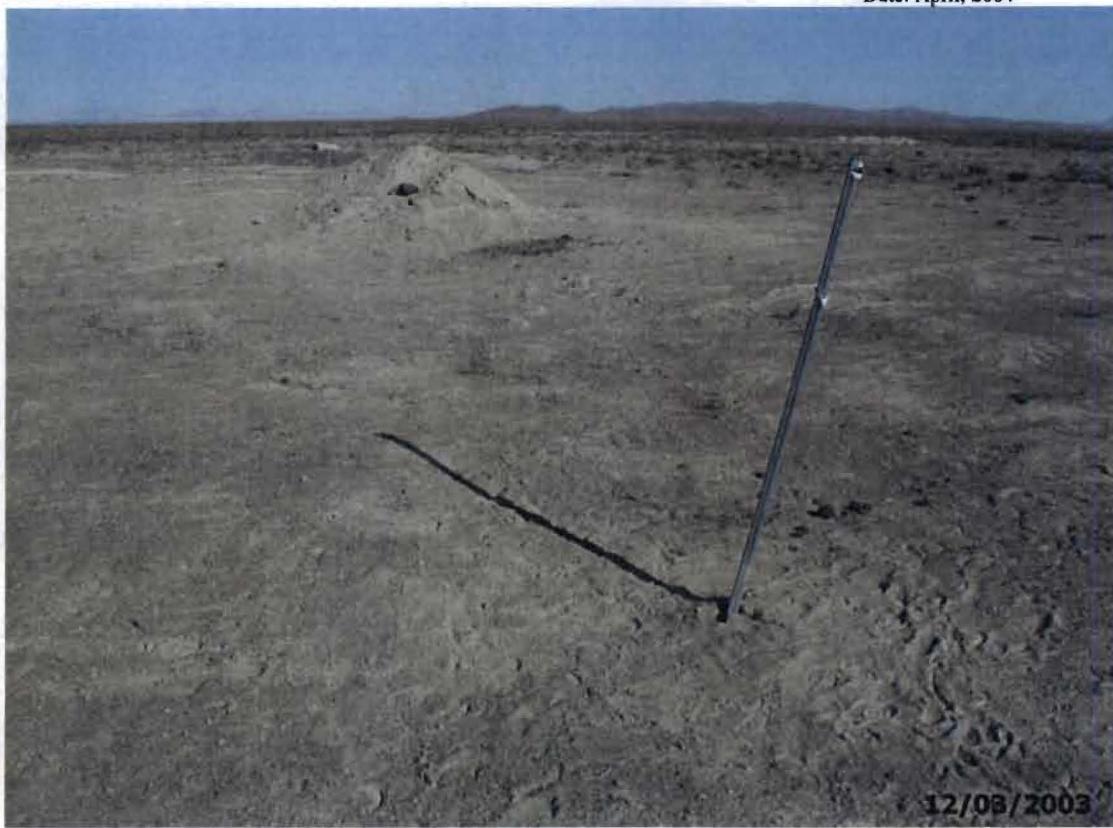
43. CAU 487 Thunderwell Site, looking west (Anomaly A-17)

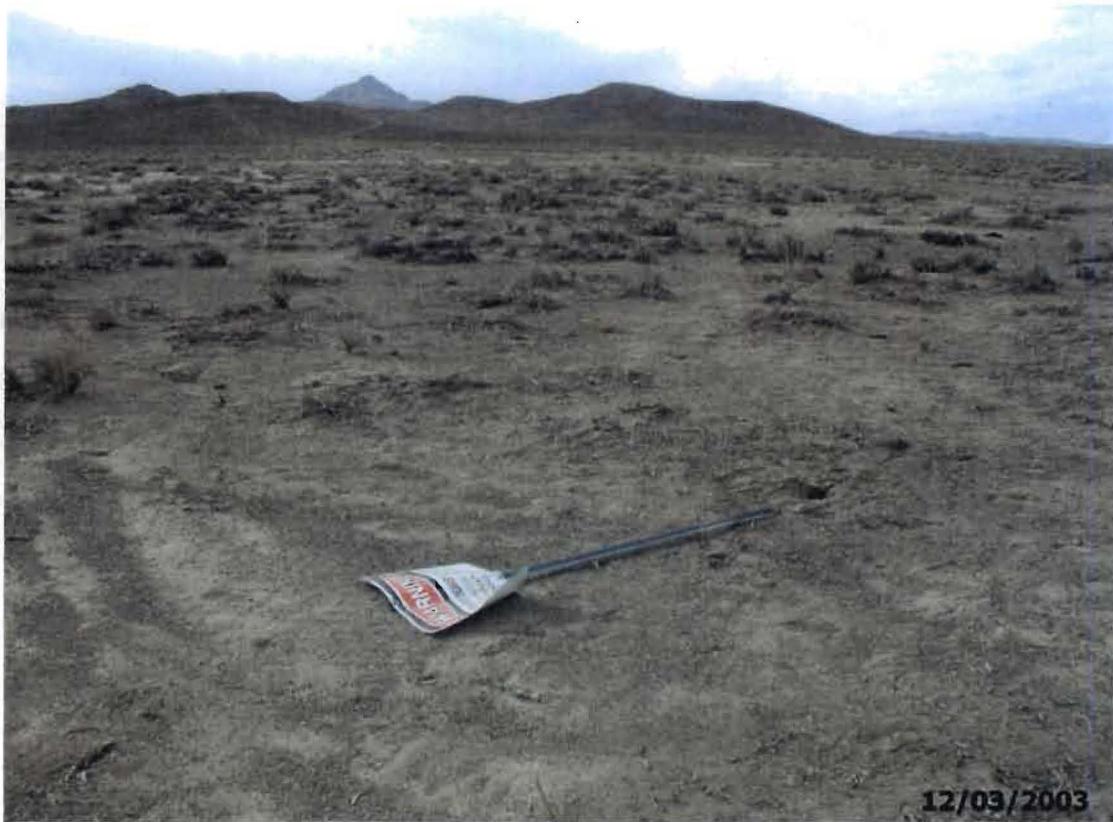
44. CAU 487 Thunderwell Site, looking south (Anomaly A-8)

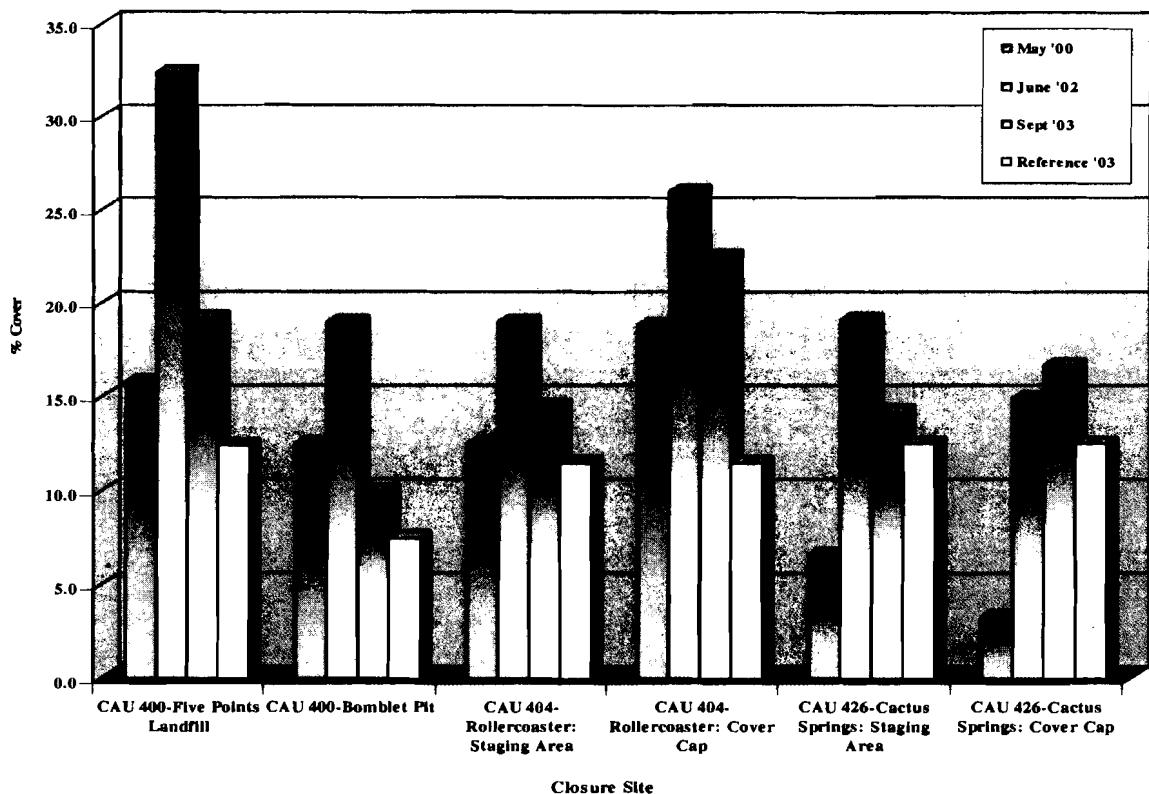
Plant cover for four closure sites exceeds cover estimates for their corresponding reference area. There is essentially no plant cover at CAU 407-Rollercoaster RADSAFE area. Cover estimates made this year are overall lower than in 2002 (Figure 6). However, estimates this year were made in September well beyond the typical period of growth for most plant species in this region. Most grasses and forbs are now dormant and annual plants that may have been present earlier in the year are gone. Growing conditions were still not optimal as the drought in the southwestern United States continues. Even under these circumstances plant cover has not declined to levels that would cause concern. Plant cover continues above 20% on the cover cap

Figure 6. Plant cover on Tonopah Test Range closure sites from May 2000 to September 2003

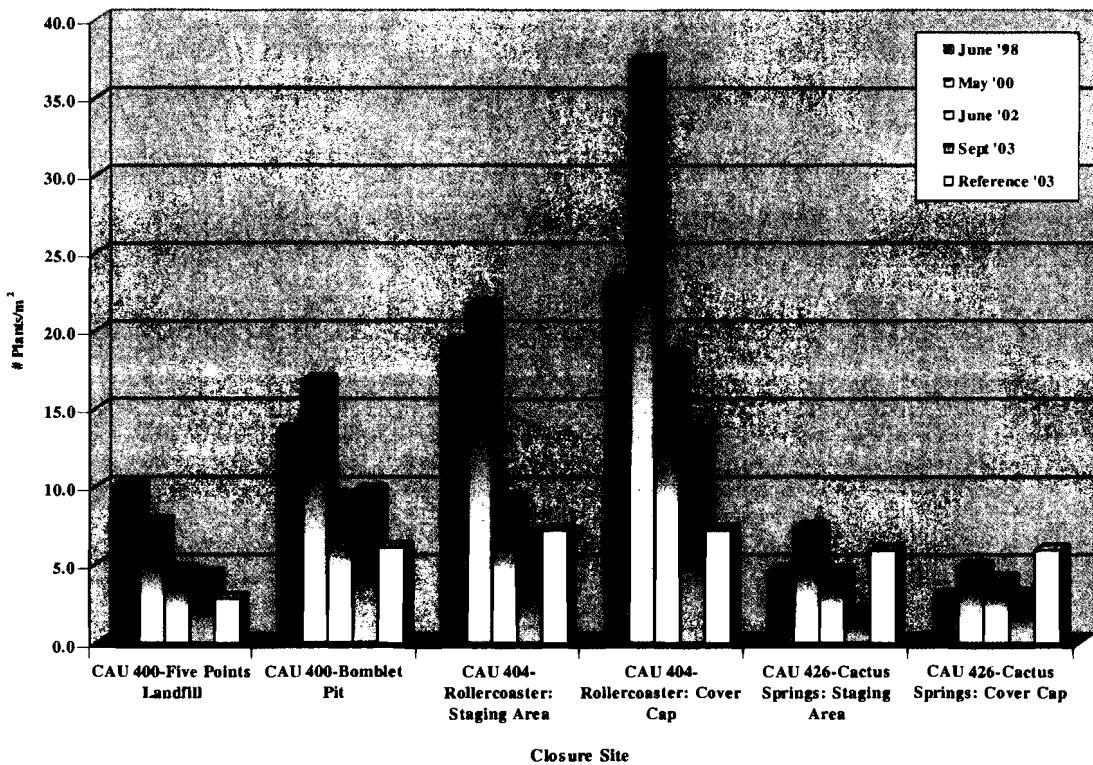
Plant density, of species included in the seed mix used to revegetate the closure sites, have all maintained at a level equal to or higher than plant densities for respective reference areas. Only at the CAU 426-Cactus Springs Waste Trenches were plant densities lower than on the reference area (Figure 7). Plant densities remain high at the CAU 404-Rollercoaster cover cap with over 12 plants/m². At CAU 400-Bomblet Pit plant density was about 10 plants/m² and plant densities at the other sites were 5 or less plants/m². The only plants at CAU 407-Rollercoaster RADSAFE site were annual weeds, primarily halogeton and Russian thistle. The site has obviously been disturbed since it was reseeded in 2000. Any plants that may have established from the original seeding have not survived the impact of new disturbances, nor the last three years of drought.

Figure 7. Perennial plant density on Tonopah Test Range Closure Sites from June 1998 to September 2003.

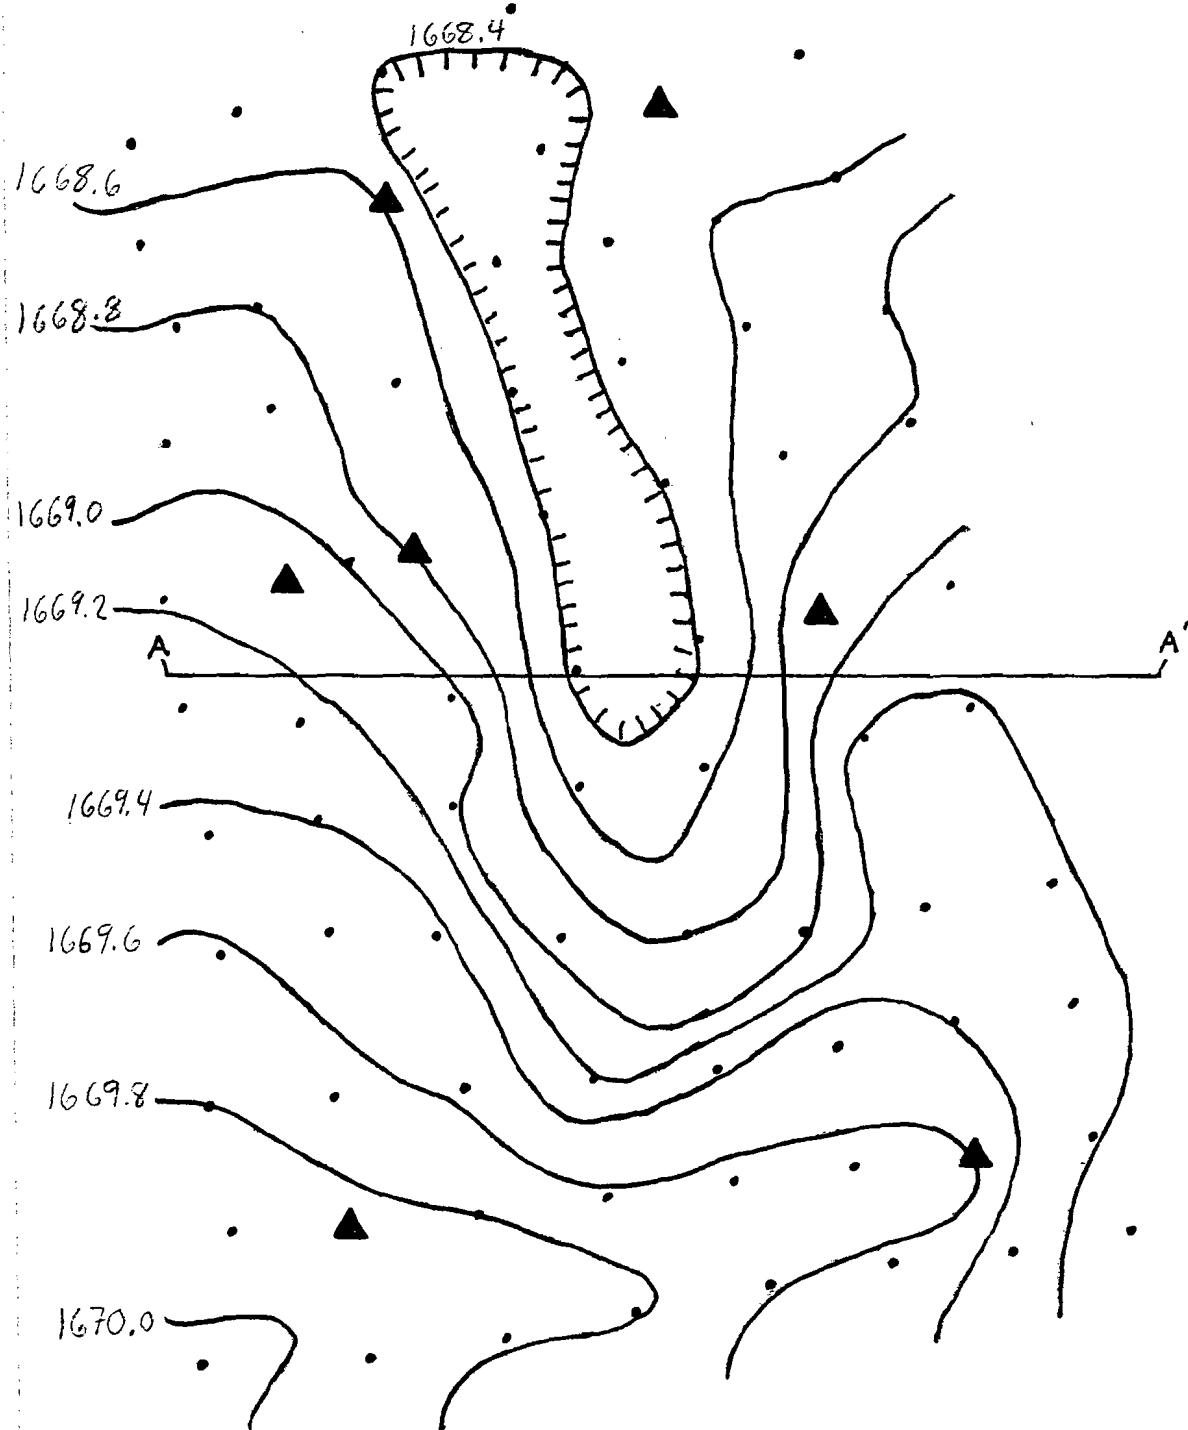
CAU 424 LANDFILL A3-1

Elevation profiles were surveyed at landfill cell A3-1 and landfill cell A3-4. Elevation data were used to prepare elevation contour maps for both sites (see Attachment F). The elevation data, contour map, and topographic profile for landfill cell A3-1 confirms that a topographically low area is present in the northeast portion of the site. The data indicate the northeast and eastern portions of the site are approximately 0.8 feet lower than the surrounding area outside of the landfill cell. This depression corresponds to a surface depression and "newly-buried construction debris" present during closure activities (see Attachment D, Figure 3 from the CAU 424 CR [DOE/NV, 1999a]).

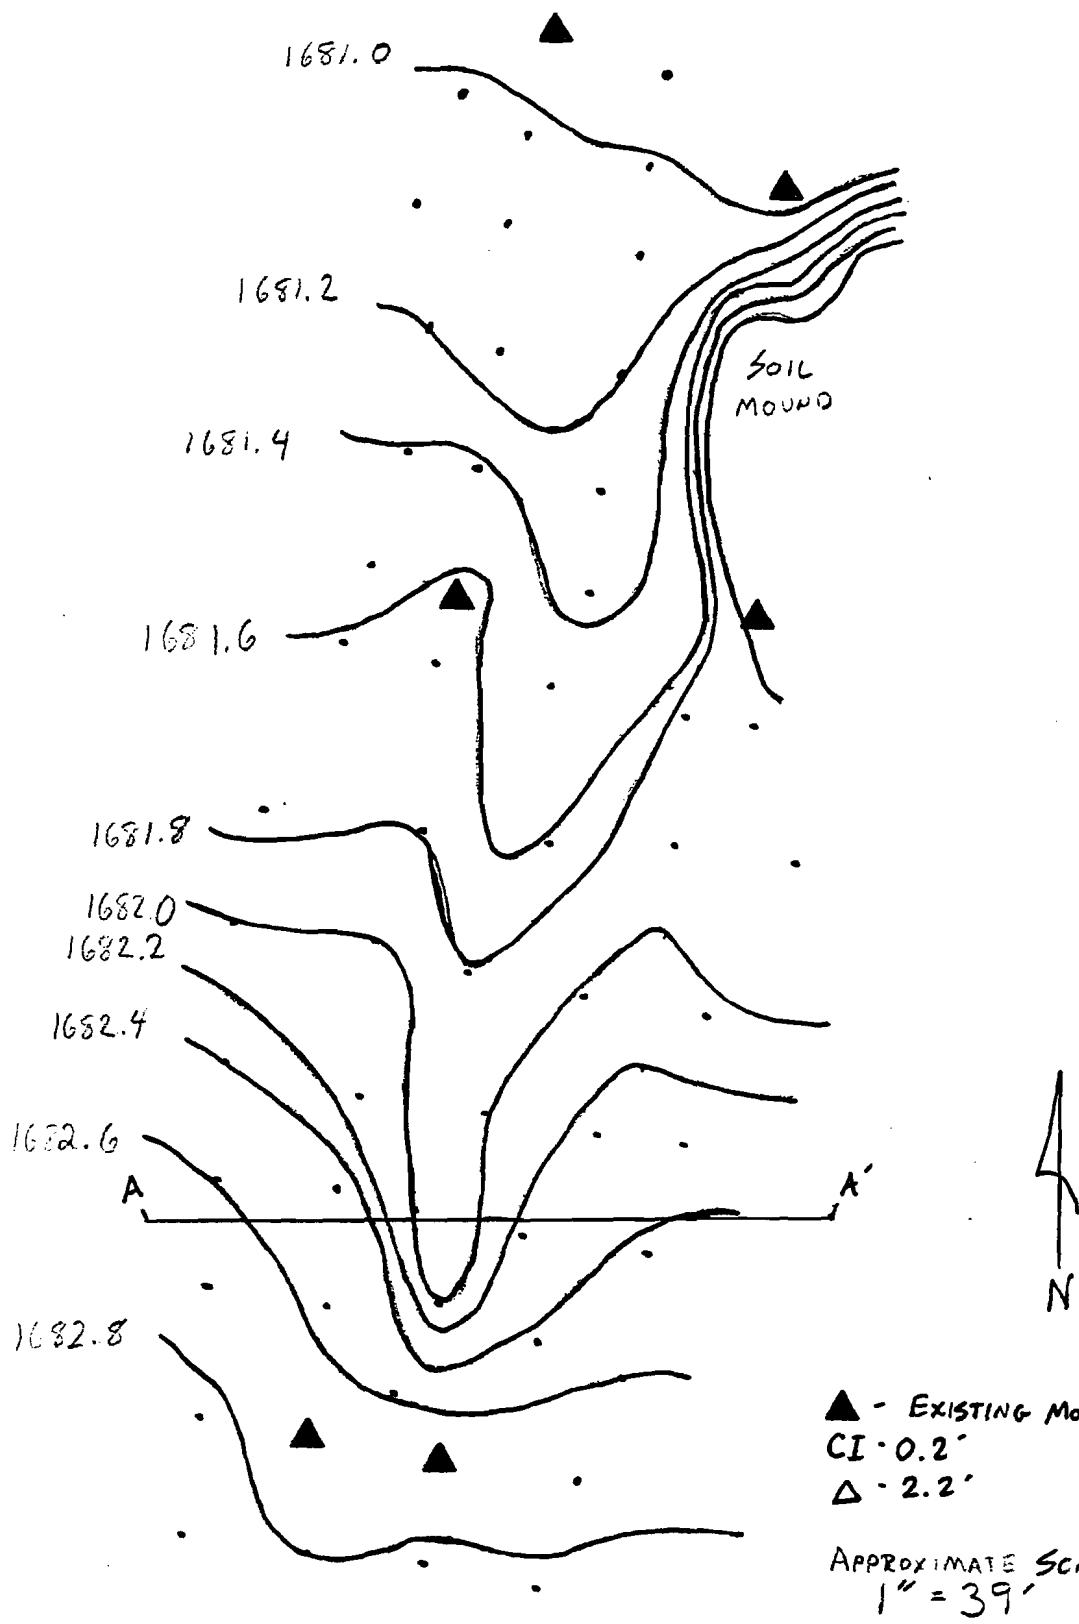
CAU 424 LANDFILL A3-4

The elevation data, contour map, and topographic profile for landfill cell A3-4 confirm that a north-south trending topographically low area is present in the south and central area of the site. The data indicate that the southern portion of the site is approximately 0.6 feet lower than the surrounding area outside of the landfill cell. The topographically low areas appear to correspond to locations of shallow fill not tested during closure activities (see Attachment D, Figure 5 from the CAU 424 CR [DOE/NV, 1999a]). The topographically low areas should be filled to the level of the surrounding grade to prevent infiltration of standing water into the buried waste unit.
