Nevada
Environmental
Restoration
Project

DOE/NV--1274

Post-Closure Inspection Report for the Tonopah Test Range, Nevada

For Calendar Year 2007

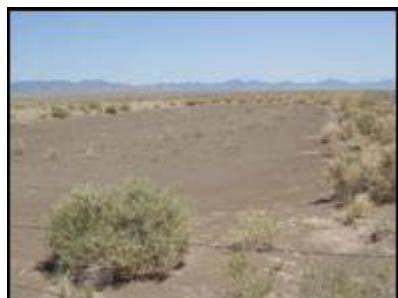
MAY 2007

The site exceeds the revegetation standard of 70 percent plant cover and plant density. Shrub cover exceeds the cover standard, and grass cover is slightly less than the standard. Both shrub and grass densities exceed the standard for reclamation success.

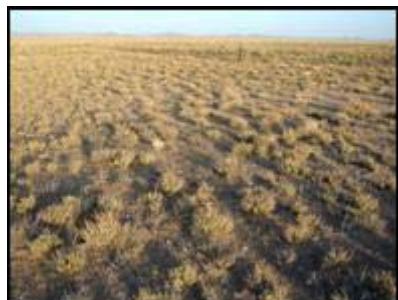
MAY 2007

Perennial plant cover at the site was approximately double the amount of cover on the reference area. When considering cover by lifeform, however, there were deficiencies. Grasses were absent, and neither grass cover nor density met reclamation success criteria. Possibly with consecutive favorable growing seasons over time, grasses may reestablish at the site. The fact that there were some Indian ricegrass plants present in 2006 was encouraging.

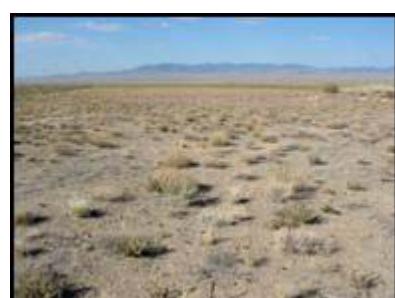
MAY 2007

Galleta grass and Indian ricegrass were the only perennial grasses found at the site. Squirreltail grass was found the first few years after revegetation but has not established on the site. The density of grasses has decreased slightly over the last 5 years (Table 7). There were no annual forbs or grasses encountered in 2007. The total plant density for the site in 2007 (5.5 plants/m²) exceeded the total plant density of the reference area (5.3 plants/m²), so this site has met the reclamation success standard.
