# **Report on the Emergency Response to the Event on May 14, 1997, at the Plutonium Reclamation Facility, Hanford Site, Richland, Washington**

**United States  
Department of Energy**

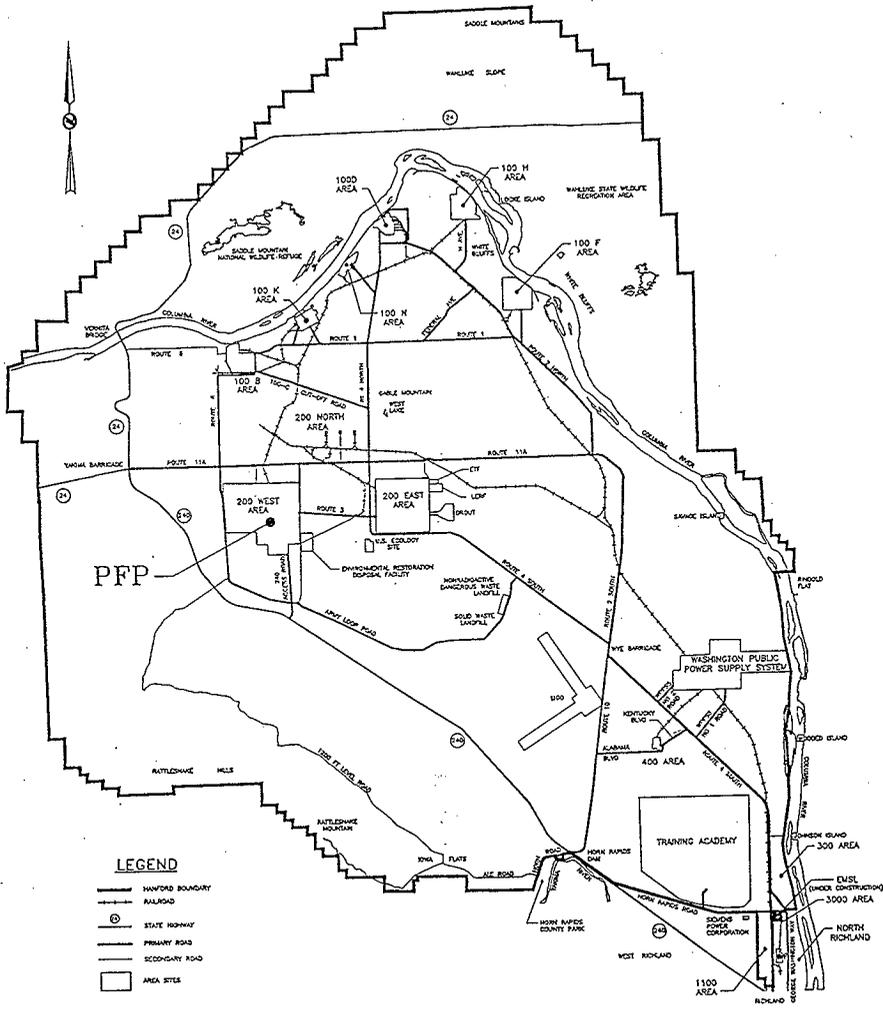
FIGURE 1 - Plutonium Finishing Plant

On May 14, 1997, at 7:53 p.m. (PDT), a chemical explosion occurred in Tank A-109 located in Room 40 on the fourth floor of the Plutonium Reclamation Facility (PRF). PRF, also known as the 236-Z Building, is an inactive plutonium processing facility, located within the Plutonium Finishing Plant (PFP) complex on the Hanford Site. PFP is located approximately 30 miles north of Richland, Washington (Figure 1) and is within a fenced protected area to provide security for the plutonium stored there.

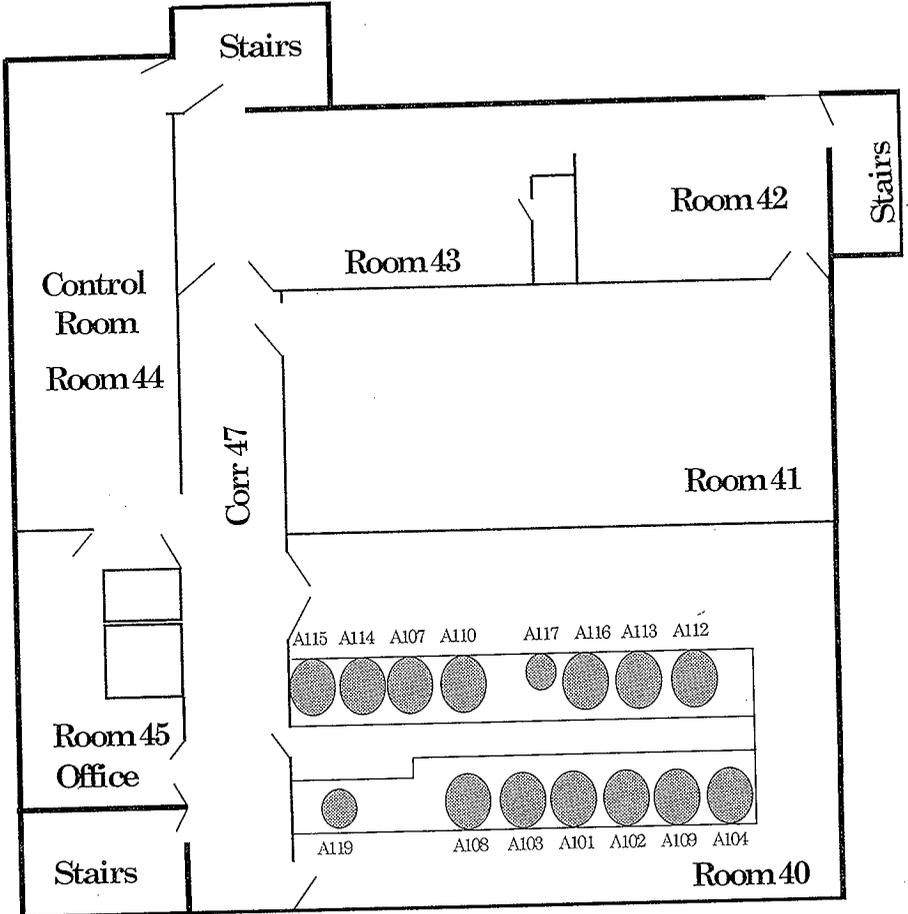
FIGURE 3  
Fourth Floor of PRF

On May 14, 1997, an autocatalytic (spontaneous) chemical reaction caused a chemical explosion in Tank A-109, a ventilated 400-gallon stainless-steel tank used to prepare a HAN and  $\text{HNO}_3$  solution. Tank A-109 is located in Room 40 on the fourth floor of the PRF (Figure 3). Water within the HAN and  $\text{HNO}_3$  solution in Tank A-109 had evaporated over a period of nearly four years. This evaporation process, which concentrated the HAN and  $\text{HNO}_3$ , and the potential presence of a catalyst (such as iron) created the conditions that led to an autocatalytic chemical reaction. The autocatalytic chemical reaction resulted in a rapid generation of gas inside Tank A-109. The gas buildup in Tank A-109 tore the lid from the tank and propelled it, and its attachments, upward with enough force to sever a 1.5-inch fire-suppression water line and to damage the ceiling and cause breaches in the roof above Room 40. Tank A-109A, a 20-liter Pyrex™ glass tank, located above Tank A-109 and previously used to add hydrazine to Tank A-109, was destroyed by the explosion. Tank A-109A was empty at the time of the explosion. The force of the Tank A-109 explosion displaced nearby Tank A-102 six inches, but did not appear to damage this empty tank or any other tanks contained in Room 40.

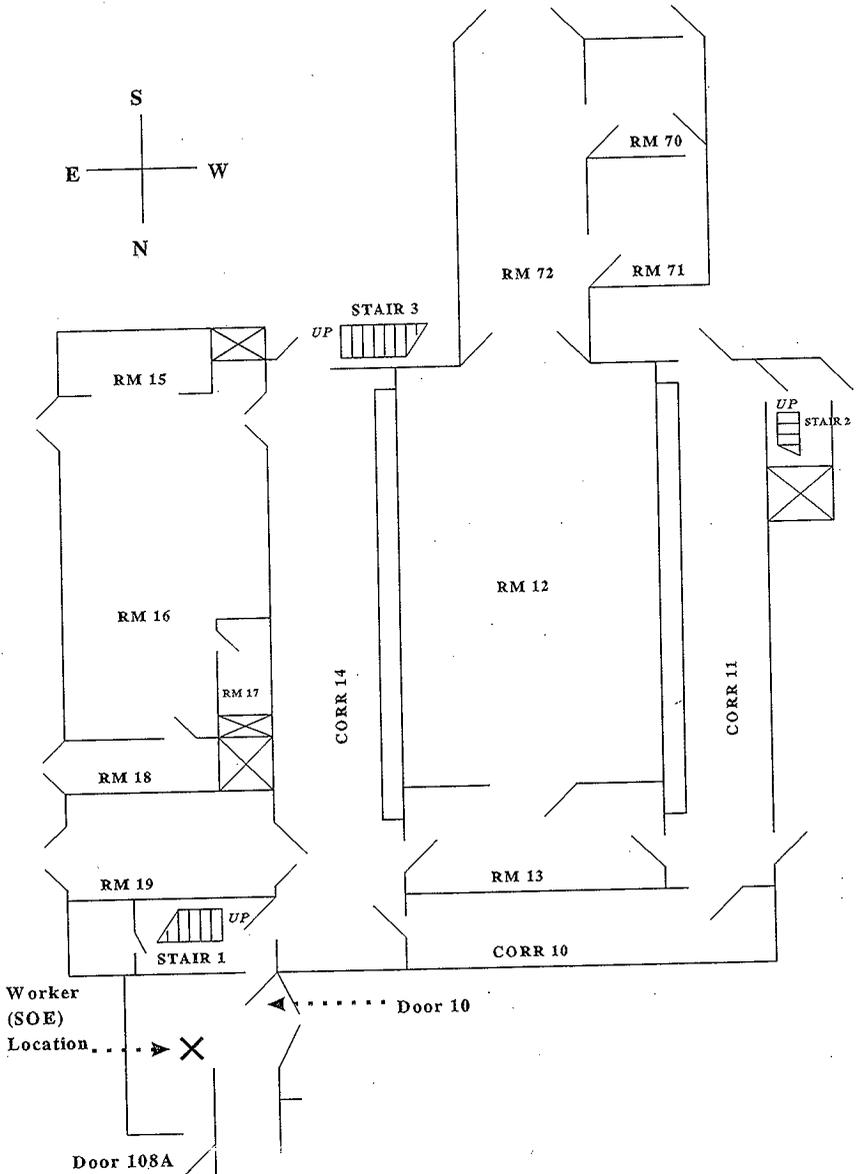
FIGURE 4 - 236Z / First Floor (PRF)

No personnel were in Room 40 or PRF at the time of the event; however one worker was in a change room near the entrance of the first floor of the PRF at the time of the explosion (Figure 4).

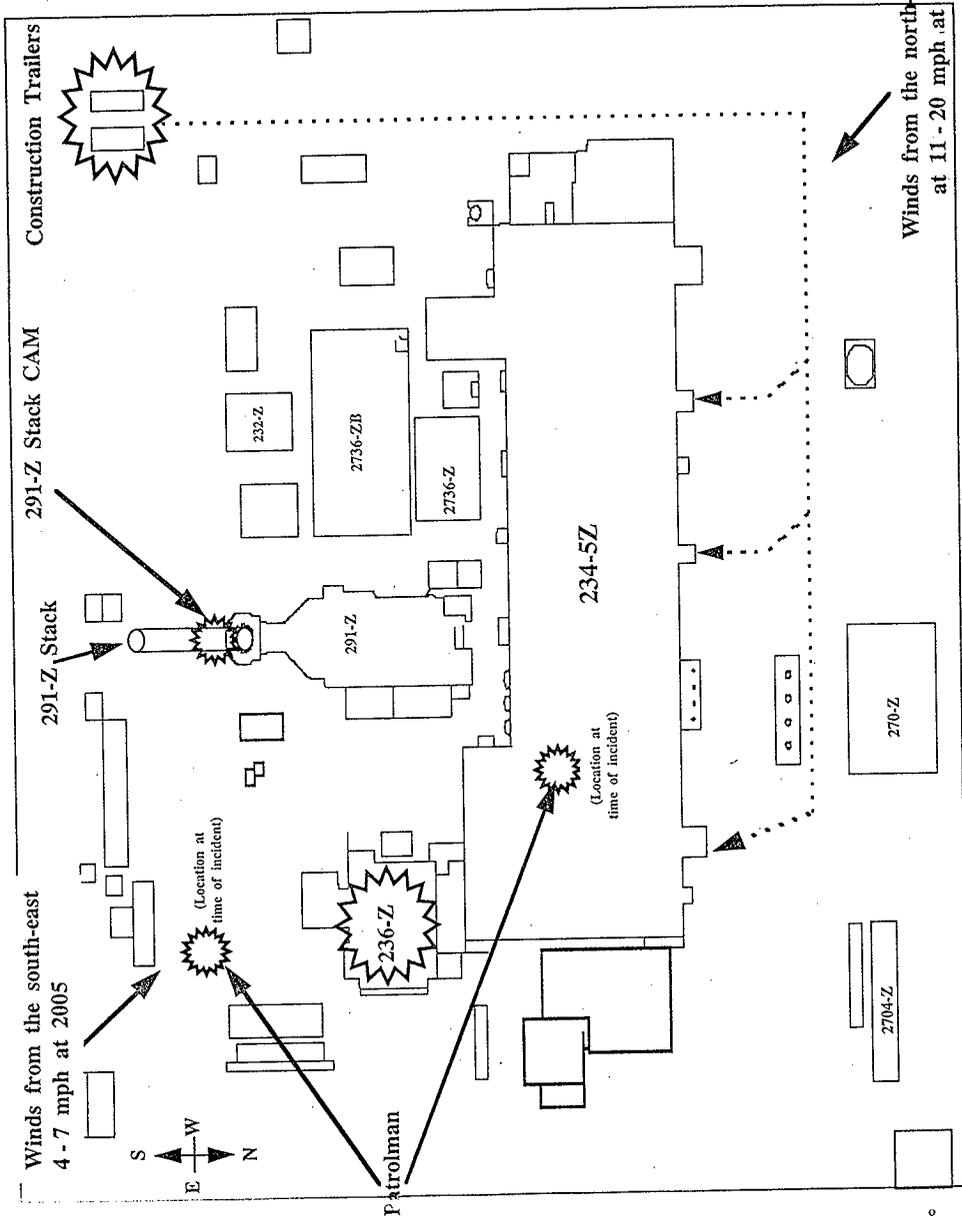
FIGURE 5 - Plutonium Finishing Plant - Aerial View

Other personnel in the general vicinity of the PRF at the time of the explosion included one security guard located on the roof of the 234-5Z facility, one security guard located southeast of the PRF, and eight construction workers located in a trailer southwest of the PRF (Figure 5). Based on the worker's locations during and after the explosion, they were potentially exposed to the emissions from the 291-Z-1 stack and from the holes in the roof of the PRF.

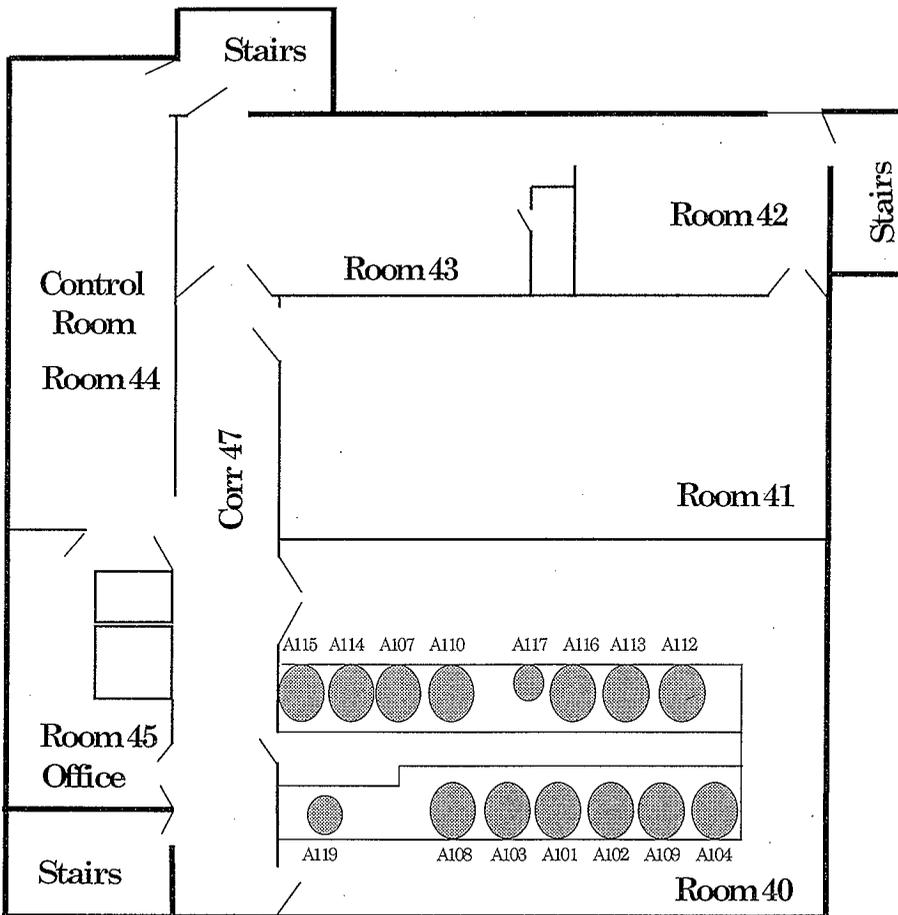
FIGURE D

Schematic of the Fourth Floor of the Plutonium Reclamation Facility

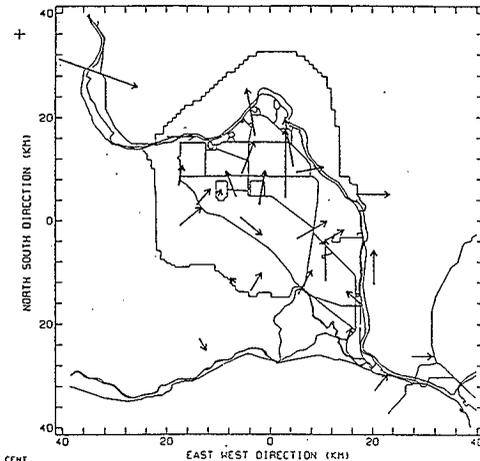
SITE ID	WIND DIR FROM	WIND SPEED (MPH)
PROS	210	4
EOC	210	3
ARMY	310	4
RSPG	230	4
EDNA	260	4
20DE	190	3
20DA	220	3
BVLY	290	15
FFTF	180	6
YAKB	190	5
30DA	130	5
HYEB	240	5
10DN	170	7
HPPS	240	4
FRNK	180	4
GABL	180	10
RING	270	4
RICH	200	3
PFP	200	1
RHTN	130	1
HMS1	160	4
PASC	270	3
GABH	200	3
10DF	170	4
VERN	270	3
BENT	330	3
VSTA	220	3

Figure D.4. Average Wind Directions and Speeds at 20:30 PDT.

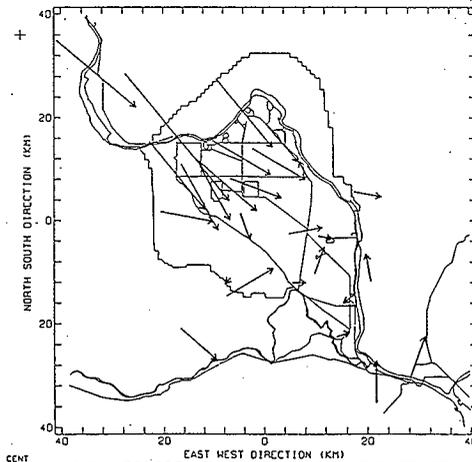
SITE ID	WIND DIR FROM	WIND SPEED (MPH)
PROS	270	2
EOC	240	8
ARMY	340	4
RSPG	280	8
EDNA	150	3
200E	290	8
200H	530	11
BVLY	310	15
FFTF	200	4
YAKB	320	13
300A	50	3
WYEB	260	3
100N	320	13
WPPS	280	2
FRNK	170	4
GABL	300	9
RING	280	4
RICH	250	2
PPF	330	9
RHTN	40	1
HMS1	310	12
PASC	200	5
GASH	300	10
100F	320	7
VERN	320	24
BENT	310	7
VSTA	180	5

Figure D.7. Average Wind Directions and Speeds at 21:15 PDT.

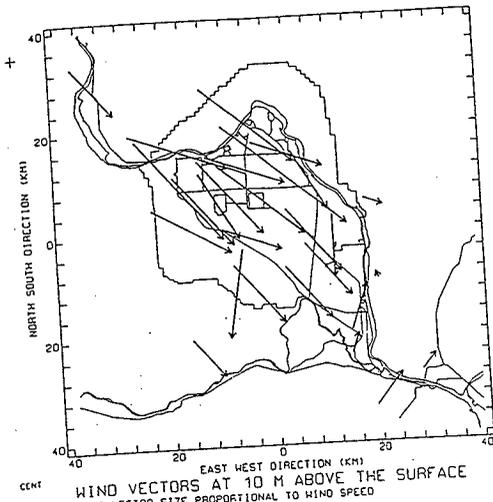
Figure D.10. Average Wind Directions and Speeds at 22:00 PDT.

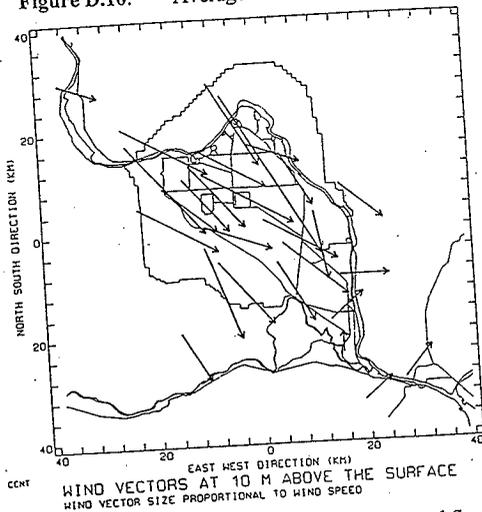
Figure D.11. Average Wind Directions and Speeds at 22:15 PDT.

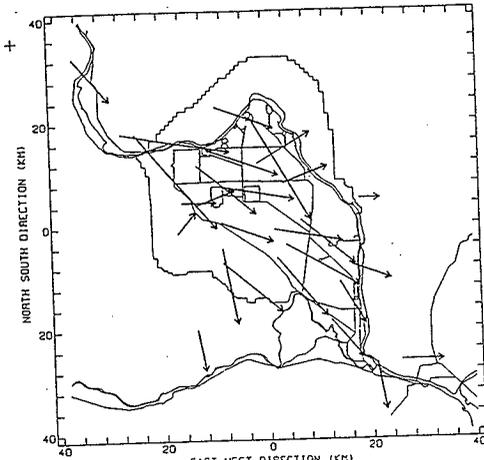
SITE ID	WIND DIR. FROM	WIND SPEED (MPH)
PROS	320	11
EDC	310	11
ARMY	290	8
RSPG	220	4
EDNA	250	7
200E	280	11
200W	270	5
BVLY	320	8
FFTF	300	12
YAKB	320	18
300A	350	7
WYEB	280	10
100N	290	9
HPPS	310	10
FRNK	250	6
GABL	330	17
RING	270	3
RICH	330	7
PPF	250	6
RMTN	350	11
HMS1	310	11
PASC	270	5
GABH	280	11
IOGF	240	9
VERN	280	16
BENT	350	7
VSTA	350	7

Figure D.14. Average Wind Directions and Speeds at 23:00 PDT.

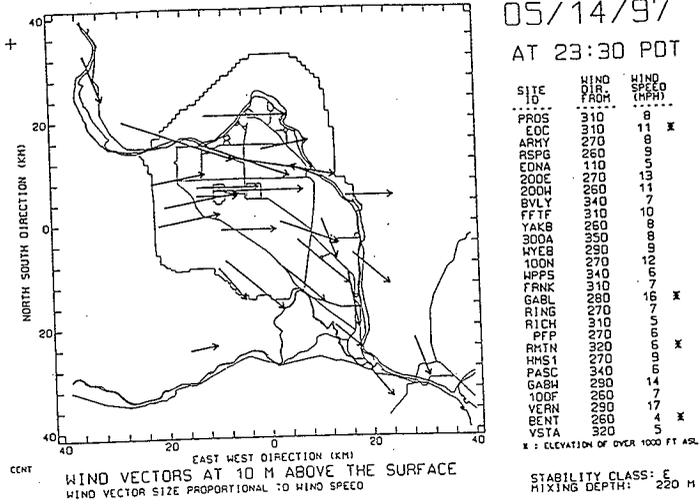
Figure D.16. Average Wind Directions and Speeds at 23:30 PDT.

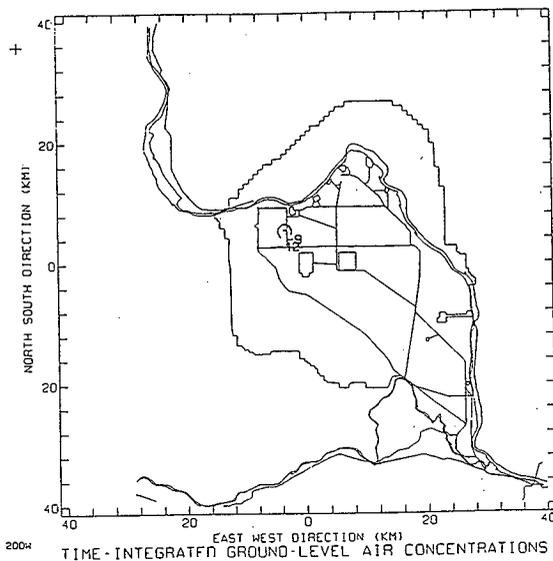
**Figure D.18.** PFP Stack Release: Time-Integrated Ground-Level Air Concentrations (Exposures) for the 15 Minutes Ending at 20:45 PDT. This simulation involves the release of 60 kg of a generic, non-reactive, non-depositing gas. Exposures are measured in units of  $\text{kg-s/m}^3$ . Contours are plotted for every three order of magnitude change in exposure (e.g.,  $-12 = 10^{-12} \text{ kg-s/m}^3$ ,  $-9 = 10^{-9} \text{ kg-s/m}^3$ ).

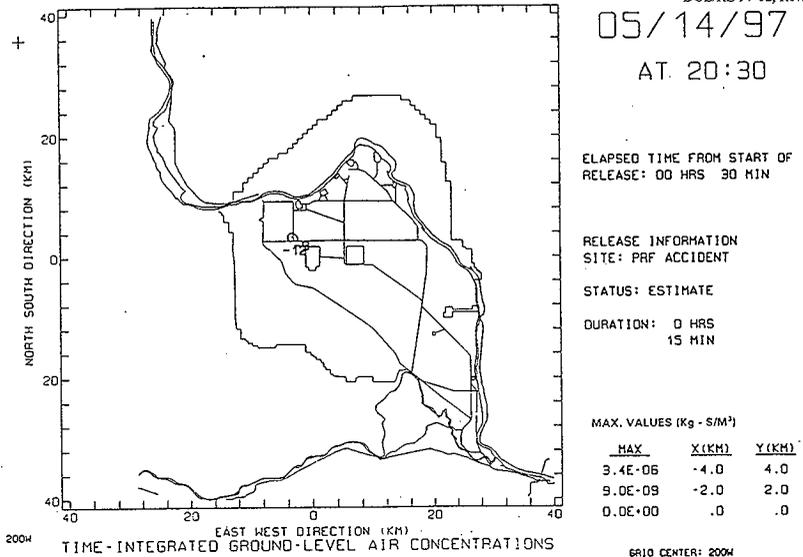
**Figure D.17. PFP Stack Release: Time-Integrated Ground-Level Air Concentrations (Exposures) for the 15 Minutes Ending at 20:30 PDT.** This simulation involves the release of 60 kg of a generic, non-reactive, non-depositing gas. Exposures are measured in units of  $\text{kg}\cdot\text{s}/\text{m}^3$ . Contours are plotted for every three order of magnitude change in exposure (e.g.,  $-12 = 10^{-12} \text{ kg}\cdot\text{s}/\text{m}^3$ ,  $-9 = 10^{-9} \text{ kg}\cdot\text{s}/\text{m}^3$ ).

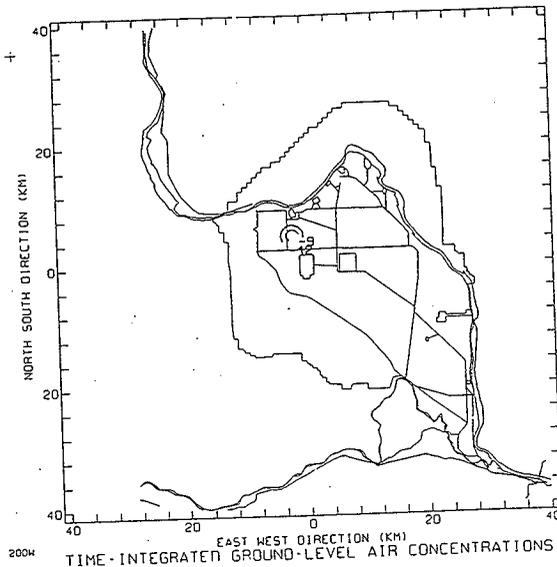
**Figure D.19.** PFP Stack Release: Time-Integrated Ground-Level Air Concentrations (Exposures) for the 15 Minutes Ending at 21:00 PDT. This simulation involves the release of 60 kg of a generic, non-reactive, non-depositing gas. Exposures are measured in units of  $\text{kg}\cdot\text{s}/\text{m}^3$ . Contours are plotted for every three order of magnitude change in exposure (e.g.,  $-12 = 10^{-12} \text{ kg}\cdot\text{s}/\text{m}^3$ ,  $-9 = 10^{-9} \text{ kg}\cdot\text{s}/\text{m}^3$ ).

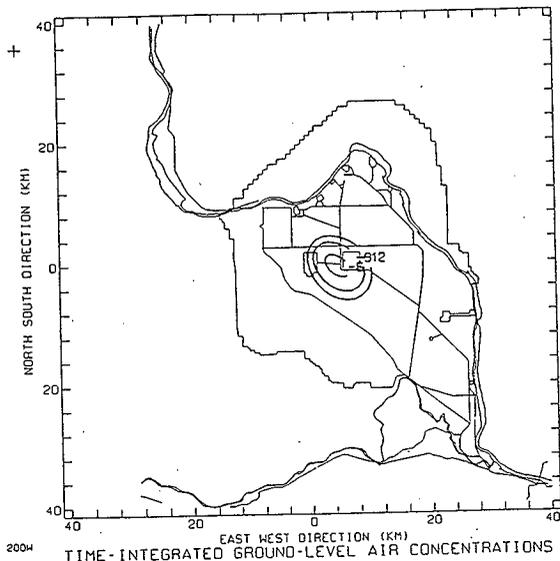
**Figure D.21.** PFP Stack Release: Time-Integrated Ground-Level Air Concentrations (Exposures) for the 15 Minutes Ending at 21:30 PDT. This simulation involves the release of 60 kg of a generic, non-reactive, non-depositing gas. Exposures are measured in units of  $\text{kg}\cdot\text{s}/\text{m}^3$ . Contours are plotted for every three order of magnitude change in exposure (e.g.,  $-12 = 10^{-12} \text{ kg}\cdot\text{s}/\text{m}^3$ ,  $-9 = 10^{-9} \text{ kg}\cdot\text{s}/\text{m}^3$ ).

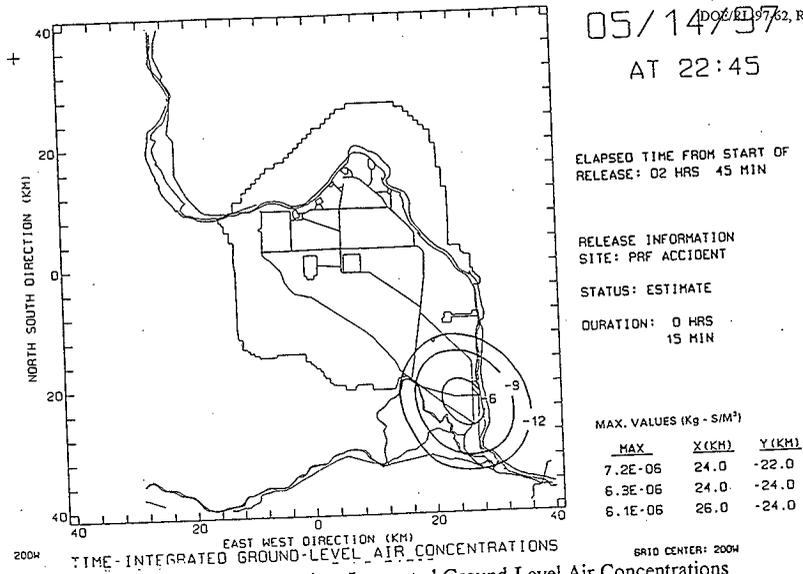
Figure D.26. PFP Stack Release: Time-Integrated Ground-Level Air Concentrations (Exposures) for the 15 Minutes Ending at 22:45 PDT. This simulation involves the release of 60 kg of a generic, non-reactive, non-depositing gas. Exposures are measured in units of  $\text{kg}\cdot\text{s}/\text{m}^3$ . Contours are plotted for every three order of magnitude change in exposure (e.g.,  $-12 = 10^{-12} \text{ kg}\cdot\text{s}/\text{m}^3$ ,  $-9 = 10^{-9} \text{ kg}\cdot\text{s}/\text{m}^3$ ).

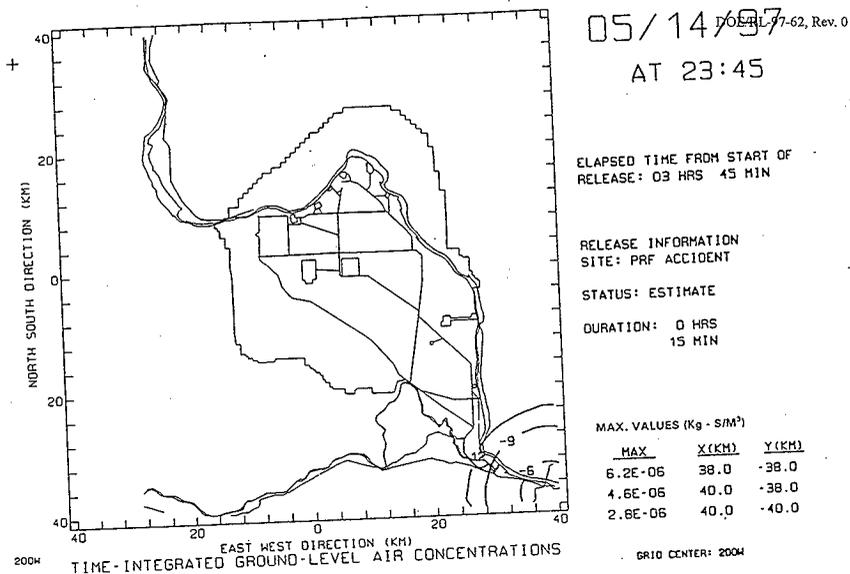
Figure D.30. PFP Stack Release: Time-Integrated Ground-Level Air Concentrations (Exposures) for the 15 Minutes Ending at 23:45 PDT. This simulation involves the release of 60 kg of a generic, non-reactive, non-depositing gas. Exposures are measured in units of  $\text{kg}\cdot\text{s}/\text{m}^3$ . Contours are plotted for every three order of magnitude change in exposure (e.g.,  $-12 = 10^{-12} \text{ kg}\cdot\text{s}/\text{m}^3$ ,  $-9 = 10^{-9} \text{ kg}\cdot\text{s}/\text{m}^3$ ).

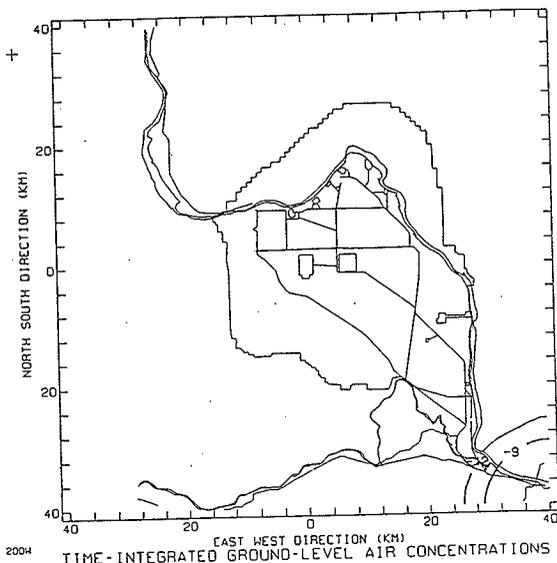
ELAPSED TIME FROM START OF  
RELEASE: 04 HRS 00 MIN

RELEASE INFORMATION  
SITE: PRF ACCIDENT

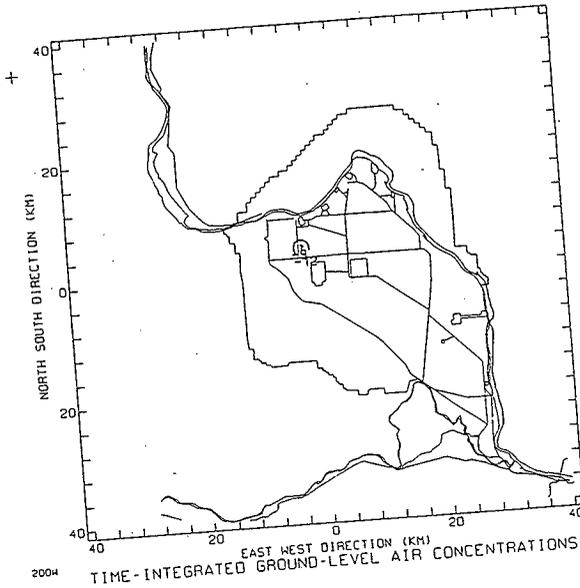
Figure D.32. PRF Roof Release: Time-Integrated Ground-Level Air Concentrations (Exposures) for the 15 Minutes Ending at 21:00 PDT. This simulation involves the release of 60 kg of a generic, non-reactive, non-depositing gas at 14 m above ground level. Note that the total release from the roof is currently estimated at only about 1% of what is used in this simulation. Exposure for a specific contaminant can be estimated by multiplying model results by an actual contaminant emission total (in kg) and then dividing by 60 kg. Exposures are measured in units of kg-s/m<sup>3</sup>. Contours are plotted for every three order of magnitude change in exposure (e.g., -12 = 10<sup>-12</sup> kg-s/m<sup>3</sup>, -9 = 10<sup>-9</sup> kg-s/m<sup>3</sup>).

4. Nevertheless, results from the model are consistent with reports from the Patrolman on the roof of 234-5Z Building at the time of the incident. The Patrolman would have been in the pathway of the release. He reported that he noted a strong, localized chemical odor some seconds after the incident and it lasted for only a brief period.

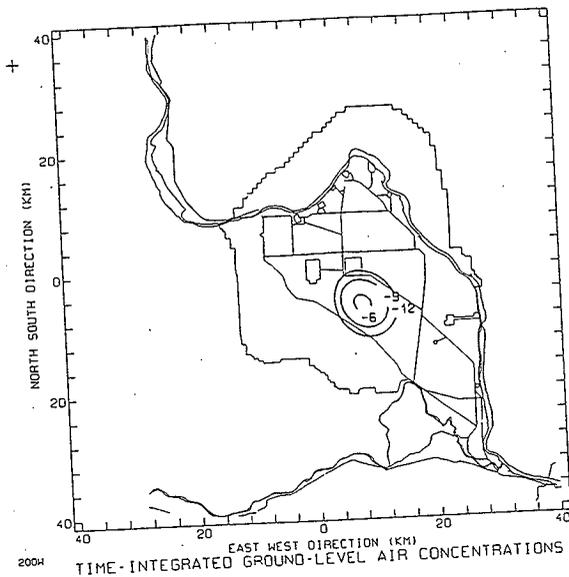
Figure D.33. PRF Roof Release: Time-Integrated Ground-Level Air Concentrations (Exposures) for the 15 Minutes Ending at 22:00 PDT. This simulation involves the release of 60 kg of a generic, non-reactive, non-depositing gas at 14 m above ground level. Note that the total release from the roof is currently estimated at only about 1% of what is used in this simulation. Exposure for a specific contaminant can be estimated by multiplying model results by an actual contaminant emission total (in kg) and then dividing by 60 kg. Exposures are measured in units of  $\text{kg}\cdot\text{s}/\text{m}^3$ . Contours are plotted for every three order of magnitude change in exposure (e.g., -12 =  $10^{-12} \text{ kg}\cdot\text{s}/\text{m}^3$ , -9 =  $10^{-9} \text{ kg}\cdot\text{s}/\text{m}^3$ ).

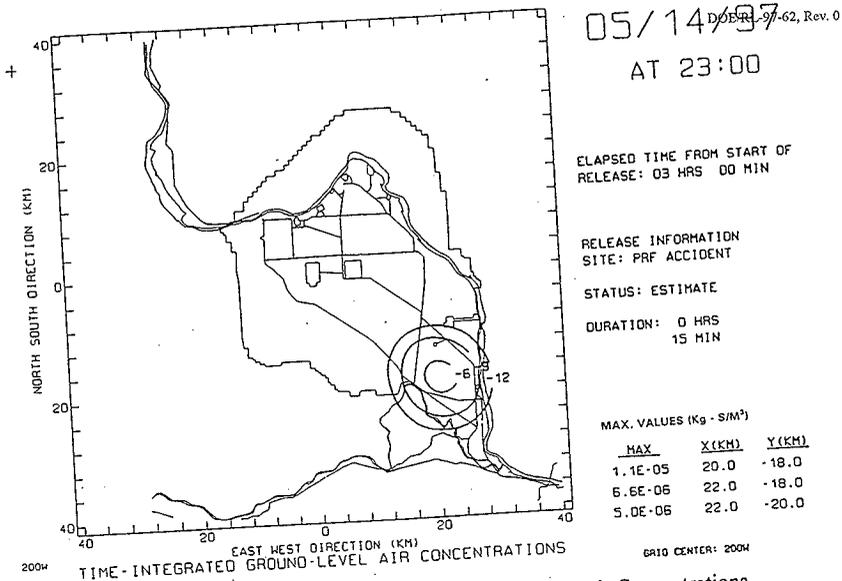
**Figure D.34. PRF Roof Release: Time-Integrated Ground-Level Air Concentrations (Exposures) for the 15 Minutes Ending at 23:00 PDT.** This simulation involves the release of 60 kg of a generic, non-reactive, non-depositing gas at 14 m above ground level. Note that the total release from the roof is currently estimated at only about 1% of what is used in this simulation. Exposure for a specific contaminant can be estimated by multiplying model results by an actual contaminant emission total (in kg) and then dividing by 60 kg. Exposures are measured in units of  $\text{kg}\cdot\text{s}/\text{m}^3$ . Contours are plotted for every three order of magnitude change in exposure (e.g., -12 =  $10^{-12} \text{ kg}\cdot\text{s}/\text{m}^3$ , -9 =  $10^{-9} \text{ kg}\cdot\text{s}/\text{m}^3$ ).

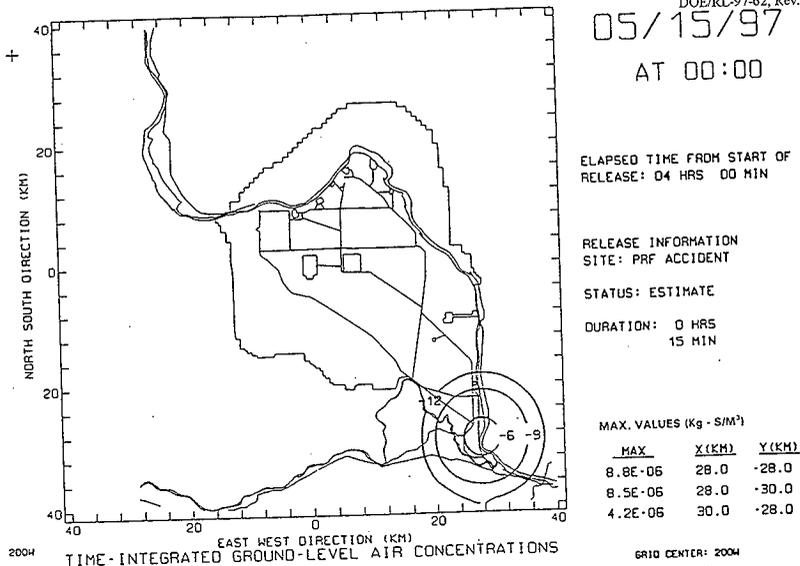
**Figure D.35. PRF Roof Release: Time-Integrated Ground-Level Air Concentrations (Exposures) for the 15 Minutes Ending at Midnight (PDT).** This simulation involves the release of 60 kg of a generic, non-reactive, non-depositing gas at 14 m above ground level. Note that the total release from the roof is currently estimated at only about 1% of what is used in this simulation. Exposure for a specific contaminant can be estimated by multiplying model results by an actual contaminant emission total (in kg) and then dividing by 60 kg. Exposures are measured in units of  $\text{kg}\cdot\text{s}/\text{m}^3$ . Contours are plotted for every three order of magnitude change in exposure (e.g.,  $-12 = 10^{-12} \text{ kg}\cdot\text{s}/\text{m}^3$ ,  $-9 = 10^{-9} \text{ kg}\cdot\text{s}/\text{m}^3$ ).
