BNWL-1117
UC-70

WASTE SOLIDIFICATION ENGINEERING PROTOTYPES, DESIGN VERIFICATION TESTING OF SPRAY SOLIDIFICATION EQUIPMENT

July 1969

J. D. Moore

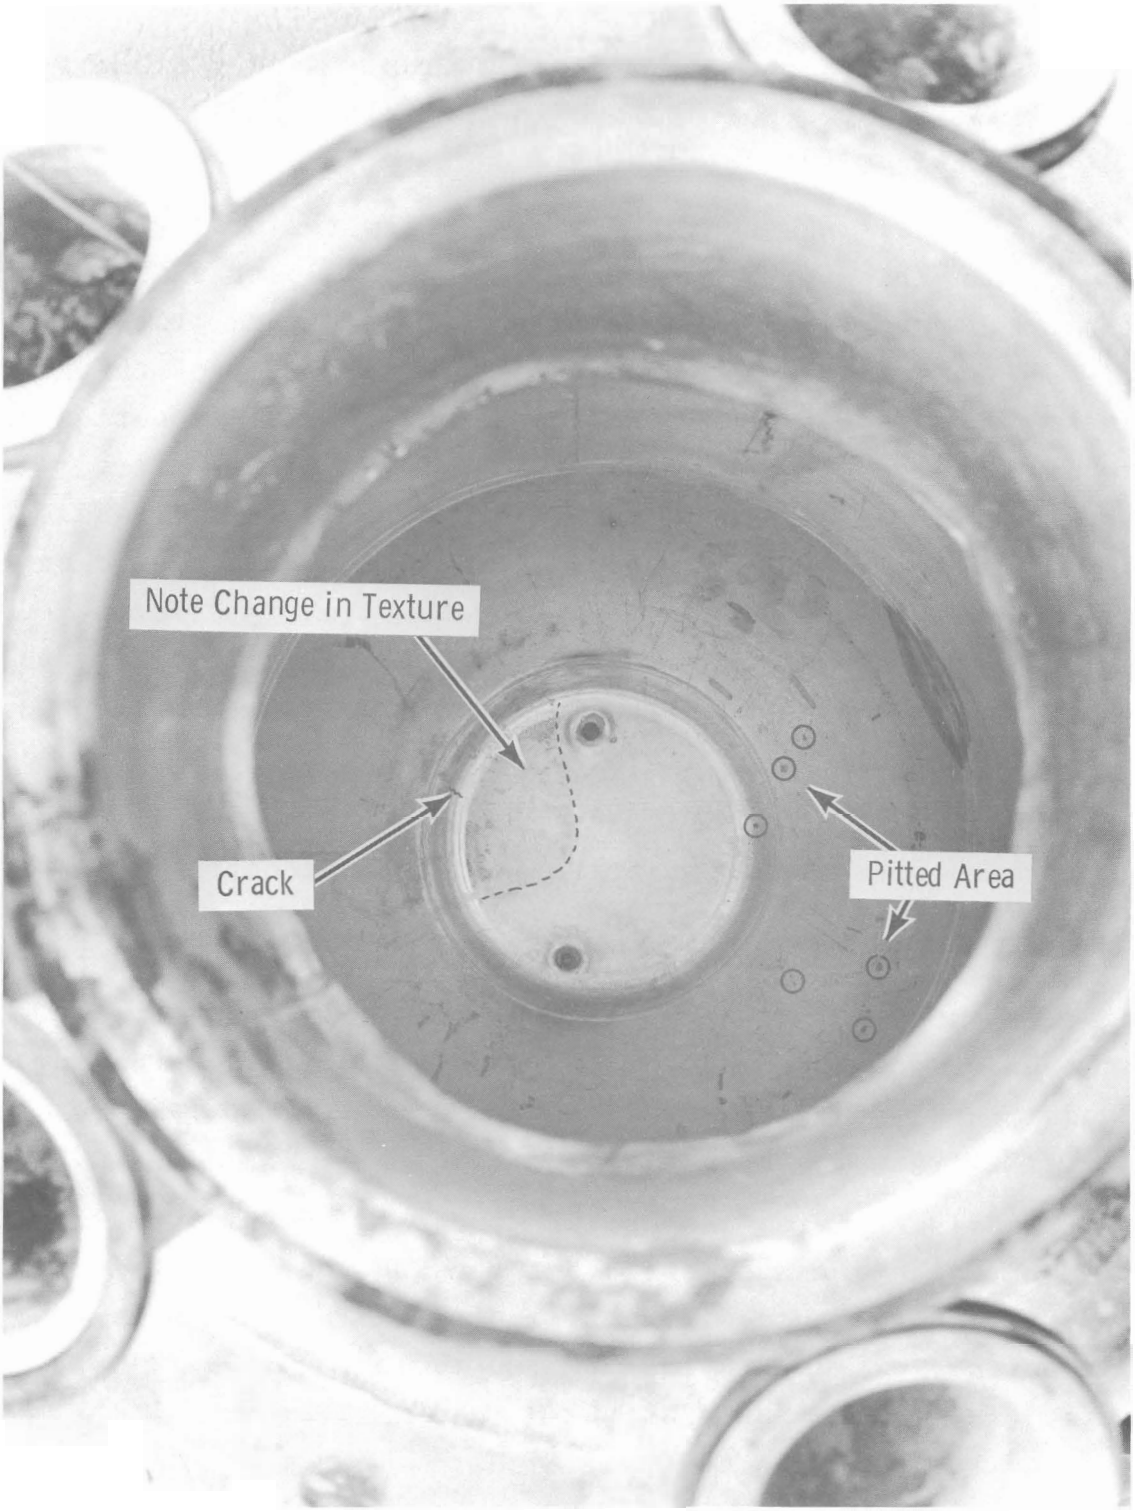
Neg 42443-1

The inside of the melter was badly corroded following run CSCM-8. Several cracks and pitted areas were located in the bottom half of the vessel. Analysis indicated they were caused by phosphorous alloying with the platinum under locally reducing

conditions. These conditions were present when a stainless steel chain fell into the melter and was dissolved in run CSCM-3. The alloying action corroded and embrittled the platinum. All of the melter except the top lid was replaced with a new vessel made of unalloyed platinum, although the composition of the old melter (platinum –0.5% rhodium) did not contribute to its failure.

Although microprobe tests for alloying in the metal surrounding the cracks were too insensitive (>3 wt% detection limit for phosphorous) to substantiate the following evidence, later laboratory tests to reproduce the melter failure indicated that the embrittlement was caused by phosphorous alloying with the platinum under locally reducing conditions, such as from inadvertent addition of stainless steel to the melter. The failures were brittle fractures at grain boundaries.[23]

Before its failure, the melter (composed of 99.5% platinum –0.5% rhodium alloy) had operated between 900 and 1250 °C for 440 hr. Since the cause of the corrosion was not known at the time, a new melter was ordered and the replacement vessel was fabricated from unalloyed platinum.

FIGURE 15. View into Corroded WSEP Melter
