ENGINEERING FACTORS INFLUENCING CORBICULA
FOULING IN NUCLEAR-SERVICE WATER SYSTEMS

C. H. Henager
K. I. Johnson
T. L. Page

June 1983

Presented at the Second International Corbicula
Symposium
Hot Springs, Arkansas
June 21-24, 1983

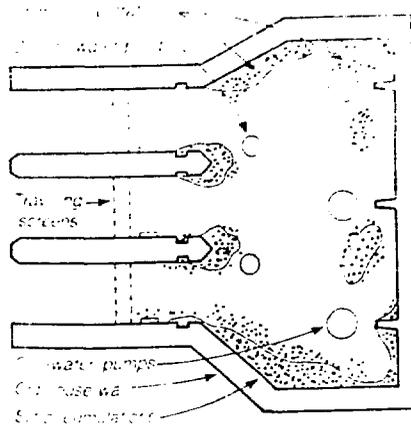
FIGURE 1. Silt and Clam Distribution in Cribhouse

Low velocity flow conditions typically occur at or near geometric discontinuities in the service water system where eddies and backwater conditions exist. Areas which are included in this category are service water inlet structures (see Figure 1), inlets to heat exchanger water boxes, and sudden changes in pipe diameter. Low velocity may also occur in lines with leaking or partially open valves.
