COMPENSATION OF LONGITUDINAL COUPLED-BUNCH INSTABILITY IN THE ADVANCED PHOTON SOURCE STORAGE RING

K. C. Harkay, A. Nassiri, J. J. Song, Y. W. Kang, R. L. Kustom
Advanced Photon Source, Argonne National Laboratory
9700 South Cass Avenue, Argonne, Illinois 60439 USA

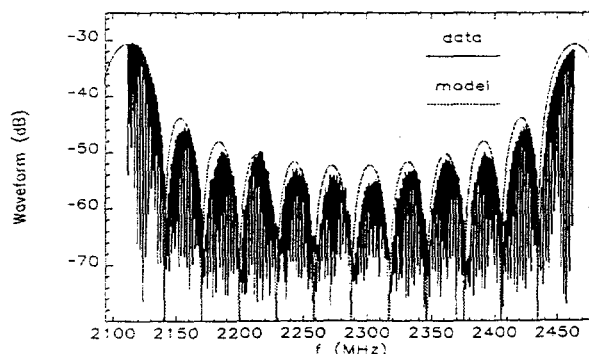
Beam spectra for a symmetric, 4×12 bunch pattern are shown in Figs. 1 and 2, cycling between a stable and unstable state, respectively. A span of one f_{rf} is shown at a high harmonic, since the peak of the CB signals are near (bunch length)$^{-1}$. The beam current is about 100 mA. The envelope of a model 12-bunch train matches the envelope of the rotation harmonics of the data in Fig. 1. The unstable beam spectrum exhibits a coupled-bunch signature. When an interbunch phase advance corresponding to a CB mode of n=

Figure 1: Stable beam spectrum, 4×12 bunch pattern.

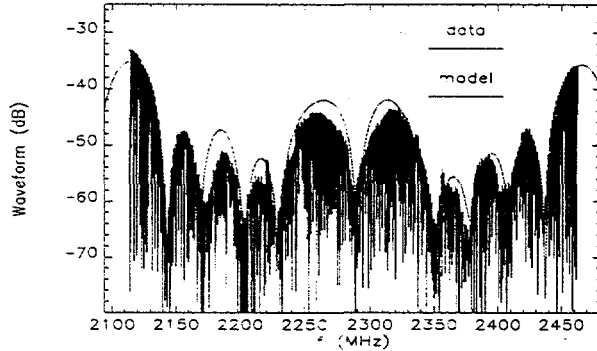
54Q was introduced in the crude model, using a maximum displacement of 7 degs of rf phase (55 ps), the result shows qualitative agreement with the data in Fig. 2.

Figure 2: Unstable beam spectrum, 4×12 bunch pattern.

The CB mode envelope in Fig. 2 is centered around 154 MHz from either rf harmonic; therefore, the CB mode is near $\pm 154/f_{rf} \times h = \pm 570$. Plugging this value of n into the expression above for different values of p gives the candidate frequencies listed in Table 2. The one frequency

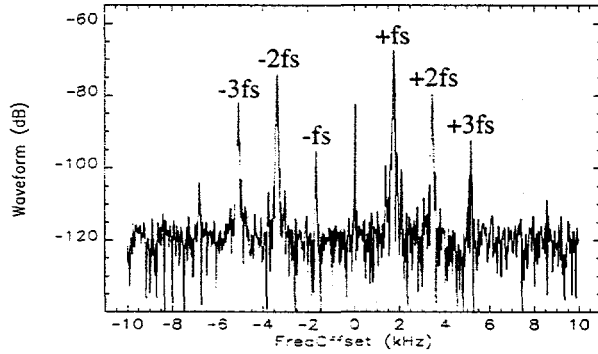
In a uniformly-filled ring, the CB spectrum is periodic in $f_{rf}/2$. When the fill pattern is non-uniform, the CB spectrum is highly degenerate. Synchrotron sidebands from several CB modes may be aliased onto every revolution harmonic. This is evidenced in the asymmetric pattern of f_s sidebands in Fig. 3 for the unstable 4×12 fill pattern.

Figure 3: Unstable beam spectrum, centered at $7f_{rf} + f_{rev}$.

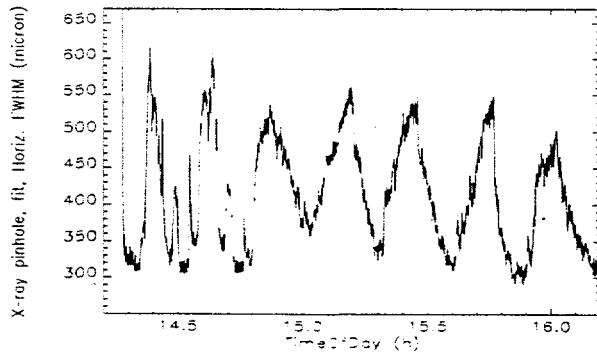
The cyclical nature of the longitudinal oscillations is seen in Fig. 4, which shows the apparent horizontal beam size over two hours for an unstable fill pattern during a 100-mA store. The maxima correlate with the CB signal in Fig. 2. The beam current decays to 85 mA during this time; the CB fluctuations persist below 75 mA. Two distinct periodicities are seen: 3-4 min and 15-20 min. Little motion is seen in the horizontal centroid or in the vertical plane.

Figure 4: Fluctuating horizontal beam size, 100-mA store.

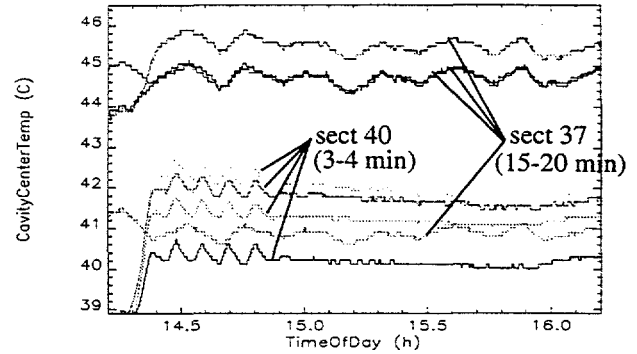
The rf cavity center temperatures in two of the four sectors over the same period reveal in Fig. 5 a direct correlation with the horizontal beam size variations. This observation is consistent with the view that the HOM frequencies are shifting into and out of resonance with a beam harmonic as the cavity temperatures vary. The measured temperature variation of the HOM frequencies is reported in Ref. 1.

Figure 5: Rf cavity temperature variation in two sectors.

The beam appeared to become unstable when the cavity temperatures cycled to their minimum values; therefore, the cavity water supply temperatures were increased in an attempt to shift the HOMs out of resonance with the beam. Sector 37 water temperature was increased by 1.5°F and sector 40 was increased by 1°F. The CB instability was thereby essentially suppressed on following stores (Fig. 6).

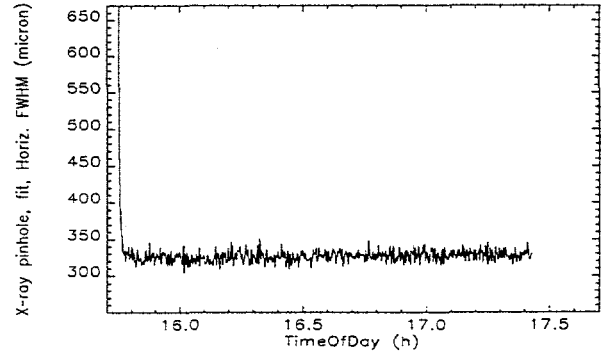
Figure 6: Constant horizontal beam size, 100-mA store, after CB instability compensation.

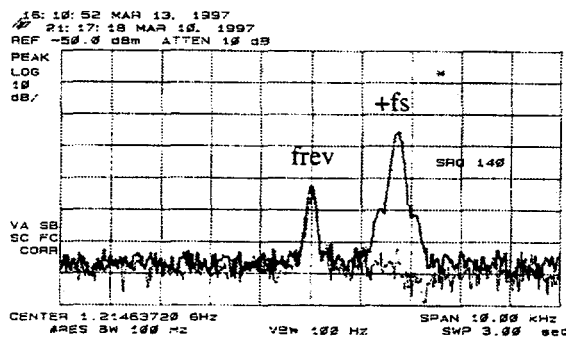
Measurements of the beam-excited rf cavity HOM spectra for different bunch patterns also suggest that the TM_{013} mode is involved in the observed CB instability. The spectra were measured using E-type probes in the rf cavities. High-resolution measurements centered on a rotation harmonic revealed a large upper synchrotron sideband, excited when the beam was unstable (Fig. 7).

Figure 7: Rf cavity signals centered on 1214.64 MHz.

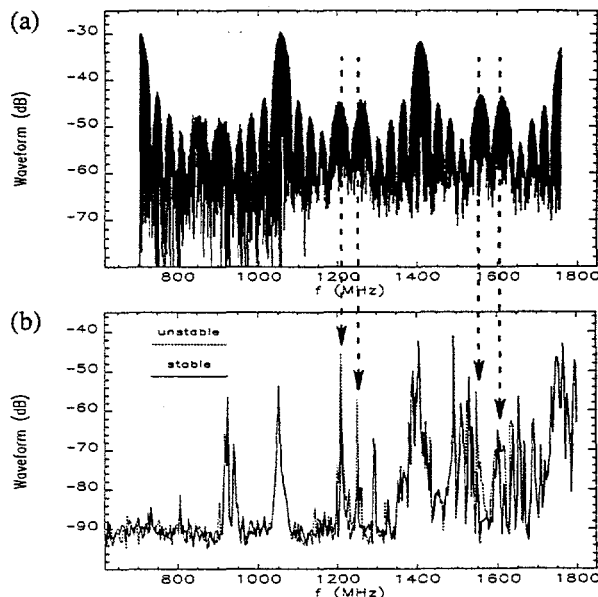
The excited HOMs were also measured over a wide frequency range with a resolution bandwidth $\geq f_{rev}$ for stable and unstable beam conditions. These are shown compared to the beam CB spectrum in Fig. 8. The lines marked show increased excitation in one cavity when the beam is unstable. The leftmost marked line is the 1210-MHz mode. The others are possibly aliased lines; the cavity probe detects true HOMs as well as beam power. It should be noted that the coupling of the cavity E-probe varies from mode to mode, and therefore, additional HOMs may be excited by the unstable beam but not revealed by the probe.

Figure 8: (a) Unstable beam CB spectrum, 4×12 bunch pattern vs. (b) excited HOM spectrum in rf cavity.

A detailed spectral analysis of the bunch train and cavity response is planned to address some of these effects. A modification to an existing passive HOM damper design is also planned to increase coupling to the TM_{013} mode [5].
