Re: Explosive Test of Chute Deployment System Unit 60 L (U) SEP 2 1961

The object of this test was to determine the minimum energy MDF that can be used for cover plate deployment and retard chute strap cutting on TX-53 unit 60-L.

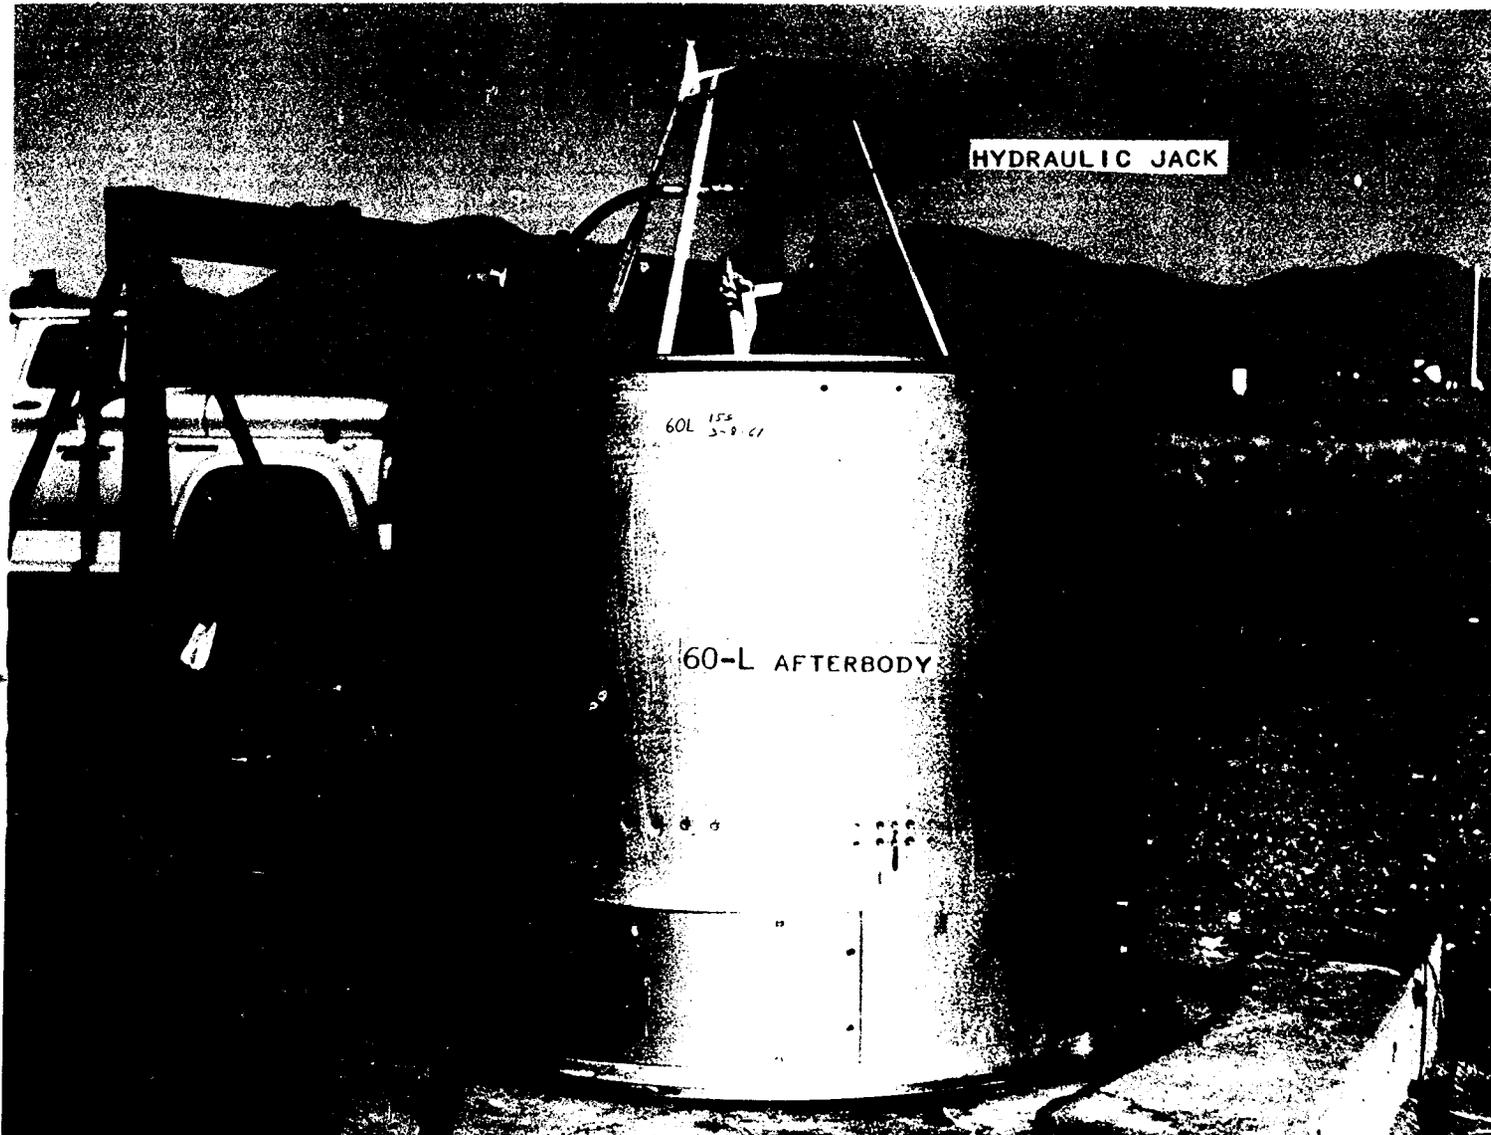
FIGURE 1 - SETUP FOR TEST RUN -- EXPLOSIVE TEST OF CHUTE DEPLOYMENT SYSTEM, UNIT 60-L

Setup for this test is shown in Fig. 1. 14 ft of 15 gr/ft shaped MDF and 14 ft of 10 gr/ft MDF were used in this test. Dupont X257D detonators were used to detonate the MDF.

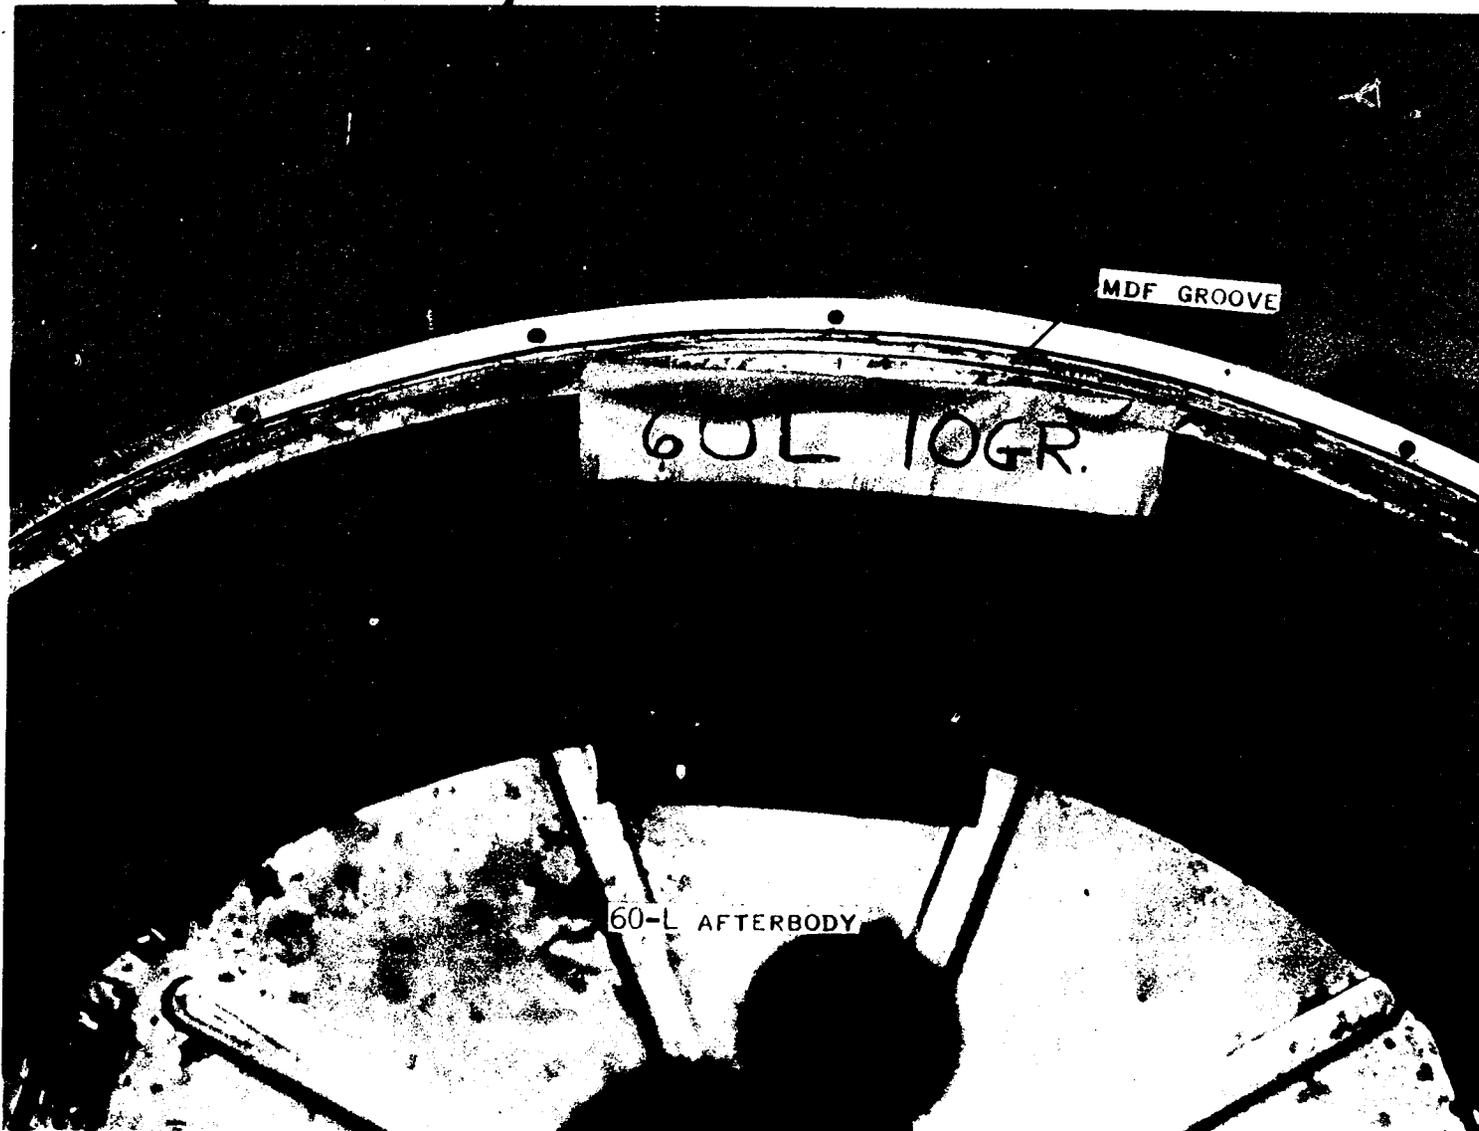
FIGURE 3 - COVER PLATE MDF GROOVE AFTER TEST -- EXPLOSIVE TEST OF CHUTE DEPLOYMENT SYSTEM, UNIT 60-L

The cover plate was deployed satisfactorily as shown in Fig. 2 and no damage occurred to the MDF groove as shown in Fig. 3. The retard chute straps were cut satisfactorily and the MDF ring held up satisfactorily as shown in Figs. 4 and 5. Fig. 6 is a velocity vs time curve obtained from Fastex camera coverage of rear cover plate deployment.

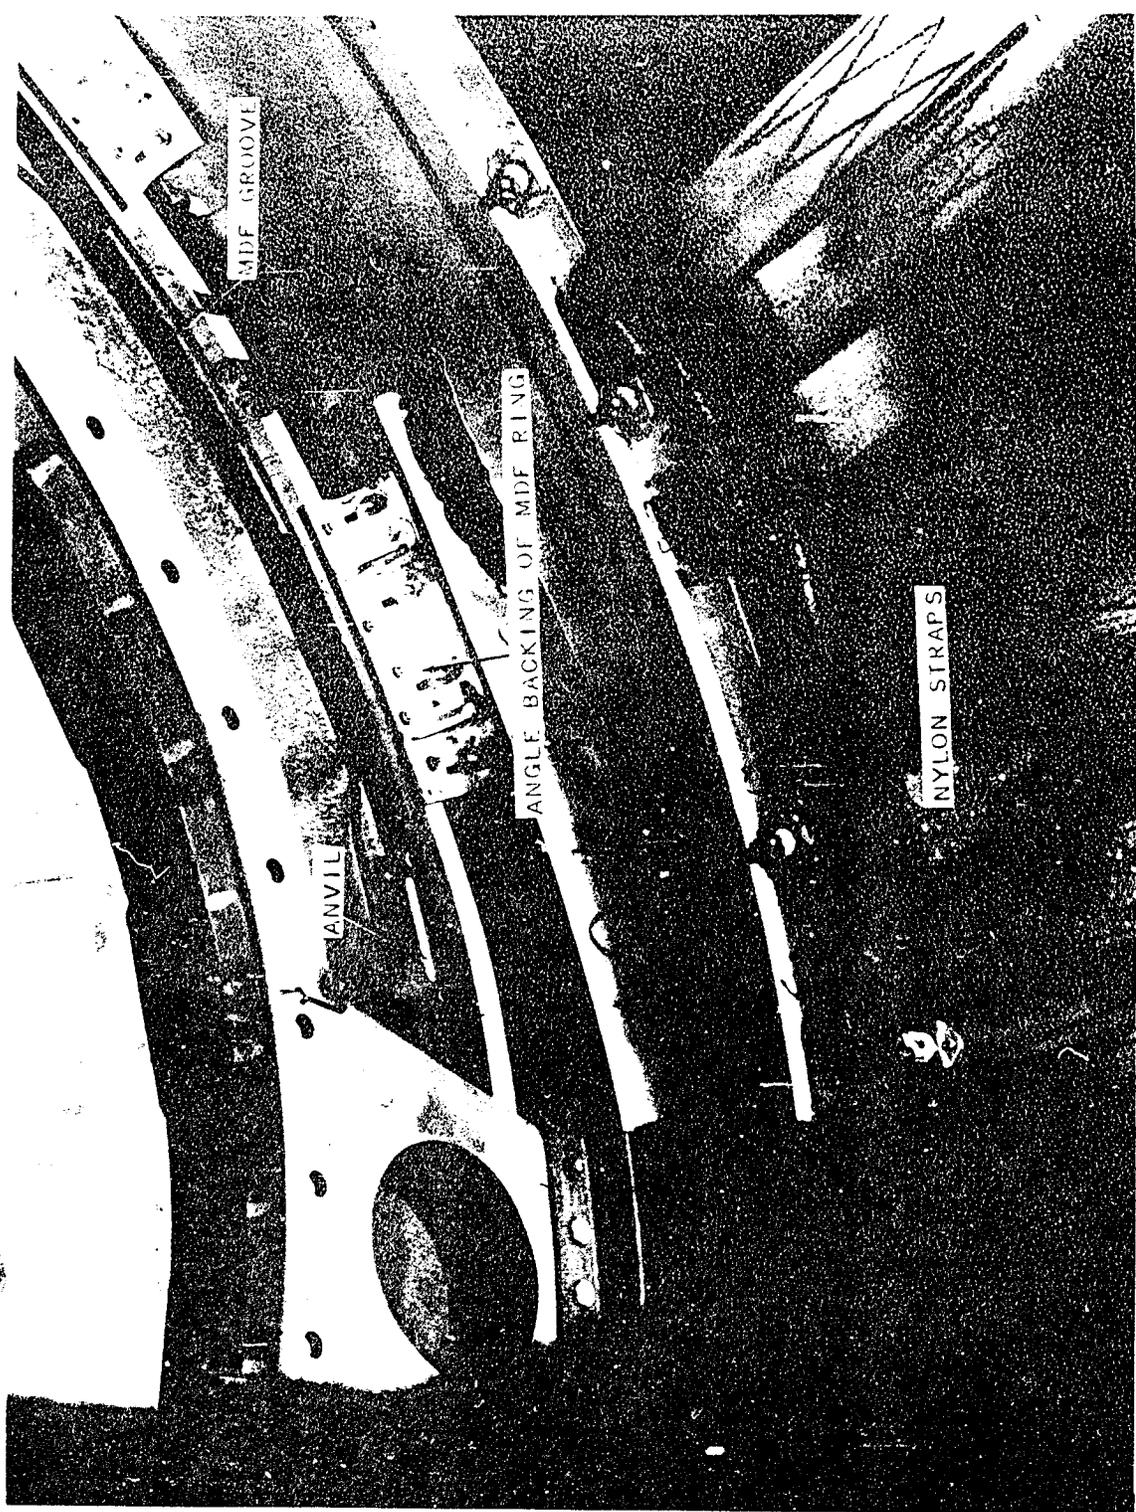
FIGURE 5 - INSIDE 60-L AFTERBODY AFTER TEST -- EXTERNAL TEST OF CH 15 (INTERNAL SYSTEM), UNIT 60-L

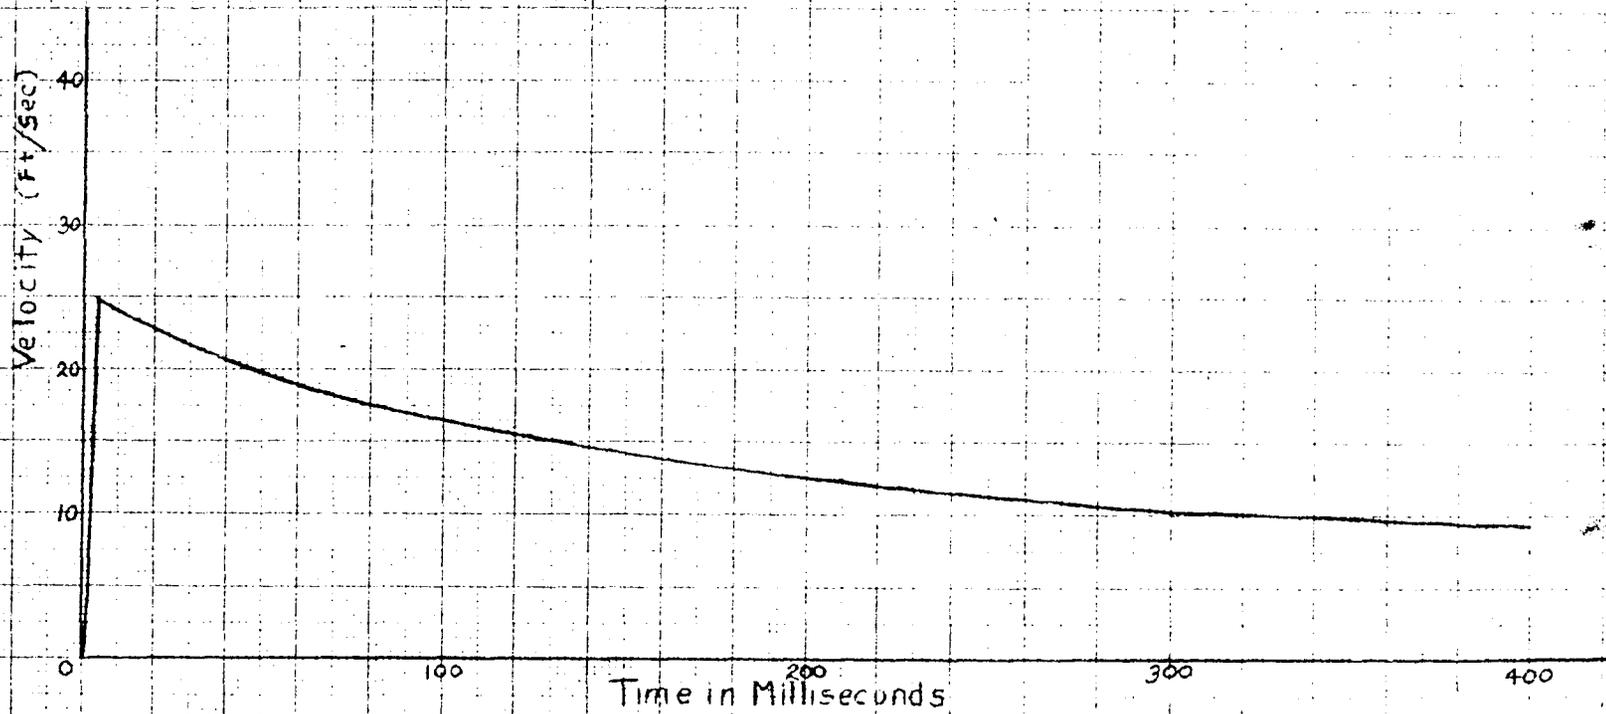
Fig. 6 Velocity vs. Time Curve of Rear Cover Plate Deployment Unit 60-L
Explosive Test of Chute Deployment System 60-L Project T-17637
