DOE/NV--729

Corrective Action Decision Document/ Closure Report for Corrective Action Unit 409: Other Waste Sites, Tonopah Test Range, Nevada

June 2001

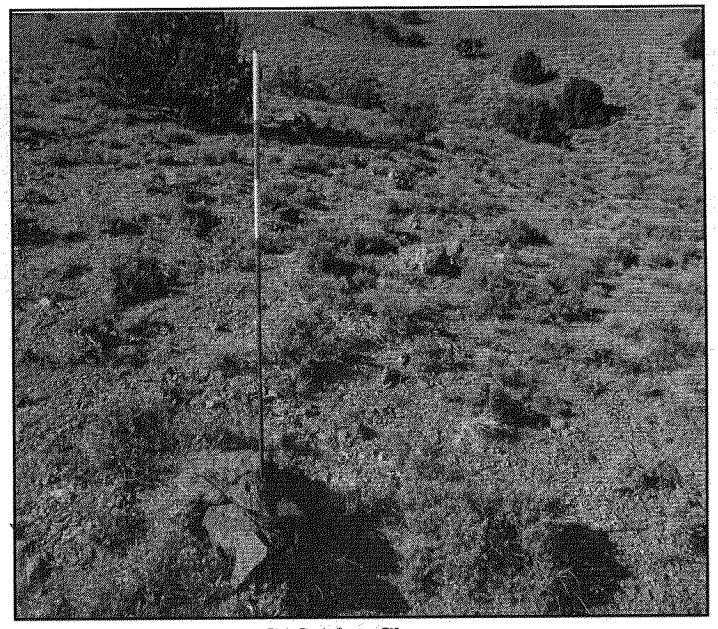
CAS Prior to Cleanup
Photograph date: 11/8/2000

Current Site Description/Observations: The discarded batteries and associated construction debris were removed on

November 8, 2000, during the ITLV CAU 409 Corrective Action Investigation. The batteries were taken to the TTR recycling collection point and the debris was taken to the TTR scrap yard. There are no remaining environmental concerns at the site.
