Re: Shock Test of Two Metal Dye Containers (Units Numbered 1 and 2) (Unc)

Object of Test

The object of this test was to assist Division 7147 in determining if the Metal Dye Container would break when subjected to a shock, simulating a 50-pound HE Explosion.

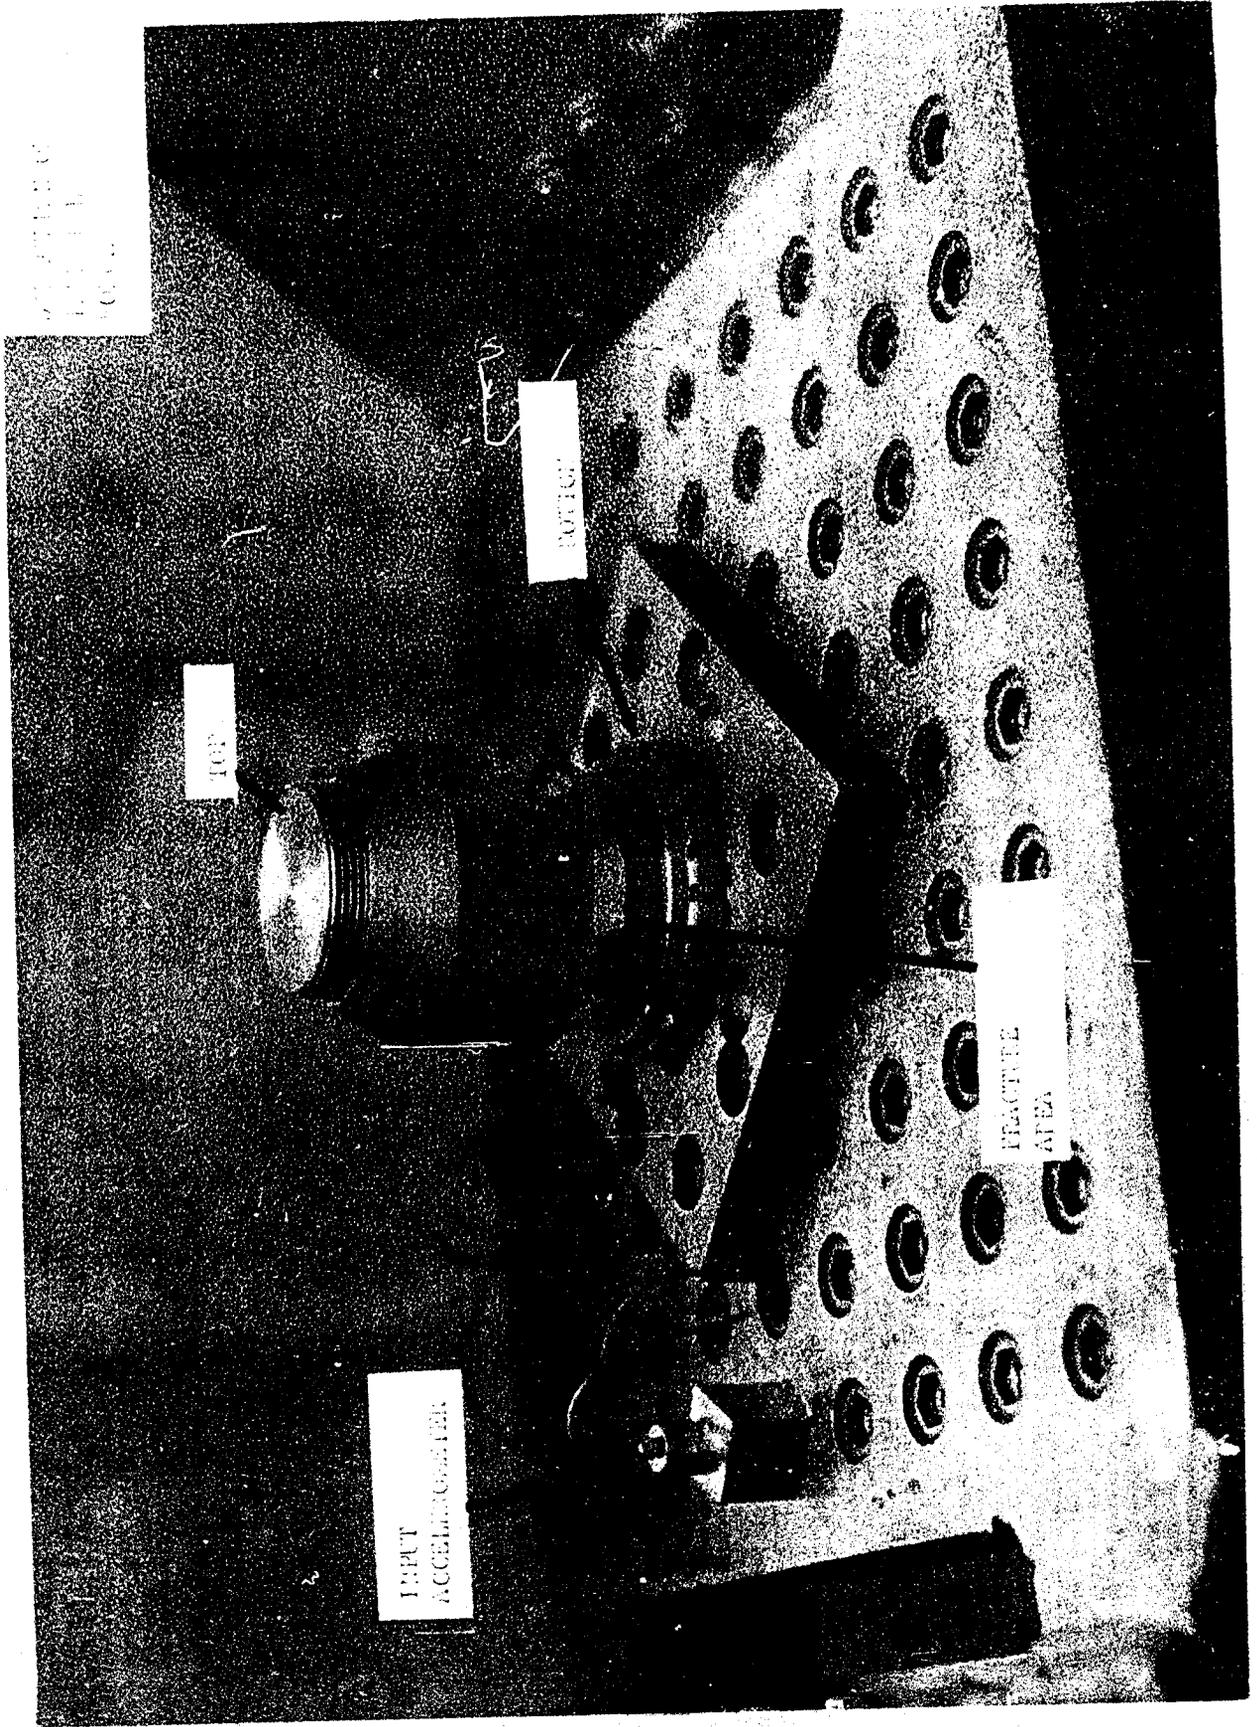
FIGURE 1. TEST FIXTURE FOR CORE TANK (UNIT NO. 1) ACCIDENT INVESTIGATION

Figure 1 shows the location of the input accelerometer on the Mechanical Shock Machine Table.

Figure 1 shows the metal dye container (Unit No. 1) mounted on Shock Machine No. 6.
