Date Submitted: 2/22/06	Operable Unit(s): 100-DR-1	Control Number: 2005-036
Originator: R. A. Carlson	Waste Site ID: 1607-D4	Lead Agency: Ecology
Phone: 373-1440	Type of Reclassification Action:	
	Rejected ☐	
	Closed Out ☐	
	Interim Closed Out ☒	
	No Action ☐

REMAINING SITES VERIFICATION PACKAGE FOR THE 1607-D4 SEPTIC SYSTEM

Attachment to Waste Site Reclassification Form 2005-036

February 2006

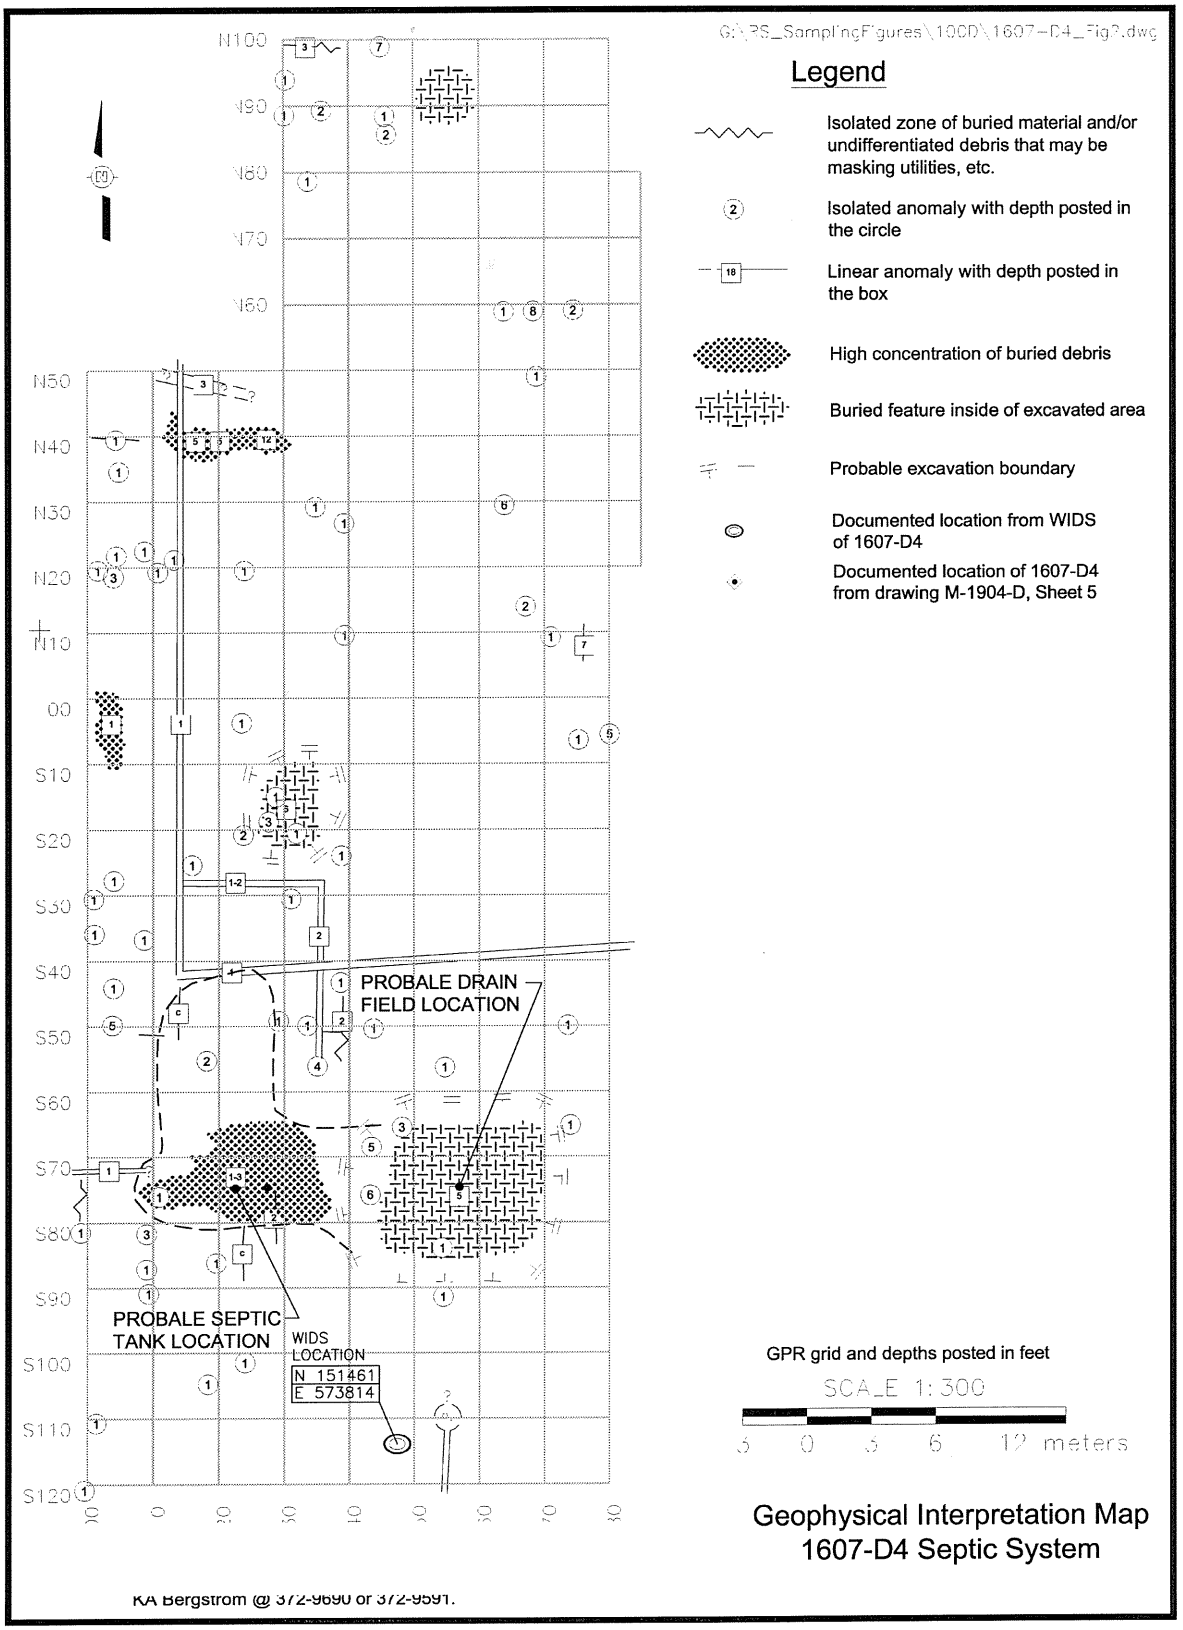
Figure 2. 1607-D4 Septic System Geophysical Interpretation Map.

A geophysical survey conducted in 1992 (Bergstrom and Mitchell 2004) and field observations made during a site visit in February 2005 were used to conclude that the first possible location, east of the southeast corner of the 115-D/DR Building (Figure 2), was the best place to locate the remaining structure of 1607-D4 Septic System.

The septic tank and the geophysical interpretation map indicated the location of the drain field. Along the VCP pipeline between the septic tank and the drain field, a "tee" section of 0.15-m (6-in.) VCP was found. It is standard practice to sample at the top of drain fields. A sediment sample was collected from within the VCP "tee" at 2 m (6.5 ft) below ground surface. A soil sample and sample duplicate were collected from below the VCP at 2.5 m (8 ft) below ground surface. The sample location (Figure 3) would appear to be outside of the drain field. However, the drain field indicated in Figure 3 has been adapted from the geophysical map (Figure 2), which does not identify the entire scope of the underground structure. The "tee," found between the septic tank and the main portion of the drain field, is the first division of several in the pipeline used to create the drain field. The "tee" it is effectively the top of the drain field.

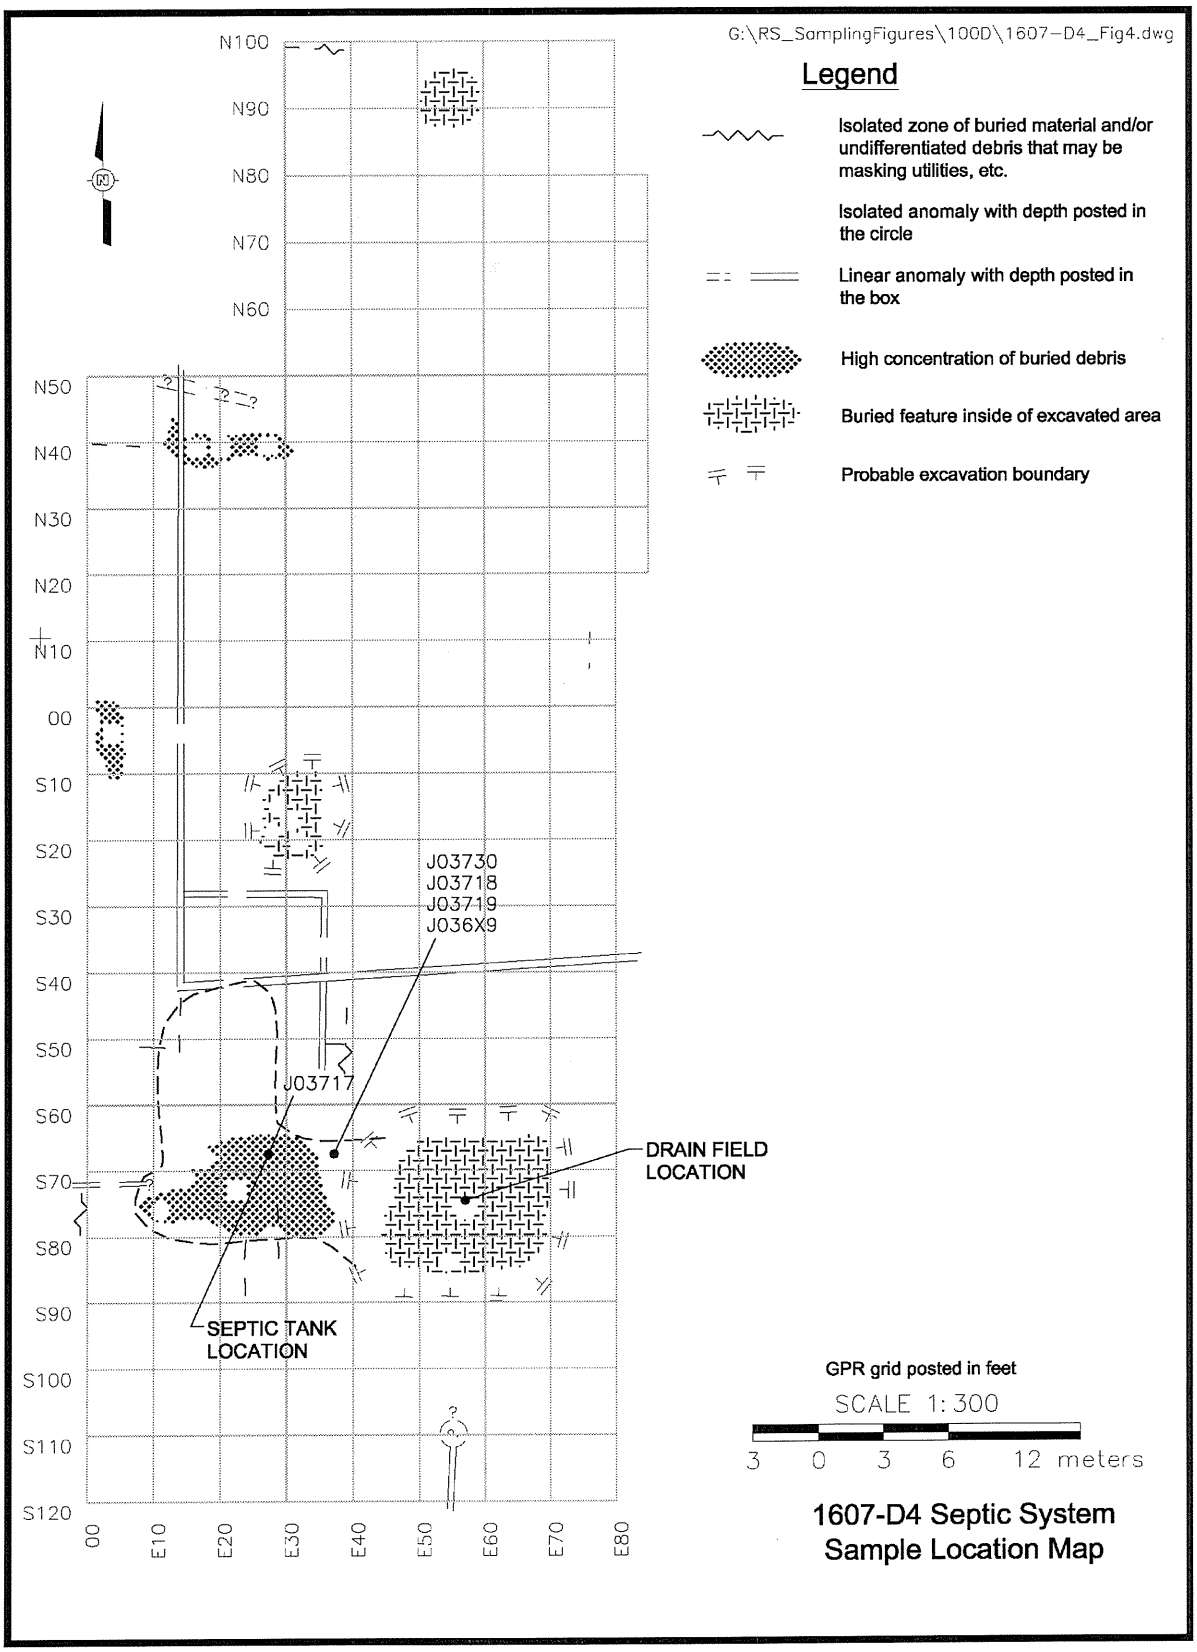
Figure 3. Confirmatory Sample Locations at the 1607-D4 Septic System Site.

One test trench was excavated in the area identified as the most likely location of the septic tank. The septic tank was located within the trench and a sample collected from below it. The work instruction also called for a residual sludge sample to be collected from within the septic tank if sufficient residual sludge was found. The septic tank was found backfilled with clean fill unrelated to the operational history of the septic tank and no sludge was sampled from within the septic tank.

During excavation, the field sampler inspected the sidewalls and excavated materials for the presence of stained soil, evidence of burning, and/or debris. In the excavation at the top of the drain field, an 0.2-m (8-in.) piece of paper-wrapped pipe was found. The original function of the small section of pipe is unknown, but the wrapping was suspected to be asbestos. A sample of the paper coating on the pipe was taken and analyzed for asbestos.

A summary of the collected samples for the 1607-D4 Septic System is provided in Table 1. Sample locations are depicted in Figure 3. Sample results are presented in Appendix A.
