Operational Limitations of Light Water Reactors  
Relating to Fuel Performance\*

H. S. Cheng

Brookhaven National Laboratory  
Upton, New York 11973

July, 1976

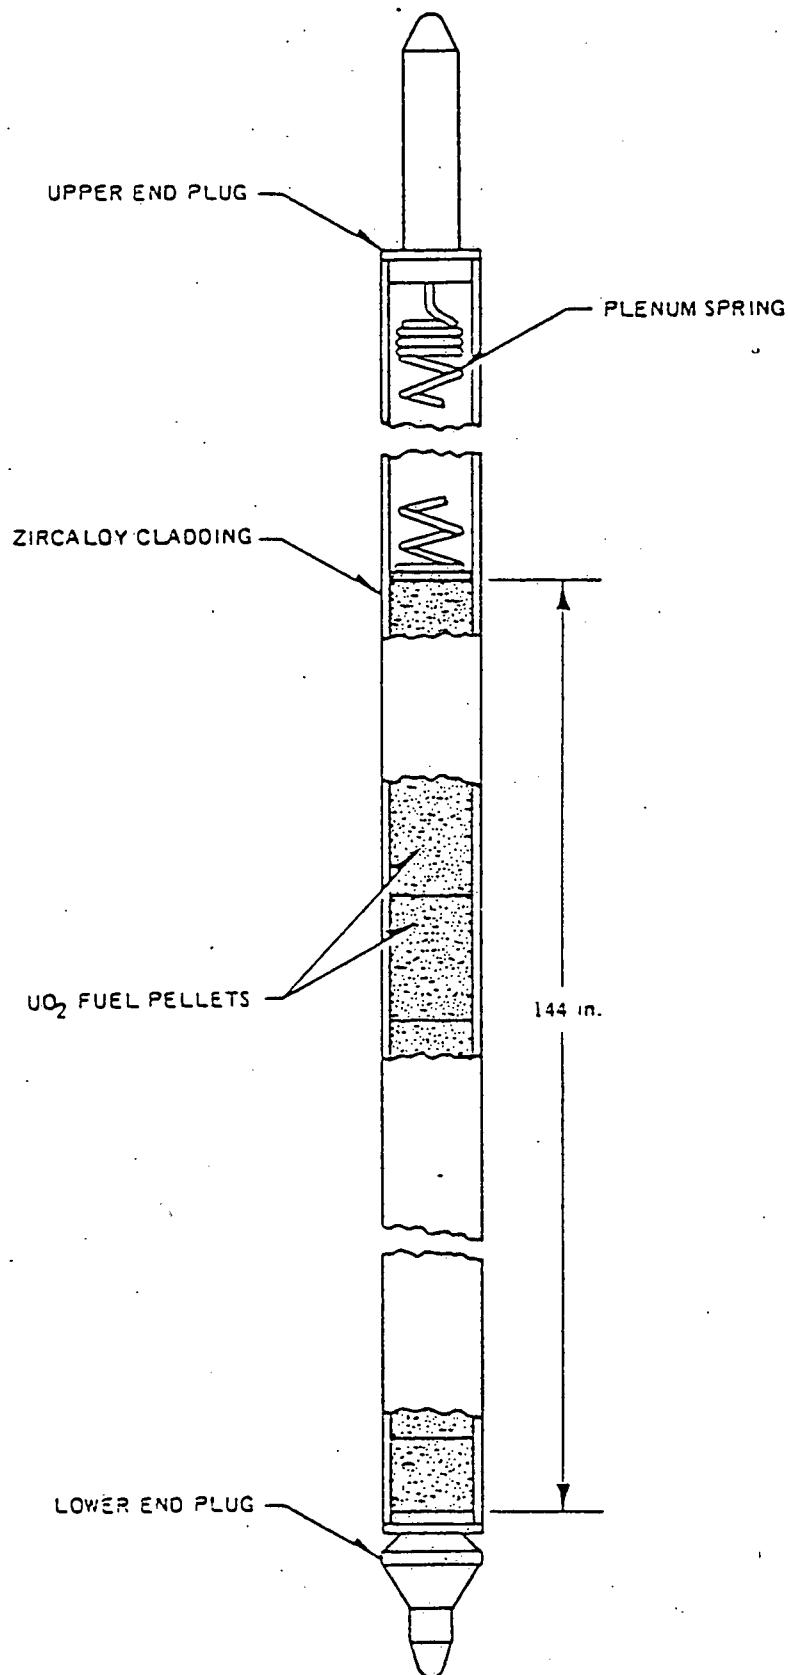
Figure 1. BWR Fuel Rod Schematic

The evolution of the nuclear power industry has resulted in a variety of fuel designs. However, the general aspects of the fuel designs are similar in many ways for both BWRs and PWRs. For current generation LWR cores, the fuel rod is a hollow Zircaloy tube (cladding) into which cylindrical fuel pellets are stacked end to end. The cladding tube is sealed by welding end plugs into each end of the tube. The fuel is slightly enriched (typically 1 to 4 w/o U-235)  $UO_2$  which is compacted into pellet form and then sintered at high temperatures with a resultant density of about 95% theoretical. Typical fuel rods are about 14-15 feet long containing an approximately 12-or 13-foot column of stacked pellets. The pellet columns are pressed downward by a spring in the top plenum of the tube. Figures 1 and 2 show the schematic of a BWR and PWR fuel rod, respectively.

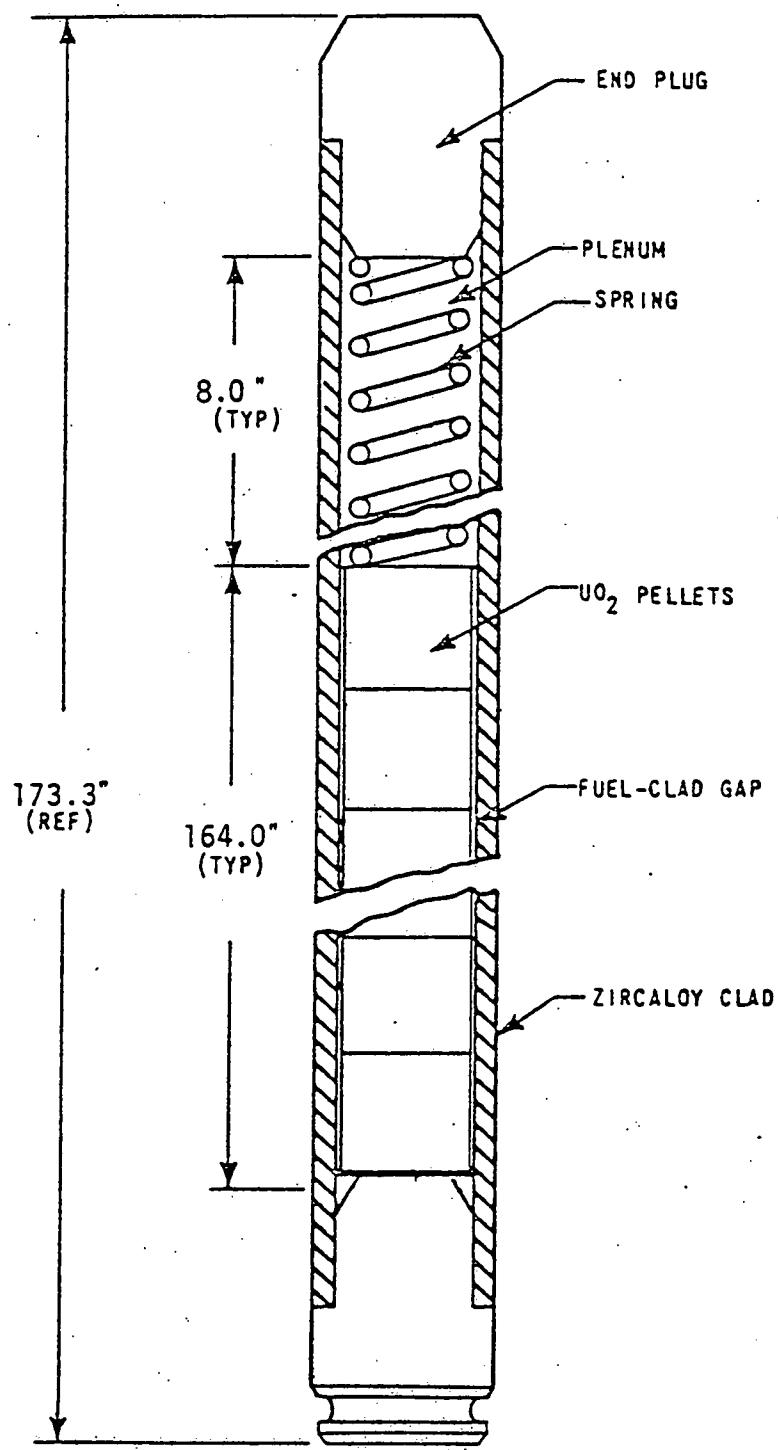
SPECIFIC DIMENSIONS DEPEND ON DESIGN VARIABLES SUCH AS  
PRE-PRESSURIZATION, POWER HISTORY, AND DISCHARGE BURNUP

Figure 2. PWR Fuel Rod Schematic

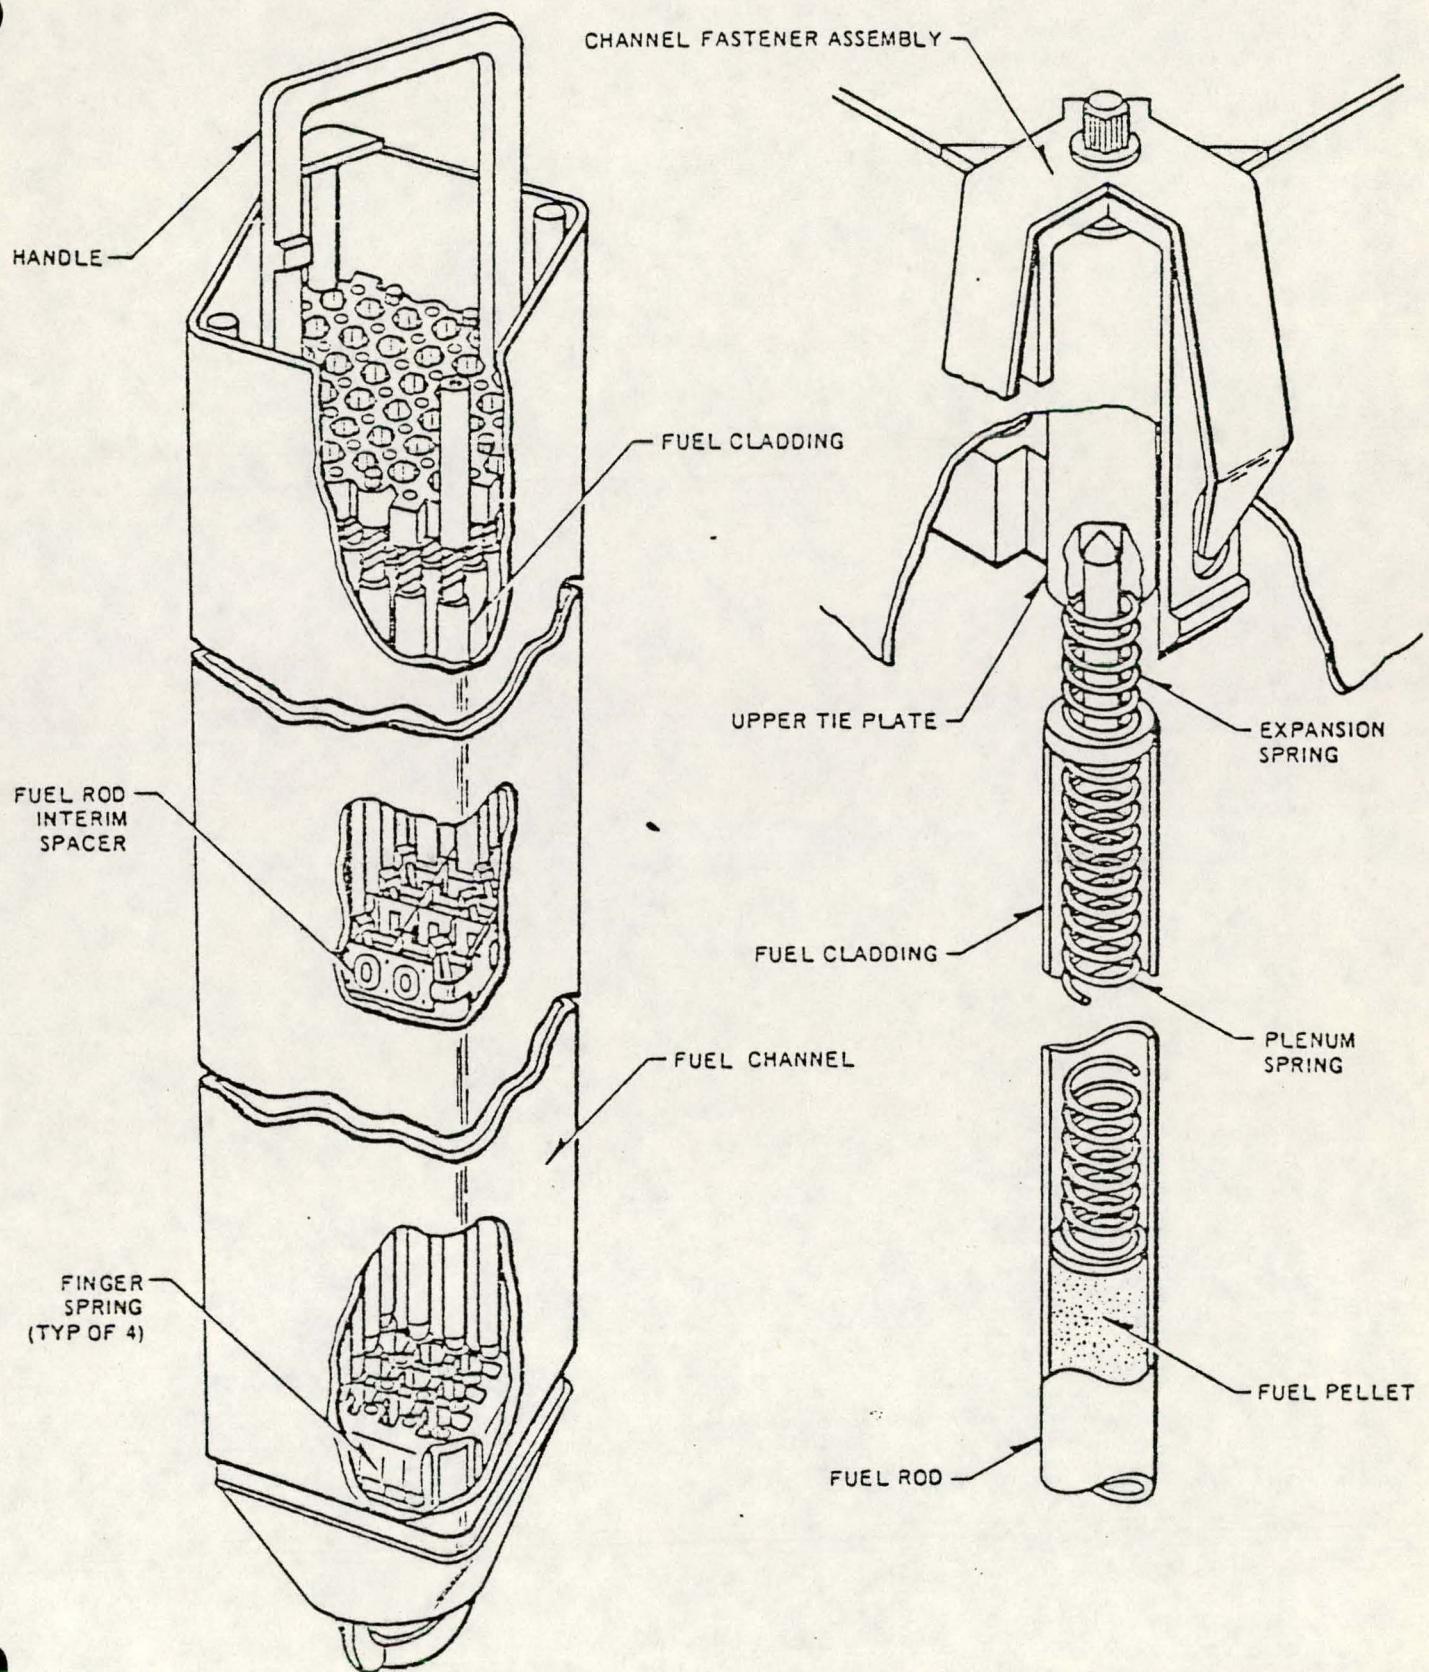
Figure 3. Fuel Assembly - GE BWR

Fuel rods are arranged in a square array to form a fuel bundle. They are uniformly spaced by means of a number of spacer grids. For BWRs, fuel bundles are also enclosed in a Zircaloy-4 channel box to prevent cross flow between fuel bundles. Figures 3 and 4 show the typical fuel assembly of a BWR and a PWR, respectively.

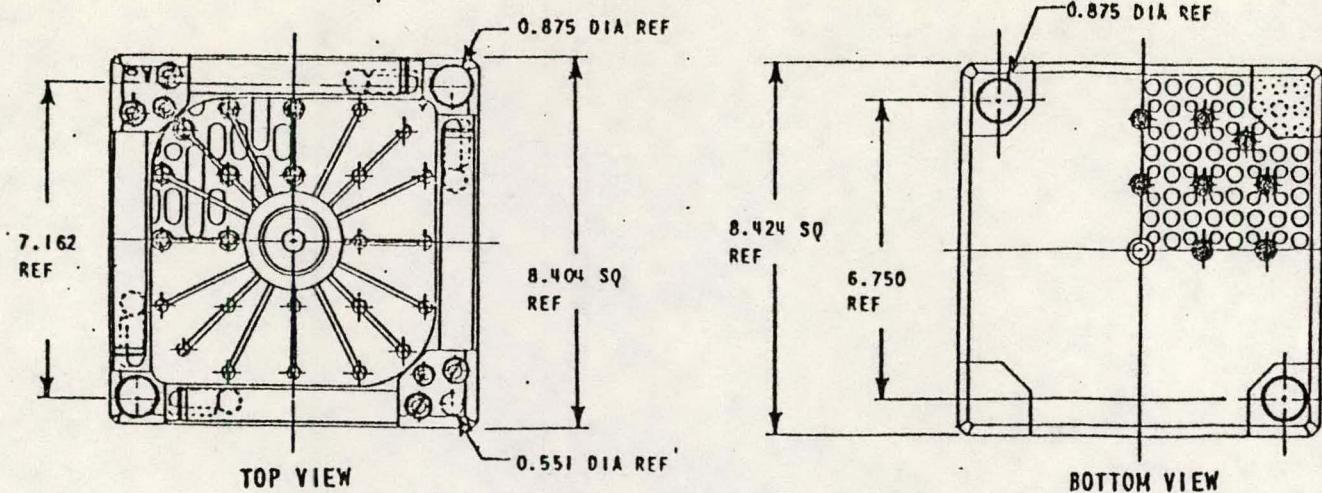
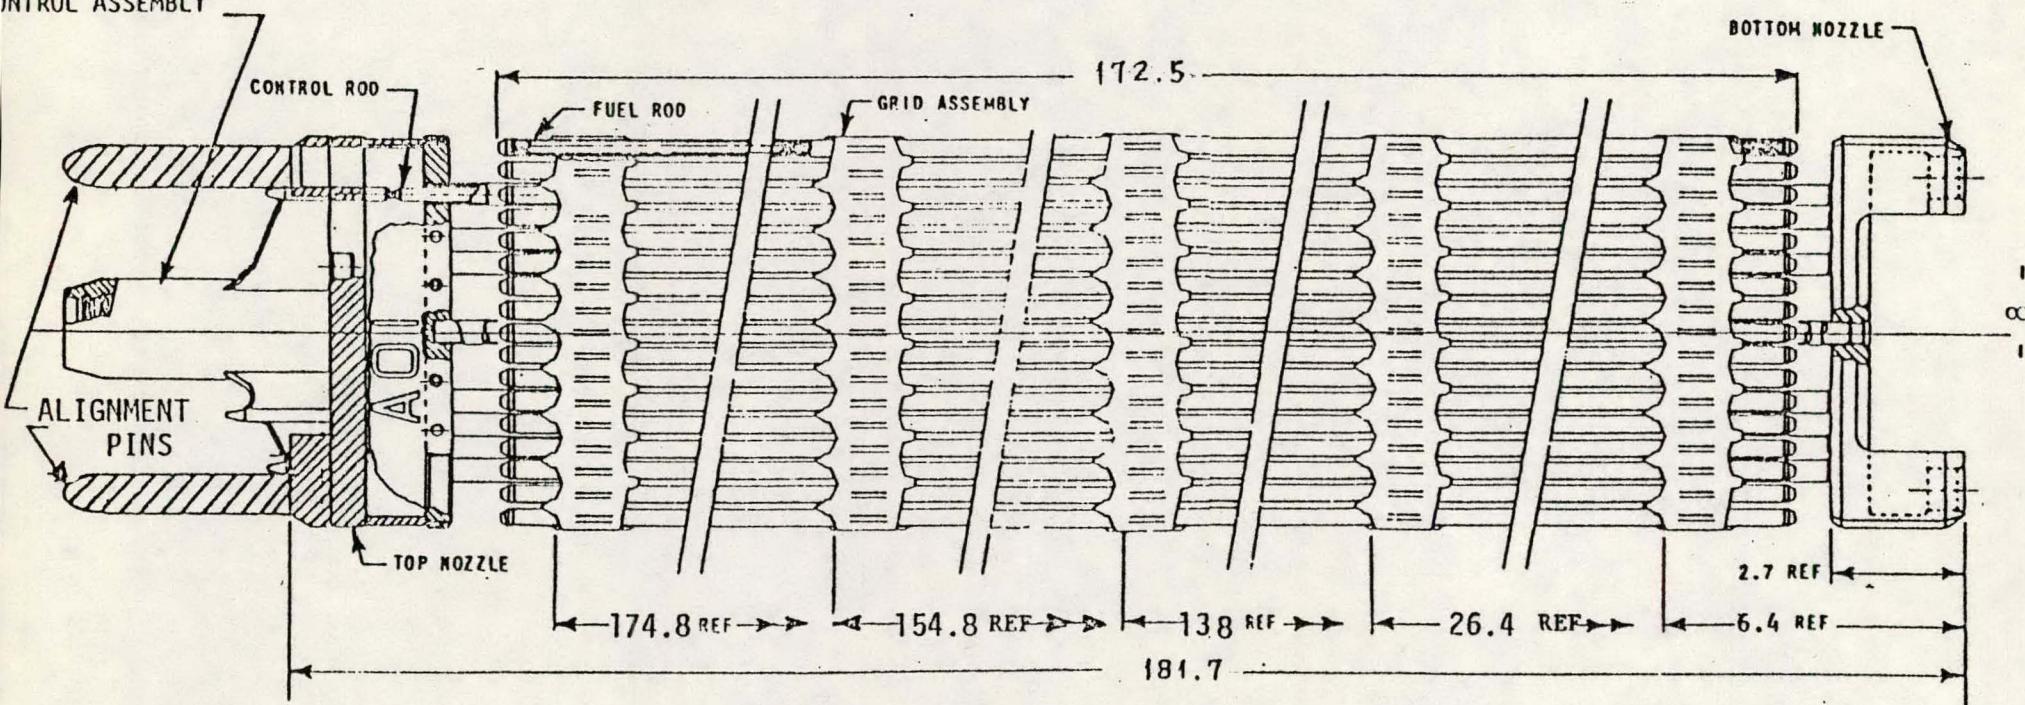
Figure

4.. Fuel Assembly Outline  
17 X 17 (W PWR)  
(Conceptual)

ROD CLUSTER  
CONTROL ASSEMBLY

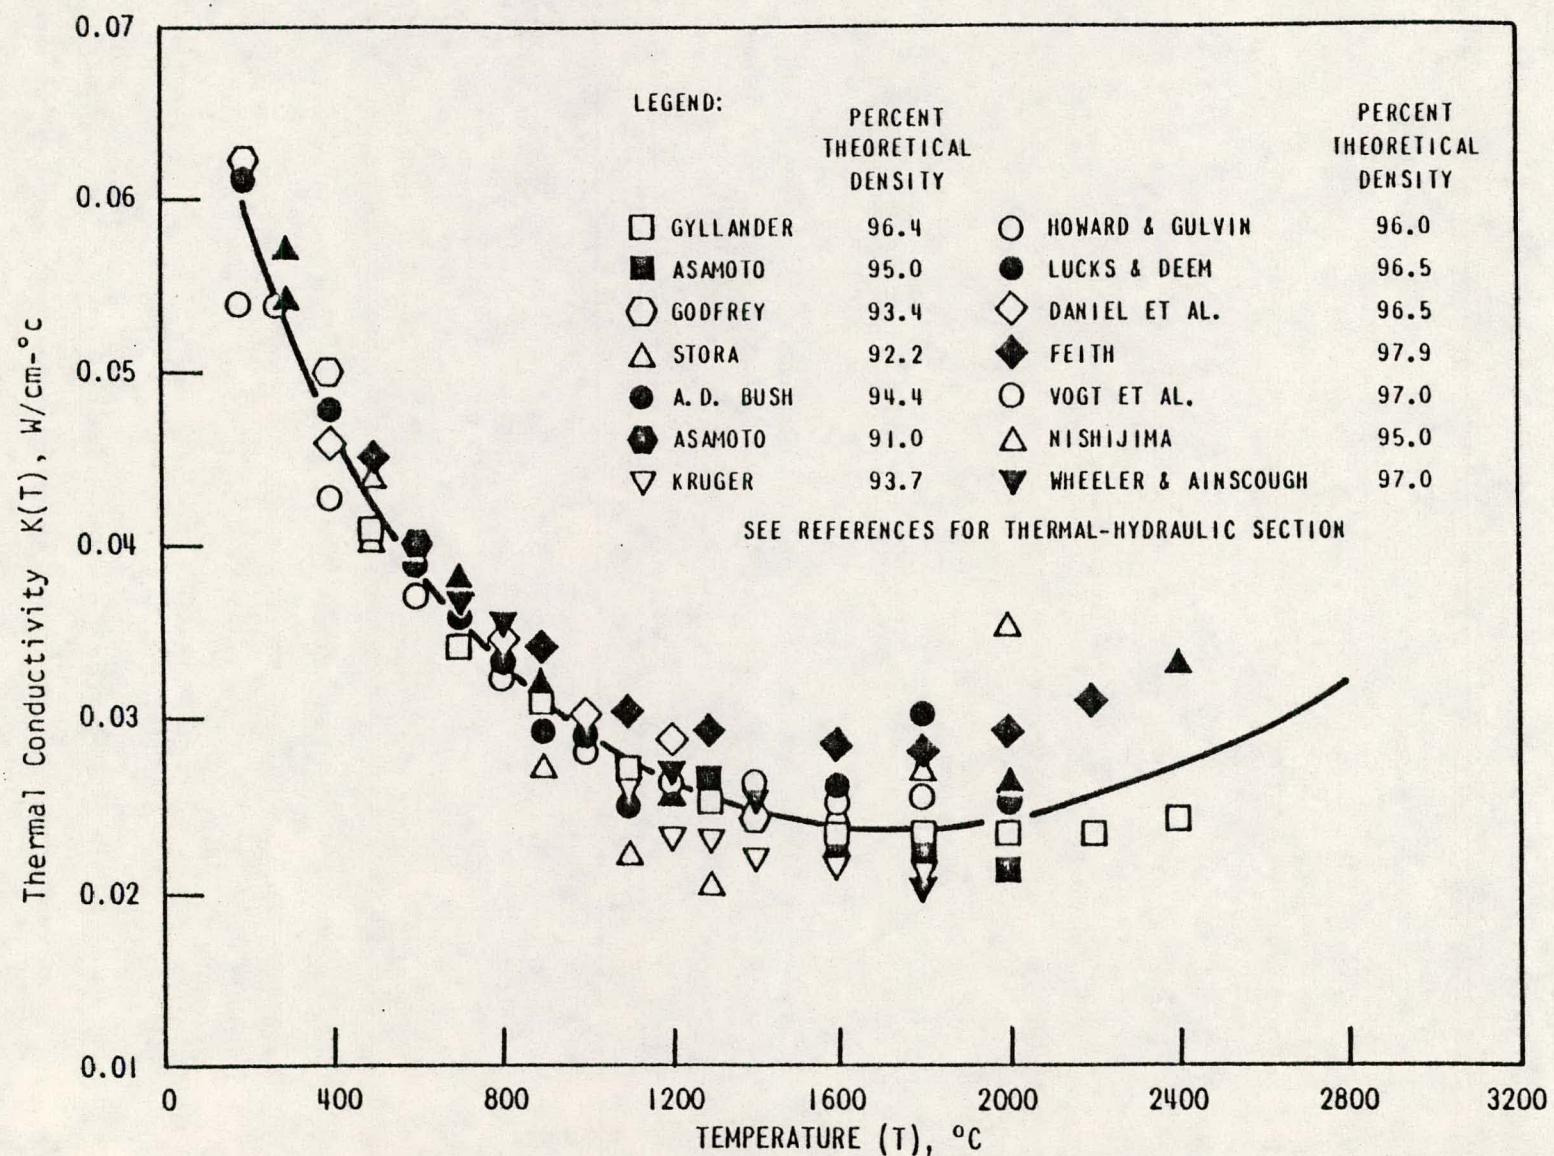
Figure A-1. Thermal Conductivity of  $\text{UO}_2$  (Data Corrected to 95% Theoretical Density)

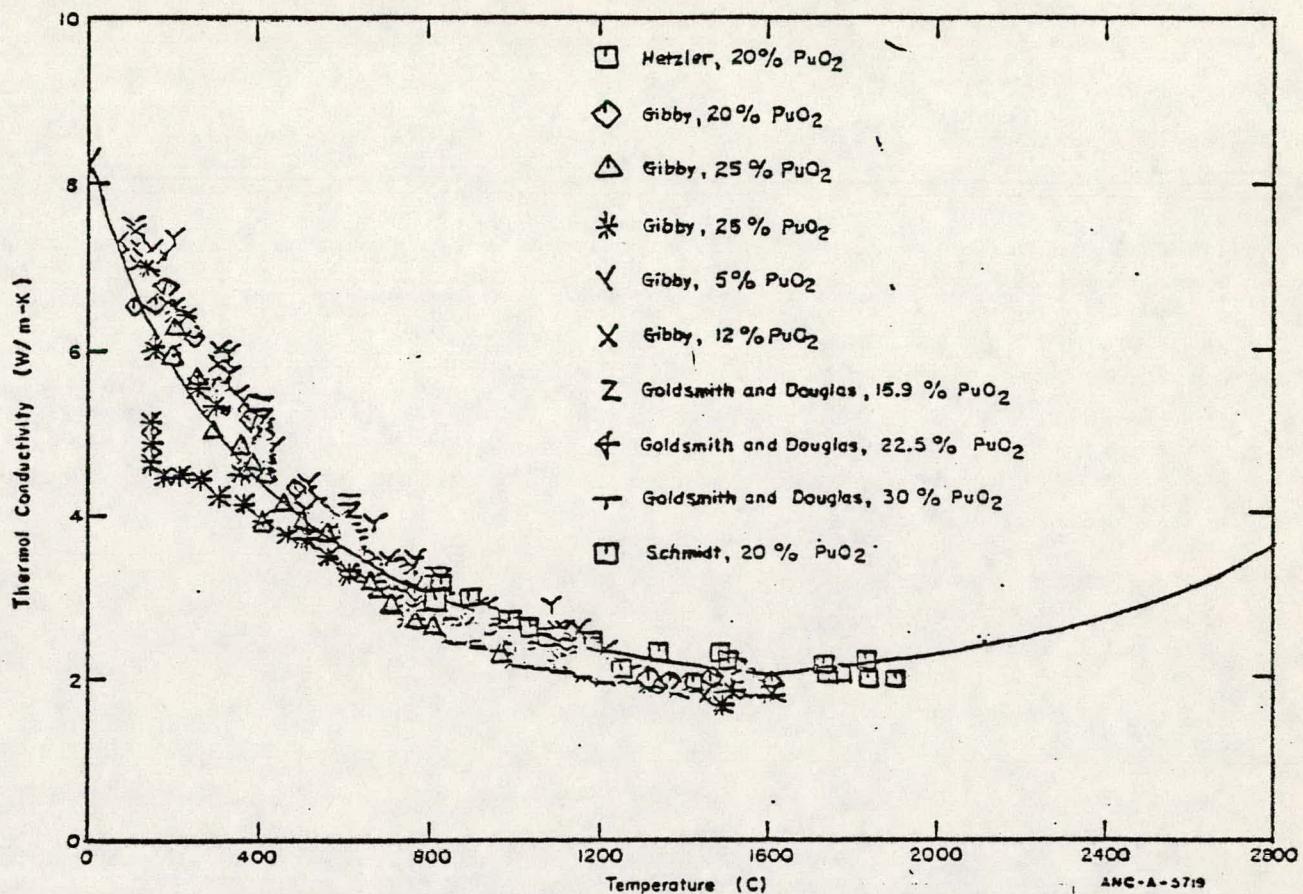
Fig. A-2. Comparison of measured mixed oxide conductivity with predictions (ANCR-1263) for 96% theoretical density Mo<sub>2</sub>. ANC-A-5719

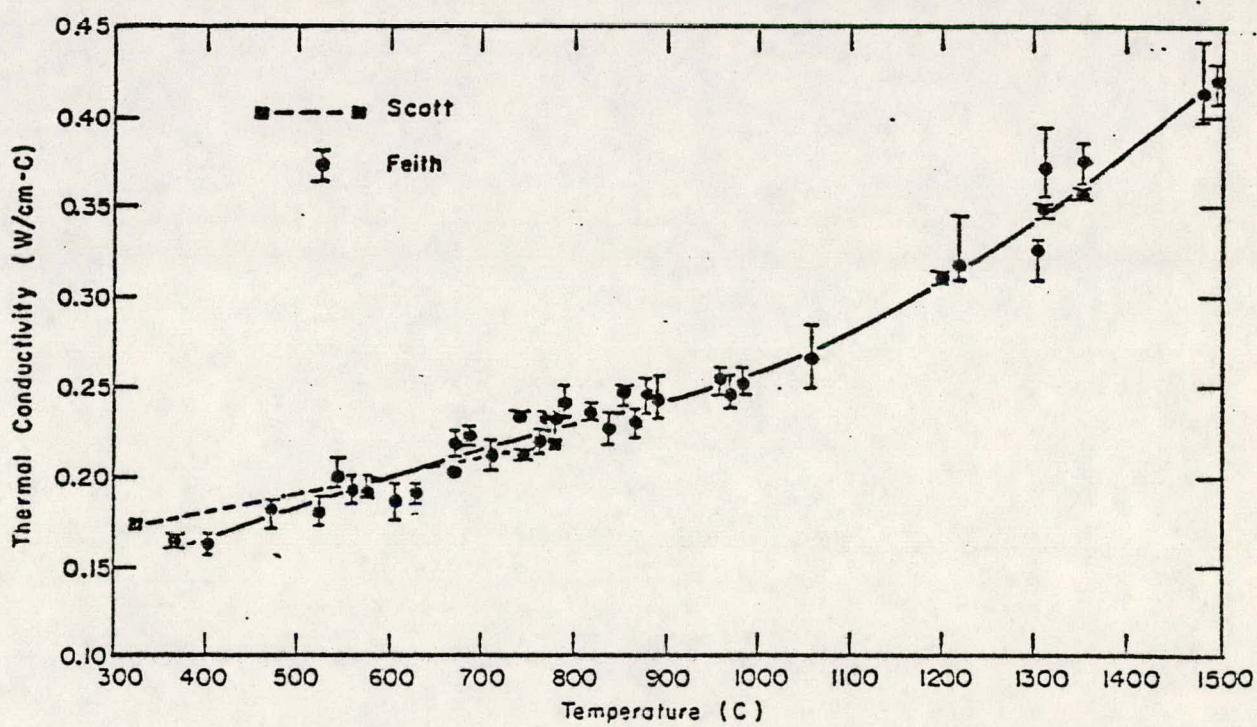
Fig. A-3. Thermal conductivity of zircaloy-4 as a function of temperature.

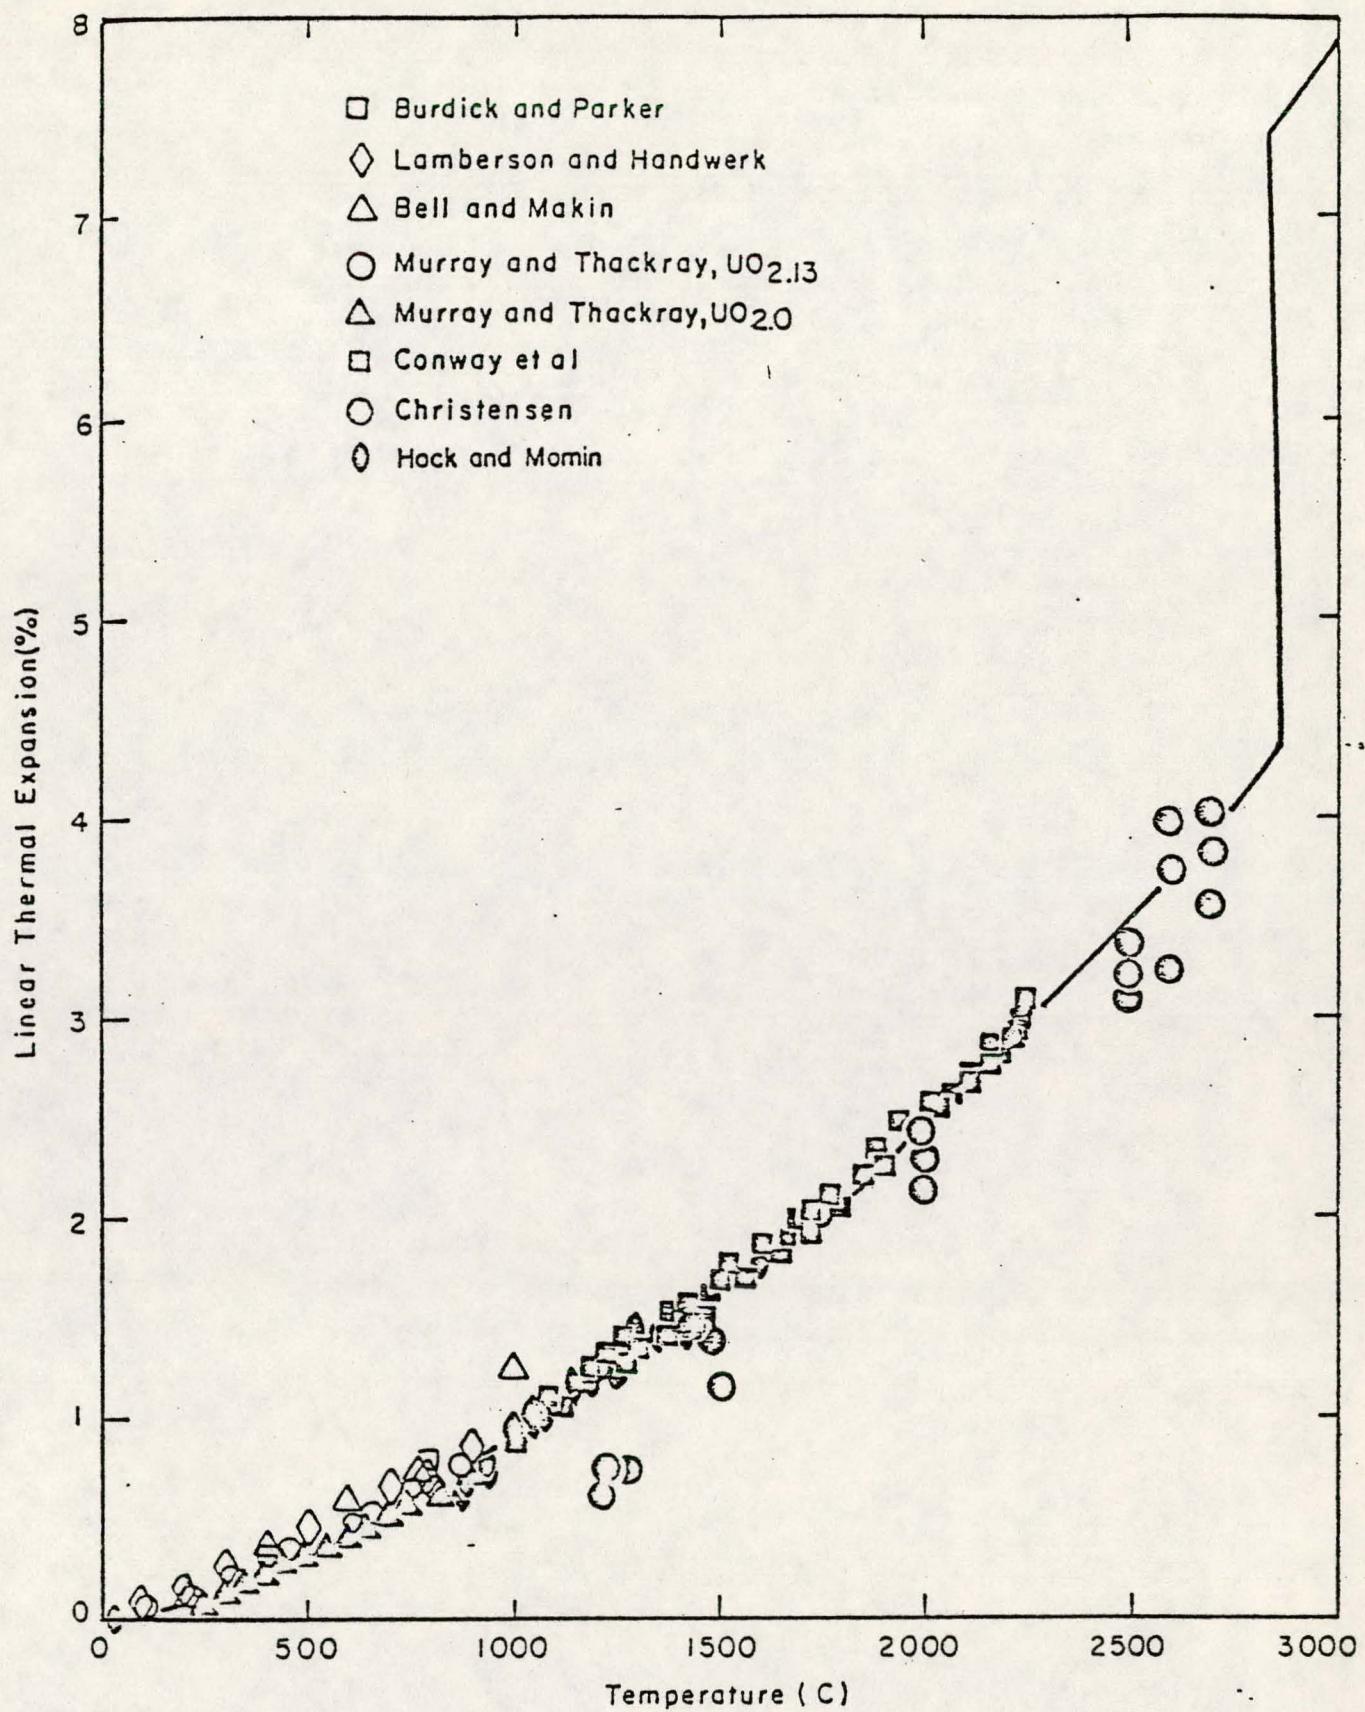
Fig. A-4. Comparison of  $UO_2$  thermal expansion data with that calculated from FHTEXP subcode.

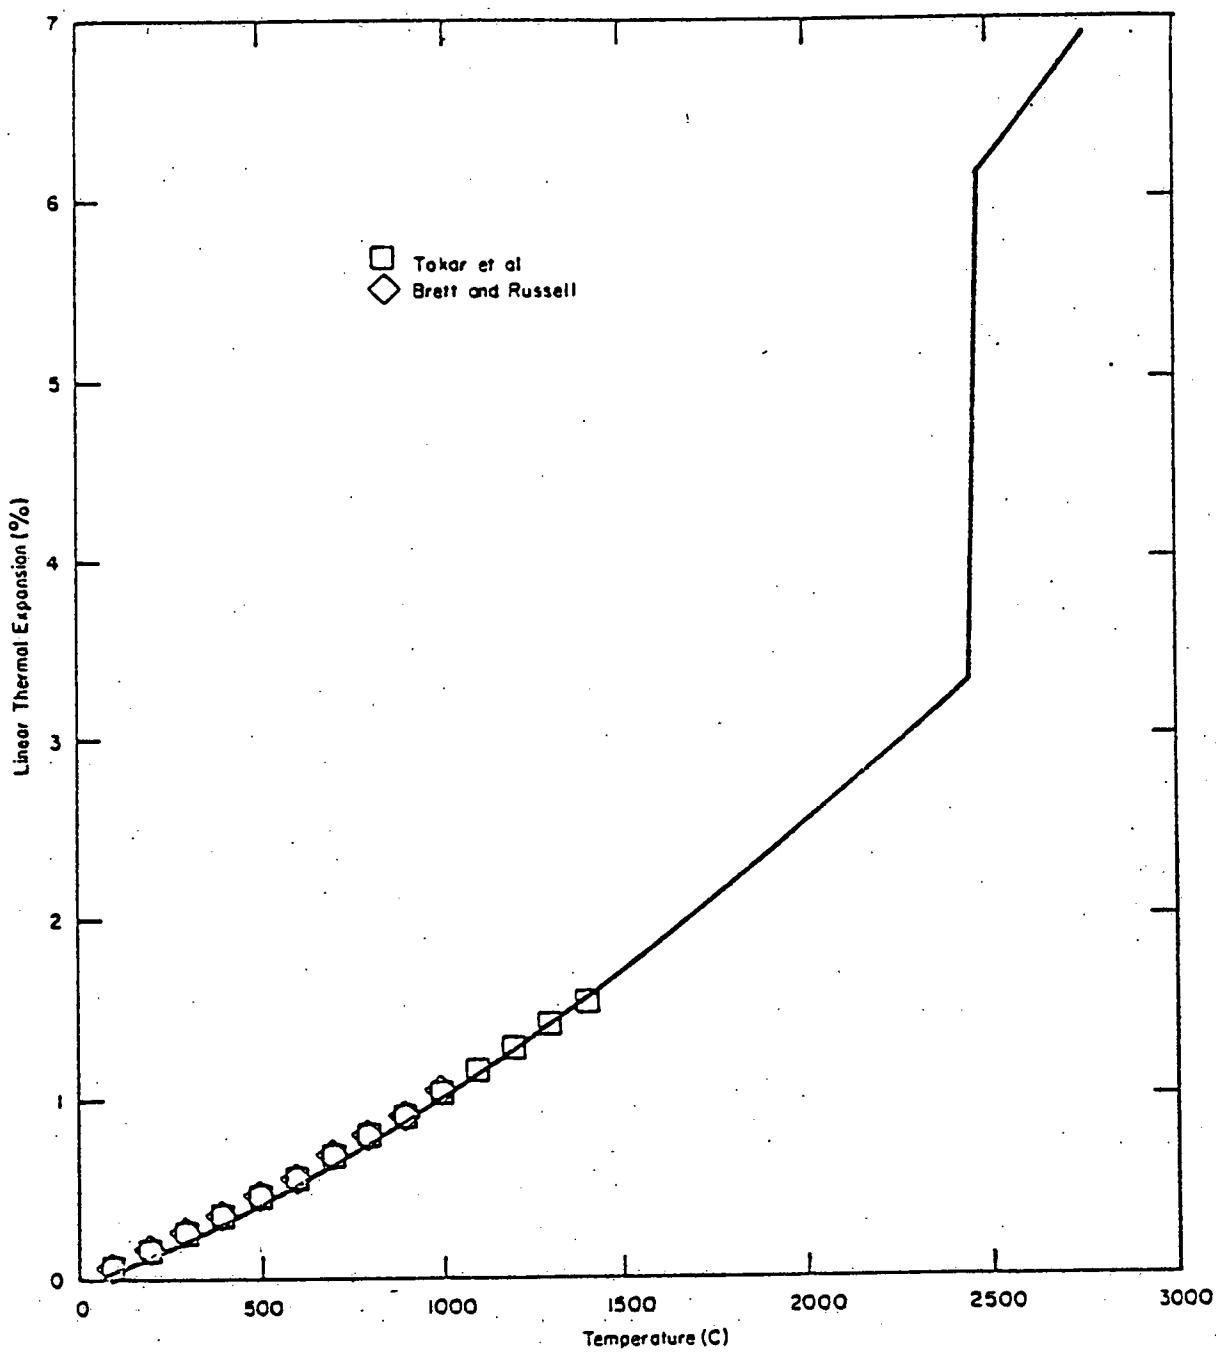
Fig. A-5. Comparison of  $\text{PuO}_2$  thermal expansion data with that calculated from FHTEXP subcode.

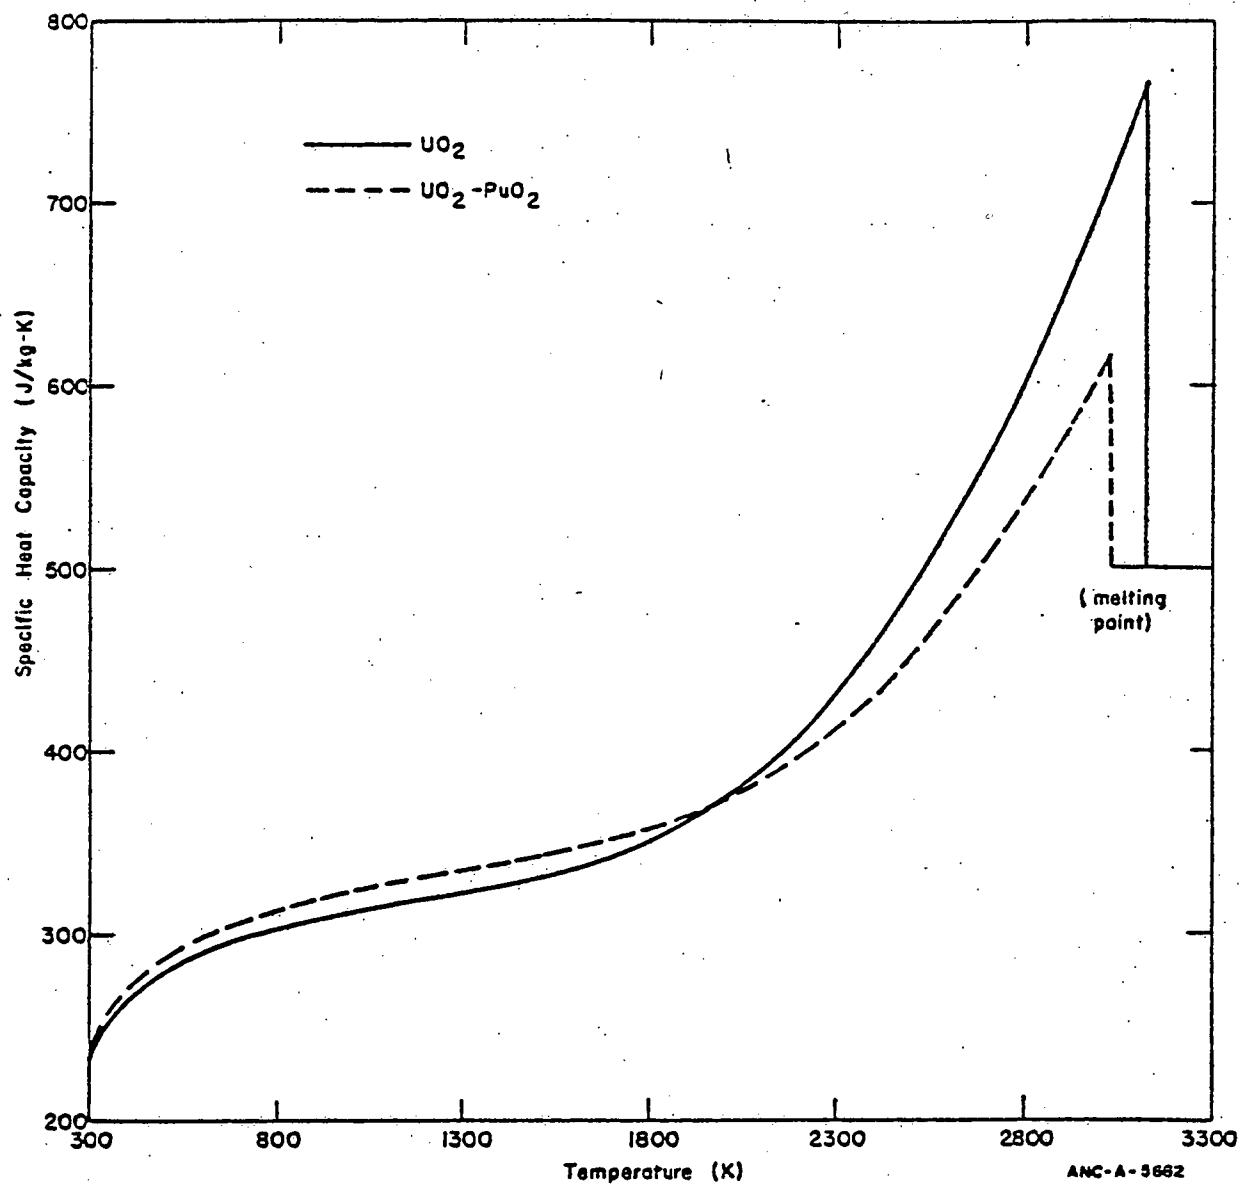
Fig. A-6. Temperature dependence of mixed oxide specific heat capacity calculated by FCP for  $\text{UO}_2$  and  $\text{UO}_2 - \text{PuO}_2$ .
