REMAINING SITES VERIFICATION PACKAGE FOR THE 100-F-44:2, DISCOVERY PIPELINE NEAR 108-F BUILDING

Attachment to Waste Site Reclassification Form 2007-006

April 2008

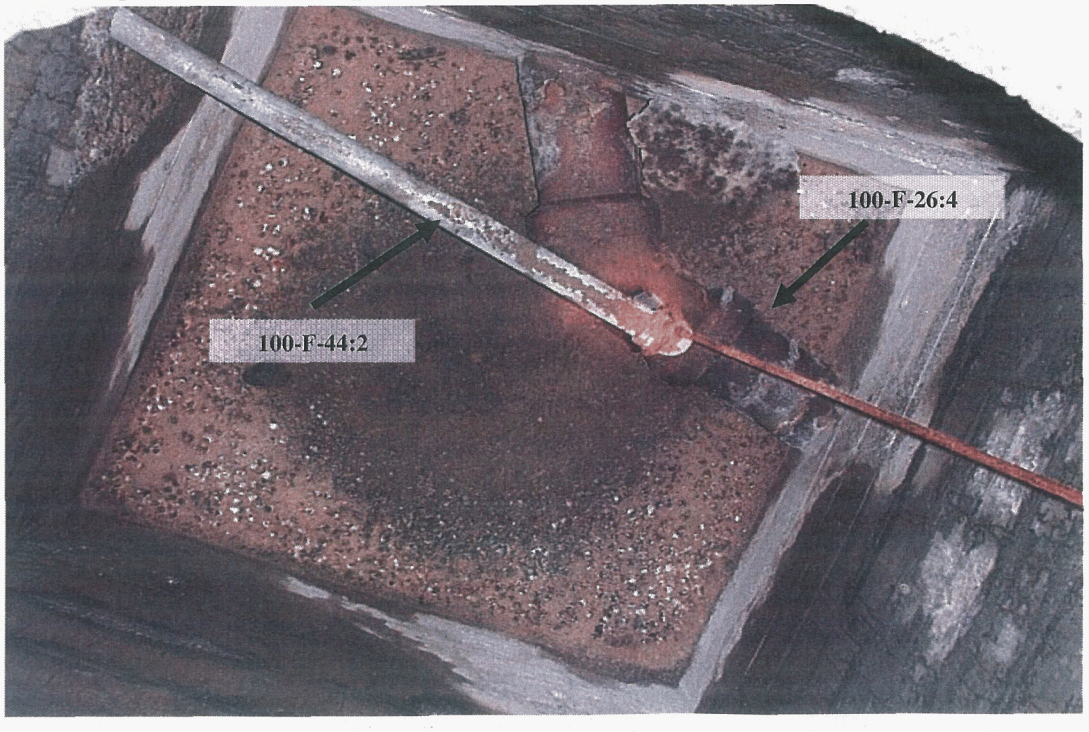
The subject junction box was installed in 1949 when the 108-F Building was expanded. A rough opening visible in the concrete wall at the 100-F-44:2 point of entry into the junction box indicates the 100-F-44:2 pipeline was added after installation of the junction box. A geophysical survey of the 100-F-44:2 subsite was conducted in January 2007 (Geophysical Site Investigation Summary form #0574490) using ground-penetrating radar. Two east-westerly trending linears were identified that appear to originate or pass through the former junction box location (Figure 3). The linear that extends to the east is consistent with the location and depth of the 100-F-26:4 pipeline. The linear that extends to the west is consistent with the location and orientation of the pipeline of interest (100-F-44:2). The assumed 100-F-44:2 pipeline linear is interpreted to be between 1 and 1.5 m (3 and 5 ft) deep.

Figure 1. Photograph of the 100-F-44:2 Pipeline Subsite (2004).

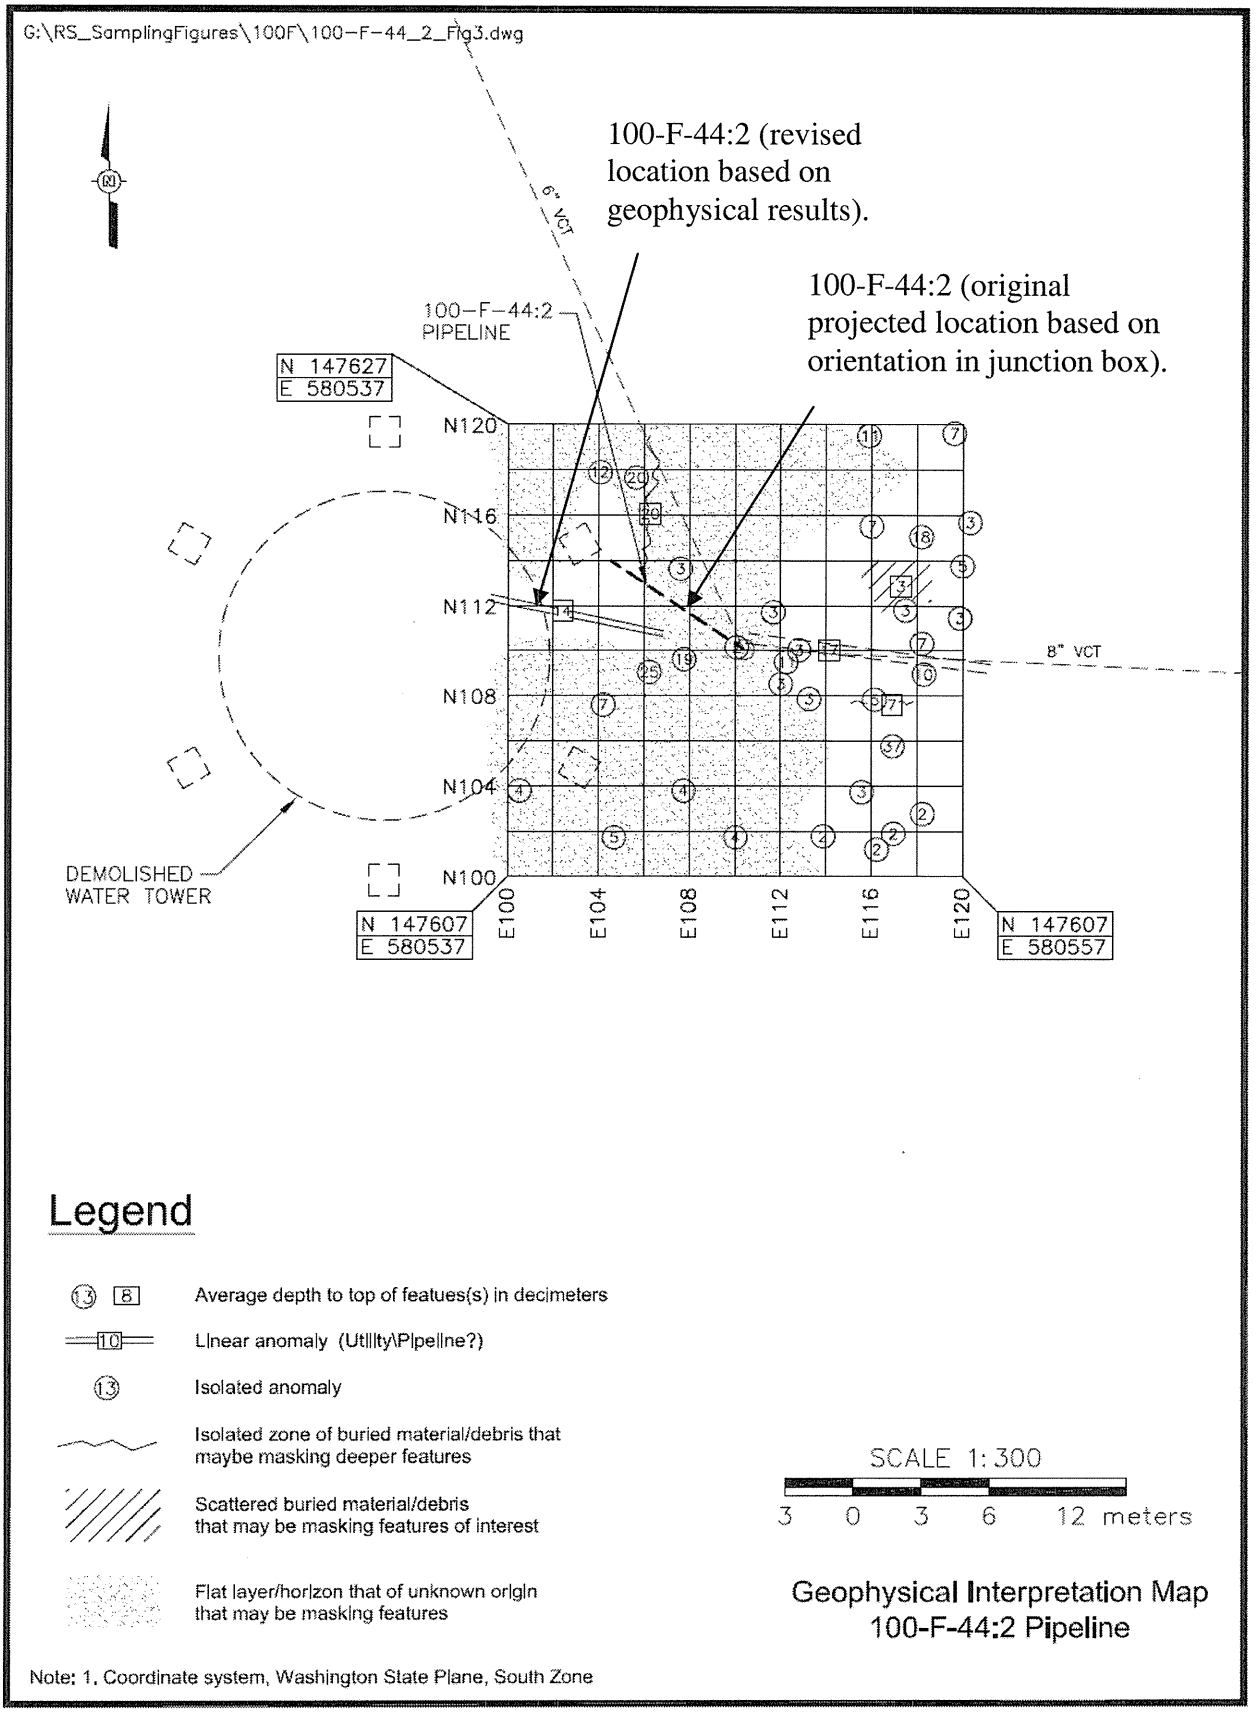
Figure 3. Geophysical Survey of the 100-F-44:2 Pipeline.

As indicated in the previous section, a geophysical investigation of the area was conducted in January 2007. The geophysical results suggested that the pipeline's path was to the water tower. Subsequent attempts to further define the extent of the pipeline were unsuccessful due to interference from buried debris in the area of the former 187-F1 elevated water tower.
