Annual Radioactive Waste Tank Inspection Program - 1994^(U)

Westinghouse Savannah River Company
Savannah River Site
Aiken, SC 19808

F. G. McNatt, Sr.

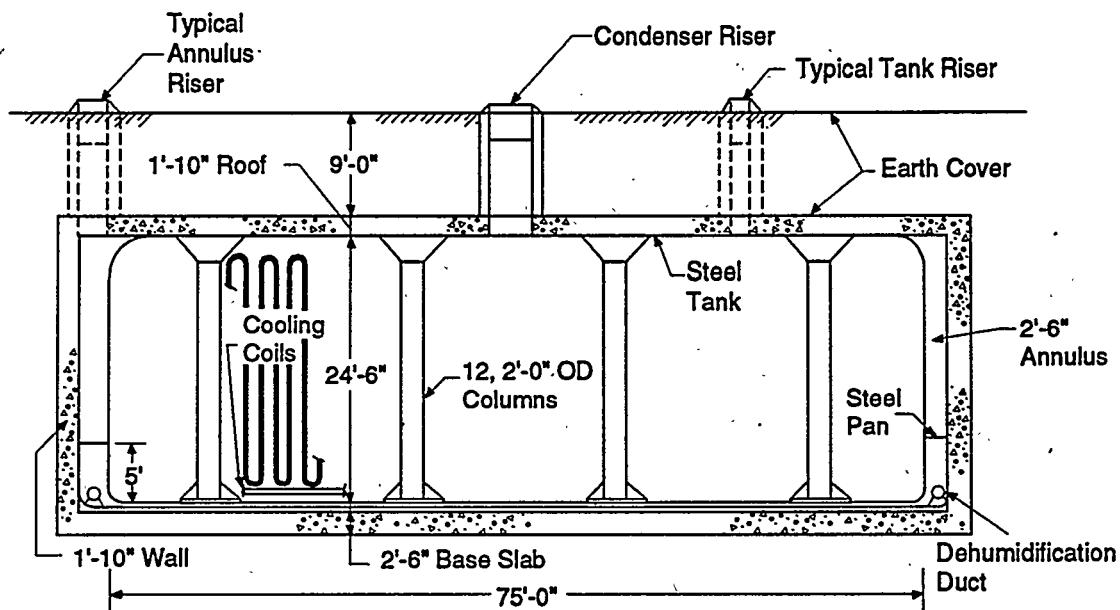
Figure 1. Cooled Waste Storage Tank, Type I (Original 750,000 Gallons).

The 12 original storage tanks constructed between 1951 and 1953 are designated Type I tanks. Tanks 1 through 8 are in F Area and Tanks 9 through 12 are in H Area. Each primary tank has a capacity of 750,000 gallons, is 75 feet in diameter and 24 1/2 feet high. Figure 1 shows the essential features of Type I tanks, including the primary tank, the secondary pan, and the concrete support structure.

A 9-foot layer of earth was placed over the tanks for radiation shielding. Cooling for each type I tank is provided by 36 parallel (water pipe) cooling coils.

A dehumidification duct in the annulus of each tank is routed from the tank top to the bottom of the annulus where it encircles the tank. The duct has distribution outlets and its cross-sectional area decreases as the distance from the air supply increases. Access to the tank interior is provided at eight locations, and to the annular space at four locations, through riser pipes. Each of the 12 riser pipes is capped at the top with a concrete plug. Each plug is provided with two 5-inch-diameter ports equipped with removable plugs. Some of these ports provide access for inspections.

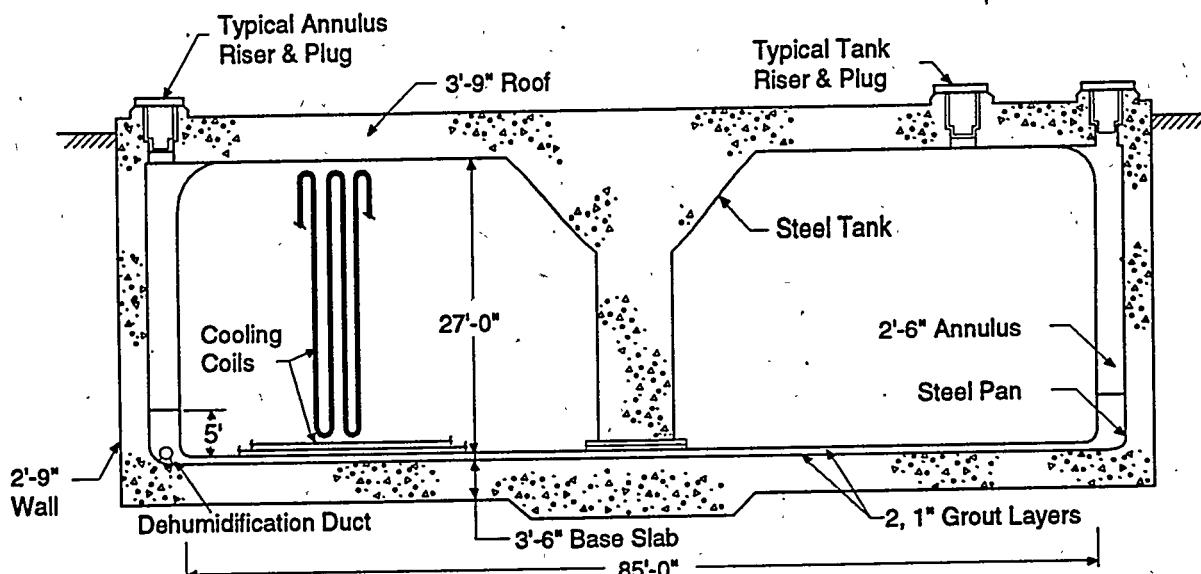
Figure 2. Cooled Waste Storage Tank, Type II (Original 1,030,000 Gallons).

Tanks 13 through 16, constructed in H Area in 1955 and 1956, are designated Type II tanks. Figure 2 is a cross section of this type. Each primary tank has a capacity of 1,030,000 gallons and is 85 feet in diameter and 27 feet high.

The primary tank is set on a 1-inch sand bed within a circular pan of 1/2-inch thick steel plate, 5 feet deep and 5 feet larger in diameter than the primary tank, thus forming an annular space 2 1/2 feet wide. The tank and pan assembly is surrounded by a cylindrical reinforced concrete enclosure with a 33-inch-thick wall and a flat concrete roof that is 45 inches thick. The tank and pan assembly and the surrounding wall are set on a foundation slab that is 42 inches thick. The roof is supported by both the wall and a central concrete column that fits within the inner cylinder of the vessel. The 45-inch-thick concrete roof provides radiation shielding; therefore, no earth overburden is required. Cooling for each Type II tank is provided by 44 parallel (water pipe) cooling coils. Access to the tank interior is provided at eight locations, and to the annular space at four locations, through riser pipes. Each of the 12 riser pipes is capped at the top with a concrete plug. Each plug is provided with two 5-inch-diameter ports equipped with removable plugs. The ports provide access for inspection. In addition to the four annulus risers, other access openings (10 to 14 additional openings per tank) have been drilled into the annulus of each of these tanks to permit inspection of seventy-three to ninety-six percent of the exterior walls of the primary vessels.

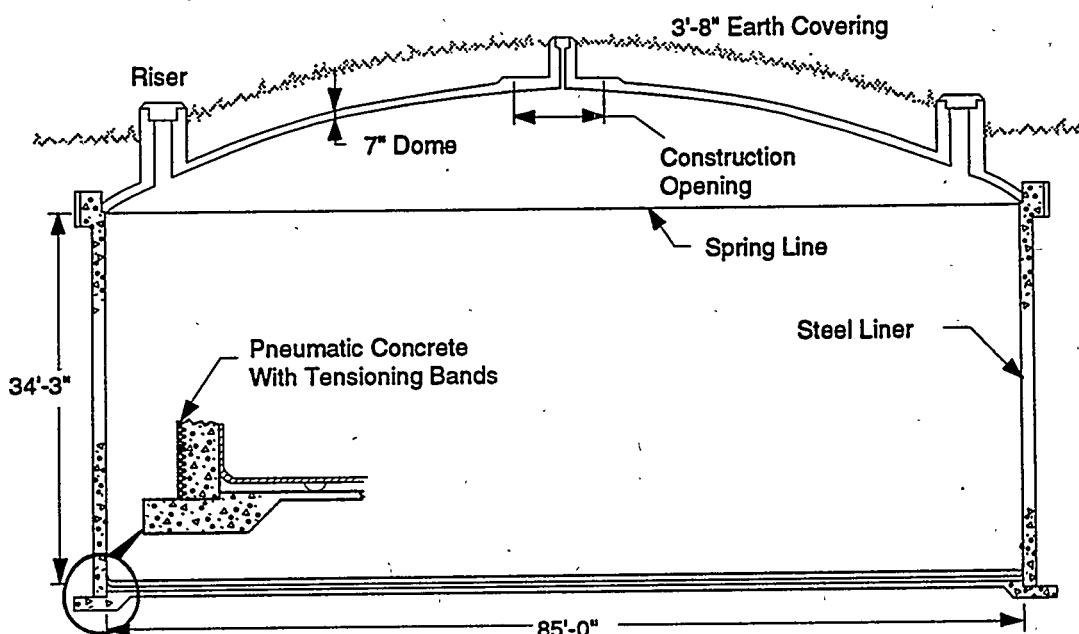
Figure 3. Uncooled Waste Storage Tank, Type IV (Prestressed Concrete Walls, 1,300,000 Gallons).

Tanks 17 through 24 are single-wall uncooled tanks. These tanks were designed for storage of waste that does not require auxiliary cooling. Tanks 17 through 20 were constructed in F Area in 1958 and Tanks 21 through 24 were constructed in H Area between 1959 and 1961. Each tank has a capacity of 1,300,000 gallons and is 85 feet in diameter and 34 feet high (Figure 3).

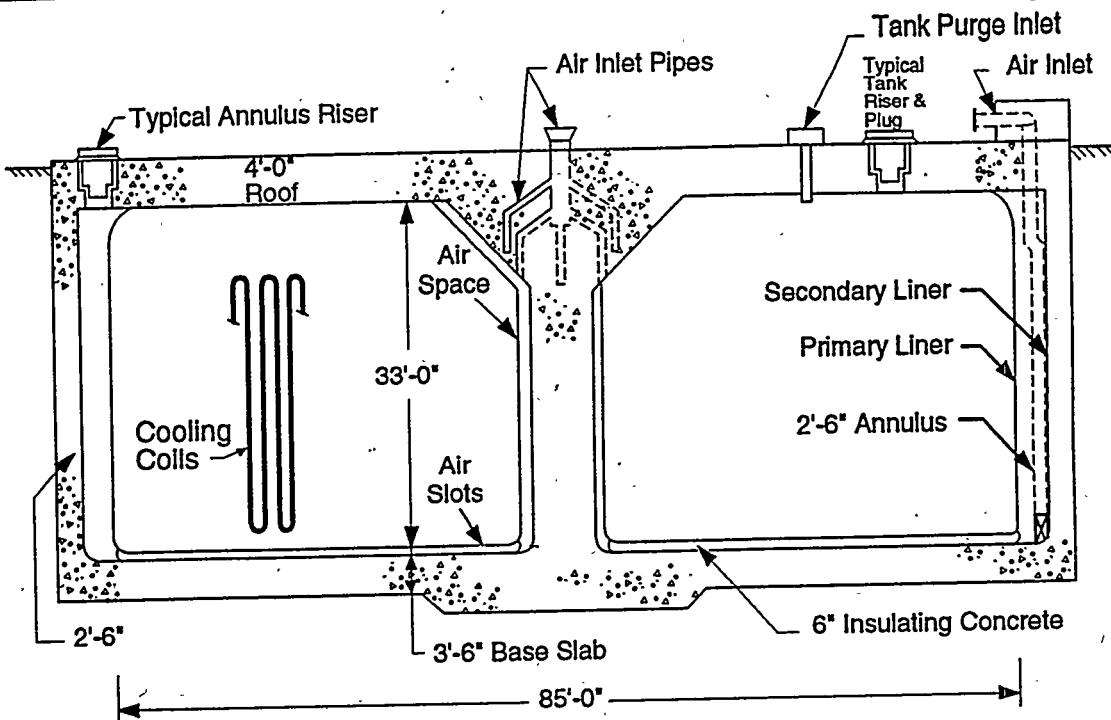
Figure 4. Cooled Waste Storage Tank, Type III (Stress Relieved Primary Liner, 1,300,000 Gallons).

The most recently constructed tanks are designated as Type III tanks (Figure 4). Twenty-seven tanks were built between 1967 and 1981. Tanks 25 through 28, 33 and 34, and 44 through 47 are located in F Area. Tanks 29 through 32, 35 through 43 and 48 through 51 are located in H Area.

heating each finished tank to relieve the stresses generated during fabrication. In addition, some stress patterns were avoided, or minimized, by mounting the roof supporting column on the foundation pad rather than on the bottom of the primary tank (as in Types I and II), and by providing an annular clearance around the roof supporting column. Each primary tank holds 1,300,000 gallons and is 85 feet in diameter and 33 feet high.

The primary tank is set on a 6-inch bed of insulating concrete within the secondary containment vessel. The concrete bed is grooved radially so that ventilating air can flow from the inner to the outer annulus. If any waste were to leak from the tank bottom or center annulus wall, liquid would move through the grooves, facilitating detection in the outer annulus.
