TIDD PFBC Demonstration Project

Topical Report

March 1994

By
Ohio Power Company
and
American Electric Power Service Corporation
Columbus, Ohio

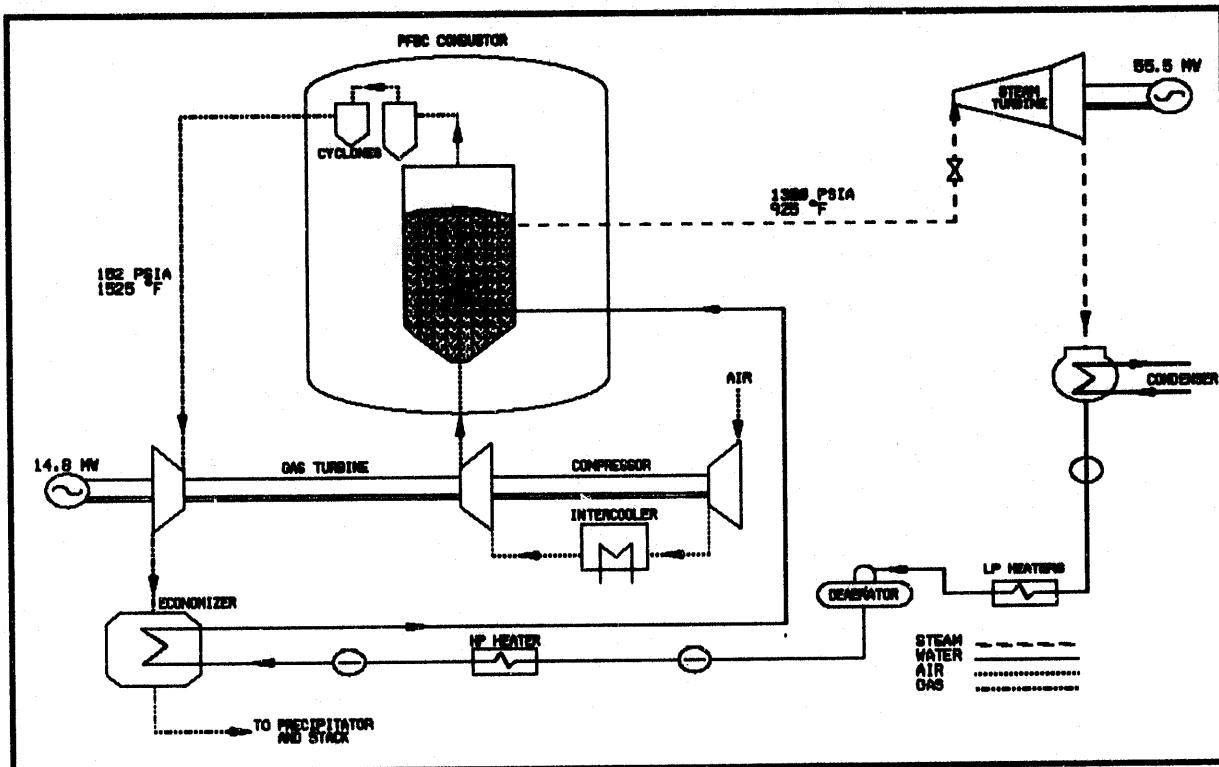
FIGURE 1
TIDD CYCLE SCHEMATIC

The Tidd Plant is a combined cycle pressurized fluidized bed combustion system with a topping air cycle and a bottoming steam cycle (Figure 1). When operated in combined cycle mode, the pressurized fluidized bed combustor provides steam to power a steam turbine cycle, and pressurized gas to power a gas turbine. The gas turbine is coupled to a generator and a compressor that supplies combustion air to the process.

The PFBC boiler contains the fluidized bed where combustion occurs. The primary and secondary cyclone ash separators are located in the

gas exit path, and remove particulate from the gas before it enters the gas turbine. The ash reinjection tanks store ash removed from the bed until it is needed to raise the bed level when increasing load.

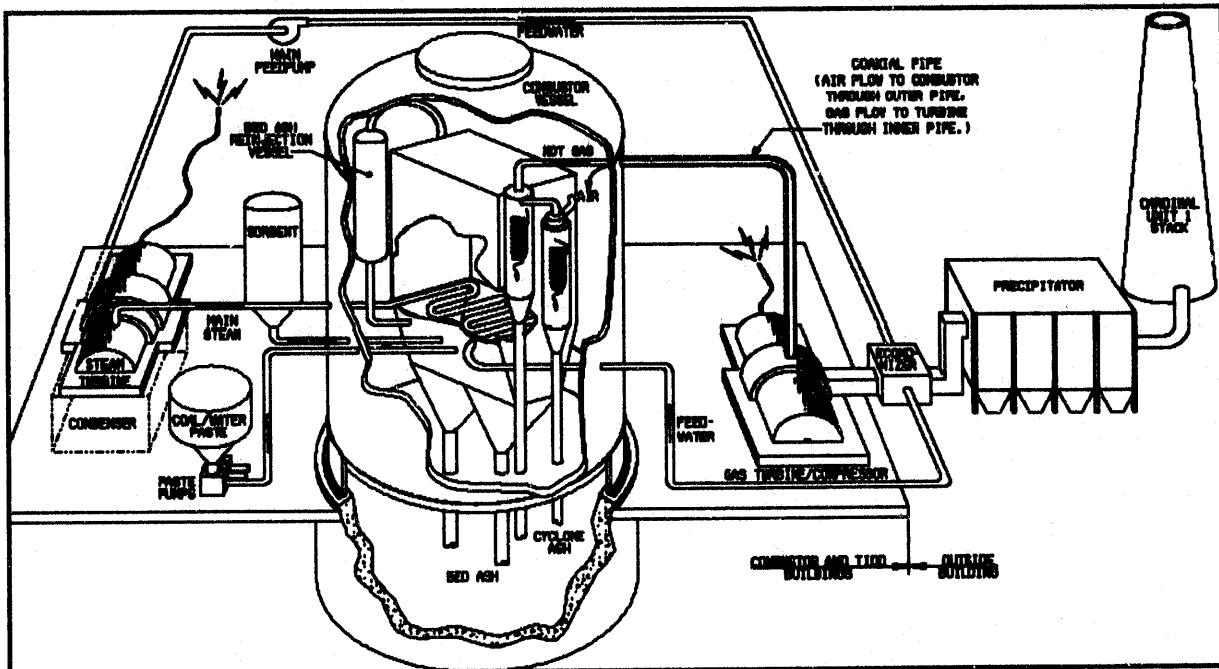
FIGURE 2
TIDD PFBC ISLAND

The boiler is contained in a pressure vessel along with the cyclone ash separators, the bed ash reinjection vessels, cyclone ash coolers, and gas collection pipes (Figure 2). This design reduces the differential pressure across the boiler membrane walls and permits recovery of heat losses by combustion air.

At full load, the evaporator tubes, along with most of the primary and secondary superheater tubes, are located in the bed. Depending on the bed level, fewer of these tubes are immersed in the bed. By raising and lowering the bed level, heat transfer to the boiler tube bank can be controlled and load can be varied. The bed level is

adjusted by transferring bed material between the bed and the reinjection vessels. Fuel feed must be adjusted to maintain bed temperature at varying bed heights. The fuel consists of crushed coal mixed with water to form a paste, which is injected into the boiler by six hydraulically operated piston pumps.

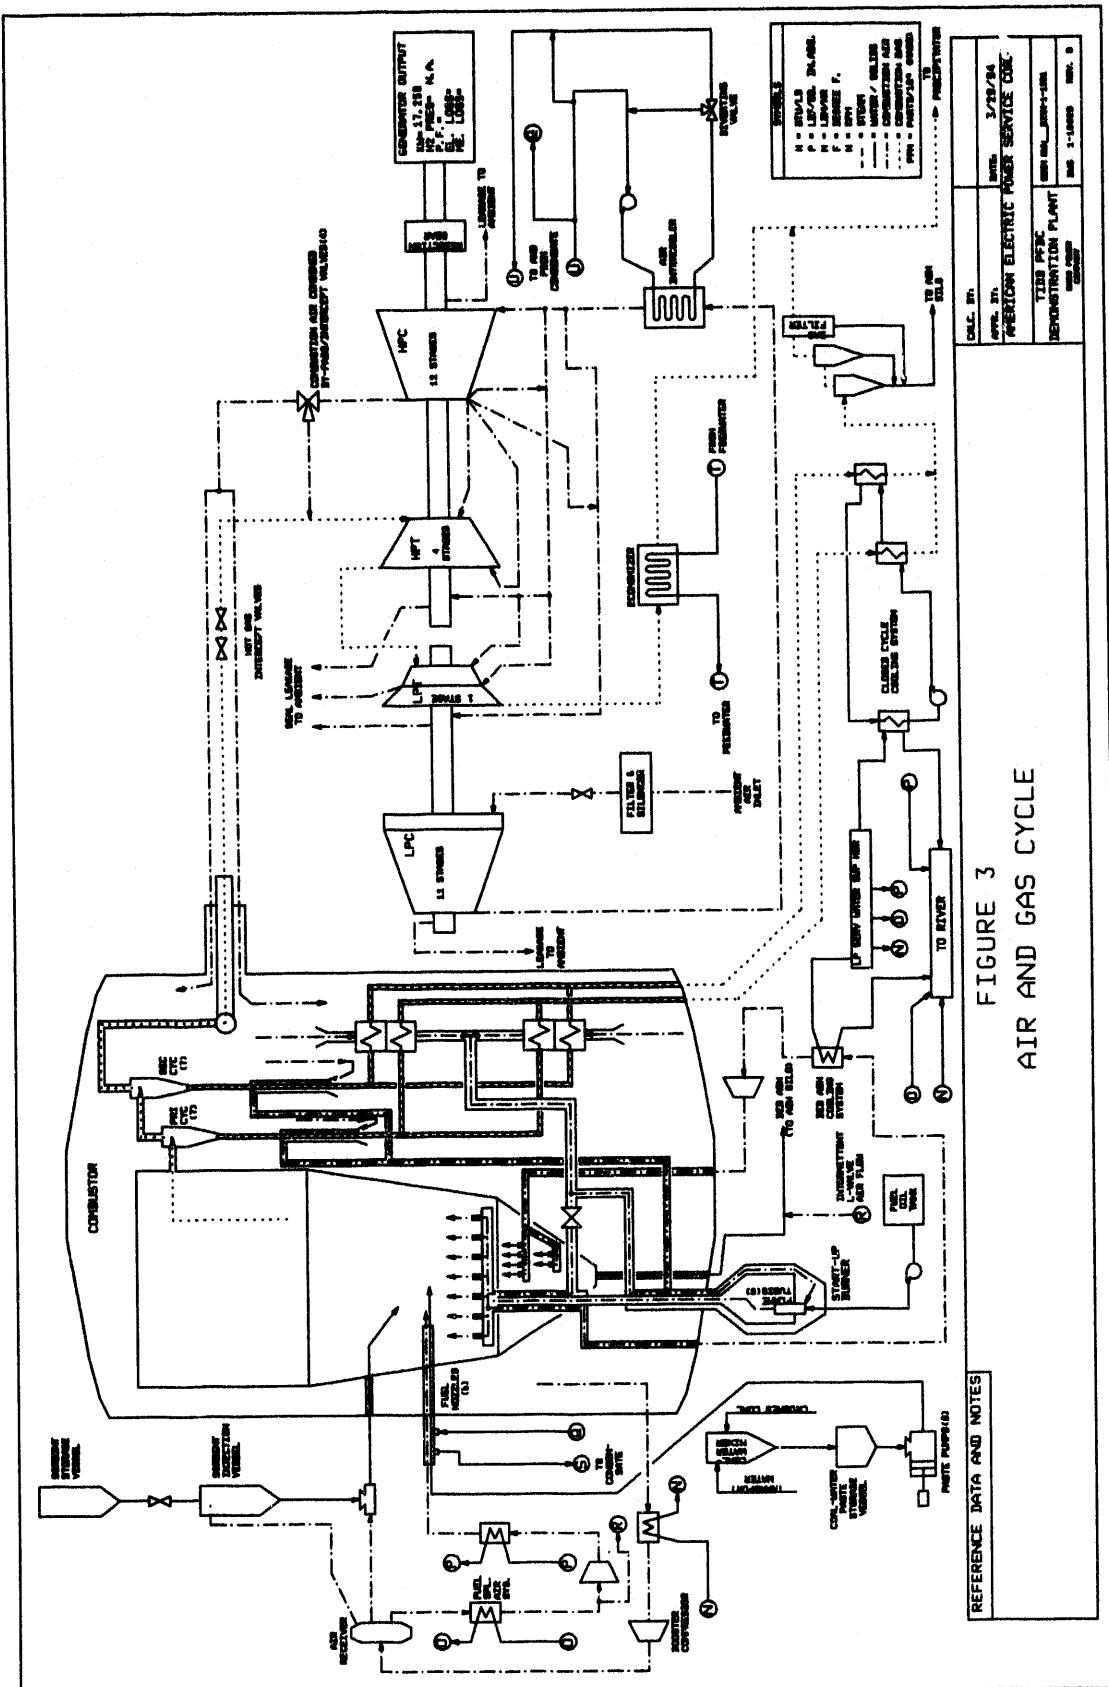
FIGURE 3
AIR AND GAS CYCLE

The design full load heat balances for the gas side and the steam side of the combined cycle are shown in Figures 3 and 4, respectively. The figures show the expected performance of the unit at 100% load, 59 F ambient air temperature, and 60% ambient relative humidity.

Ambient air enters the low pressure compressor section of the gas turbine and is compressed to 59 psia. The compressed air is cooled by condensate in the gas turbine intercooler. The air then enters the high pressure compressor, where it is further compressed to 174 psia and 572 F (Figure 3).
