DOE/PC/91309-T12

HIGH TEMPERATURE ALKALI CORROSION OF CERAMICS
IN COAL GAS

Quarterly Progress Report #11
for the Period
March 1, 1994 - June 1, 1994

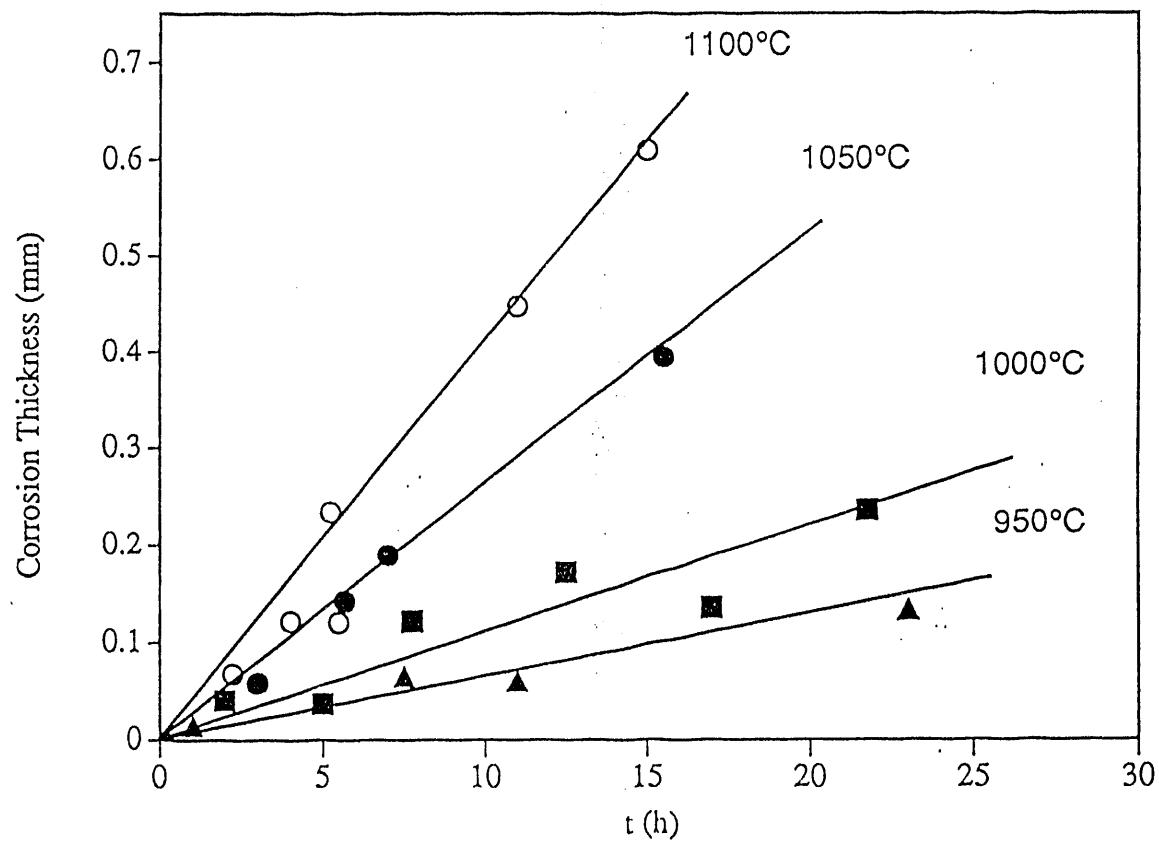
Figure 1. Mullite reaction layer thickness versus time

The reaction thickness of the mullite in the alkali-containing atmosphere versus reaction time is shown in Figure 1. The reaction layer thickness appears to be linearly related to the reaction time. The linear reaction rate constants are 6, 10, 25 and 39 $\mu\text{m}/\text{h}$ at 950°C, 1000°C, 1050°C and 1100°C respectively. X-ray diffraction analysis of the as-received material showed only mullite and a trace of corundum were present. No cristobalite was detected. Density measurements (using archimedes method) gave a true density of 3.004 and a bulk density of 2.998 g/cc for the as-received material. Elemental analysis using EDAX (energy dispersive analysis of x-rays) measurements of the samples (which were cut on a diamond saw) before corrosion show only aluminum and silicon as the major constituents with trace iron, copper and potassium.

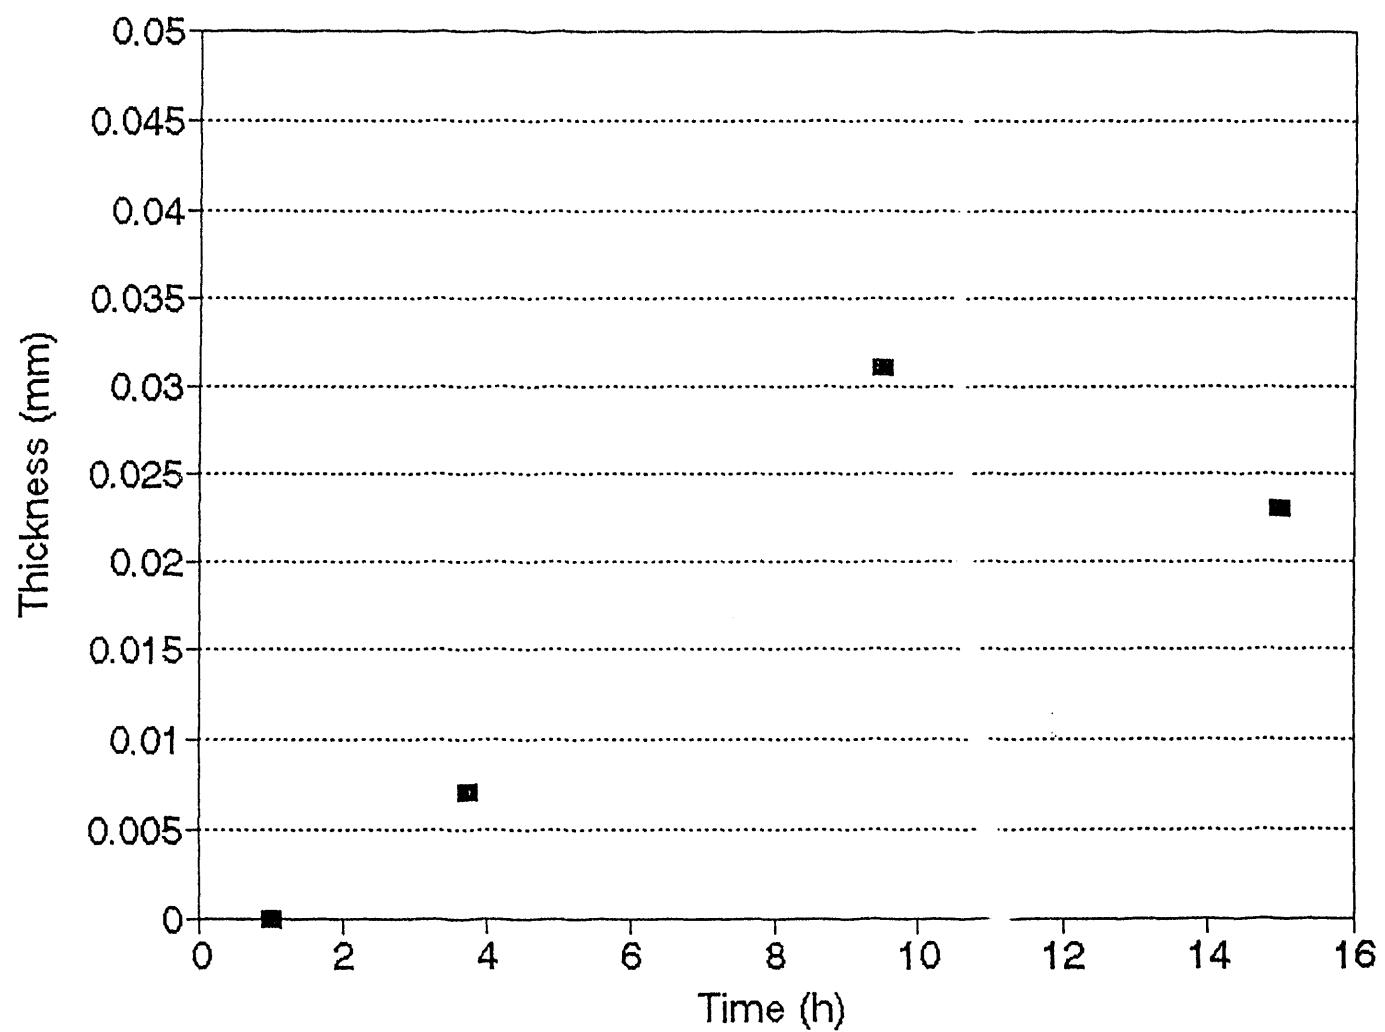
Figure 3. Zirconia reaction layer thickness versus time

The alkali corrosion kinetics of zirconia (TTZ, Coors) at 950°C is shown in Figure 3. The SEM micrographs of the as-received zirconia fracture surface and after reaction at 950°C is shown in Figure 4. As seen in this figure, the transformation toughened zirconia is very dense with only a few isolated pores occurring within the grains. The alkali reaction product after a 950°C for 15 h exposure, however, is very porous in comparison to the as-received material.
