Annual Radioactive Waste Tank Inspection Program - 1992^(U)

Westinghouse Savannah River Company
Savannah River Site
Aiken, SC 19808

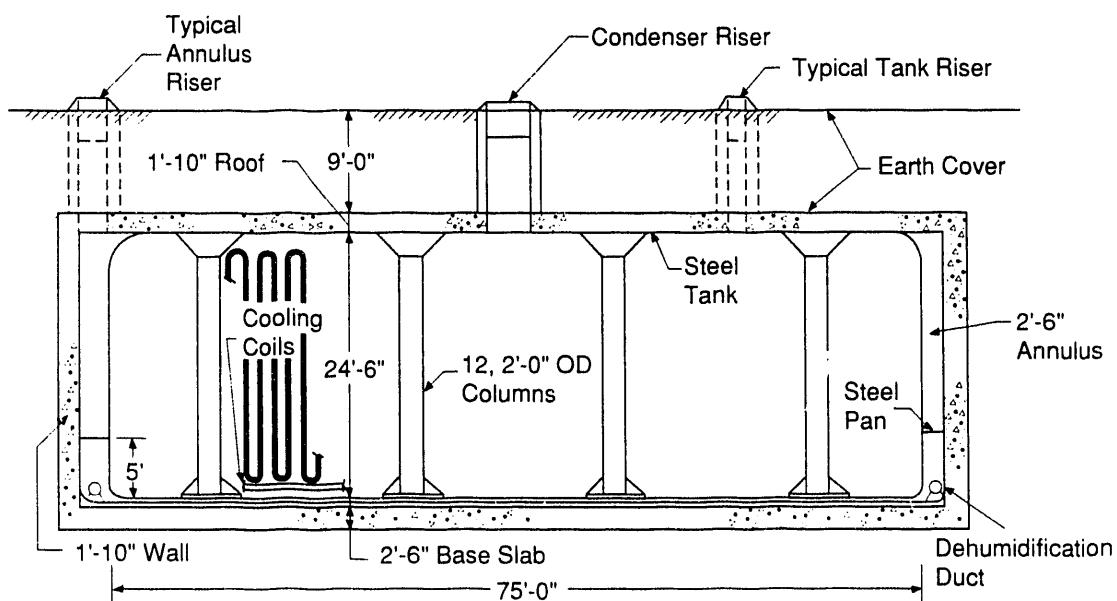
Figure 1. Cooled Waste Storage Tank, Type I (Original 750,000 Gallons).

The 12 original storage tanks constructed between 1951 and 1953 are designated type I tanks. Tanks 1 through 8 are in F Area and Tanks 9 through 12 are in H Area. Each primary tank has a capacity of 750,000 gallons, is 75 feet in diameter and 24 1/2 feet high. Figure 1 shows the essential features of type I tanks, including the primary tank, the secondary pan, and the concrete support structure.

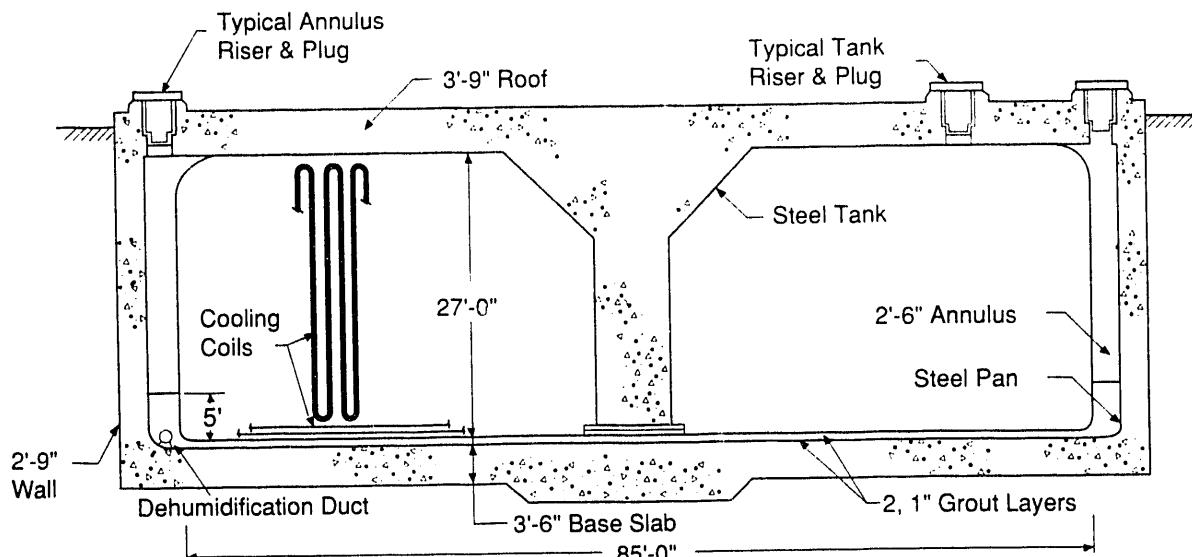
Figure 2. Cooled Waste Storage Tank, Type II (Original 1,030,000 Gallons).

Tanks 13 through 16, constructed in H Area in 1955 and 1956, are designated type II tanks. Figure 2 is a cross section of this type. Each primary tank has a capacity of 1,030,000 gallons and is 85 feet in diameter and 27 feet high.

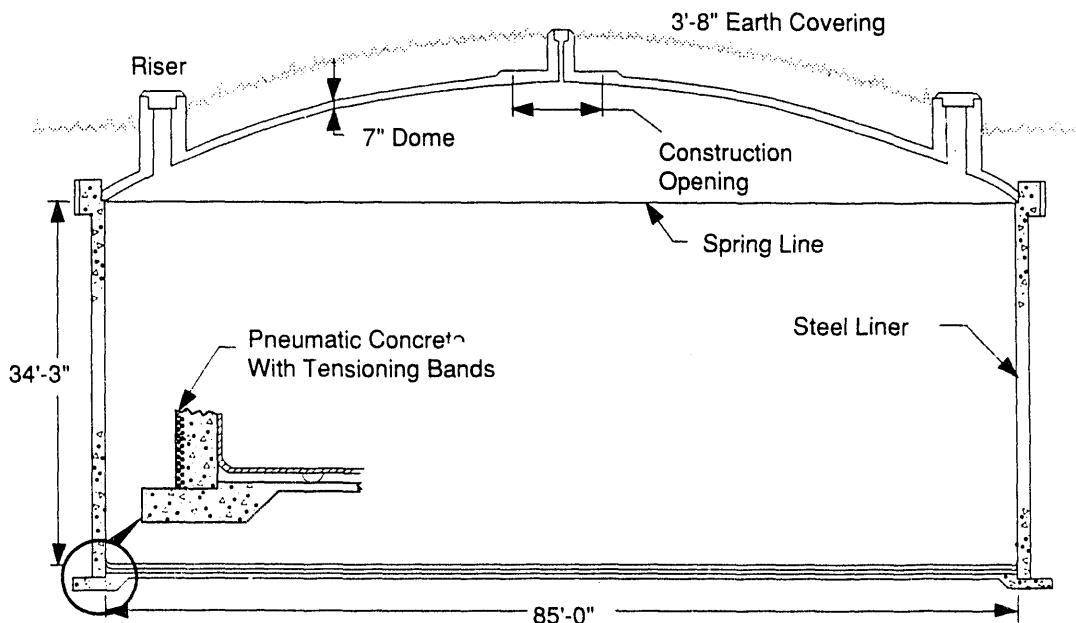
Figure 3. Uncooled Waste Storage Tank, Type IV (Prestressed Concrete Walls, 1,300,000 Gallons).

Tanks 17 through 24 are single-wall uncooled tanks. These tanks were designed for storage of waste that does not require auxiliary cooling. Tanks 17 through 20 were constructed in F Area in 1958 and tanks 21 through 24 were constructed in H Area between 1959 and 1961. Each tank has a capacity of 1,300,000 gallons and is 85 feet in diameter and 34 feet high (Figure 3).

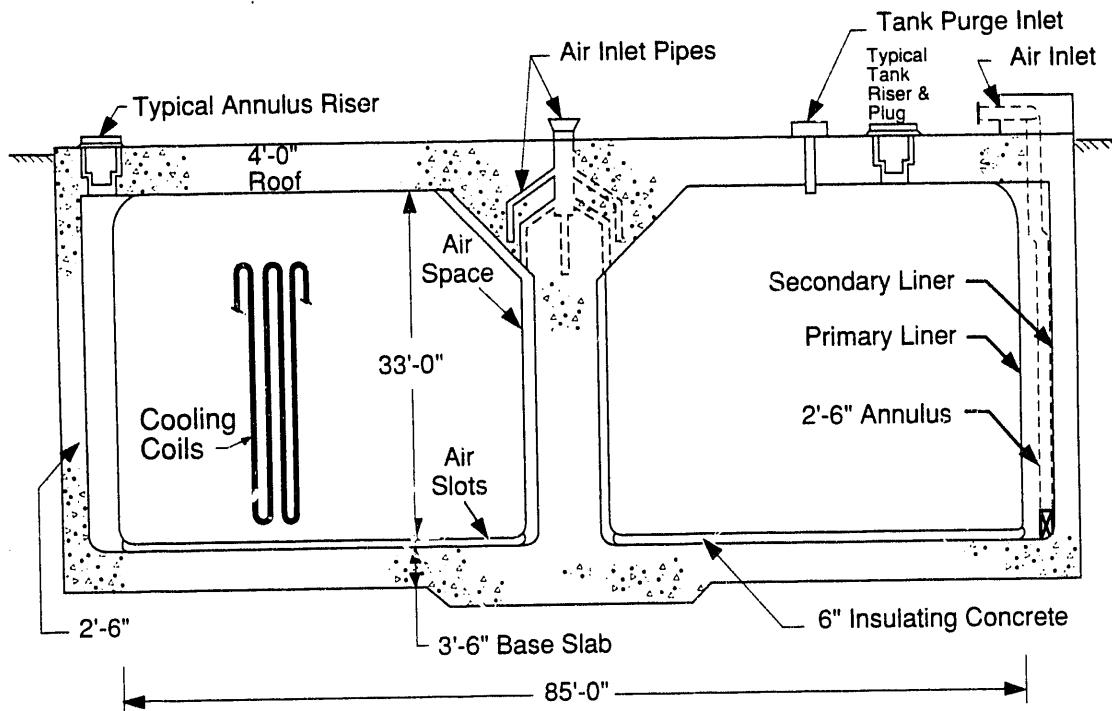
Figure 4. Cooled Waste Storage Tank, Type III (Stress Relieved Primary Liner, 1,300,000 Gallons).

The most recently constructed tanks are designated as type III tanks (Figure 4). Twenty-seven tanks were built between 1967 and 1981. Tanks 25 through 28, 33 and 34, and 44 through 47 are located in F Area. Tanks 29 through 32, 35 through 43 and 48 through 51 are located in H Area.
