**AGING MANAGEMENT GUIDELINE  
FOR  
COMMERCIAL NUCLEAR POWER PLANTS-  
ELECTRICAL SWITCHGEAR**

**FINAL REPORT**

Ogden Environmental and Energy Services Co., Inc.  
1777 Sentry Parkway West  
Abington Hall, Suite 300  
Blue Bell, PA 19422

Sandia National Laboratories  
Albuquerque, NM 87185  
for the  
U.S. Department of Energy

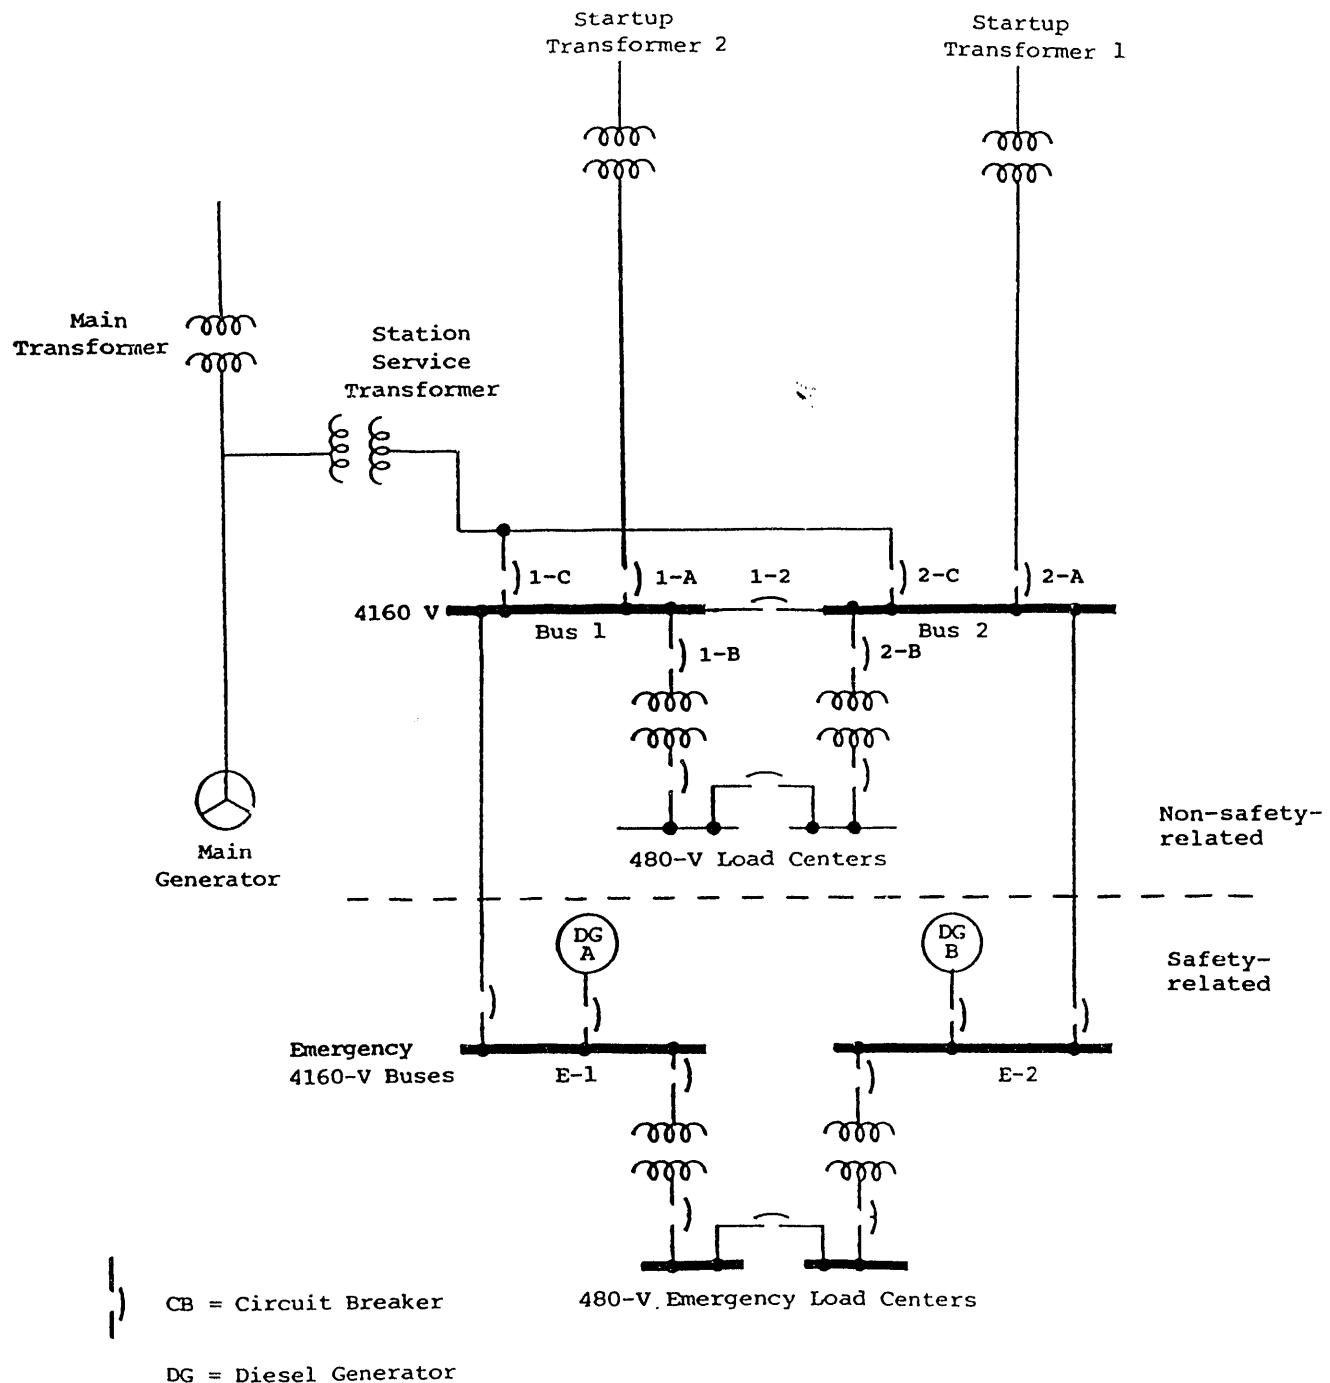
Figure 3-1. Simplified Nuclear Power Plant Electrical System.

For each plant entering license renewal, an assessment must be performed to identify switchgear that is important to license renewal. Figure 3-1 shows a simplified nuclear power plant electrical system. Per paragraph 1 of the definition of systems and components important to license renewal provided in the introduction (Section 2.5), all switchgear deemed safety-related is important to license renewal. This grouping would typically include safety-related 4-kVac,\* 480-Vac,\*\* and 125-Vdc\*\*\* switchgear. Paragraphs 2 and 3 of the definition of systems and components important to license renewal generally would not bring additional switchgear into the scope of important to license renewal.

This LCO causes the electrical distribution equipment between the offsite transmission network and the onsite Class 1E (safety-related) distribution to be included within the scope of SSCs important to license renewal. Figure 3-1 shows a simplified arrangement of a plant electrical system with the traditional safety-related equipment grouping indicated. Figure 3-2 indicates the scope of electrical equipment important to license renewal, with the start-up transformers and the switchgear between the start-up transformers and the safety-related emergency switchgear included in the scope.

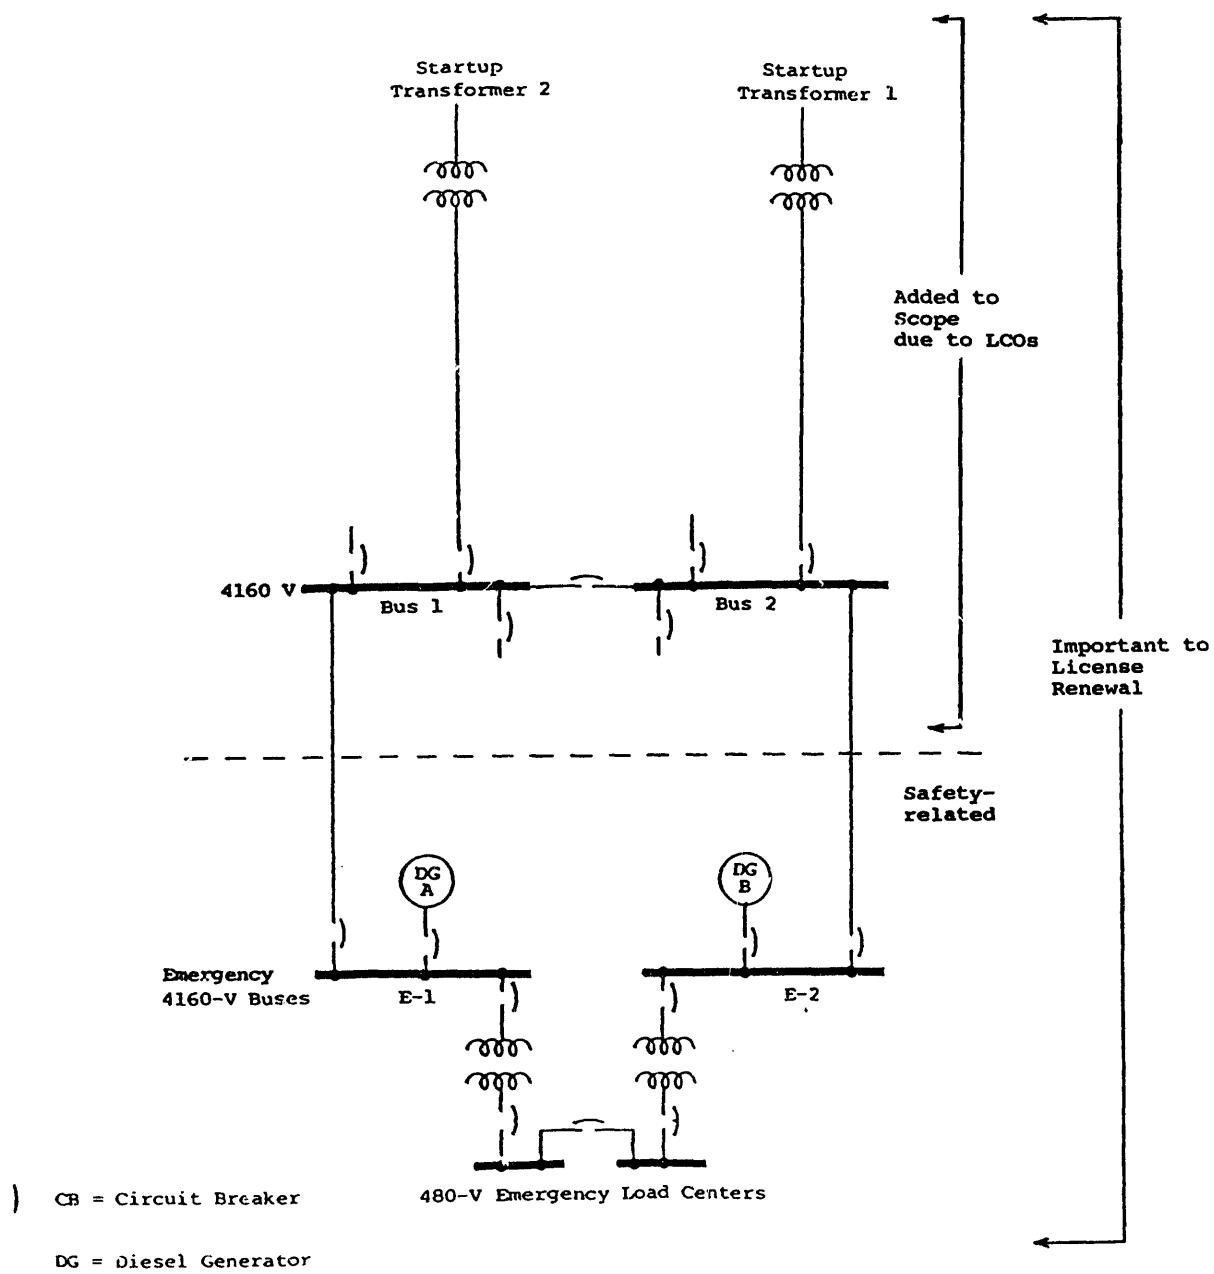
Figure 3-2. Scope of Electrical Equipment Important to License Renewal.

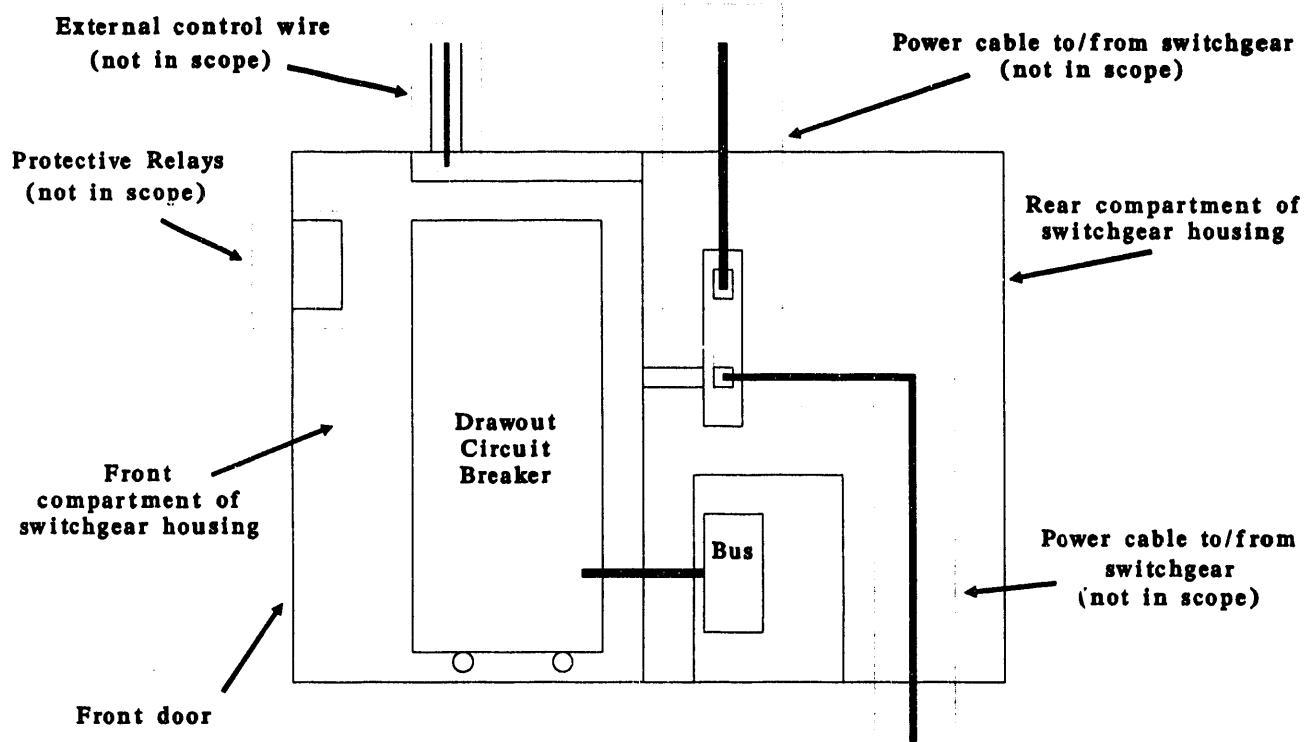
All components within the switchgear housing are within the scope of this document except as noted above.

Figure 3-3. Definition of Component Boundaries.

Figure 3-3 provides a pictorial description of the boundaries of components within the scope of this document.

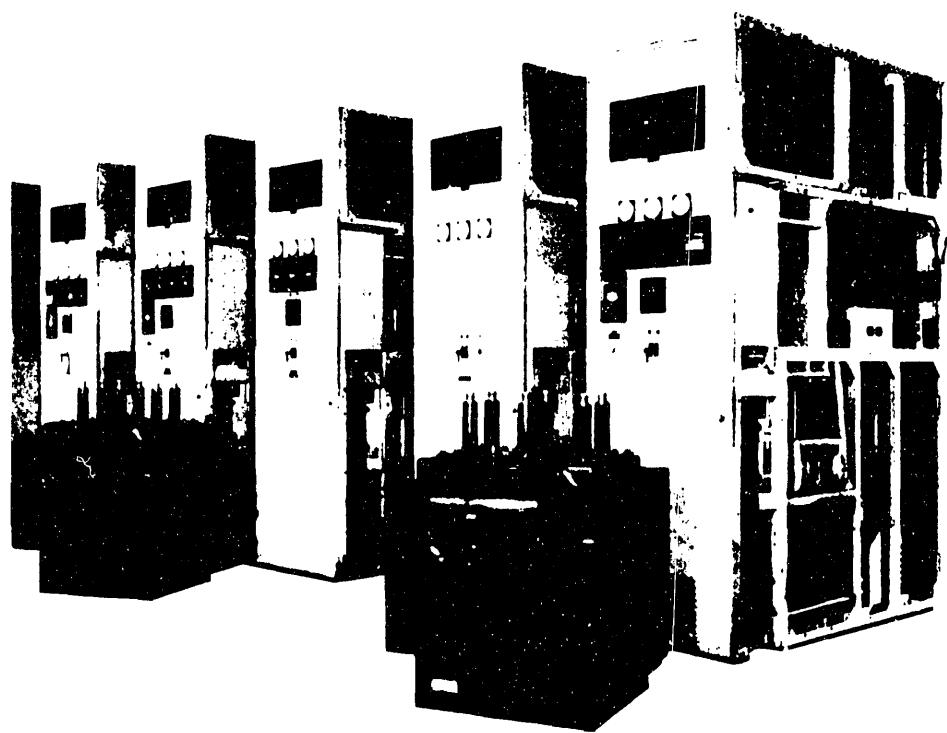
Figure 3-4. Medium-Voltage Switchgear Housing Units, General Electric 15-kV Switchgear [3.4] with Circuit Breakers in Front.

The stationary switchgear structure is an assembly of steel housing units. The housing units are mounted side by side and connected mechanically and electrically to form a metal-clad switchgear structure. See Figures 3-4 and 3-5. Each unit consists of a formed and welded front enclosure and a rear enclosure having a bolted rear cover. Each enclosure is further subdivided into compartments as described below.[3.2]

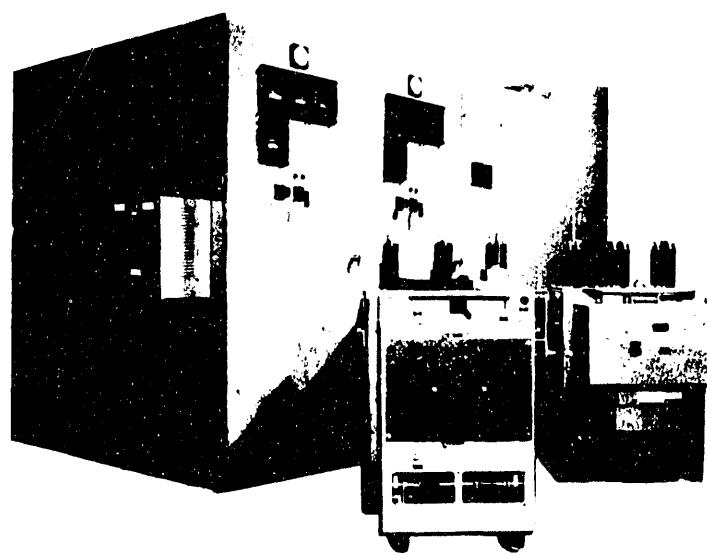
Figure 3-5. Medium-Voltage Switchgear Structure: An Assembly of Housing Units, General Electric 15-kV Switchgear [3.4] with Circuit Breakers in Front.

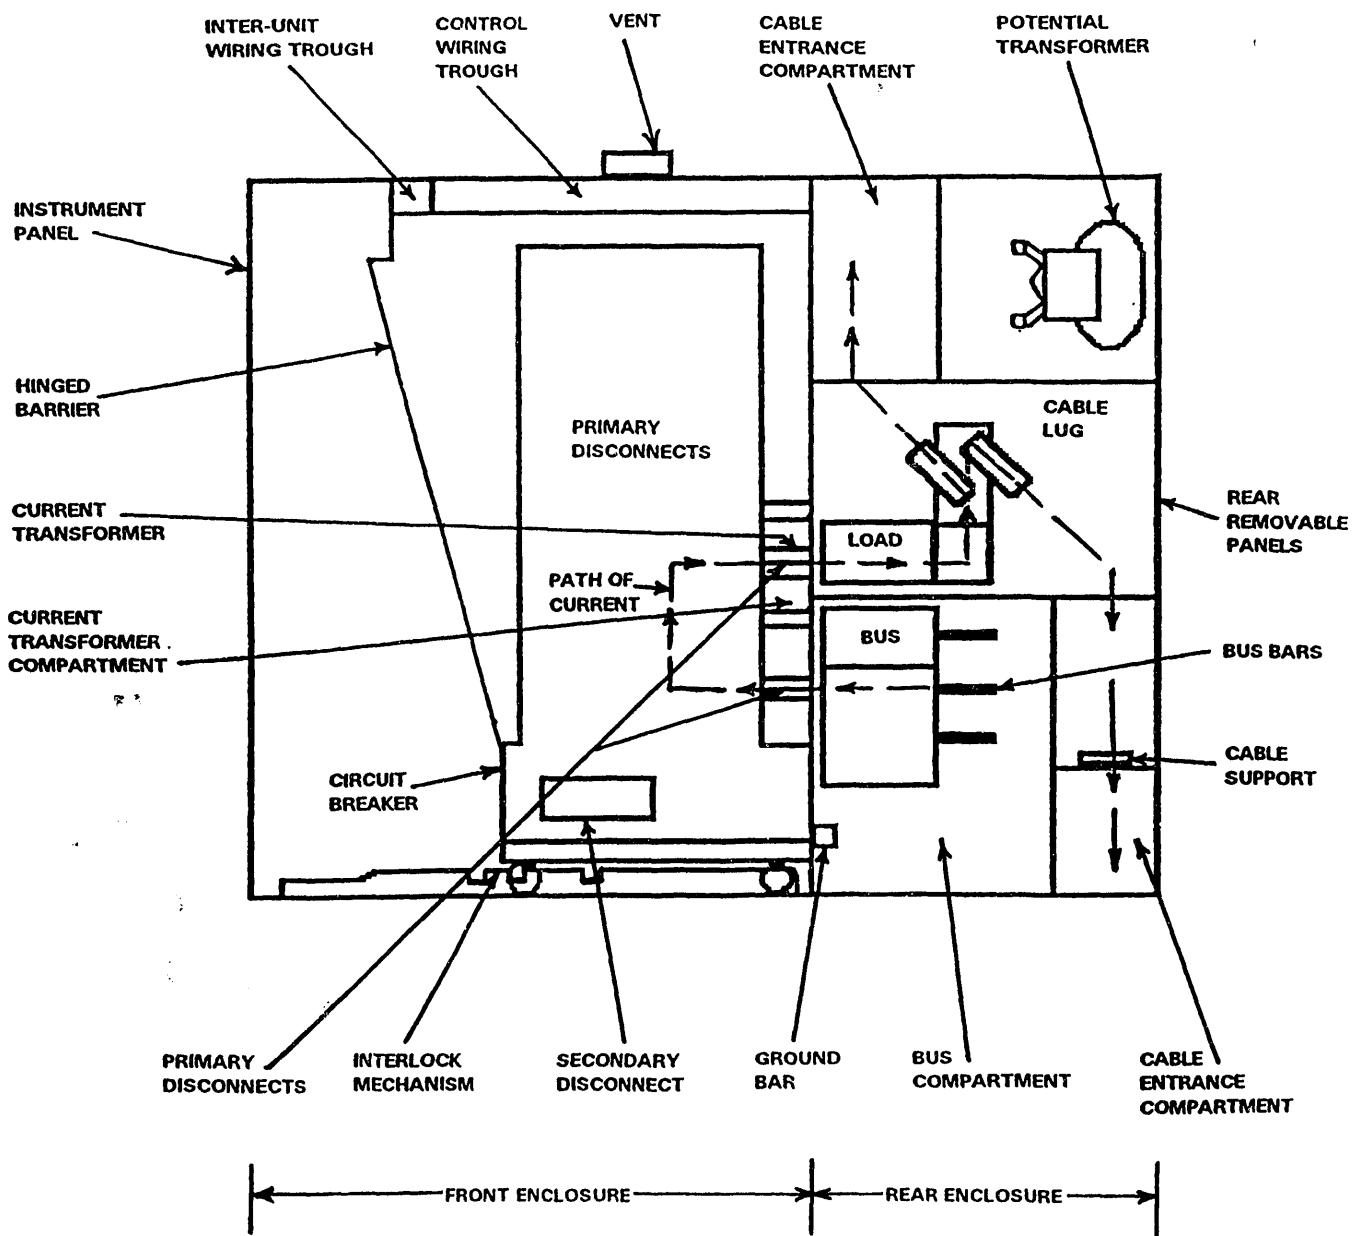
Figure 3-6. Front and Rear Enclosure (Side View) of Medium-Voltage Switchgear Housing Unit, Siemens-Allis Medium-Voltage Switchgear Housing Unit.[3.5]

The front enclosure contains the circuit breaker compartment. The rear enclosure contains the bus, cable, and transformer compartments. See Figure 3-6. The housing structure may contain space heaters. These heaters are used to keep moisture from condensing on the switchgear components if the unit is located in a potentially moist environment. In all switchgear, the protective and auxiliary relays are located in the front enclosure above the circuit breaker. In some switchgear, these relays are mounted on stationary panels at the top of the cubicle, whereas in others, the relays are mounted on the doors (note: consideration of these protective relays is outside of the scope of this document). Each compartment is separated by grounded metal barriers to isolate the low-voltage components, such as the protective relays, from the primary circuit elements.[3.3]

The circuit breaker compartment contains a mechanical interlock, primary and secondary disconnects, a control wiring trough, a vent, and an instrument panel on the front of the hinged door. See Figures 3-6 and 3-7. The circuit breaker compartment may also contain automatic, grounded, metal shutters that cover the primary disconnects at the back or top of the circuit breaker compartment when the circuit breaker is removed. Medium-voltage circuit breakers roll into the compartment on wheels. See Figure 3-8. The circuit breaker is placed in the connected position using a racking mechanism (see Section 3.4.1.3).

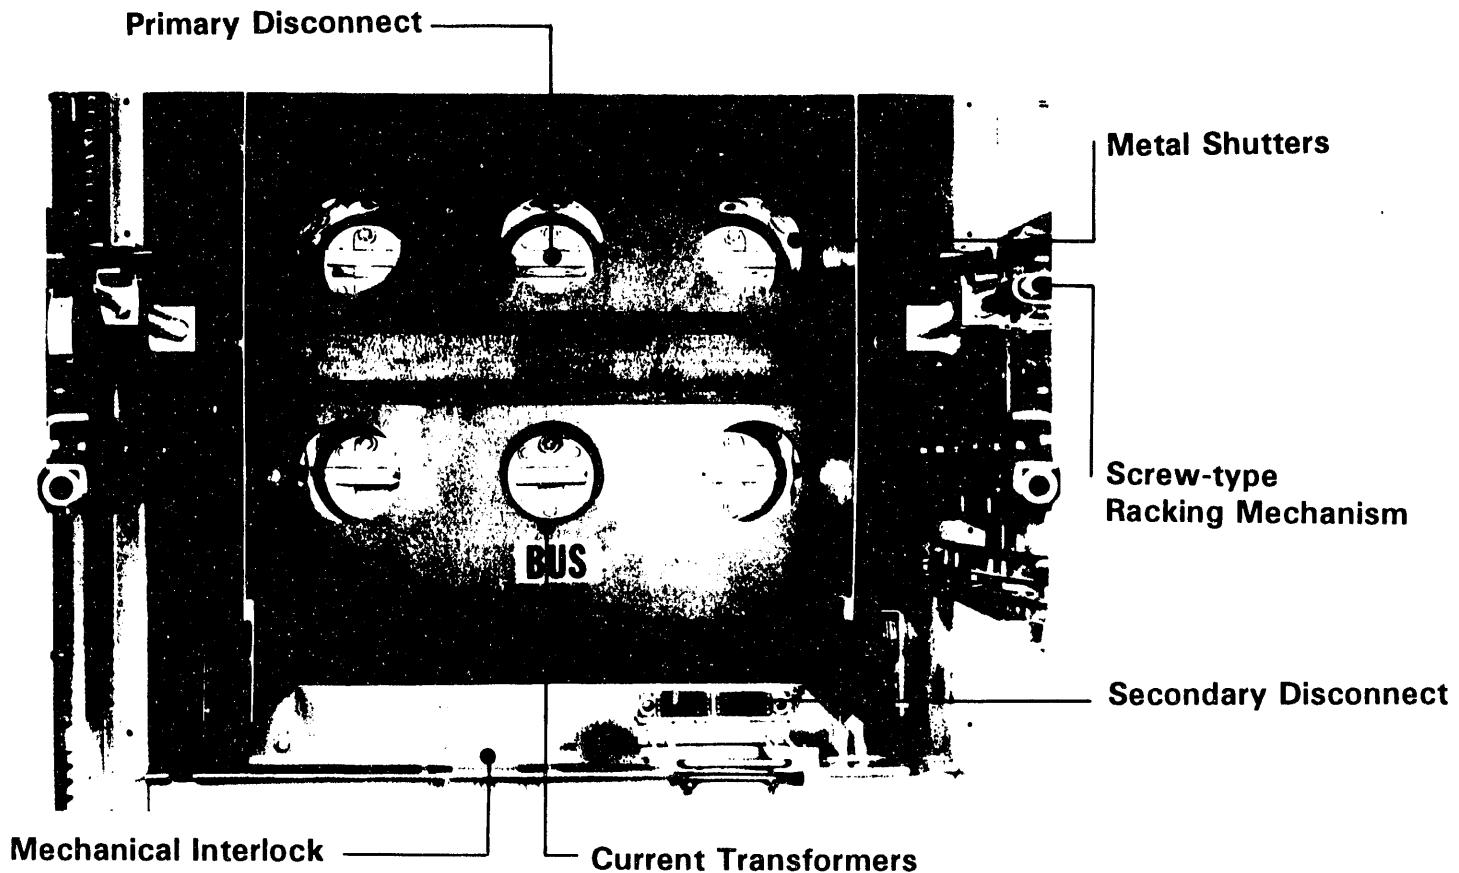
Figure 3-7. Siemens-Allis Medium-Voltage Vacuum Type Circuit Breaker Compartment.[3.6]

(Note: The metal shutters are open and therefore not visible.)

the switchgear compartment. The levering device may consist of a metal lever that is inserted into the compartment to move the breaker into position (see Figure 3-15) or it may consist of a mechanical gear assembly that will move the breaker in and out of the cubicle when manually driven by a crank or electrically driven by a drive motor (see Figures 3-16 and 3-7). The type of racking mechanism used varies with switchgear manufacturer. [3.2, 3.8]

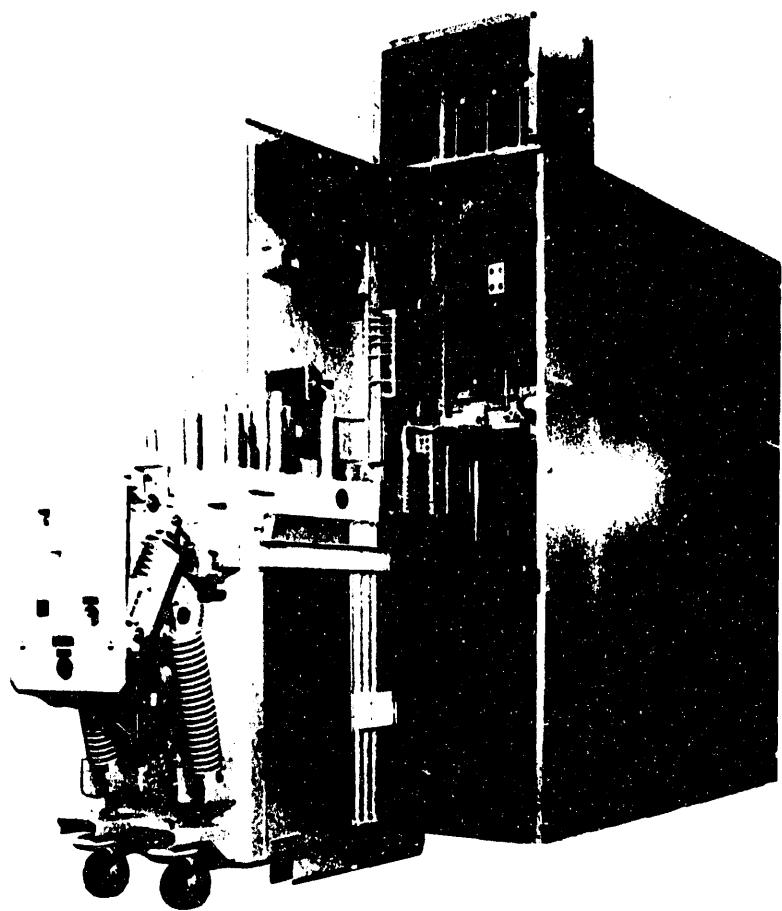
Figure 3-8. General Electric Medium-Voltage Magne-Blast Circuit Breaker and Housing Unit.[3.4]

A drawout circuit breaker is the removable and interchangeable switching and fault interrupting device used to provide control and protection of electrical apparatus and power systems. Such circuit breakers are contained in individual grounded metal compartments and are controlled either remotely or from the switchgear panel. See Figures 3-8 and 3-12.

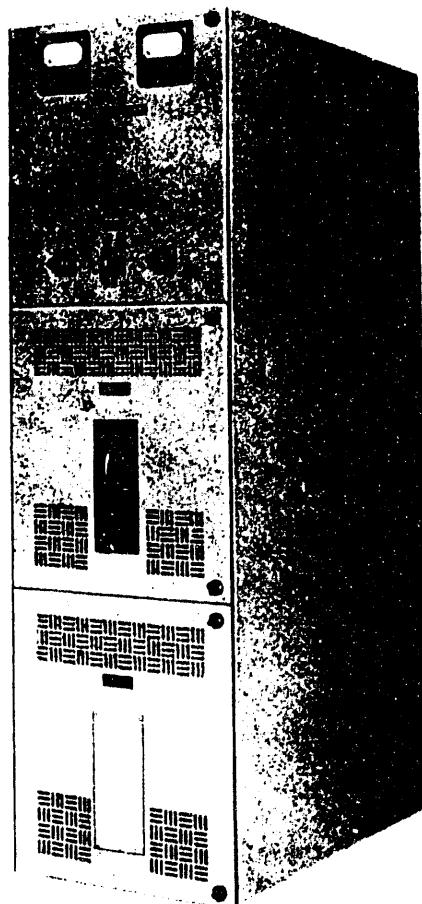
Figure 3-9. Front Enclosure of Low-Voltage Switchgear Housing Unit,  
Westinghouse Metal-Enclosed Switchgear Housing Unit  
Containing Type DB-50 Circuit Breaker.[3.7]

The housings of low-voltage stationary switchgear are very similar to those of medium-voltage switchgear. Low-voltage housings differ from medium-voltage housings in that they contain only two compartments within the housing: a circuit breaker compartment and a bus/cable compartment. The circuit breaker compartment and instrument and control devices are located in the front of the housing. See Figures 3-9 and 3-10. The bus and cable compartment is located at the rear of the housing. See Figure 3-11. In this configuration, there are no additional segregated compartments within the housing. Rather, the equipment in each compartment is separated by appropriate distances. Low-voltage circuit breakers are smaller than medium-voltage breakers and are usually lifted for insertion into the circuit breaker compartment. See Figure 3-12. Their small size also permits the use of several breakers, stacked vertically, in the switchgear housing unit. See Figure 3-13. In addition, primary disconnect shutters are optional in low-voltage switchgear circuit breaker compartments. [3.3, 3.7]

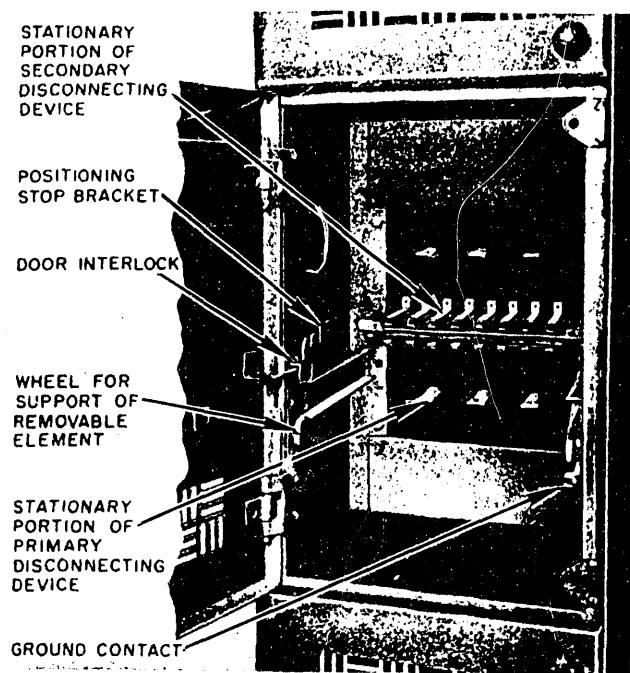
Figure 3-10. Westinghouse Type DB-15 Low-Voltage Circuit Breaker Compartment.[3.7]

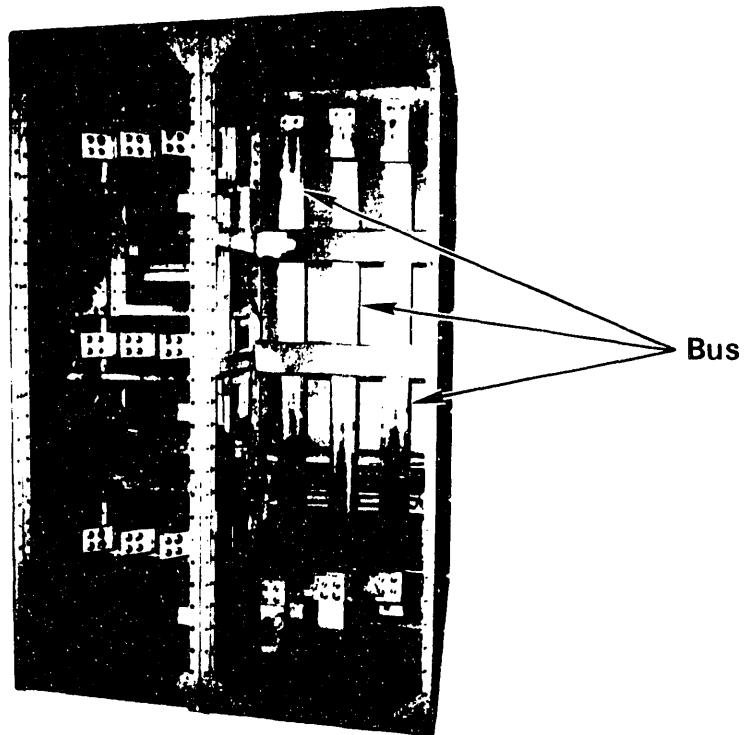
Figure 3-11. Rear Enclosure of Low-Voltage Switchgear Housing Unit, Westinghouse Metal-Enclosed Switchgear Housing Unit.[3.4]

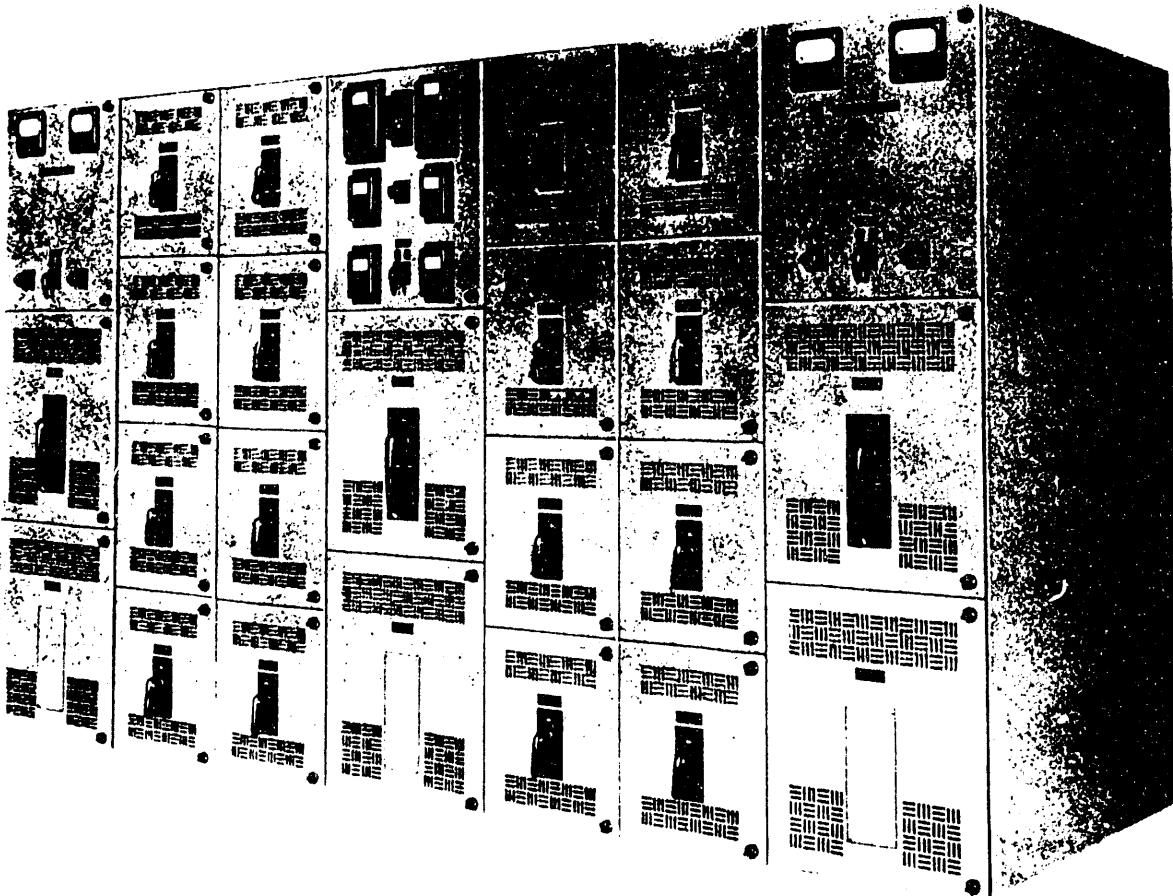
Figure 3-13. Low-Voltage Switchgear Structure: An Assembly of Housing Units, Westinghouse Low-Voltage Switchgear Containing Types DB-25 and DB-50 Circuit Breakers.[3.7]

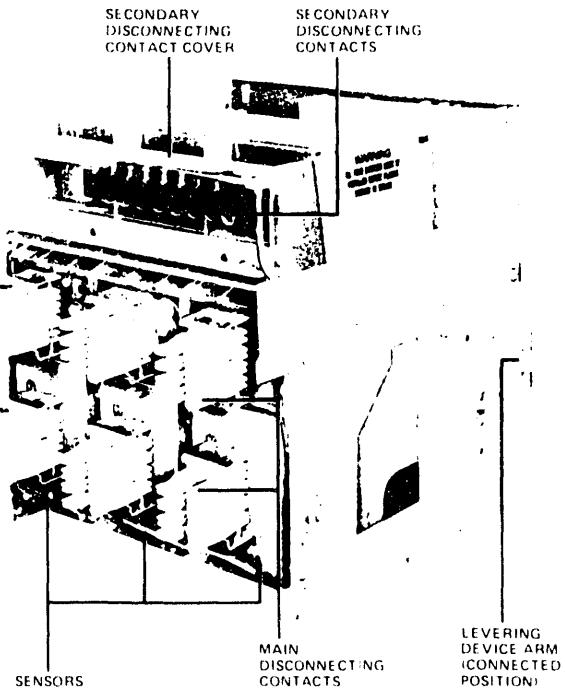
Figure 3-14. Primary and Secondary Disconnects (Finger/Stab Design with Fingers on the Circuit Breaker), Westinghouse Low-Voltage Type DS and DSL Circuit Breakers.[3.8]

The primary disconnect is a plug-in connector that, when in the fully engaged position, connects the main power circuit of the circuit breaker with the bus and load of the metal-clad switchgear. See Figure 3-14. The primary disconnect is required to carry normal load current continuously and abnormal or short-circuit currents for short intervals; however, it is a no-load disconnect and cannot make or break normal or abnormal loads (that is, the main contacts of the circuit breaker must be open when the disconnect is opened or closed).[3.9]

The secondary disconnecting device used on most circuit breakers consists of floating or sliding fingers mounted on the circuit breaker which engage with flat contact segments mounted in the circuit breaker compartment. See Figure 3-14. These disconnects connect the circuit breaker control and position-indicating circuits to the control network of the metal-clad switchgear.[3.7]

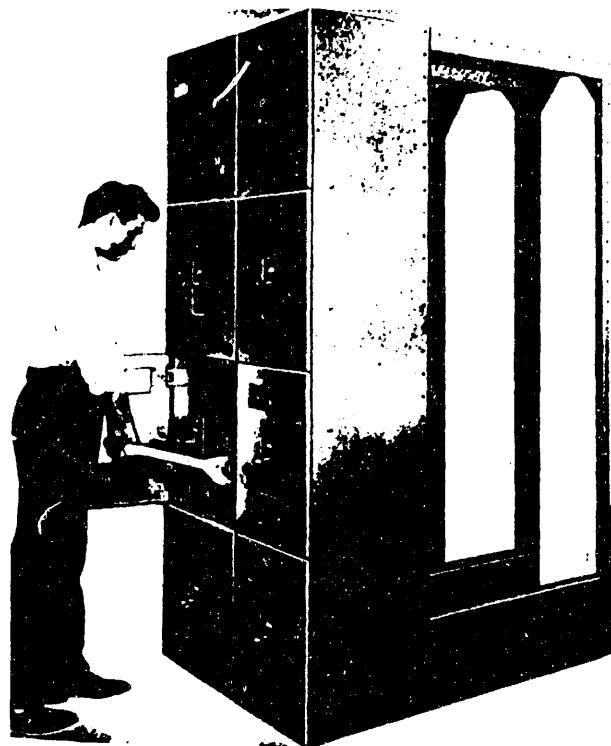
Figure 3-15. Manual Lever Circuit Breaker Racking Mechanism, Westinghouse Low-Voltage Switchgear.[3.7]

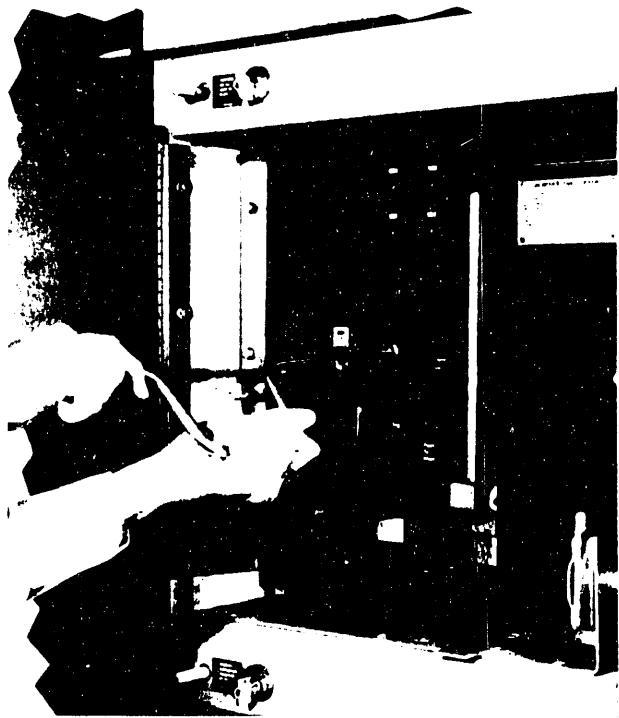
Figure 3-16. Worm-Gear Circuit Breaker Racking Mechanism, Westinghouse Low-Voltage Circuit Breaker, Types DS and DSL.[3.8]

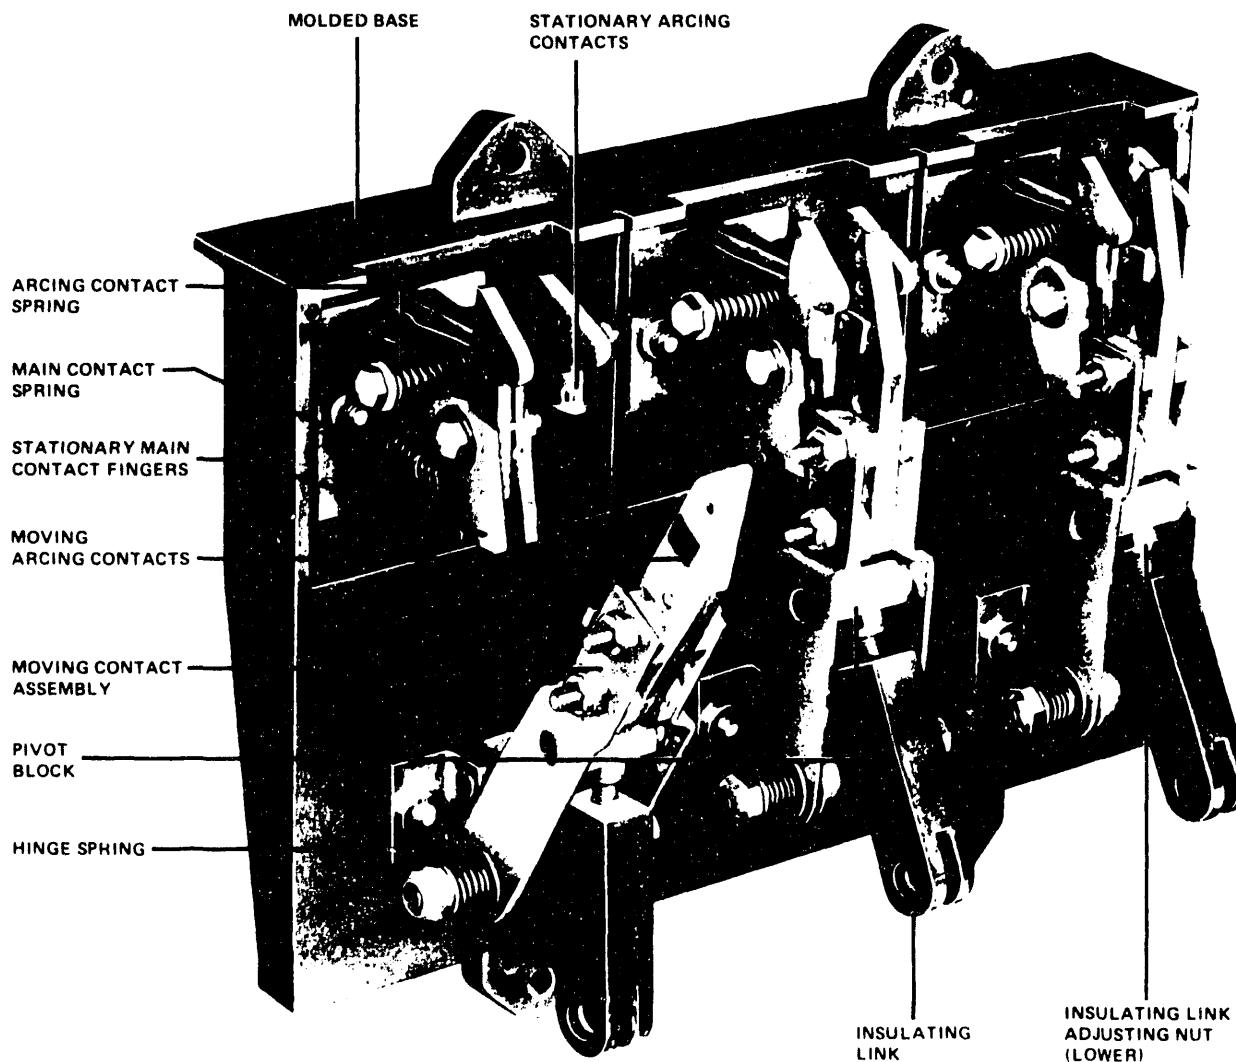
Figure 3-17. Circuit Breaker Main Contacts, Westinghouse Type DS and DSL Low-Voltage Circuit Breakers.[3.8]

The main contacts carry the power circuit load. When the main contacts close, the power circuit load flows through the circuit breaker. Proper contact mating is essential as it helps to minimize power path contact resistance to prevent the contacts from overheating. Proper mating is achieved through spring loading of the contacts. A compression spring in the closing mechanism bears on the moving contact in the closed position and pushes the contacts together so that good contact mating occurs. Spring loading also facilitates contact "wipe" or cleaning of the contacts as they come together. When the main contacts open, the power flow through the circuit breaker is interrupted or broken via transfer of the power circuit load from the main contacts to the arc extinguishing system. See Figure 3-17.[3.2, 3.8]

The arc extinguishing system interrupts or breaks and extinguishes normal and fault currents. A basic arc extinguishing system consists of arcing contacts and an arc-chute. The arc extinguishing process begins as the main contacts open and transfer the arc to the arcing contacts. The arcing contacts are usually made of an alloy of a high conductivity material, such as silver or tungsten, which is resistant to damage by the high temperatures that accompany an arc. The arcing contacts are often plated with an additional layer of metal to increase the dielectric strength of the gap between the contacts during opening under load and fault conditions and to reduce the probability of restrike and flashover. See Figure 3-17.[3.9]

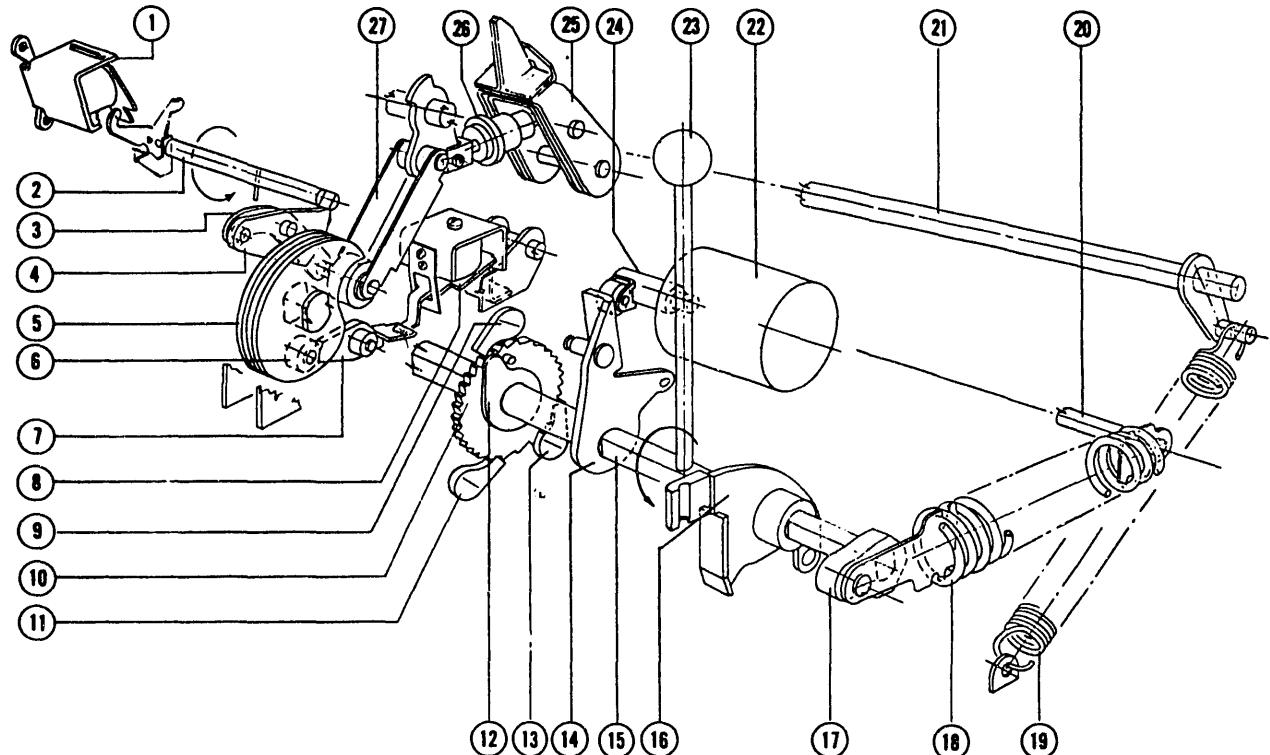
1. Shunt Trip Device	10. Ratchet Wheel	19. Reset Spring
2. Trip Shaft	11. Hold Pawl	20. Closing Spring Anchor
3. Roller Constraining Link	12. Drive Plate	21. Pole Shaft
4. Trip Latch	13. Emergency Charge Pawl	22. Motor
5. Close Cam	14. Oscillator	23. Emergency Charge Handle
6. Stop Roller	15. Crank Shaft	24. Motor Crank and Handle
7. Spring Release Latch	16. Emergency Charge Device	25. Moving Contact Assembly
8. Spring Release Device	17. Crank Arm	26. Insulating Link
9. Oscillator Pawl	18. Closing Spring	27. Main Drive Link

Figure 3-18. Stored Energy Spring Operating Mechanism.[3.8]

The stored energy spring mechanism generally consists of a spring charging motor, a closing spring, and a mechanical assembly or linkage. See Figure 3-18. In a stored energy spring closing operation, the closing spring is charged (compressed or extended, depending on the design) by the electric motor and ratcheting mechanism. Upon receipt of a mechanical or electrical closing signal, the close release latch allows the closing spring to act on the mechanical assembly. Discharge of the closing spring causes the mechanism to close the main and arcing contacts and to charge (compress or extend) the opening springs. As soon as the closing springs discharge during closure, the charging motor is energized to recharge the closing springs such that an immediate closure could follow a circuit breaker opening. In an opening operation, the contacts are opened by the mechanical assembly when the trip latch is released. Upon receipt of an electrical or mechanical opening signal, the trip latch releases the prop system that prevented the opening springs from pulling the main contacts open. Once the prop system is released, the main contacts open and the linkage systems and trip latches reset to positions so that they are ready to reclose. During the opening operation, the arc is transferred from the main contacts to the arcing contacts, which carry the arc into the arc-chute. The arcing contacts open after the main contacts to protect the surface area of the main contacts from severe damage by arcing. For this reason, the arcing contacts are considered sacrificial and may be replaced during the service period of the circuit breaker.[3.8]

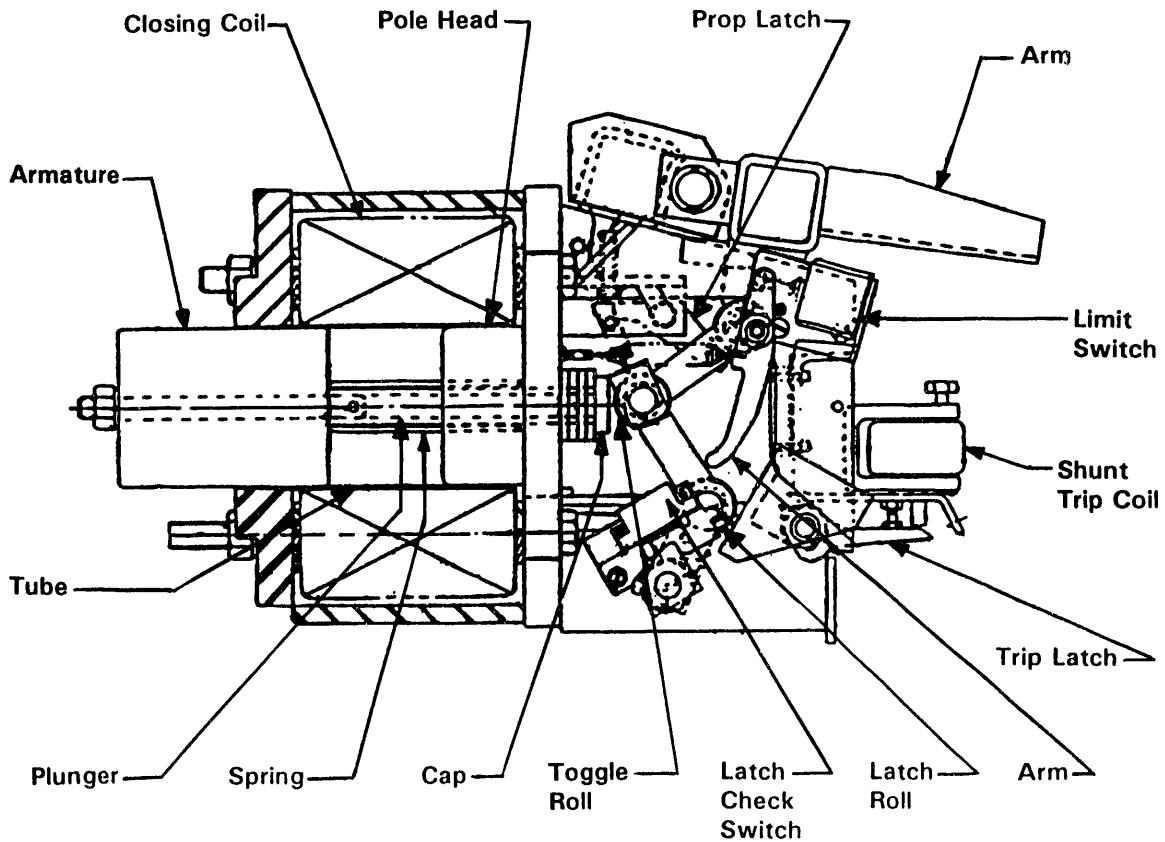
Figure 3-19. Solenoid Operated Mechanism.[3.10]

The solenoid operated mechanism generally consists of a solenoid and a mechanical assembly or linkage. See Figure 3-19. The solenoid operated mechanism differs from the stored energy spring mechanism in that the force used to electrically close the breaker is supplied by an ac or dc solenoid coil. Upon receipt of an electrical closing signal, the solenoid will energize and a plunger will push the mechanical assembly so that the circuit breaker contacts close. Mechanical closing of the solenoid type breaker uses a lever handle to move the mechanism directly. As the mechanism closes, the opening springs charge. To open the circuit breaker contacts, the trip latch must be released. Upon receipt of an electrical or mechanical opening signal, the trip latch will free the opening springs and force the main contacts to open. When the breaker contacts open, the linkage will reset for the next closure.[3.10]
