# Characterization and Possible Repair of Defects in Soft X-ray Projection Lithography Masks

Andrew M. Hawryluk  
*Lawrence Livermore National Laboratories*

This paper was prepared for submittal to :  
OSA Proceedings on Soft X-ray Projection Lithography '93  
May 10-12, 1993, Monterey, CA

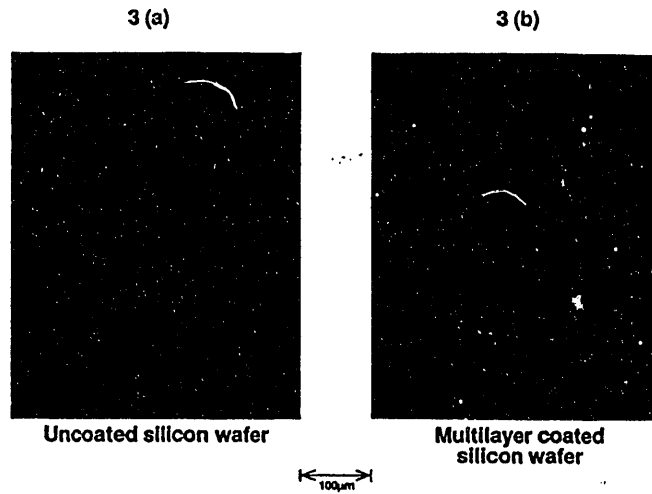
**Figure 3**

(a) Dark field inspection of a reference silicon wafer. (b) Dark field inspection of a multilayer coated silicon wafer. Both samples were handled and stored identically and the photographs taken under identical illumination conditions. The multilayer coated wafer shows many more defects (approximately  $7500/\text{cm}^2$ ) than the reference wafer (approximately  $4/\text{cm}^2$ ).

Optical inspection of the mask blanks was performed using both dark field imaging and inspection with an industrial inspection tool. Fig. 3a is an optical photograph of the dark field image from a reference wafer for a mask blank and Fig. 3b is an optical photograph of the dark field image for a mask blank. Both photographs were taken at the same microscope magnification, exposure and development conditions and are representative of the samples. Upon inspection of the uncoated silicon wafer (the reference wafer) very few defects were detected.

However, inspection of the multilayer coated wafer illustrated many surface defects. Inspection of the photograph reveals approximately 15 surface defects in an area  $400 \mu\text{m} \times 500 \mu\text{m}$ , implying  $7,500 \text{ defects/cm}^2$ .

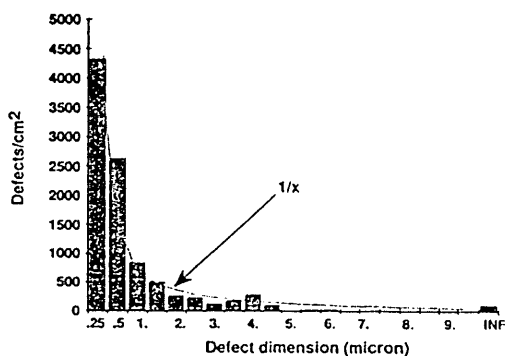
Figure 4

Defect-size histogram for a multilayer coated silicon wafer. Notice that the defect distribution closely matches a "1/x" curve.

comparison. This tool has been used to inspect masks for proximity print x-ray lithography and is capable of detecting defects as small as 50 nm. At present, the SemSpec requires a pattern on the mask for electron beam focusing and is not well suited to inspect unpatterned mask blanks. Future improvements under consideration include focal plane mapping by an optical technique that should permit inspection of mask blanks. A useful feature of the SemSpec is that it is capable of measuring the dimensions of detected defects, Fig. 4. From this information, we determined that a majority of the defects are submicron in size, and the defect distribution closely follows a "1/x" curve.
