NUREG/CR-6043
PNL-8614
Vol. 1

Aging Assessment of Essential HVAC Chillers Used in Nuclear Power Plants

Phase I

Prepared by
D. E. Blahnik, R. F. Klein

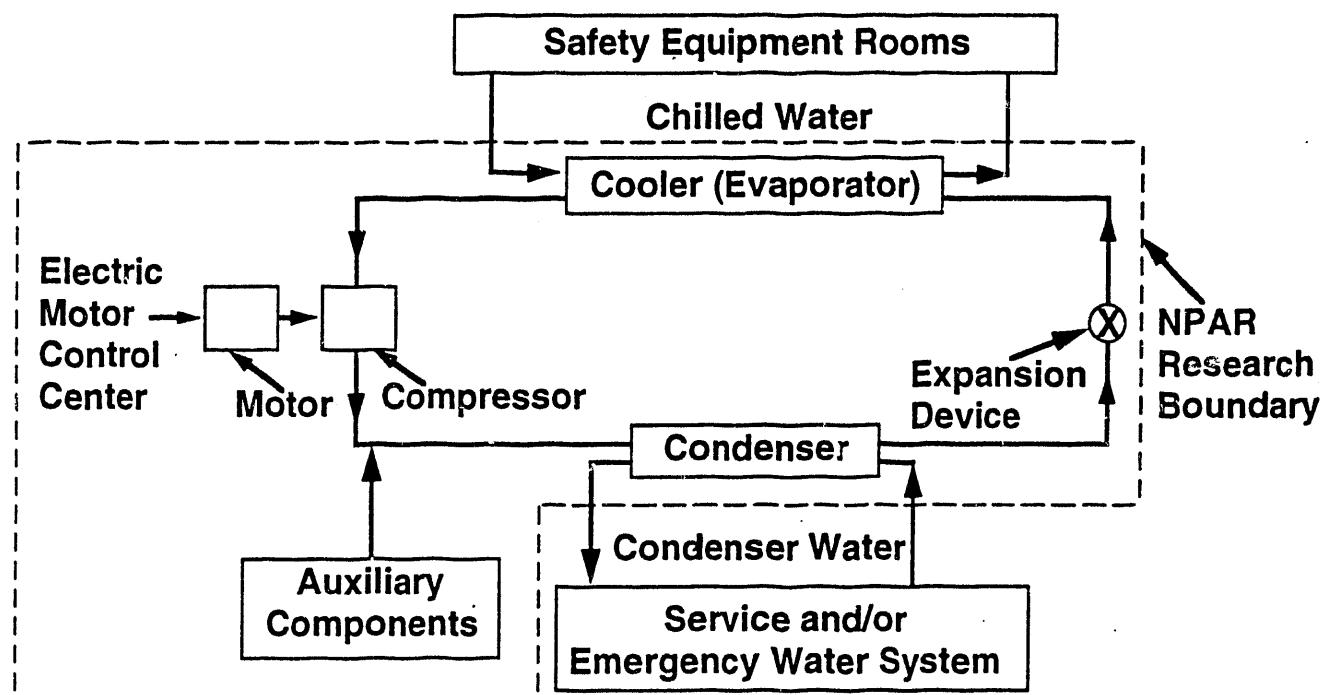
Figure 1.1 Research Boundary for Phase I Essential Chiller Study

A simplified diagram of the major components of a centrifugal chiller and the interfacing systems is shown in Figure 1.1. The research boundary selected for the Phase I study is indicated by the dashed line. The major components of the chiller are typically a motor-driven centrifugal compressor, a condenser HX, an expansion device, and the evaporator-cooler HX. The refrigerant used as heat transfer media is usually CFC-11 or CFC-12 refrigerant. The chiller waste heat is removed

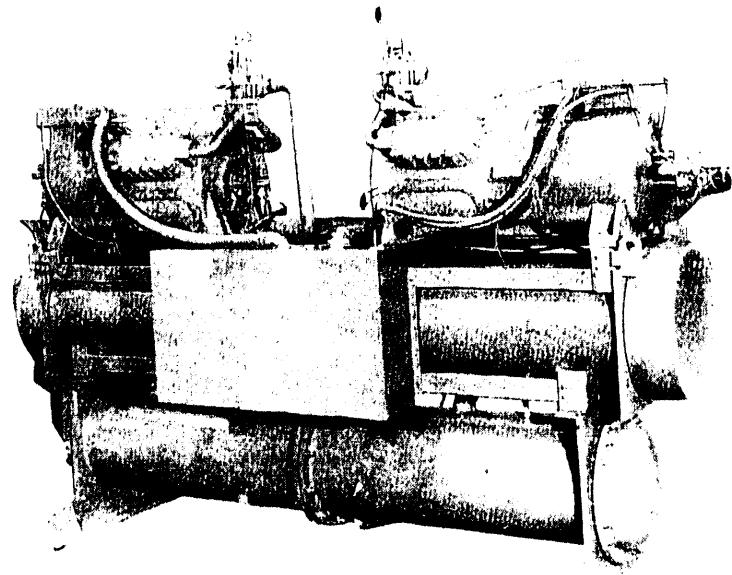
Figure 2.1 Reciprocating Water Chiller Description (Permission to use this copyrighted material is granted by the York International Corporation.)

This study focused on the centrifugal water chiller as a reference design. The centrifugal chiller is described in greater depth later in the report and is shown in Figure 4.1. Illustrations of alternative reciprocating, screw, and absorption water chiller designs are shown in Figures 2.1, 2.2, and 2.3, respectively.

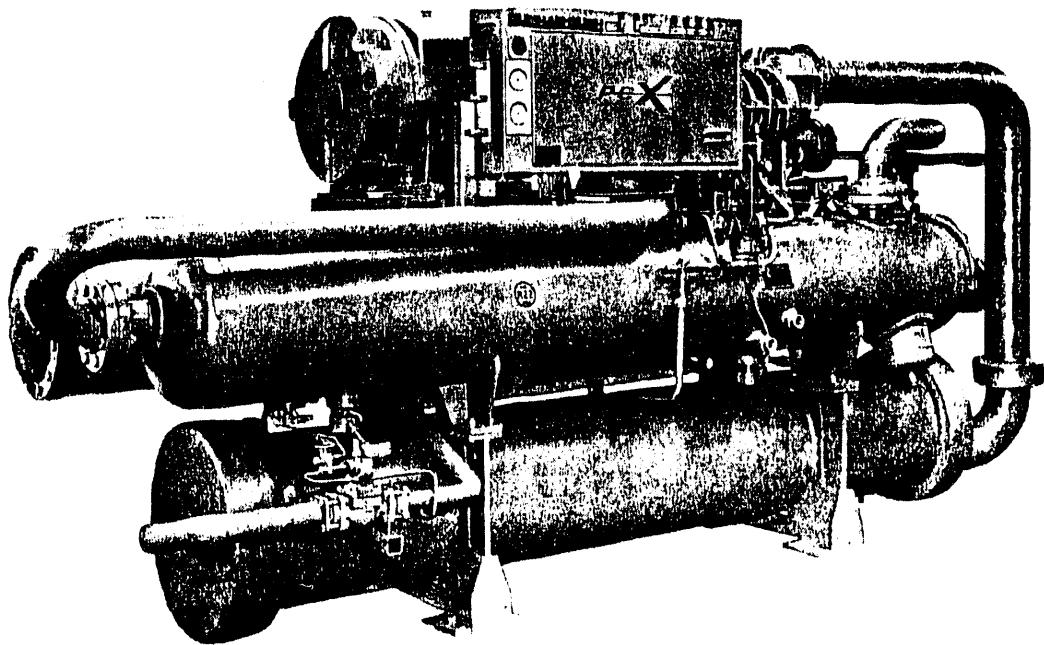
Figure 2.2 Screw Water Chiller Description (Permission to use this copyrighted material is granted by Dunham-Bush, Inc. The above graphic is from an obsolete Dunham-Bush, Inc. document.)

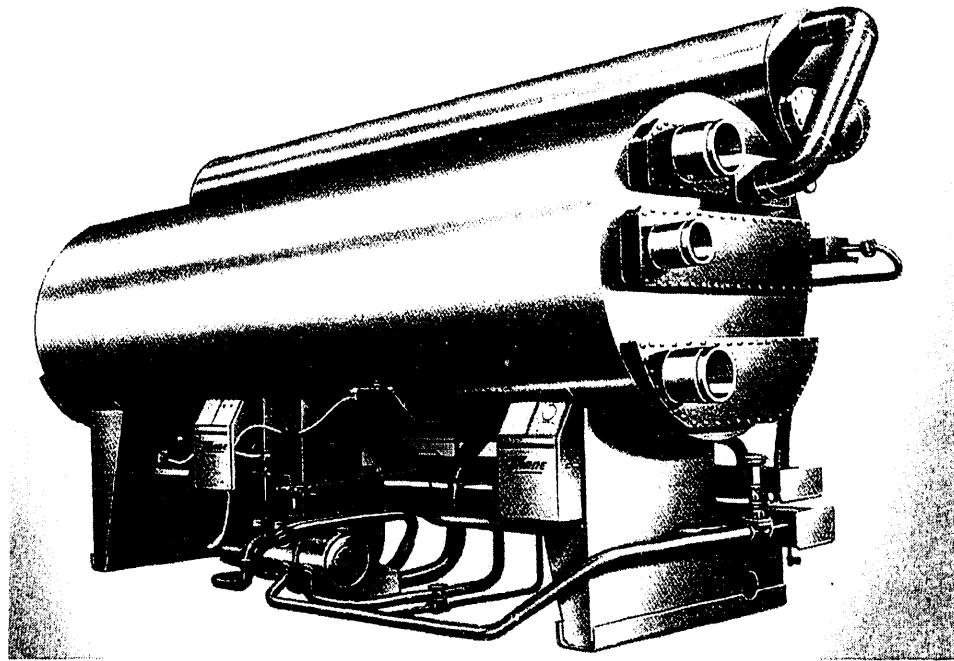
Figure 2.3 Absorption Water Chiller Description (Permission to use this copyrighted material is granted by The Trane Company.)

Absorption water chillers range in size between 100 and 1700 tons. These machines have a total of four heat exchangers: condenser, generator (concentrator), evaporator, and absorber. The chillers are usually powered by hot water or low-pressure steam. Water is the refrigerant, and lithium bromide, a salt that strongly attracts water, is the absorbent. Heat is transferred from the chilled water to the cooling water through evaporation and condensation of the refrigerant water.

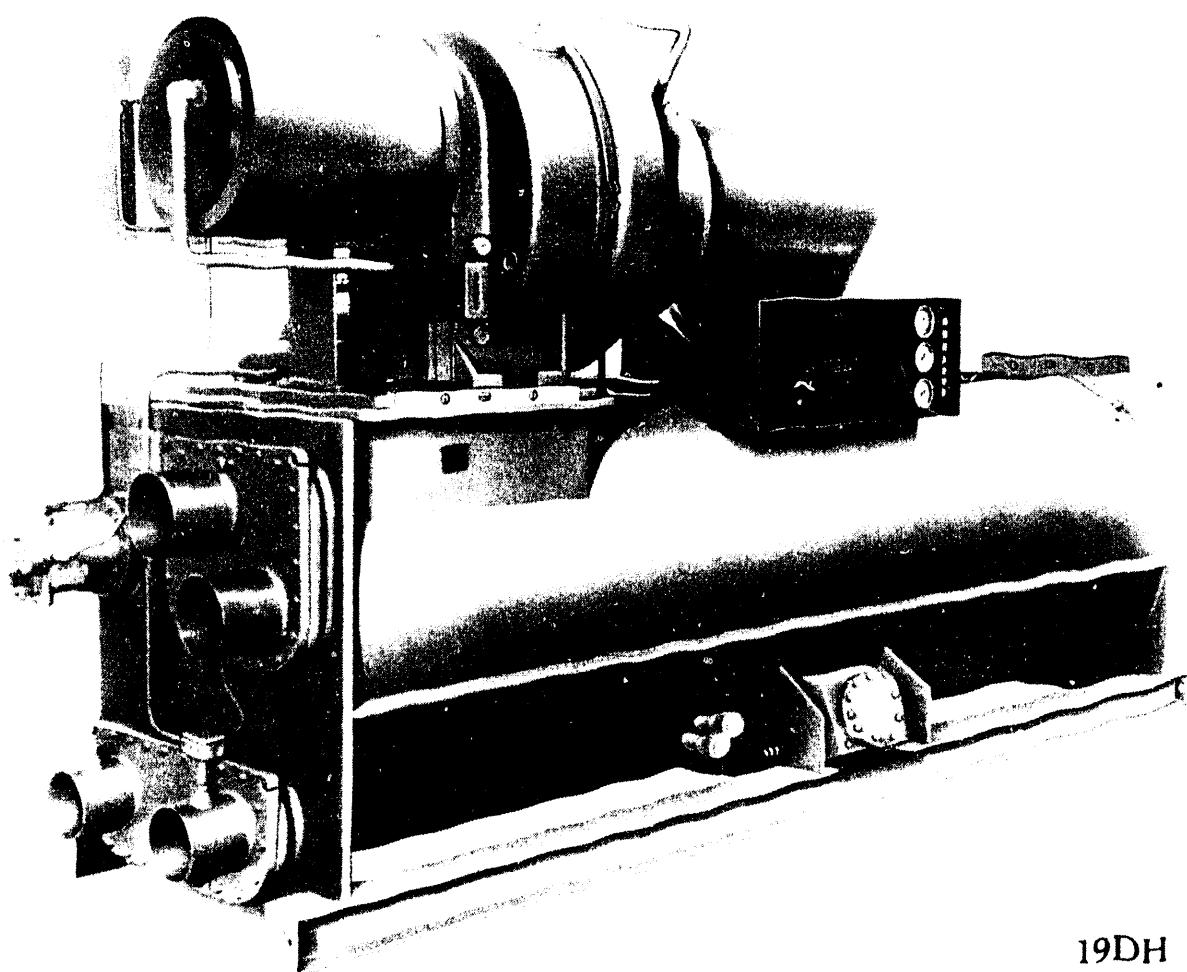
Figure 4.1 Recent Model of Liquid Hermetic Centrifugal Chiller Manufactured by the Carrier Corporation - Reference Design (Permission to use this copyrighted material is granted by the Carrier Corporation.)

A photograph of a recently marketed hermetic centrifugal chiller is shown in Figure 4.1. It is quite similar to older chillers that are still in service at NPPs. The newer chillers have advanced controls, and computer control is now available. Many improvements (e.g., solid state controls, more efficient moisture/air purge units, etc.) have been made in recent years; and the older chillers can be upgraded because manufacturers make many of the new features available in retrofit kits.

The reference chiller shown in Figure 4.1 is a Carrier Corporation model. For comparison purposes, a York International Corporation chiller is shown in Figure 4.2, and a chiller manufactured by The Trane Company is pictured in Figure 4.3. Most of the NPP centrifugal chiller market is divided among these three manufacturers.

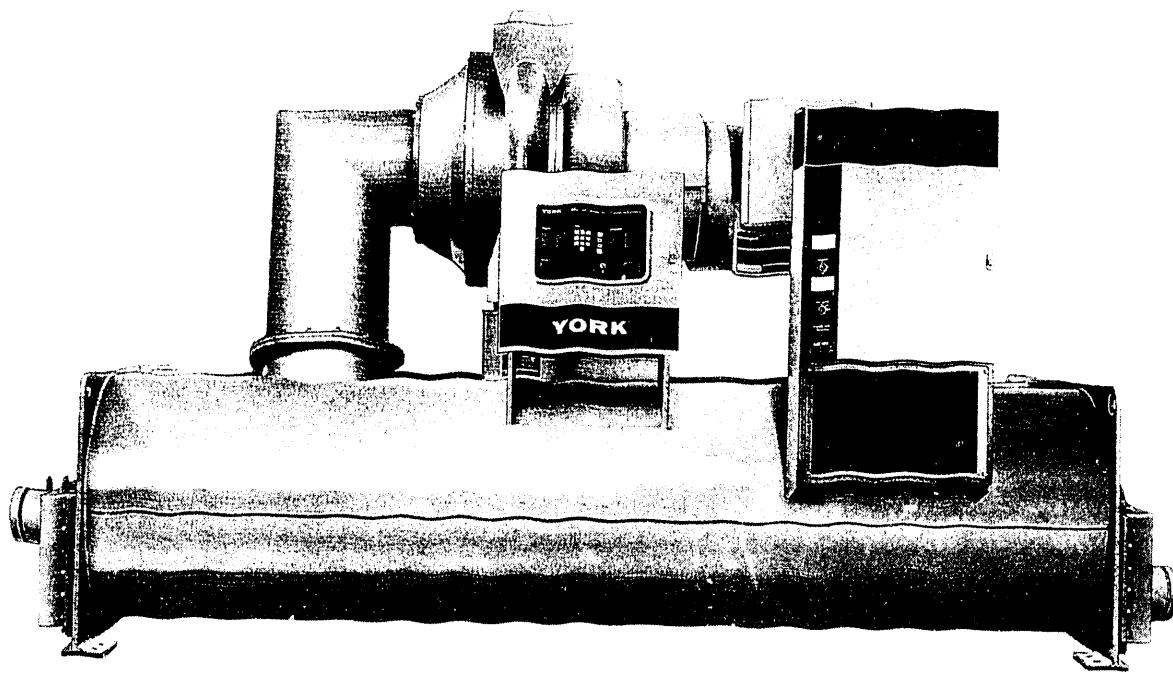
Figure 4.2 Recent Model of Liquid Hermetic Centrifugal Chiller Manufactured by the York International Corporation (Permission to use this copyrighted material is granted by the York International Corporation.)

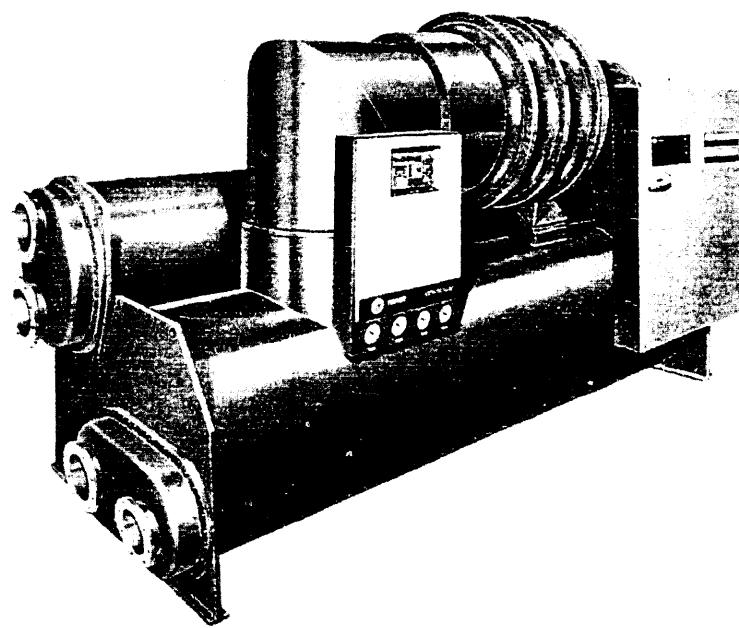
Figure 4.3 Recent Model of Liquid Hermetic Centrifugal Chiller Manufactured by The Trane Company (Permission to use this copyrighted material is granted by The Trane Company.)

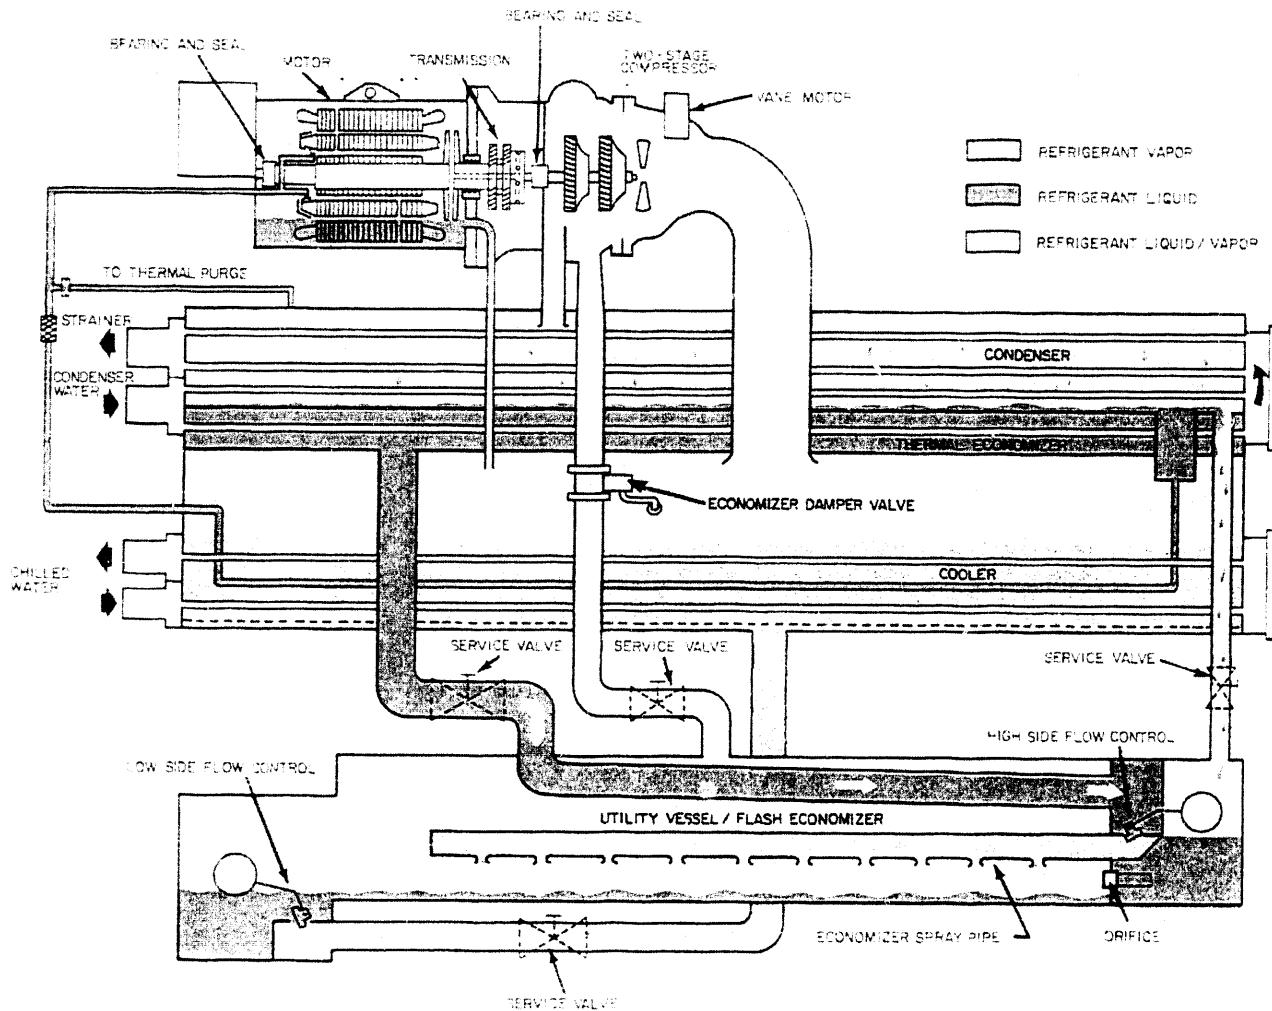
Figure 4.4 Reference Centrifugal Chiller Cross-Sectional View Showing Refrigerant Flow Path (Permission to use this copyrighted material is granted by the Carrier Corporation.)

A cross-sectional view with the refrigerant flow path of the reference chiller (Carrier Corporation) is illustrated in Figure 4.4. The compressor cross-section view is shown in Figure 4.5, and a view of a purge unit is shown in Figure 4.6. Typical piping and wiring are illustrated in Figure 4.7. Dimensions and layout requirements are given in Figure 4.8.

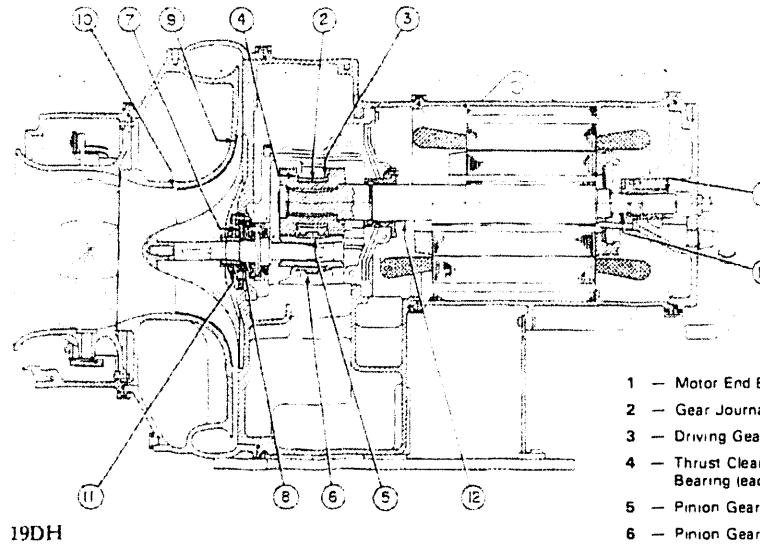
In-line impeller design

→ In-line impeller design, with diaphragm between stages, allows for more flexibility in compressor component selection, which results in first cost savings on other machine components. Also provides higher head capabilities, prevents uneven loading and allows for routine, easy maintenance.

1 — Motor End Bearing	8 — High-Speed Journal Bearing
2 — Gear Journal Bearing	9 — Front of Impeller to Volute Wall
3 — Driving Gear Bearing To Housing	10 — Impeller Eye to ID of Inlet Ring
4 — Thrust Clearance on Gear Bearing (each side)	11 — Labyrinth Behind Impeller to Spacer Ring
5 — Pinion Gear Journal Bearing	12 — Labyrinth Behind Transmission and Motor Shell
6 — Pinion Gear Bearing To Housing	
7 — Thrust Bearing	13 — End-Bell Bearing Labyrinth

Figure 4.5 Reference Centrifugal Chiller Compressor Cross-Section (Permission to use this copyrighted material is granted by the Carrier Corporation.)

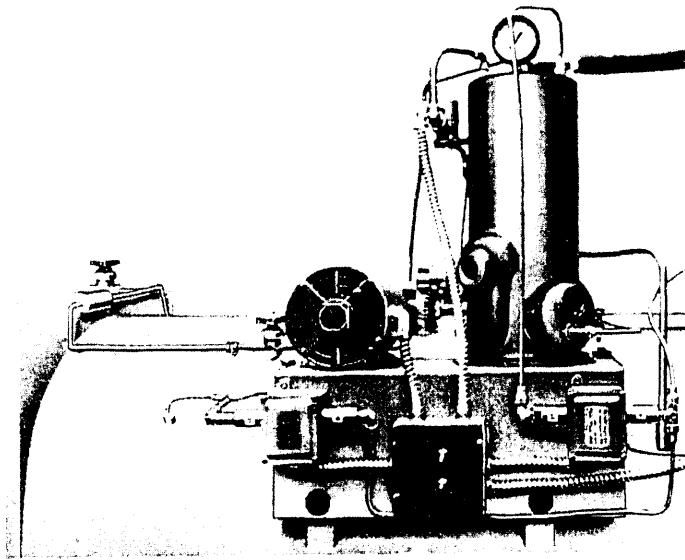
Figure 4.6 Reference Centrifugal Chiller Purge Unit (Permission to use this copyrighted material is granted by the Carrier Corporation.)

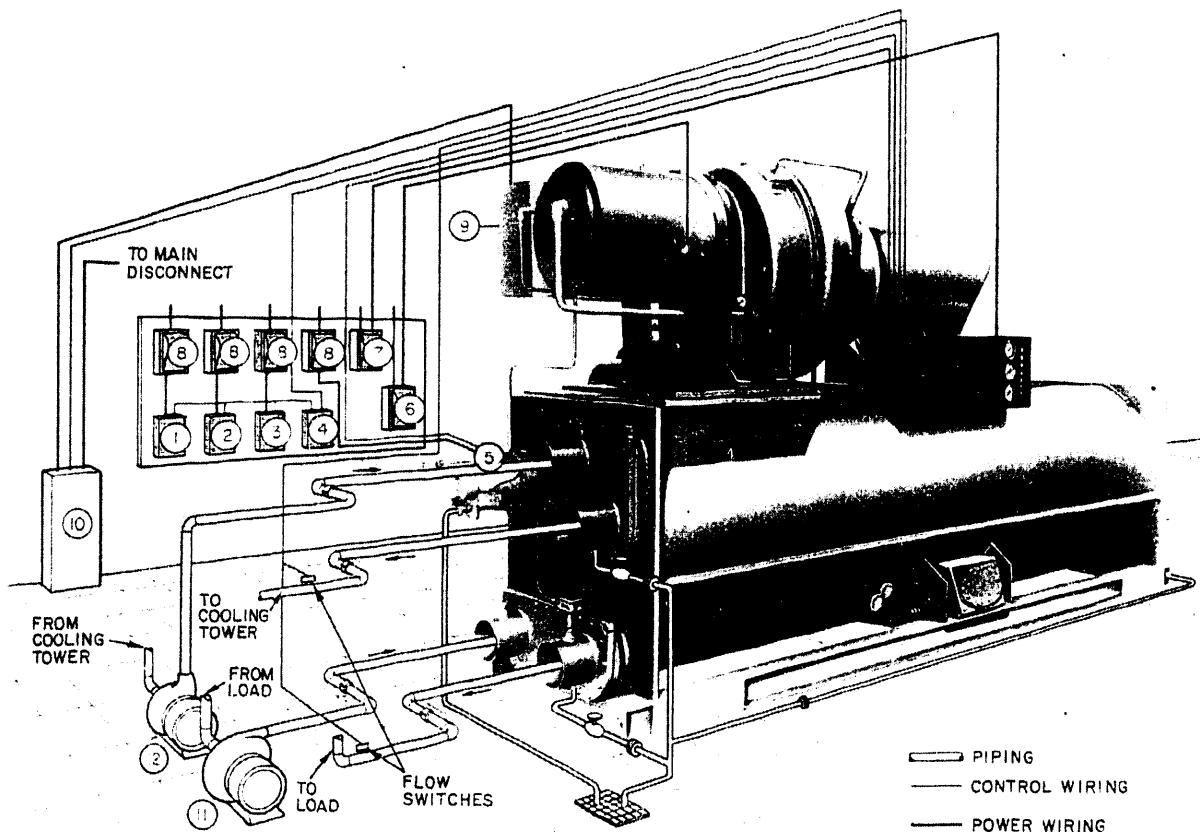
- 1 -- Cooling Tower Fan Starter
- 2 -- Condenser Water Pump Starter
- 3 -- Cooler Water Pump Starter
- 4 -- Pilot Relay
- 5 -- Oil Pump Starter
- 6 -- Fused Disconnect for Oil Heater and Thermostat
- 7 -- Fused Disconnect for Purge System
- 8 -- Fused Disconnect
- 9 -- Compressor Motor Terminal Box
- 10 -- Compressor Motor Starter
- 11 -- Cooler Water Pump
- 12 -- Condenser Water Pump

Figure 4.7 Reference Centrifugal Chiller Piping and Wiring Illustration (Permission to use this copyrighted material is granted by the Carrier Corporation.)

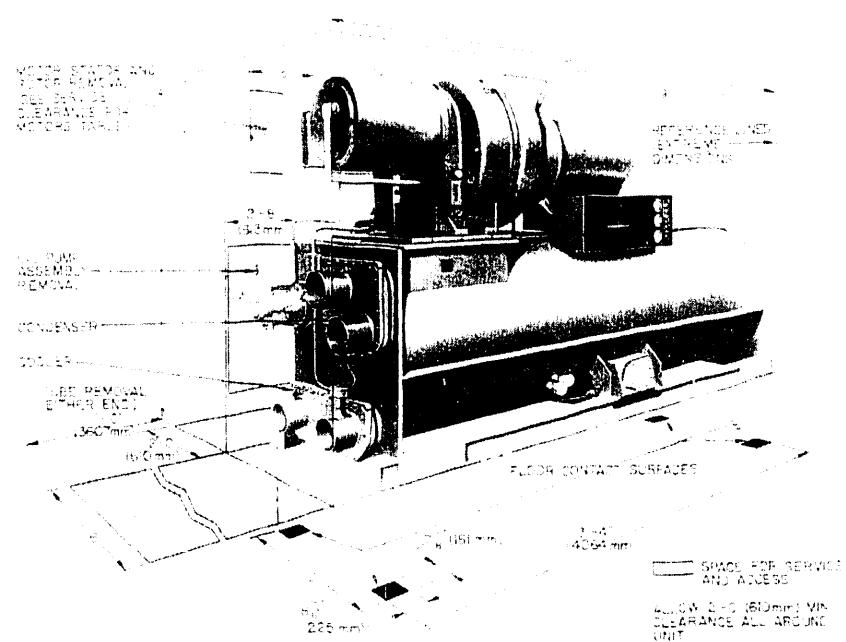
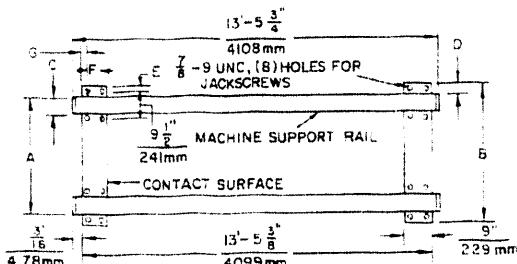
Service clearance should be provided per ANSI Standard E21.1-1947 (NFC) and local safety codes. Clear space adequate to access and service the unit. Allow 1-1/2 ft. (460 mm) of clearance at components of the chiller. Minimum clearance of 2 ft. (610 mm) is required between the unit and adjacent structures or equipment.

Figure 4.8 Reference Centrifugal Chiller Dimensions and Layout Requirements (Permission to use this copyrighted material is granted by the Carrier Corporation.)

A liquid open centrifugal chiller is illustrated in Figure 4.9. This figure shows the dimensional envelope changes compared to the liquid hermetic centrifugal chiller shown in Figure 4.8. The open centrifugal chiller has a motor that is sealed external to the refrigerant system boundary and is exposed to the chiller room environment.

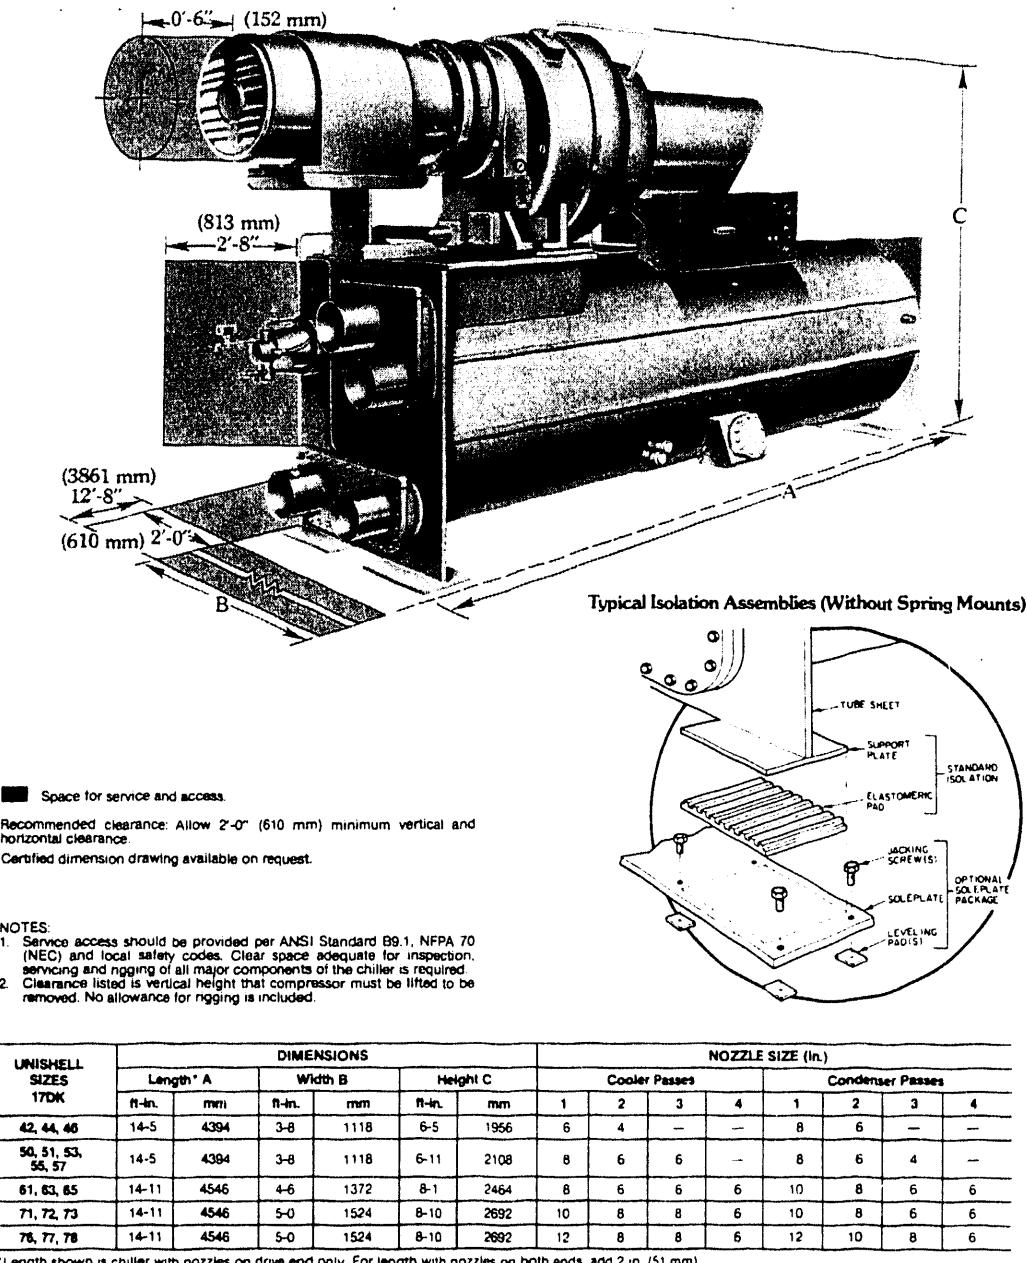
Figure 4.9 Recent Model of Liquid Open Centrifugal Chiller Manufactured by the Carrier Corporation (for comparison with hermetic centrifugal chiller shown in Figure 4.8) (Permission to use this copyrighted material is granted by the Carrier Corporation.)

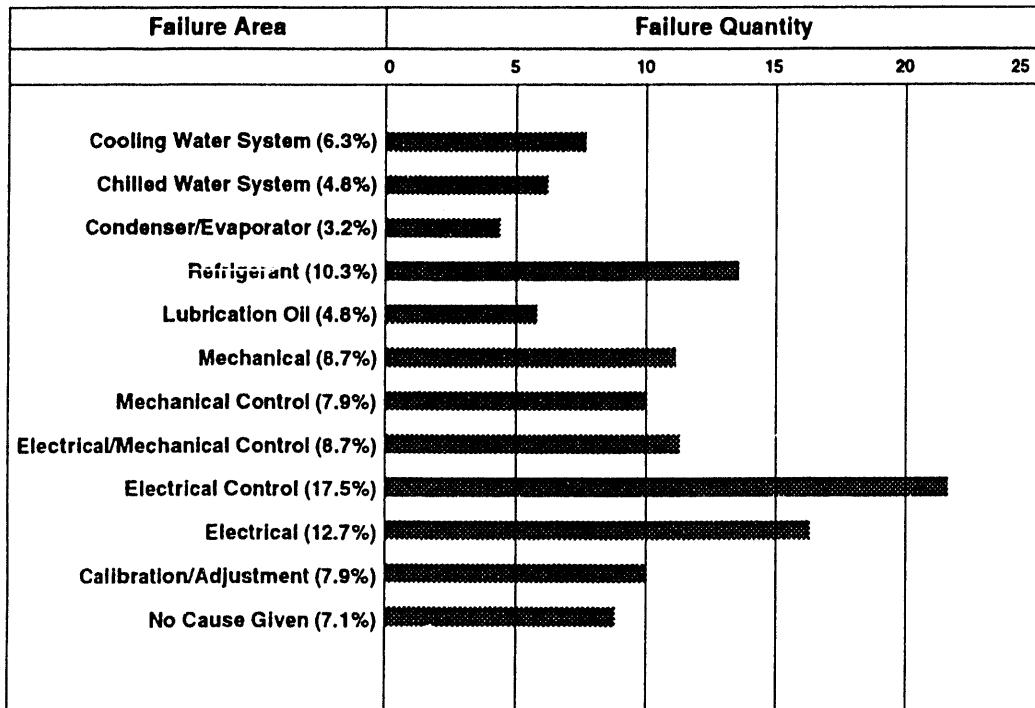
Figure 7.1 Summary of Chiller Failures (LER and NPE Databases)

The information shown in Figure 7.1 summarizes the quantities and failure areas from the LER and NPE

databases. Duplicate failures were removed for this summary. Only failures that caused the chiller to shut down were included. About 11% of the failures were partially caused by flow rate variations in the cooling and chilled water systems and partially by the chiller condition (e.g., chiller fouling, load and capacity limitations, entrance strainers, etc.). Condenser/evaporator failures were only about 3% because most of the age degradation occurs gradually, maintenance access is usually easier, and it is handled during scheduled downtime. The refrigerant/lubrication oil system-related failures accounted for about 15% of the failures. About 17% of the failures were mechanical and mechanical control related. Electrical/mechanical control components caused about 9% of the failures. Electrical and electrical control components made up about 30% of the failures. Misadjustment and miscalibration resulted in approximately 8% of the failures, and the 7% balance

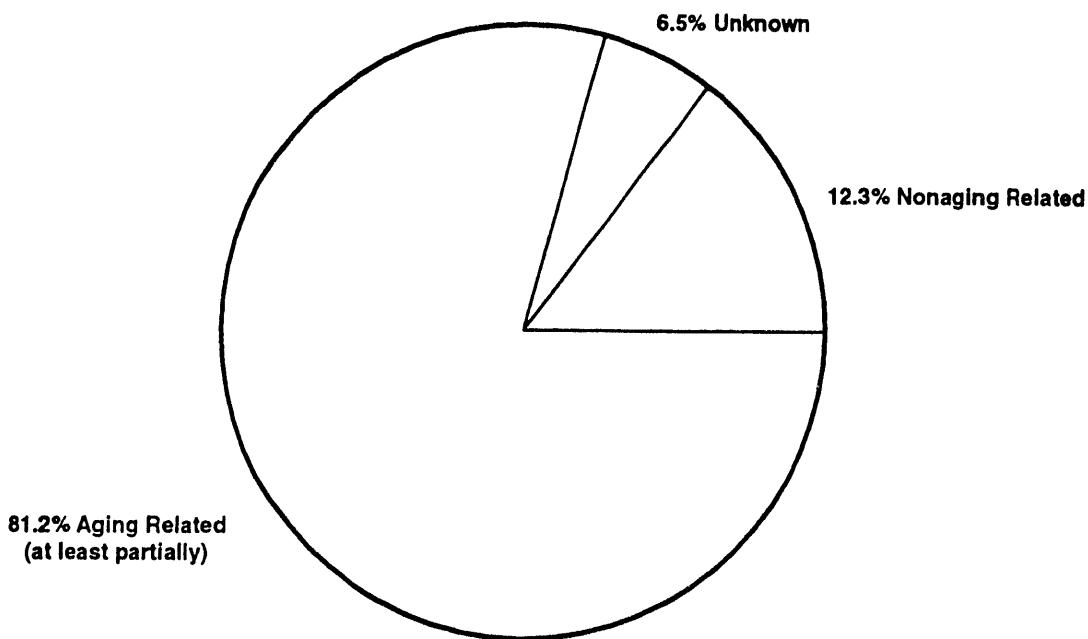
Figure 7.2 Aging Versus Nonaging Related Chiller Failures

Using the same failure databases, an attempt was made to determine the degree to which failures were age-related. The aging versus nonaging failures are illustrated in Figure 7.2. About 81% of the failures were at least partially related to aging (time-related degradation). More detailed information would be needed to segregate the failures which were primarily or solely age-related. About 12% of the failures were primarily due to design, manufacturing, installation, procedure, and human errors. The 7% balance of failures was unknown or unassignable.

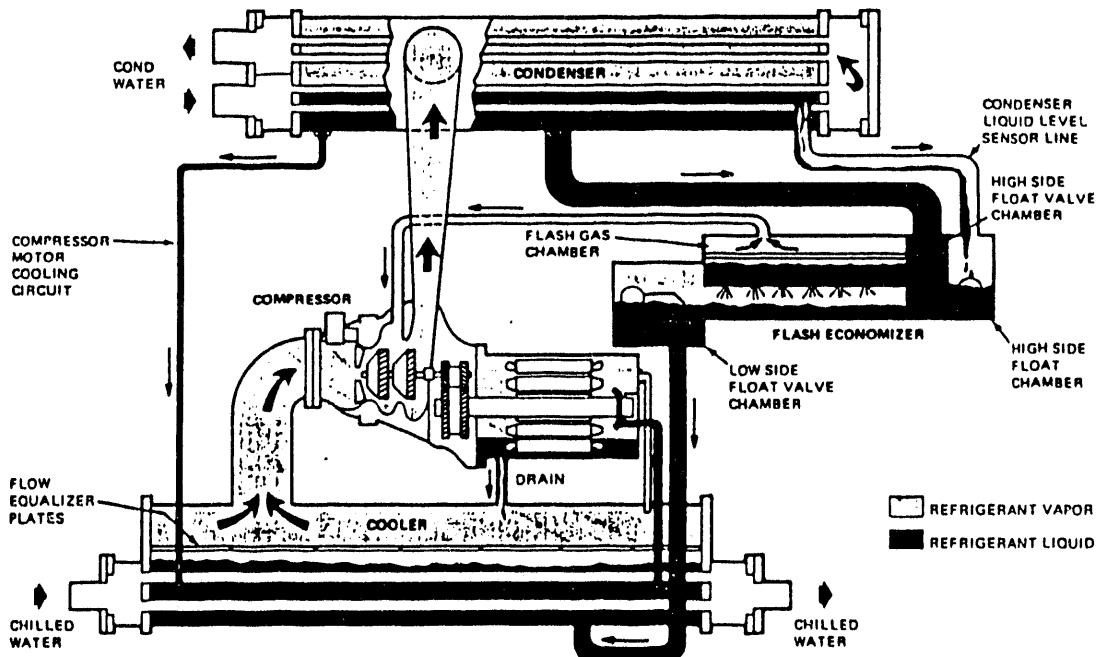
Fig. 12 – 19FA Refrigeration Cycle

Refrigerant liquid from a sump at the bottom of the condenser (Fig. 12) is subcooled by passage thru a line immersed in the refrigerant within the cooler. The liquid then enters the compressor motor end where it sprays on and cools the compressor rotor and stator. It then collects in the base of the motor casing and drains back into the cooler. Refrigerant gas is vented from the compressor motor casing and returns to the upper

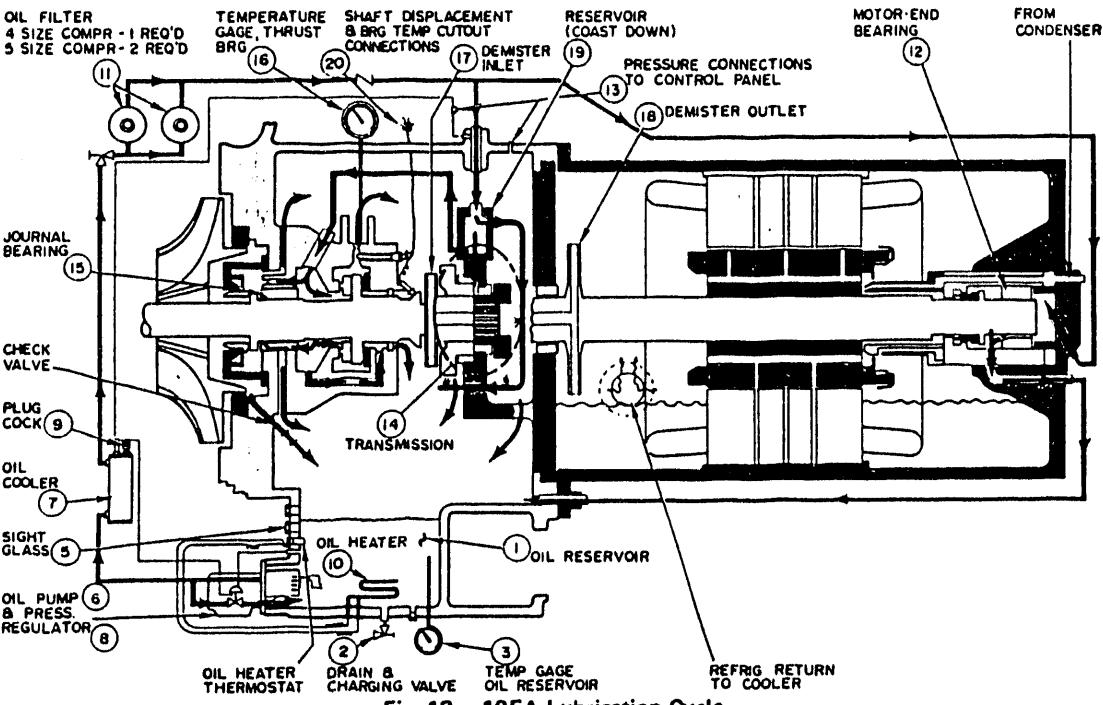
The motor-driven oil pump (6) discharges oil to an oil cooler (7) at a rate and pressure controlled by an oil regulator (8). The differential pressure (supply versus return) is registered on a gage at the machine control center.

Water flow thru the oil cooler is manually adjusted by a plug cock (9) to maintain the oil at an operating temperature, at the reservoir, of approximately 145 F. During machine shutdown, the oil temperature is also maintained at 140 to 150 F by an immersion heater (10) so that absorption of refrigerant by the oil is minimized.

Fig. 13 — 19FA Lubrication Cycle

After it leaves the oil cooler, the oil is filtered (11) and a portion flows to the motor-end bearing (12) and seal. The remainder lubricates the compressor transmission (14) and the thrust and journal bearings (15). Thrust bearing temperature is indicated on a gage (16) mounted on the bearing inspection cover. Oil from each circuit returns by gravity to the reservoir.

General — The compressor oil pump and oil reservoir are located in the compressor base. Oil is pumped thru an oil cooler and a filter to remove heat and any foreign particles. Part of the oil flow is directed to the compressor motor-end bearings and seal. The remaining flow lubricates the compressor transmission, thrust and journal bearings and seal. Oil is then returned to the reservoir to complete the cycle (Fig. 13).
