Computational Modeling and Assessment Of Nanocoatings for Ultra Supercritical Boilers

Task 4 Technical Report

Fireside Corrosion Testing

March 31, 2010

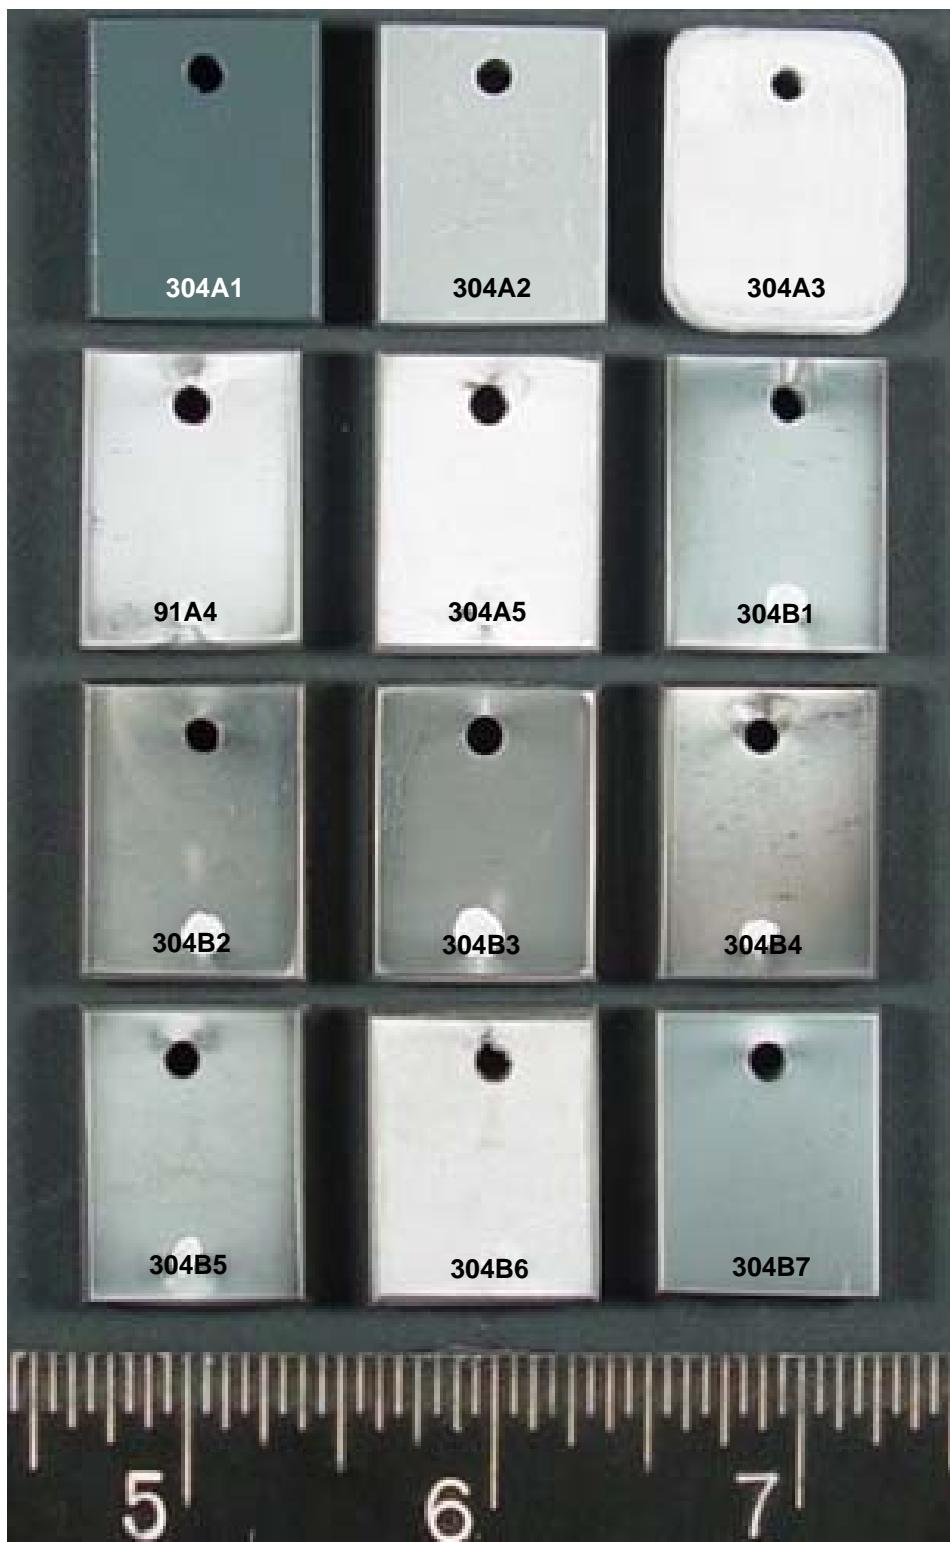
FIGURE 2-1
Representative Photograph of the Nanocoating Samples in the As-Supplied Condition on a 304 Substrate Coupon (A4 is on a 91 Substrate).

Figure 2-1 displays the representative condition of the nanocoating materials on a 304 substrate (except A4 which is on a 91 substrate) as they were received from the SwRI or the commercial vendors. Upon receiving the coated test coupon specimens, sacrificial samples were removed from each coating/substrate combination and prepared for microscopic analysis. The purpose of the evaluation was to pre-characterize the as-supplied coating compositions, thickness, and uniformity, and to identify potential flaws in the coatings that could lead to poor performance. Table 2-1 presents the nominal compositions (where available) and as-measured compositions by standardless semi-quantitative EDS analysis of the as applied coatings. For samples that were supplied on multiple substrate materials; the values presented in Table 2-1 represent the average composition for a given coating.

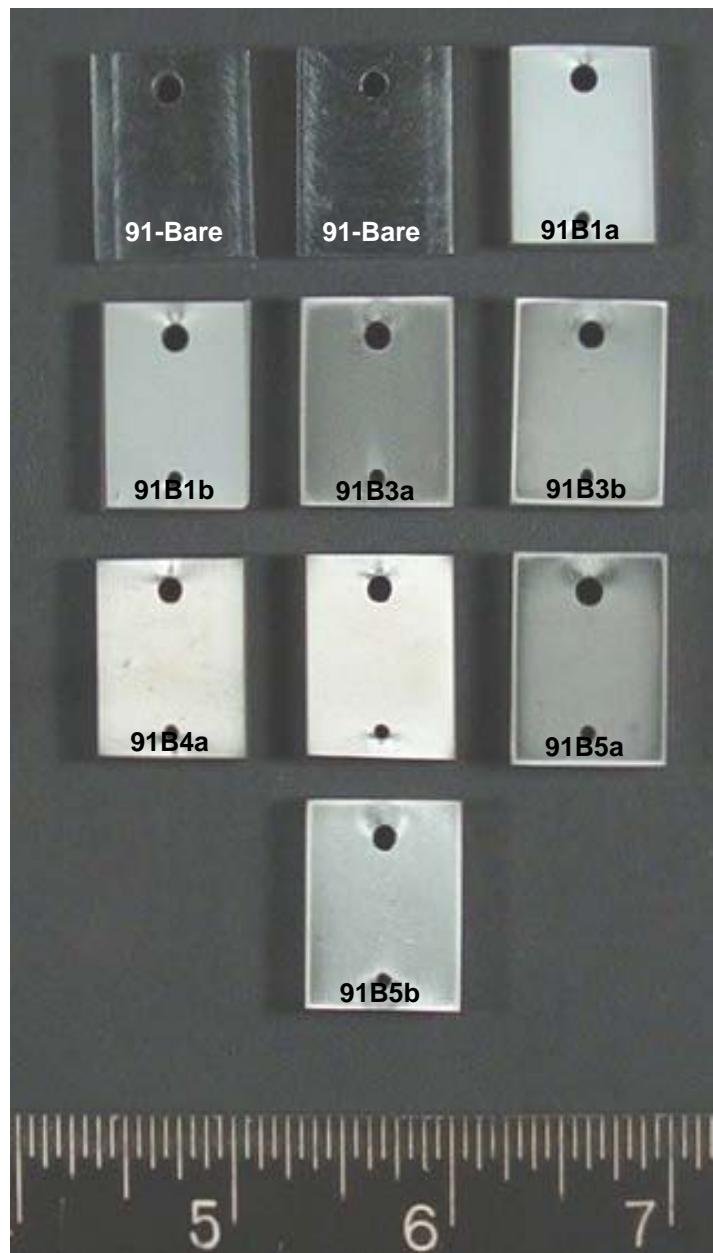
FIGURE 4-1
Representative Photograph Showing the Nanocoating and Uncoated Control Samples in the As-supplied Condition, Prior to Performing the Screening Test Under Synthetic Waterwall Conditions. Duplicate Samples Were Removed after 50 Hours.

As mentioned in Section 3, preliminary screening test of 100 hour duration was carried out on a six different nanocoating materials (B1, B3, B4, B5, B6 and B7) for both waterwall and superheater/reheater conditions. The waterwall test was carried out at 975°F (524°C) using a deposit containing 75% FeS and 1% alkali chlorides, while the superheater/reheater test was performed at 1200°F (649°C) using a deposit containing 30% alkali sulfates. Although these deposit formulations are more aggressive for their respective environments than FW traditionally uses, with little to no experience with these materials, the intent of the screening test was to acquire a basic understanding of the corrosion performance of nanocoating materials when exposed to boiler environments. The nanocoatings that were tested under waterwall conditions included B1, B3, B4 and B5 on 91 substrate material; for superheater/reheater conditions the screening test samples included nanocoatings B1, B3, B4, and B5 on a 91 substrate material and B1, B3, B4, B5, B6, and B7 on a 304SS substrate material. Figures 4-1 and 4-2 illustrate the conditions of the nanocoating materials (and uncoated control samples) prior to exposure to waterwall and superheater/reheater screen test conditions, respectively.

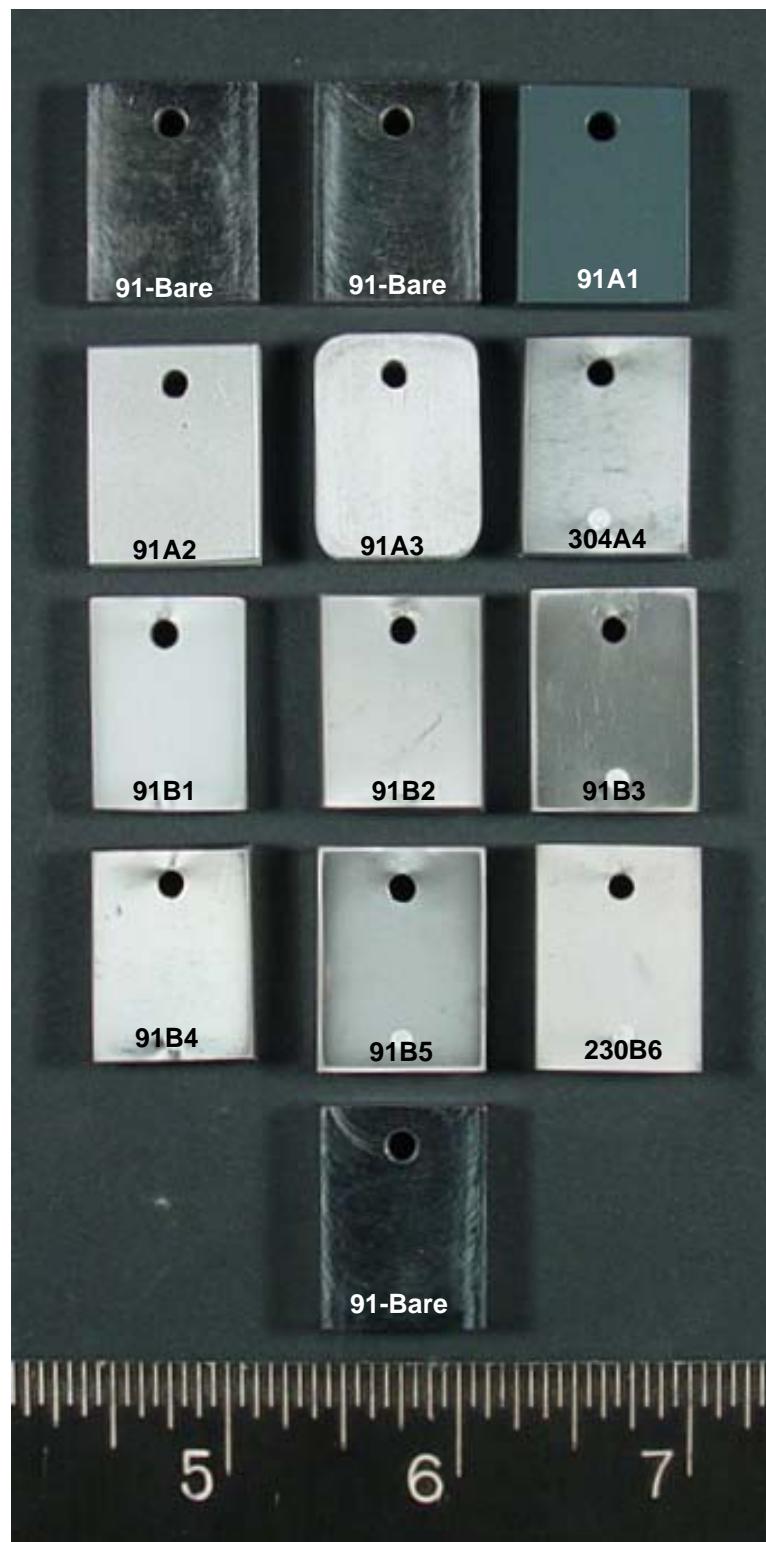
FIGURE A-1

Nanocoating Samples Prior to Testing at 455°C (850°F) for Waterwall Conditions. The Coupons are Labeled with the Substrate Material Followed by the Coating Designation.

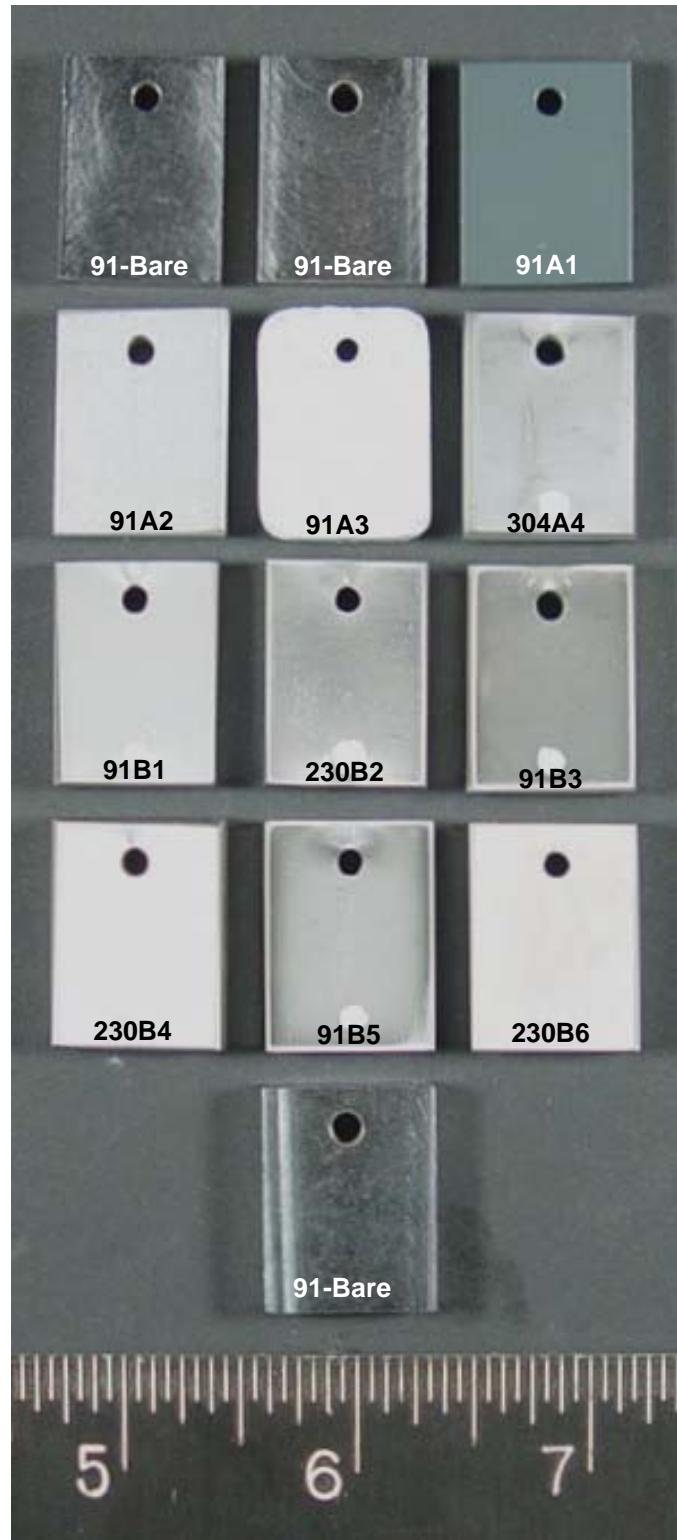
FIGURE A-5
Nanocoating Samples Prior to Testing at 595°C (1100°F) for Waterwall Conditions. The Coupons are Labeled with the Substrate Material Followed by the Coating Designation.

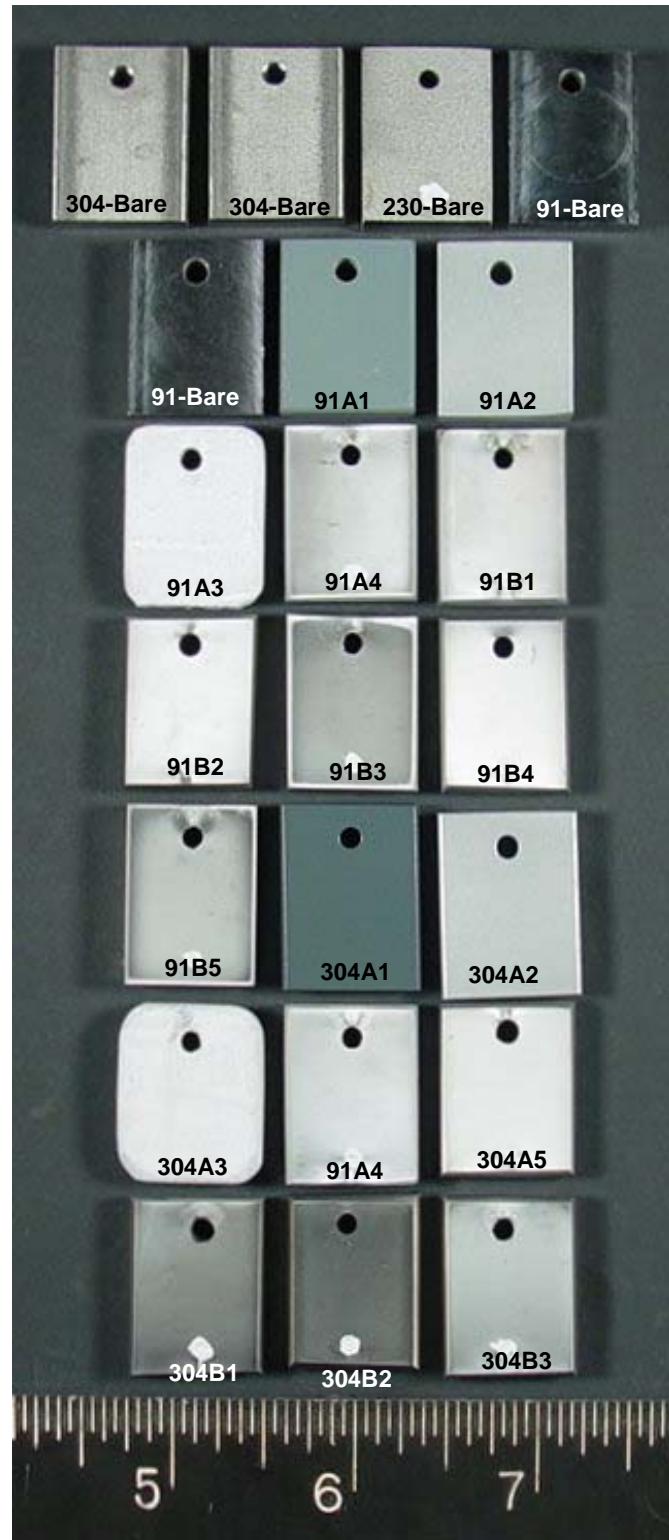
FIGURE A-7

Nanocoating Samples Prior to Testing at 595°C (1100°F) for Superheater/Reheater Conditions (Board 1). The Coupons are Labeled with the Substrate Material Followed by the Coating Designation.
